ARMANDO HOME INSPECTIONS 281-702-6530 myhomeinspector76@yahoo.com

PROPERTY INSPECTION REPORT FORM

Juan Perdomo	10/14/2022 10:00 am
Name of Client	Date of Inspection
19602 Adelaide Meadows Ct, Katy, TX 77449	
Address of Inspected Property	
Armando Mendez	Professional Home Inspector TREC# 24993
Name of Inspector	TREC License #
Name of Sponsor (if applicable)	TREC License #

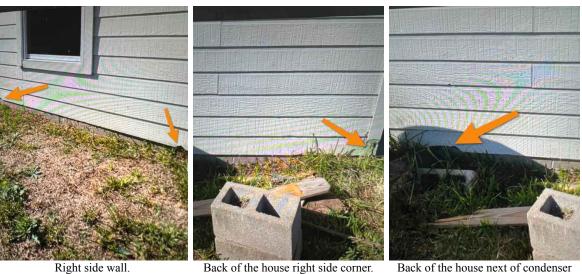
2: Fiber cement siding damaged

There are areas of the fiber cement siding and trim that are damaged and will need repair.

Right side wall.

Back of the house next of condenser unit.

Recommendation: Contact a qualified carpenter.

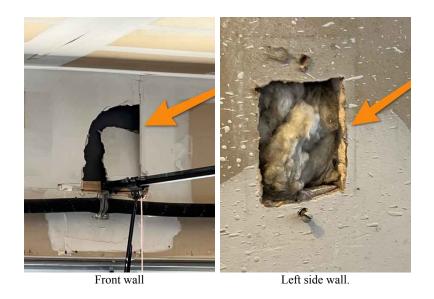
3: Garage walls need to be patched/repaired

There are walls in the garage that are in need of patching/repairing to give a proper fire barrier between the garage and the wall cavity.

Recommendation: Contact a qualified professional.

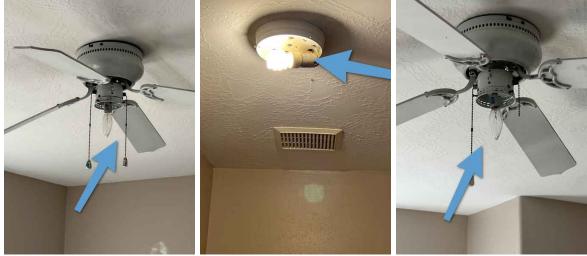
There were bare bulbs present on some light fixtures. I recommend installing covers or globes on any fixtures in the home without globes to prevent accidental breakage, and possible electrocution.

Primary bedroom.

Laundry room

Second level. Middle bedroom.

Recommendation: Contact a qualified professional.
