Town &
Country
Home
Inspection

Report

for the property located at:
31603 Johlke Rd
Magnolia, Texas 77355

Date of Inspection: **March 25, 2019**

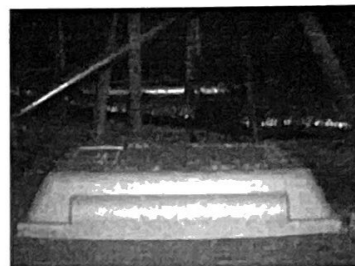
9. Observed no insulating cover or insulation installed on attic access. Recommend installing a insulation cover over attic ladder. This will help with energy efficiency for the home.

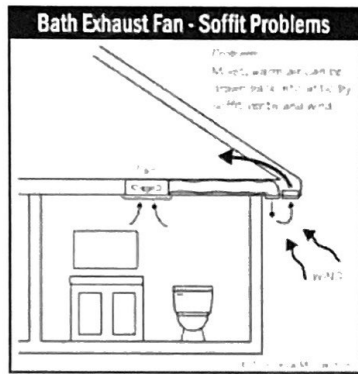
34. Observed exhaust vents routed to soffit. The problem is moist warm air can be drawn back into the attic by soffit vents and wind. Recommend rerouting the ducts to exhaust at a higher vent.
