Gene Inspections

Inspection Report

PROPERTY INSPECTION REPORT FORM

<u>Manuela Guidry</u>	<u>9/27/2022</u>
<i>Name of Client</i>	<i>Date of Inspection</i>
<u>5606 Buckow Drive, Houston, TX 77396</u>	
<i>Address of Inspected Property</i>	
<u>Gene Goodwin</u>	<u>21879</u>
<i>Name of Inspector</i>	<i>TREC License #</i>
<u> </u>	<u> </u>
<i>Name of Sponsor (if applicable)</i>	<i>TREC License #</i>

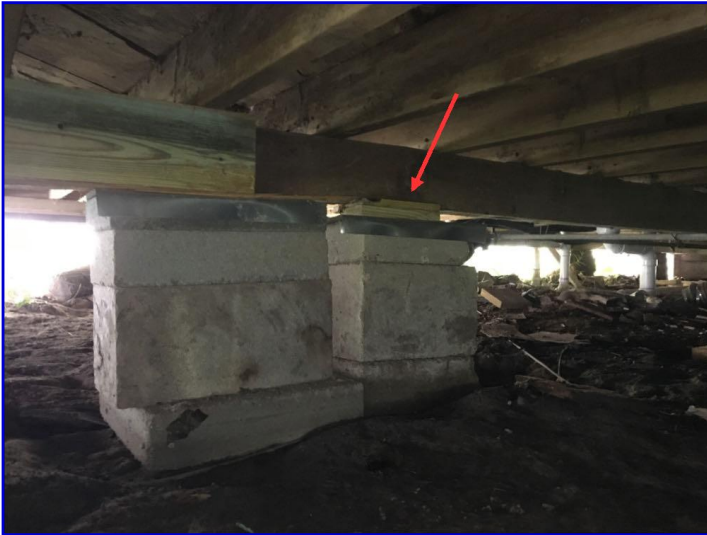
- Wood shims were added to the tops of piers indicating previous settlement of the pier and beam foundation. The grade under the home was currently lower than the level of grade on all sides, causing any water to remain under the home (the crawl space was moist). Adding dirt backfill to the crawl space and/or adding a gutter system will help direct runoff away from the crawlspace, hence reducing future settlement in the pier and beam foundation.

Wood shims were added to the tops of piers indicating previous settlement of the pier and beam foundation

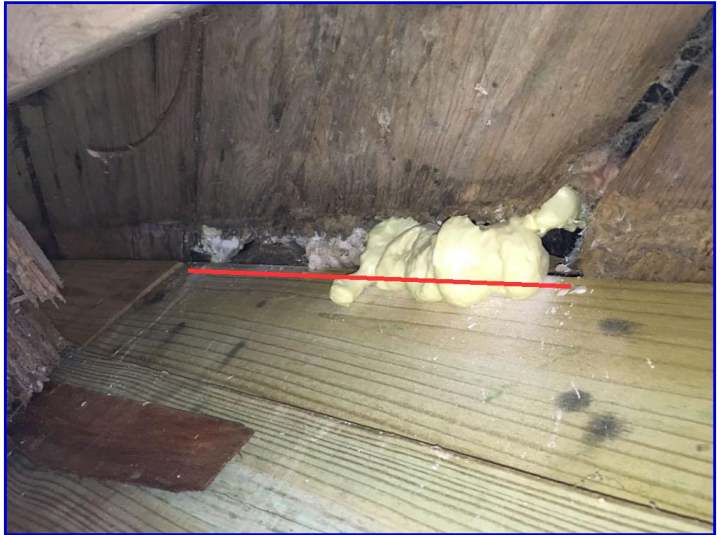
- There was no underfloor insulation provided in the crawl space which is appropriate for optimum comfort, heating and AC efficiency.
- Deteriorated end of a sub-flooring board observed at the rim joist connection at the back left corner of the crawlspace (appeared underneath the left bedroom).

Deteriorated end of a sub-flooring board observed at the rim joist connection at the back left corner of the crawlspace

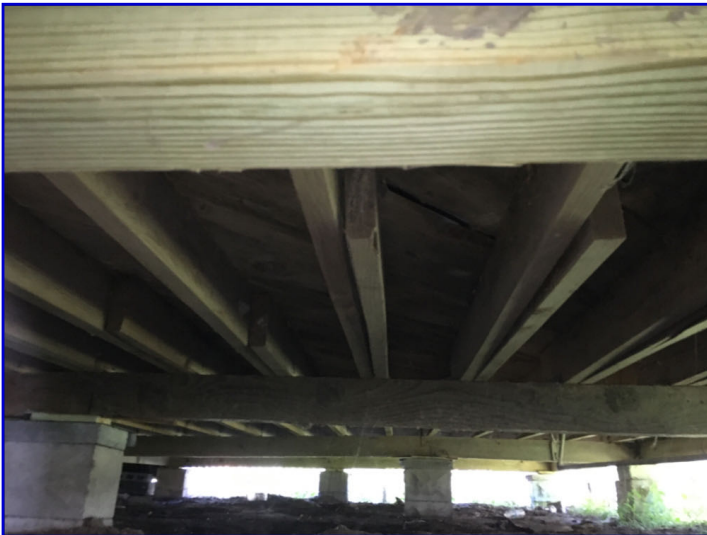
There was no underfloor insulation provided in the crawlspace

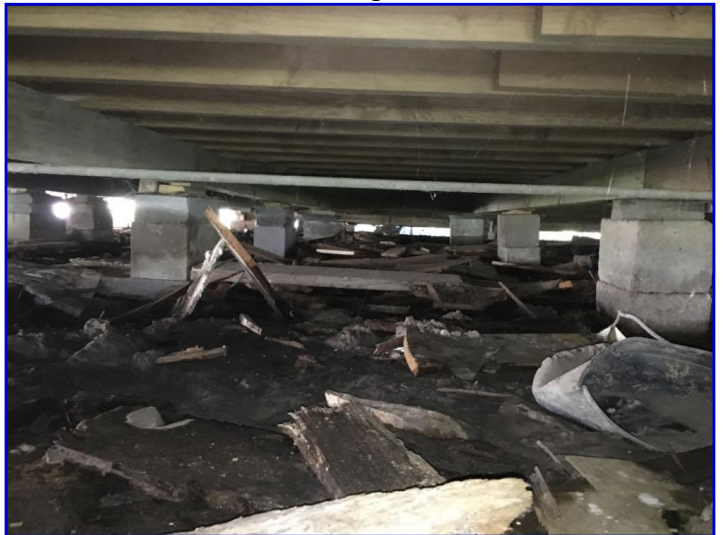
- Only the left side and back side of the crawl space were entered and inspected due to the build-up of debris. The review of joists, structural support, etc. in other parts of the crawl space was limited and performed from the crawl space perimeter. Recommend consulting sellers for additional information prior to close.

Only the left side and back side of the crawlspace were entered and inspected due to the build-up of debris

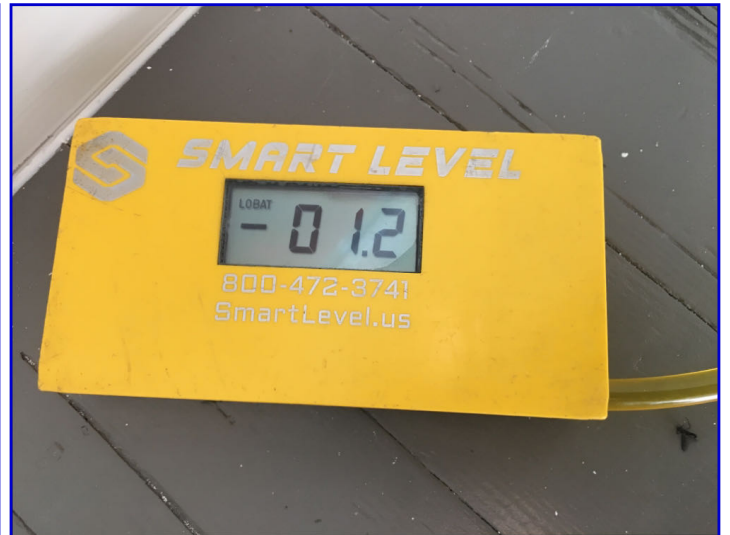
Foundation Elevation: Middle left side of home

- Observed a 2.6-inch difference in foundation elevation between the middle left side and back left corner of the home. We recommend a Professional Structural/Geo-Technical Engineer to evaluate the performance of this foundation before making a final decision to buy or not to buy the house.

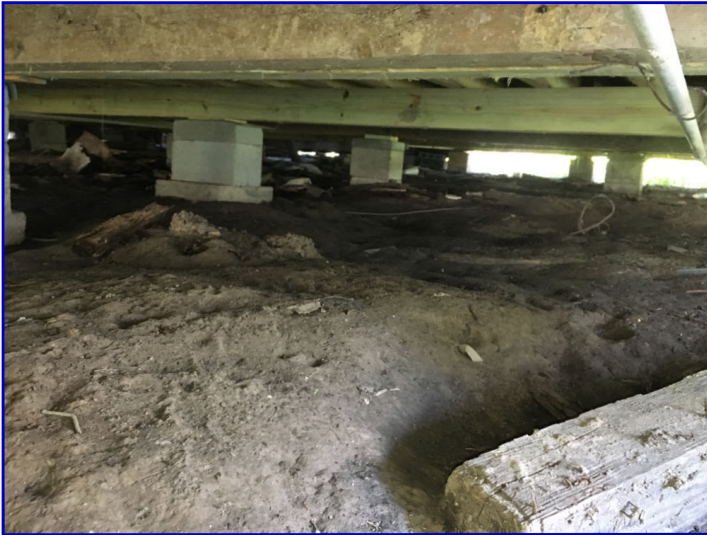
The grade under the home is currently lower than the level of grade on all sides, causing any water to remain under the home

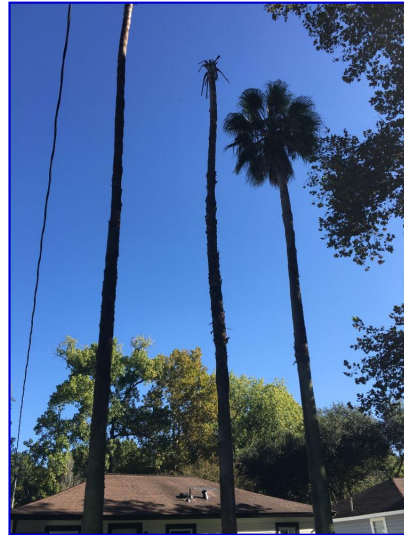
2 dead palm trees were noted on the back side of the home

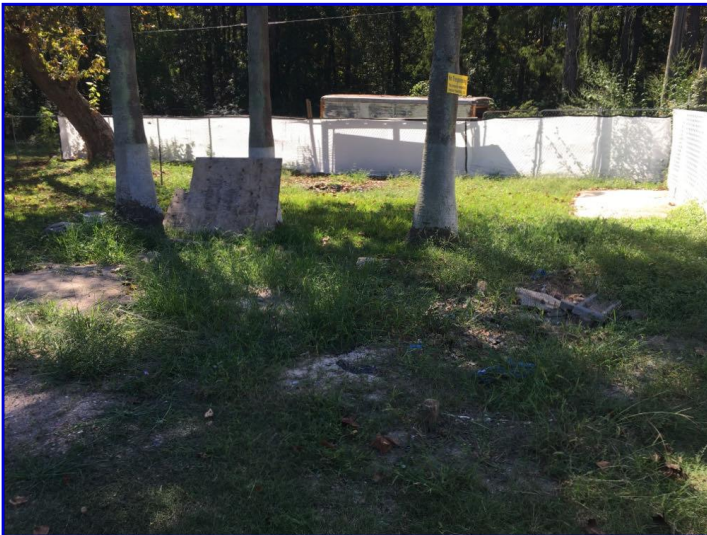
Observed a build-up of debris in the backyard

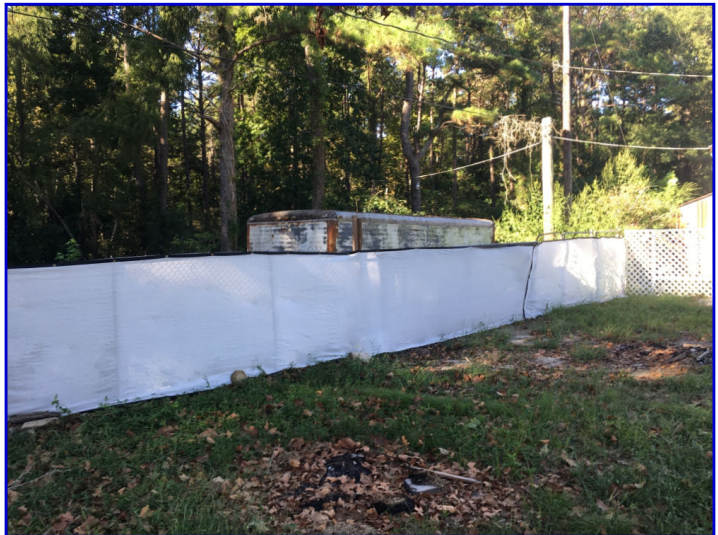
Observed a storage trailer behind the fence

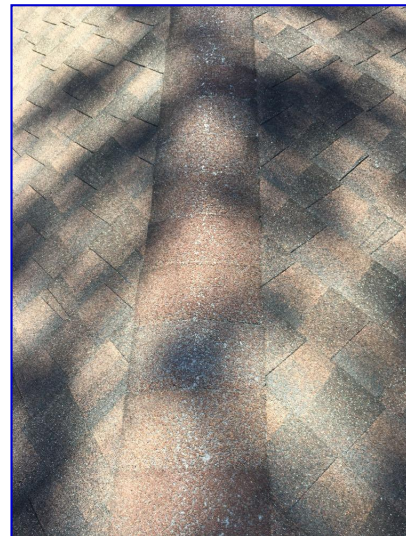
Granular loss and exposed felt observed to the hip shingles on the back side of the roof

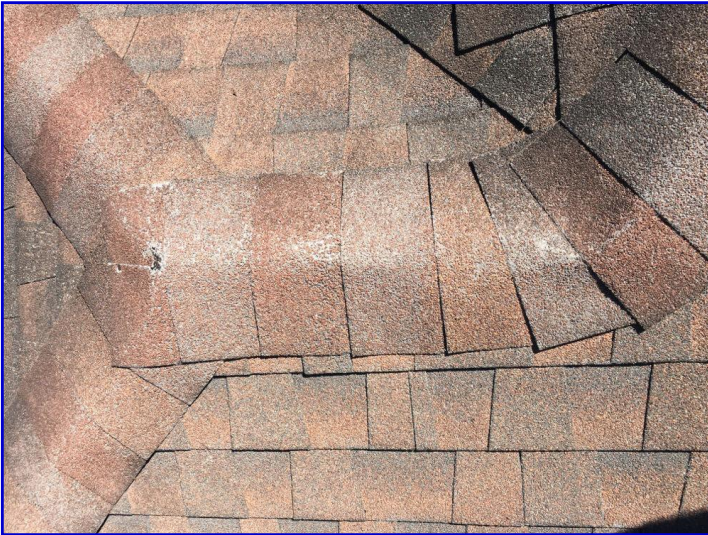
Granular loss and exposed felt observed to a short section of ridge shingles on the front right side of the roof

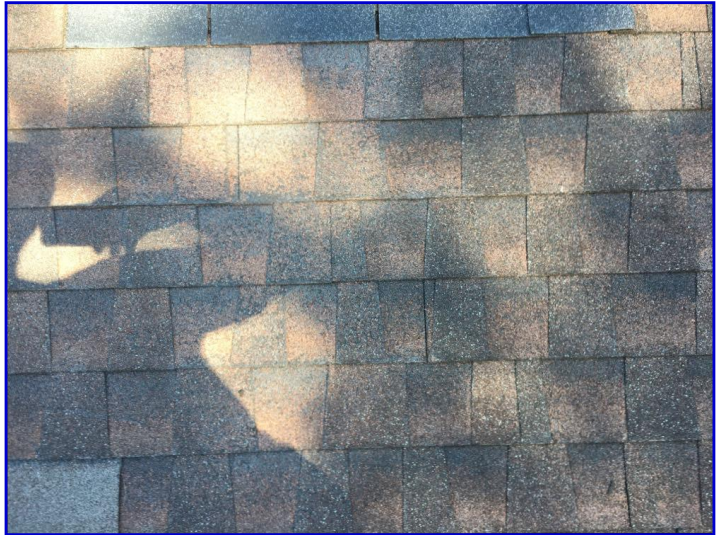
Granular loss observed to field shingles on the back side of the roof

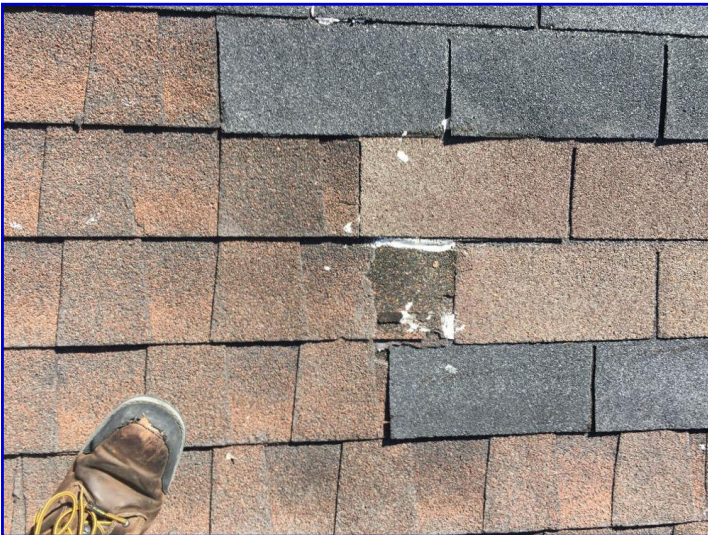
Damage to roof shingle observed on the right side of the roof

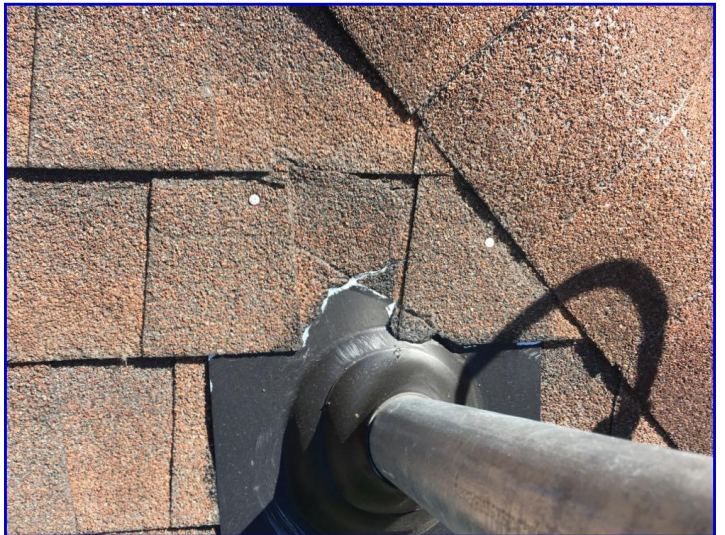
Damage to roof shingle observed on the right side of the roof

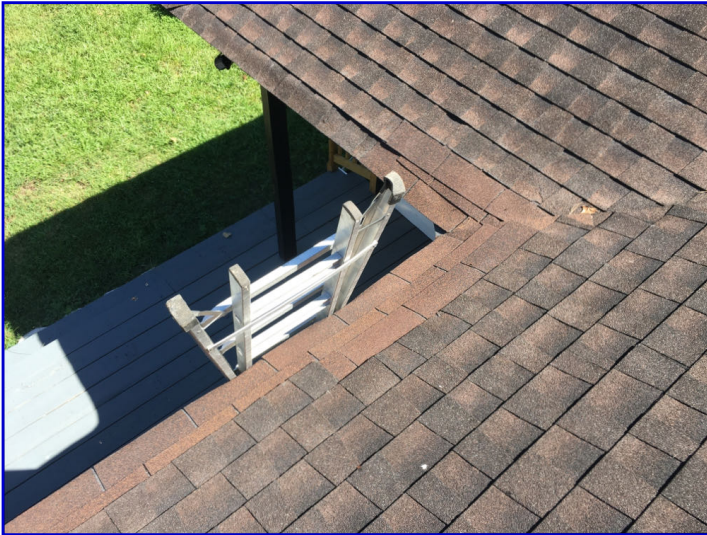
- There were sections of shingles replaced on the front side, right side and back side of the roof which appeared to be a non-professional installation. Recommend consulting sellers for more information.

There were shingles replaced on the front side of the roof

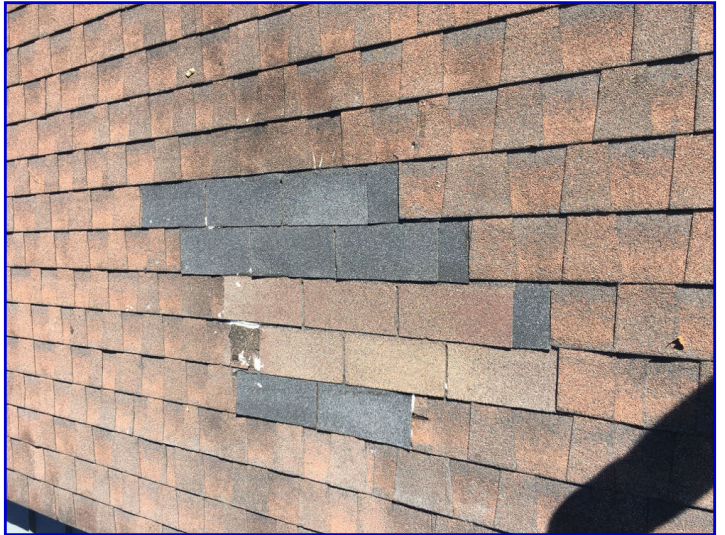
There were shingles replaced on the right side of the roof

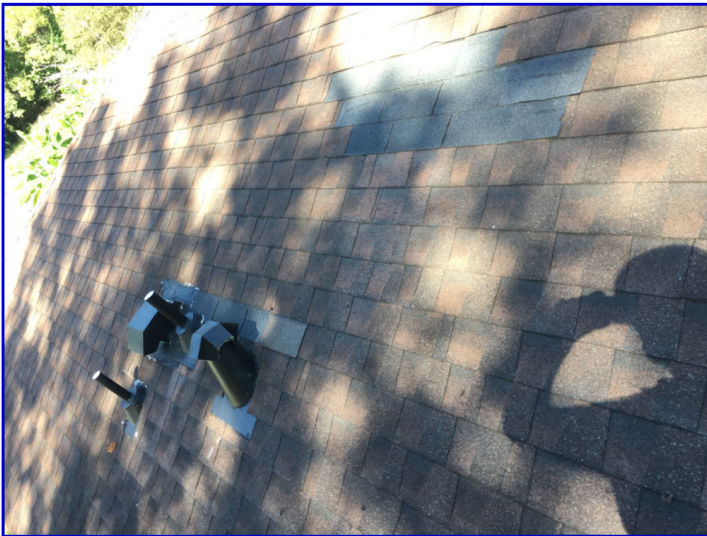
There were shingles replaced on the back side of the roof

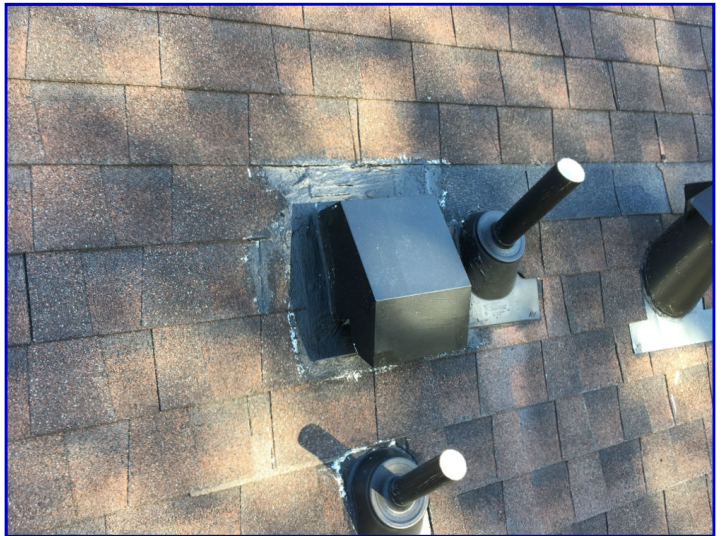
- The range vent flashing on the back side of the roof was covered with mastic, which may indicate previous water intrusion into the structure. Mastic is a temporary fix and is not considered a reliable long-term repair, since ultraviolet radiation will eventually degrade it.

The range vent flashing on the back side of the roof was covered with mastic

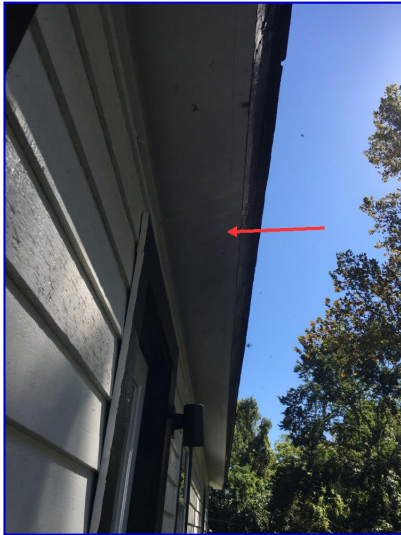
- There were no soffit vents installed for the lower ventilation in the attic. There should be one square foot of ventilation split evenly between upper vents (ridge, static, turbine or gable vents, but not a combination of these) and lower soffit vents for every 300-square feet of attic space, depending on insulation depth and roof sheathing type. Balanced attic ventilation maintains proper humidity and temperature control in the attic and prevents premature aging of the roof.

There were no soffit vents installed for the lower ventilation in the attic

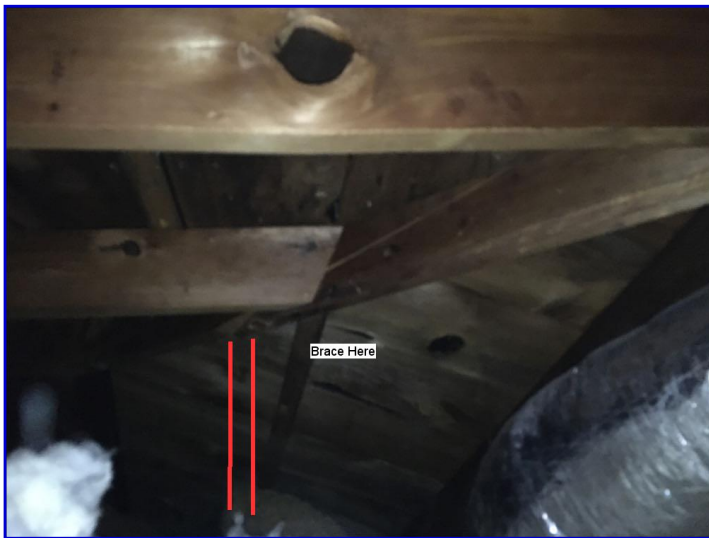
There was no support brace installed at the hip rafter joint at the back left corner of the attic

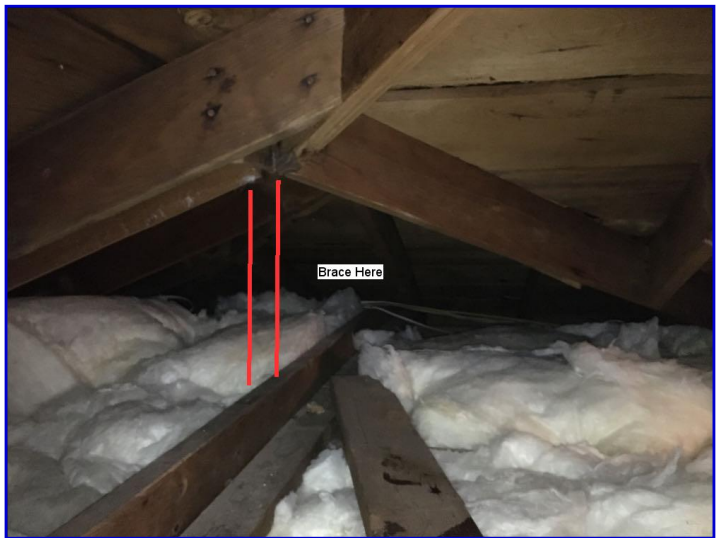
There was no support brace installed at the junction of the hip rafter and ridge rafter at the front right corner of the attic

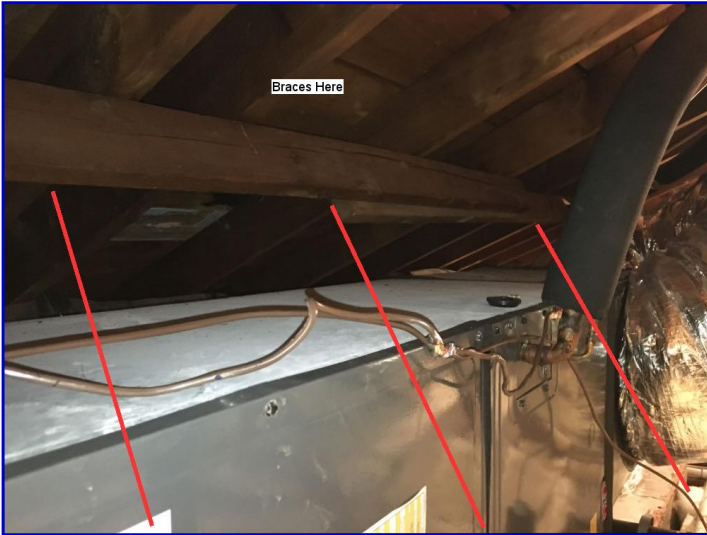
There was a missing section of purlin bracing at the back left side of the attic (which had been removed for the HVAC installation)

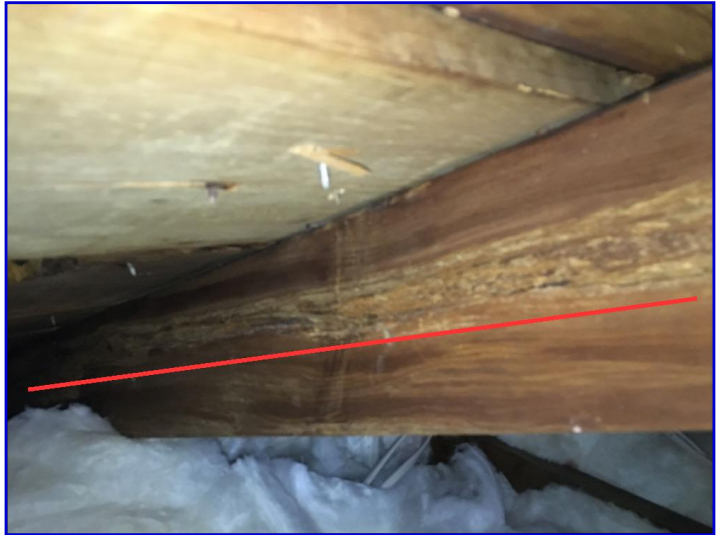
There was wood destroying insect damage to a rafter on the right side of the attic

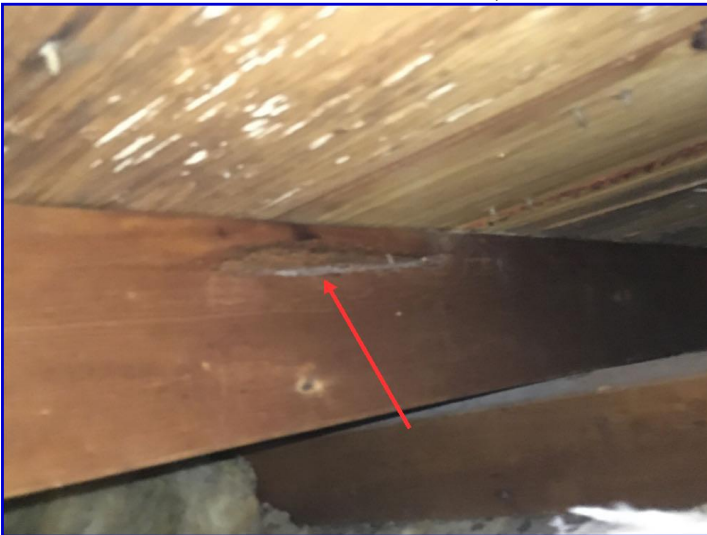
There was wood destroying insect damage to a rafter on the front left side of the attic

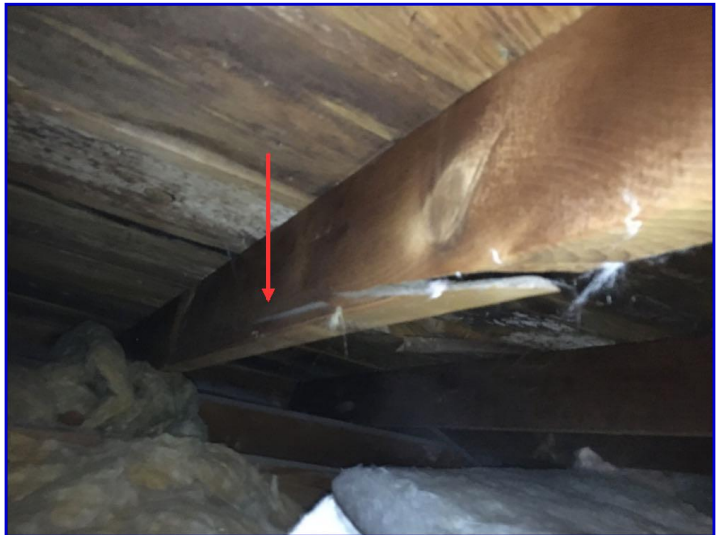
There was a cracked rafter on the front left side of the attic

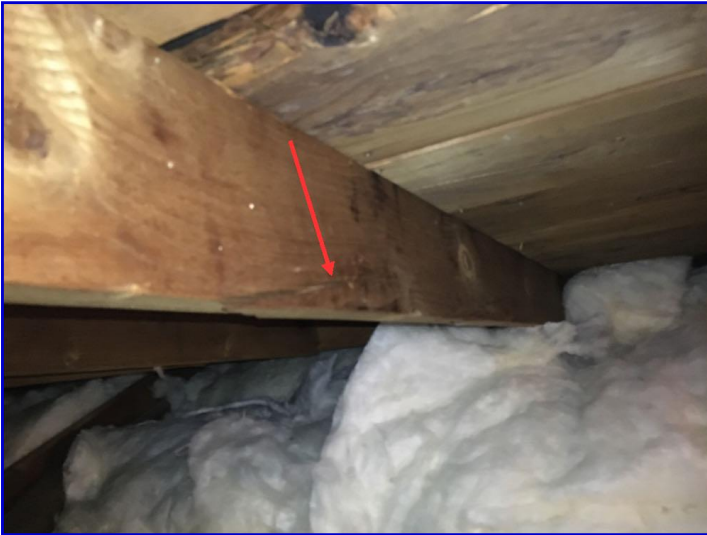
There was a cracked rafter on the front right corner of the attic

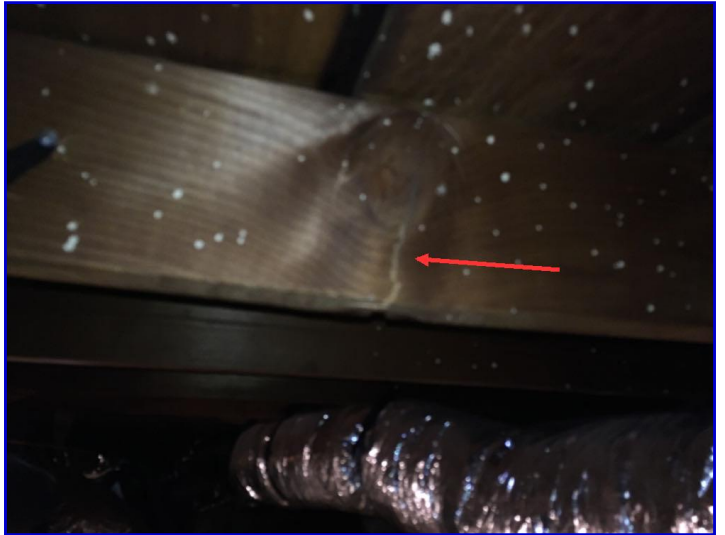
There was a cracked rafter on the back right corner of the attic

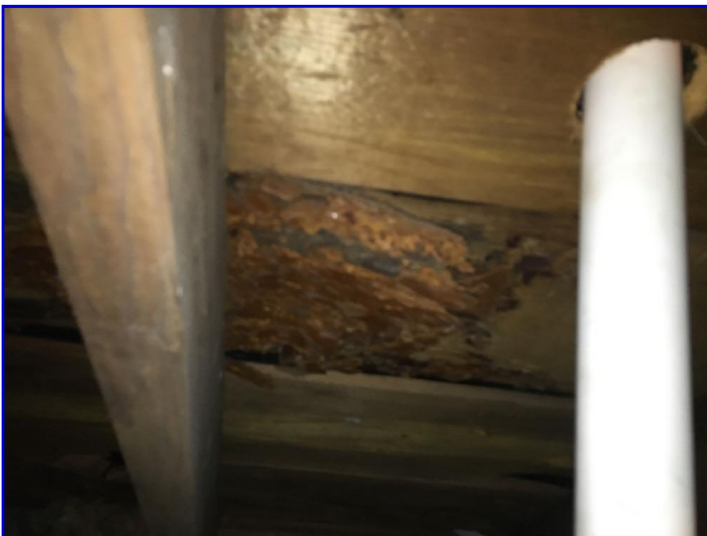
Moisture deteriorated roof sheathing board on the back side of the attic behind the range vent

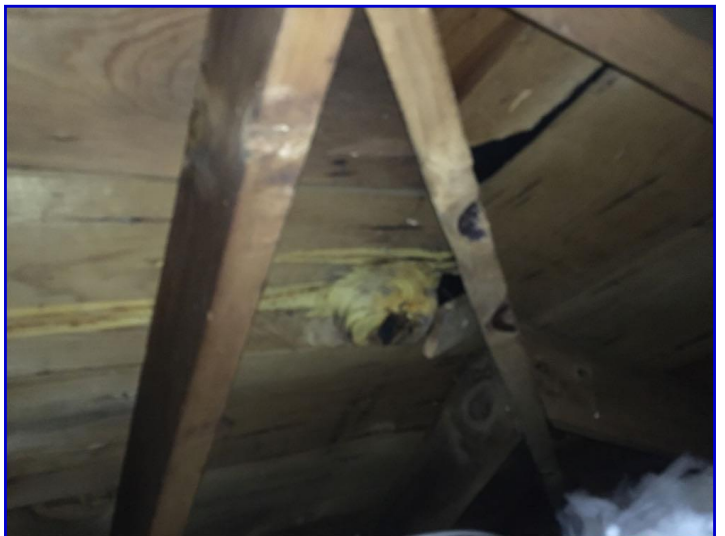
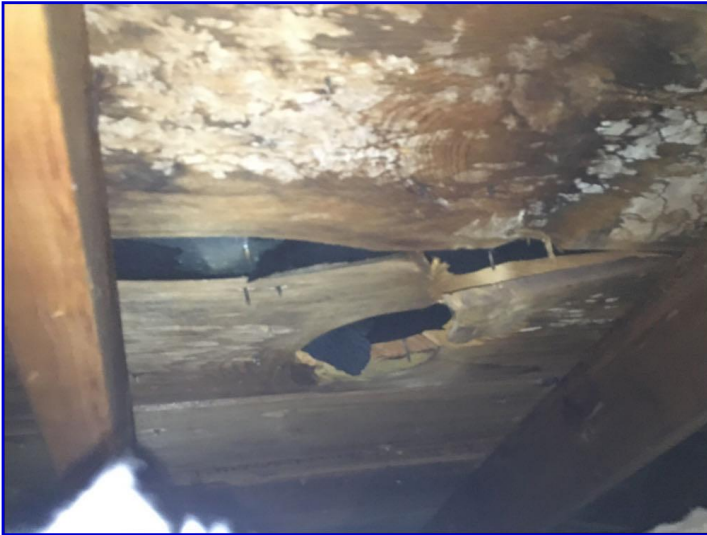
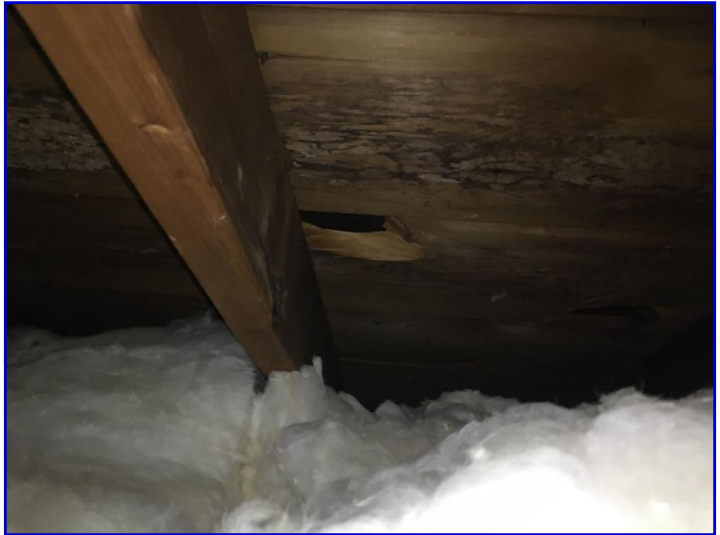
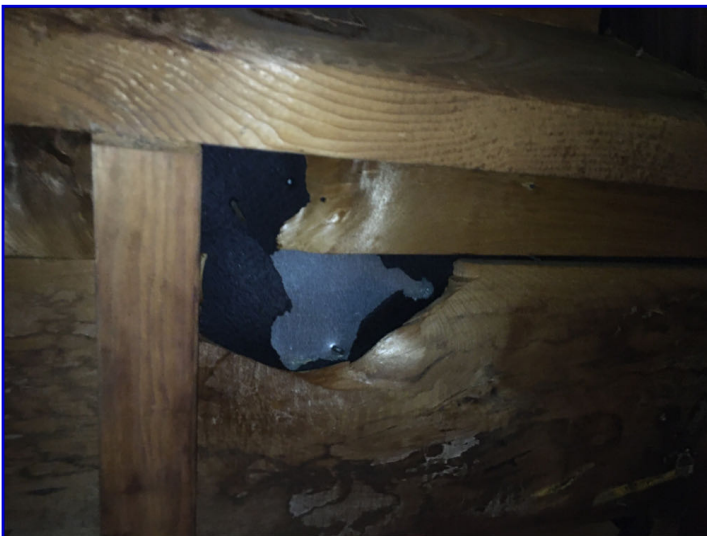
1. There were damaged sections of roof sheathing boards at various sections around the attic which can create soft spots on the roof susceptible to foot damage of the underlying roof felt (potential cause of a leak)
2. Moisture deteriorated roof sheathing board on the back side of the attic behind the range vent

There were damaged sections of roof sheathing boards at various sections around the attic

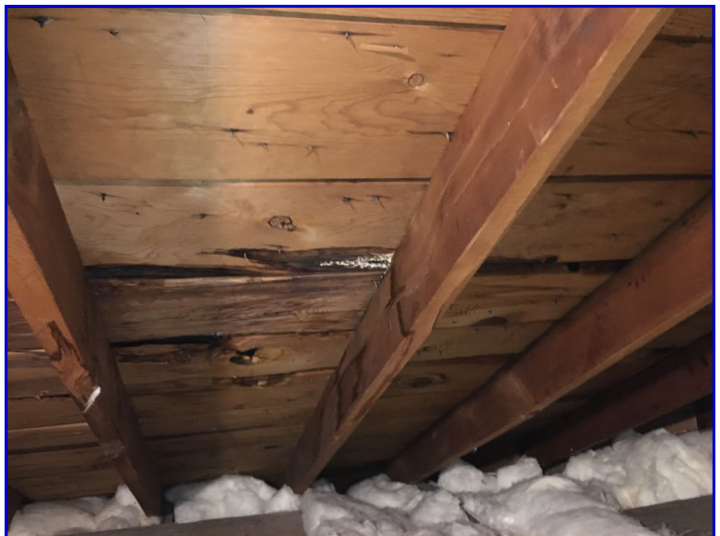
- Dry roof sheathing stain observed on the front side of the attic. The stain was probed with an ExTech Moisture Meter, which showed no moisture present at time of inspection. Recommend consulting with the homeowner to see if repairs were made and monitoring the area during the next heavy rain for possible issues.

Dry roof sheathing stain observed on the front side of the attic

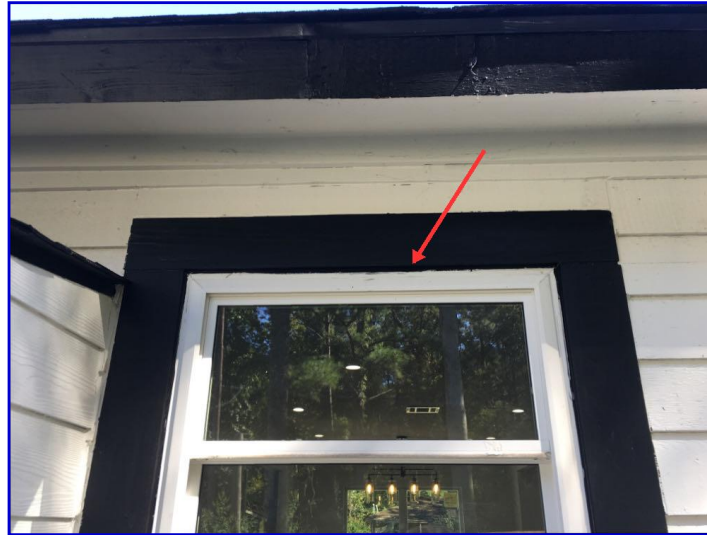
Windows were installed without head flashing which helps prevent moisture intrusion

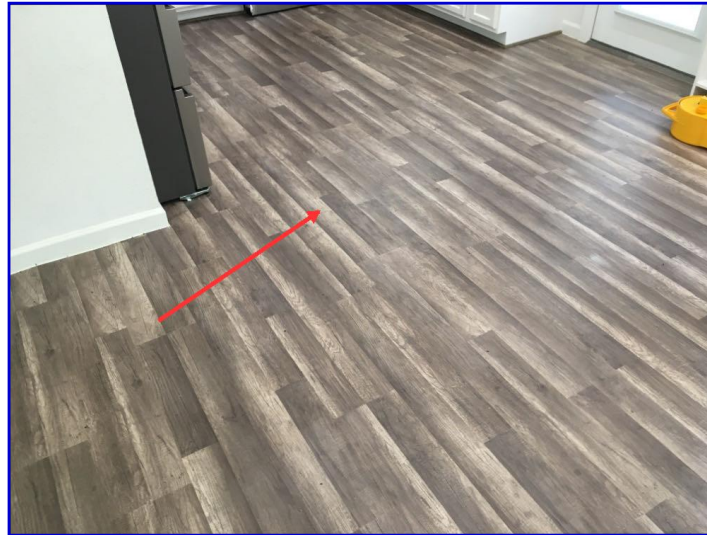
- Observed a hump in the floor on the front side of the kitchen, cause unknown (this area wasn't visible from the attic perimeter).

Observed a hump in the floor on the front side of the kitchen

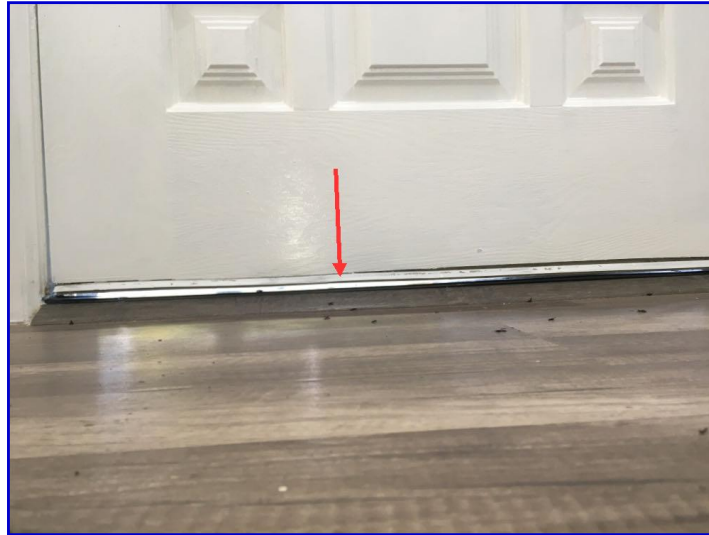
- Gap observed between the bottom of the front entryway door and threshold. The threshold height should be adjusted to prevent the entrance of the elements (collection of lovebugs in the home).

Gap observed between the bottom of the front entryway door and threshold

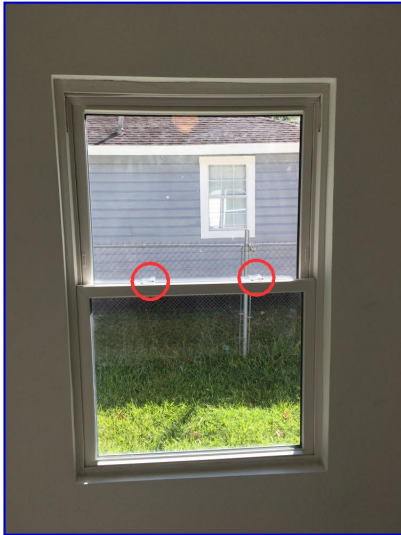
The middle bedroom window didn't close completely and lock

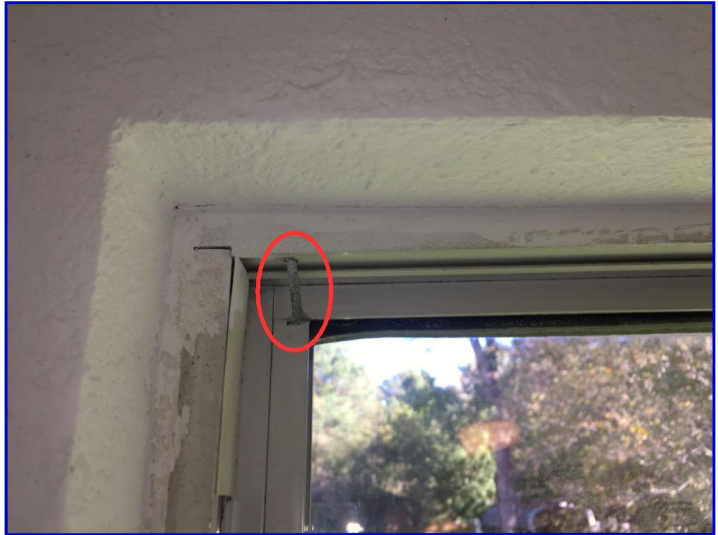
Observed incompletely installed window attachment screws in the front bedroom and middle bedroom

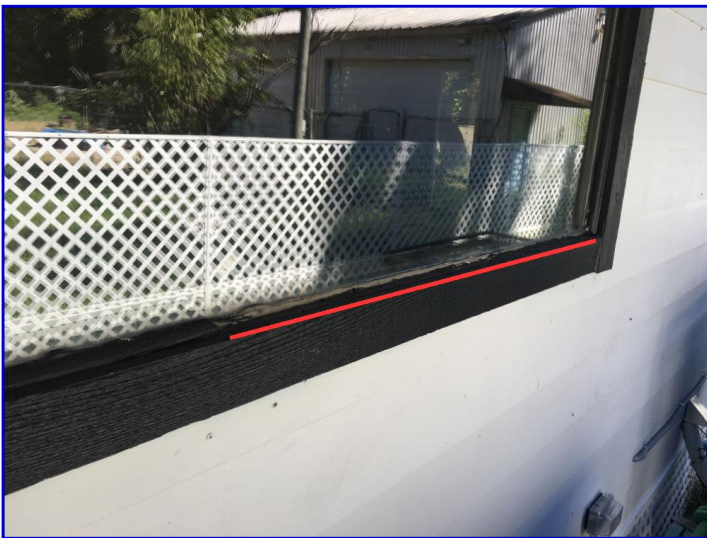
Damaged/missing wood glazing bead observed on the window on the right side of the home

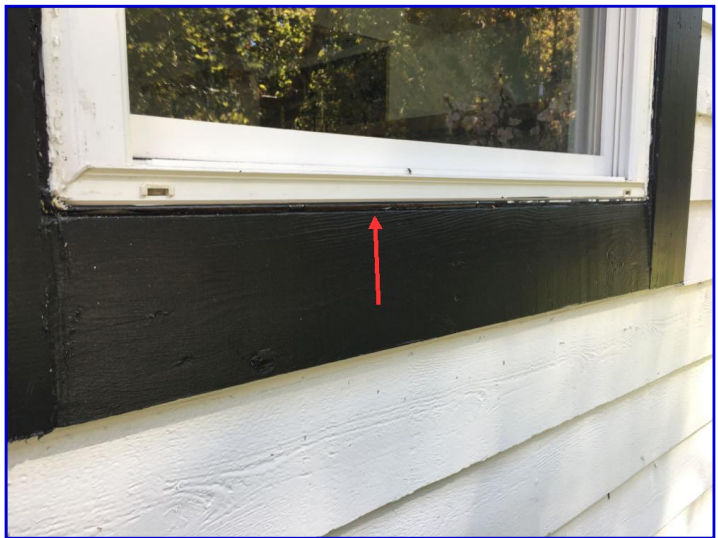
Observed gaps around window frames which should be sealed to prevent moisture entry

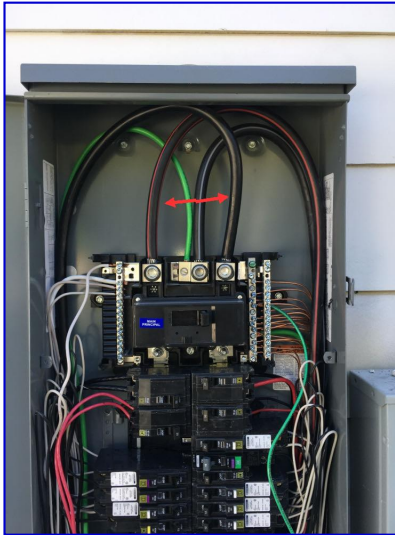
The service wires weren't labeled in order to verify proper size to match the main breaker

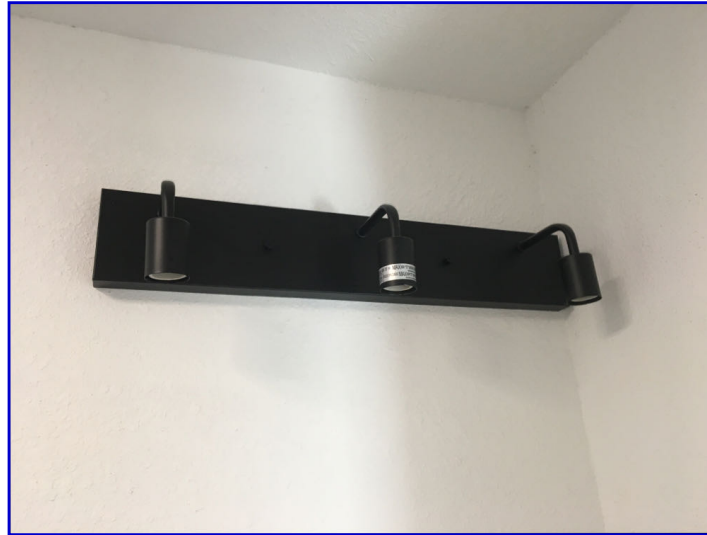
There were no bulbs installed in the light fixture above the bathroom sink

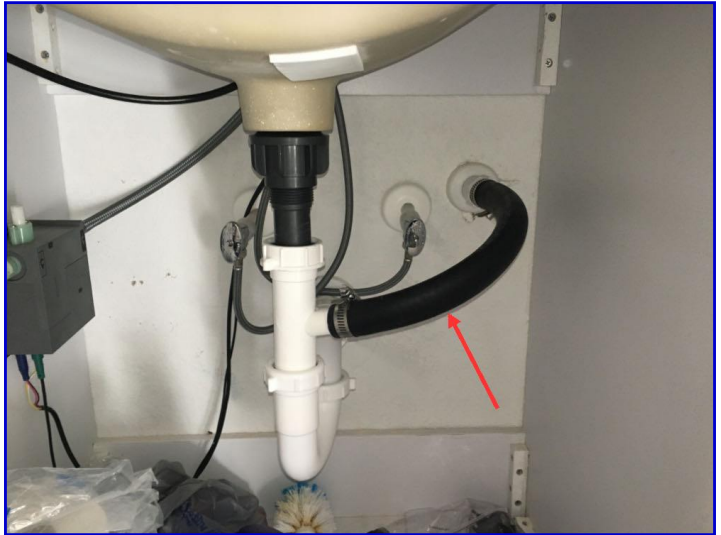
The attic AC unit primary condensate drain line was connected to the bathroom lavatory drain line

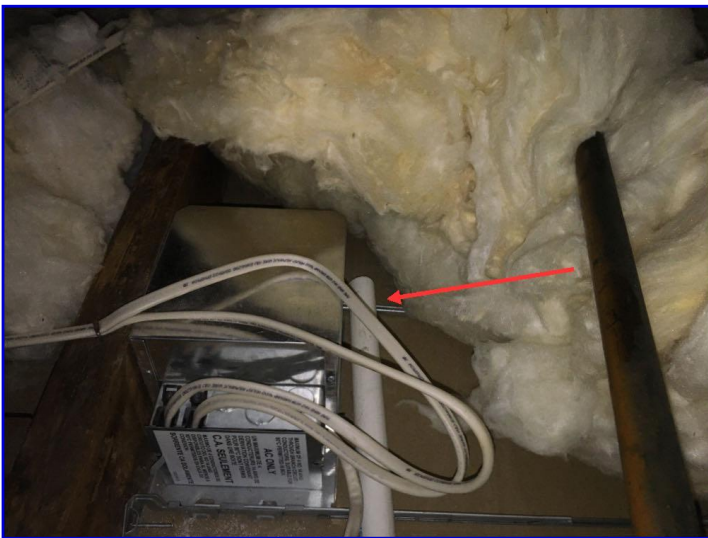
The AC unit secondary condensate drain line incorrectly terminated in the attic

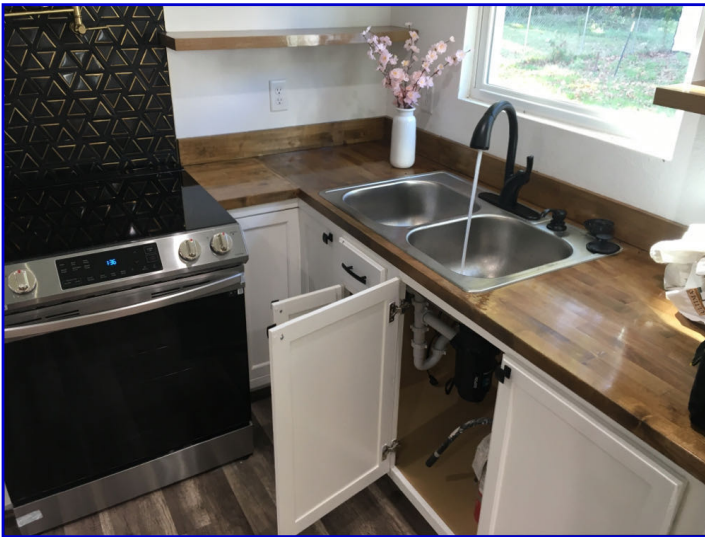
- Observed a non-professional installation of the kitchen sink. It was installed too close to the range (with limited space for access) and a section of the kitchen cabinet partition was removed to accommodate the drain line (which had a 90-degree fitting attached).

The sink was installed too close to the range (with limited space for access)

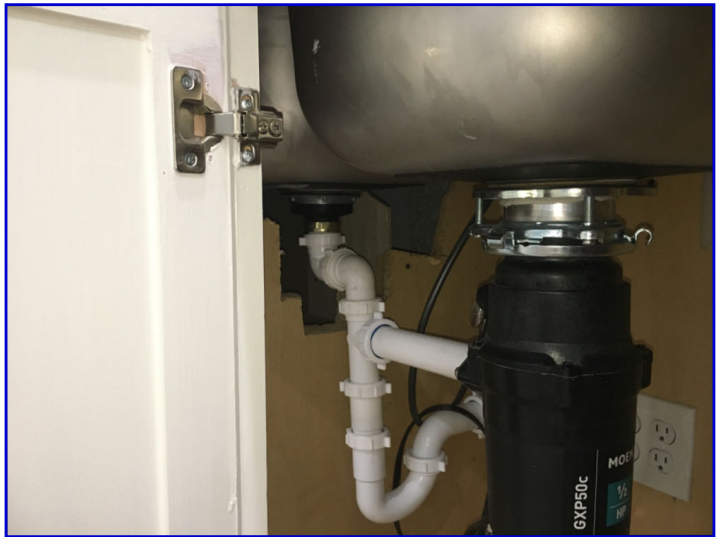
A section of the kitchen cabinet partition was removed to accommodate the kitchen sink drain line (which had a 90-degree fitting attached)

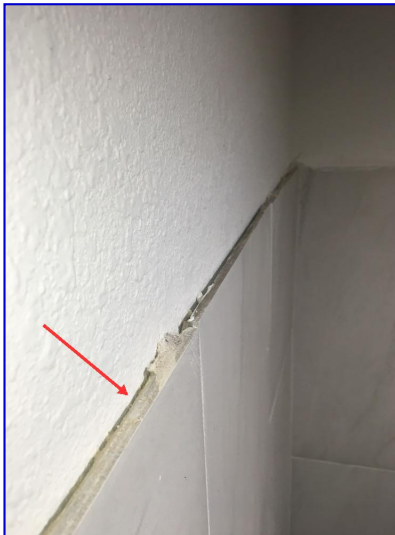
- The top of the bathroom shower surround should be sealed to prevent moisture penetration.

The top of the bathroom shower surround should be sealed to prevent moisture penetration
