Summary Only

20802 Hallow Cane Dr Hockley TX 77447

Home Plate Inspections, LLC Steven Walters TREC#22910 14918 Gyrfalcon Fork Cypress, TX 77429 281-541-2013

General Summary

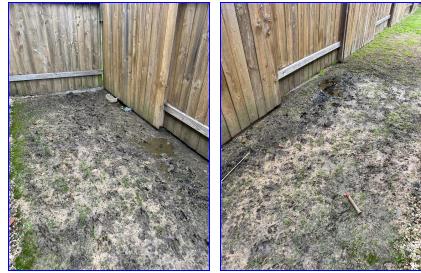
B. Item 1(Picture)

The left side of the house is extremely muddy and washed out. It appears this areas is a high traffic area for animals. Due to the way drainage is in the neighborhood, this area needs grass to be installed to prevent a consistent muddy area. Item 1(Picture) Item 2(Picture)

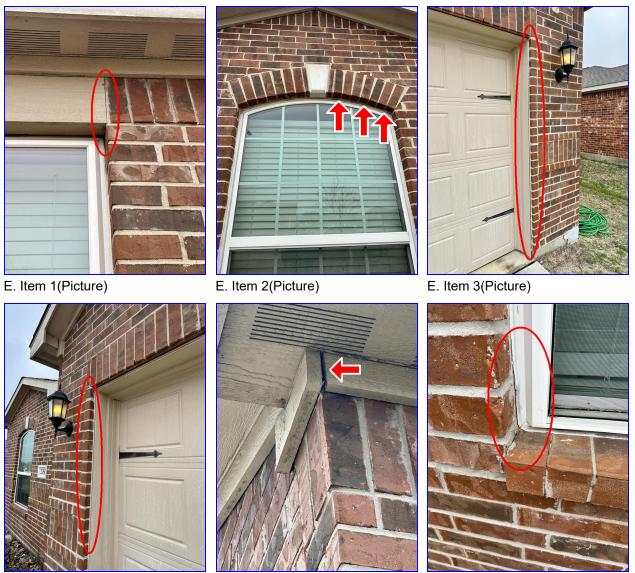
E. Item 4(Picture)

On the exterior of the home there are several areas that need to caulked/sealed to prevent possible water penetration. Caulking a home is routine maintenance that should be done when the original caulking is shrinking/cracking. Recommend a qualified contractor to caulk and seal needed areas. Item 1(Picture) Item 2 (Picture) Item 3(Picture) Item 4(Picture) Item 5(Picture) Item 6(Picture) Item 7(Picture) Item 8(Picture) Item 9 (Picture) Item 10(Picture)

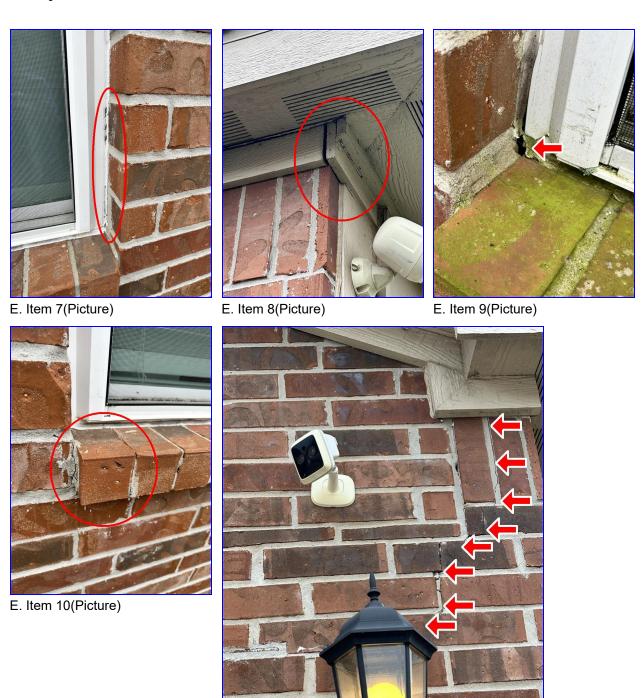
E. Item 11(Picture)

On the front of the house there was some settlement cracking in the brick that was observed. Recommend to monitor over time and repair as needed. Item 11(Picture)

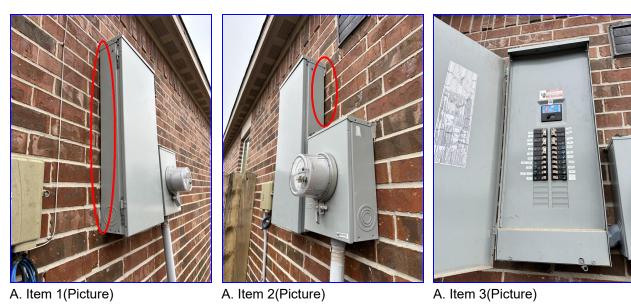
A. Item 4(Picture)

The electrical panel needs to be sealed to the brick to prevent any possible water penetration behind the panel. Recommend qualified contractor to seal panel box. Item 1(Picture) Item 2(Picture) Item 3(Picture) Item 4(Picture)
