PROPERTY INSPECTION REPORT

Concerning: 21114 Barker Canyon Lane, Katy, TX 77450

Report Identification: 21114 Barker Canyon Lane, Katy , TX 77450 - July 5, 2021

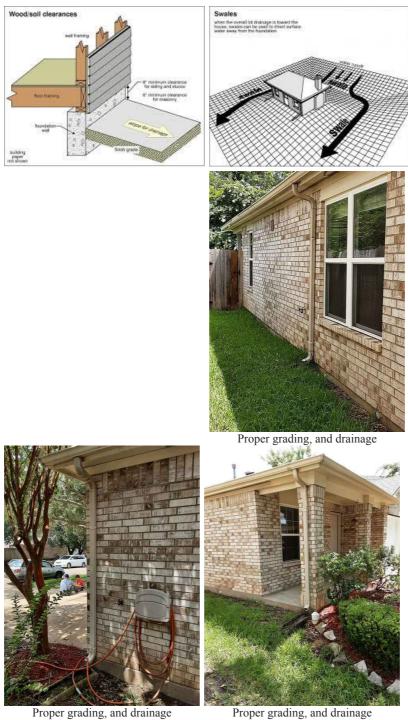
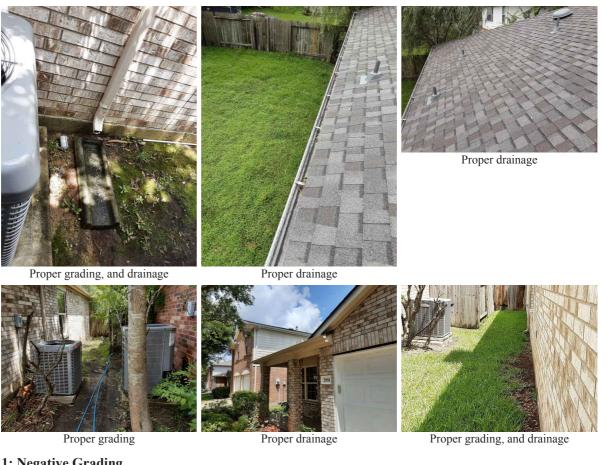
1: Negative Grading Recommendation

Grading is sloping towards the home in some areas. This could lead to water intrusion and foundation issues. Recommend qualified landscaper or foundation contractor regrade so water flows away from home.

Negative Grading in the back of the house

Recommendation: Contact a qualified landscaping contractor

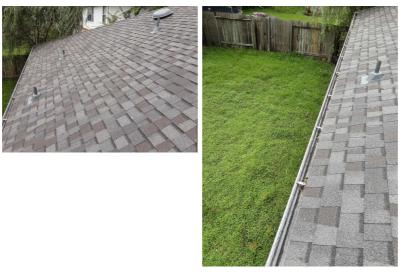
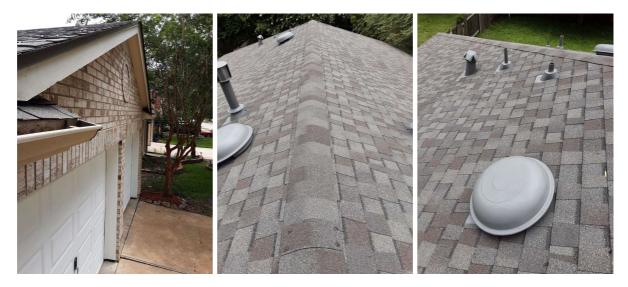
The roofing materials, the flashing, the penetrations through the roof, are functioning as intended at the time of the inspection. I recommend the tree branches be trimmed.

1: Tree branches, and leaves on the roof Recommendation

Many trees drop their leaves every fall, and many drop their needles year-round. If this debris stays on the roof, it can clog the gutters and affect the roof by absorbing moisture. This excess moisture on the roof can cause mold, moss, or algae growth, which can discolor the roof and reduce its life.

Recommendation: Contact a qualified professional.

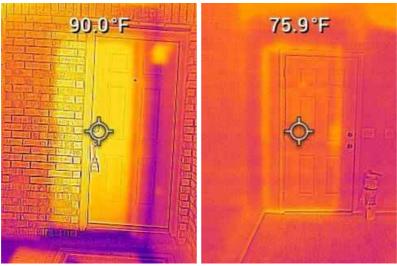
Some conditioned air escaping from the front door front door

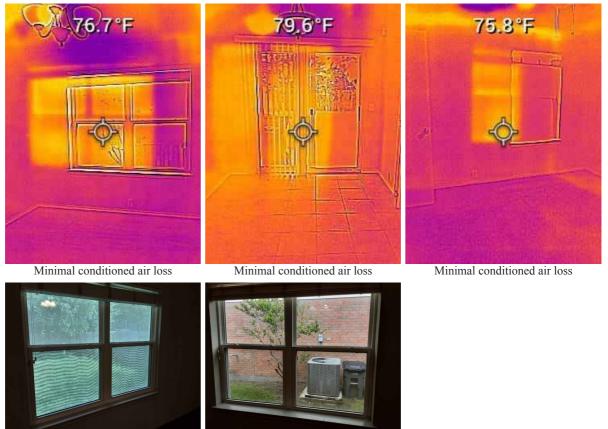
high-efficiency double pain 1: Minor crack at the window sill.

A minor crack was observed on the window corner frame on the outside. I recommend a handyman to seal it, so that moisture does not enter the structure

Recommendation: Contact a qualified professional.

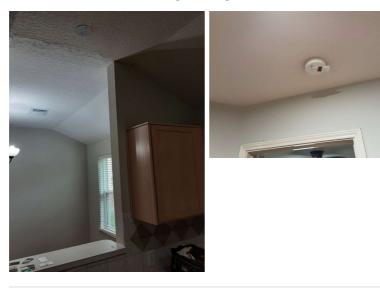
3: Smoke detector missing Recommendation

Inoperable smoke detectors

Recommendation: Contact a qualified professional.

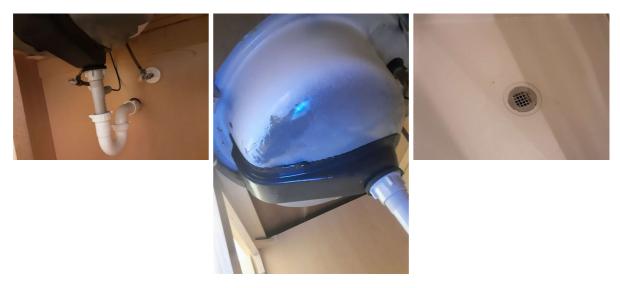
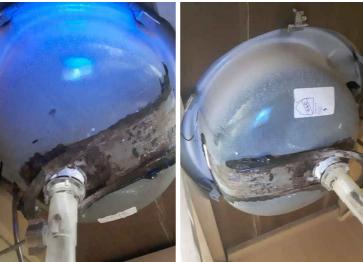
1: Sink overflow missing

One of the master bathroom sink overflows is missing. I recommend a certified plumber to evaluate and repair

Sink overflow missing

Recommendation: Contact a qualified professional.

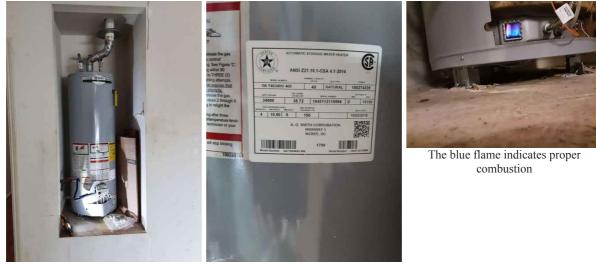
1: Improper Installation Constant

The water heater is improperly installed. Recommend a qualified plumber evaluate & repair.

Each standard vent gas water heater is supplied with a specific draft hood. This ensures the safe, correct operation of the water heater. However, **the draft hood must be installed correctly**. Do not use a draft hood other than the one that is supplied with the water heater. Gas water heater draft hoods act as a device, which in case of down-draft, a condition that forces air/wind back into the vent pipe/chimney, prevents air from extinguishing the gas burner.

Improper draft hood Installation

Recommendation: Contact a qualified plumbing contractor.

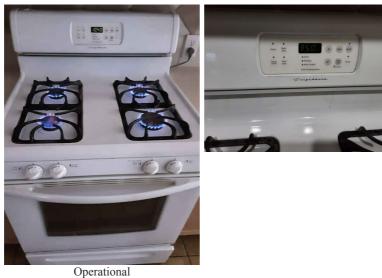
1: Range Not Fastened ©Recommendation

Range was not fastened to the floor. This poses a safety hazard to children. Recommend a qualified contractor secure range so it can't tip.

Recommendation: Contact a qualified handyman.
