PROPERTY INSPECTION REPORT

Concerning: 1529 Rosewood Street, Houston, TX 77004
(Address of Inspected Property)

By: Mark Denton, TREC #10503 06/29/2020
(Name and License Number of Inspector) (Date)

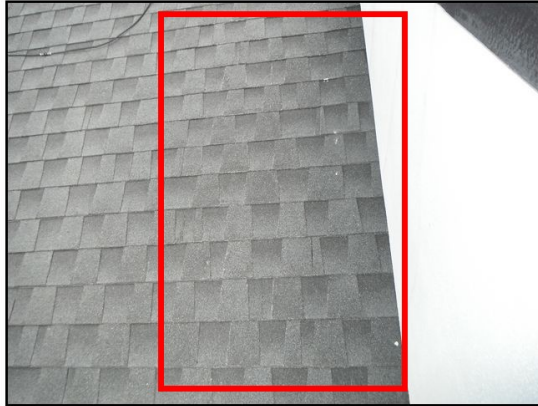
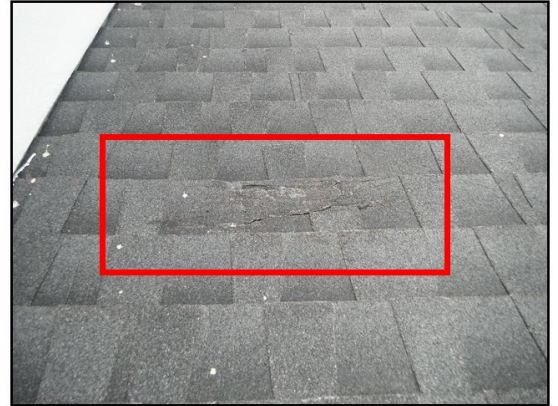
Observed scuffed/damaged/missing shingles. Probably due to foot traffic and/or impact. Scuffing the mineral surface off of a composition shingle exposes the asphalt to ultraviolet light which causes it to deteriorate and can greatly reduce the life of the shingle. Replace scuffed shingles.

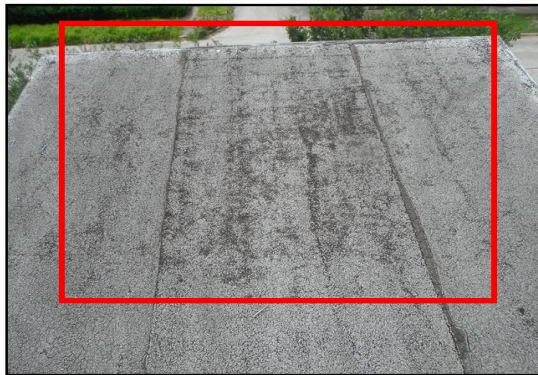
Minor "alligatoring" of roll roofing surface.

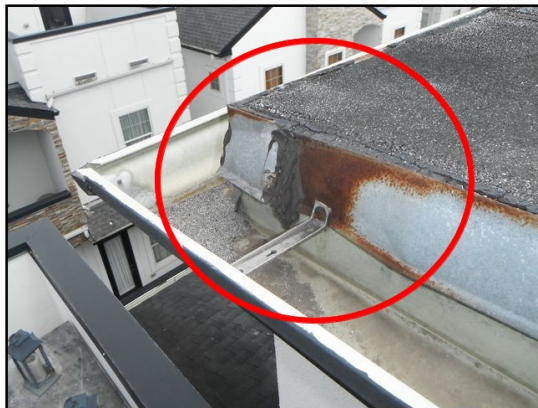
Observed rusted flashing; roll roofing at gutters.

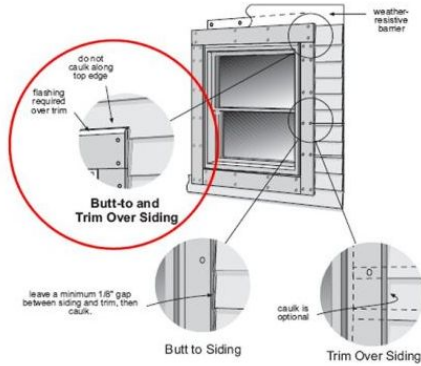
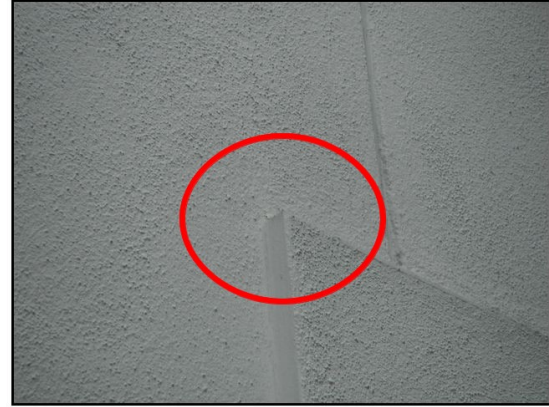
Head flashing missing over window/door trim pieces. Without head flashing over window trim, sealing must be maintained as a defense against water penetration.

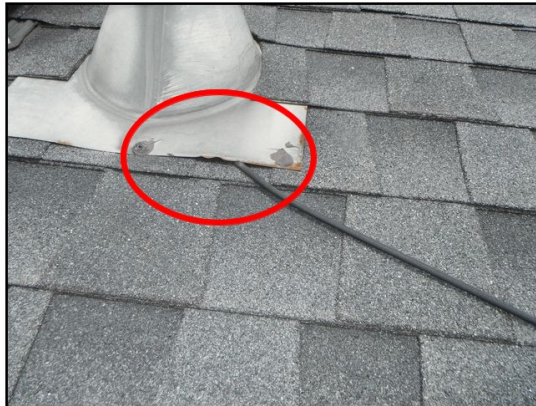
Lower side of roof jack is not sealed down properly and/or exposed nails, causing water penetration from wind driven rains.

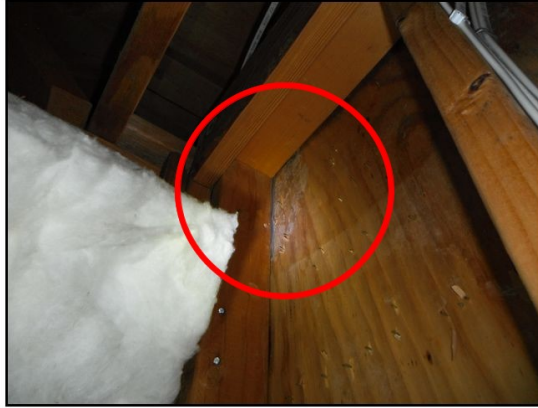
EVIDENCE OF ROOF WATER PENETRATION:
Possible from damaged areas of flashing on gutters.

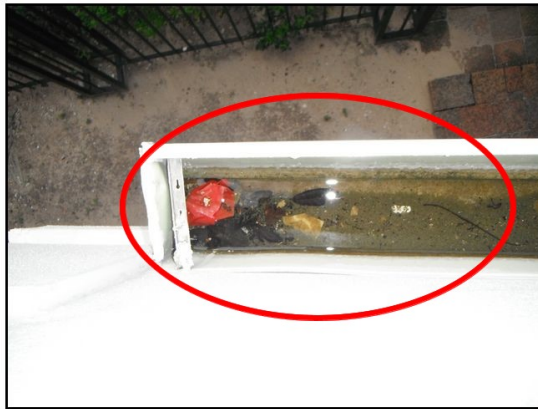
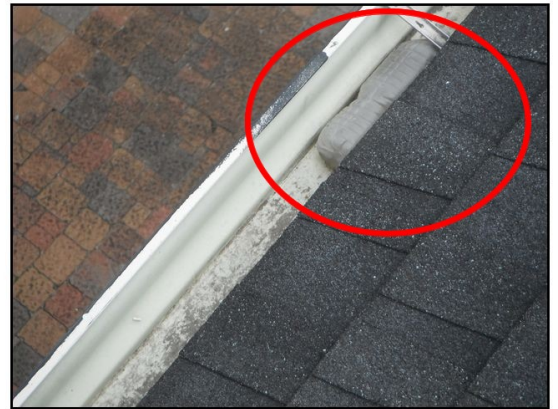
RAIN GUTTERS AND DOWNSPOUTS:
Need general maintenance, clean out debris, resecure to fascia board, tilt toward drains, seal leaks, etc.

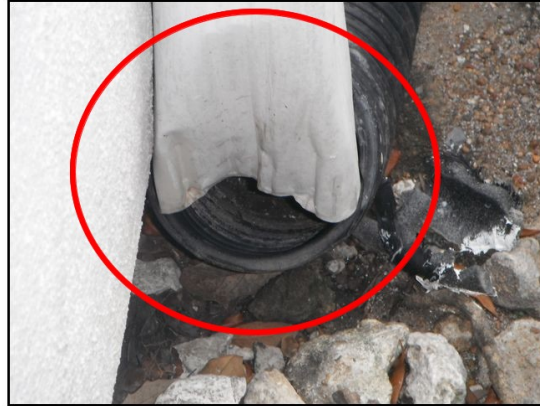
End of downspout(s) needs to be better connected to drain system at one or more locations.

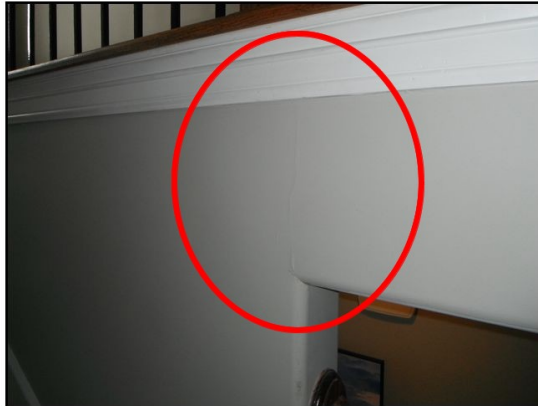
Cosmetic cracks and/or repaired cracks in sheetrock observed over some/many doors, windows, and/or corners.

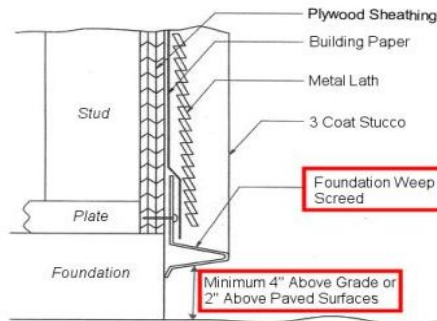
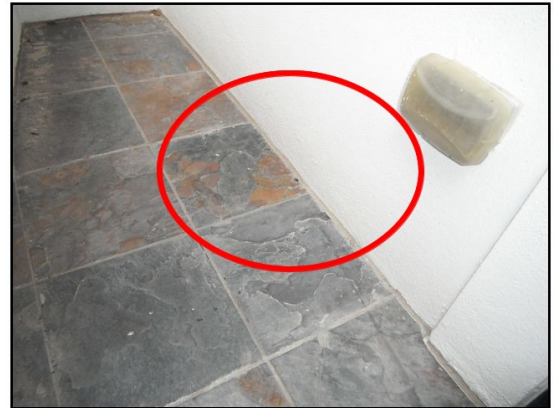
FOUNDATION WEEP SCREED INSTALLATION DETAIL

Inadequate space and/or missing weep screed at base of stucco. "Corrosion-resistant weep screed or plastic weep screed, with a minimum vertical attachment flange of 3-1/2" shall be provided at or below the foundation plate line on exterior stud walls in accordance with ASTM C 926. The weep screed shall be placed a minimum of 4" above the earth or 2" above paved areas and shall be of a type that will allow trapped water to drain to the exterior of the building". Per IRC R703.6.2.1.

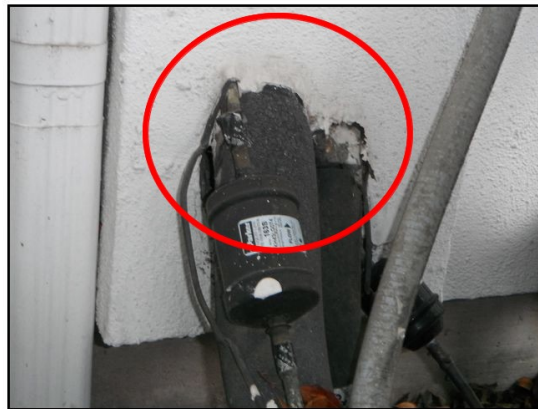
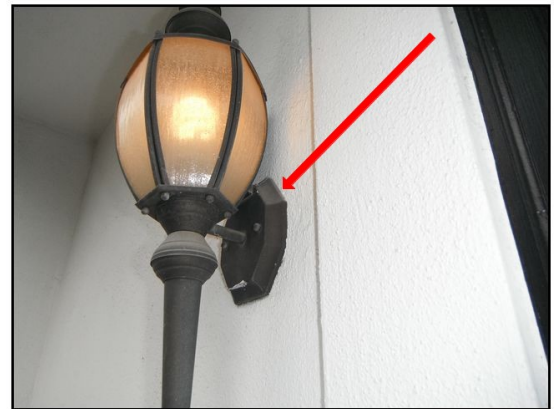
Possible water entry from cracks and/or penetrations in stucco siding. Recommend sealing/caulking around all cracks and exterior siding penetrations including but not limited to light fixtures, electrical outlets/service panels, dryer, bath vents, etc.

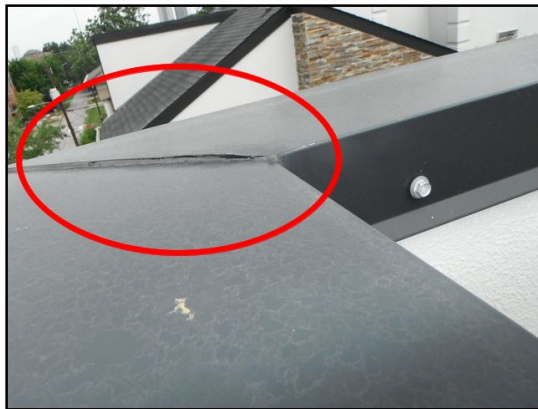
Parapet wall caps not properly sealed.

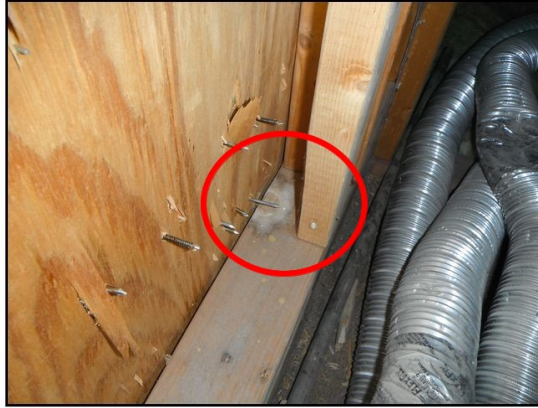
Water stains/damage on interior of one or more penetrations.

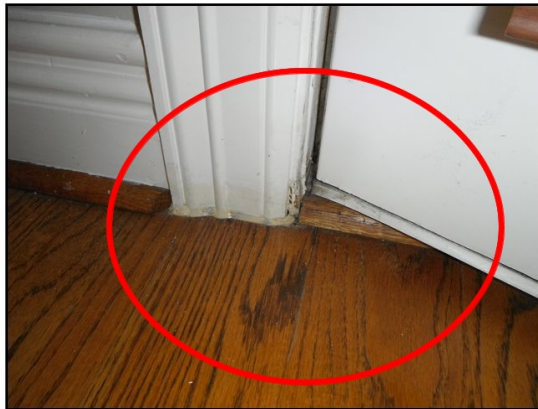
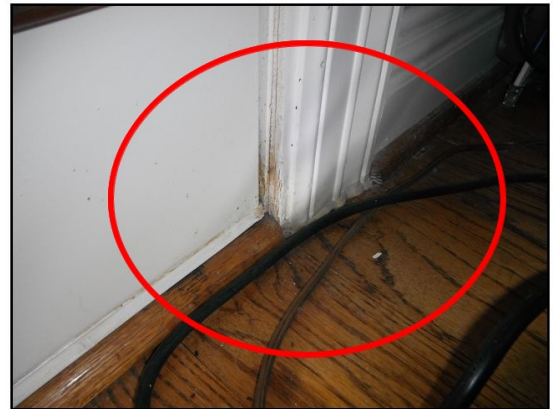
Water stains/damage on interior of one or more window/door jambs.

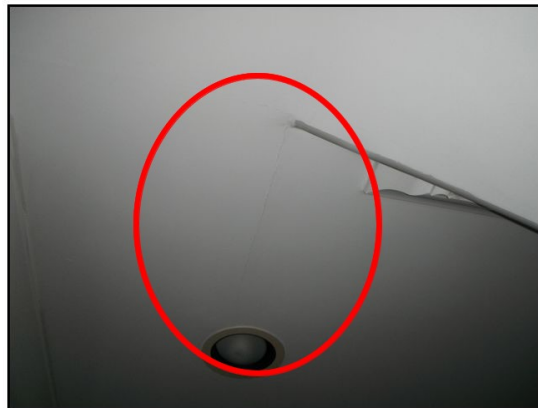
Cosmetic cracks and/or repaired cracks in sheetrock observed in ceiling; 4th floor.

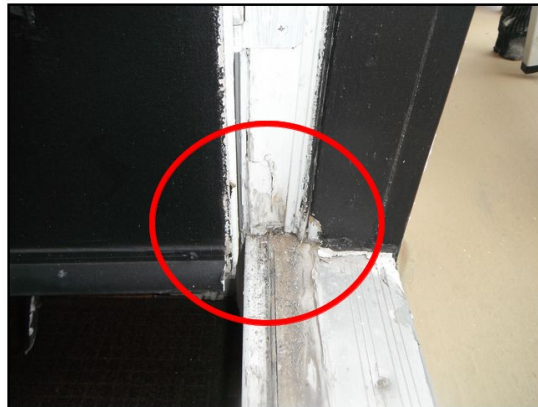
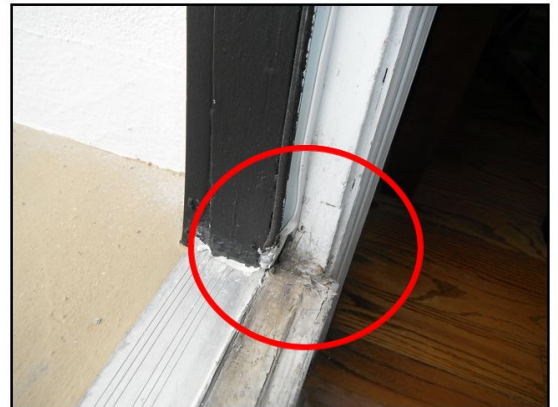
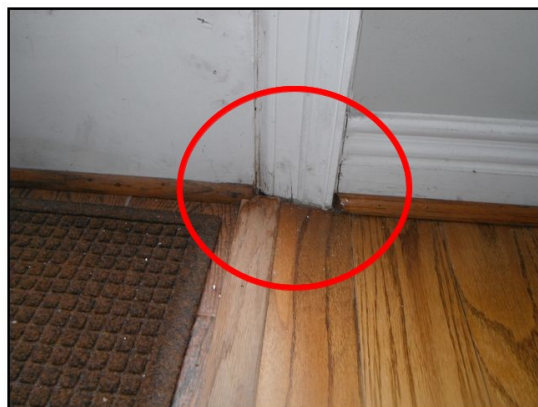
Wood rot of lower door and/or jamb; roof top terrace access door.

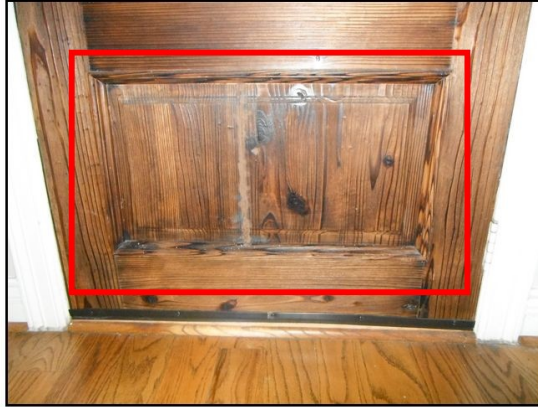
Front door has multiple cracks and previous repairs.

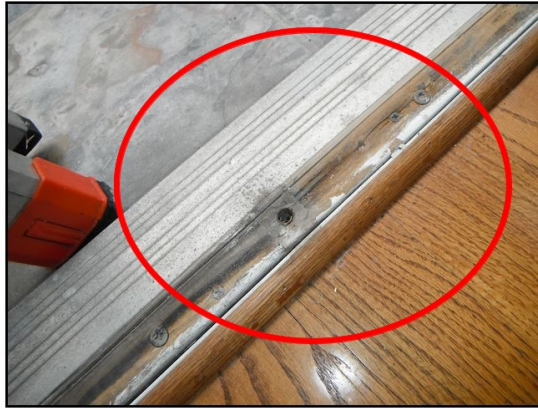
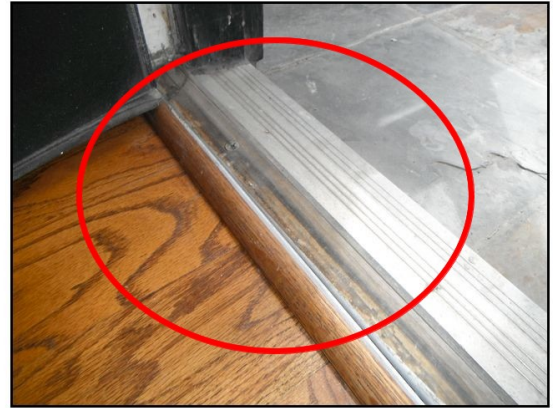
Improper threshold at one or more balcony access doors.

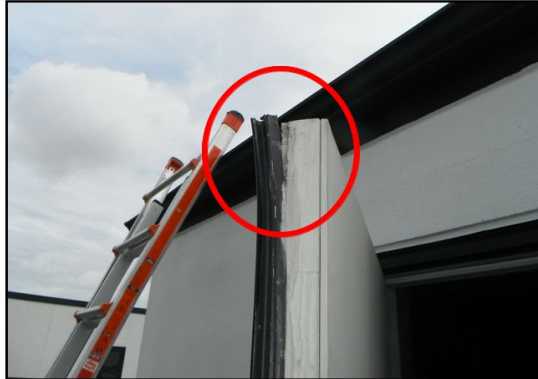
Steel skin delaminating from wood core; roof top deck storage room.

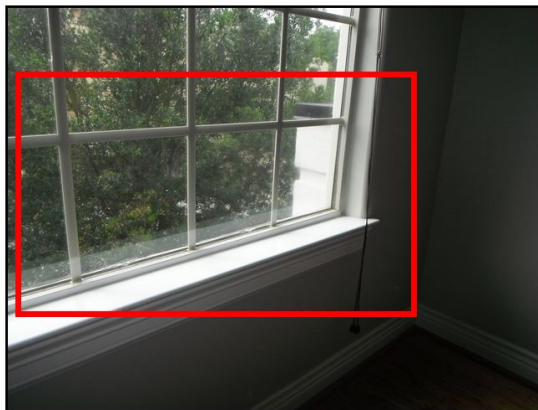
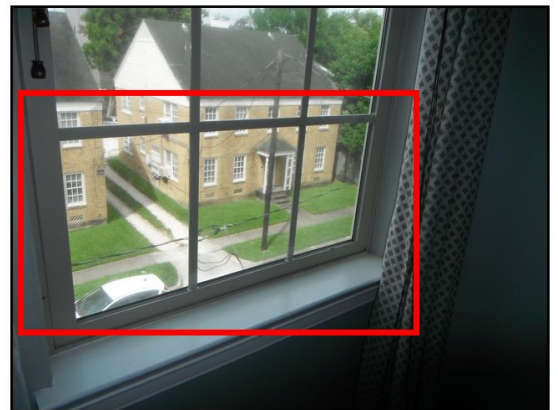
One or more of the thermal pane windows observed to have lost their seals. This has resulted in condensation and/or a fog like film to develop between the panes of glass. The thermal pane windows no longer function as designed when they loose their seals. The windows that have noticeably lost their seals are listed but may not be limited to the following: stair landing at 3rd floor. master bedroom.

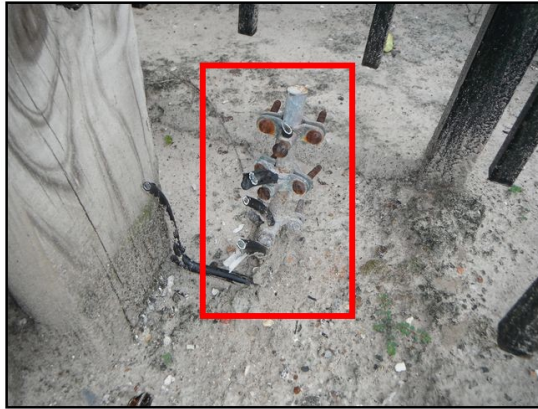
Ground conductors cut.

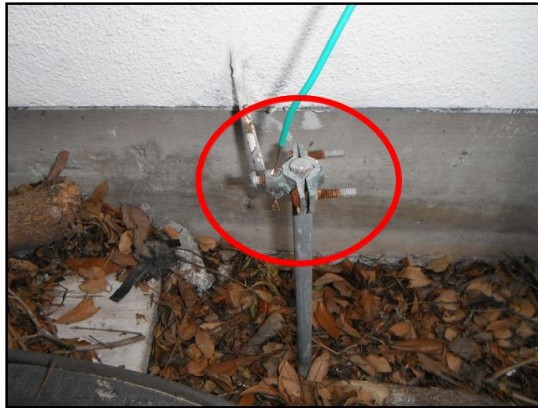
Ground clamp and/or wire not properly secured to ground rod with acorn type clamp below service meter.

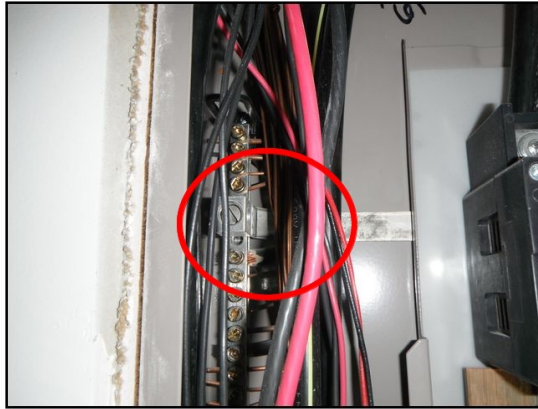
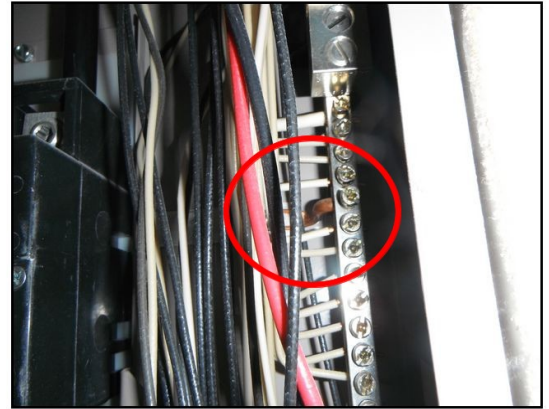
Improper wiring to sub-panel, there is no floating neutral. Per NEC 250.24(A)(5).

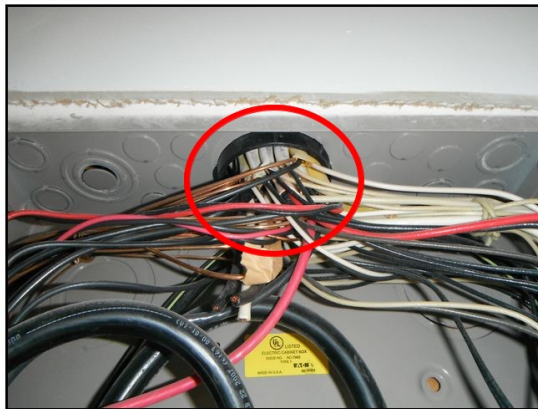
Overcrowded condition where conductors pass thru breaker panel and into house wall. This condition may/will cause an amperage drop due to heat build-up.

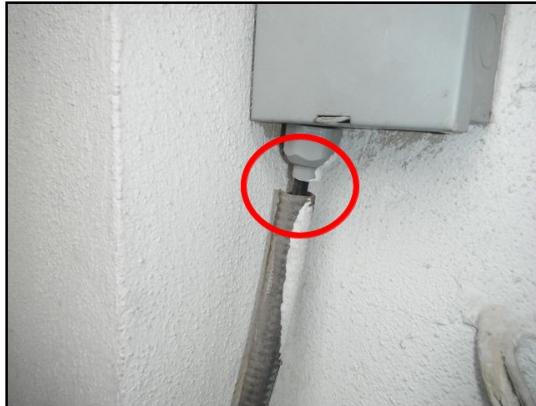
Electrical conduit not secured in place; 3rd & 4th floors HVAC disconnect.

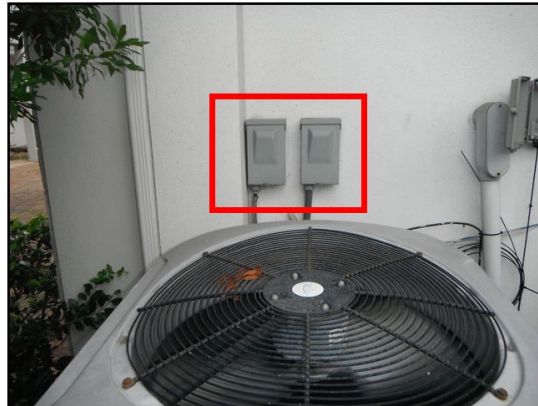
AC disconnect improperly located below and/or behind compressor.

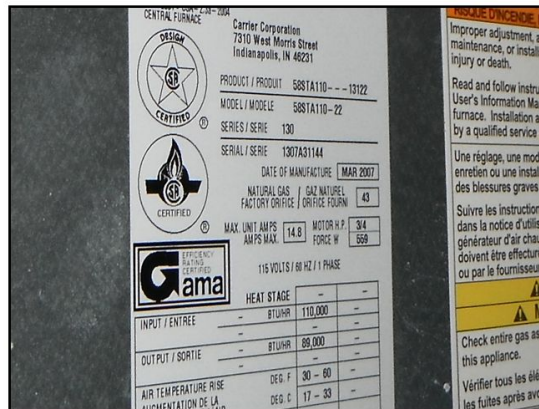
Due to age of unit and/or general condition, recommend service by qualified HVAC contractor prior to use.

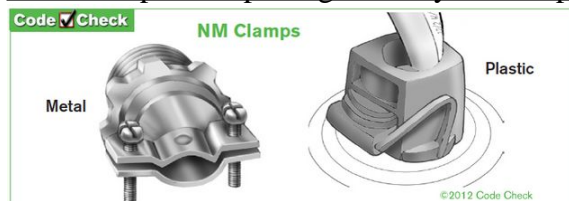
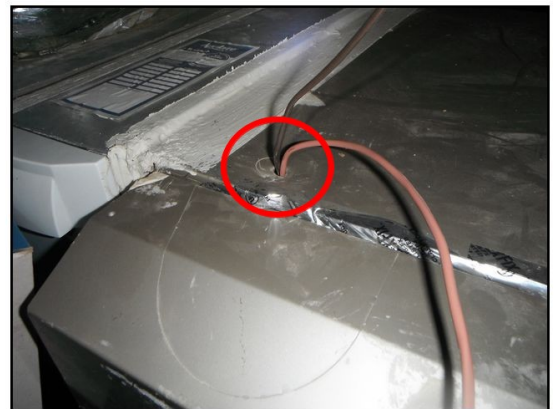
Thermostat wiring not secured to attic unit(s), missing small fitting that secures wiring to cabinet to prevent pulling loose by service personnel or homeowner.

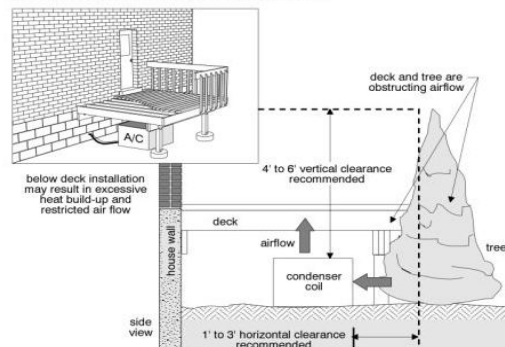
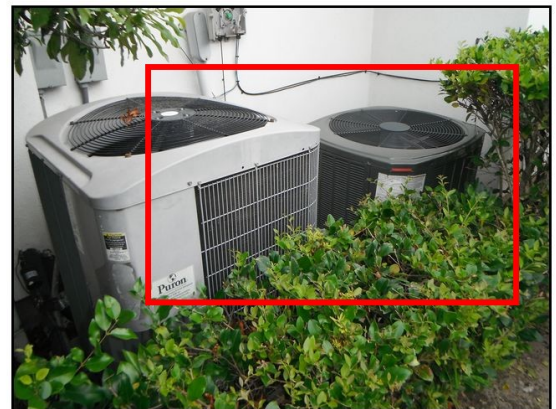
Condenser coil location requirements

Keep plant vegetation a minimum of 2 feet away from sides of A/C unit and a minimum of 4 feet over unit to allow proper air flow across coils and/or proper access to unit for servicing.

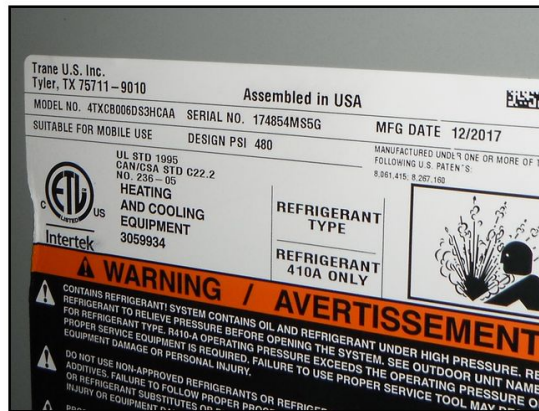
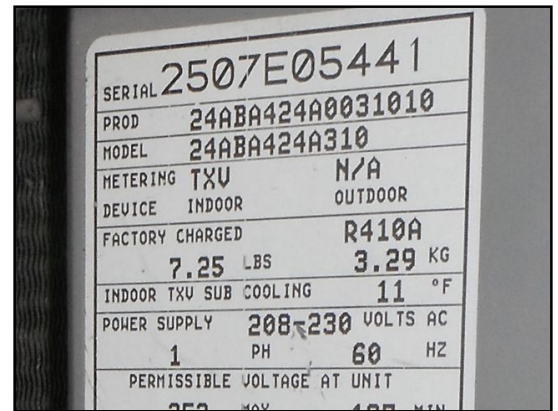
Improper sizing of breaker to unit may void manufacture's warranty. Data plate on unit states maximum breaker size to be 35 amps, observed size in service panel is 40 amps.

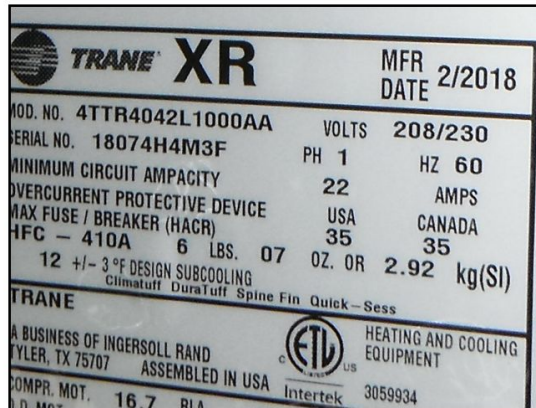
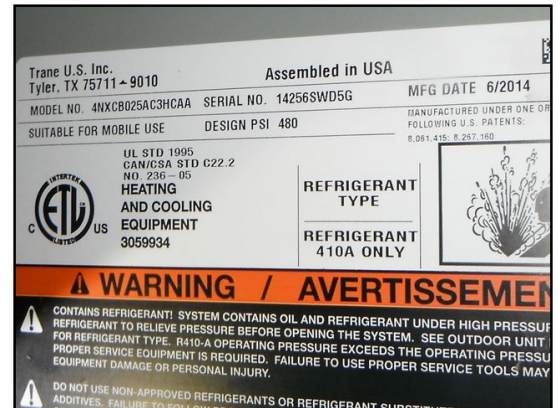
Unit has exceeded its normal serviceable life span; replacement should be expected and budgeted for in near future.

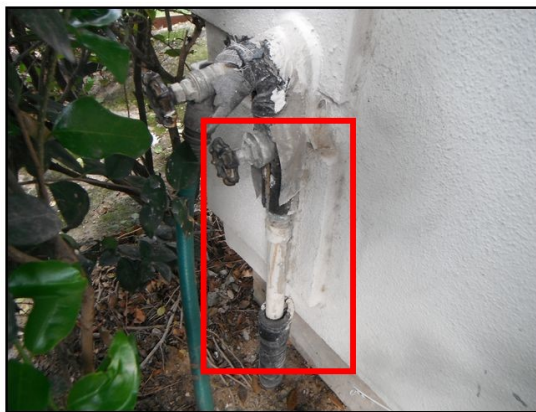
Recommend insulating exterior water line(s) to prevent freeze damage.

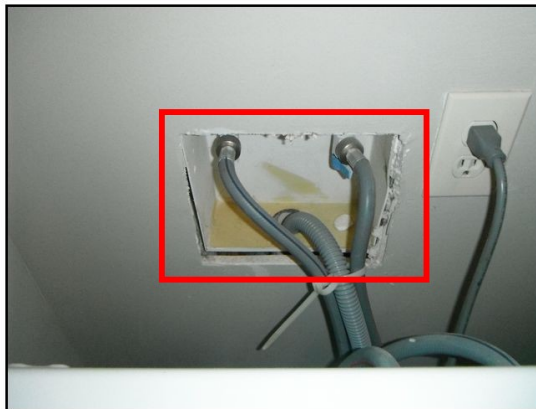
Watertight box missing trim ring.

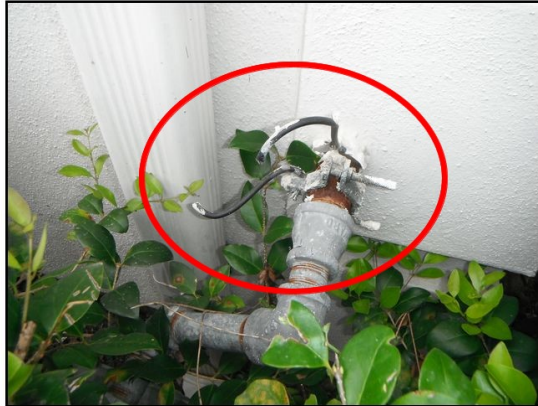
Exposed exterior gas piping not protected from corrosion as required. Per IRC 2603.3.

Above ground gas lines are not properly bonded as required by 2006 IRC/G2411.1 (310). Recommend further evaluation by qualified contractor; ground conductors cut.

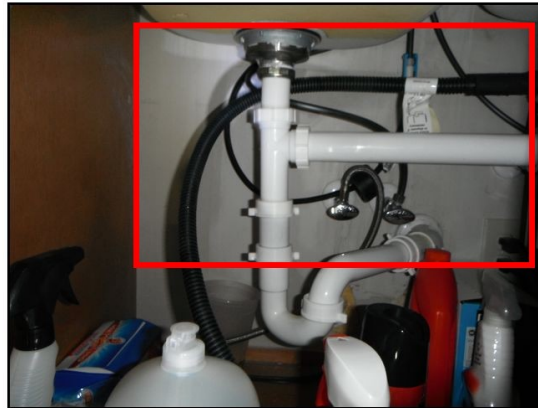
Drain line needs to be elevated above side inlet of disposal to underside of countertop to prevent debris and gray water from draining down line from disposal and back into dishwasher.

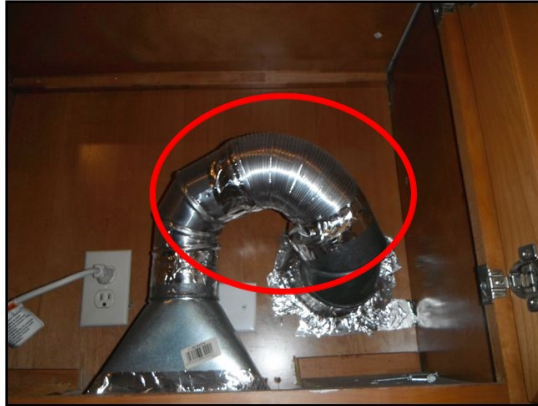
Improper vent duct material used; *Current industry standards requires smooth interior single-wall duct constructed of galvanized steel, stainless steel or copper. The duct serving the hood shall have a smooth interior surface. Per IRC 1503.1.*

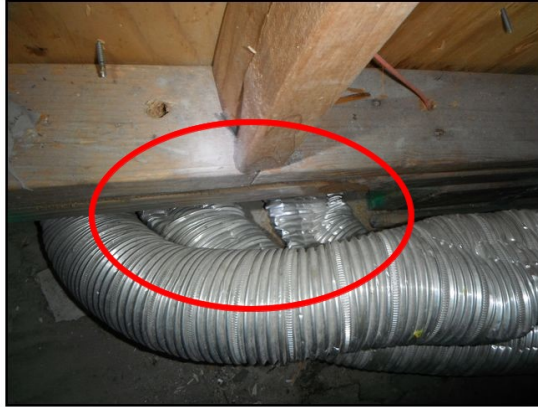
One or more bathroom vent tubes damaged.

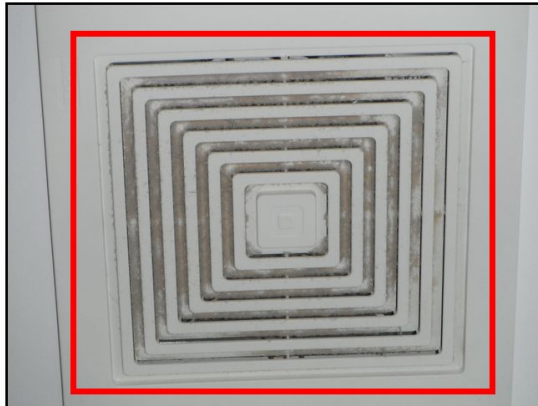
One or more exhaust vent grills have build up of dust, recommend cleaning.

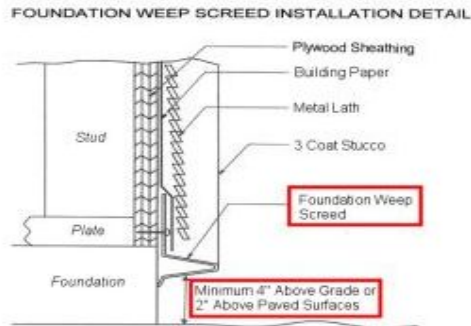
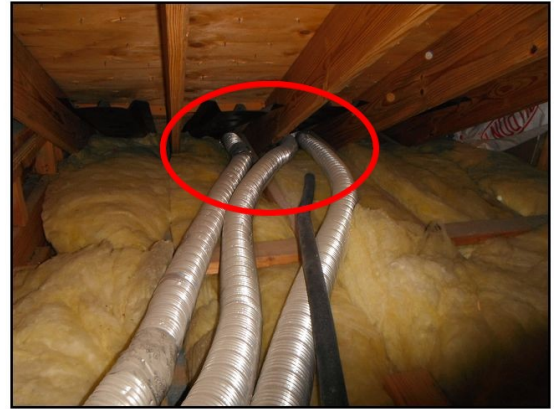
Improperly vents to soffit. Should vent to exterior.

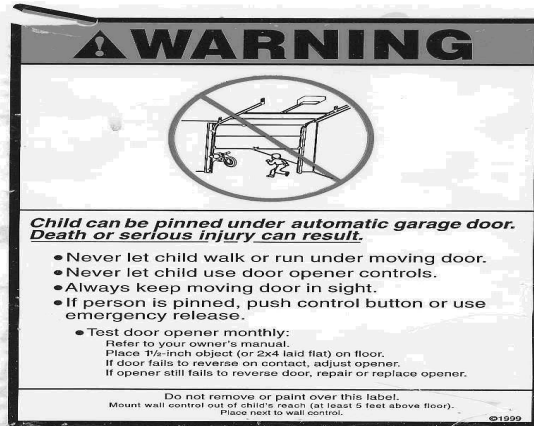
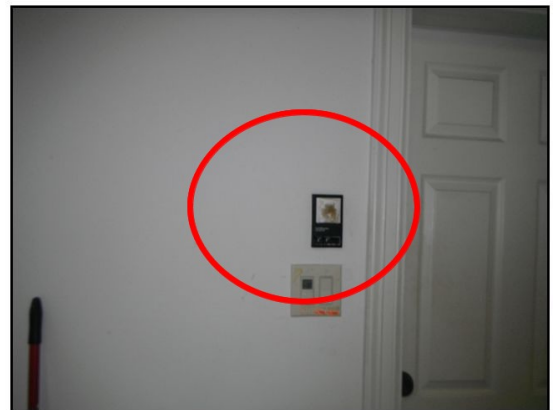
Missing required safety sticker / decal next to operator button.
