Inspection Report

Property Address: 24742 Levante Drive Richmond TX 77406

PROPERTY INSPECTION REPORT

Prepared For:			
Concerning: 24742 Levante Drive, Richmond, TX 77406			
(Address or Other Identification of Inspected Pr By: James Messina / ABET Home Services 1/12/2021			
ву:

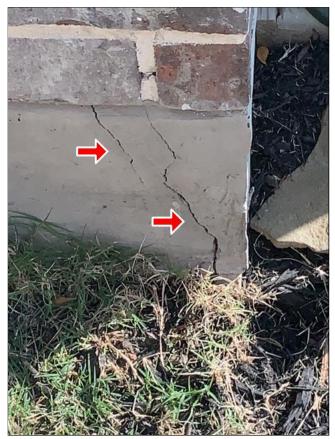
A. Item 1(Picture)

(2) Slab corner spalls require cleaning and/or resealing at the front corner

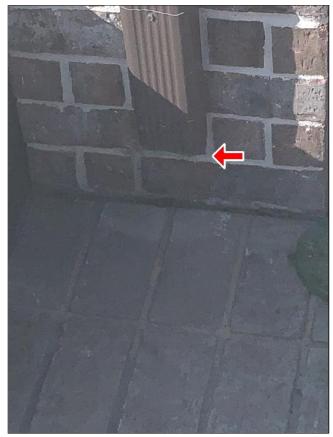
B. Item 1(Picture)

(2) There is a missing down spout diverter at the rear porch

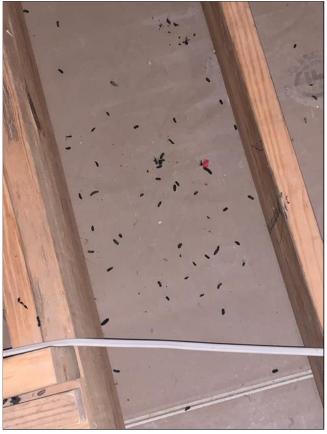
D. Item 1(Picture)

(2) There is visible evidence of rodent activity in the attic space above the garage. Droppings were observed on the attic floor at this location. Further investigation is needed by a qualified pest control company

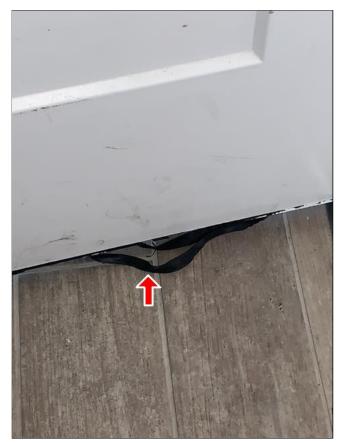
G. Item 1(Picture)

Appears to be in good condition and functioning as intended
🛛 🗆 🗖 G.	Doors (Interior & Exterior)
	Garage Door Material: Metal Comments:
	 (1) All interior and exterior doors were checked for proper latching and proper fit and operation in door frames. Attic and exterior doors were inspected for proper weatherstripping. Installation of safety glass in exterior doors was verified. All exterior doors were inspected for proper operation. Wood frame doors were inspected for wood rot and deterioration. All exterior doors were checked for signs of water penetration. (2) The weatherstripping is damaged at the base of the garage rear entry door

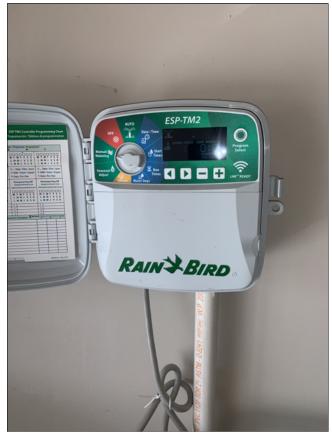
A. Item 1(Picture)

(2) There is a damaged spray head at zone number four near the sidewalk
