## MECHANICAL INSPECTION

9231 Fordshire Dr  
Houston, TX 77025

# PROPERTY INSPECTION REPORT FORM

Robert & Patricia Pando c/o Katy Pando <i>Name of Client</i>	01/06/2023 12:00 pm <i>Date of Inspection</i>
9231 Fordshire Dr, Houston, TX 77025 <i>Address of Inspected Property</i>	
Gary Atherton <i>Name of Inspector</i>	TREC#24236 <i>TREC License #</i>
<i>Name of Sponsor (if applicable)</i>	<i>TREC License #</i>

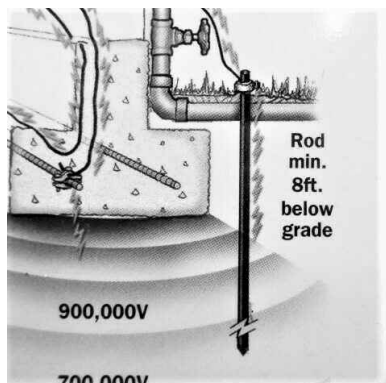
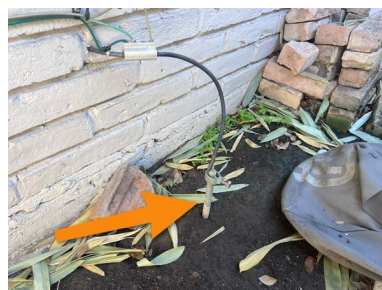
The ground rod was sticking out of the ground a few inches, and, since ground rods are typically 8 feet long and all 8 feet of the rod are required to be in the ground, it is recommended that the ground rod be pounded down flush with the top of the ground. The clamp on the rod should be an acorn clamp is approved for direct burial in the ground.

**Obtain Cost Estimate**

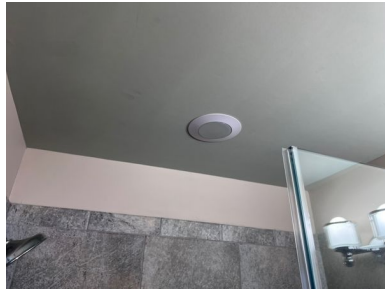
### 3: Light Fixture - Nonfunctional

A light fixture that was non-functional when the switch was on was observed. The problem may be a burned out bulb, defective light fixture, or defective switch.

**Further investigation is recommended**

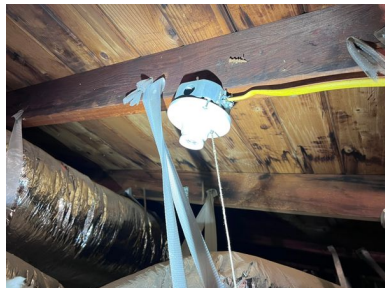
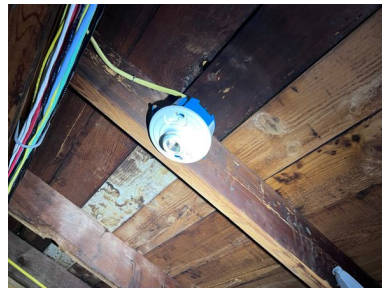
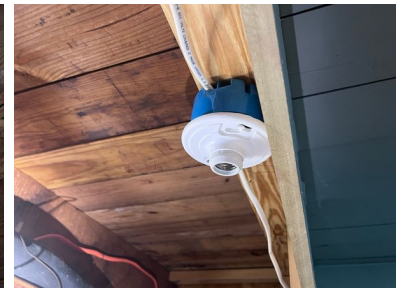
Attic

### 4: Light Fixture - Missing bulb

A light fixture had a missing bulb.

**Obtain Cost Estimate**

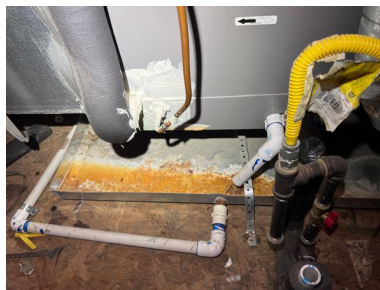
Living Room

**3: Overflow Pan - Debris in pan**

Insulation and/or debris was observed in the overflow pan. The pan needs to be cleaned out to prevent clogging of the drain line.

**Obtain Cost Estimate**

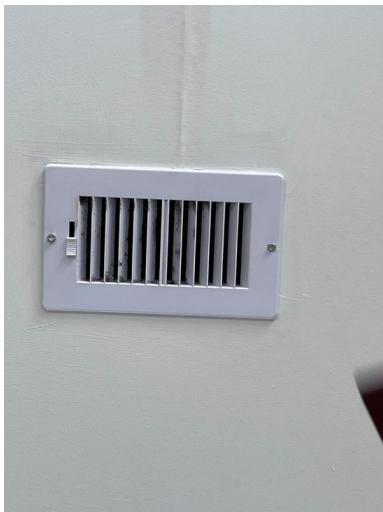
### 2: Registers - Microbial growth observed

Some of the registers were covered with mildew/debris. It is recommended that a service company be contacted to check the inside a of the duct work to determine if there is a build-up of debris/mold/mildew inside, and make any needed repairs. Further investigation is recommended.

**Obtain Cost Estimate**

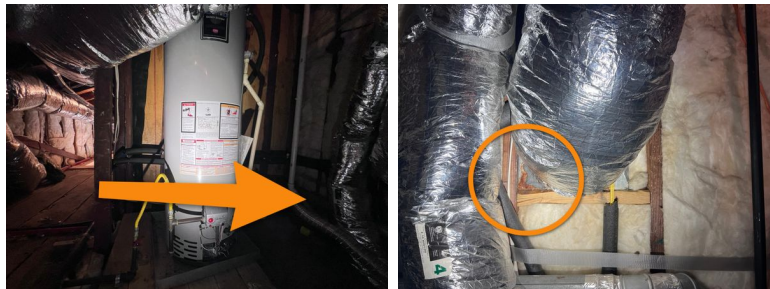
Attic

**4: Rigid Ducts - Exterior rusting**

**Obtain Cost Estimate**

Recommendation: Contact a qualified professional.

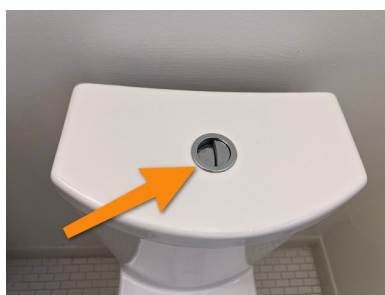
Master Closet Half Bath

**3: Toilet - Flush handle needs repair**

The flush handle was damaged and/or not operating properly and needs to be replaced.

**Obtain Cost Estimate**

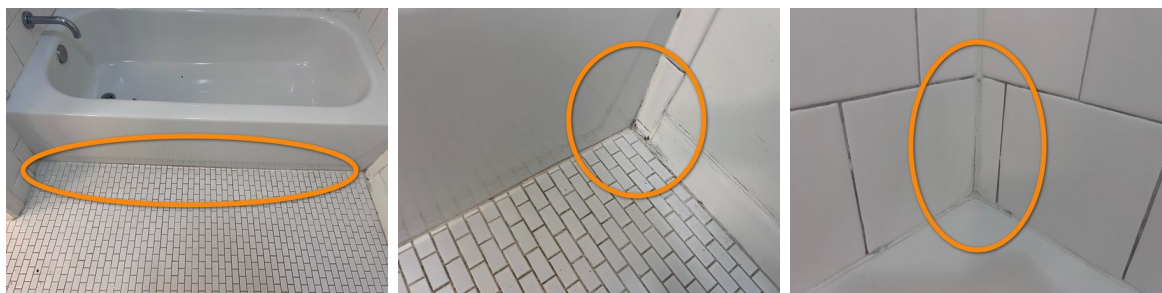
Hall Bath

**4: Tub - Caulk needed**

The tub needs to be caulked.

**Obtain Cost Estimate**

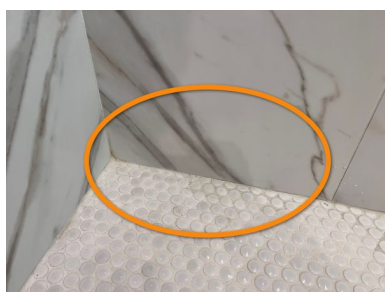
Master Bath & Apartment

**6: Shower - Caulking needed**

The shower needs to be caulked.

**Obtain Cost Estimate**

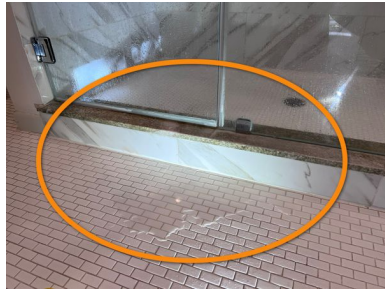
**7: Shower/Tub - Rubber door seal loose**

The rubber threshold/seal strip for the shower door is leaking water and needs to be repaired.

**Obtain Cost Estimate**

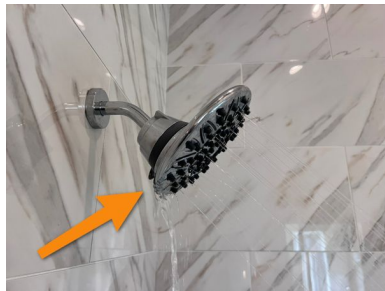
Master Bath

**8: Shower/Tub - Shower head leak**

The shower head was leaking at the connection and needs to be repaired.

**Obtain Cost Estimate**

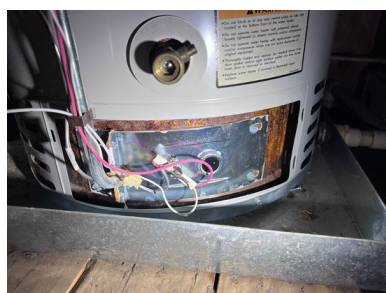
The bottom of the water heater tank is beginning to rust. This indicates that the bottom of the heat exchanger has been rusting. Further investigation is recommended with a service company to determine the extent of the rust and make any necessary repairs.

**Obtain Cost Estimate**

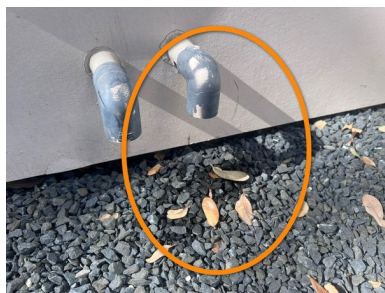
Water was dripping from the relief valve drain line indicating that the temperature/pressure relief valve was leaking.

**Obtain Cost Estimate**

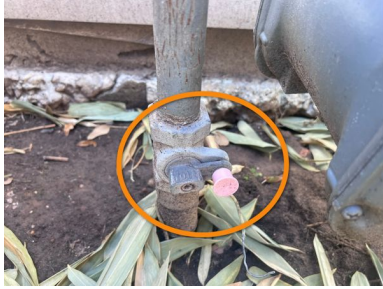
**1: Gas service turned off**

Gas service was not provided to the house at the time of the inspection, therefore the gas fired equipment could not be operationally checked. It is recommended that the gas fired equipment be operationally checked

by a service company when the gas service is reinstated.

**Further investigation is recommended.**

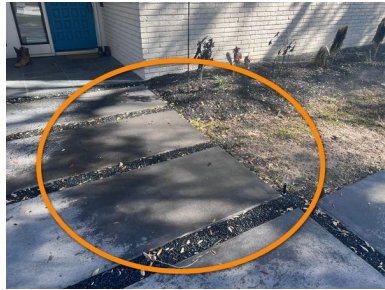
**1: Adjust sprinkler head spray**

Spraying Walk Way, Spraying driveway, Spraying street -  
The sprinkler head spray was in need of adjustment/repair.

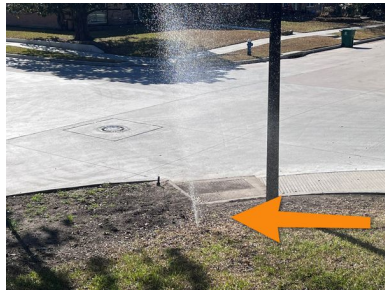
## 2: Broken water pipe

**Obtain cost estimate**

Recommendation: Contact a qualified professional.
