PROPERTY INSPECTION REPORT

Report I.D. # 072720-A

Concerning: 5816 Petty Street
Houston, Texas 77007

Clear View Inspections
Lee Fasbinder, T.R.E.C. #7507
713.409.4631 or cvi@att.net

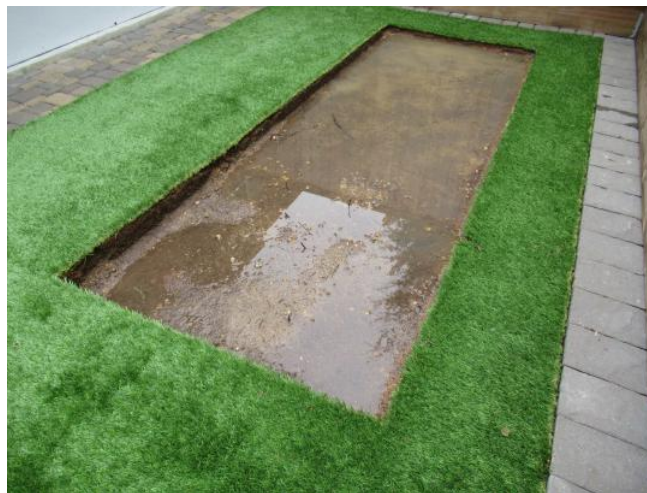
The open cut out in the backyard synthetic turf needs to be properly filled in and leveled out. Cover repaired grade with synthetic turf.

Open area is a breeding ground for insects.

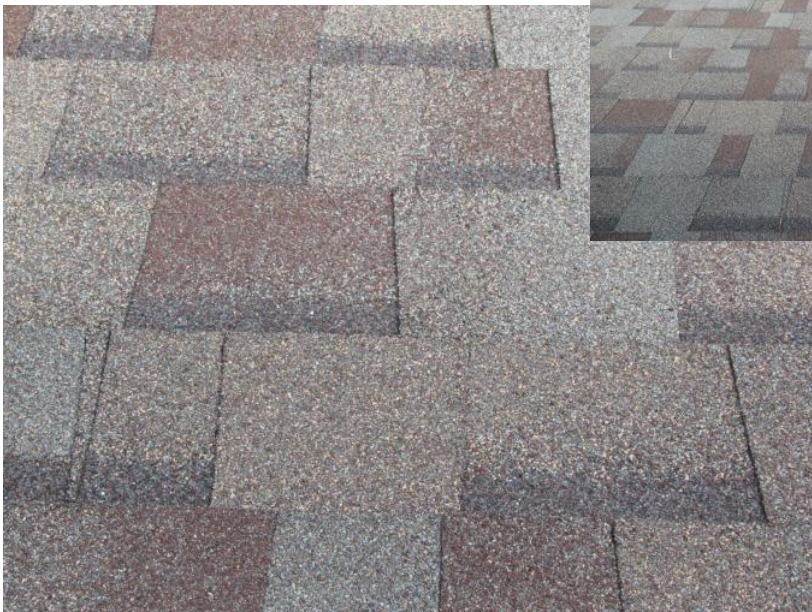
This roof covering (shingles) appear to be original (14-15 years in age). The shingles are showing normal wear for its age. At the time of this inspection, the covering is functioning as intended. I estimate that this covering will need to be replaced within the next 4 years.

There was no evidence of any water intrusion inside the attic or the home due to failure of the roof covering.

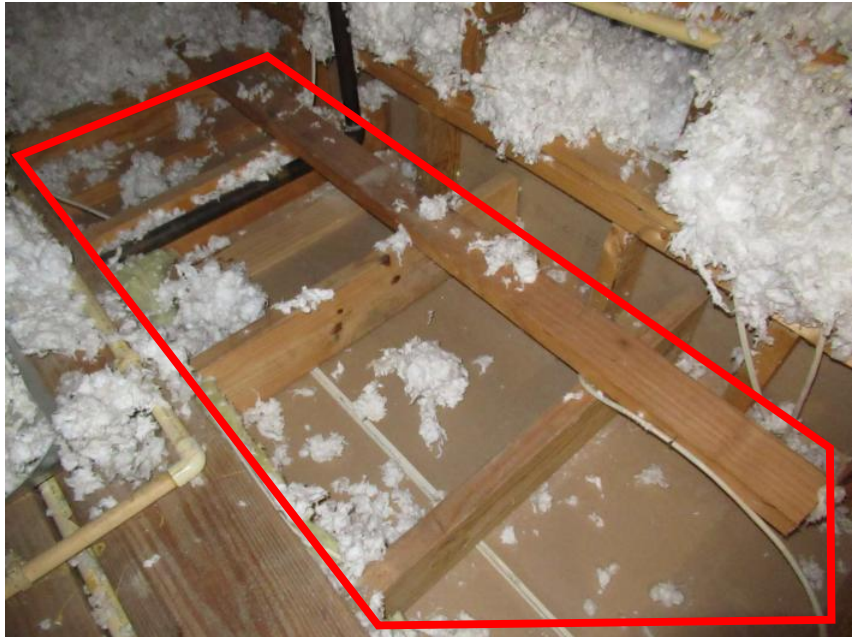
A small area of attic ceiling insulation is missing on the sheetrock in the upstairs middle bedroom. Insulation needs to be installed with a minimum of an R-30 rating (12"-13" loose fill fiberglass or equivalent).

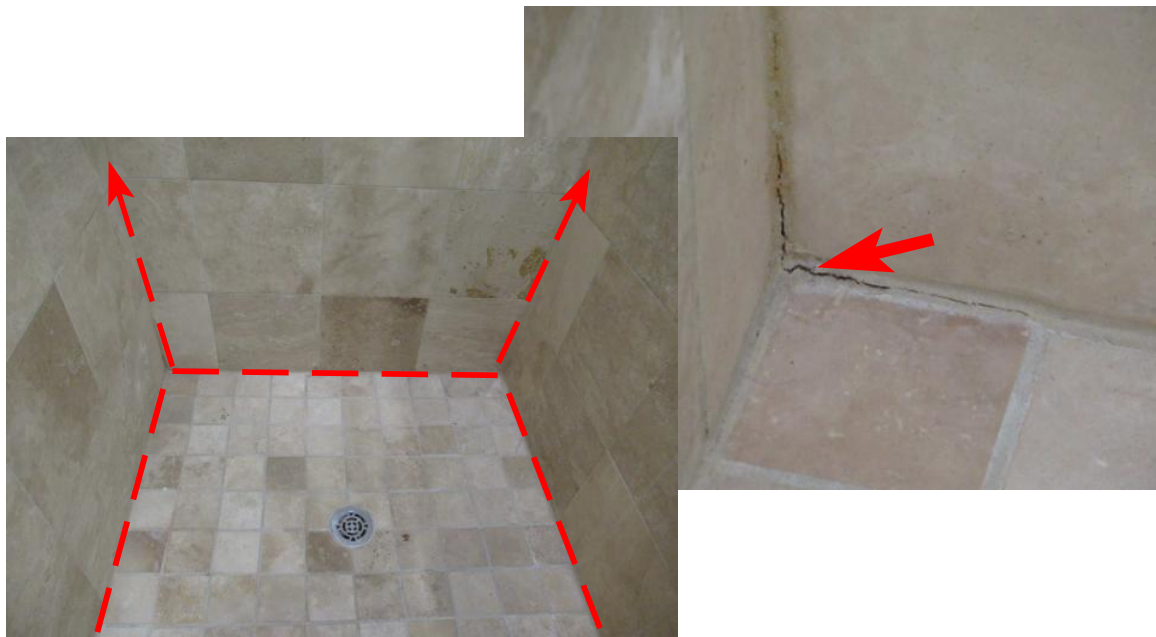
The grout in the right angle corners (vertical and horizontal) in the master shower enclosure are cracked. The corners must be water tight sealed with silicone type caulking.

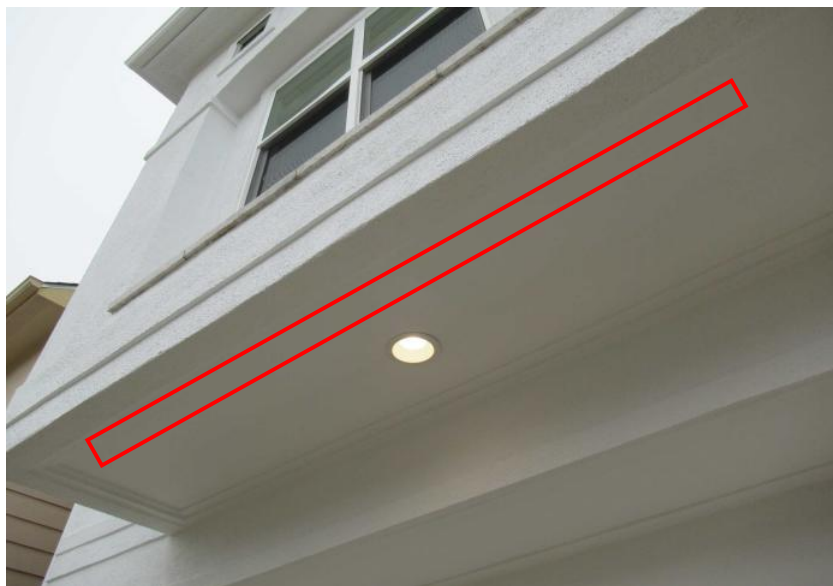
Weep screed is missing.

A weep screed (opening) needs to be properly installed on the underside of the garage door overhand. Contact a professional stucco contractor for repairs.

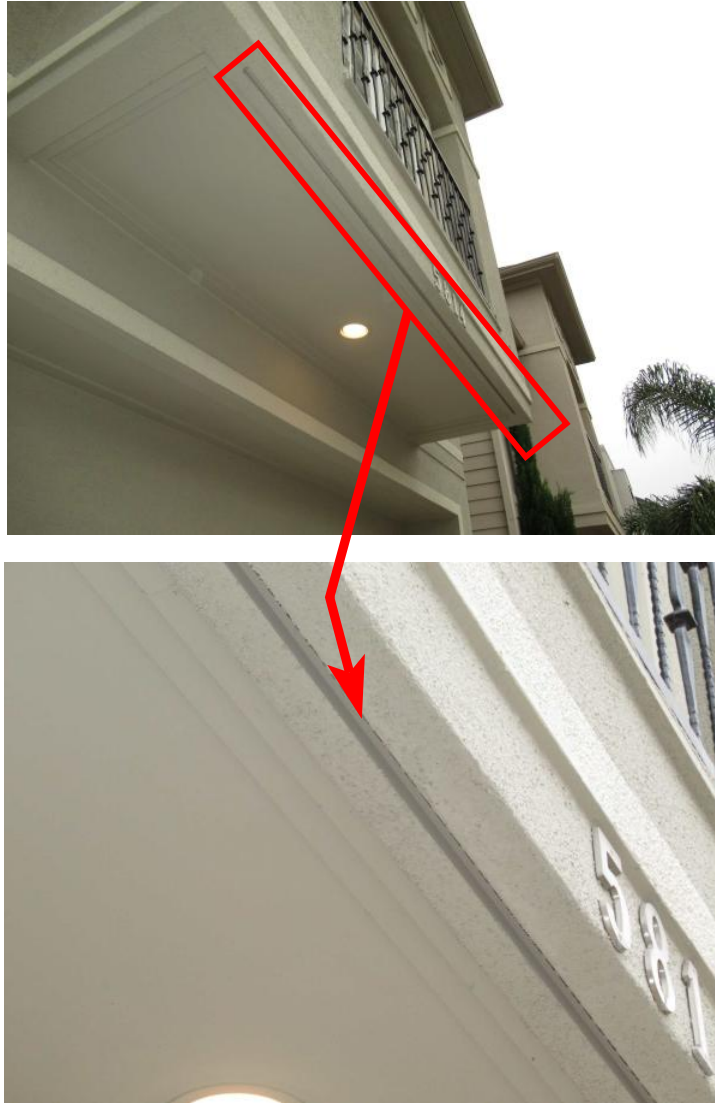
This is weep screed properly installed on the home to the right. Same builder, same type design.

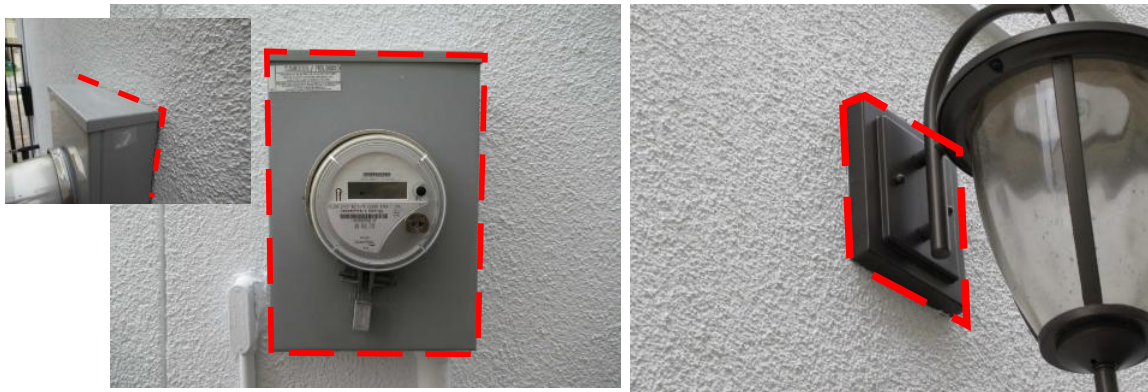
- ***Coach light base.....right side of the home***
- ***The electric meter box....right side of the home***

Caulk in and around following exterior protrusions:

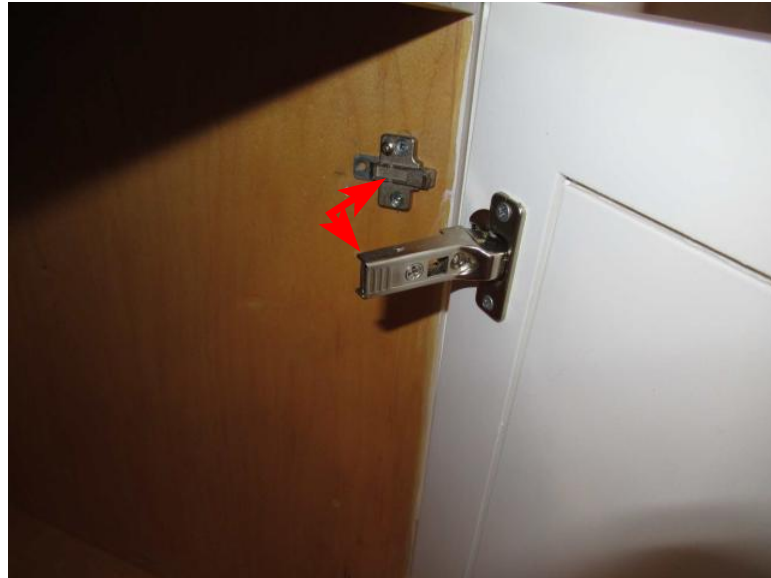
The top hinge on the cabinet, under the master bathroom right side sink, is not attached. In need of repair.

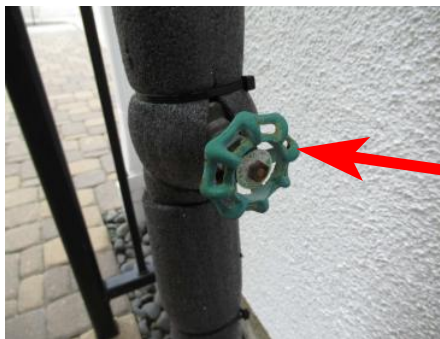
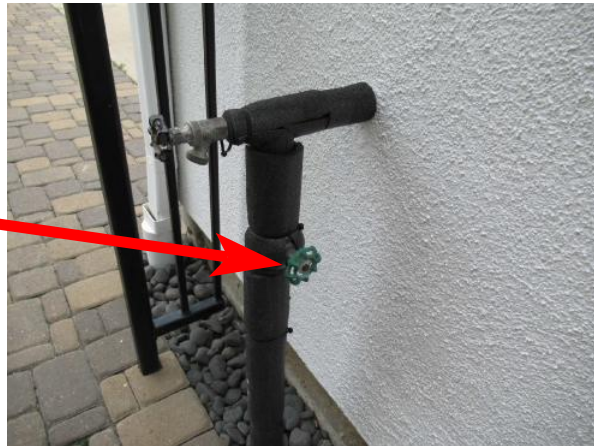
The main water shut off valve is located on the right side of the home (exterior). Everyone should know where this is located in case of any emergency.
