PROPERTY INSPECTION REPORT FORM

1005 N Danville St, Willis, TX 77378

02/24/2023 9:00 am

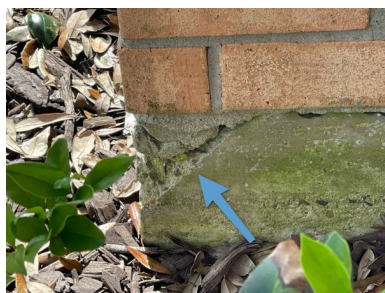
1: Foundation: Corner Pops

Foundation corners cracked and/or sheared off (Corner pops) were observed. This condition does not adversely affect the performance of the foundation, however cosmetic improvements may be necessary.

Recommendation: Contact a foundation contractor.

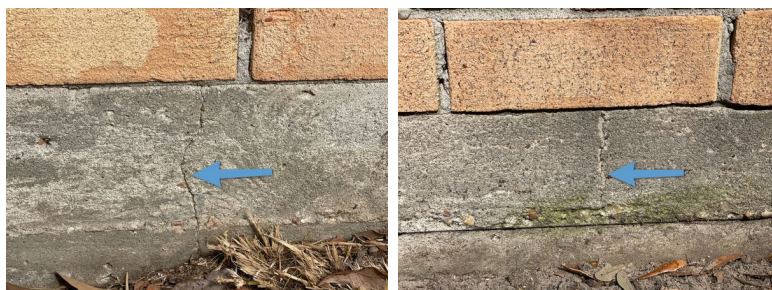
2: Foundation: Slab Cracks/Fractures

Cracks/fractures were observed in the foundation slab at the time of the inspection.

Recommendation: Contact a foundation contractor.

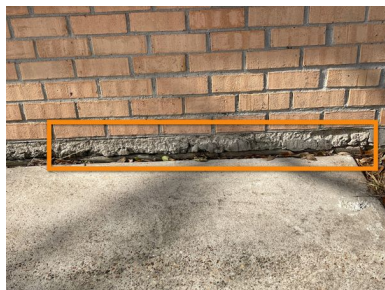
3: Foundation: Deterioration/Spalling

Moderate/Repair Recommended

Deterioration (known as spalling) was observed. Spalling refers to concrete that has become pitted, flaked, and/or broken up.

Recommendation: Contact a foundation contractor.

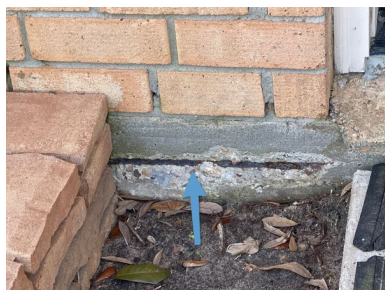
4: Foundation: Exposed Rebar

Minor; Improve as necessary

Exposed rebar in the foundation was observed. Exposed rebar, if left untreated, can cause extensive structural damage and may cause the rebar to break away.

Recommendation: Contact a foundation contractor.

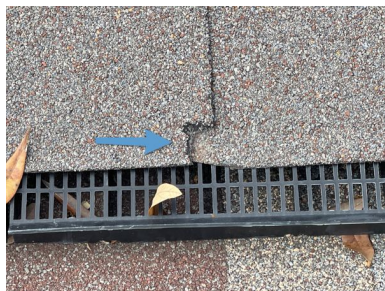
3: Shingles: Damaged

Damaged shingles were observed.

Recommendation: Contact a qualified roofing professional.

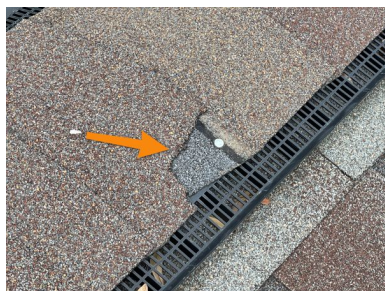
4: Shingles: Cracked/Torn

🟡 Moderate/Repair Recommended

Cracked/torn shingles were observed on the roof surface.

Recommendation: Contact a qualified roofing professional.

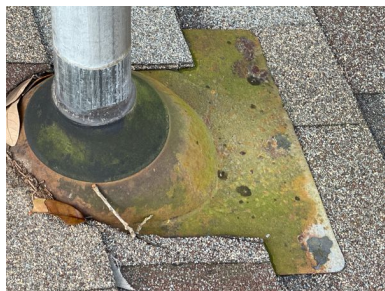
5: Flashing: Rust

🔧 Minor; Improve as necessary

Rust was observed on areas of roof flashing. Rust can eat away at the flashing leaving openings that can allow moisture to enter the structure.

Recommendation: Contact a qualified roofing professional.

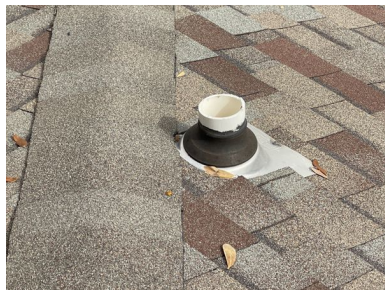
6: Flashing/Boot: Improperly Placed

🟡Moderate/Repair Recommended

One or more roof penetration flashing/boots were observed to be installed in close proximity/into areas of the valley/ridge shingles, this configuration could make the roof penetration prone to leaks.

Recommendation: Contact a qualified roofing professional.

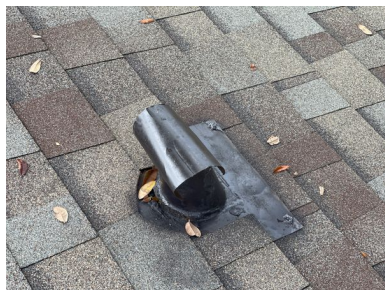
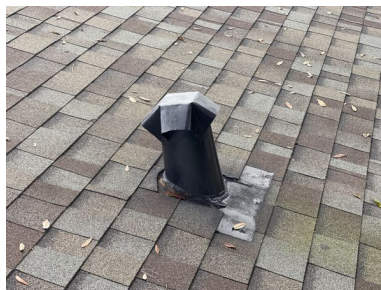
7: Abandoned Roof Vents

🟡Moderate/Repair Recommended

One or more roof vents appeared to be abandoned at the time of the inspection. It is recommended that the vents properly be removed if no longer in use.

Recommendation: Contact a qualified professional.

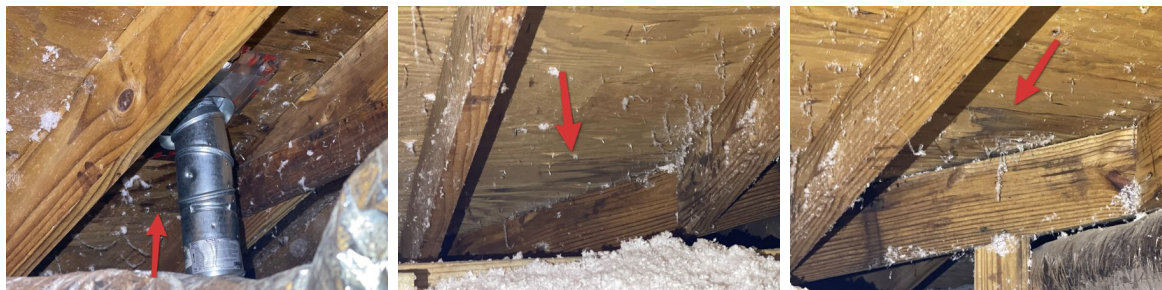
1: Roof Decking: Moisture Staining/Damage

Moisture staining/damage was observed on areas of the roof structure. This indicates a previous/present leak has occurred in the roof system.

Recommendation: Contact a qualified professional.

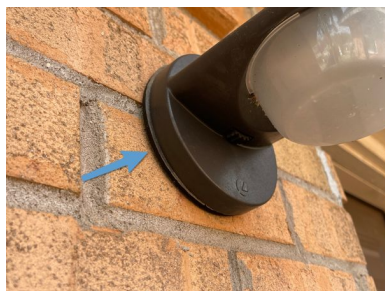
5: Exterior: Deficient Penetration Sealant

Cracking, deteriorated, and/or missing sealant was observed around exterior utility wall penetrations.

Recommendation: Contact a qualified professional.

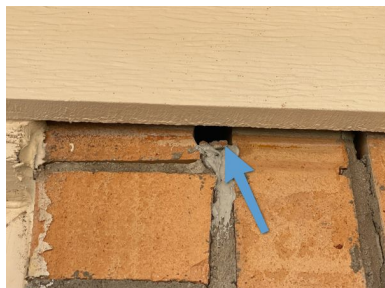
6: Exterior: A/C Wall Penetrations

🔧Minor; Improve as necessary

It is recommended the area of the wall where the cooling system utilities penetrate the exterior wall be properly flashed and/or sealed.

Recommendation: Contact a qualified professional.

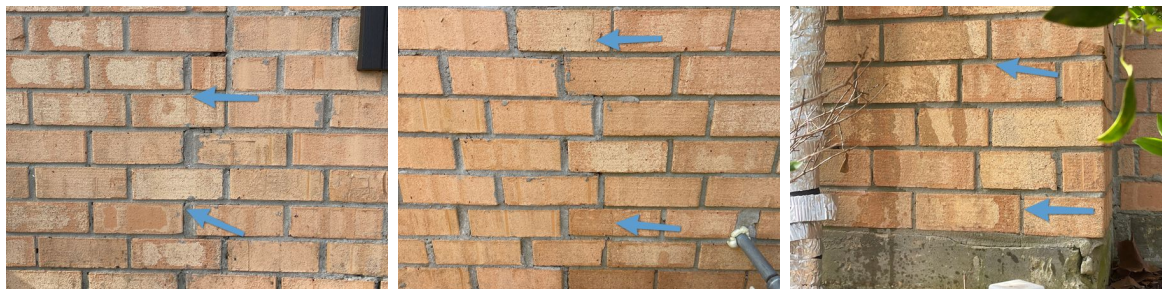
8: Exterior: Cracks/Fractures

Minor; Improve as necessary

Exterior wall cracks/fractures were observed.

Recommendation: Contact a qualified professional.

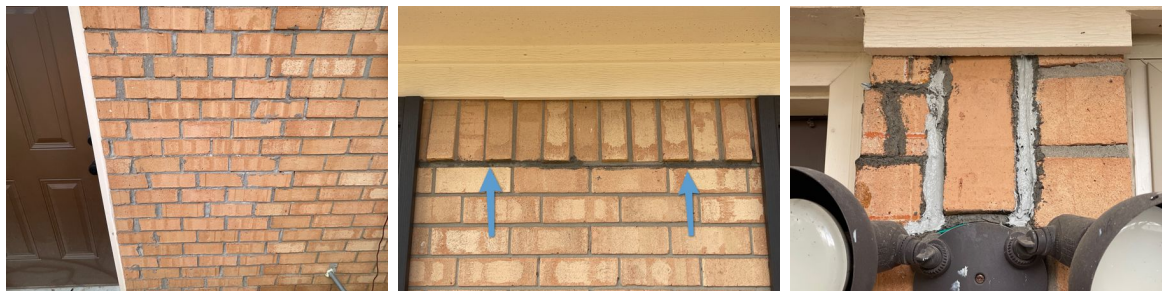
9: Exterior: Deficient Mortar Between Bricks/Stone

Minor; Improve as necessary

Cracking, deteriorated, and/or damaged mortar on the exterior brick/stone walls was observed.

Recommendation: Contact a qualified professional.

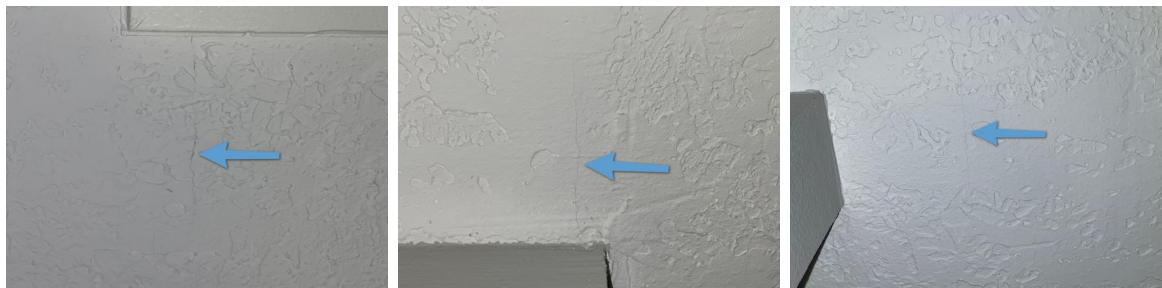
1: Ceilings: Drywall Joint Separation Cracks

Drywall joint separation cracks were observed.

Recommendation: Contact a qualified professional.

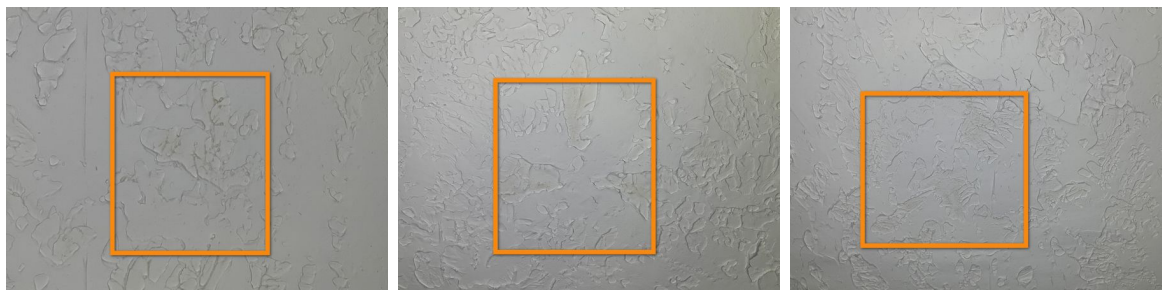
2: Ceilings: Stains

Moderate/Repair Recommended

Unknown stains were observed on areas of the ceiling. The stains and source of the stains were unable to be identified. Further investigation may be necessary.

Recommendation: Contact a qualified professional.

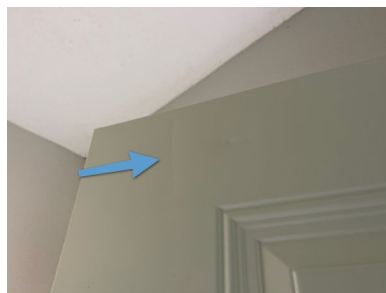
2: Doors General: Damage

Damage to one or more doors was observed.

Recommendation: Contact a qualified professional.

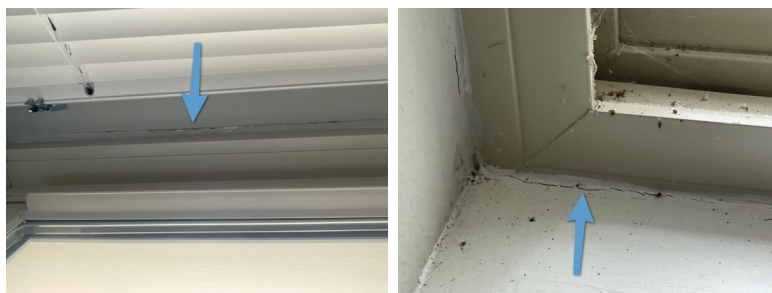
1: Windows: Deficient Sealant

Cracking, deteriorated, and/or missing caulking/sealant was noted around the interior/exterior of the windows.

Recommendation: Contact a qualified professional.

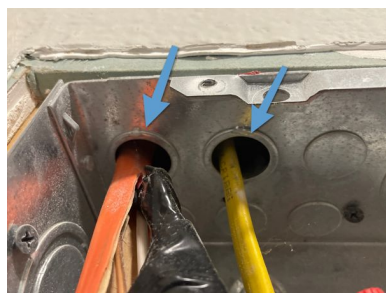
Cable clamps (sometimes referred to as bushing or grommets) were missing. Cable clamps should be installed where conductors pass through the electrical panel.

Recommendation: Contact a qualified electrical contractor.

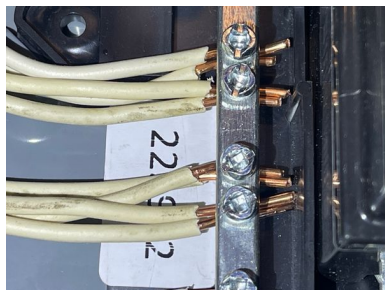
4: (EP) General: Neutrals Double Lugged

Moderate/Repair Recommended

Improper double lugging of neutral conductors was observed. Each neutral conductor should terminate to its own individual terminal.

Recommendation: Contact a qualified electrical contractor.

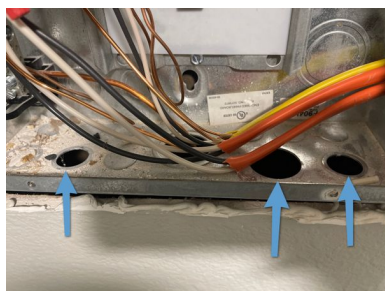
8: Panel/Dead Front: Knockouts Missing

Openings in the electrical panel/dead-front were noted. All openings should be properly sealed with "knock outs".

Recommendation: Contact a qualified electrical contractor.

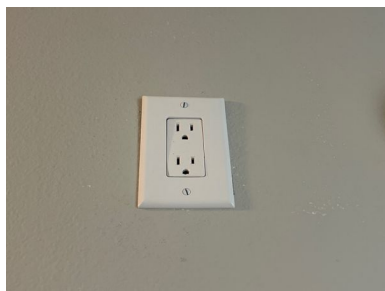
1: Receptacles: Loose

🟡Moderate/Repair Recommended

Loose receptacles were observed. Loose receptacles should be properly secured.

Recommendation: Contact a qualified electrical contractor.

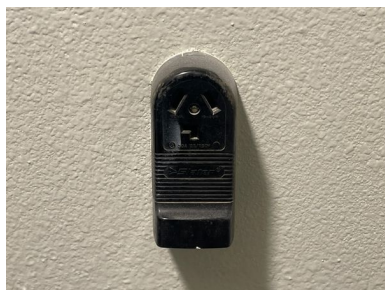
🟡Moderate/Repair Recommended

The dryer receptacle was observed to be a 3-pronged type. Current recommended standards now call for dryer receptacles to be wired with a ground conductor, I.e., 4-pronged receptacle. Most current dryer connections use a 4-pronged cord. Upgrading should be considered.

Recommendation: Contact a qualified electrical contractor.

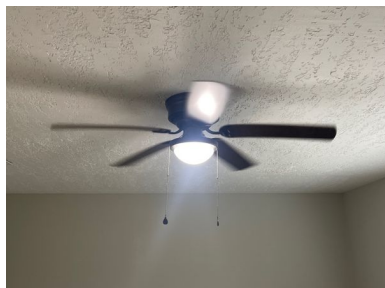
Living Room

🟡Moderate/Repair Recommended

Ceiling fan(s) that were noisy when operated were observed.

Recommendation: Contact a qualified electrical contractor.

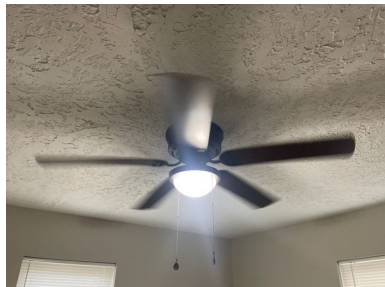
Master Bedroom

One or more ceiling fan(s) were observed to be wobbly, unbalanced, and/or loose when operated.

Recommendation: Contact a qualified professional.

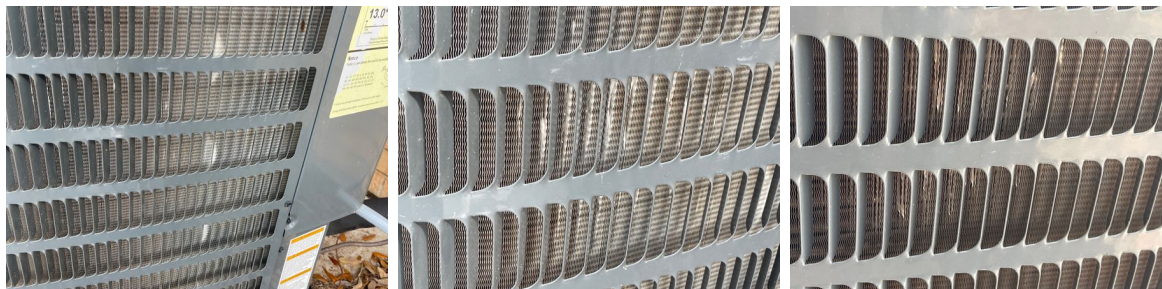
Areas of the fins on the condenser were observed to be damaged. Damaged fins can restrict the air flow and/or the efficiency of the unit.

Recommendation: Contact a qualified HVAC professional.

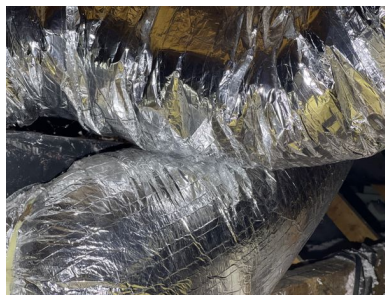
Sections of the duct system were observed to be in contact with each other. Condensation can develop between contacted areas of the duct work.

Recommendation: Contact a qualified HVAC professional.

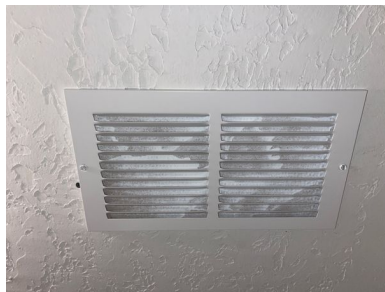
Laundry Room

One or more output registers appeared to be blocked off at the time of the inspection.

Recommendation: Contact a qualified professional.

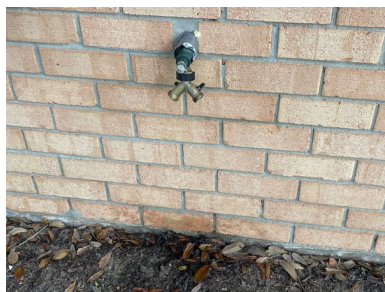
Back Exterior

One or more exterior faucets were observed to have a drip/leak when in the off position.

Recommendation: Contact a qualified plumbing contractor.

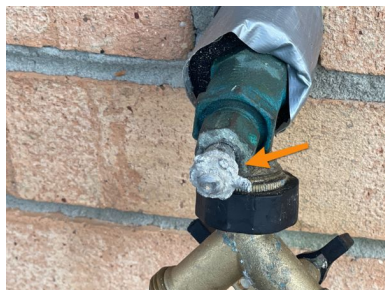
Back Exterior

One or more exterior faucet handles were observed to be broken/missing. These faucets were unable to be tested/operated.

Recommendation: Contact a qualified professional.

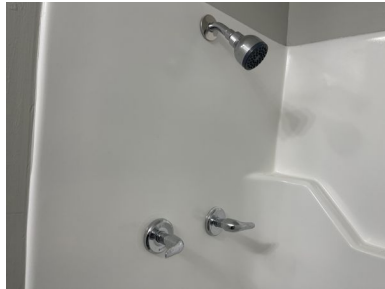
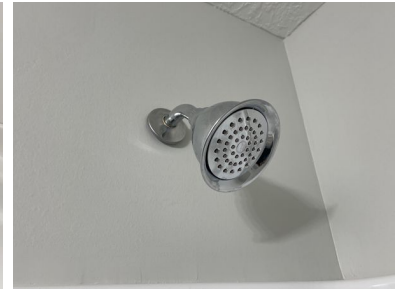
4: Bathtubs/showers: Loose Fixture Components

🔴 Moderate/Repair Recommended

Loose bathtub/shower fixture components were observed.

Recommendation: Contact a qualified plumbing contractor.

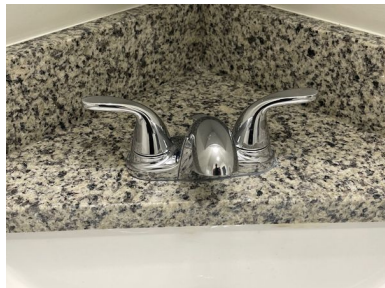
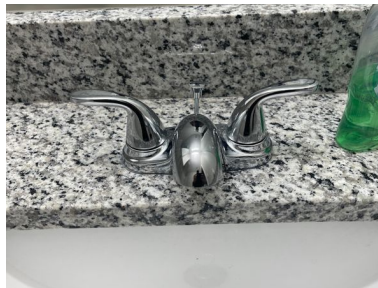
5: Sinks: Loose Fixture Components

Loose sink fixture components were observed.

Recommendation: Contact a qualified plumbing contractor.

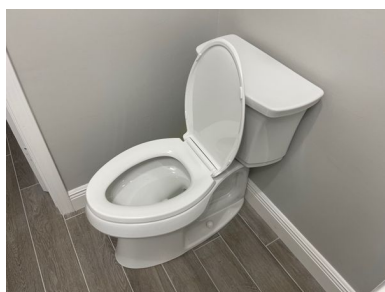
Master Bathroom

🟡Moderate/Repair Recommended

Loose toilets were observed. Loose toilets should be checked for leaks at the seal, re-secured, and sealed at the base.

Recommendation: Contact a qualified plumbing contractor.

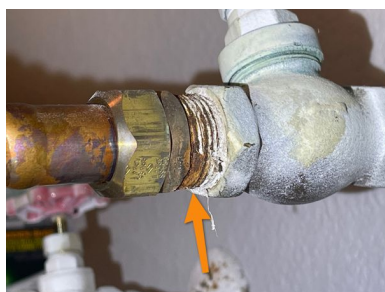
1: Water Lines: Rust/Corrosion

🟡Moderate/Repair Recommended

Rust/Corrosion was observed on areas of the water lines at the water heater. Over time, rust/corrosion can eat away at the water lines and cause leaks.

Recommendation: Contact a qualified plumbing contractor.

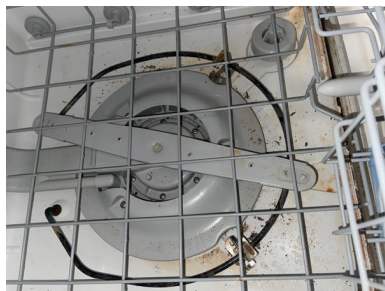
Staining was noted in the bottom of the dishwasher. Staining can indicate the dishwasher is not fully/properly draining.

Recommendation: Contact a qualified appliance repair professional.

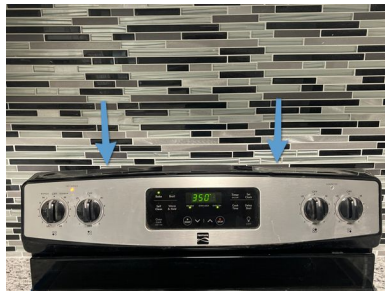
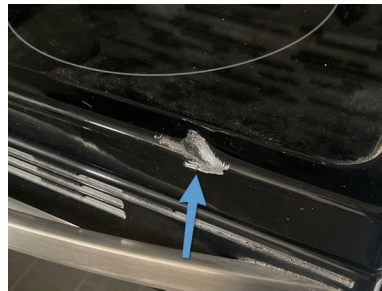
The oven was observed to be dented/damaged.

Recommendation: Contact a qualified professional.
