Inspection Report

Property Address:
2033 County Rd 6026
Dayton TX 77535

Sunbelt Inspections

PROPERTY INSPECTION REPORT FORM

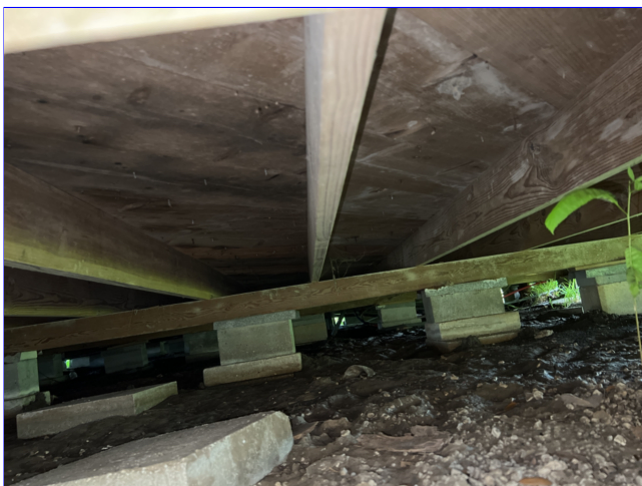
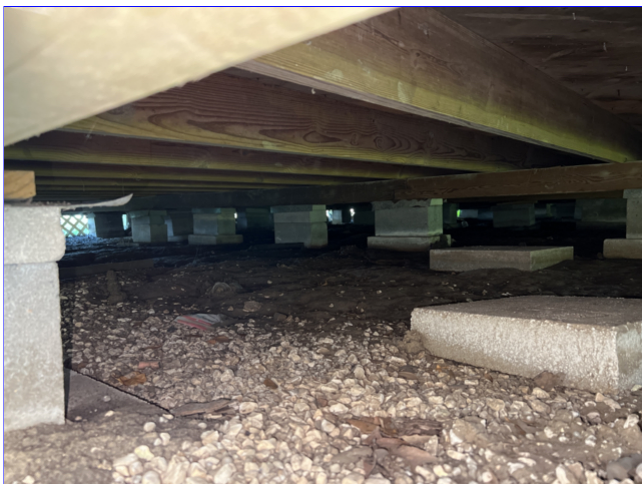
A. Photo 1(Picture) Foundation pictures.

A. Photo 2(Picture) Foundation pictures.

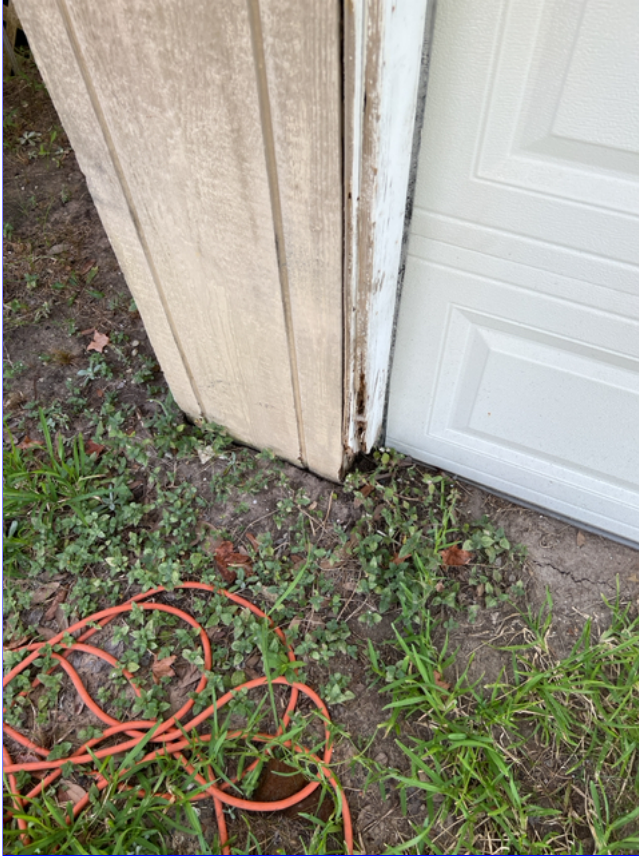
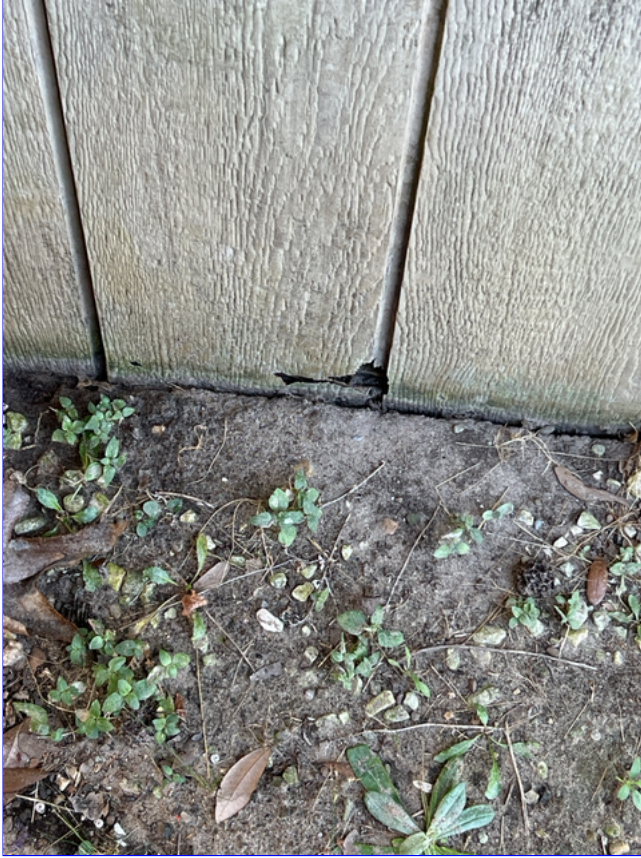
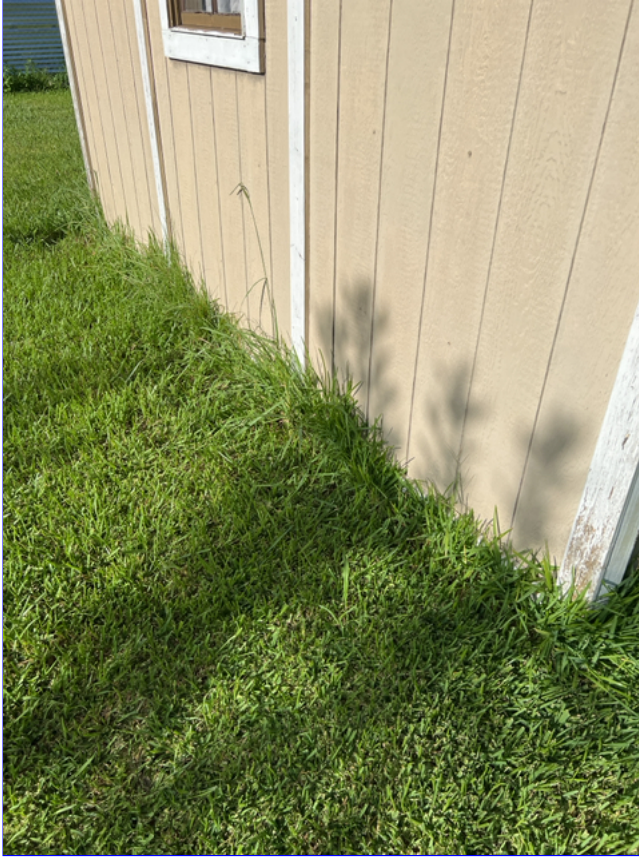
The grading and drainage around the garage is deficient. Soil levels around the garage are causing wood

rot around much of the base of the siding. With the slab being so close to the grade, water is coming in through base of the wall and entering the interior space. Fungal growth as well as moisture damage was observed on the base of the interior walls.

B. Photo 1(Picture) The grading and drainage around the garage is deficient.

B. Photo 2(Picture) The grading and drainage around the garage is deficient.

B. Photo 3(Picture) The grading and drainage around the garage is deficient.

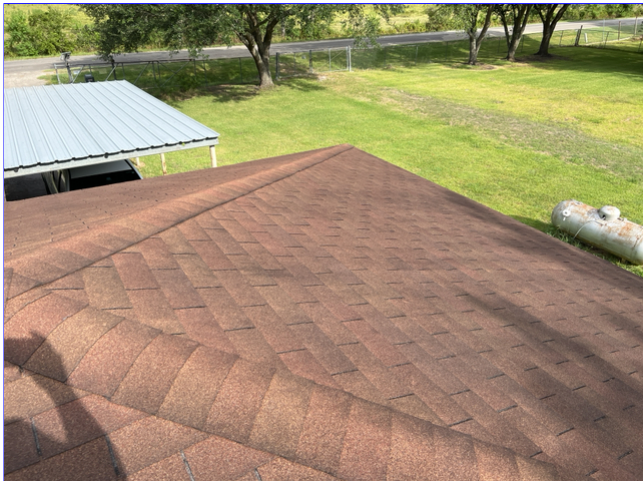
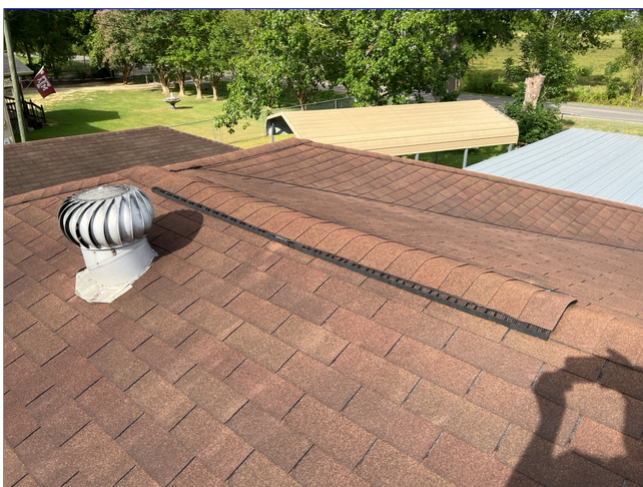
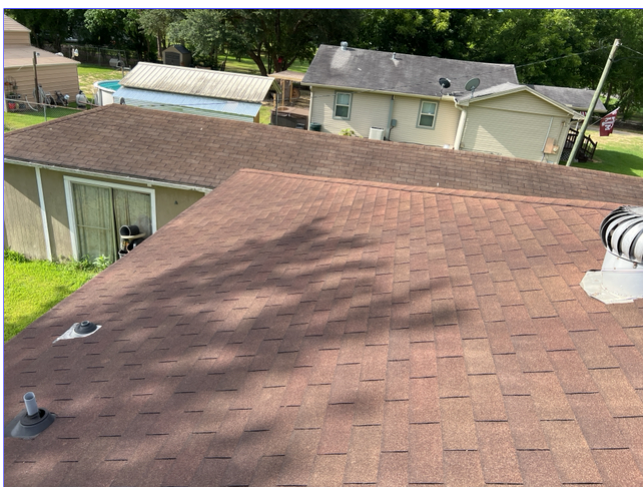
(1) The roof covering is not new and shows signs of wear consistent with its age. The overall condition of the roof covering is not new and is in need of repair. This roof covering is probably around 10-12 years old. This type of 3-tab composition shingles typically lasts about 15 years in this climate.

C. Photo 1(Picture) Roof pictures

C. Photo 2(Picture) Roof pictures

C. Photo 3(Picture) Roof pictures

A general seal up of roof penetrations, exposed nail heads and flashings is recommended as routine maintenance.

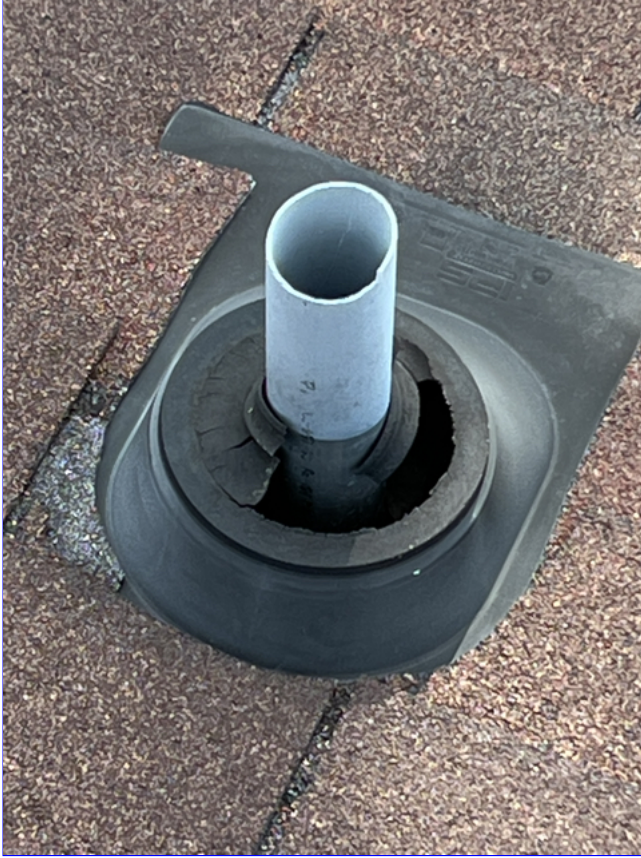
(2) Both of the roof jacks above the kitchen area need to be replaced. One of the roof jacks needs to have the piping extended

C. Photo 4(Picture) Both of the roof jacks above the kitchen area need to be replaced.

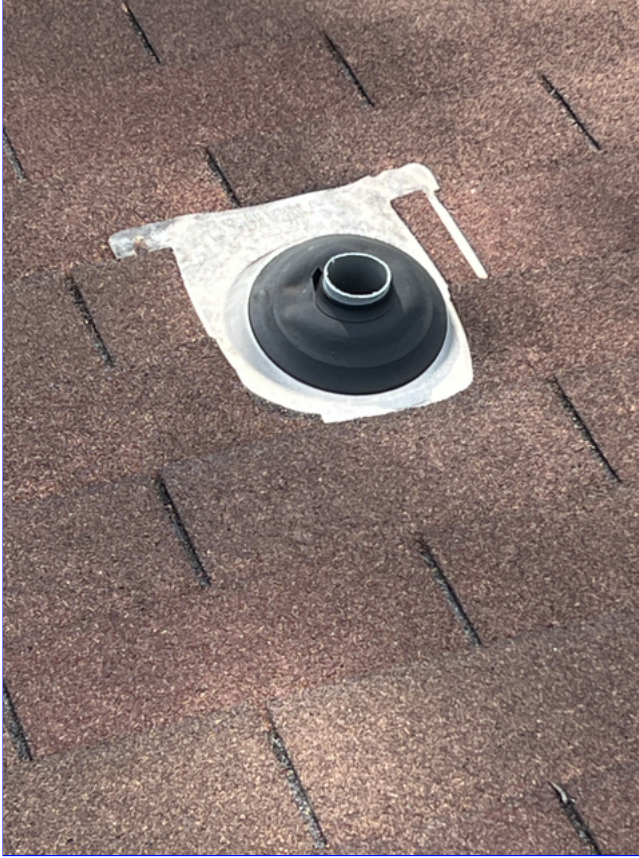
C. Photo 5(Picture) One of the roof jacks needs to have the piping extended

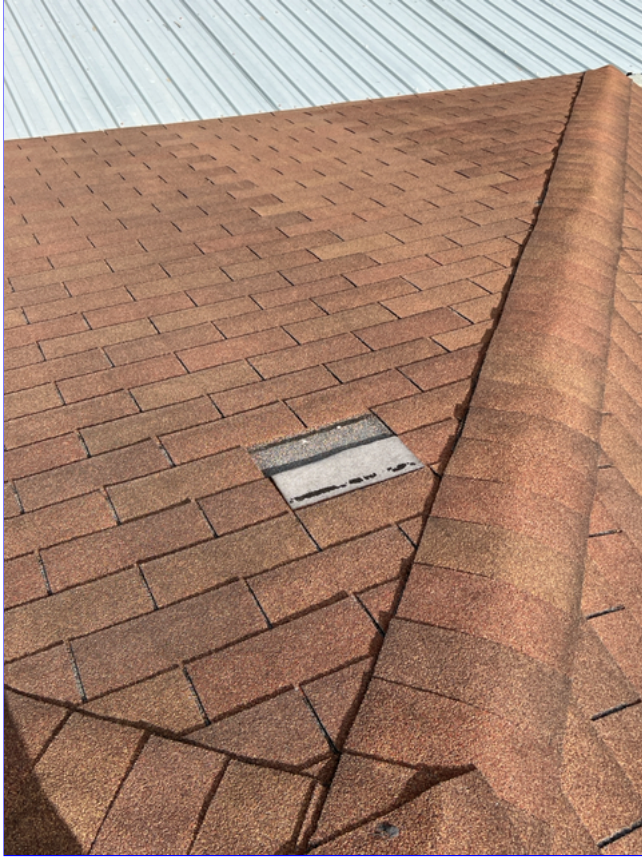
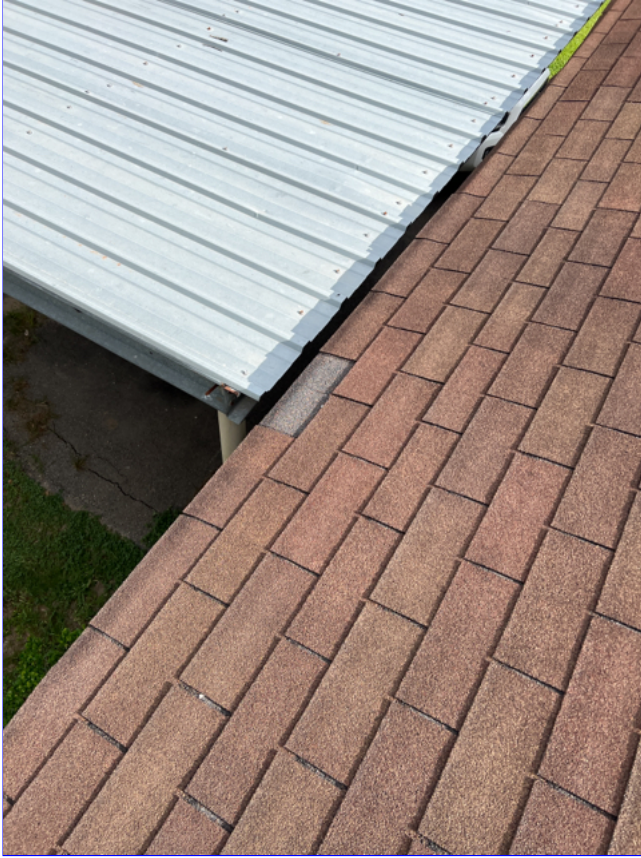
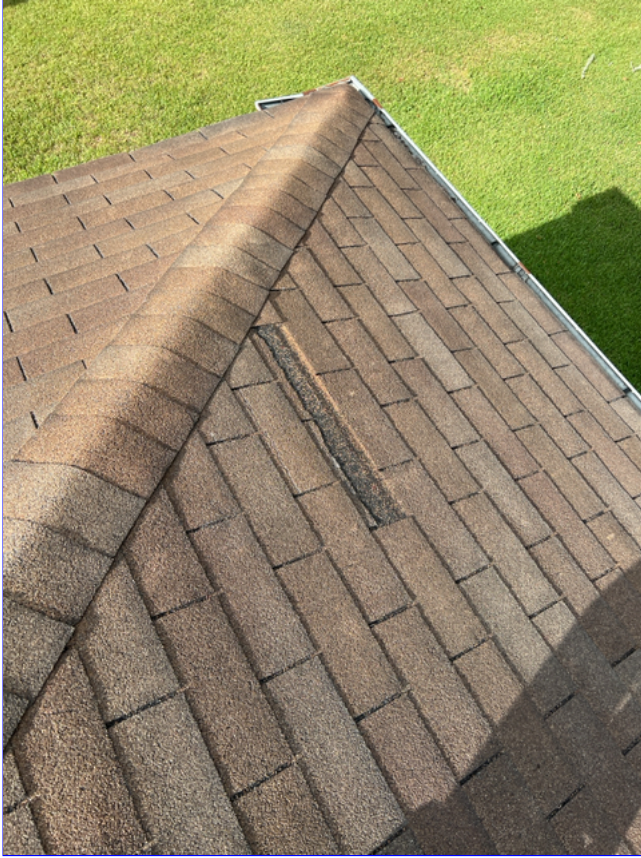
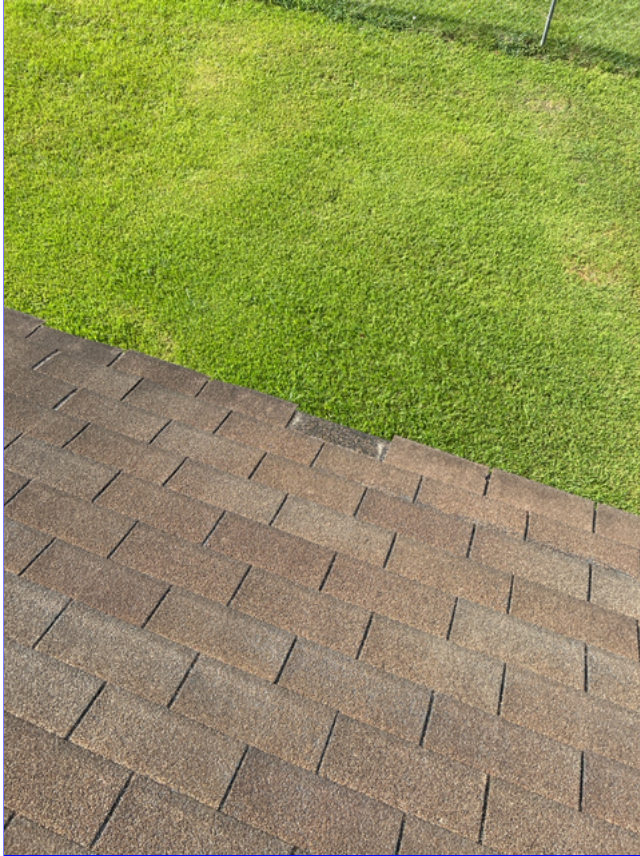
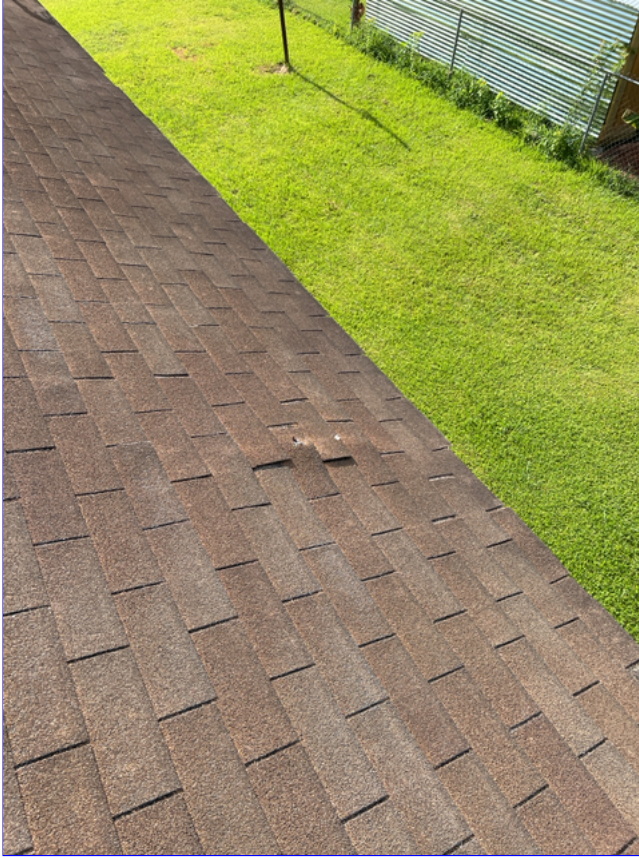
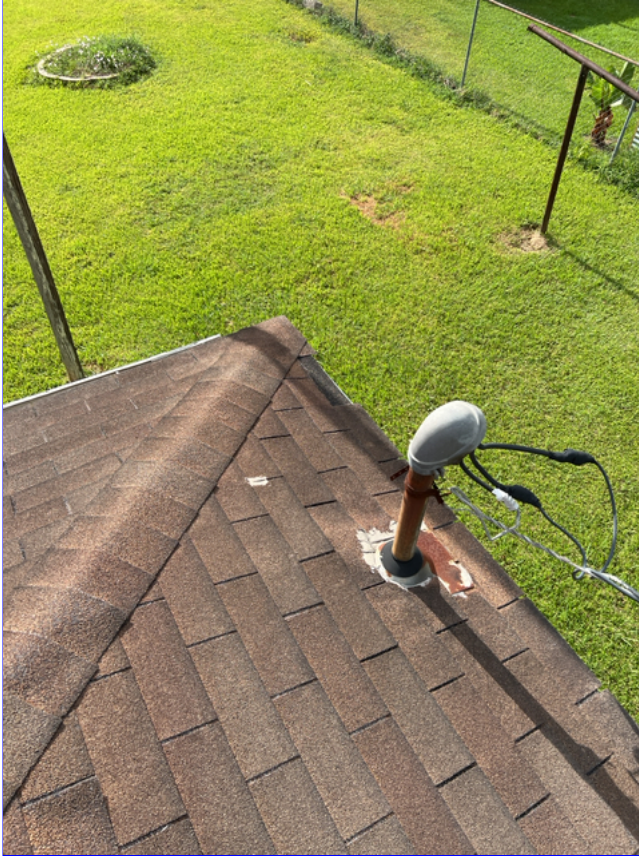
(3) Several missing and damage shingles were observed on the roof. Recommend correction.

C. Photo 6(Picture) Several missing and damage shingles were observed on the roof.

C. Photo 7(Picture) Several missing and damage shingles were observed on the roof.

C. Photo 8(Picture) Several missing and damage shingles were observed on the roof.

C. Photo 9(Picture) Several missing and damage shingles were observed on the roof.

C. Photo 10(Picture) Several missing and damage shingles were observed on the roof.

C. Photo 11(Picture) Several missing and damage shingles were observed on the roof.

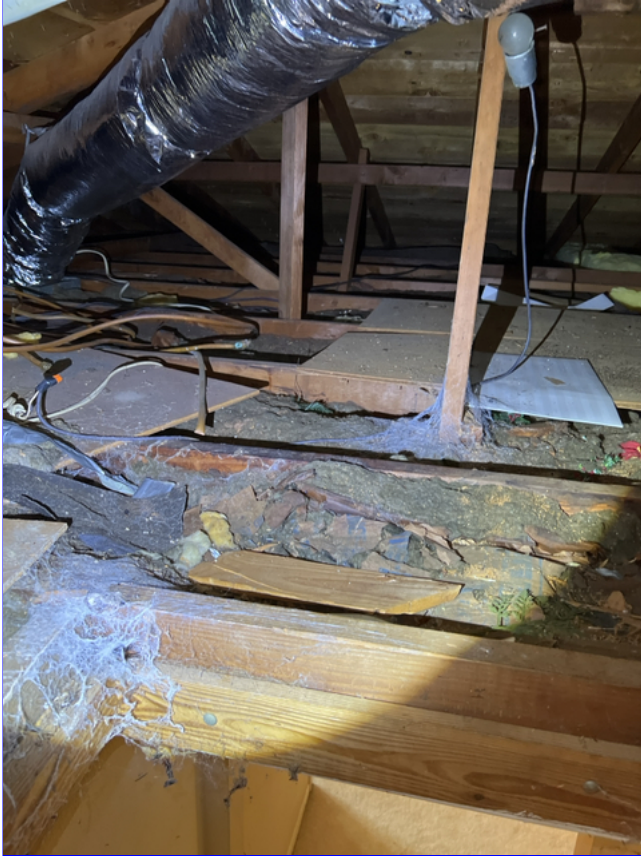
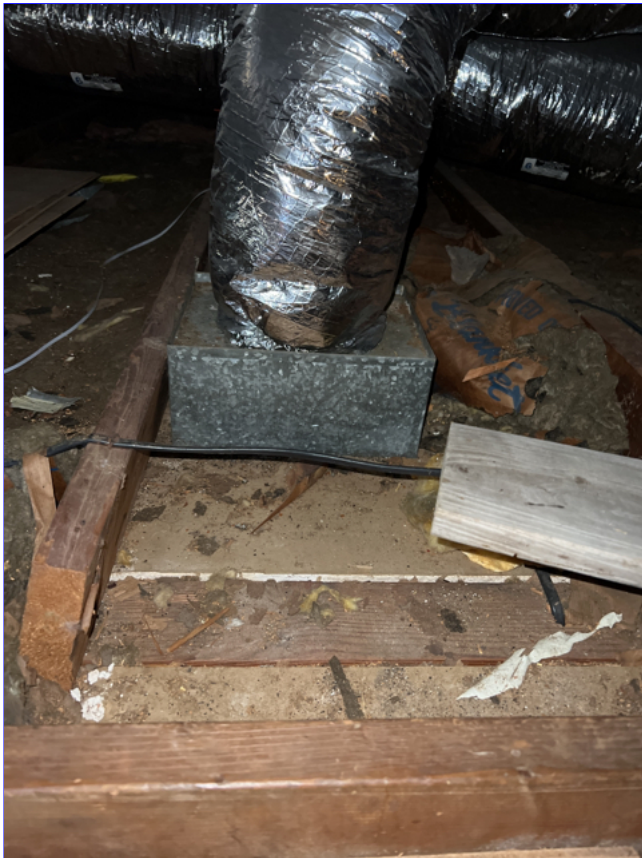
The insulation in the attic is matted down and no longer insulating as intended. Insulation is also missing in places.

D. Photo 1(Picture) The insulation in the attic is matted down and no longer insulating as intended.

D. Photo 2(Picture) The insulation in the attic is matted down and no longer insulating as intended.

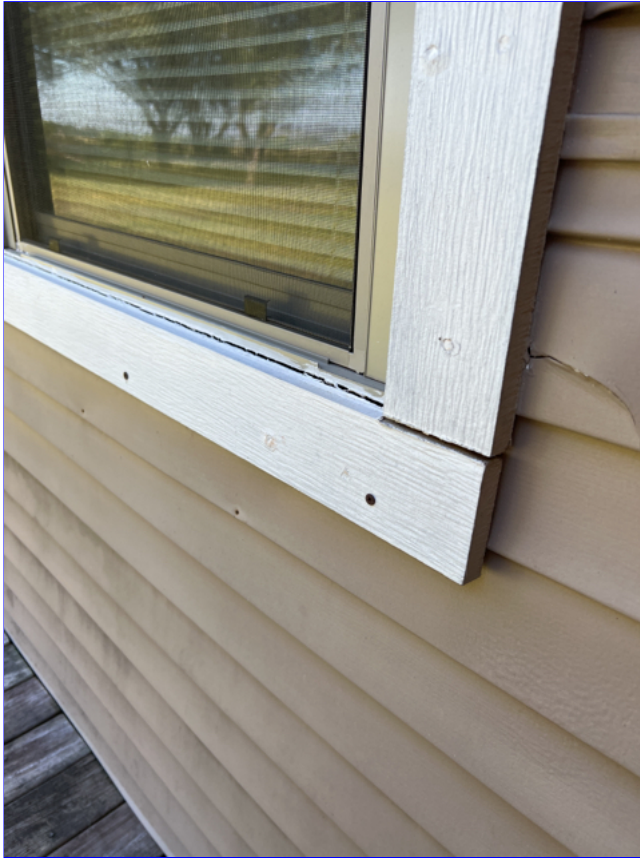
(1) Separation in the trim around the windows was observed. This is due to settlement in the house. I recommend correction.

E. Photo 1(Picture) Separation in the trim around the windows was observed.

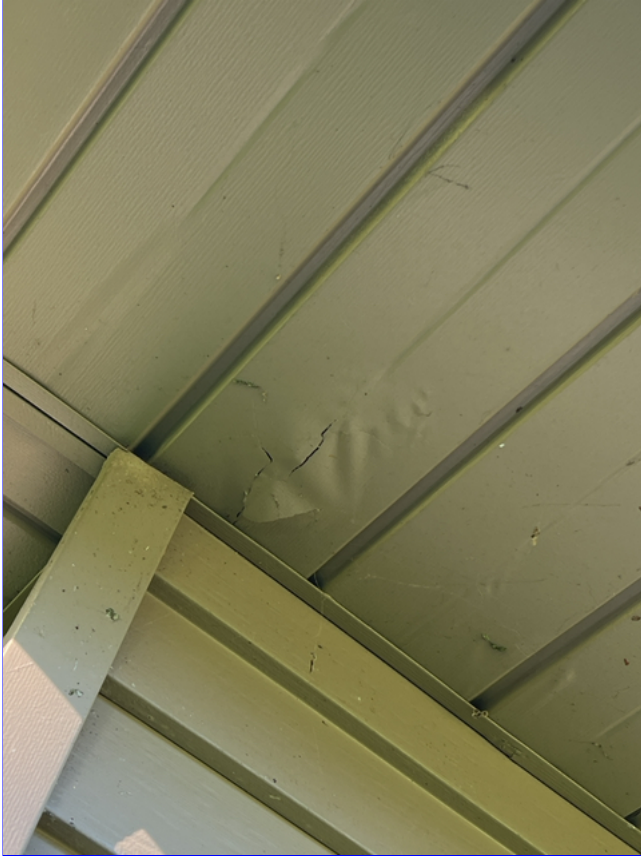
(2) The underside of the soffit around the home has many locations, where the paint is peeling and needs to be repainted.

E. Photo 2(Picture) paint is peeling

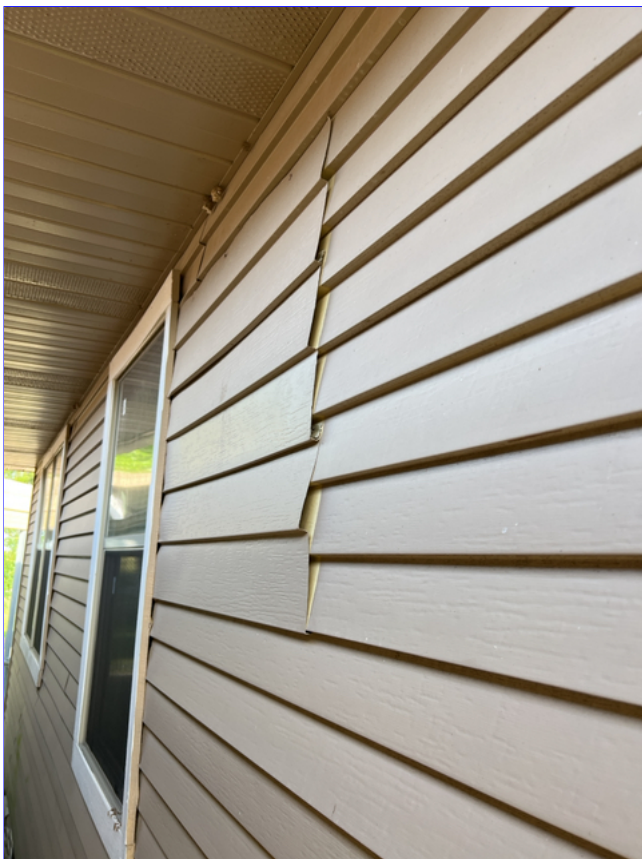
(3) The section of siding was replaced on the right side of the house. The wrong size siding was installed which is now causing large gaps.

E. Photo 3(Picture) The wrong size siding was installed which is now causing large gaps.

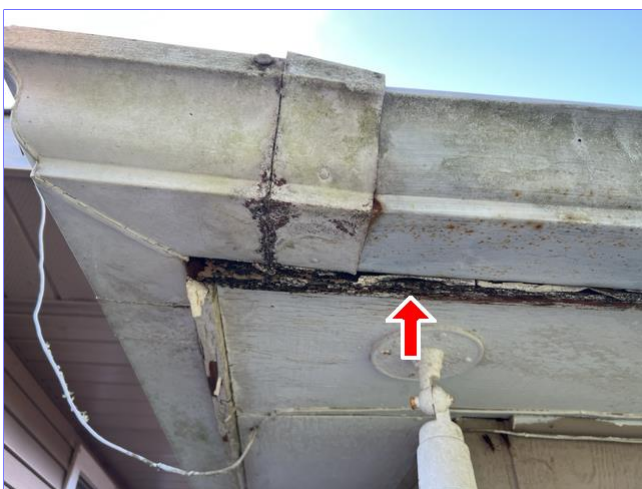
(4) The fascia board behind the gutters on the garage is showing wood rot around most of the garage. The gutters are also in poor condition and appear to be leaking at the seams of the gutter.

E. Photo 4(Picture) The fascia board behind the gutters on the garage is showing wood rot around most of the garage.

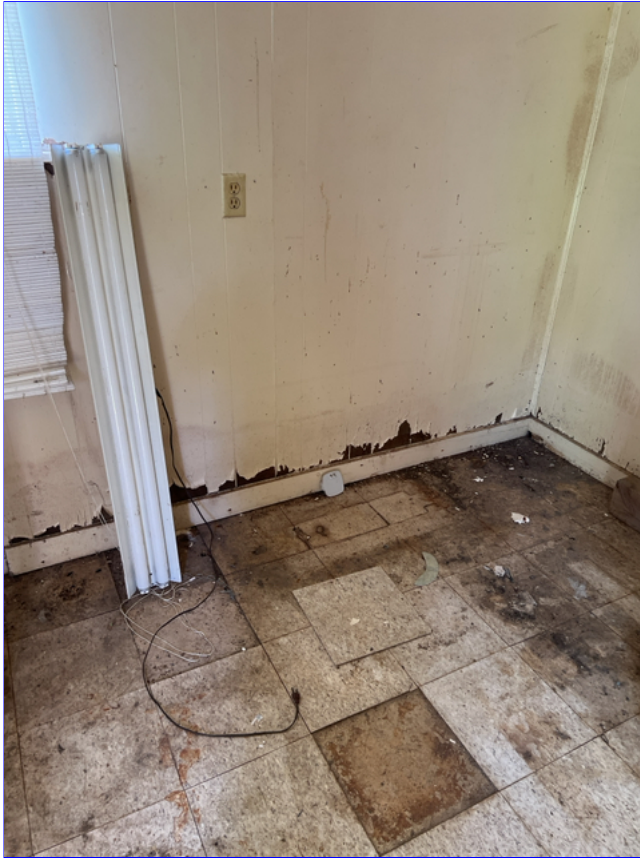
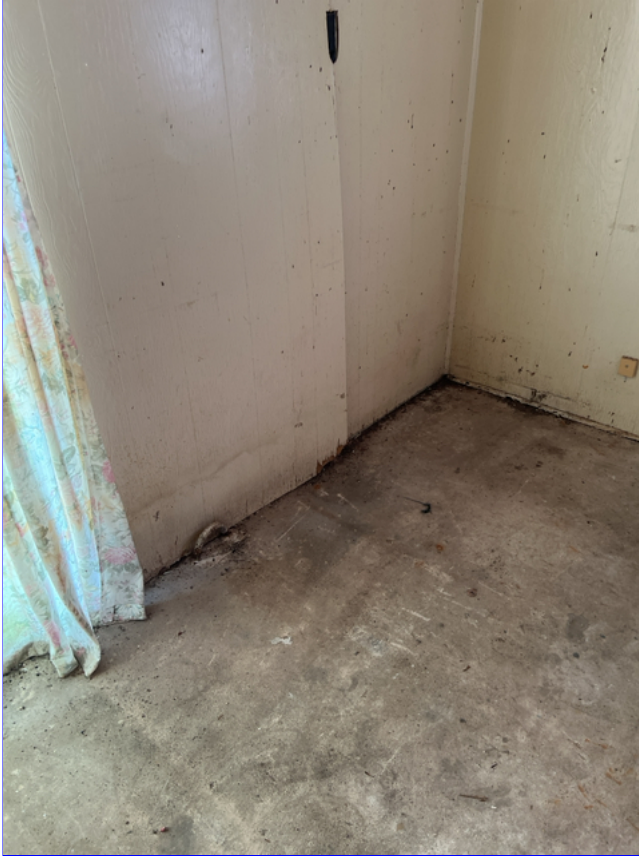
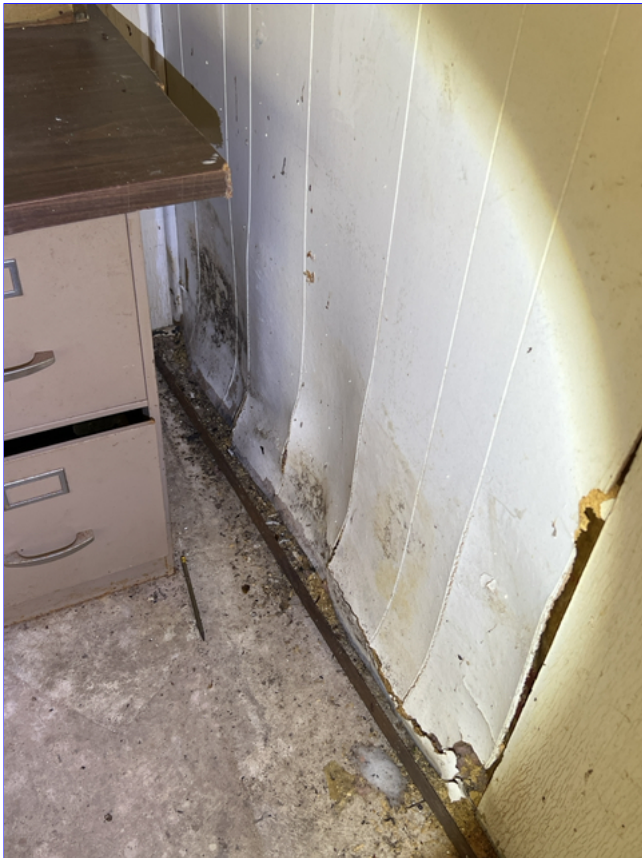
(5) The poor drainage around the outside of the garage has caused moisture damage to the interior walls.

E. Photo 5(Picture) The poor drainage around the outside of the garage has caused moisture damage to the interior walls.

E. Photo 6(Picture) The poor drainage around the outside of the garage has caused moisture damage to the interior walls.

E. Photo 7(Picture) The poor drainage around the outside of the garage has caused moisture damage to the interior walls.

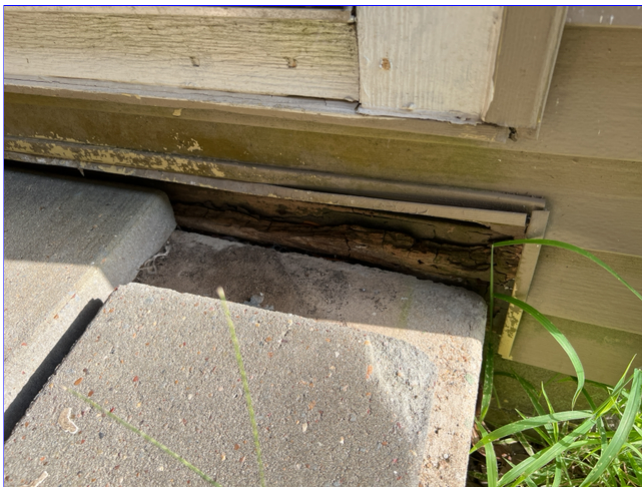
(6) Wood rot was observed at the wall under the back door to the home.

E. Photo 8(Picture) Wood rot was observed at the wall under the back door to the home.

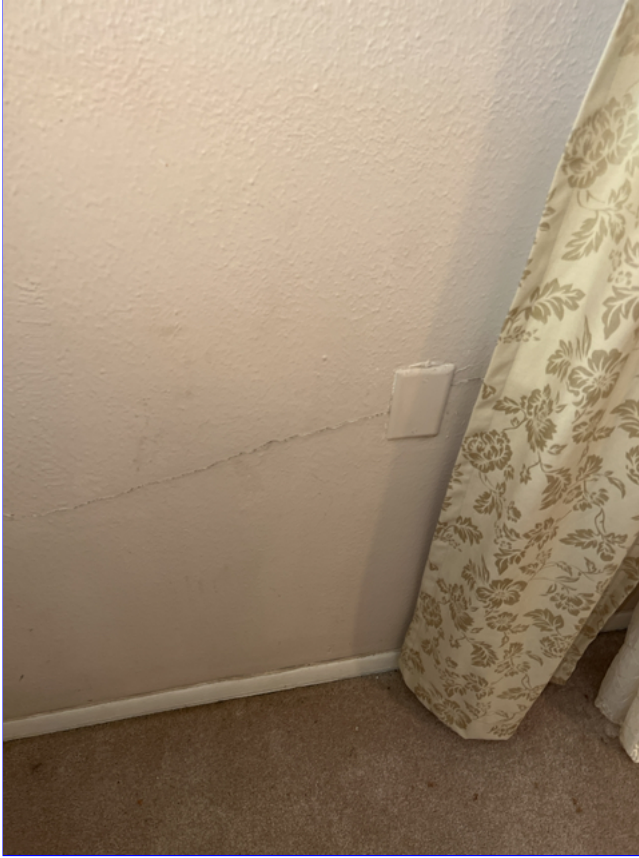
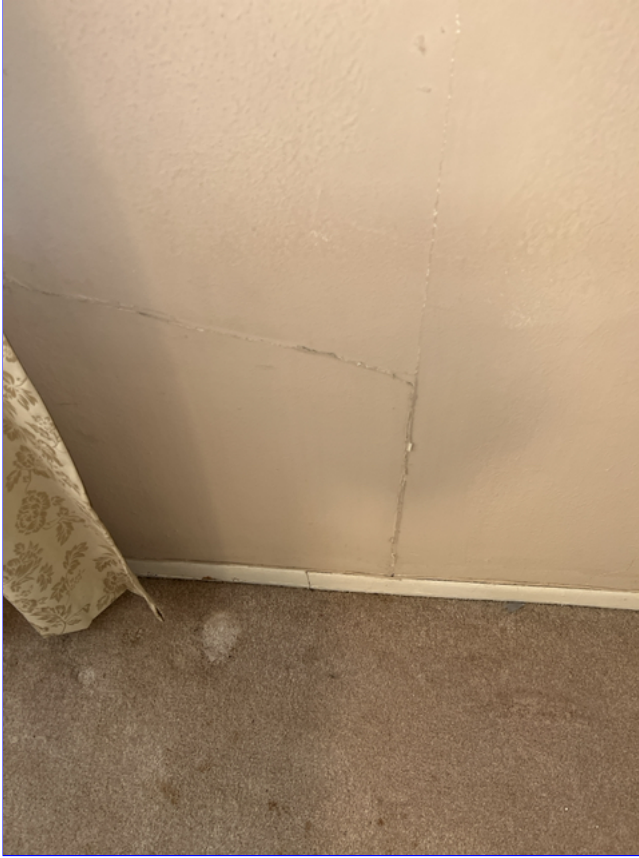
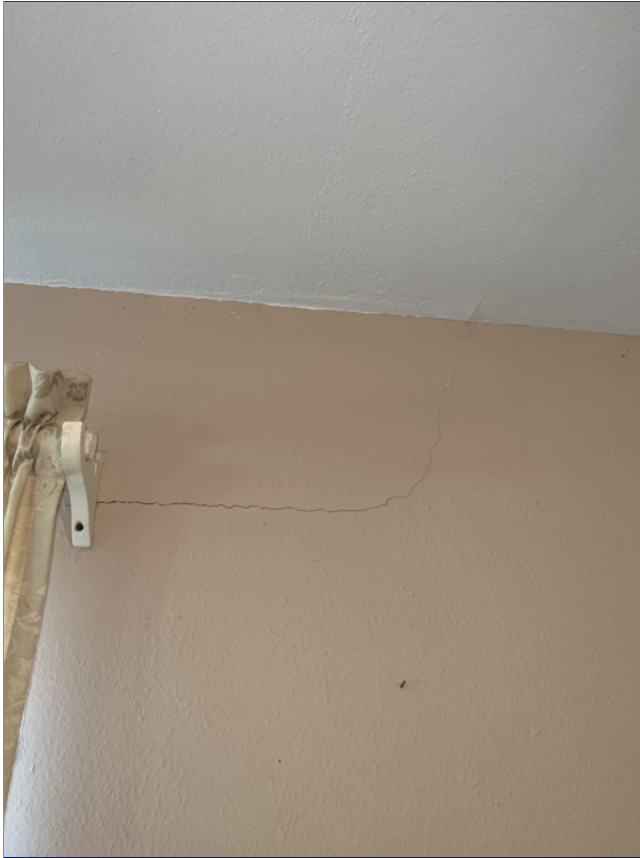
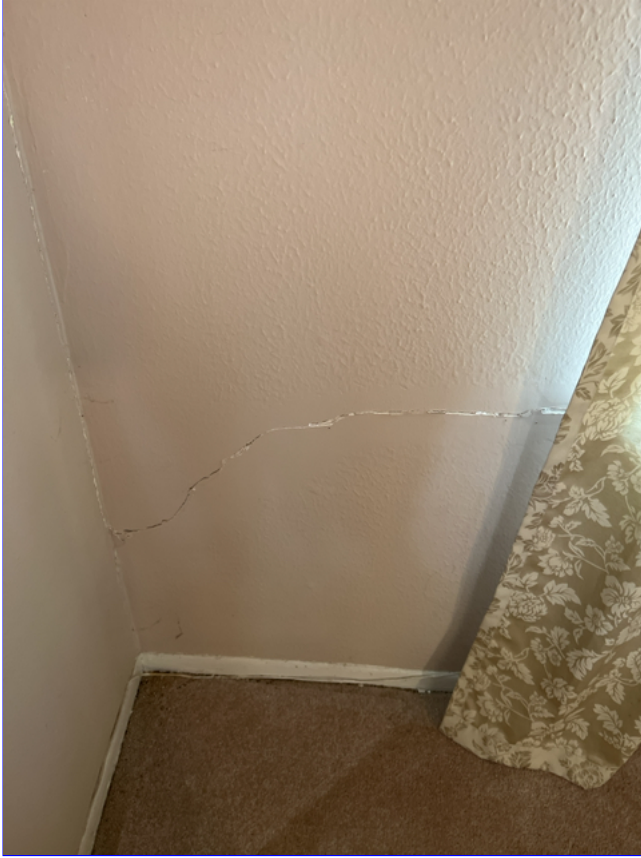
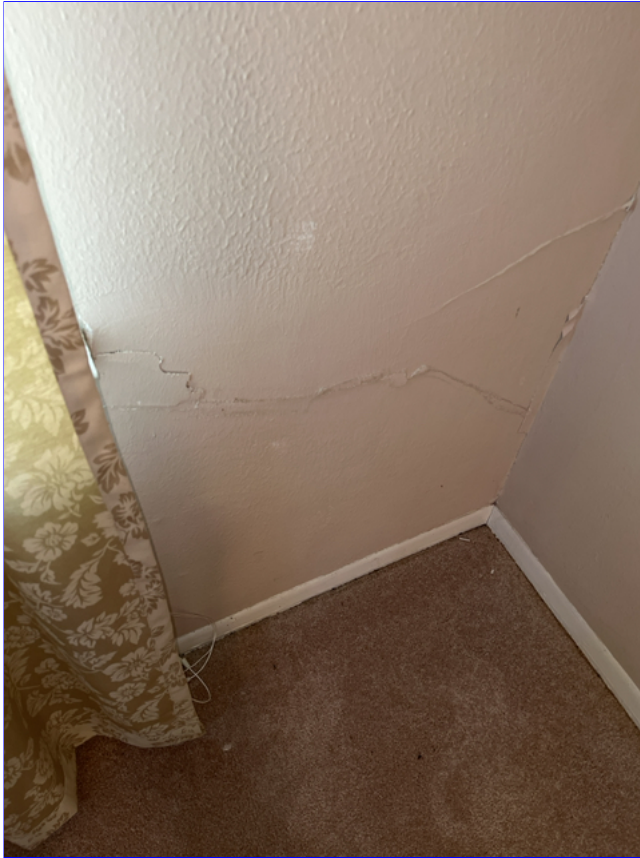
(7) The drywall on the inside of the home has many structural cracks throughout. Some of these cracks have been previously repaired and returned.

E. Photo 9(Picture) The drywall on the inside of the home has many structural cracks throughout.

E. Photo 10(Picture) The drywall on the inside of the home has many structural cracks throughout.

E. Photo 11(Picture) The drywall on the inside of the home has many structural cracks throughout.

E. Photo 12(Picture) The drywall on the inside of the home has many structural cracks throughout.

E. Photo 13(Picture) The drywall on the inside of the home has many structural cracks throughout.

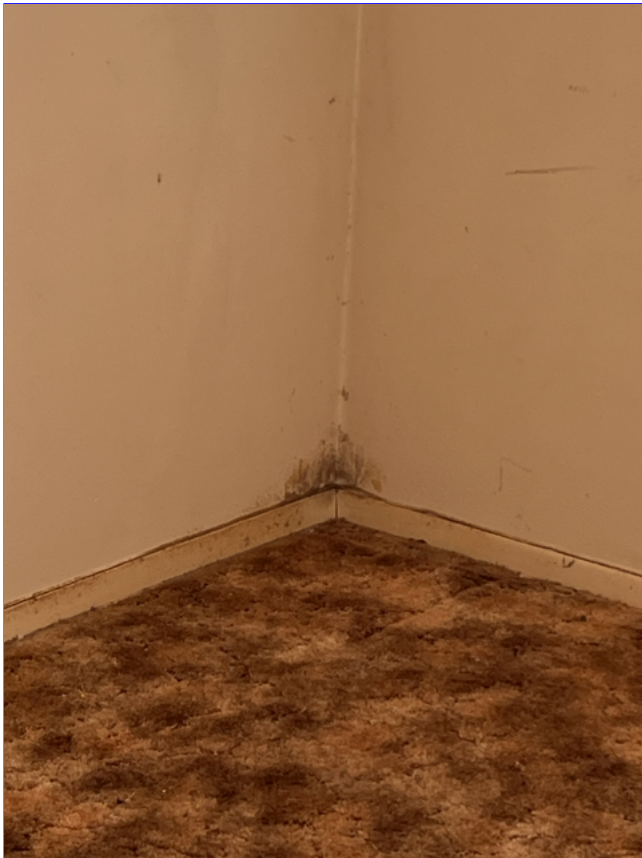
(8) Stain was observed at the bottom of the wall in the corner of the left rear bedroom. I am unable to determine the cause of the stain and it tested dry during the inspection.

E. Photo 14(Picture) Stain was observed at the bottom of the wall in the corner of the left rear bedroom.

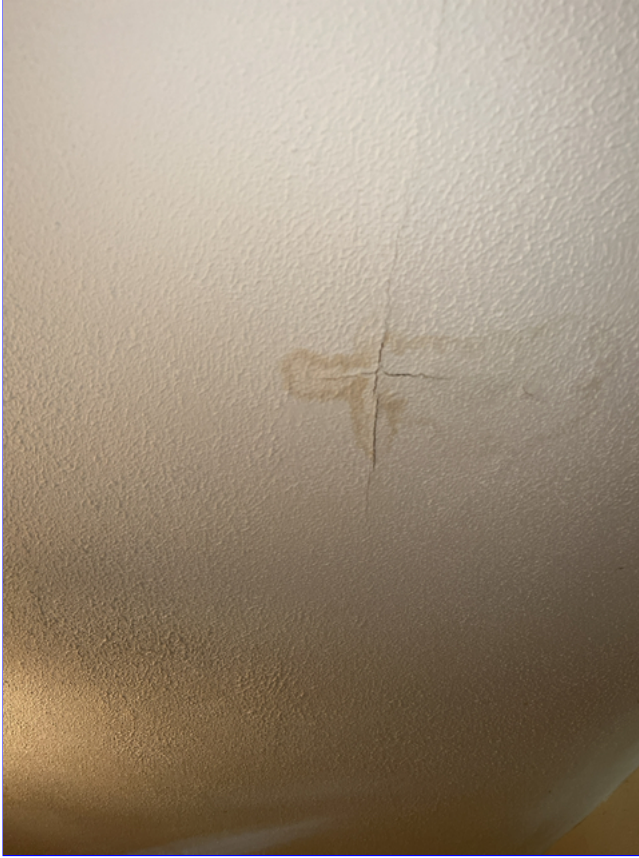
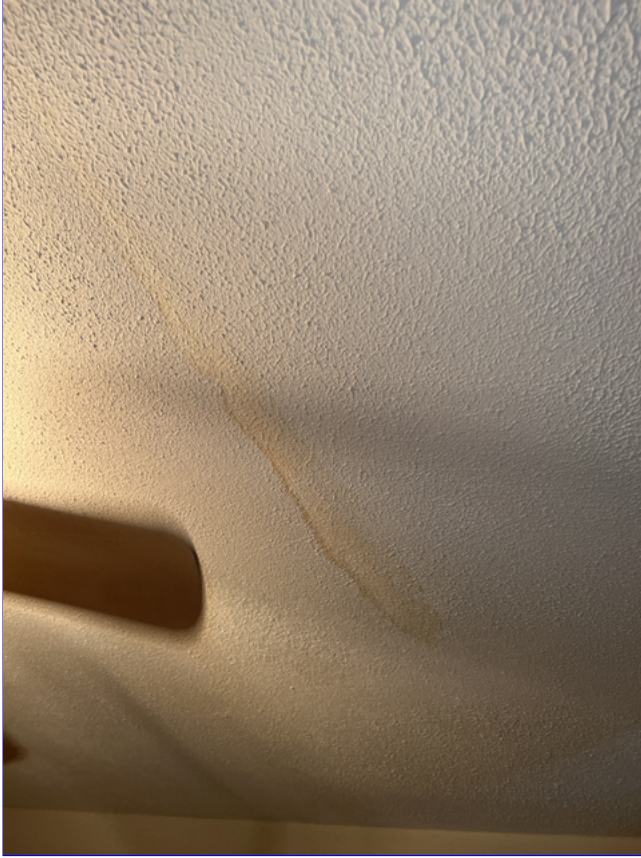
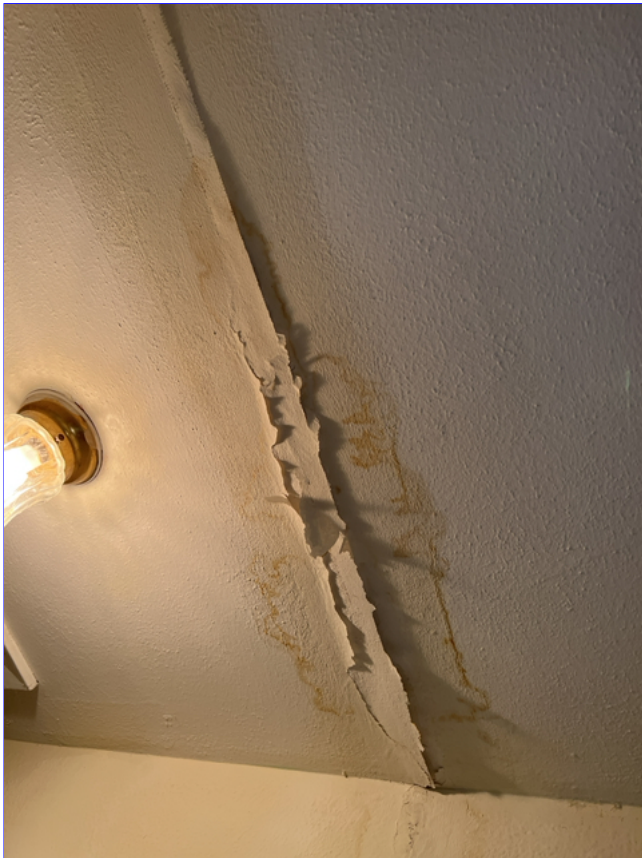
Water stains were observed to the ceiling in the front middle bedroom of the house. Hey staying was also visible to the ceiling in the hallway.

F. Photo 1(Picture) Water stains were observed to the ceiling in the front middle bedroom of the house.

F. Photo 2(Picture) Water stains were observed to the ceiling in the front middle bedroom of the house.

F. Photo 3(Picture) Water stains were observed to the ceiling in the front middle bedroom of the house.

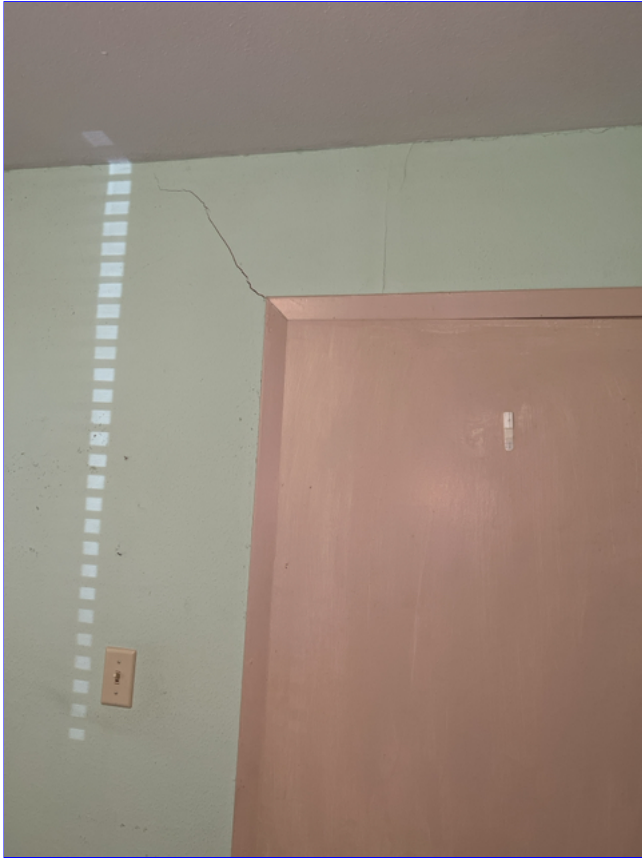
G. Photo 1(Picture) The left front bedroom door will not close because it is hitting the frame.

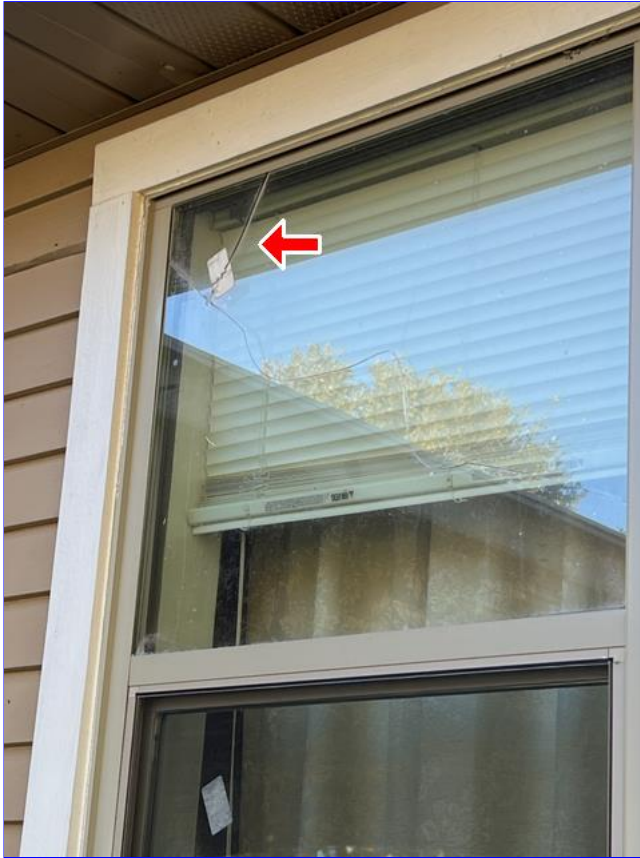
(1) A window at the front of the home has a broken pane of glass. Recommend correction.

H. Photo 1(Picture) A window at the front of the home has a broken pane of glass.

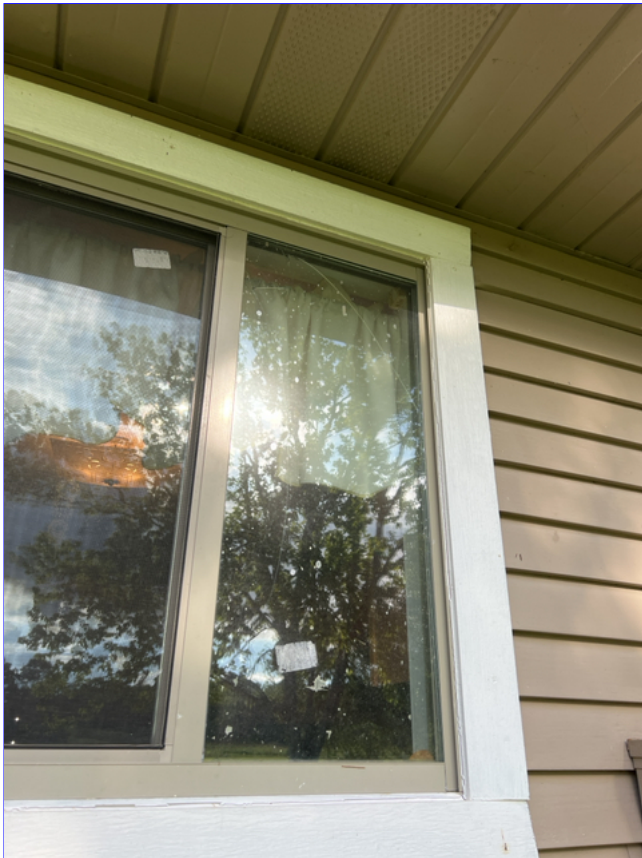
(2) A window at the rear of the home has a broken pane of glass. Recommend correction.

H. Photo 2(Picture) A window at the rear of the home has a broken pane of glass.

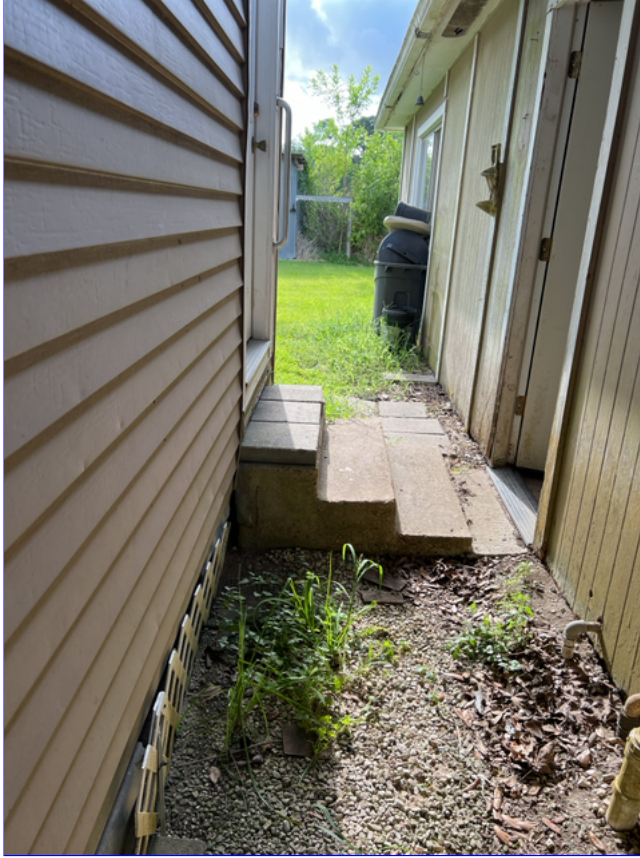
I. Photo 1(Picture) If more than three stairs are going into the home a hand rail is required.

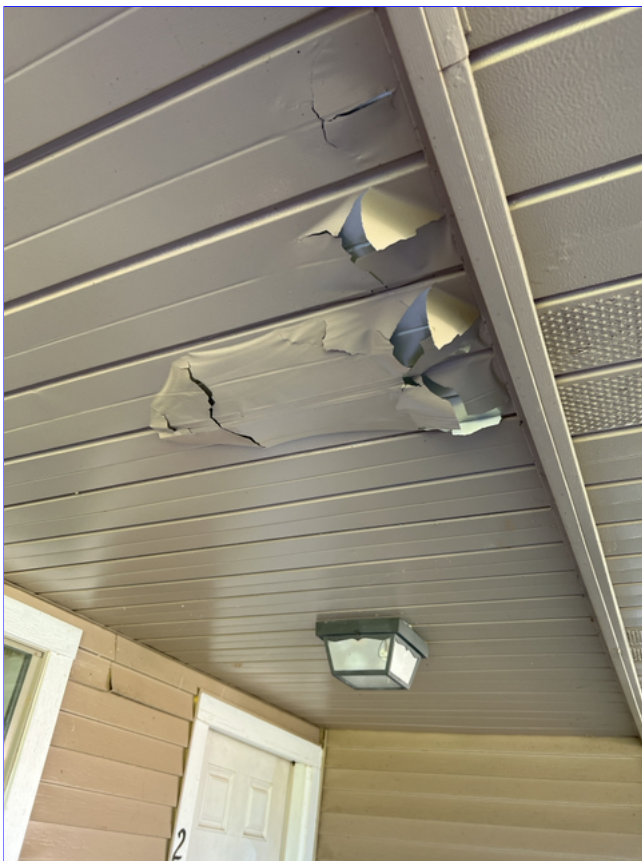
Paint is missing and peeling away under the front porch. Recommend correction.

K. Photo 1(Picture) Paint is missing and peeling away under the front porch.

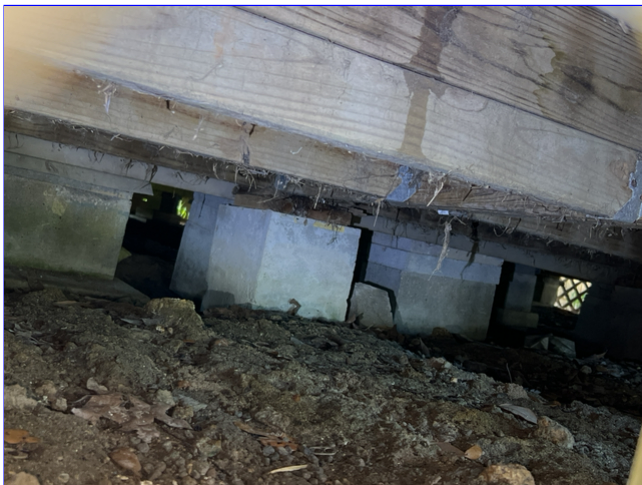
Termite shields are missing on top of some of the blocks under the house. Recommend correction.

L. Photo 1(Picture) Termite shields are missing on top of some of the blocks under the house.

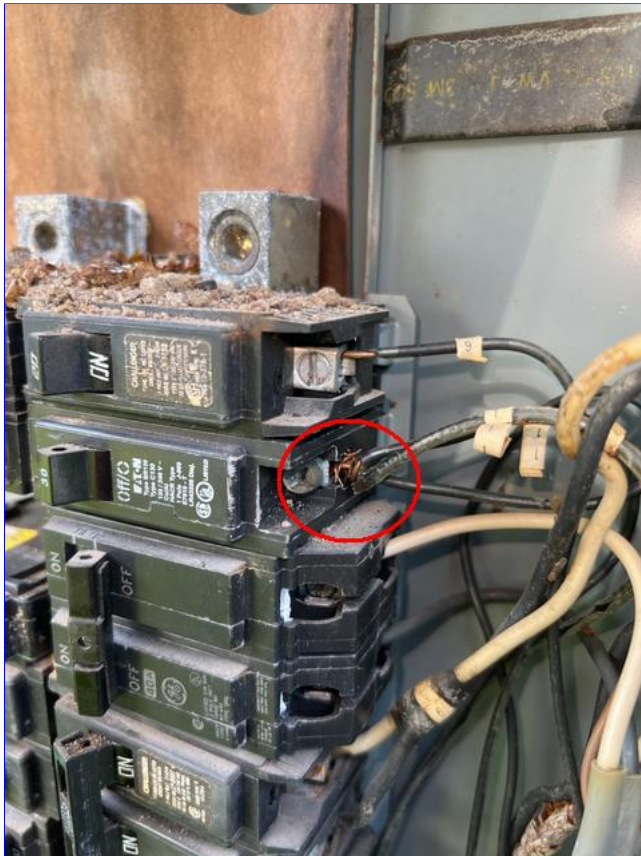
- (1) Open breaker knockouts need filler plates installed. Recommend correction.
- (2) Some breakers, are triple tapped. This is a safety issue that should be request repaired

A. Photo 1(Picture) Some breakers, are triple tapped.
