Inspection Report

Property Address:
2033 County Rd 6026
Dayton TX 77535

Sunbelt Inspections

PROPERTY INSPECTION REPORT FORM

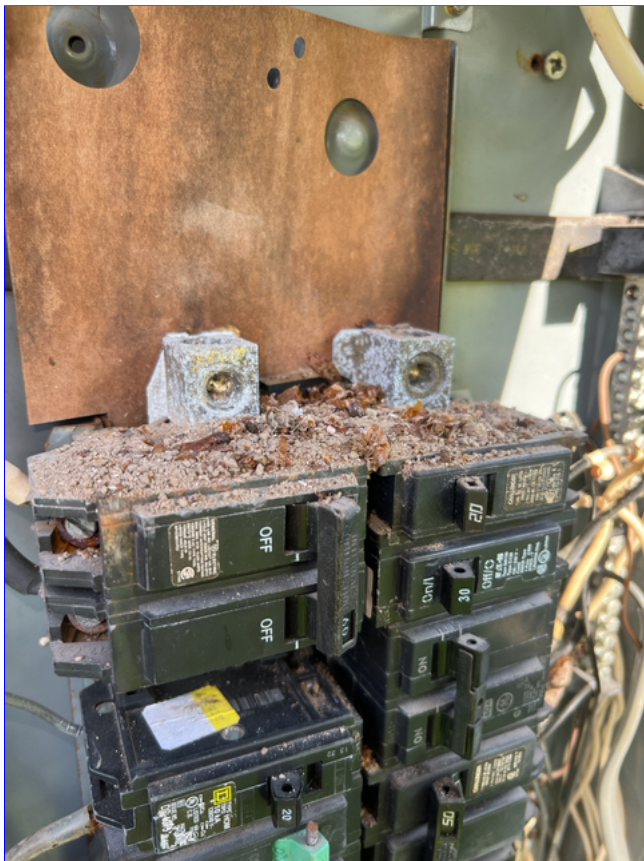
(3) The main lugs and bus bar inside the electric panel are showing corrosion. I recommend having a licensed electrician further evaluate the panel and wiring.

A. Photo 2(Picture) The main lugs and bus bar inside the electric panel are showing corrosion.

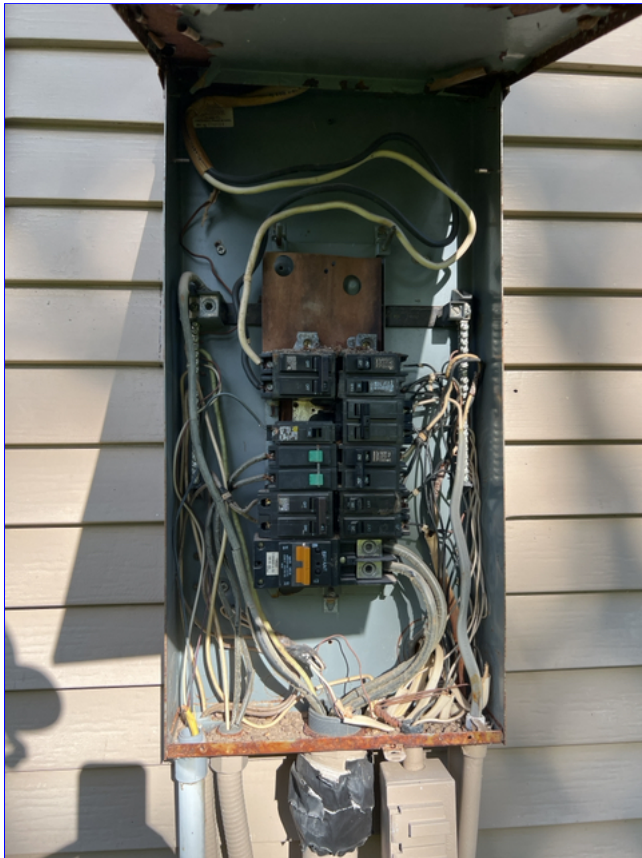
(4) The main electrical service panel, shown with dead front cover removed for inspection purposes. The panel inspected okay.

A. Photo 3(Picture) The main electrical service panel

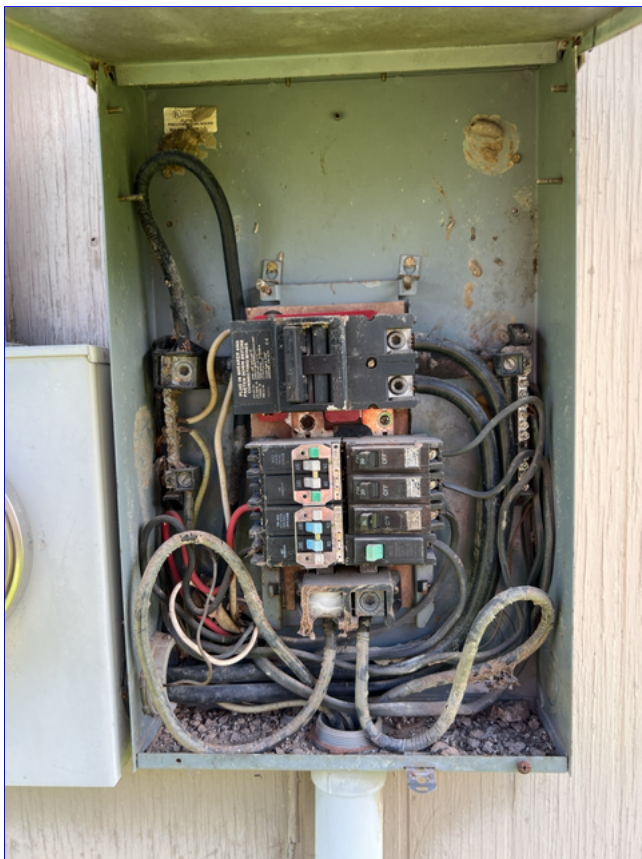
(5) The main electrical panel was located at the backside of the garage. The panel is missing a dead front cover which is a safety hazard and also supplies us with the labels that identify different breakers. The inside of the panel is corroded and has lots of debris from the elements. Recommend having this panel all cleaned up by a licensed electrical contractor.

A. Photo 4(Picture) The panel is missing a dead front cover which is a safety hazard

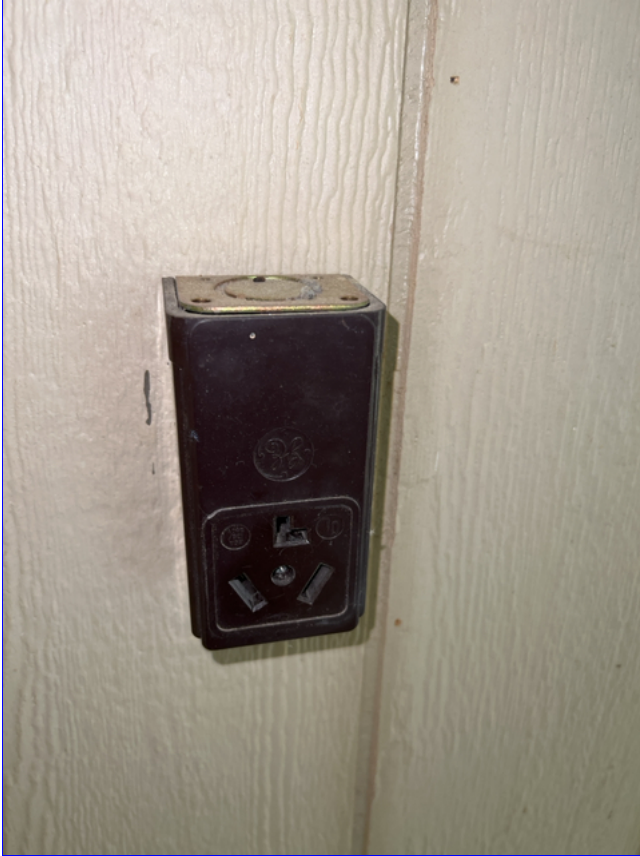
- (1) The breaker(s) serving A/C compressor unit(s) appear(s) oversized. A (60) amp breaker is serving an A/C condenser unit rated for a maximum of 40 amps. I recommend that the breaker be downsized to meet the A/C manufacturer's specifications.
- (2) Ground Fault Circuit Interrupters (GFCI's), were not observed to be installed in all required wet locations. GFCI's are intended to protect persons from accidental electrocution in locations susceptible to moisture. I recommend that you upgrade all applicable locations to GFCI protection for personal safety reasons.
- (3) The 220 volt outlet at the dryer location, is three prong. Most modern electric dryers use a four prong outlet.

B. Photo 1(Picture) The 220 volt outlet at the dryer location, is three prong.

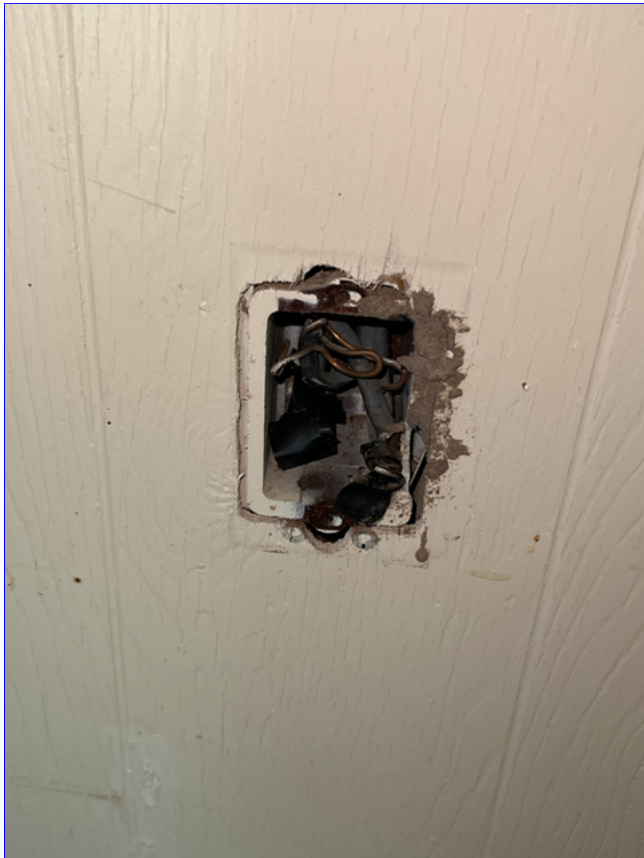
(4) A missing electrical outlet was observed in the garage.

B. Photo 2(Picture) A missing electrical outlet was observed in the garage.

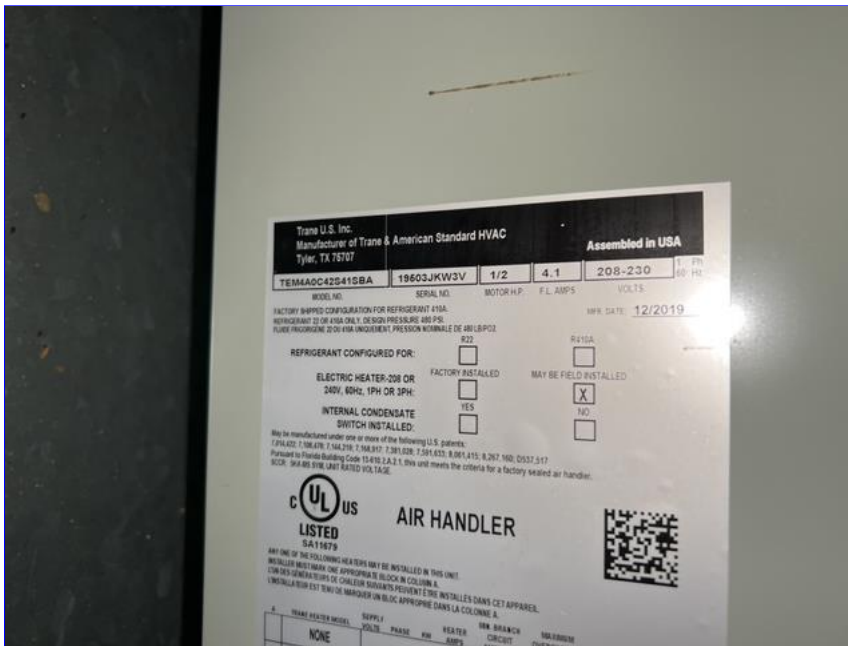
Furnace service tag. The furnace was manufactured in 2019. The furnace operated as intended.

A. Photo 1(Picture) Furnace service tag.

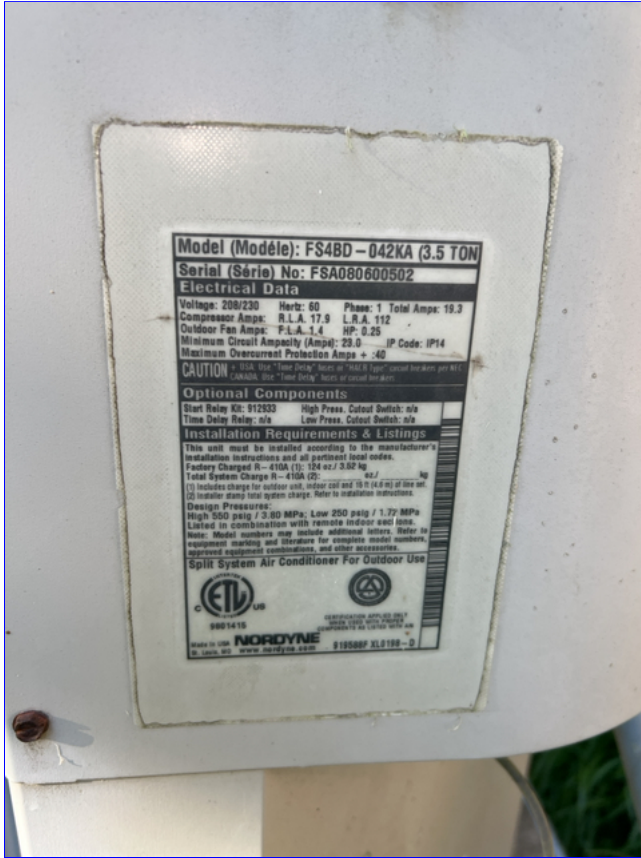
B. Photo 1(Picture) Air Conditioning service tag(s).

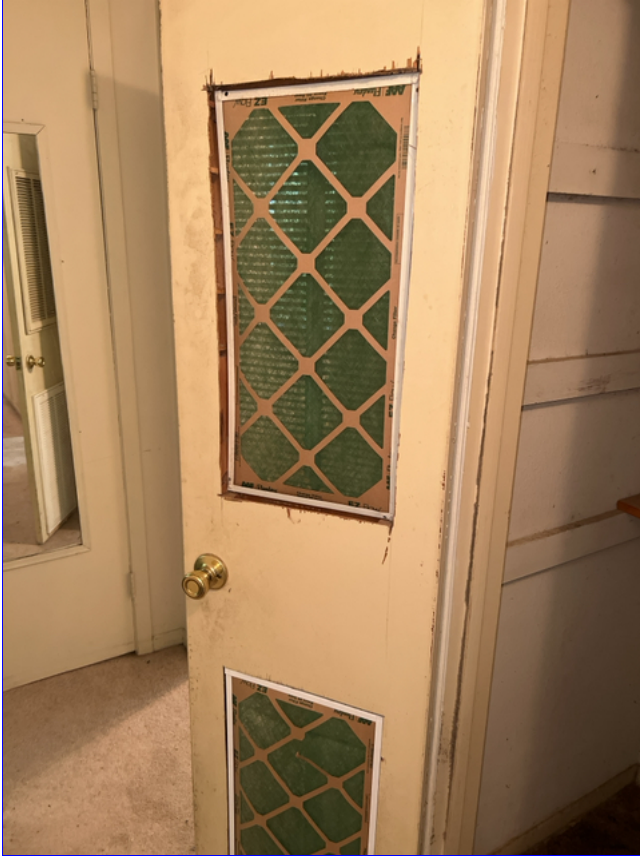
(1) Air Conditioning service tag(s). The manufacturing tag indicates the unit was manufactured in 2006. The return for the air conditioning system is located in the hallway closet. The hallway door has been cut out and filters have been installed. The interior space of this closet is showing moisture staining. The issue with this installation is that the door is not sealed and air and dirt can go past the filters and into the unit. I recommend removal of this return and having a licensed HVAC technician find a new place for it.

B. Photo 2(Picture) The hallway door has been cut out and filters have been installed.

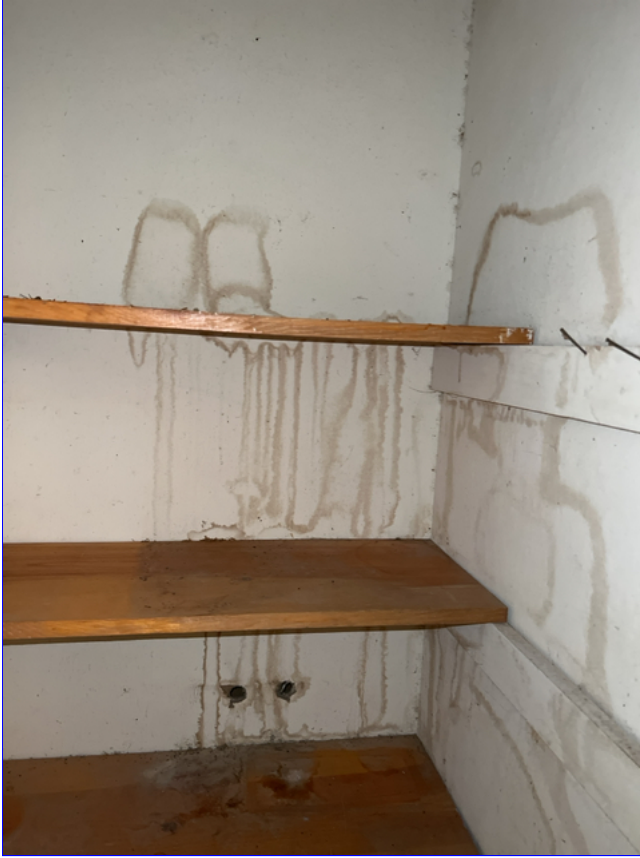
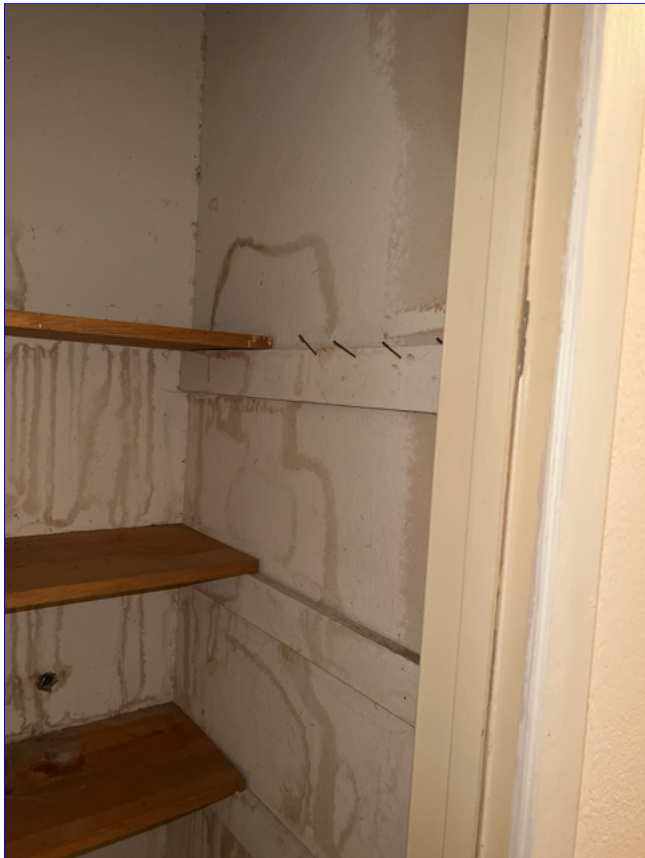
B. Photo 3(Picture) The interior space of this closet is showing moisture staining.

B. Photo 4(Picture) The interior space of this closet is showing moisture staining.

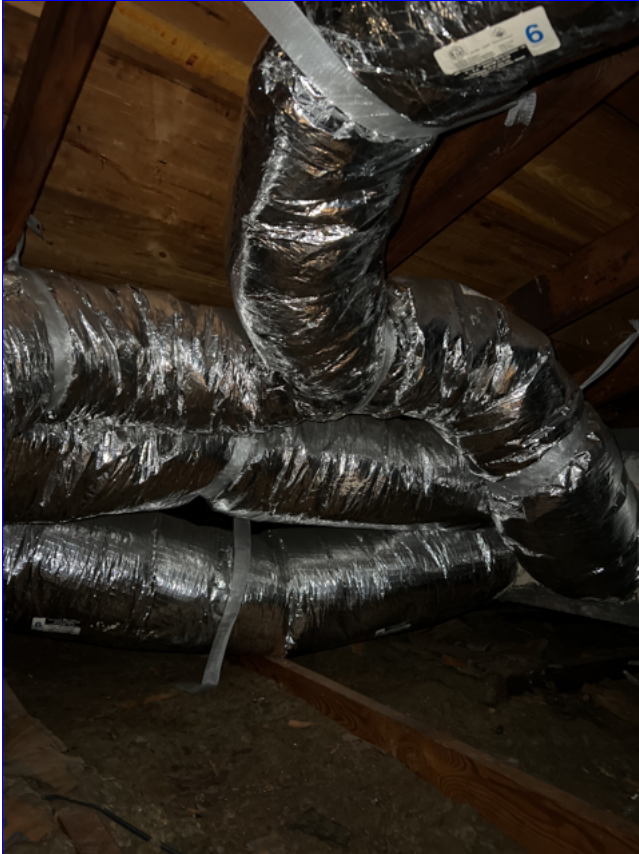
The ductwork in the home appears to have been replaced when the furnace was replaced. It only looks a couple years old.

C. Photo 1(Picture) The ductwork in the home appears to have been replaced when the furnace was replaced.

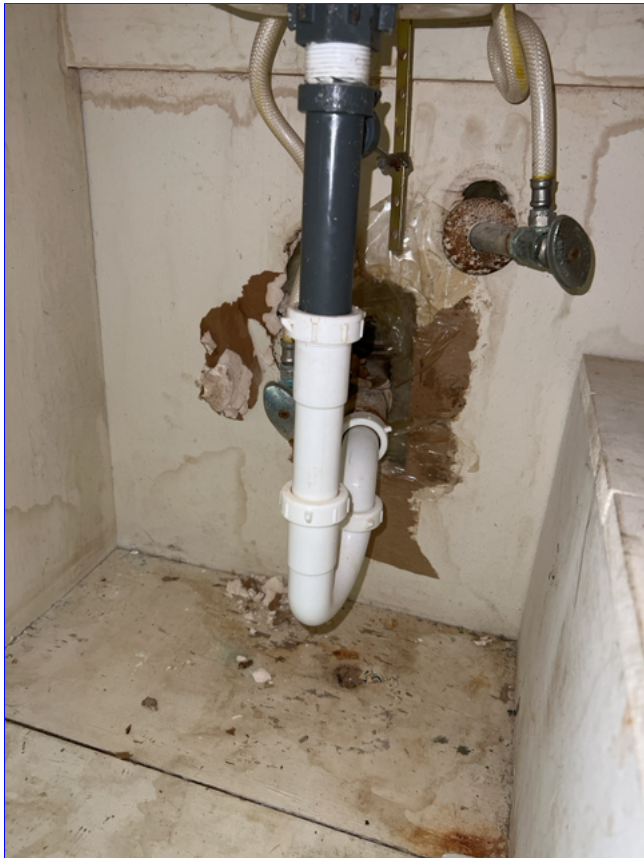
While no water could be ran down the drains of the home no signs of leaks were observed. I did observed where the wall behind the bathroom sink was damaged during repair.

B. Photo 1(Picture) I did observe where the wall behind the bathroom sink was damaged during repair.

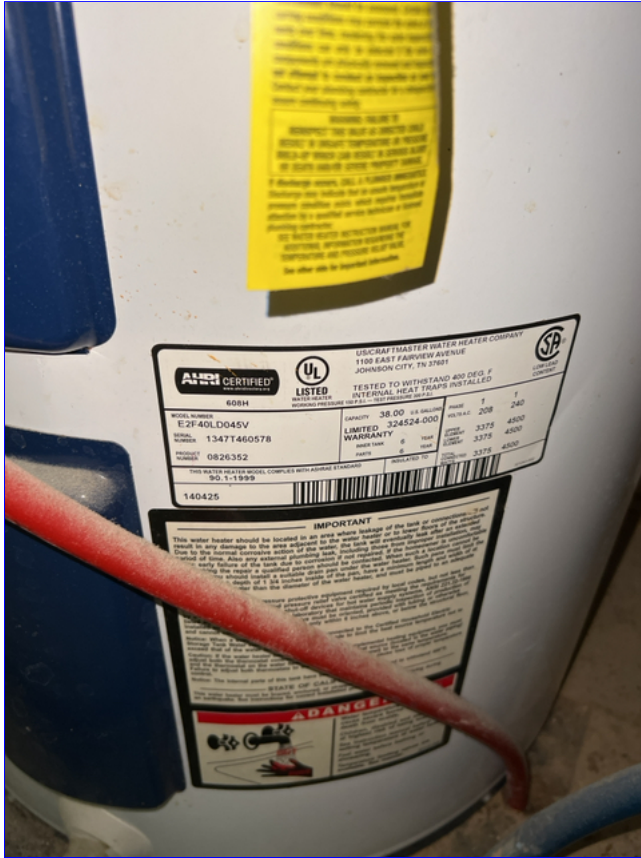
C. Photo 1(Picture) Water heater service tag.

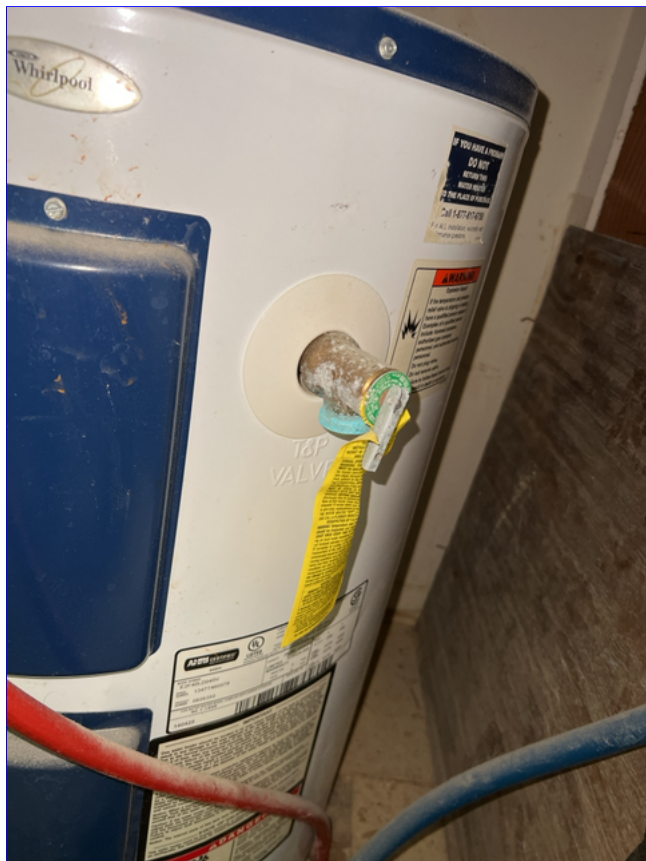
C. Photo 2(Picture) The T&P (Temperature and Pressure) relief valve on water heater

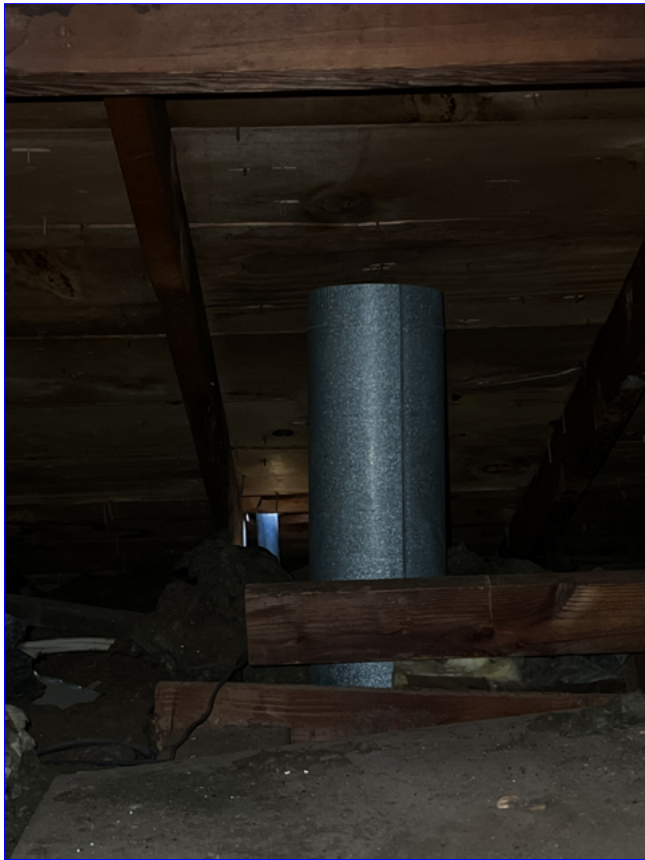
C. Photo 1(Picture) The vent piping for the range hood is terminating in the attic space.

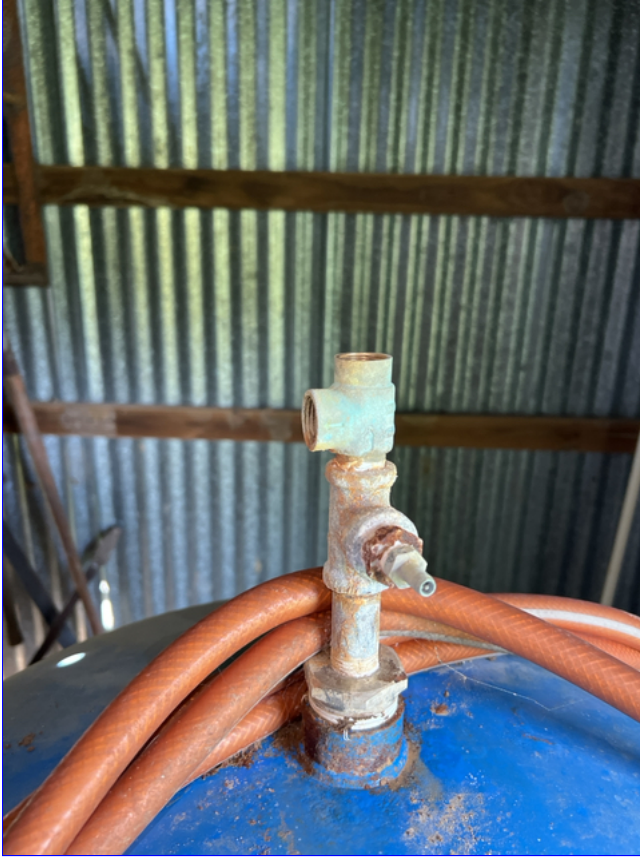
A. Photo 1(Picture) The water well is missing fittings at the top of the tank.

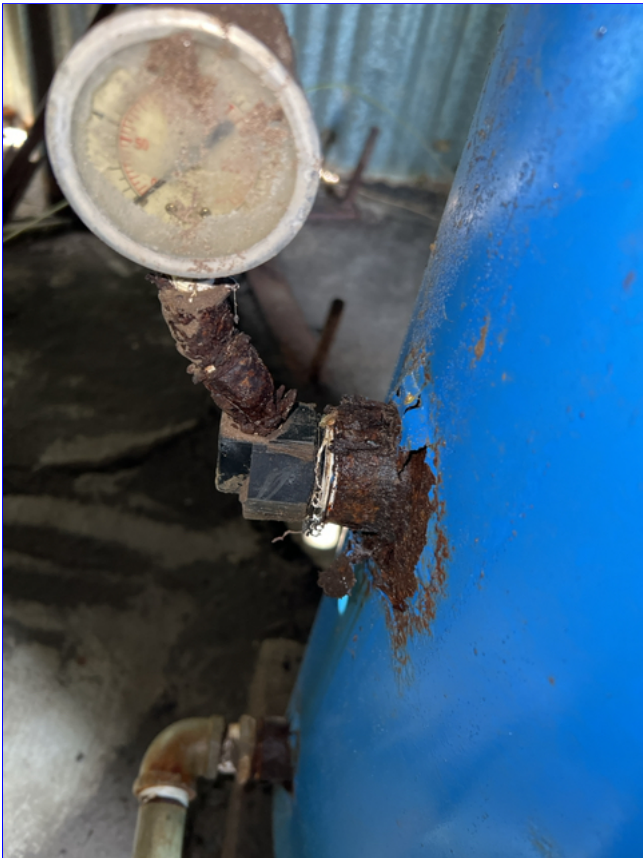
A. Photo 2(Picture) I also observed rust on the outside of the tank and at the pressure gauge.
