MECHANICAL INSPECTION

902 Rolling Mill Dr
Sugar Land, TX 77498

PROPERTY INSPECTION REPORT FORM

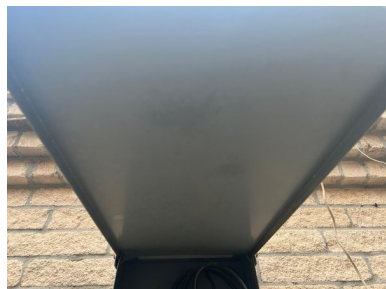
2: No Antioxidation Solution

The aluminum conductors were not coated with an anti-oxidation solution. Per the standards set forth by the Texas Real Estate Commission, we are required to recommend that the wires should be coated with an anti-oxidation solution, however this is not required by the current building codes.

Obtain cost estimate

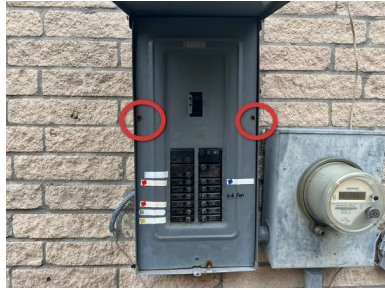
3: Cover Plate - Missing screw

The dead front cover for the breaker panel was missing one or more screws.

Obtain Cost Estimate

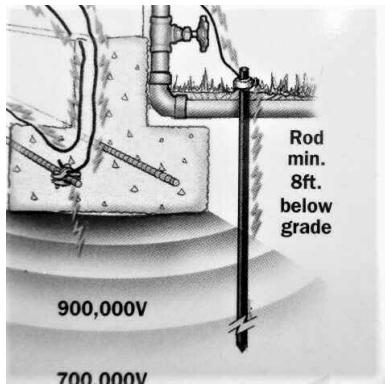
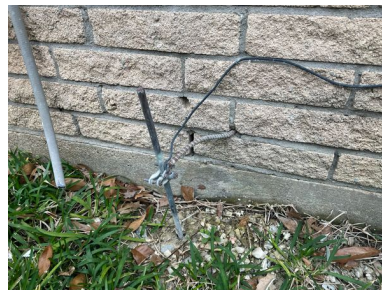
4: Ground Rod - Not flush with grading

The ground rod was sticking out of the ground a few inches, and, since ground rods are typically 8 feet long and all 8 feet of the rod are required to be in the ground, it is recommended that the ground rod be pounded down flush with the top of the ground. The clamp on the rod should be an acorn clamp approved for direct burial in the ground.

Obtain Cost Estimate

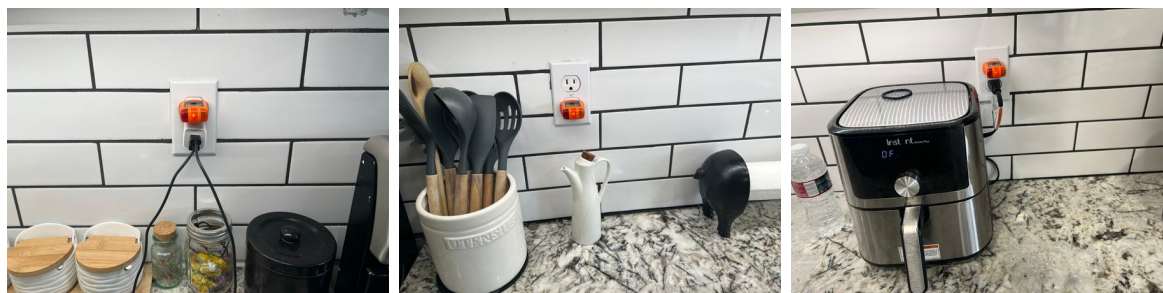
1: GFCI - Missing at outlet

A GFCI device was not installed at one or more locations that are currently required to have GFCI protection. It is recommended that an electrician install GFCI devices at all of the currently required locations.

Obtain Cost Estimate

Recommendation: Contact a qualified professional.

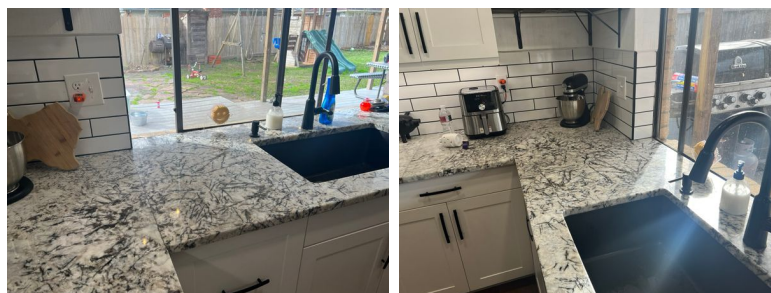
Kitchen

2: GFCI Missing - Outlet within 6 feet of sink/tub

Obtain Cost Estimate

Recommendation: Contact a qualified professional.

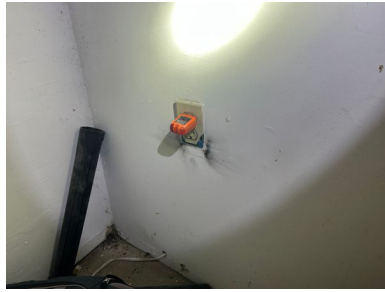
Garage

3: Outlet - Damaged

An outlet was damaged and should be replaced.

Recommendation: Contact a qualified professional.

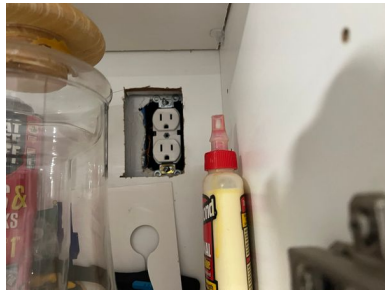
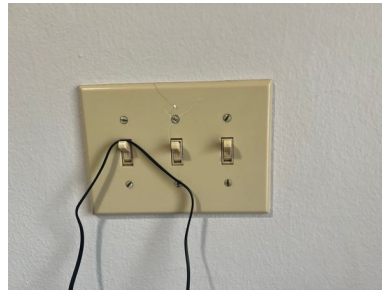
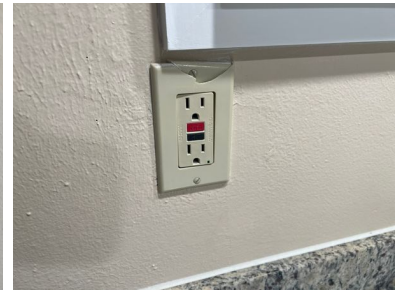
Kitchen, Entry, Master Bathroom

4: Cover Plate - Damaged/Missing

A missing or damaged cover plate was observed.

Obtain Cost Estimate

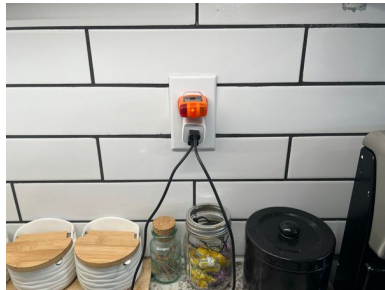
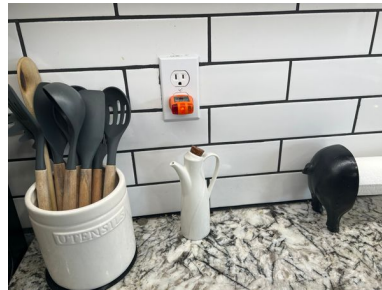
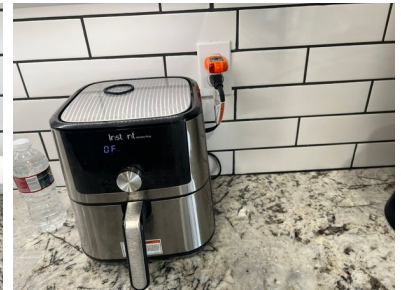
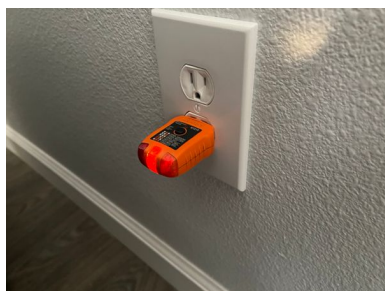
Kitchen, North Bedroom

5: Outlet - Ungrounded

A three prong outlet that was not grounded properly and needs to be repaired. It is recommended that an electrician be contacted, and the necessary repairs made to the outlet.

Obtain Cost Estimate

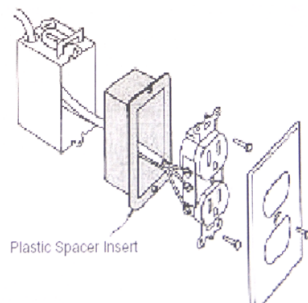
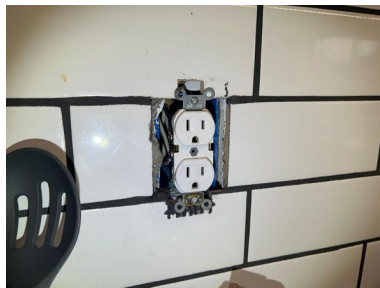
6: Outlets - Box extenders missing at backsplash

We observed outlets located in countertop backsplashes that were not protected by extender boxes. This is considered to be a fire hazard, and it is recommended that the extender boxes be installed.

Obtain Cost Estimate

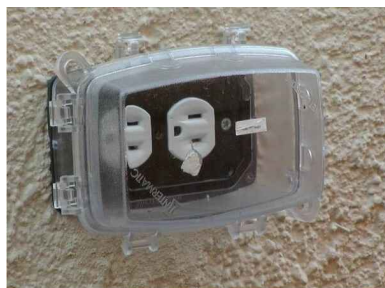
South

7: Exterior Outlet - No water tight cover

An exterior outlet that was not protected by a water tight cover plate was observed.

Obtain cost estimate

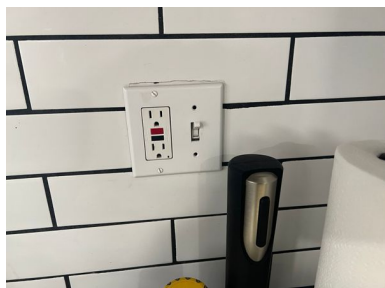
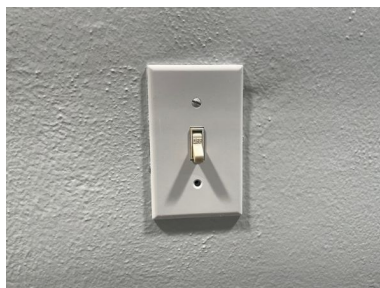
Wet Bar, Hall Bath

8: Cover Plate - Missing screw

A screw was missing on cover plate.

Obtain Cost Estimate

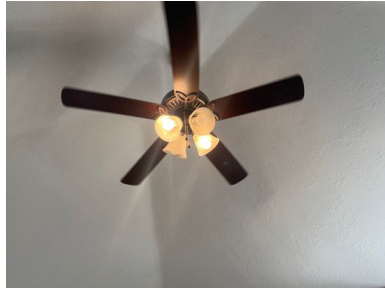
9: Light Fixture - Nonfunctional

A light fixture that was non-functional when the switch was on was observed. The problem may be a burned out bulb, defective light fixture, or defective switch.

Further investigation is recommended

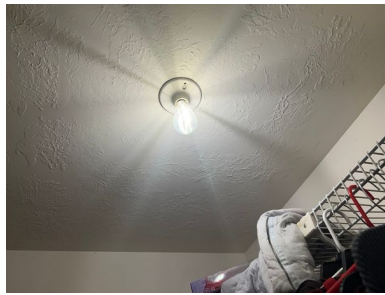
10: Light Fixture - Closet missing cover

One or more of the closet light fixtures are missing covers. For safety purposes, it is recommended that protective covers be installed over the bare bulbs.

Obtain Cost Estimate

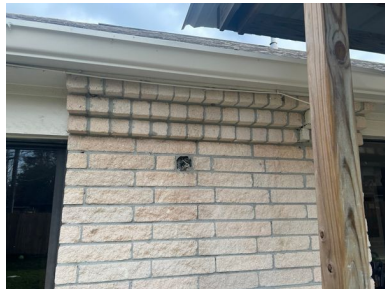
South

11: Light Fixture - Missing

A light fixture was missing.

Obtain Cost Estimate

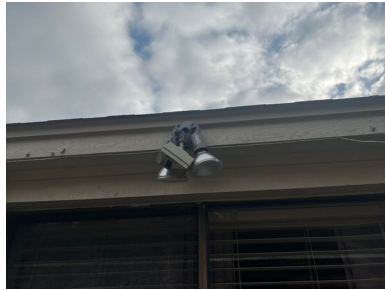
West

12: Light Fixture - Damaged

A light fixture that was damaged and needs to be replaced was observed.

Recommendation: Contact a qualified professional.

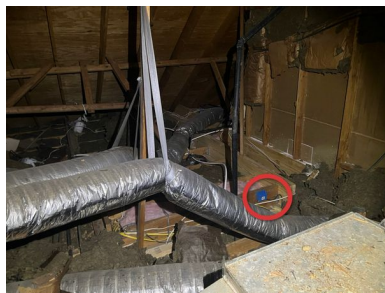
Attic

13: Open junction box

An open junction box that was missing a cover was observed.

Obtain Cost Estimate

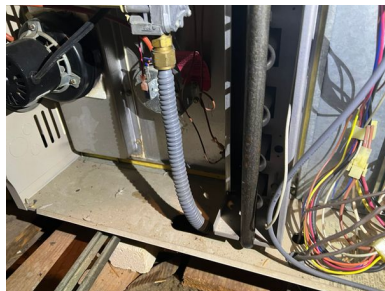
4: Sediment trap missing

Sediment traps were not installed at the gas supply lines for one or more of the gas fired furnaces. A sediment trap is intended to catch sediment/moisture/debris in a gas supply line before it can enter into the gas equipment.

Recommendation: Contact a qualified professional.

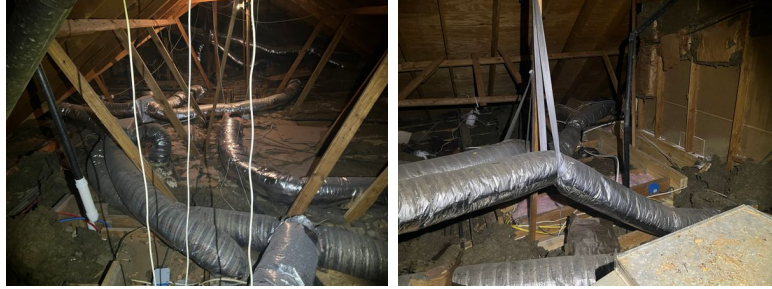
2: Ducts - Not supported properly

The ducts were laying on the insulation and ceiling joints and are not supported properly. The ducts should be supported in accordance with the manufacturer's installation instructions, which typically includes hanging the ducts from the rafters supported by 1 1/2 inch straps spaced approximately every four feet. Have a service company make the necessary repairs.

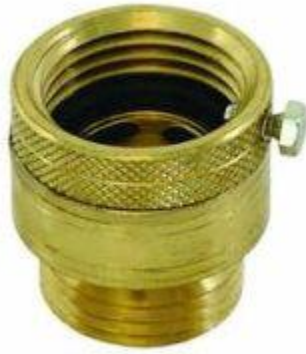
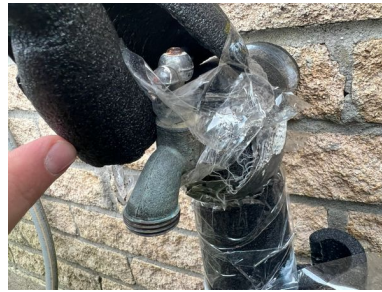
1: Vacuum Breaker - Missing

The atmospheric vacuum breaker devices were missing at one or more of the hose bibbs, and it is recommended that they be installed to prevent cross connections, which can allow contaminated water to enter the potable water supply.

Obtain Cost Estimate

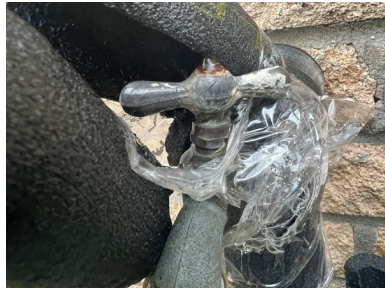
2: Hose Bibb - Leaking at valve stem

A leak was observed at a hose bibb around the valve stem.

Obtain Cost Estimate

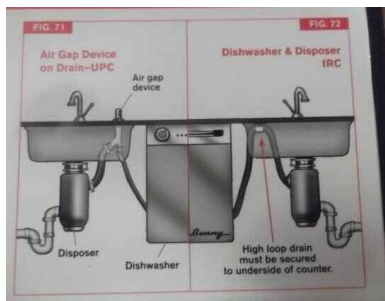
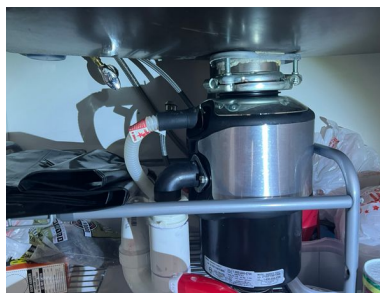
1: No Anti-Siphon

The drain line under the sink was not equipped with an anti-siphon device, nor was it looped up so that the top of the loop is at least six inches above the entrance of the drain line into the disposal. It is recommended at least that the drain line be looped to prevent the water from the garbage disposal from siphoning back into the dishwasher, or an anti-siphon device installed.

Obtain Cost Estimate

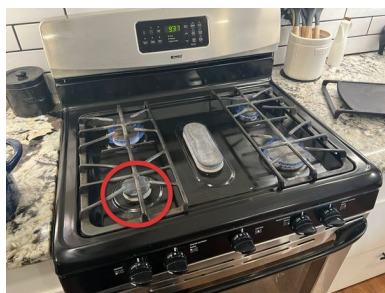
1: Electronic Igniter - burner nonfunctional

The electronic igniter for the left front burner was non-functional and needs to be repaired/replaced.

Obtain Cost Estimate

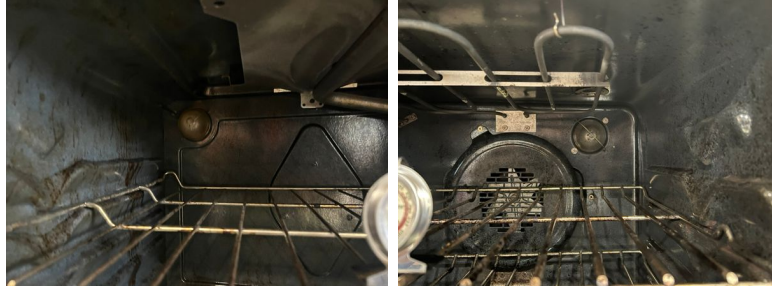
2: Interior Light - Nonfunctional

The interior light was non-functional. The cause could be a burned out light bulb, a defective switch, or related wiring.

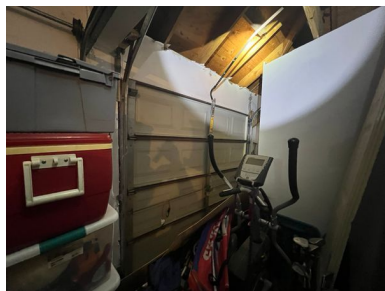
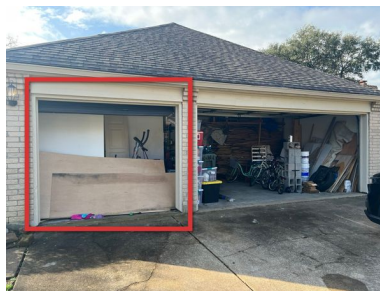
1: Opener - did not auto-reverse

The garage door opener did not stop the descent of the door when the door was subjected to a reasonable resisting pressure. This could cause possible personal injury or damage to house, and the opener is in need of

Obtain Cost Estimate

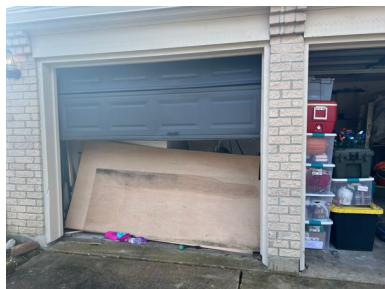
2: Not operating properly

The single door was not operating properly at the time of the inspection and would not open all the way. Further investigation is recommended by a service company.

Recommendation: Contact a qualified professional.
