## STRUCTURAL INSPECTION

902 Rolling Mill Dr  
Sugar Land, TX 77498

FEBRUARY 7, 2023

REF: CONDITION OF PROPERTY SURVEY

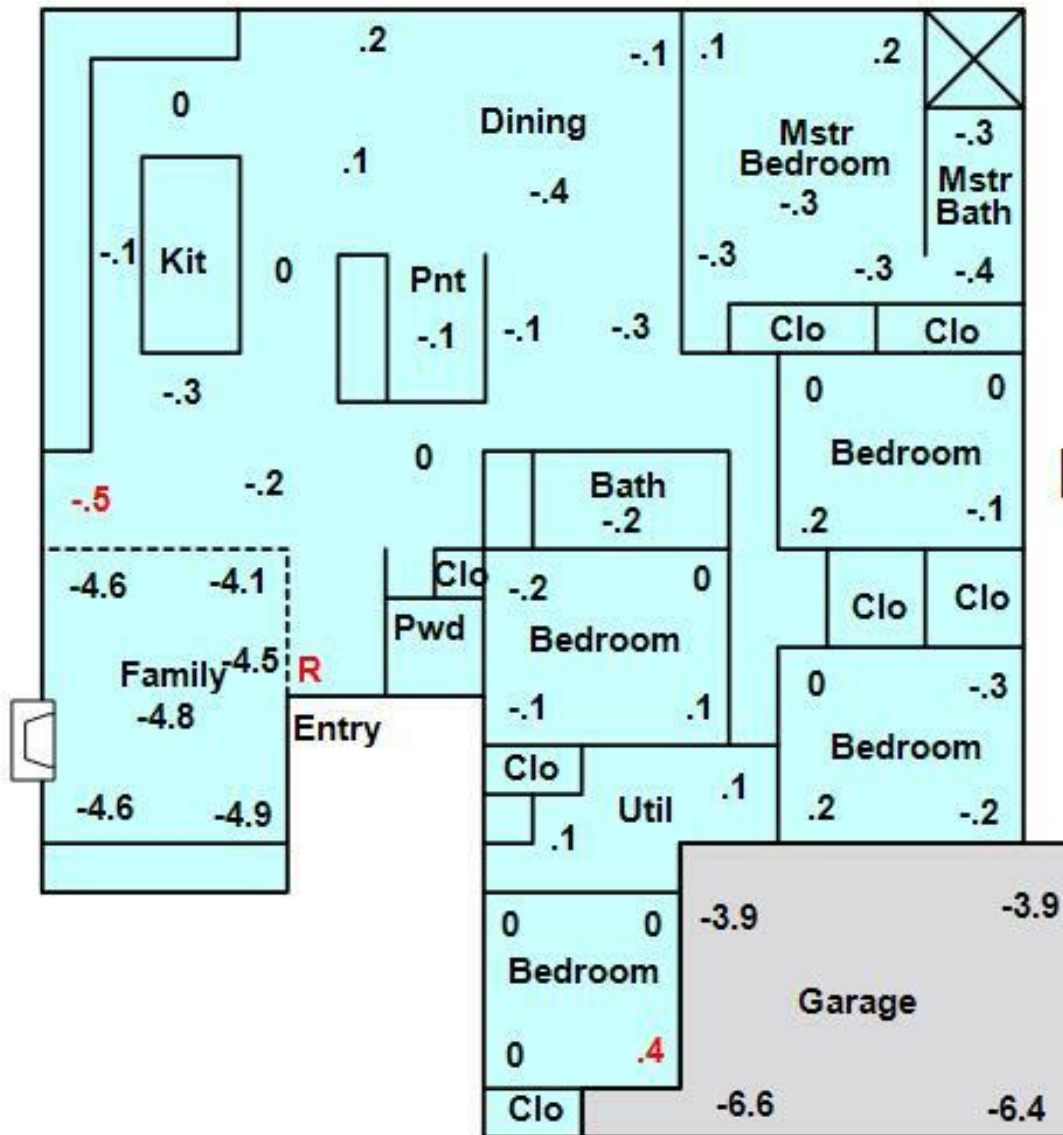
## Elevation Readings 902 Rolling Mill Drive

See our field sketch below showing the elevation readings for this structure. Note that the “R” on the sketch is our randomly chosen starting reference point, where the elevation is 0, and all other elevation readings are taken relative to the reference point, and are measured in inches to the nearest 1/10 inch. Height adjustments were made for variations in the height or thickness of the various floor coverings. If there is a step up or a step down into an area such as a garage, sunken room, balcony/patio area, or raised rooms, the elevation readings will have larger numbers due to the amount of the step.

The floors were checked with an electronic level, and were observed to be acceptably level throughout the house. The difference in elevation between the high point and low point was 0.9 of an inch. The high point was located at the northeast bedroom, and the low point was located at the kitchen. The unlevelness takes place over a horizontal distance of approximately 40 to 45 feet.

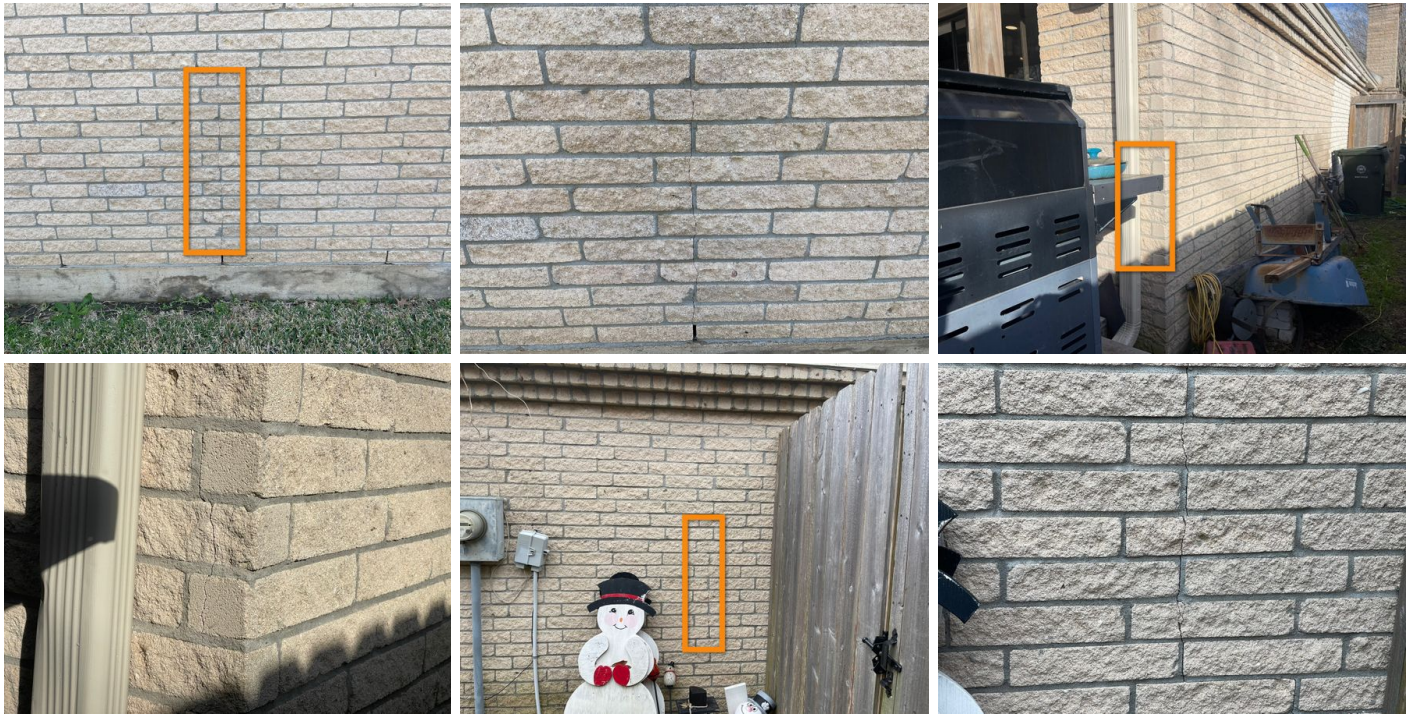
### Veneer - Cracks/Patches

Cracks and/or patches were observed in the exterior veneer at the time of the inspection, including at the locations shown in the photos. It is recommended that the cracks be repaired for cosmetic purposes.

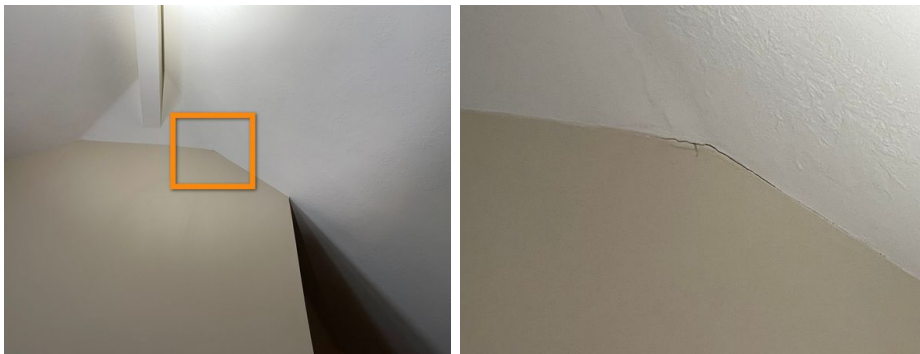
**Sheetrock Cracks/Patches/Compression ridges**

Sheetrock cracks, patches, and/or compression ridges were observed in the house during the inspection, including at the specified locations. It is recommended that the cracks be repaired.

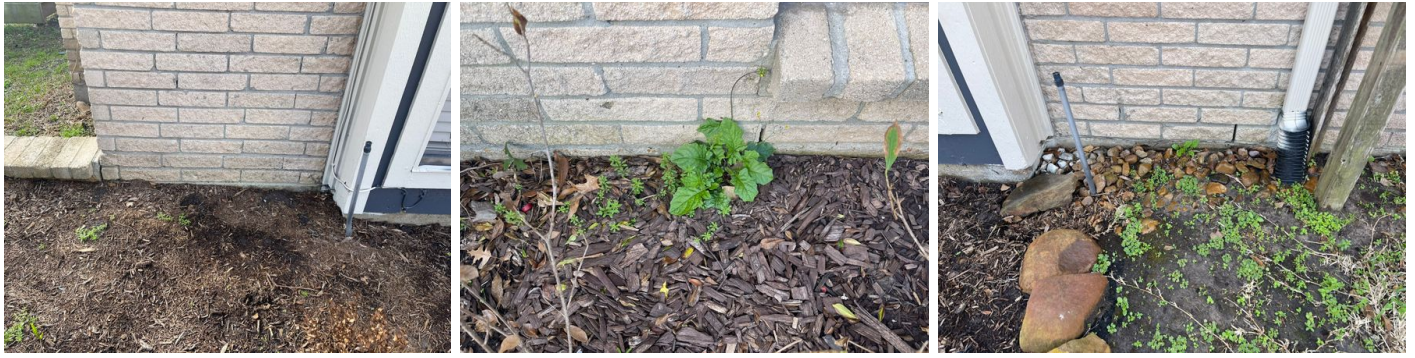
**Slab Not visible - High Soil**

It is pointed out that a portion of the foundation concrete could not be viewed due to soil that was graded near or above the top of the foundation and/or heavy foliage growing against the house. The soil and/or foliage should be removed, and 3-4 inches of foundation concrete exposed.

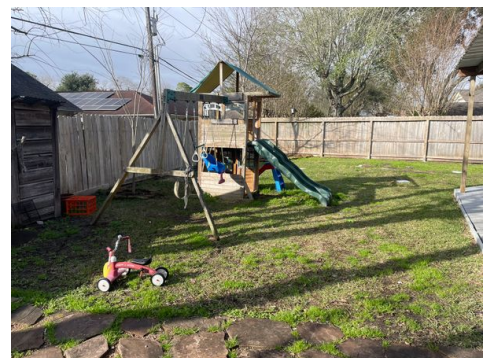
4.6.1 Perimeter Grading/Drainage

The perimeter drainage was observed to be poor at some areas where the lot is not sloped away from the house (6 inch drop in the first 10 feet) and water will pond. Poor drainage conditions near the foundation can contribute to foundation movement. It is recommended that a company specializing in drainage solutions be contacted to provide a recommended solution, along with a cost estimate to provide proper drainage.

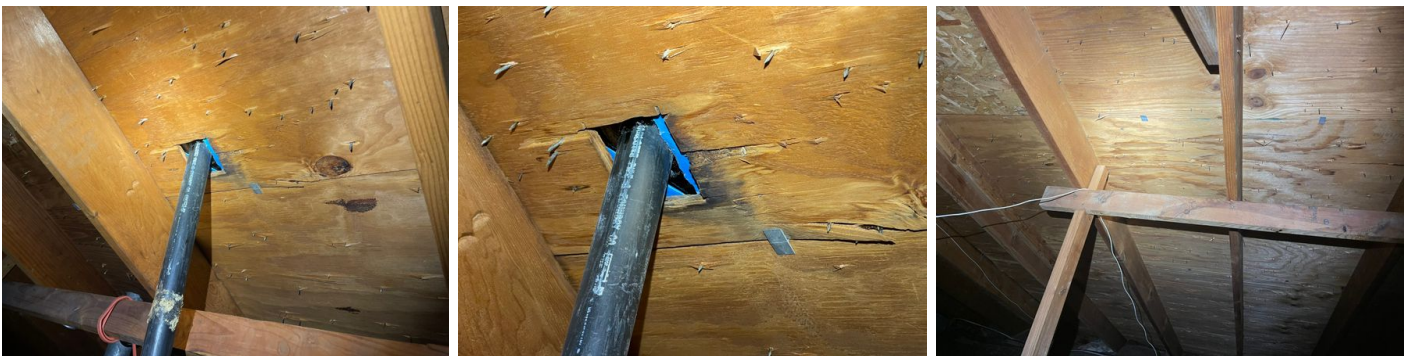
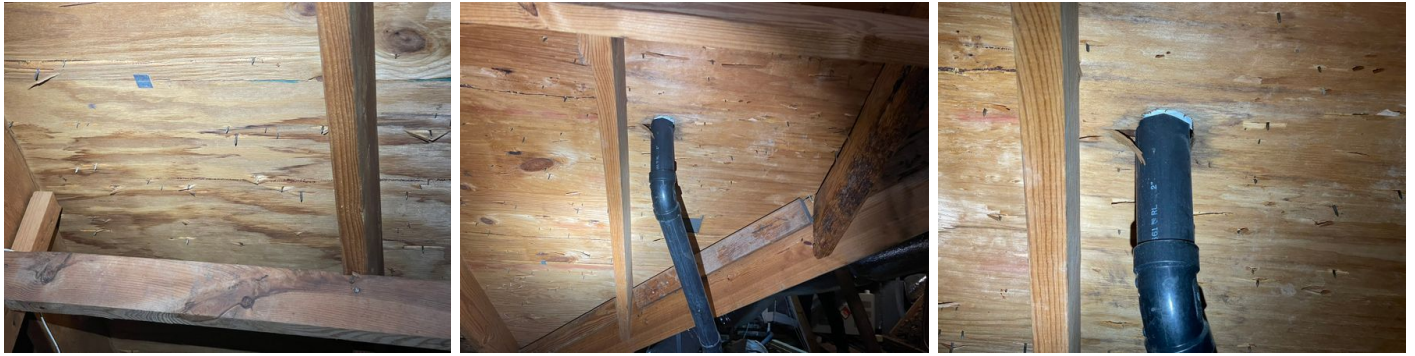
**Roof Leaks: Attic stains appear to be from previous leaks**

After observing the interior of the structure, evidences of current roof leaks were not visible. The absence of evidences of roof leaks does not guarantee that roof leaks were not present; rather, that no evidences of leaking were visible at the time of the inspection. Some stains were visible in the attic, but the stains appeared to be related to previous roof leaks. It is recommended that you check with the owner and/or a service company concerning the stains.

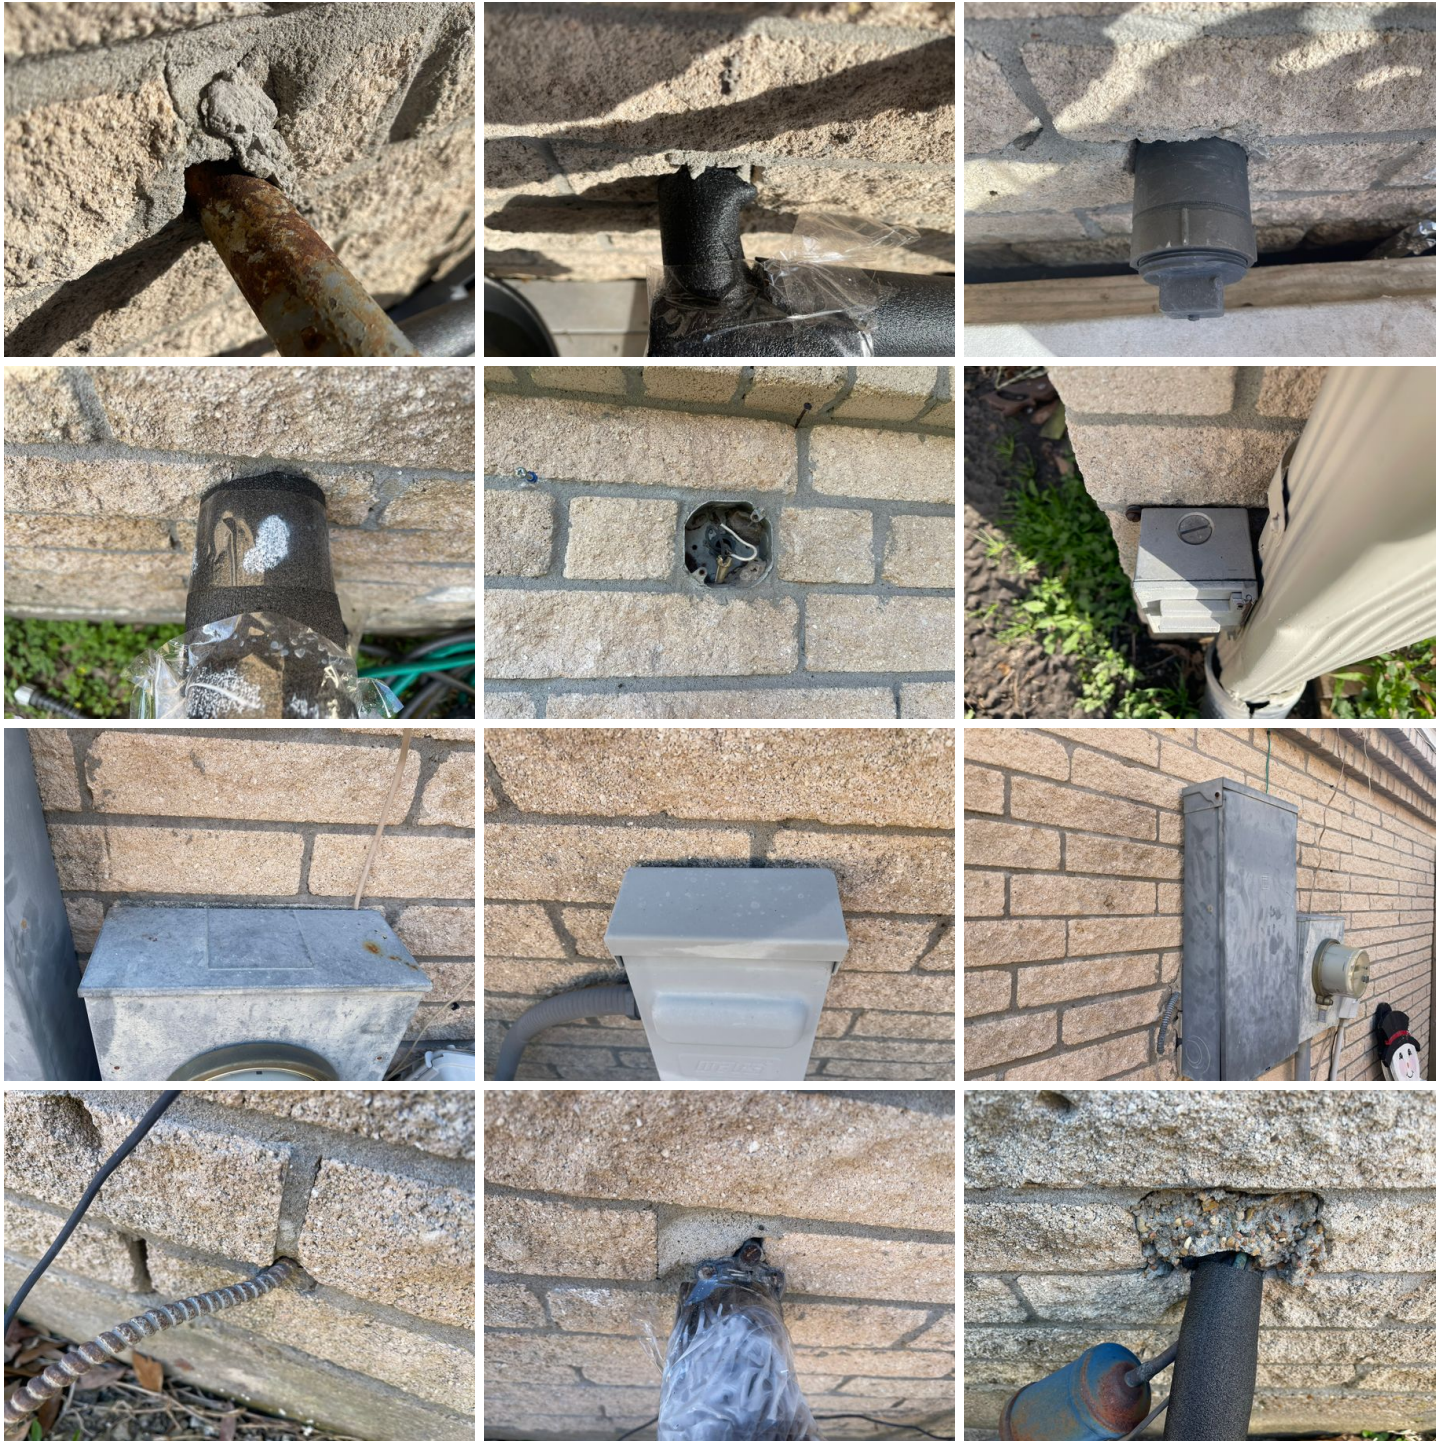
Sealants deteriorated/missing, Electrical Wiring, Electrical Box, Hose Bibb, Light Fixtures, Electric outlet

A substantial vulnerability to water penetration was observed at penetrations/openings through the exterior building envelope, and it is recommended that all penetrations/openings be sealed against water penetration. Typical examples on a structure may include light fixtures, air conditioning refrigerant lines, water piping, gas piping, vent caps, windows, doors, expansion joints, etc. Below is a representative sample of locations and/or photographs showing some, but not necessarily all, locations where there is a vulnerability to water penetration. Have a contractor provide a cost estimate to seal all vulnerable areas on the exterior building envelope against water penetration and/or open up any clogged weepholes in the veneer.

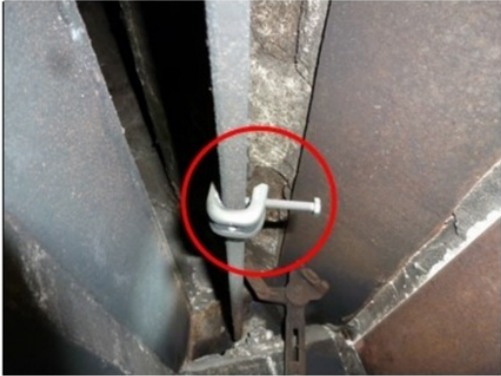
**DAMPER - C CLAMP MISSING**

The damper was not equipped with a C-Clamp device to prevent closing the damper completely to allow the hazardous combustion gases a path to escape up the chimney.

HEI file photo showing c-clamp in masonry fireplace

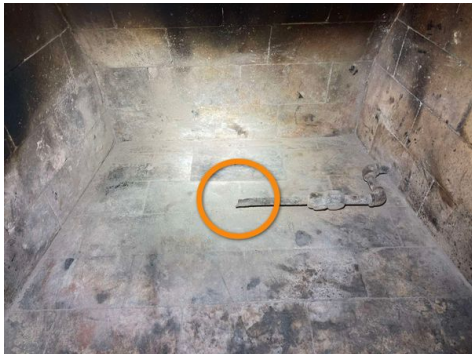
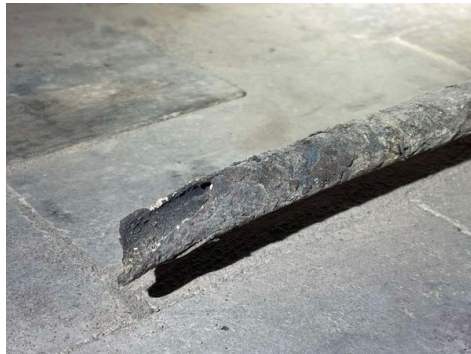
**LOG LIGHTER - DAMAGED**

The gas log lighter was damaged and it is recommended that it be replaced. You may also consider installed a ceramic gas log instead of the log lighter.

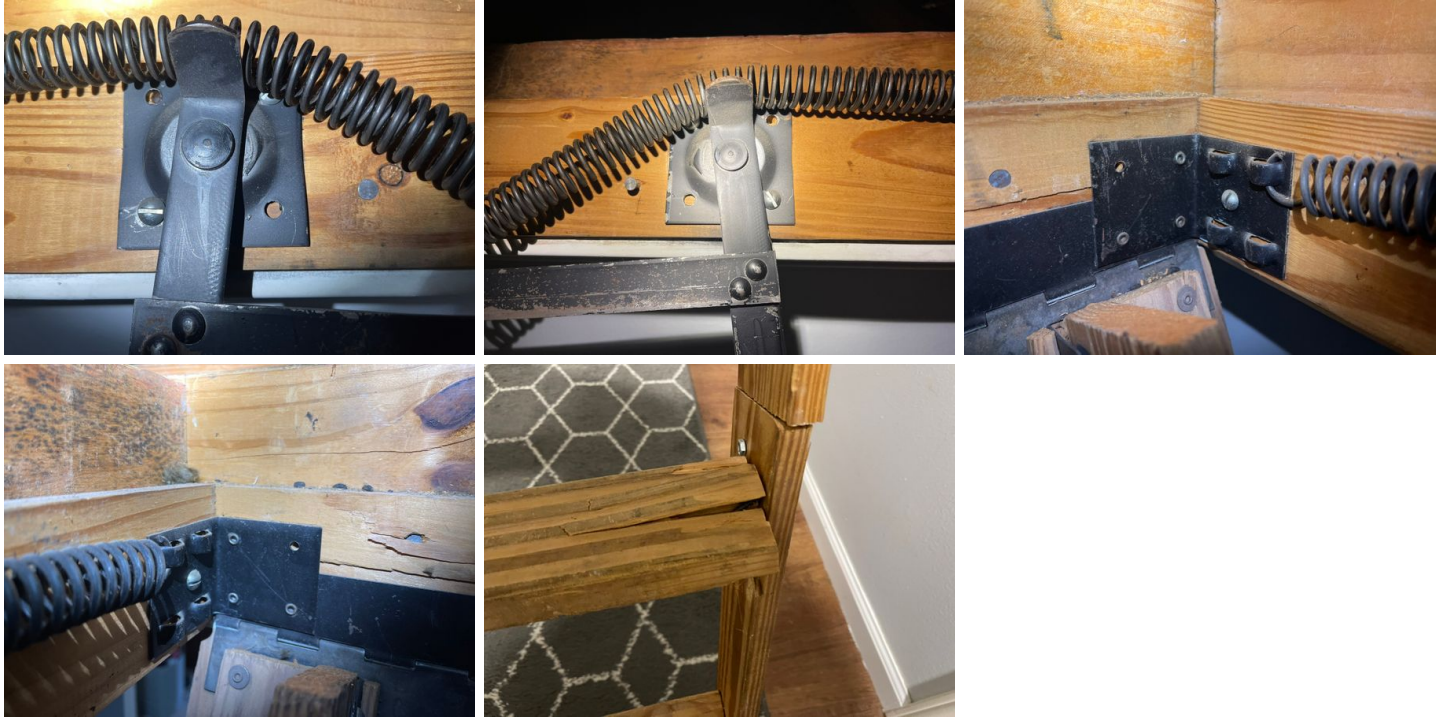
**LADDER ATTACHMENT IMPROPER**

Nail(s) missing in corner bracket(s), Nail(s) missing in spring arm pivot(s), Step broken

The stair assembly was not properly installed or secured to the framing members, and repair is needed for safety purposes. The condition(s) can be a safety hazard, and repair is needed, as an improperly installed stair assembly can possibly collapse.

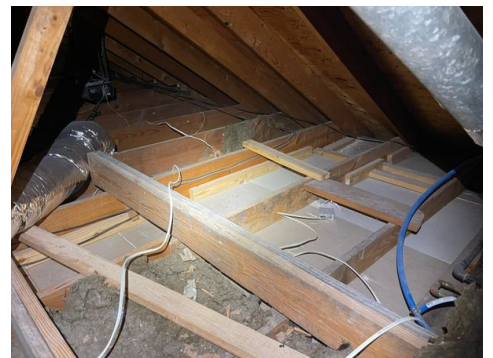
9.4.1 Insulation

**INSULATION MISSING - BETWEEN JOISTS**

The insulation in the attic was missing from between some of the joists. Have a service company provide a cost estimate for repairs.

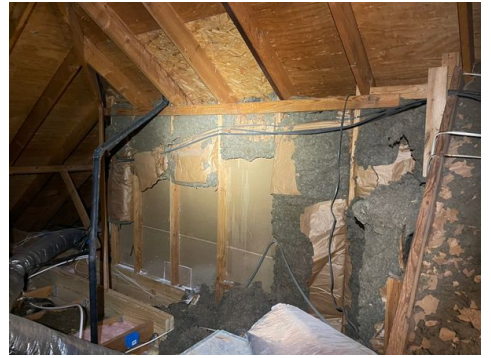
9.4.2 Insulation

**INSULATION LOOSE/MISSING - WALLS**

The insulation in the attic was loose/missing at some of the vertical walls, and needs to be repaired.

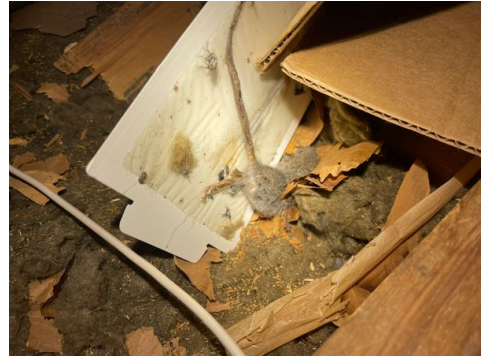
9.7.1 Miscellaneous

**RODENTS, BIRDS, BEES, OR OTHER PESTS**

We observed evidence of rodent infestation in the attic. Although HEI disclaims inspections for rodents and other pests, it is recommended that further investigation be done to find the source of entry of the pests into the attic, and to make all needed repairs to remove the pests, clean and sanitize the attic from any fecal/urine material and nesting materials. It is recommended that you contact a pest control company concerning this condition.

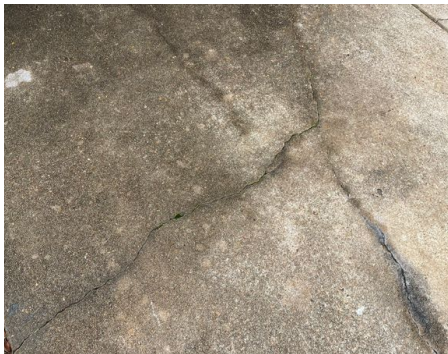
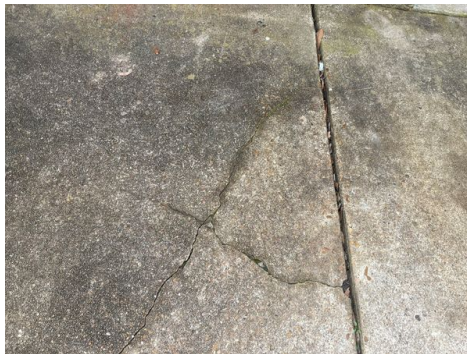
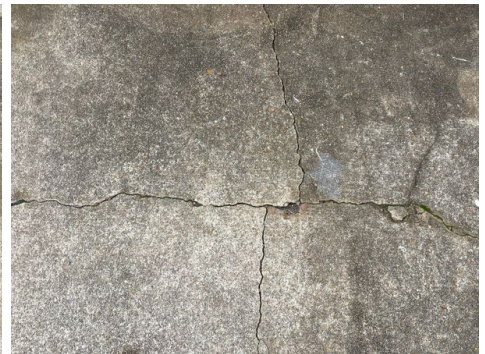
#### Flatwork Concrete/Patios/Walkways: Cracks Driveway

Cracks and some separations were observed in the driveway concrete. In our opinion, the driveway is still in serviceable condition at this time.

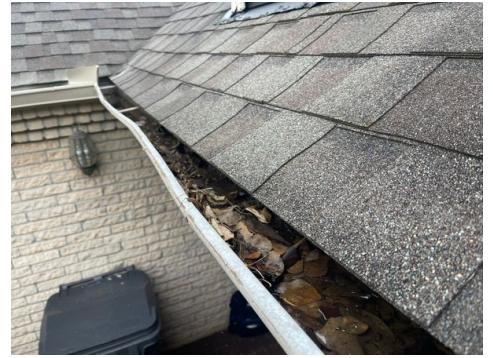
The gutters were observed to have debris in them and are in need of cleaning.

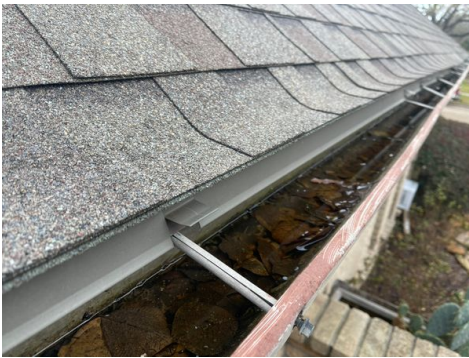
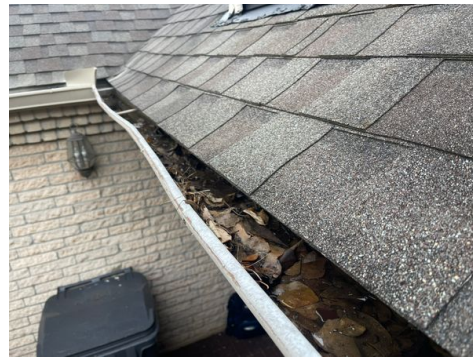
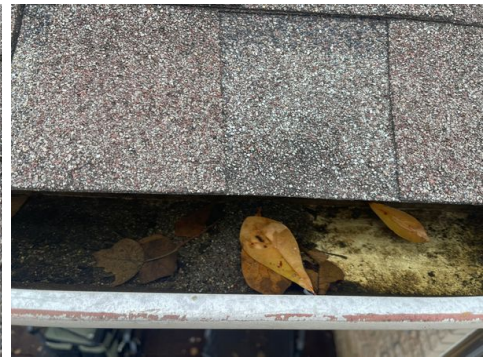
11.2.2 Gutters and Downspouts

**HOLDING WATER**

The gutters were observed to be holding water and are in need of adjustment.

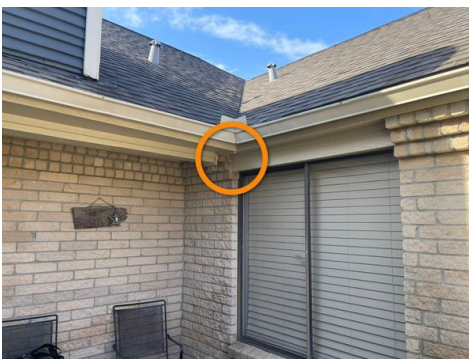
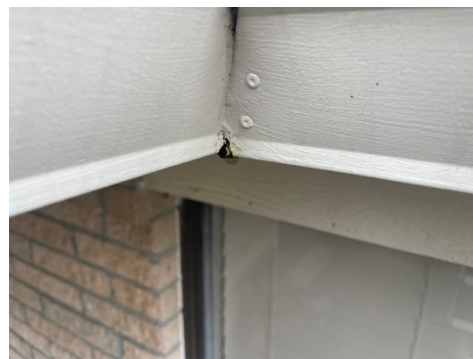
11.2.3 Gutters and Downspouts

**LEAKING**

The gutter was leaking at the joints and needs to be sealed and made watertight.

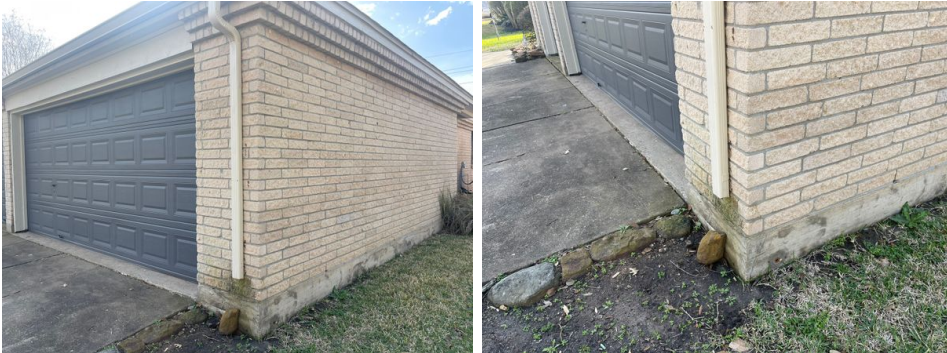
11.2.4 Gutters and Downspouts

**ELBOW DIVERTERS**

Some of the elbow diverters were missing/damaged at the bottom of the downspouts. It is recommended to install the missing/damaged elbows.

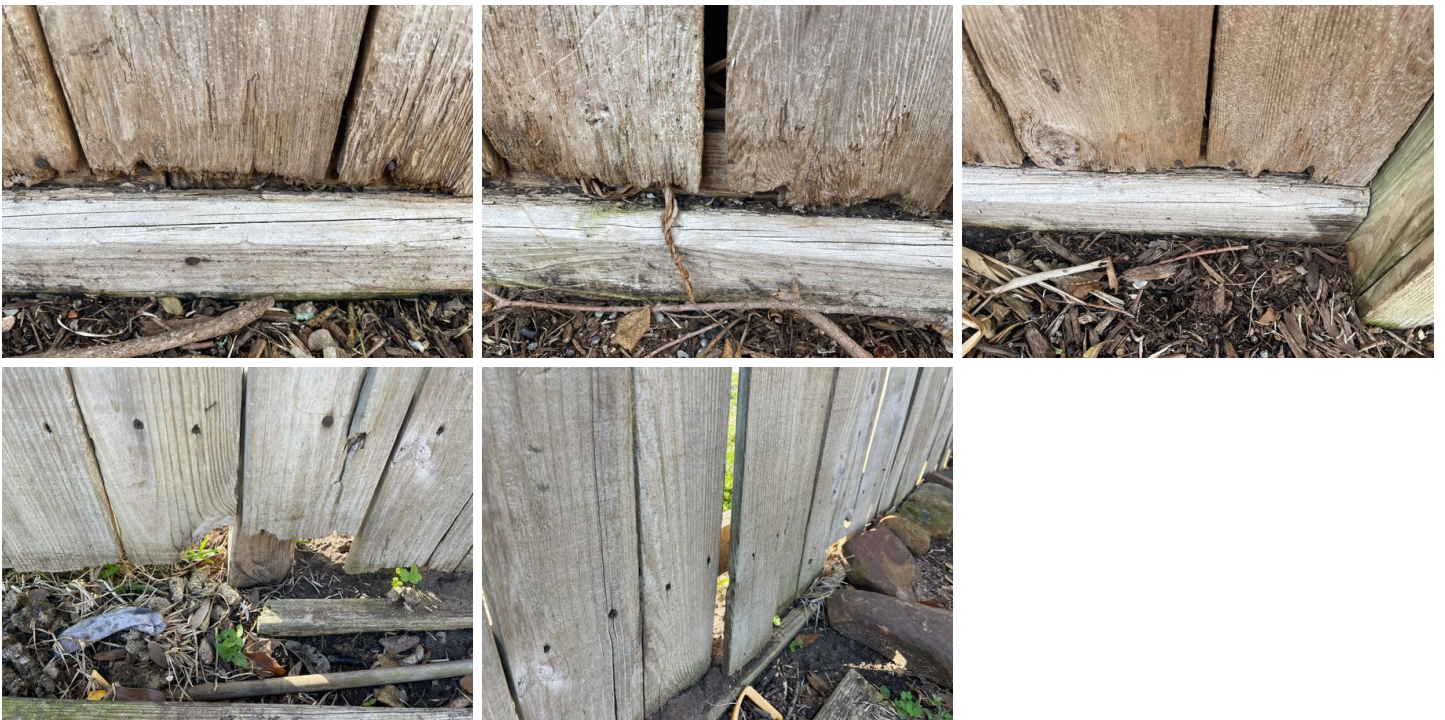
11.3.1 Gates and Fences

**WOOD FENCE**

Damaged, Starting to rot

The wood fence was in need of some repairs.

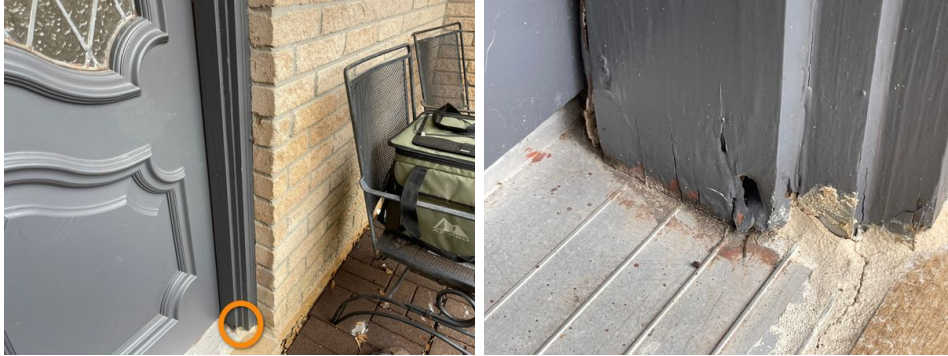
#### 11.4.1 Wood Rot

### **WOOD ROT**

We observed evidences of wood rot and it is recommended that all rotted wood be replaced. Have a contractor provide a cost estimate to determine the entire scope of the wood rot, and provide a cost estimate to replace all rotted wood in the house.

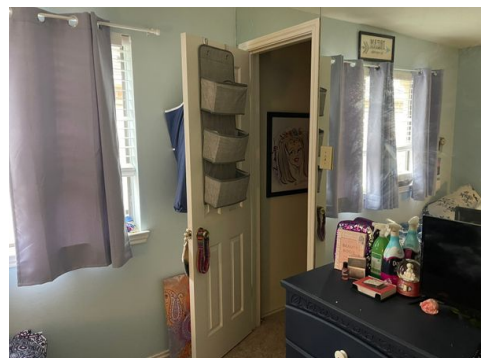
We observed a "ghost" door that opens/closes by itself, and the door needs to be adjusted. Contact a service company to make the needed repairs.

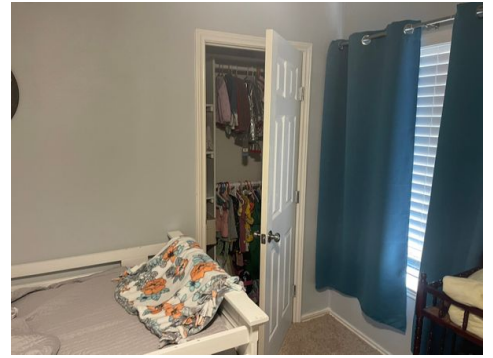
12.1.3 Doors

**DRAGS ON CARPET**

The door(s) was dragging on the carpet, and should be trimmed on the bottom. A one inch gap between the bottom of the door and the carpet is recommended to allow for proper air flow for the HVAC system.

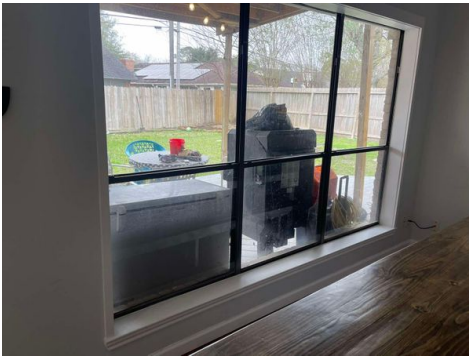
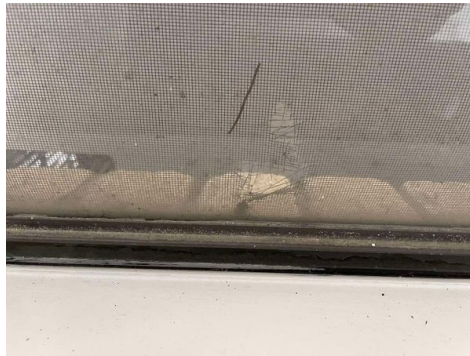
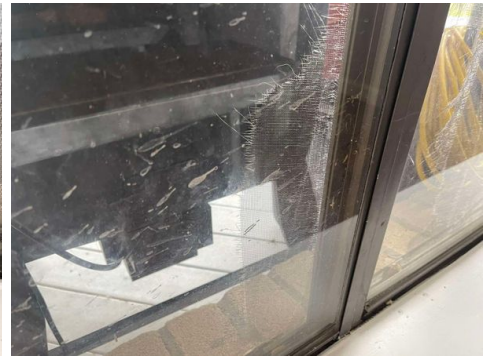
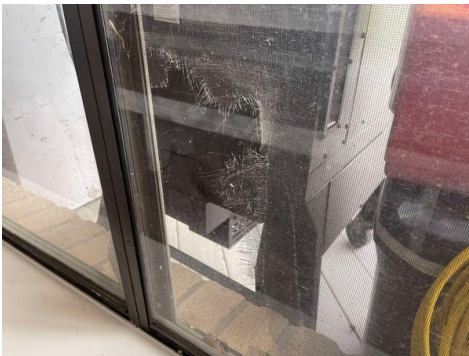
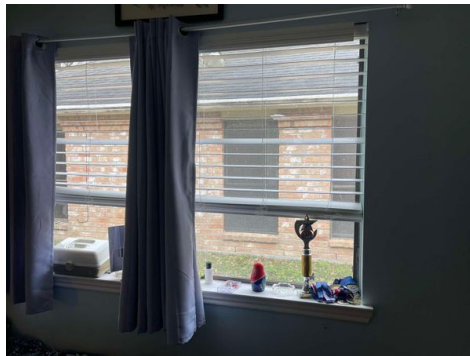
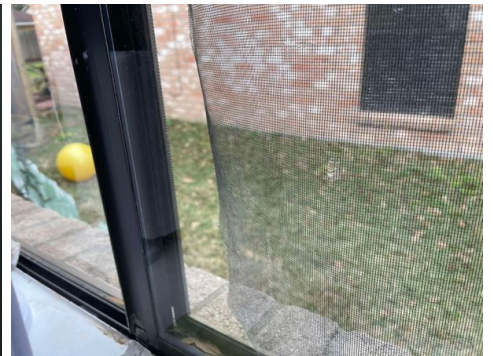
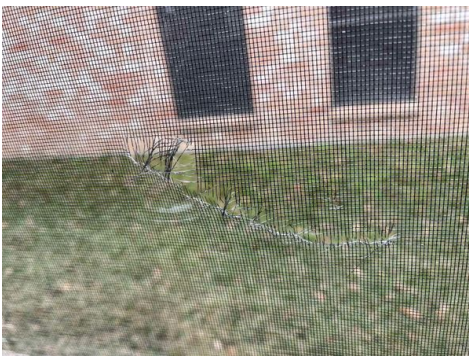
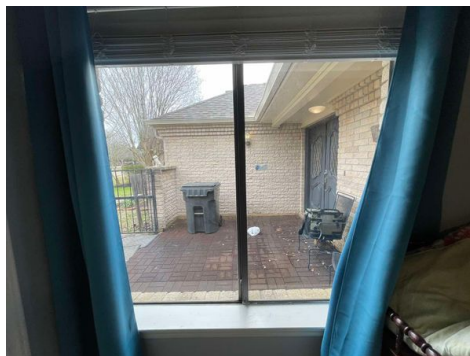
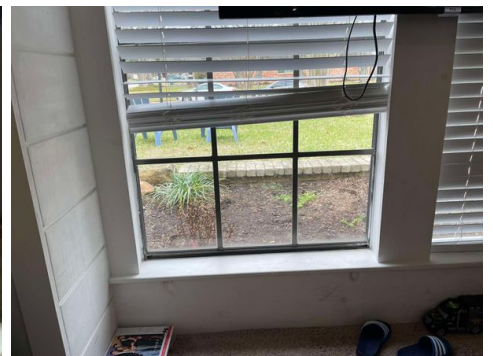
12.2.1 Windows

**WINDOW SCREENS DAMAGED/MISSING**

Window screens were observed to be damaged and missing.

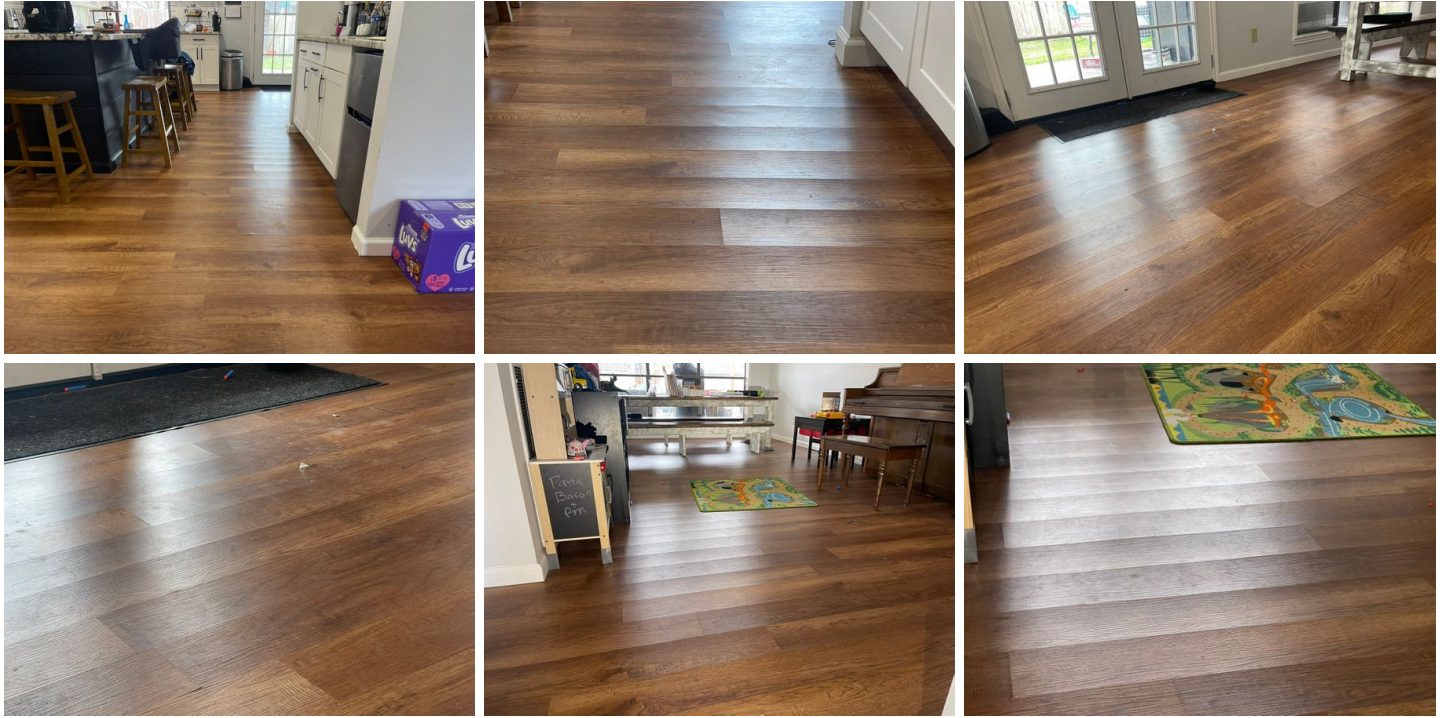
12.3.1 Floor coverings

**FLOOR CUPPING**

The vinyl floor was observed to be cupped, with the edges of the boards curling downwards into a “cupping” effect. This condition is typically caused when the floors have excessive moisture. Further investigation with a floor specialist and/or a service company is recommended to determine the source of the condition, and to provide a cost estimate for any needed repairs.

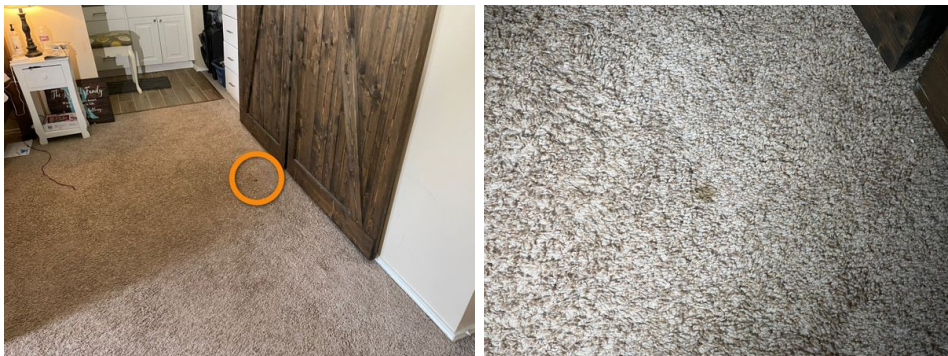
12.3.2 Floor coverings

**CARPET STAINED**

The carpet was observed to be stained, and it is recommended that it be cleaned or replaced.

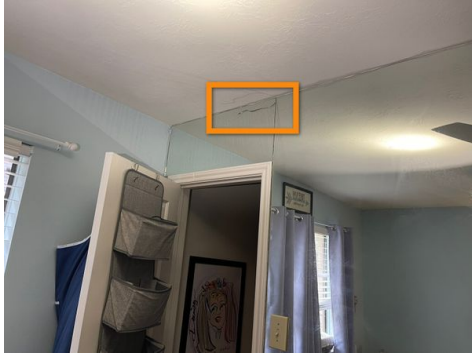
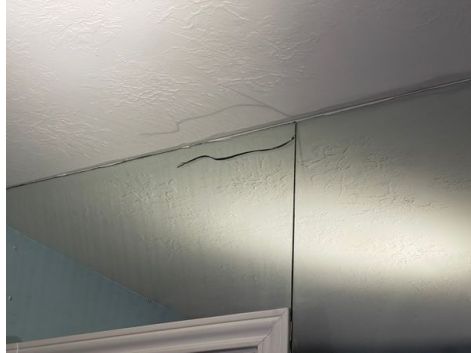
**MIRROR CRACKED/DAMAGED**

The mirror was cracked/damaged and needs to be replaced. Have a contractor provide a cost estimate at the above locations.
