Date: November 9, 2020

Subject: Structural Foundation Inspection Report (Level B)
Slab Foundation
7447 Cambridge Street #32, Houston, TX

7447 CAMBRIDGE STREET #32, HOUSTON, TX

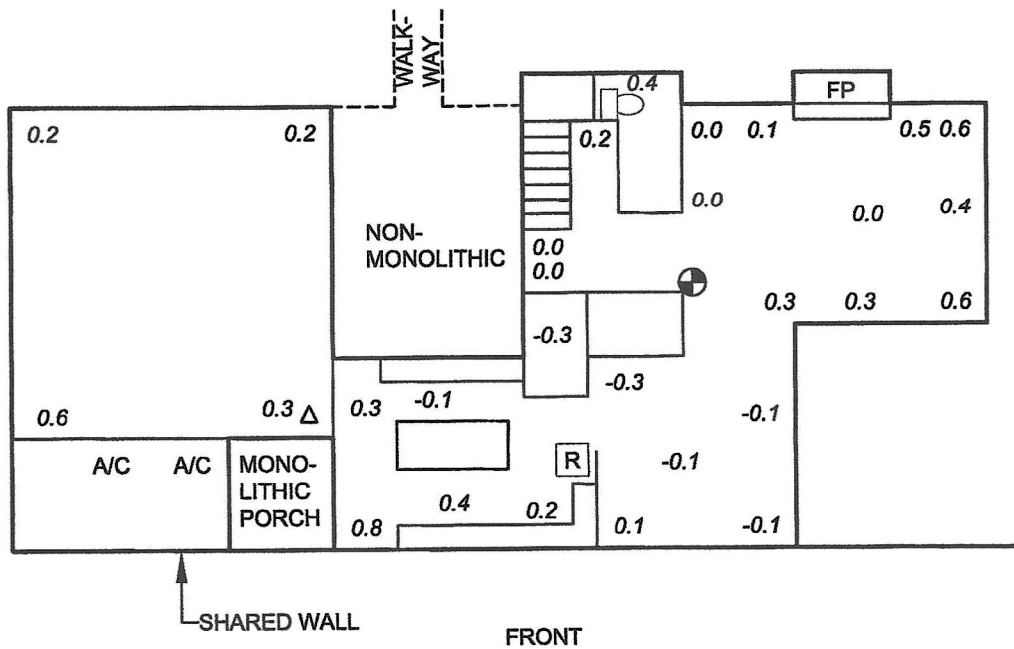
LIMITED REPAIR PLAN

Based on our visual observations of the structure and our review of the elevation map, it is our opinion that the structure is experiencing seasonal movement and the foundation is performing as intended.

PRE-LIFT ELEVATIONS BY CE (11.6.20)

- NO FOUNDATION REPAIRS RECOMMENDED AT THIS TIME.
