## MECHANICAL INSPECTION

11511 Olympia dr  
HOUSTON, TX 77077

# PROPERTY INSPECTION REPORT FORM

June Chapman in C/O Debbie Cooper <i>Name of Client</i>	10/05/2022 9:00 am <i>Date of Inspection</i>
11511 Olympia dr, HOUSTON, TX 77077 <i>Address of Inspected Property</i>	
Luis Mireles <i>Name of Inspector</i>	TREC#22797 <i>TREC License #</i>
<i>Name of Sponsor (if applicable)</i>	<i>TREC License #</i>

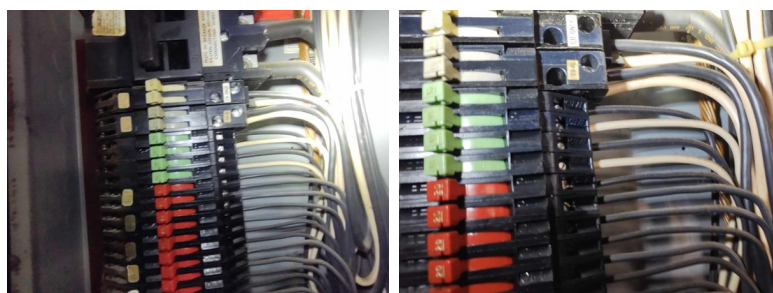
We observed one or more white wires that were used as a power wires, and were connected to a circuit breaker. Typically, the white wires are the grounded/neutral conductors, and if they are used as a power conductor, they must be permanently marked or wrapped with black or red tape to identify them as a “hot” ungrounded conductor.

**Obtain Cost Estimate**

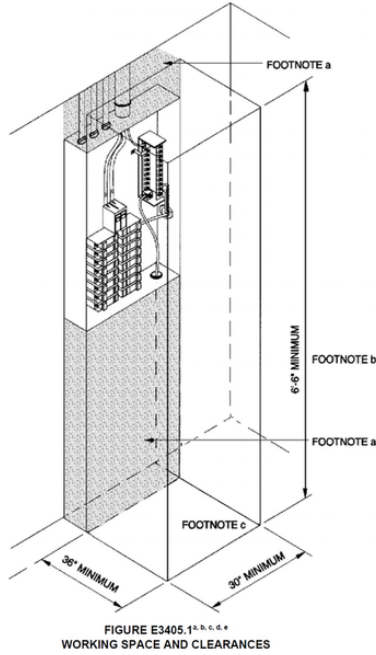
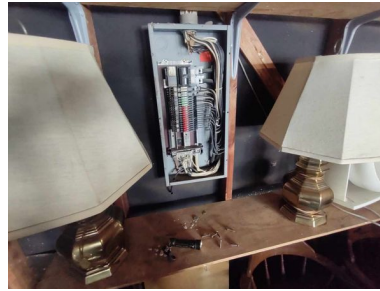
**5: Breaker Panel - Inadequate Clearance**

The breaker panel did not have the required three foot clearance at the front and it is recommended that the minimum required clearance be made or that the panel be relocated.

**Obtain Cost Estimate**

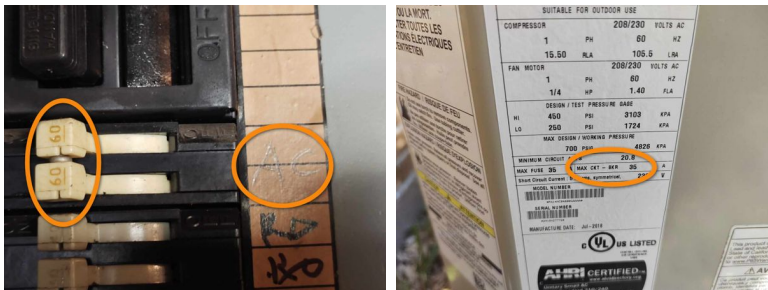
**6: Breakers Oversized - A/C condensing unit**

The circuit breakers for air conditioning condensing unit was rated higher than the maximum size allowed by the manufacturer of the condensing unit. The breakers should be replaced by the size listed on the manufacturer's nameplates located on the condensing unit.

**Obtain Cost Estimate**

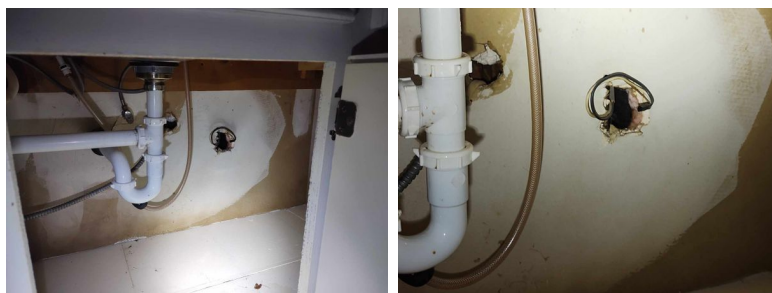
**6: Unprotected wire splice**

Kitchen sink,

Wiring that was spliced and not enclosed in a junction box was observed.

**Obtain Cost Estimate**

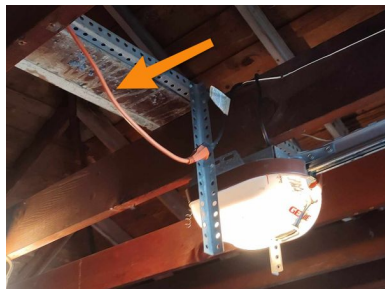
**7: Power Cord Wire - Improperly hard wired**

Garage

Wiring that is not approved to be hard wired into the electrical system, including extension cord wiring or lamp cord wiring, was observed. For safety purposes, the unapproved wiring should be replaced with an approved wiring.

**Obtain Cost Estimate**

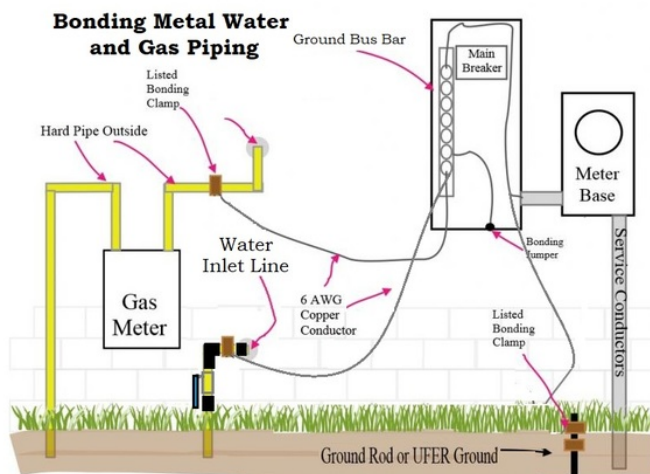
**8: Gas and/or Water Piping - Bonding Not visible**

The location(s) where the water supply piping and/or gas supply piping were bonded together and/or back to the electrical ground system were not visible at the time of the inspection. It is recommended that an electrician be contacted to determine if the plumbing in the house is properly bonded and to make any needed repairs.

Recommendation: Contact a qualified professional.

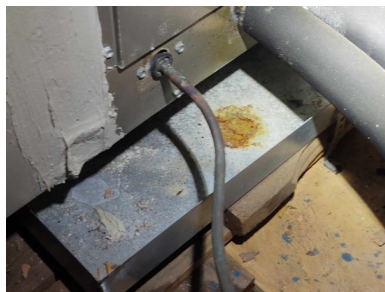
Rust was observed in the overflow pan under the coil, apparently due to water backing up at the primary drain line and overflowing into the pan. No water was observed in the overflow pan at the time of the inspection, however since the equipment was only operated for a short time during the inspection, It is recommended that the primary drain line and the coil be checked by an air conditioning service company.

**Obtain Cost Estimate**

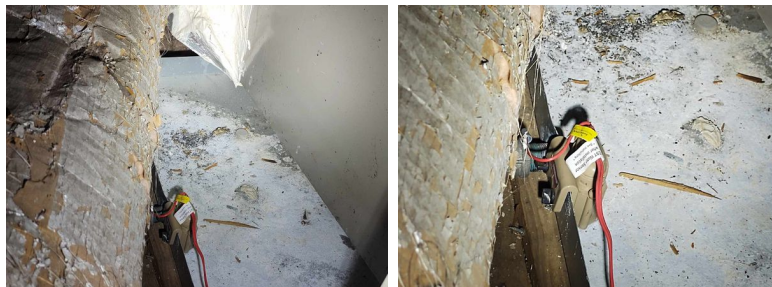
**2: Overflow Pan - Debris in pan**

Insulation and/or debris was observed in the overflow pan. The pan needs to be cleaned out to prevent clogging of the drain line.

**Obtain Cost Estimate**

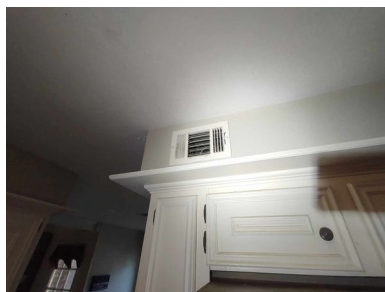
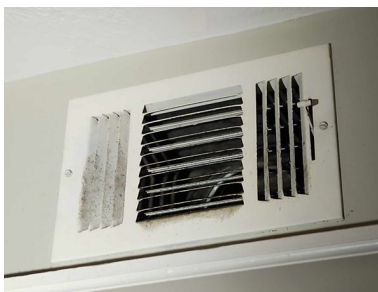
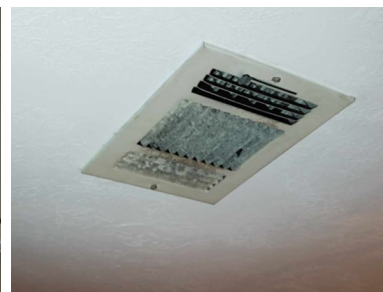
Some of the registers were covered with mildew/debris. It is recommended that a service company be contacted to check the inside a of the duct work to determine if there is a build-up of debris/mold/mildew inside, and make any needed repairs. Further investigation is recommended.

**Obtain Cost Estimate**

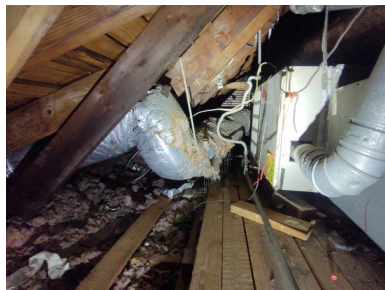
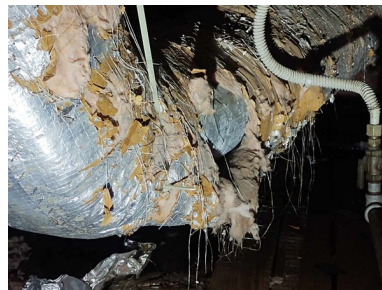
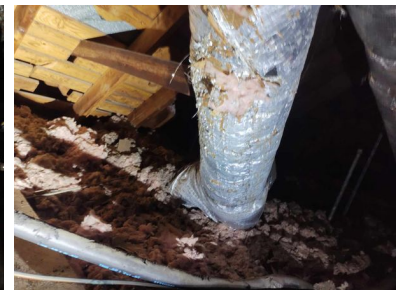
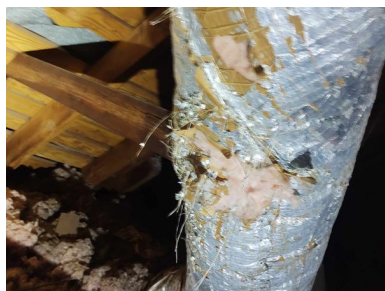
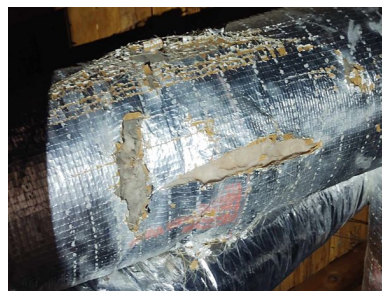
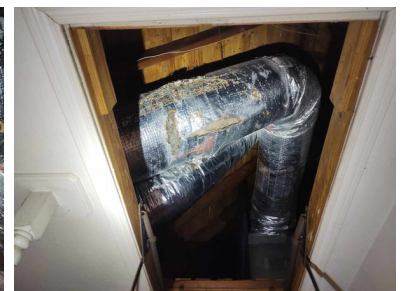
### 3: Ducts - Sheathing/Insulation damaged

The sheathing and/or insulation around the air ducts is damaged/missing, and the damaged duct work needs to be repaired or replaced.

**Obtain Cost Estimate**

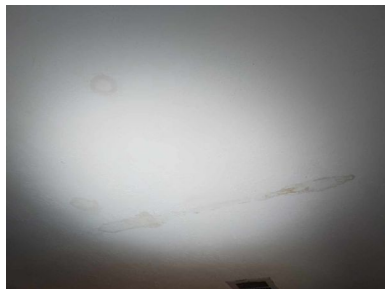
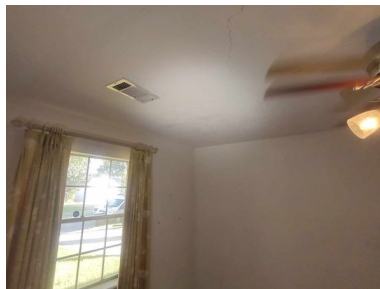
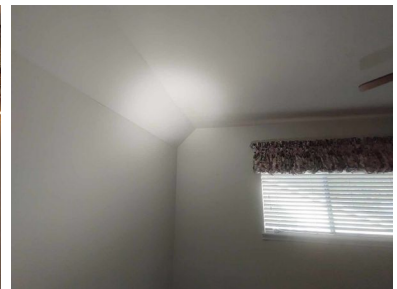
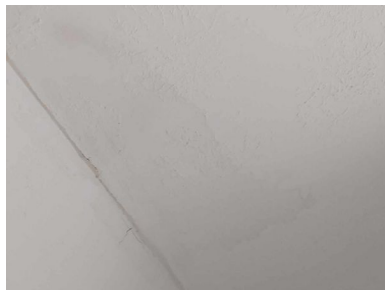
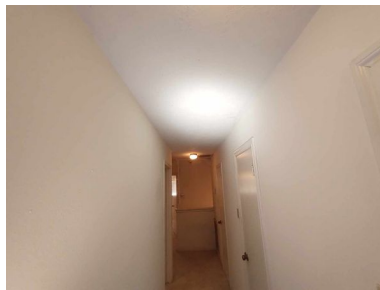
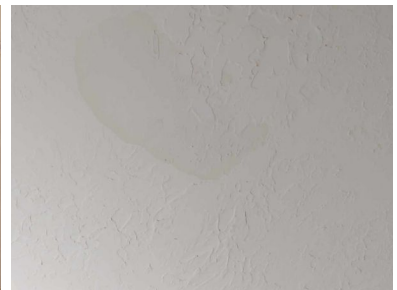
**2: Water Stains/Damage Observed**

Master bedroom, 2nd floor hallway, 2nd floor west bedroom,

**Obtain Cost Estimate**

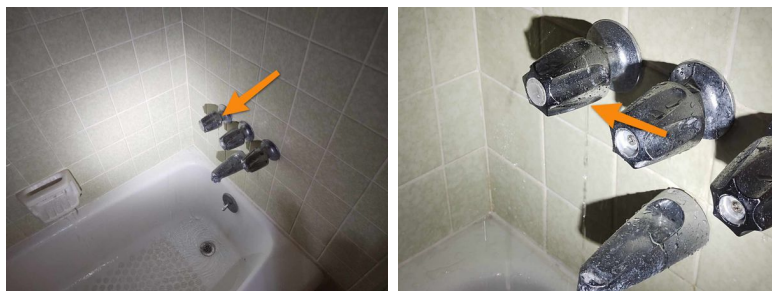
A water valve was leaking around the valve stem and needs to be repaired/replaced.

**Obtain Cost Estimate**

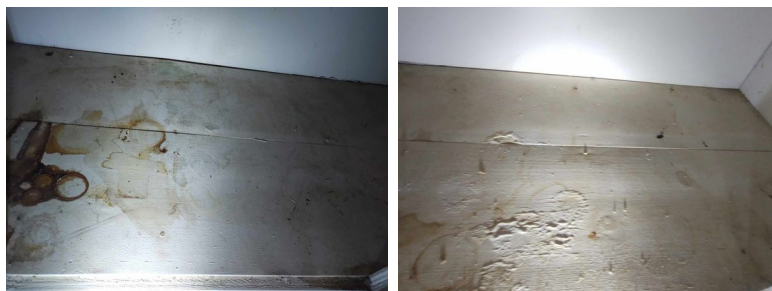
Evidence of a previous leak was visible under a sink, where water stains/damage were visible at the bottom of the cabinet. No leaks were visible at the time of the inspection.

**Further investigation is recommended.**

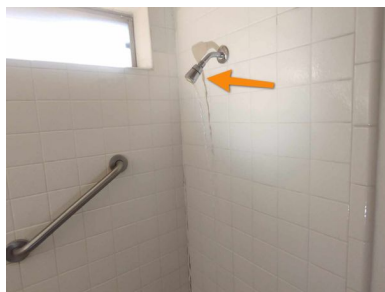
The diverter valve was leaking water past the valve when the valve was turned to the faucet or shower.

**Obtain Cost Estimate**

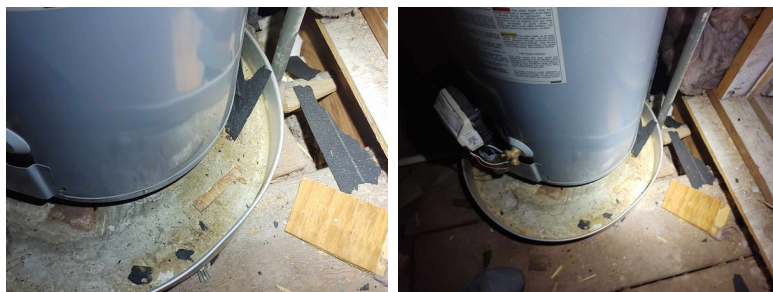
**2: Overflow Pan - Remove Insulation/debris**

Insulation and/or debris was observed in the overflow pan and needs to be removed.

**Obtain Cost Estimate**

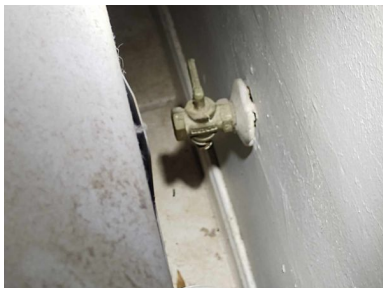
An unused gas valve that was not capped was observed. The unused gas valve needs to be properly capped to prevent accidental gas leaks.

**Obtain Cost Estimate**

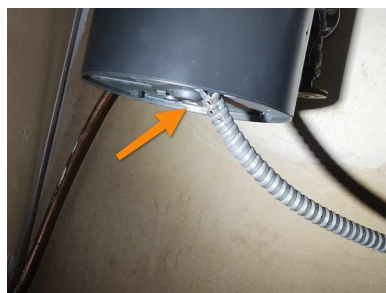
The electrical connection at the bottom of the disposal was missing the proper clamp connection to the housing.

**Obtain Cost Estimate**

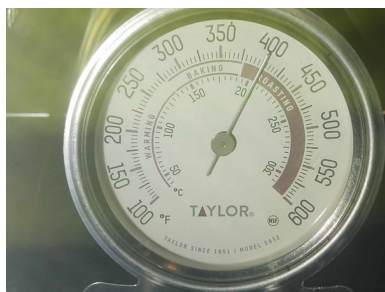
Lower oven

Both oven thermostats were checked, and one was properly calibrated, and the other was not properly calibrated. The thermostats were set at 350 degrees, and the lower oven did not heat to within the allowable  $\pm 25$  degrees. The ovens were checked with an oven thermometer, and the upper oven was found to heat to 330 degrees, and the lower oven to 400 degrees.

**Obtain Cost Estimate**
