STRUCTURAL INSPECTION

11511 Olympia dr
HOUSTON, TX 77077

OCTOBER 5, 2022

REF: CONDITION OF PROPERTY SURVEY

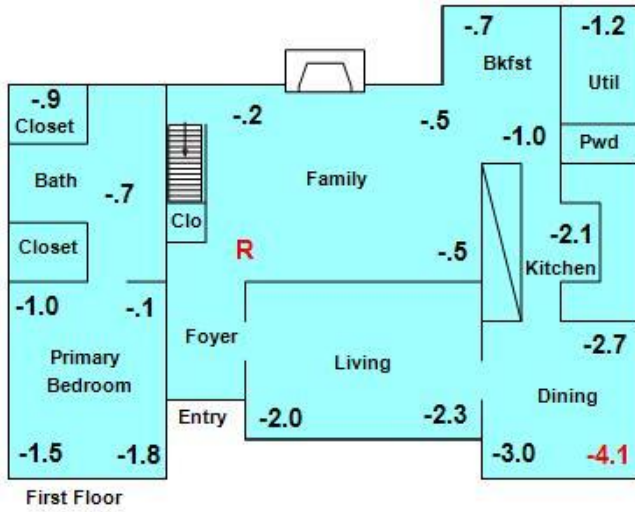
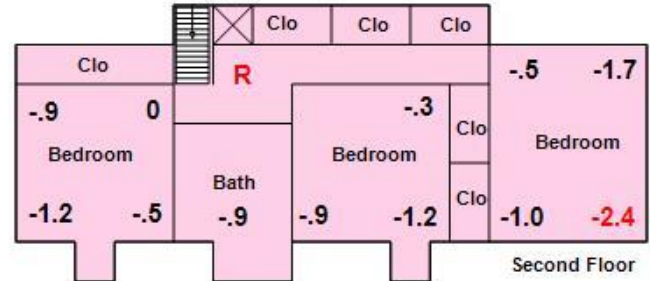
Elevation Readings
11511 Olympia Drive

The floors were checked with an electronic level, and were observed to be sloping a more than normal degree towards the perimeter of the house.

Due to the more than acceptable amount of movement of the foundation of this structure, it is our opinion that releveling of the foundation is needed at this time. It is recommended that at least three foundation repair contractors be contacted in order that they may make their own assessment of the scope and cost of the work needed to bring this foundation back to an acceptable degree of levelness.

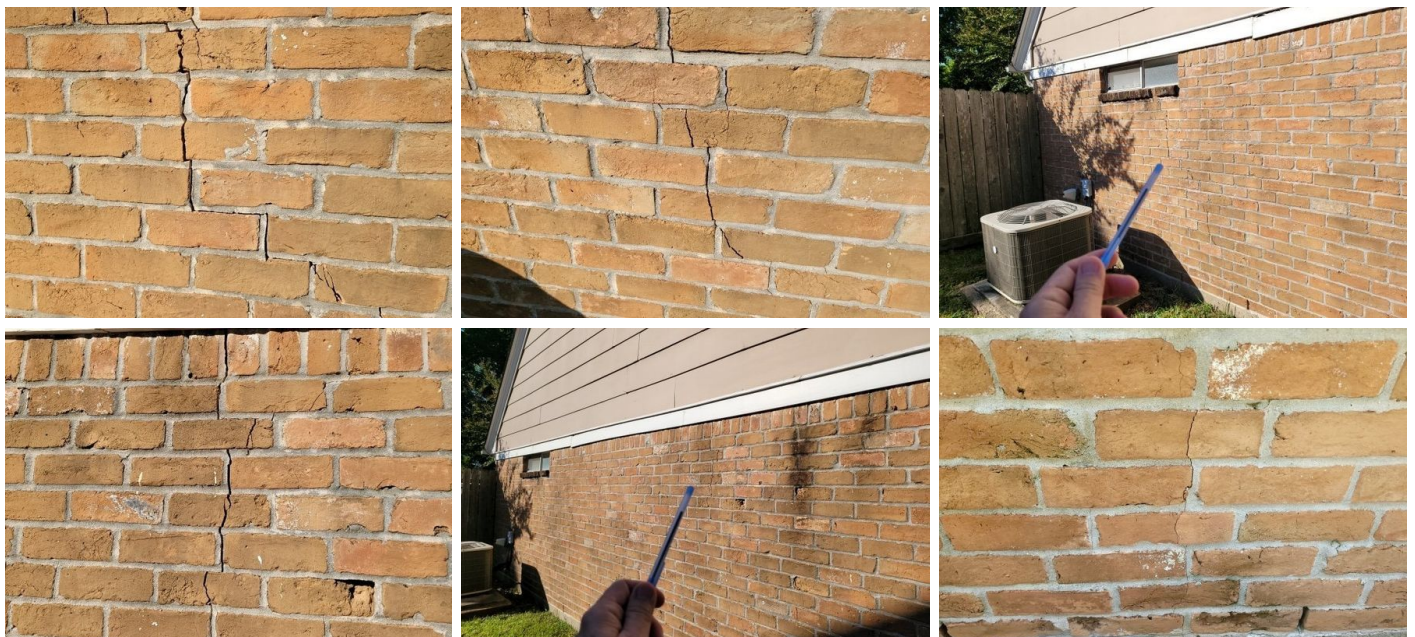
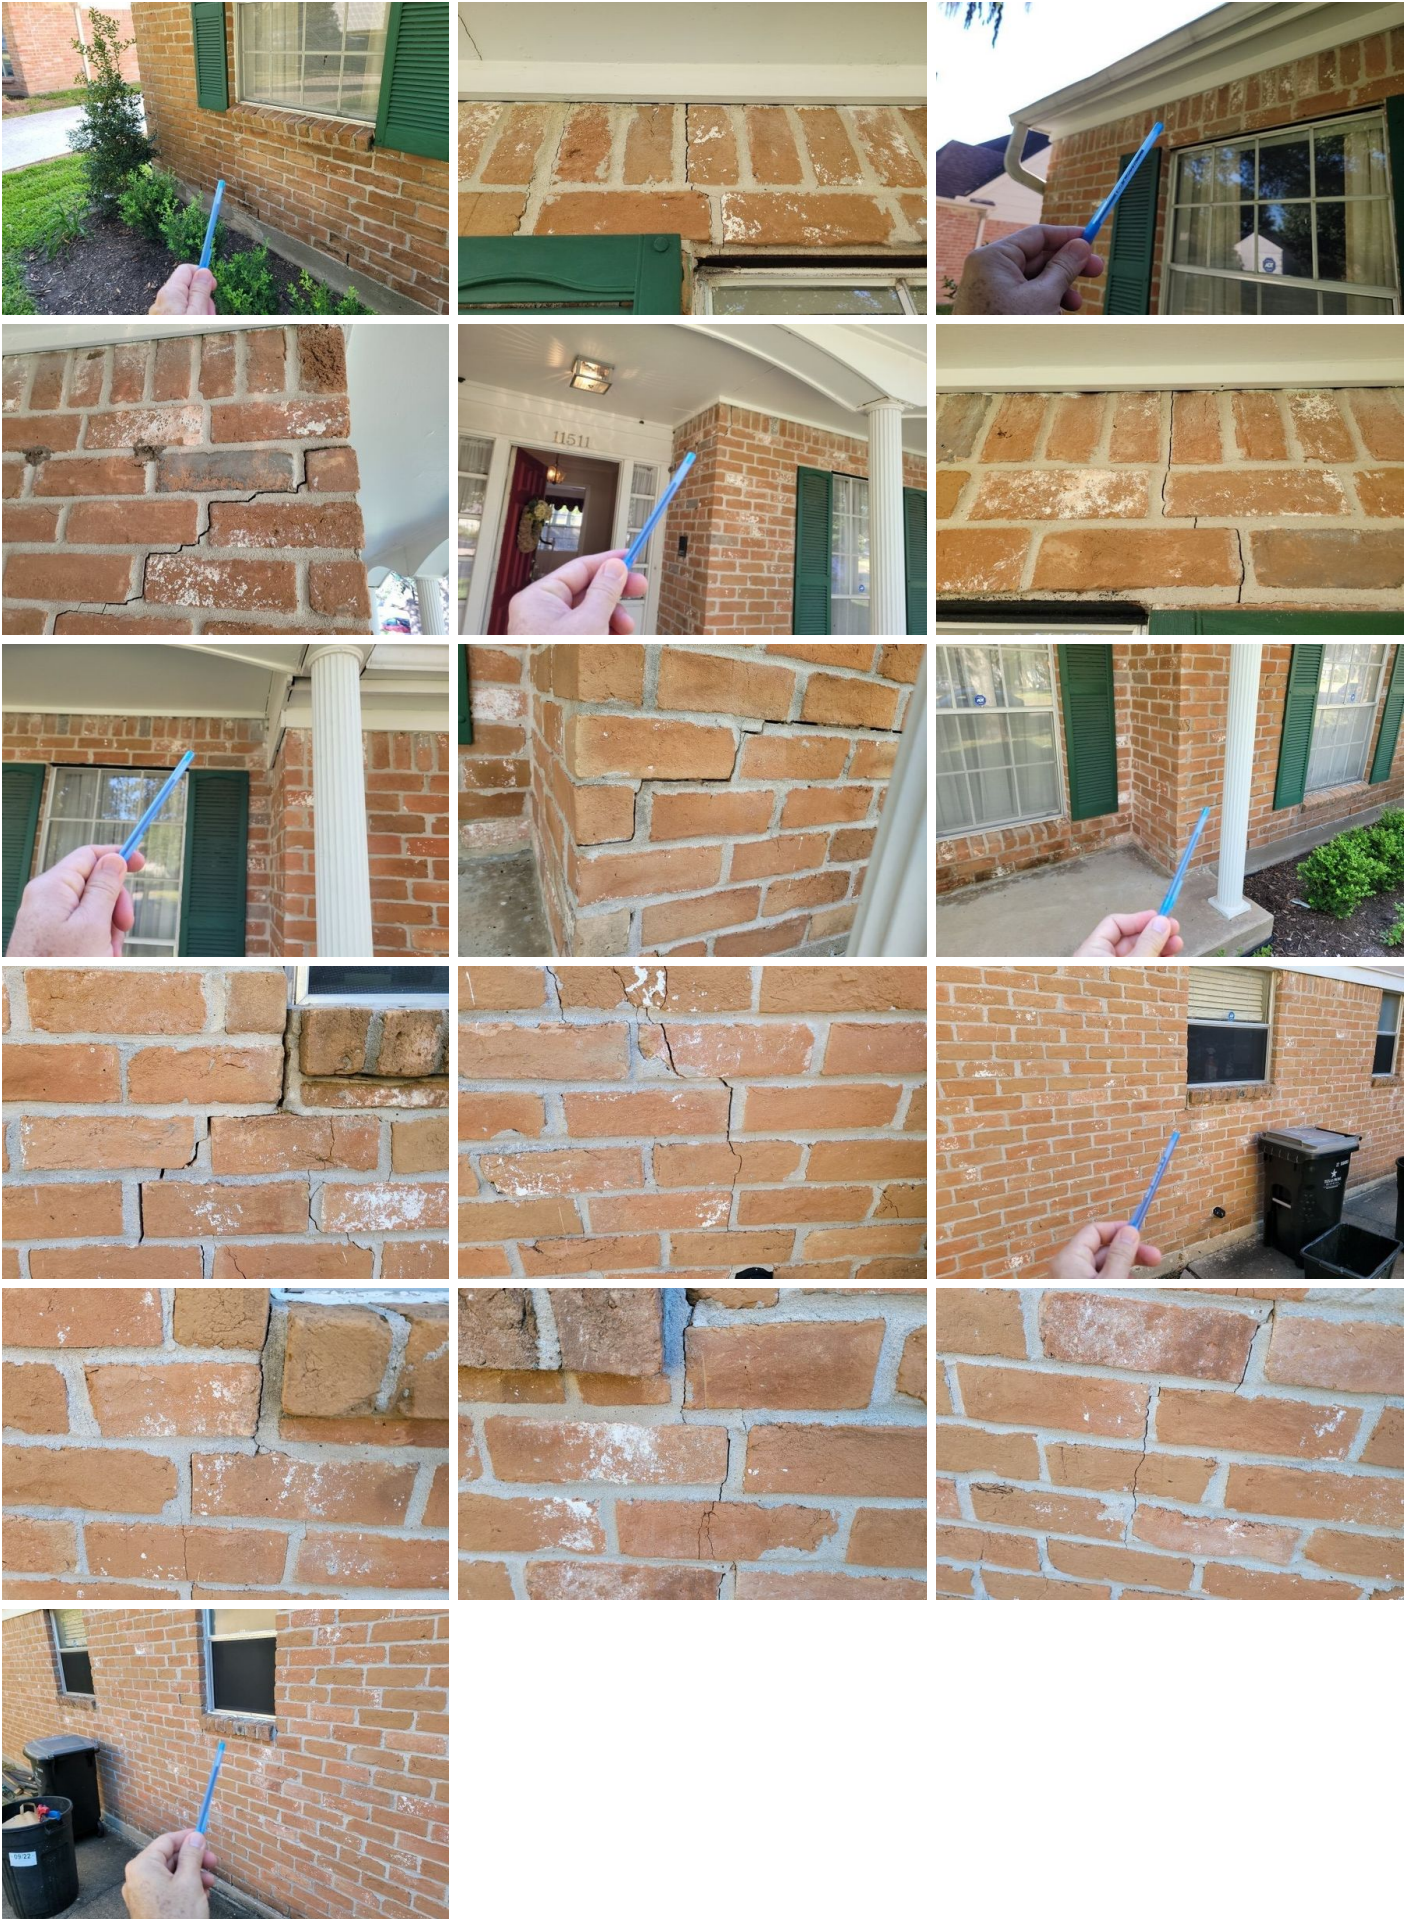
Veneer - Cracks/Patches

Cracks and/or patches were observed in the exterior veneer at the time of the inspection, including at the locations shown in the photos. It is recommended that the cracks be repaired for cosmetic purposes.

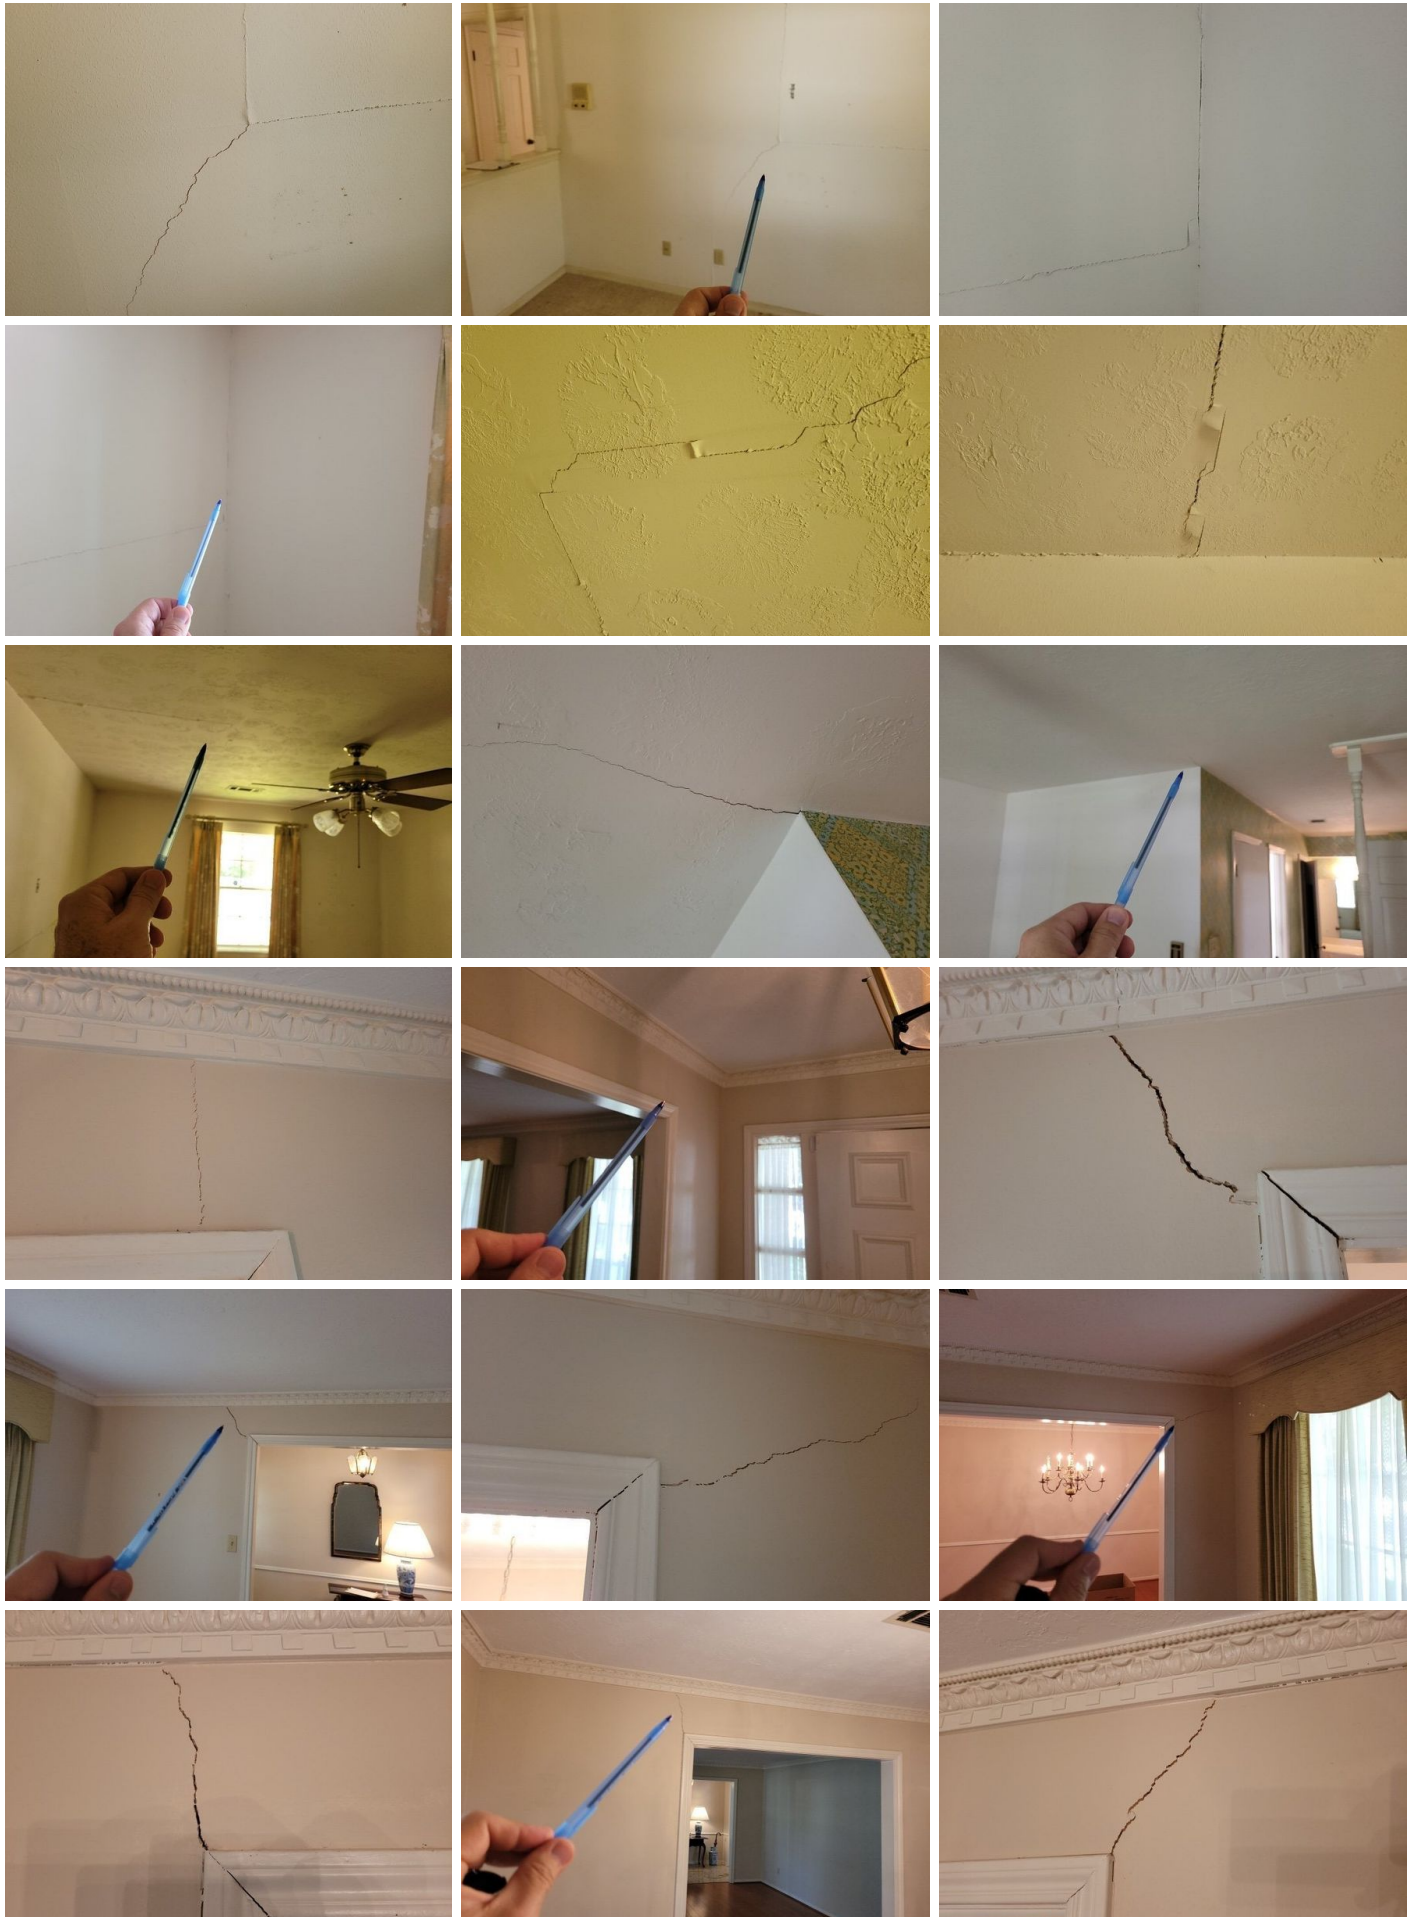
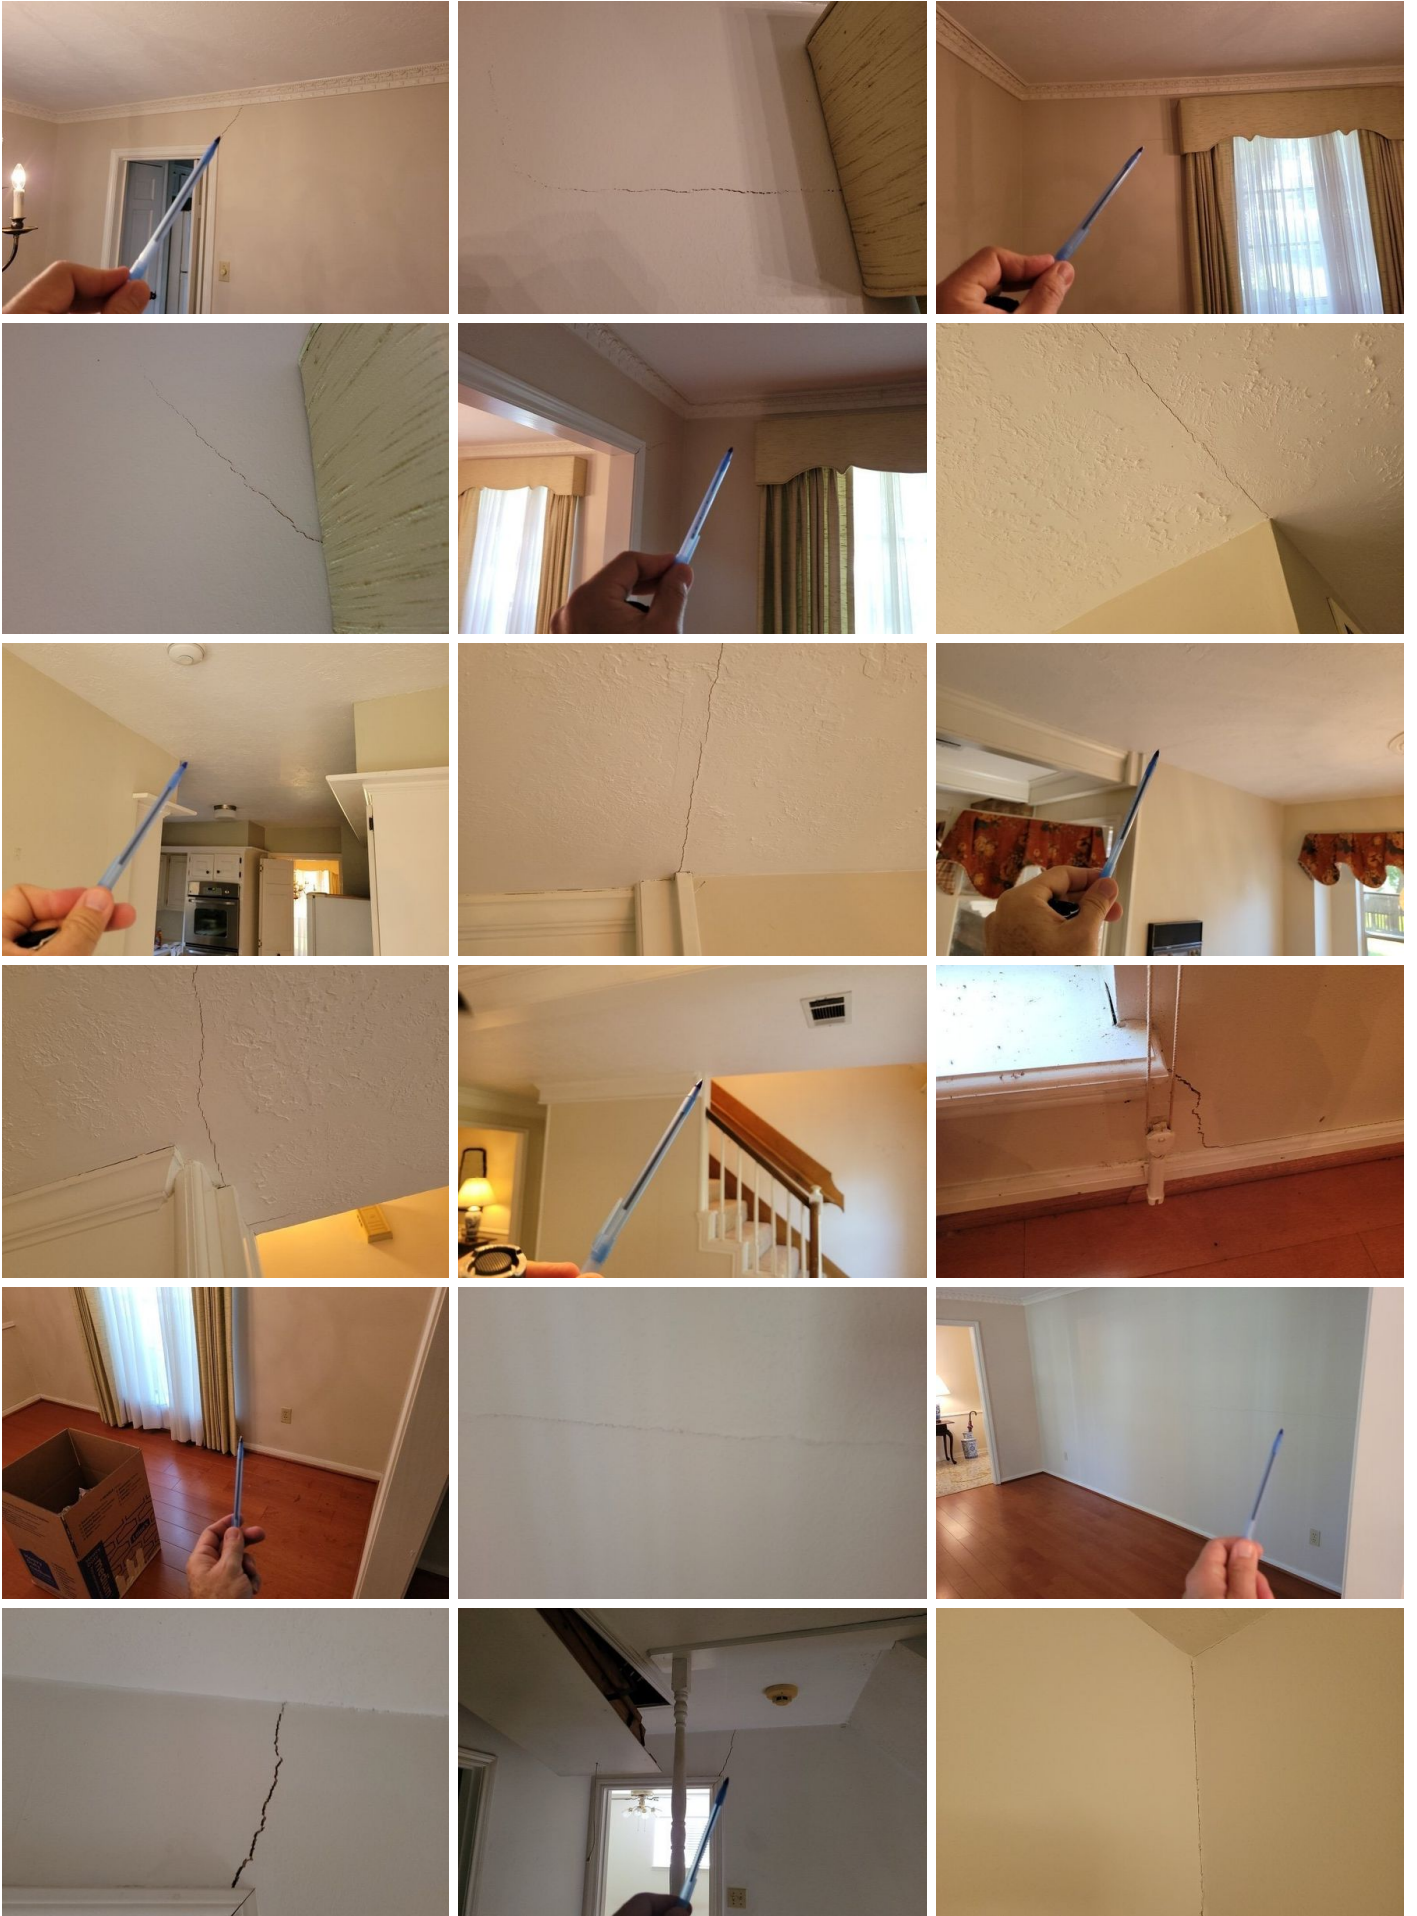
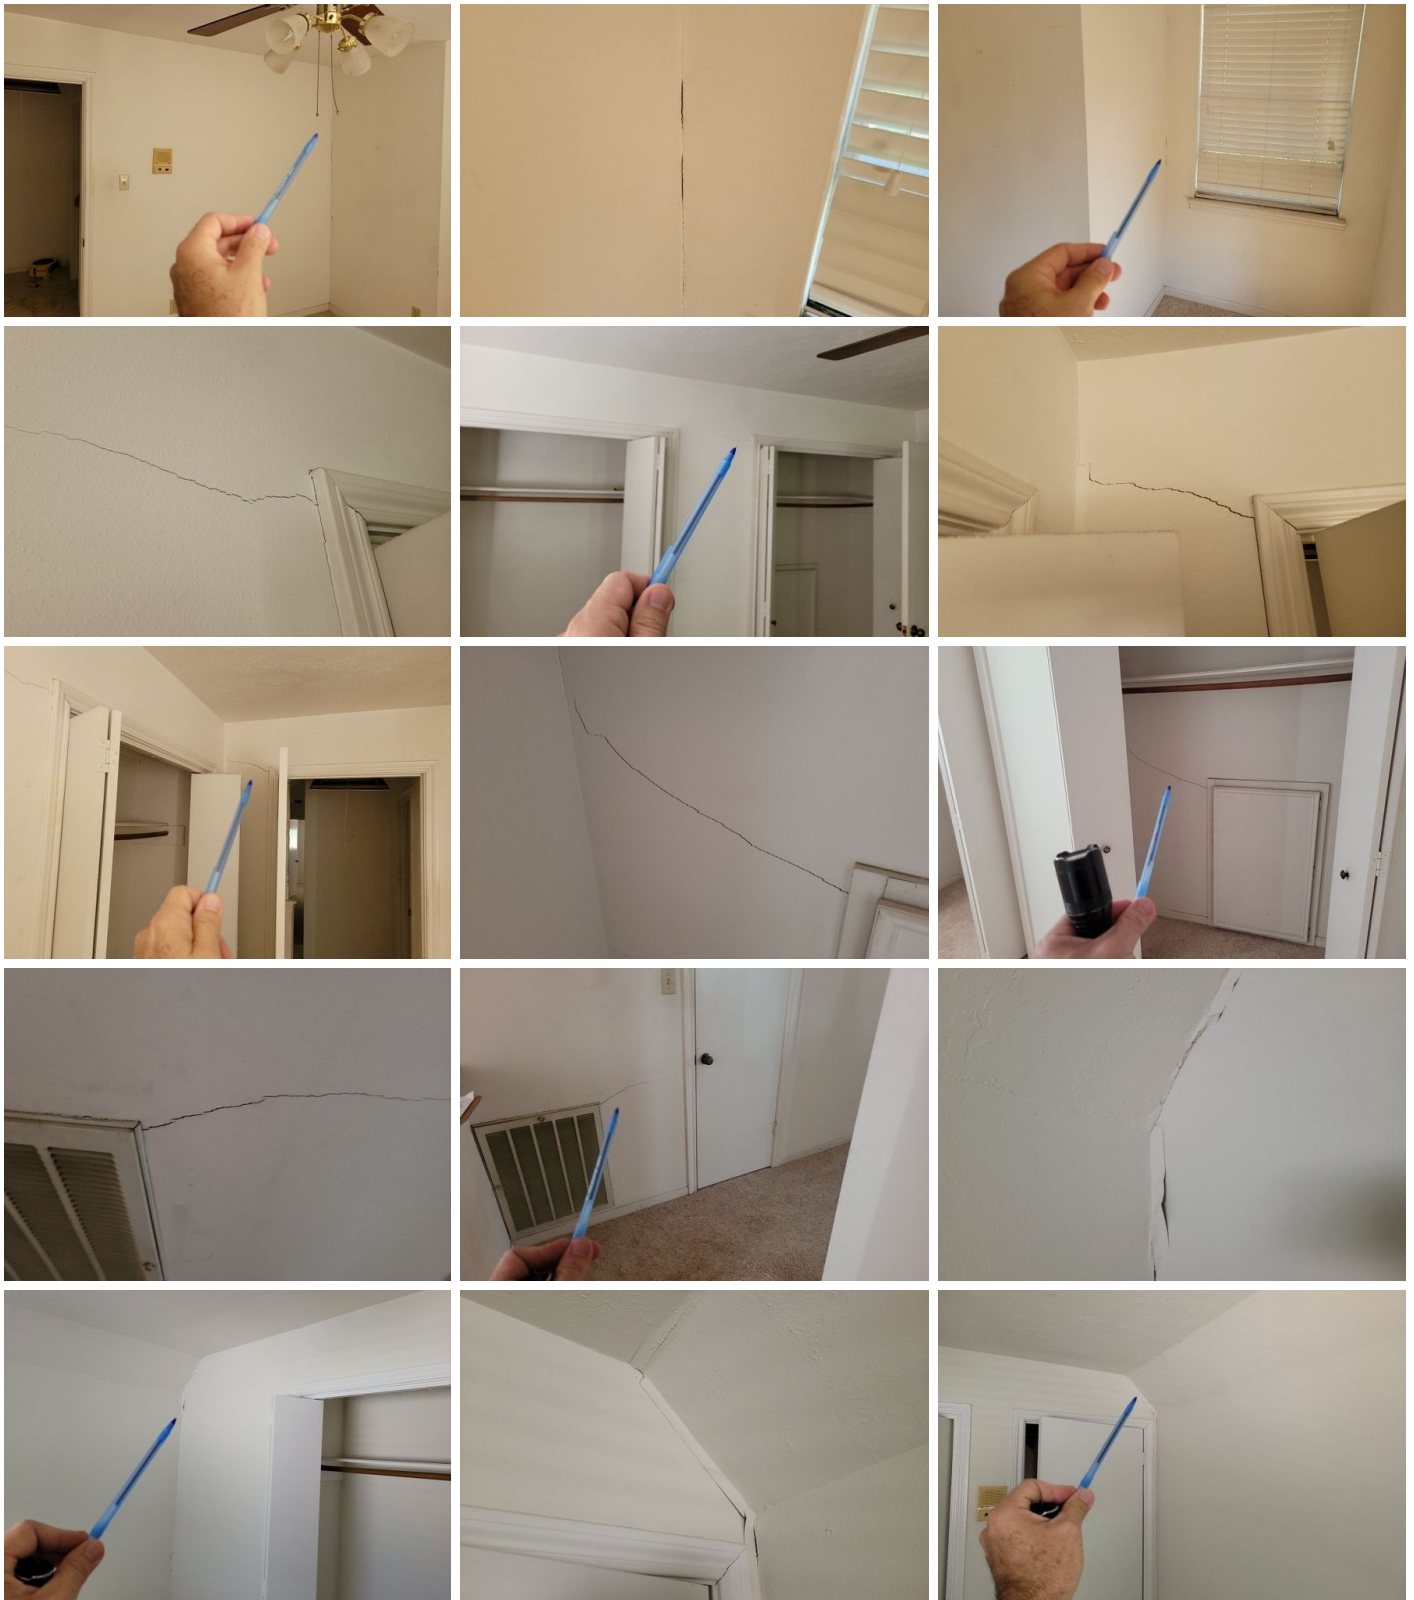
Sheetrock Cracks/Patches/Compression ridges
Throughout the house

Sheetrock cracks, patches, and/or compression ridges were observed in the house during the inspection, including at the specified locations. It is recommended that the cracks be repaired.

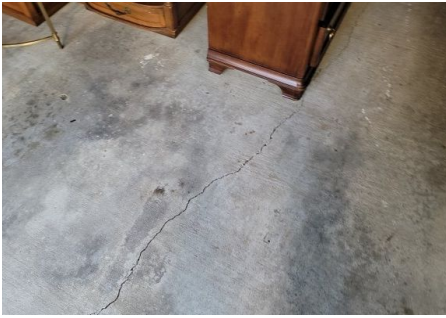
Concrete Cracks - Garage

Cracking of the foundation concrete exists in virtually all foundations. It is pointed out that cracking is a normal property of concrete and other brittle materials, and Hedderman Engineering, Inc. assumes no responsibility should cracks be found that are not mentioned in this report. Some cracking was observed in this concrete foundation, including at the garage floor.

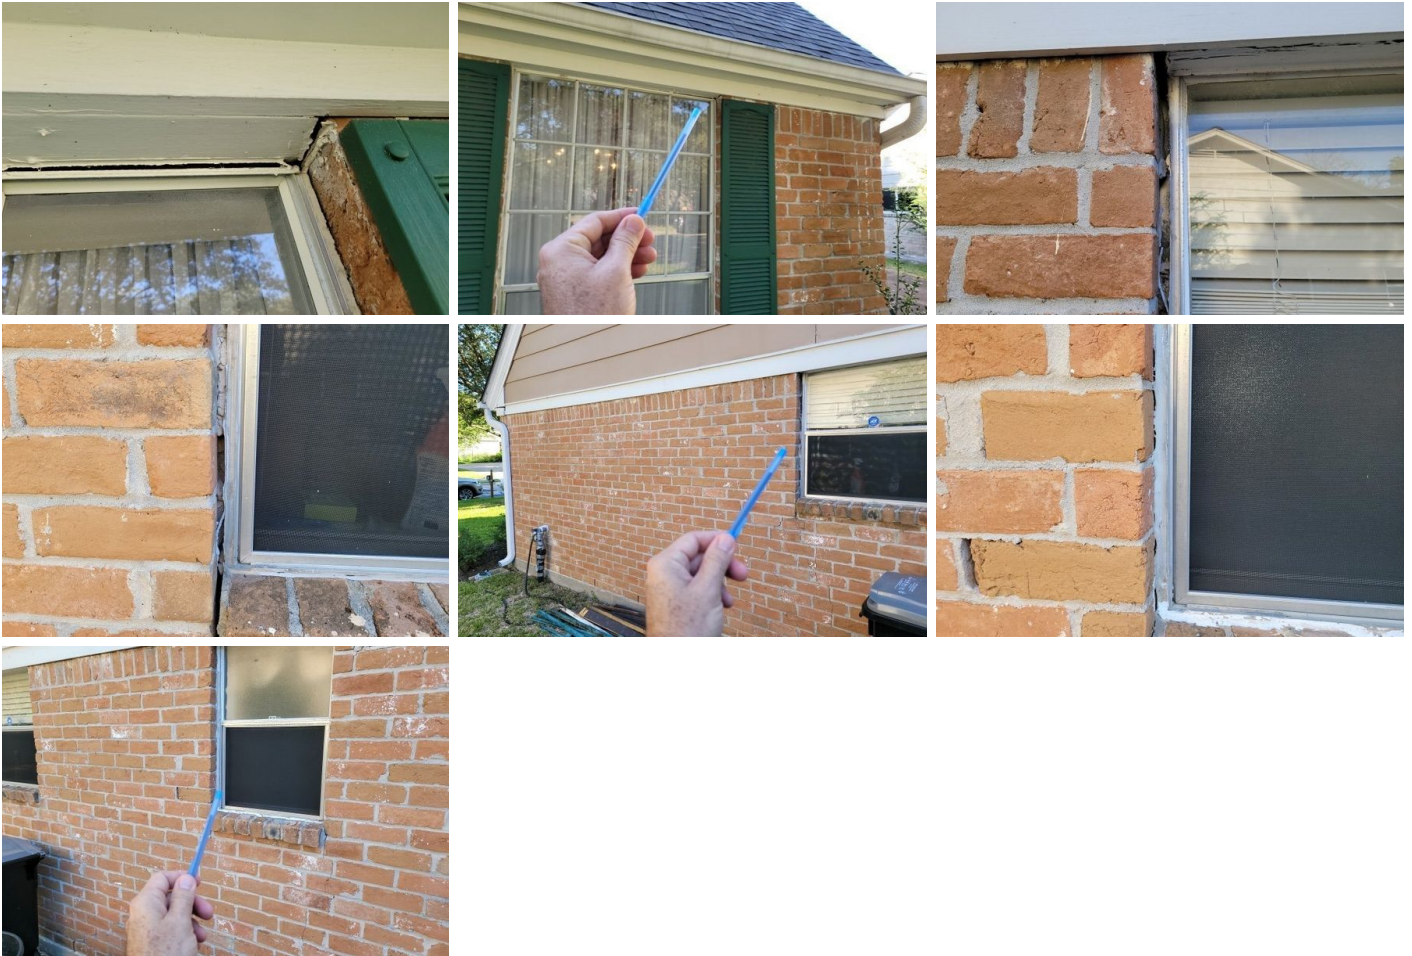
Front West

Separation of Materials: Window frame

The window frame was separated from the exterior brick veneer apparently due to movement.

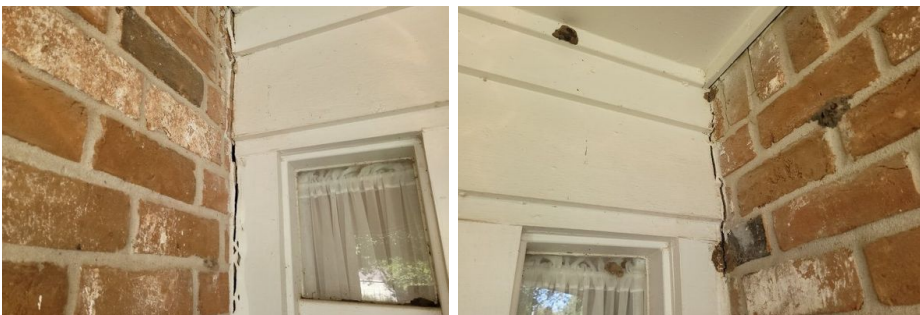
Front Door

Separation of Materials: Door frame

The door frame was separated from the exterior brick veneer apparently due to movement.

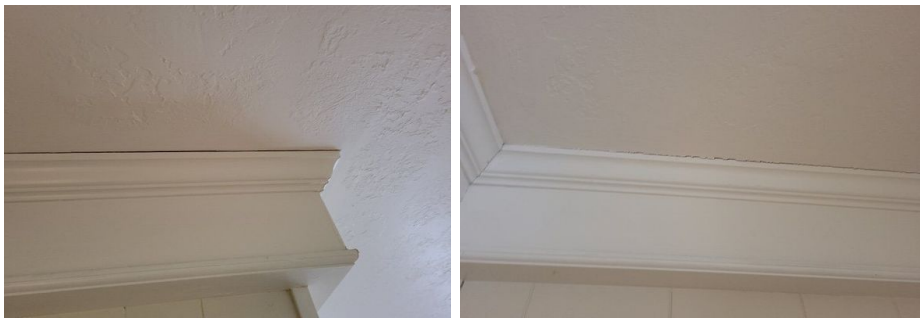
Hallway

The crown molding was observed to be separated at the ceiling which is typically related to movement in the house.

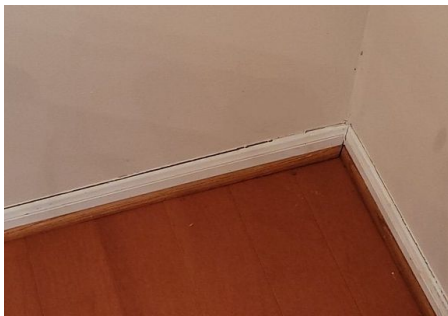
Dining Room

Separation of Materials: Baseboard separation

The baseboard trim was observed to be separated, which can be an evidence of movement.

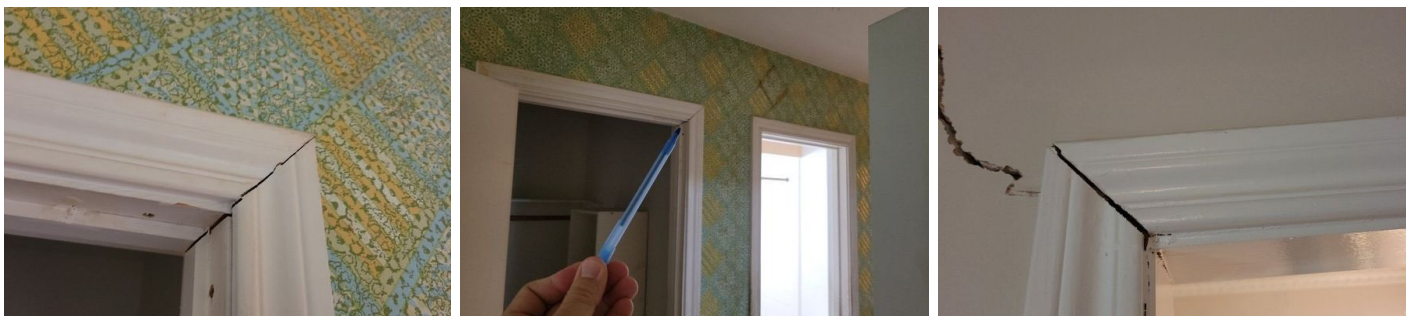
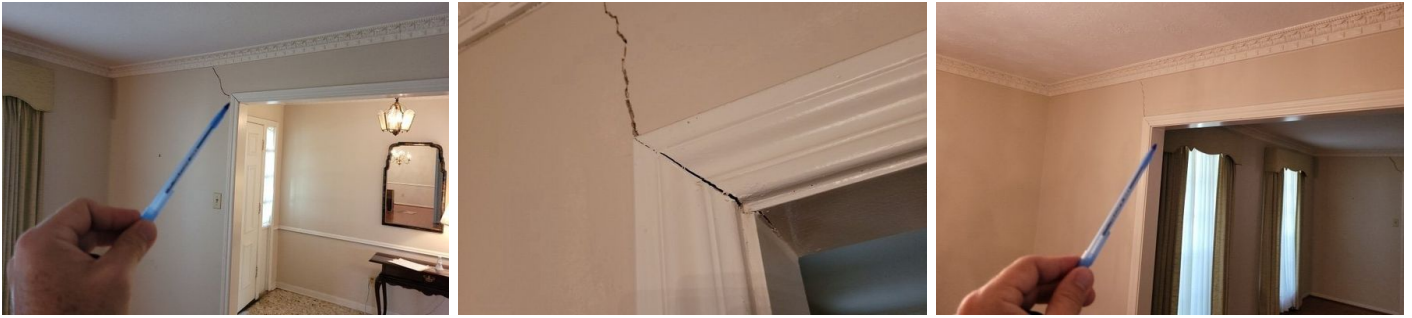
Master Bath Living Room

Separation of Materials: Door trim separation

We observed door trim that had separations at the trim joints at some locations.

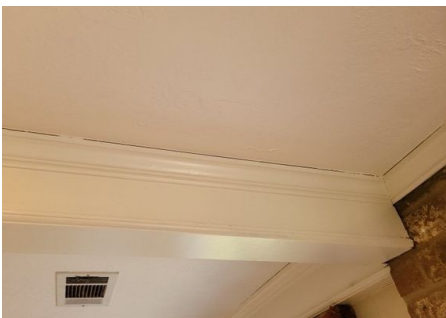
Family Room

The decorative beam was separated from the ceiling and/or the crown molding.

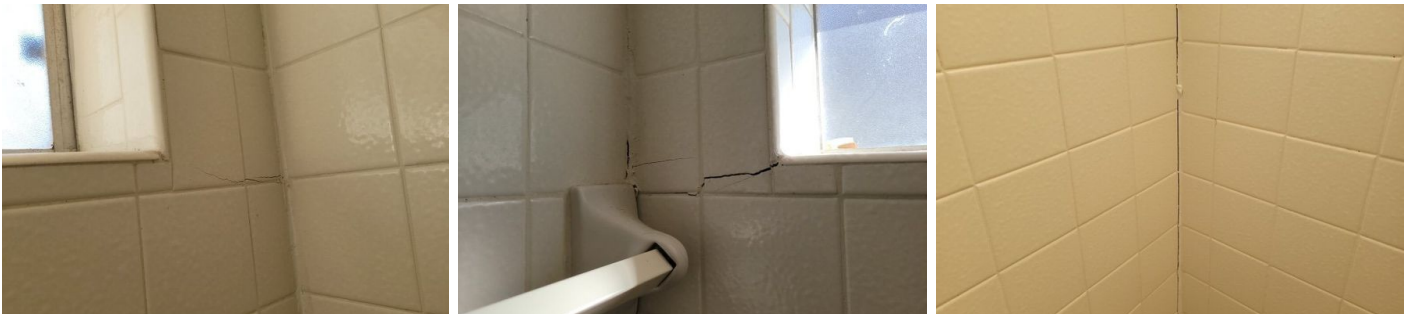
Master Bath

Separation of Materials: Wall tile cracked

The tile on the wall was cracked which can be an evidence of movement of the house.

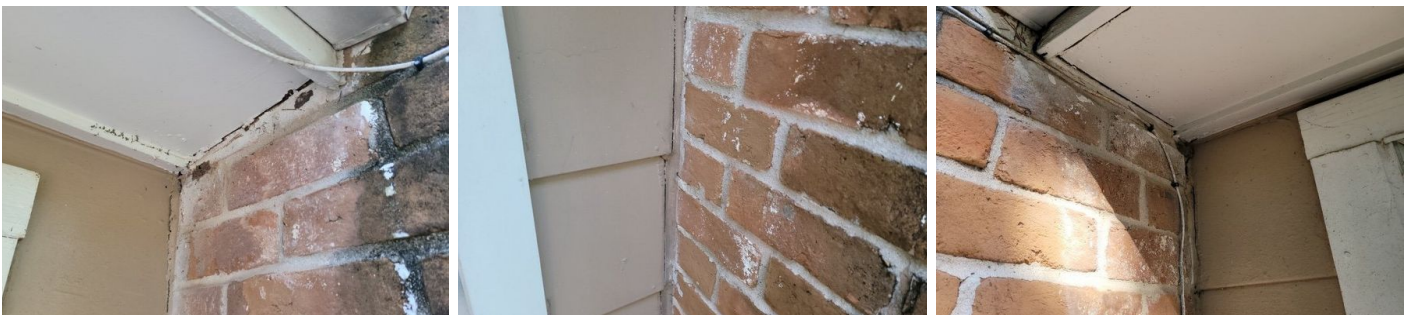
Separation of Materials: Chimney separated

The chimney was separated from the exterior wall due to movement of the foundation.

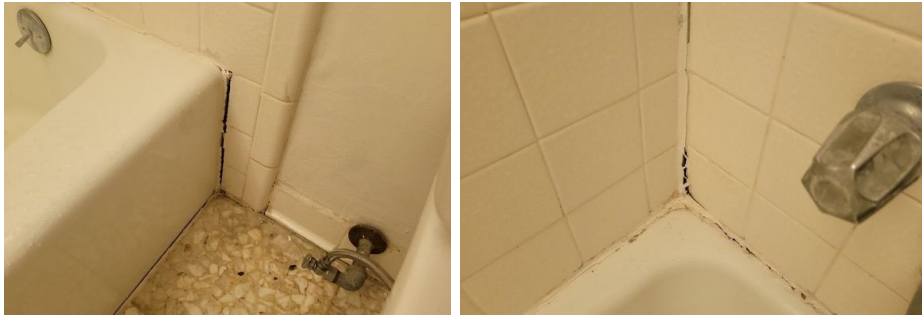
Master Bath

Separation of Materials: Vanity separated

We observed that the bath vanity was separated from the bathroom wall which can be an evidence of movement of the foundation.

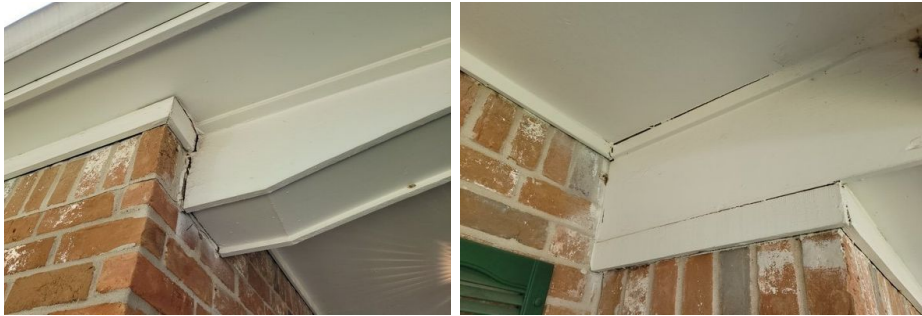
Front

Separation of Materials: Separation between veneer and siding

We observed separations between the veneer and siding, and the separations appear to be related to movement of the foundation.

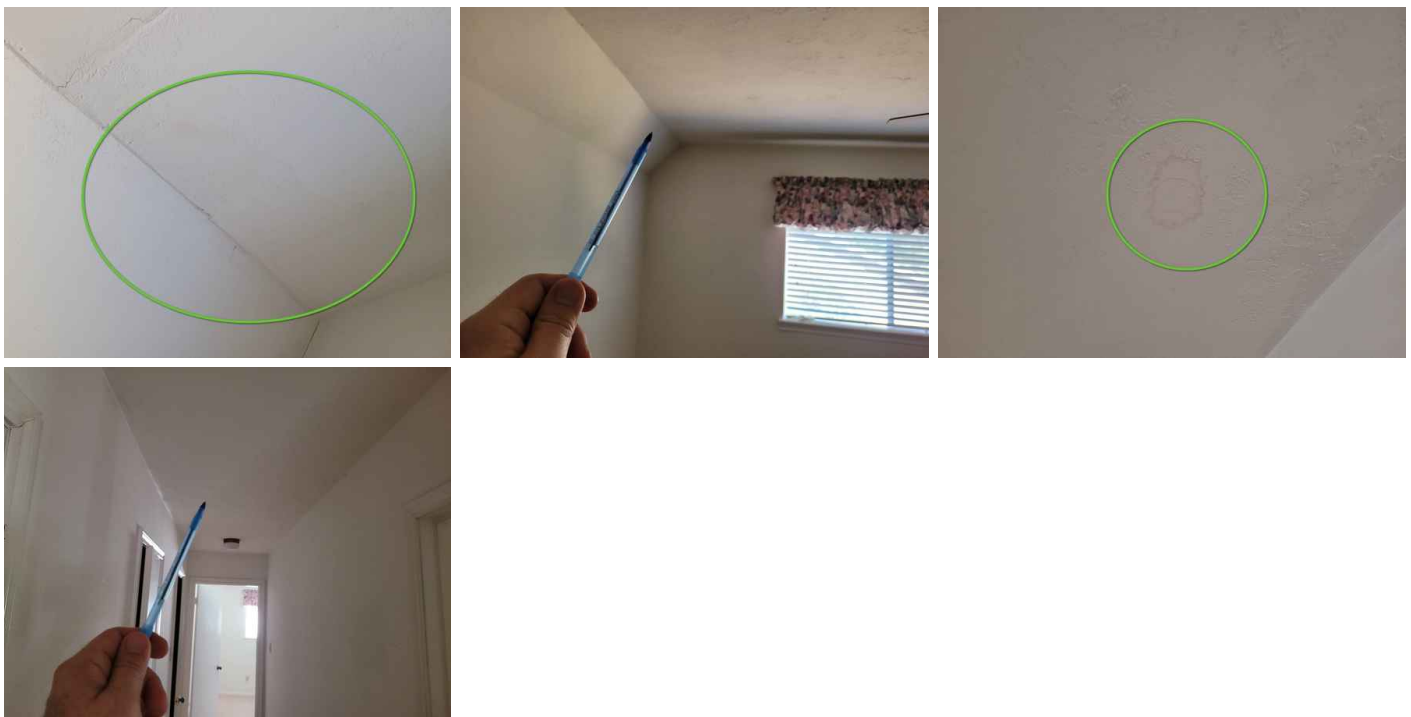
2nd Floor Hallway West Bedroom

Roof Leaks: Stains appear to be from previous leaks

After observing the interior of the structure, evidences of current roof leaks were not visible. The absence of evidences of roof leaks does not guarantee that roof leaks were not present; rather, that no evidences of leaking were visible at the time of the inspection. Some stains were visible, but the stains appeared to be related to previous roof leaks. It is recommended that you check with the owner and/or a service company concerning the stains.

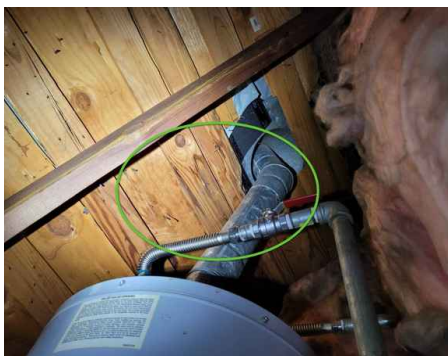
Roof Leaks: Attic stains appear to be from previous leaks

After observing the interior of the structure, evidences of current roof leaks were not visible. The absence of evidences of roof leaks does not guarantee that roof leaks were not present; rather, that no evidences of leaking were visible at the time of the inspection. Some stains were visible in the attic, but the stains appeared to be related to previous roof leaks. It is recommended that you check with the owner and/or a service company concerning the stains.

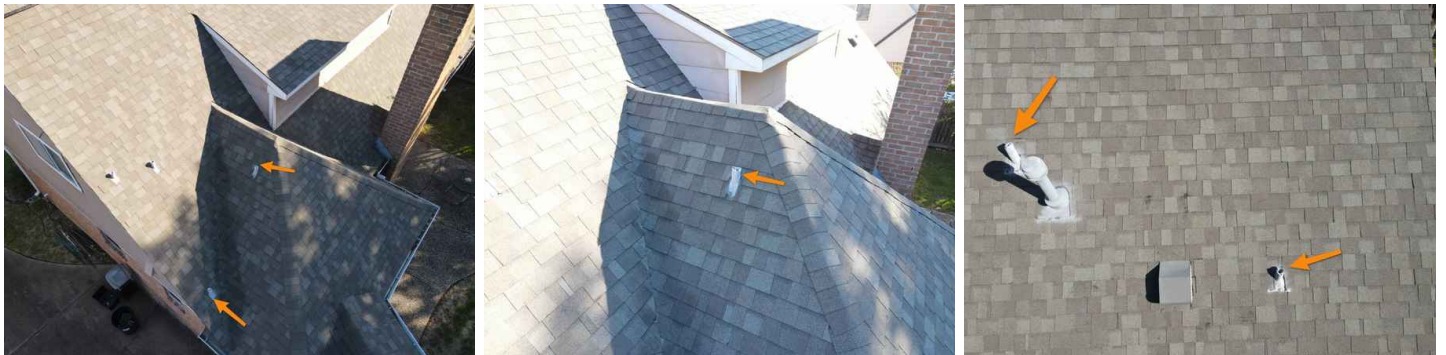
The roof jacks at the plumbing vent pipes were observed to have the conditions as described above. Further investigation with a roofing contractor is recommended to make all needed repairs.

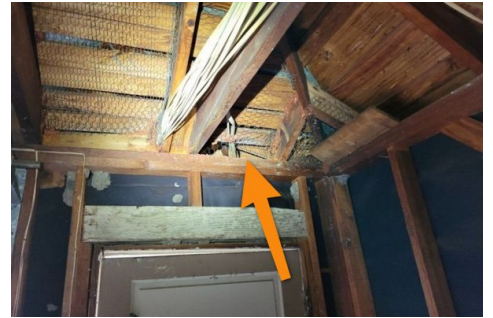
FIRESTOP MISSING BETWEEN GARAGE AND HOUSE

No firestop has been provided in the garage at the breezeway to prevent a fire from spreading between the garage and house.

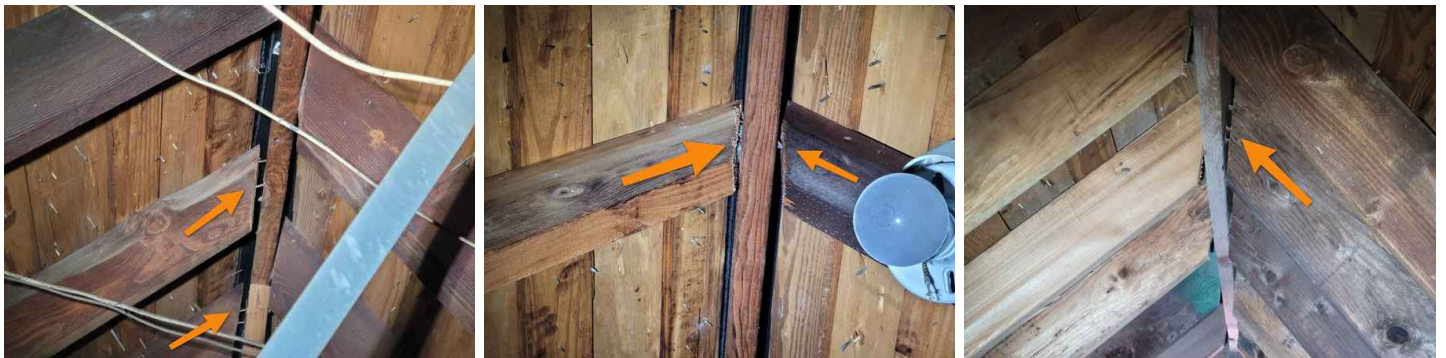
6.5.1 Rafters

RAFTER NOT FLUSH ON RIDGE BEAM

We observed rafters that were separated at the top of the rafter, where the rafter meets the top ridge beam. Rafters should be flush against the ridge beam, and it is recommended that 3 foot make-up pieces be "sistered" onto the rafters, so that the make-up pieces are flush against the ridge. This will allow the rafters to bear against the ridge beam for the entire length of the miter cut on the rafter.

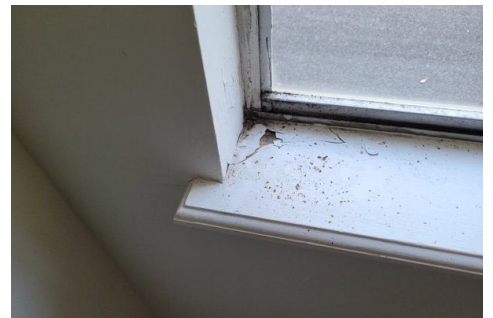
WATER STAINS/WATER DAMAGE

Evidences of water penetration to the interior of the structure were observed, including water stains and/or water damaged materials.

Further investigation is recommended with service companies to determine the source(s) of the water penetration along with any secondary damages, and also to provide a cost estimate for any needed repairs.

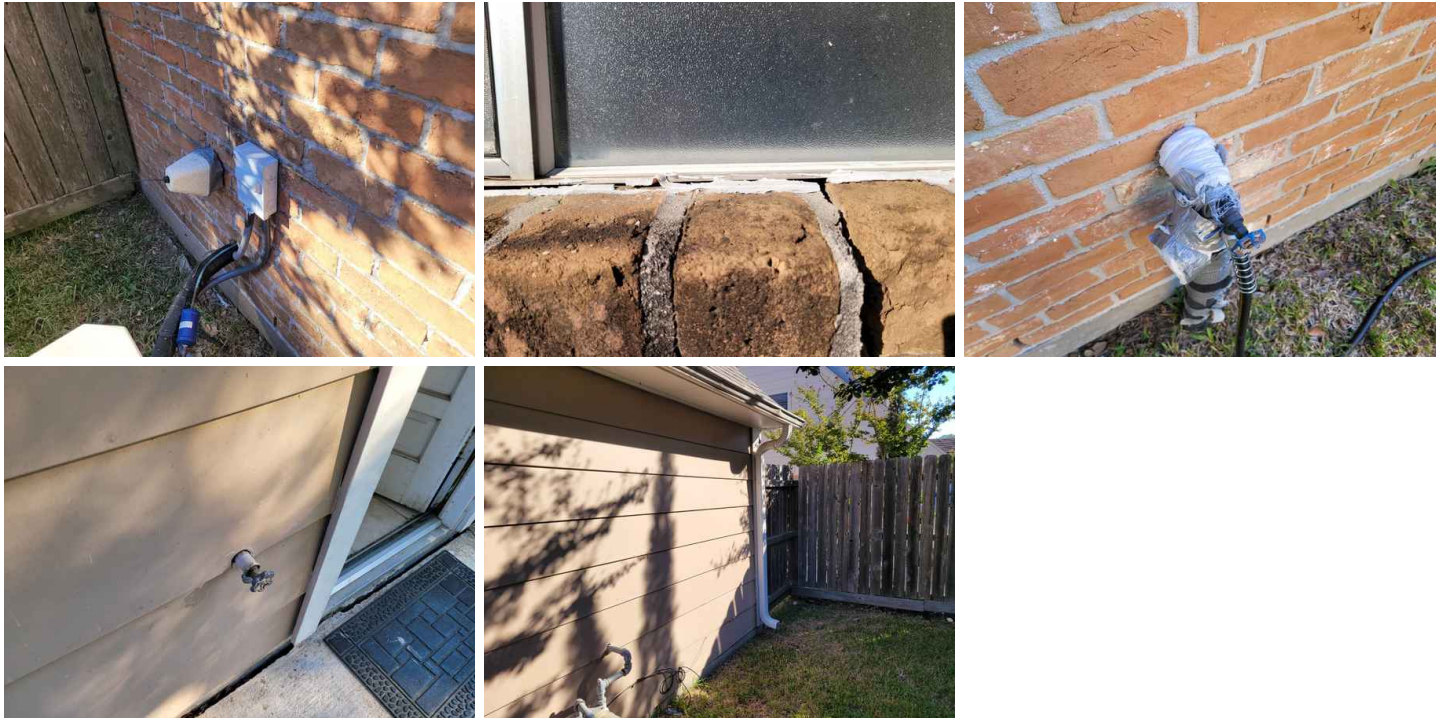
7.1.2 Water Penetration

VULNERABILITY TO WATER PENETRATION

A substantial vulnerability to water penetration was observed at penetrations/openings through the exterior building envelope, and it is recommended that all penetrations/openings be sealed against water penetration. Typical examples on a structure may include light fixtures, air conditioning refrigerant lines, water piping, gas piping, vent caps, windows, doors, expansion joints, etc. Below is a representative sample of locations and/or photographs showing some, but not necessarily all, locations where there is a vulnerability to water penetration. Have a contractor provide a cost estimate to seal all vulnerable areas on the exterior building envelope against water penetration and/or open up any clogged weepholes in the veneer.

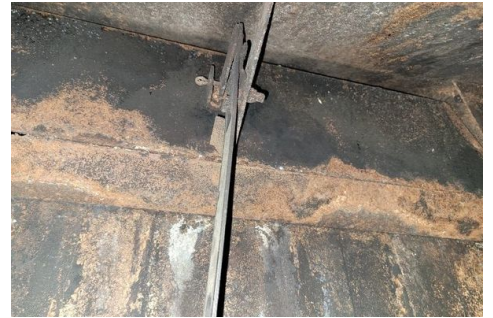
DAMPER - C CLAMP MISSING

The damper was not equipped with a C-Clamp device to prevent closing the damper completely to allow the hazardous combustion gases a path to escape up the chimney.

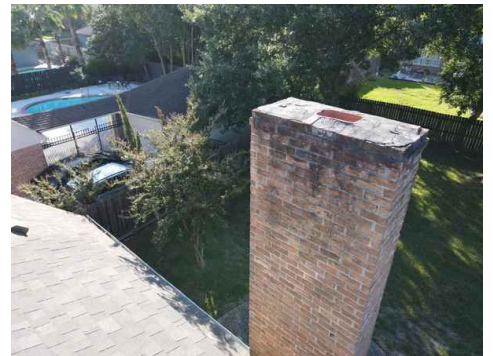
8.2.2 Masonry fireplace

WEATHER CAP - MISSING

The top of the chimney flue did not have a spark arrester/weather cap installed in the flue to prevent water penetration down the chimney and bird entry into the chimney. Evidences of water penetration were visible at the firebox, where the firebrick was stained.

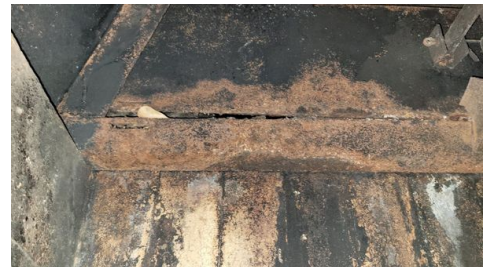
8.2.3 Masonry fireplace

DAMPER - SEVERELY RUSTED

The damper was severely rusted and difficult to operate. It should either be repaired, if possible, or replaced by a fireplace service company.

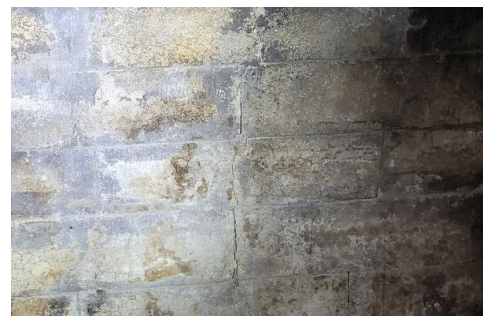
8.2.4 Masonry fireplace

GROUT MISSING - FIREBOX

Some of the grout was missing at the joint of the front wall of the firebox, which can be a fire hazard as it can allow the heat of the fire to enter the wall cavity, and it is recommended that the separation be properly filled with mortar.

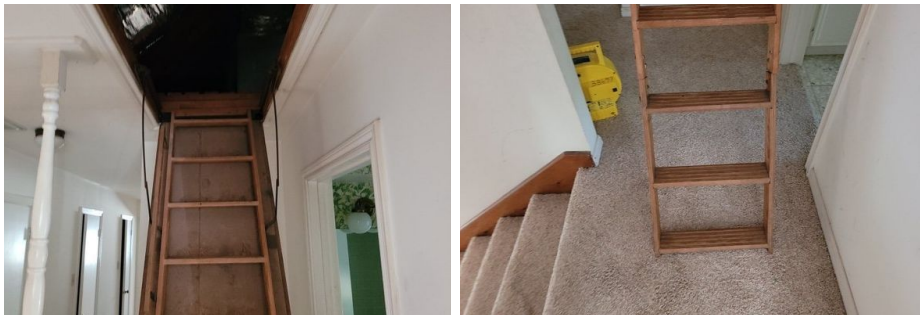
Ladder: Original ladder - Not rated

The access ladder into the attic appeared to be the original installation ladder, and the ladder was not labeled to indicate the rated capacity of the ladder. The ladder does not meet current code requirements for ladders into attics. Consideration should be given to replacing the ladder with a ladder that meets current code requirements.
