STRUCTURAL INSPECTION

11511 Olympia dr
HOUSTON, TX 77077

OCTOBER 5, 2022

REF: CONDITION OF PROPERTY SURVEY

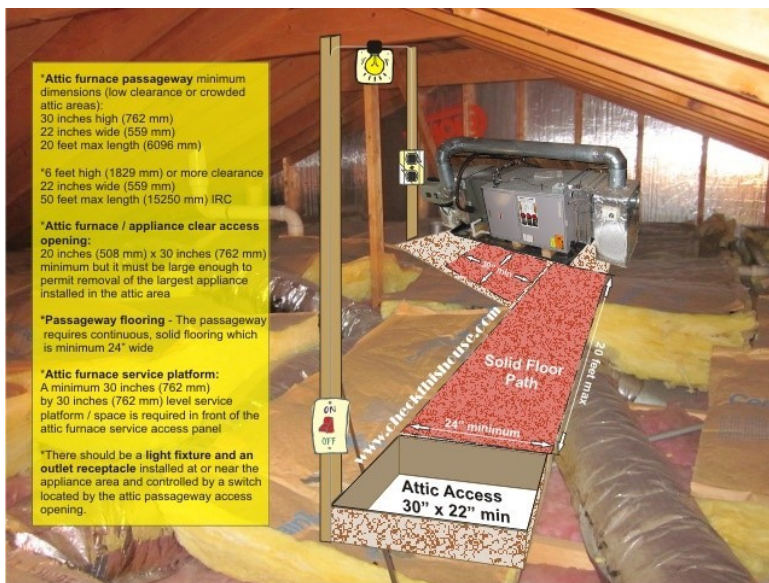
INADEQUATE WALKWAY AND/OR PLATFORM DECKING

The attic did not have adequate service decking to all the equipment in the attic. The service decking should be a continuous deck that is a minimum of 24 inches wide, that extends from the attic access opening to all equipment in the attic. The platform decking should be a continuous deck that is a minimum of 30 inches wide, that extends along all sides of the appliance where access is required. In addition, the decking should be free from any obstructions, such as gas lines, electrical wiring, ductwork, framing members, etc.

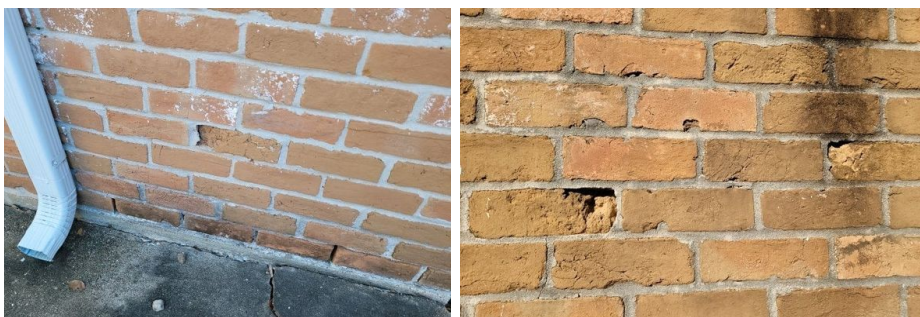
West East

Brick/Stone Veneer: Eroded Brick - Monitor

Some of the bricks were eroded slightly at various locations of the house. The degree of the erosion was not such that the bricks need to be repaired. The condition needs to be monitored in the future, and repairs made if the condition worsens.

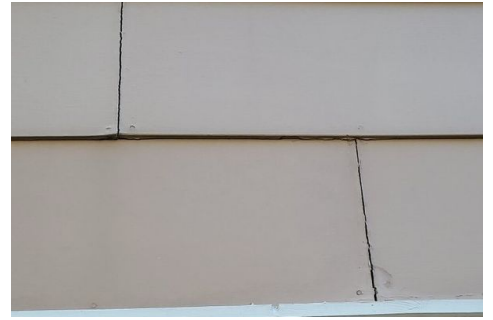
10.8.1 Wood Siding

The wood siding was unsealed at the vertical joints which can allow water to enter the living space and also to damage the ends of the siding. Have the vertical joints sealed.

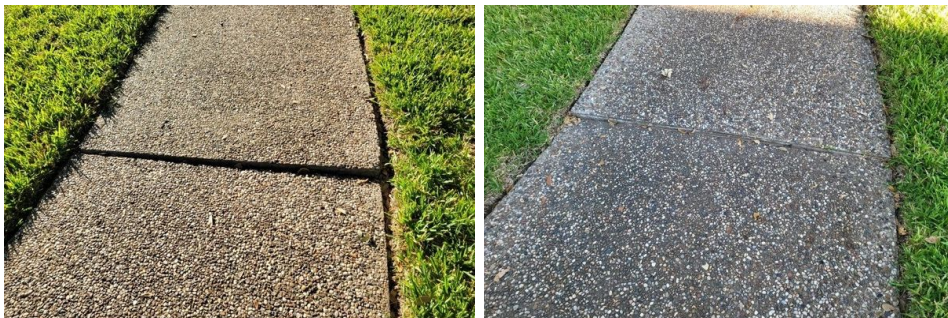
The sidewalk was uneven at the front of the house, and presents a tripping hazard.

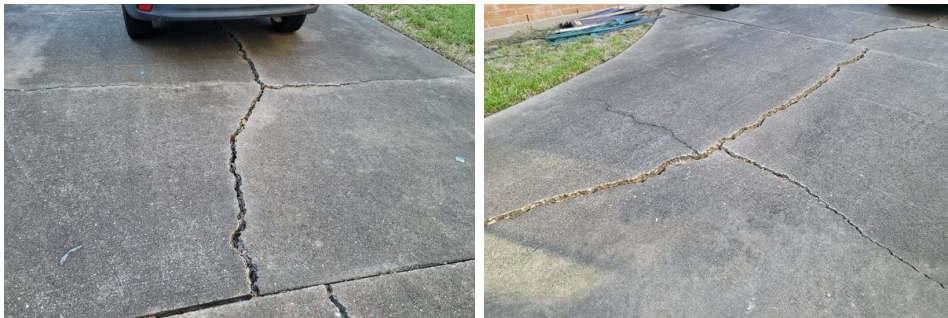
11.1.2 Flatwork Concrete/Patios/Walkways

DRIVEWAY REPAIR

The driveway concrete was badly cracked, and the damaged portion presents a tripping hazard. It is recommended that a contractor be contacted to provide a cost estimate to make the needed repairs.

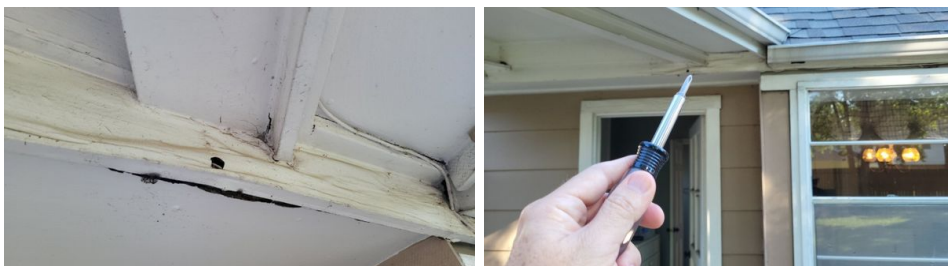
11.4.1 Wood Rot

WOOD ROT

We observed evidences of wood rot and it is recommended that all rotted wood be replaced. Have a contractor provide a cost estimate to determine the entire scope of the wood rot, and provide a cost estimate to replace all rotted wood in the house.

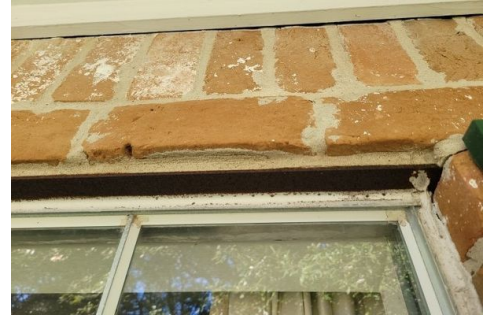
11.9.1 Miscellaneous Exteriors

PAINT - LINTELS

The metal lintels over the windows and doors in brick veneer were not painted or the lintels were rusting, and need to be painted. Have a contractor provide a cost estimate for repairs.

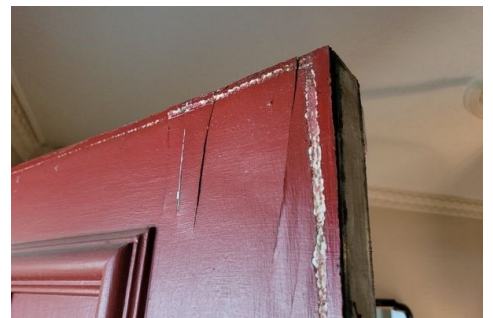
DAMAGED

We observed a door(s) that was damaged, and needs to be replaced. Contact a service company to make the needed repairs.

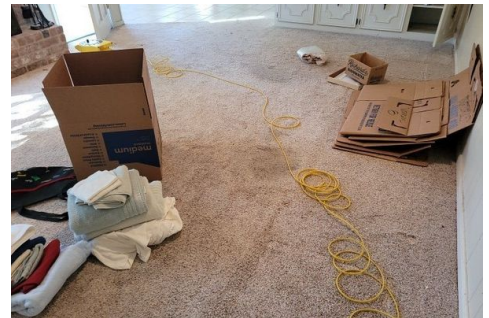
CARPET STAINED

The carpet was observed to be stained, and it is recommended that it be cleaned or replaced.

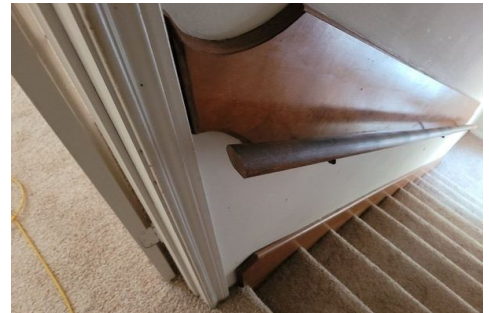
12.4.1 Stairs/Handrails/Guardrails

HANDRAIL NOT TERMINATED INTO WALL
