## Property Inspection Report

11419 Pampass Pass, Houston, TX 77095

Date of Inspection: 2/27/2023 Time: 8:15 AM - 12:15 PM

Inspector: James Sprouse

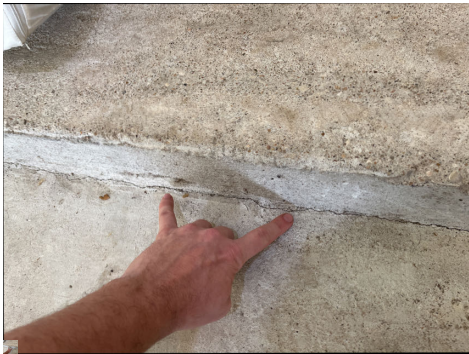
Hairline cracks were noted on the foundation. Cracking in post tensioned slabs prior to tensioning the strands/tendons is very common and this situation has a specific name called "Restrained to Shortening" or RTS cracks. As concrete shrinks during the drying process it would not crack if it were supported by a perfectly smooth frictionless surface, but in reality this is not the case. The ground surface the slab is poured on will restrain the concrete from sliding, which develops stresses in the concrete causing cracks to develop, i.e. RTS cracking. If reinforcing steel or wire mesh were added near the surface ( 1.5" to 2" below the top) it would strengthen the concrete and help resist the dry shrinkage forces that develop, however most post tensioned residential slabs typically do not have any reinforcement other than the post tension cables, which are not designed for dry shrinkage. The good news is these RTS cracks are typically harmless and may partially close up if not too much debris has fallen in these cracks before the cables are tensioned. These cracks were located in the garage.

Garage: RTS hairline crack

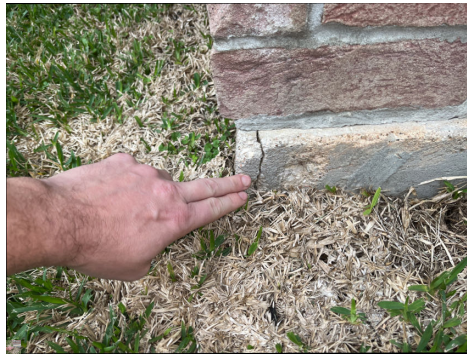
Corner cracks were noted on one or more corners of the foundation. Corner cracks are generally caused by the early removal of form boards and/or improper flashing installation between the slab and the brick veneer/stone veneer. No structural defect was noted with this condition. We recommend having these cracks patched/sealed to minimize the opportunity of insect infestation. This was observed on the left, front, rear

Left: Corner crack

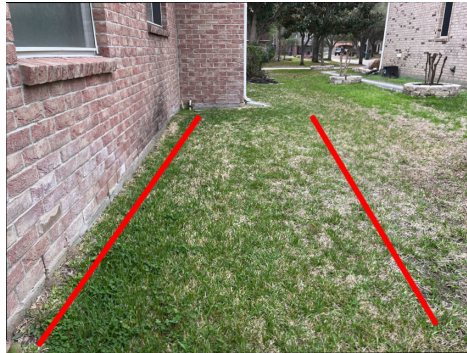
Around house: Insufficient grading/drainage

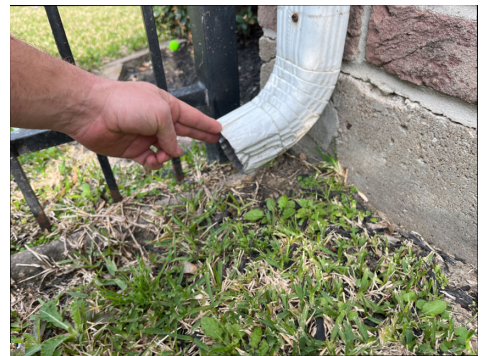
One or more downspouts were discharging too close to the foundation. We recommend having downspouts discharge water at least five (5) feet from the house. Storm water should be encouraged to flow away from the building at the point of discharge.

Downspout extension missing, discharge near structure

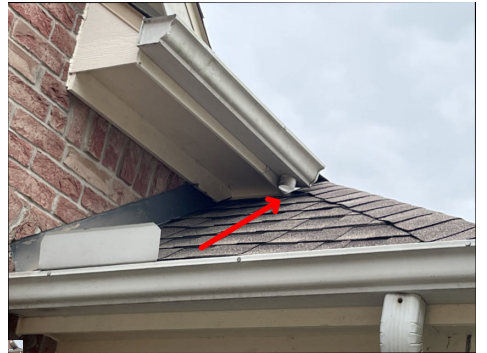
One or more downspouts terminated above roof surfaces rather than being routed to gutters below or to the ground level. This is very common, but it can reduce the life of roof surface materials below due to large amounts of water frequently flowing over the roof surface. Granules typically are washed off of composition shingles as a result, and leaks may occur. We recommend considering having a qualified contractor install extensions as necessary so downspouts don't terminate above roof surfaces.

Downspout extension missing, discharge on roof

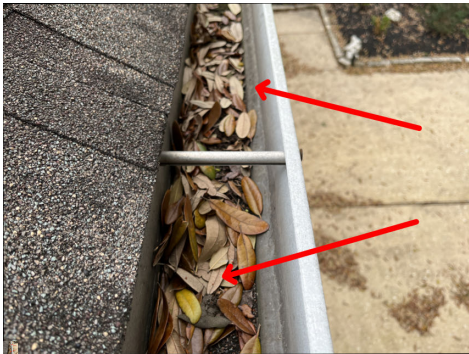
The gutters had debris/leaves accumulation. We recommend cleaning to avoid spilling roof runoff around the building – a potential source of water entry or water damage.

Debris in gutters

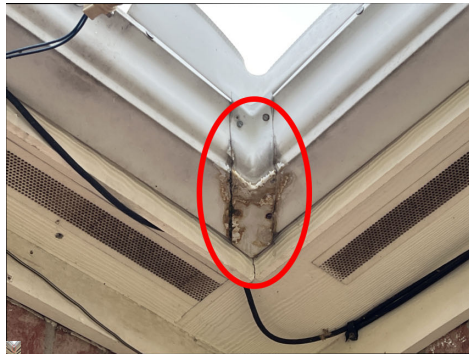
Damaged/corroded gutters were noted. We recommend having these repaired to prevent leakage.

Left: Damaged/rusted gutter joint

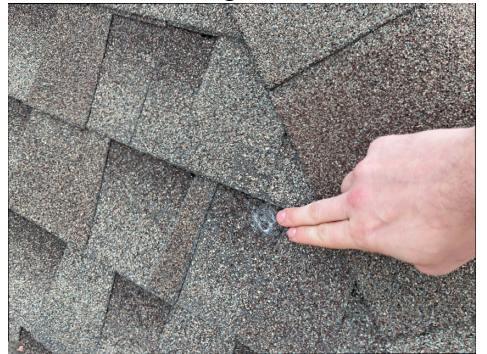
Damage was noted on portions of the roof covering that was consistent with patterns caused by inclement weather. We recommend having the roof covering further evaluated by a qualified roofing contractor who can determine the cause of this damage, and consulting the sellers about any existing roof insurance or warranties that may provide financial assistance for repair of any confirmed weather damaged materials.

Various areas: Apparent weather damage

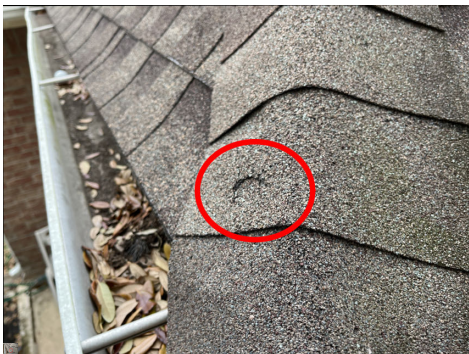
Damaged, torn and/or missing shingles were observed on the roof. We recommend having all damaged shingles replaced to prevent further damage and water intrusion.

Front left: Damaged shingle

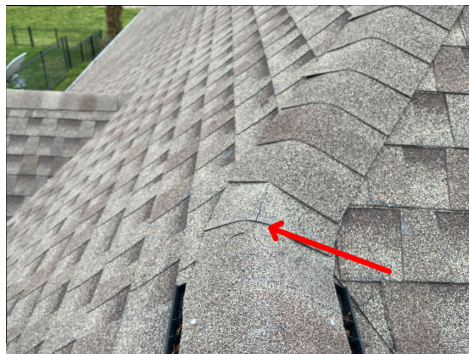
Left front: Damaged ridge shingles

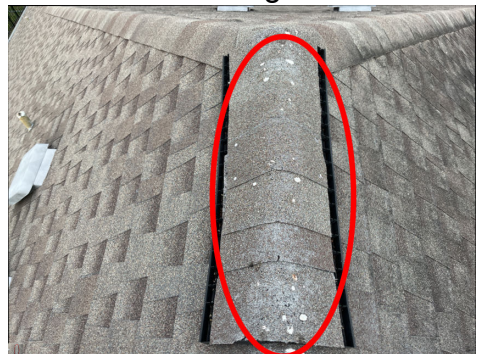
The degree of granule loss/deterioration on the shingles indicated the roofing material was nearing the end of its life cycle. Replacement will become necessary in the near future. It would be wise to budget for the replacement.

Top ridge: Granule loss/deterioration

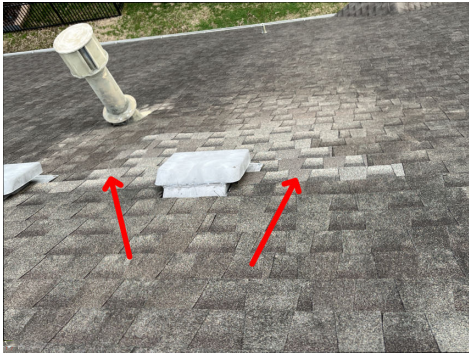
Prior repairs to the roofing were evident. This would suggest that problems have

been experienced in the past. We recommend asking the sellers about any previous roof leaks and monitoring these areas.

Evidence of prior repair

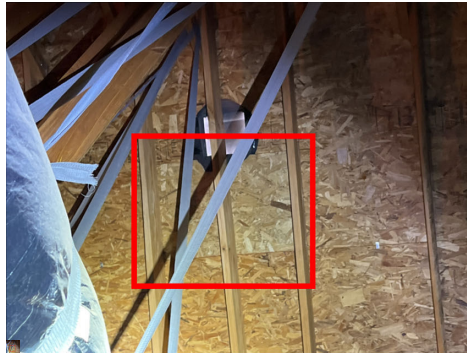
Area of prior repair viewed from attic

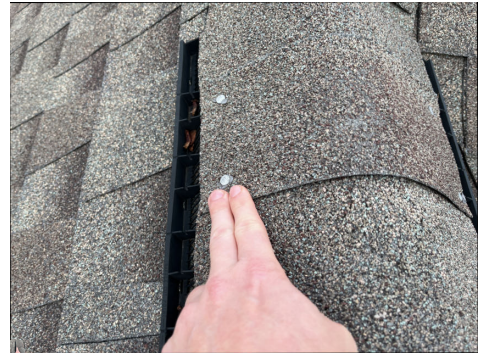
Exposed nail heads were noted at the roof protrusions and/or ridge shingles. Nail heads at either the vent & roof flashing or at the composition shingles can allow water to penetrate past the roof covering given enough time. As the exposed portion of the nail rusts, more space will become available between the nail and the roofing material for water to penetrate. This condition can usually be remedied by sealing or caulking affected areas.

Exposed nail heads

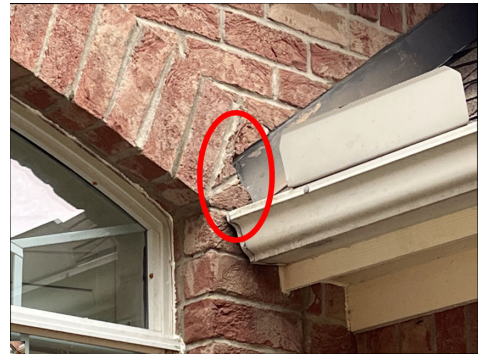
Missing kickout flashing

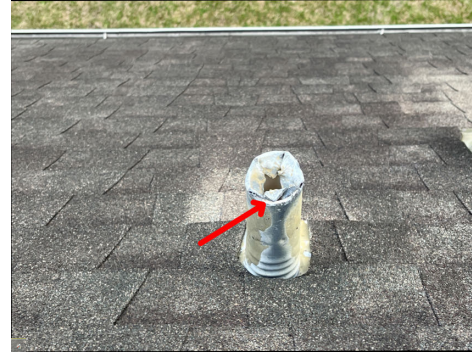
Damaged lead flashings were observed multiple plumbing vents where a gap was noted between the flashing and the vent. This could allow for water intrusion into the attic space. We recommend repair.

Damaged lead flashings

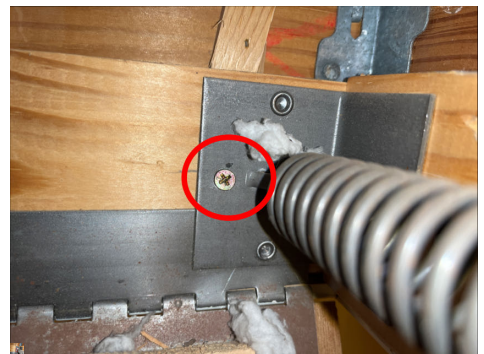
Improper fasteners (nails/screws) were use to secure the attic pull down stairs to the structure. 16d penny nails or 1/4" x 3" lag screws should be used. We recommend repair.

Improper fasteners used on attic stairs

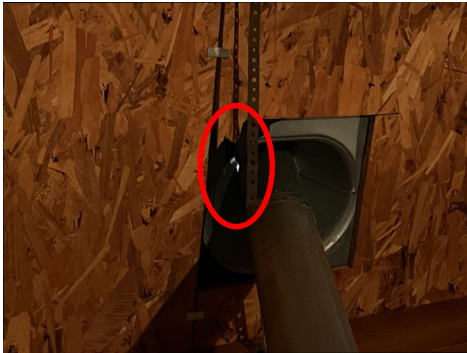
Daylight was visible from the attic space at one or more roof protrusions. We recommend having these areas sealed to prevent water intrusion.

Daylight at roof protrusions

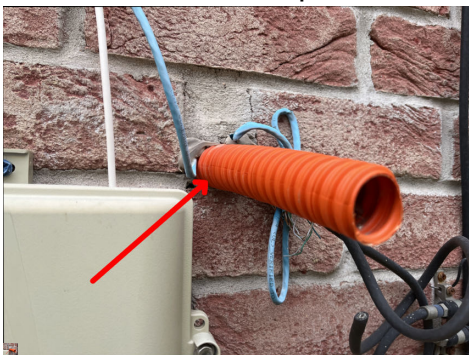
The exterior caulking in multiple areas around the house at various siding transitions, expansion joints, wall protrusions, doors, windows and other areas, was deteriorated or insufficient. Exterior caulking is the first energy efficient measure to install. This helps minimize air flow and moisture through cracks, seams, utility penetrations and openings. Controlling air infiltration is one of the most cost effective measure in modern construction practice. Good caulking and sealing will reduce dust, dirt, and prevent damage to structural elements. We recommend updating regularly.

Around house: Deteriorated/insufficient caulk at wall protrusions

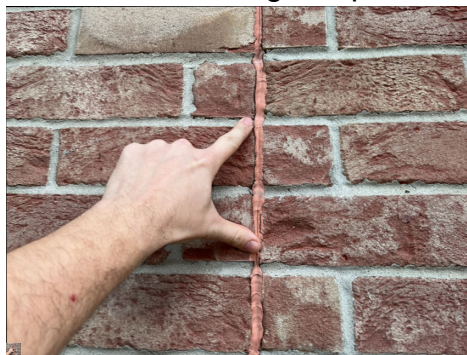
Left: Deteriorated caulk at expansion joint

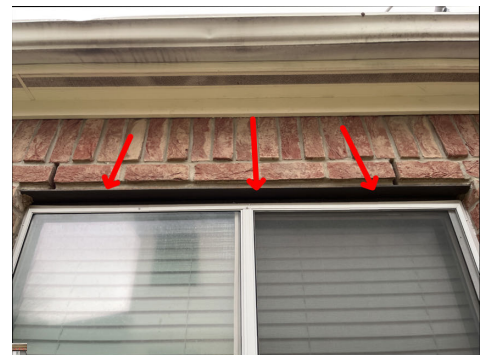
The lintels over the openings (windows/doors) were found to be rusted. These elements support the brick veneer above the openings. We recommend having them (re)painted to prevent deterioration.

Around house: Rust on lintels

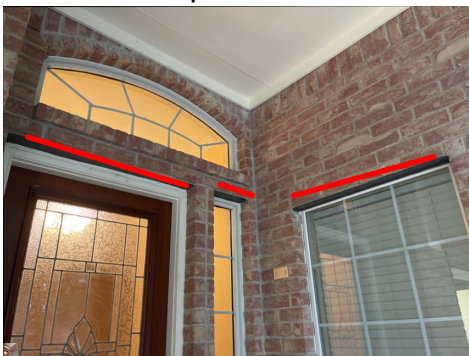
Weep holes (openings in the mortar joints to allow moisture to seep out) were missing at the structure's brick/stone veneer over the windows/doors. Weep holes should be placed every 33 inches on center at the base of the wall as well as over the windows and doors where the brick veneer is support by lintels. No indication of moisture damage was noted on the inside structure. It might do more harm than good to try and create these as this point in time. We recommend monitoring the areas.

Front: Missing weep holes

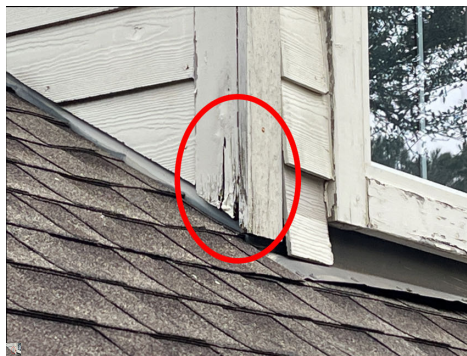
Wood decay was observed on the exterior siding. We recommend repairs/replacement to all decayed wood to prevent further deterioration and creating conducive conditions for wood destroying insect activity. This was noted on the front.

Front dormer: Wood decay at trim

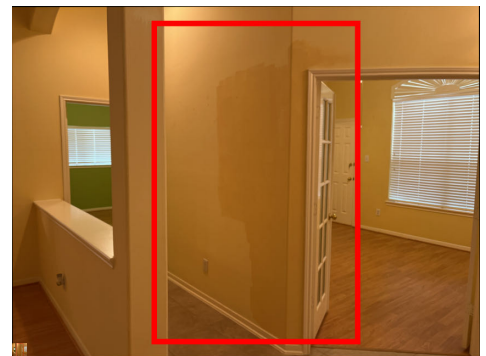
Note: Discoloration on the interior wall finishes appeared to be the result of poor/incomplete painting. No indication of water, or other damage was visible in these areas. We recommend having the affected walls repainted for improved aesthetic value.

Foyer: Incomplete painting

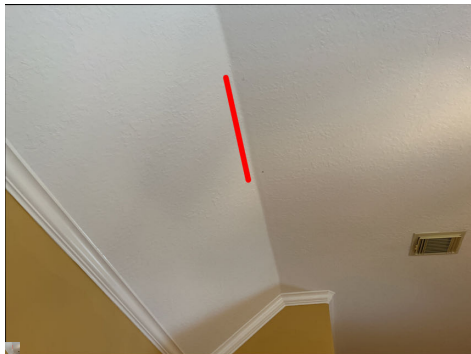
Hairline cracks, which were by nature mainly cosmetic, were noted on the ceiling. We recommend having these caulked and painted.

Bedroom 2: Hairline crack

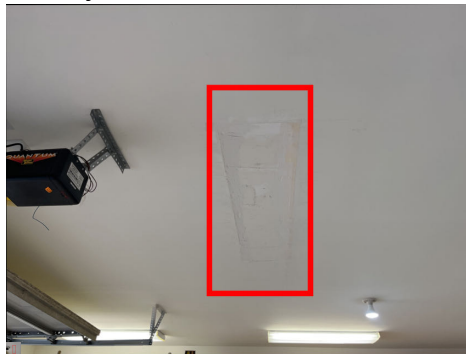
Evidence of patching was detected, which indicates previous work performed. We recommend monitoring.

Garage: Patchwork

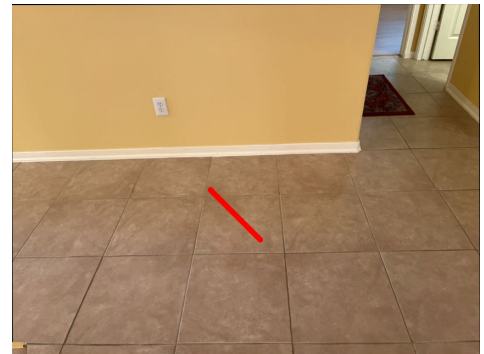
Cracked floor tile was noted in the house. The tile sounded solid when knocked on. We recommend monitoring and replacing if the condition gets worse. This was noted in the entry hall.

Entry hall: Cracked tile

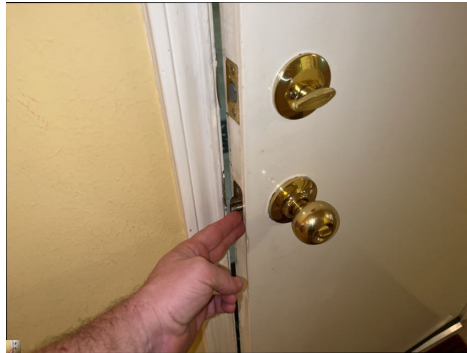
A door in the house would not latch when shut. We recommend having the door and/or hardware adjusted. This was noted in bathroom 3, and at the garage man door.

Garage: Would not latch

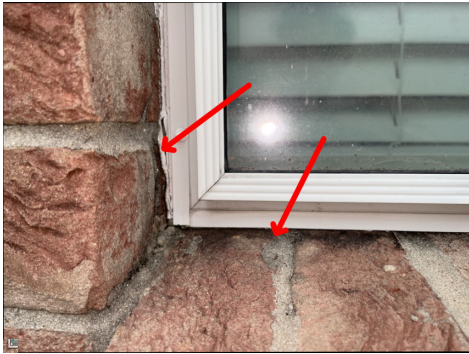
The exterior and interior caulk around the windows was deteriorated. We recommend repair. Exterior caulking is the first energy efficient measure to install. The purpose of exterior caulking is to minimize air flow and moisture through cracks, seams, utility penetrations and openings. Controlling air infiltration is one of the most cost effective measures in modern construction practices, a home that is not sealed will be uncomfortable due to drafts and will use about 30% more heating and cooling energy than a relatively air-tight home. In addition, good caulking and sealing will reduce dust and dirt in the home and prevent damage to structural elements.

Around house:  
Deteriorated/missing caulk

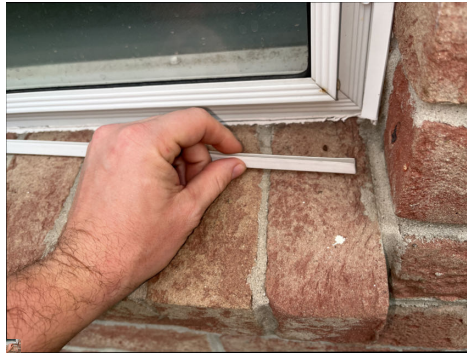
Damaged/loose weather stripping was noted at multiple windows. We recommend having these repaired to reduce air infiltration and help keep the pane secure.

Left: Damaged weatherstripping

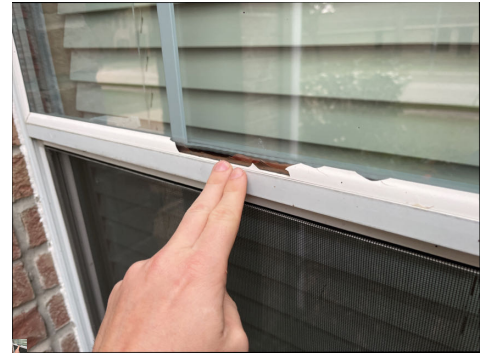
Front: Damaged weatherstripping

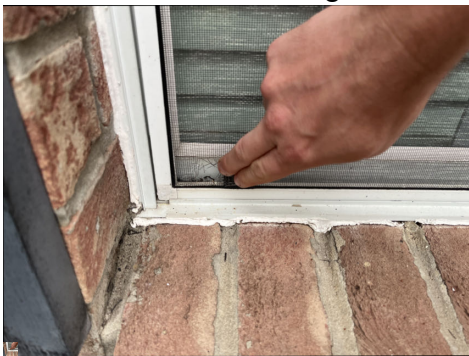
Damaged window screens were found. We recommend having these replaced to prevent insect intrusion.

Front: Damaged screen

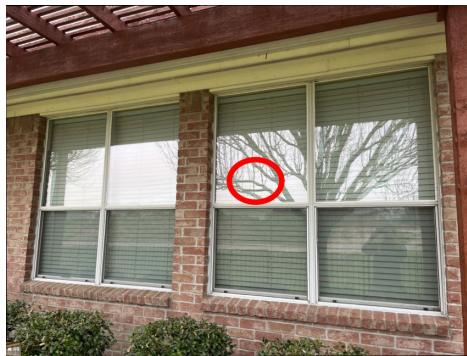
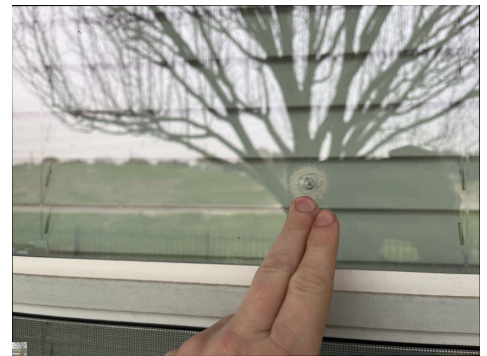
A window pane was cracked/damaged. We recommend having this repaired/replaced. This was observed in bedroom 2.

Bedroom 2: Damaged pane

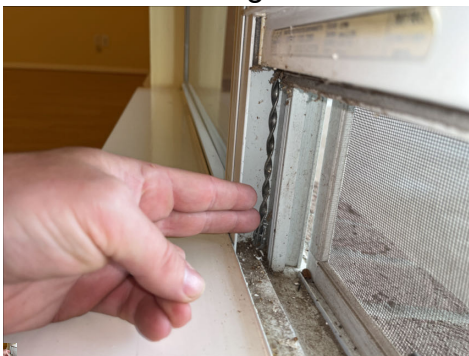
Window hardware was loose or missing. We recommend having this repaired/replaced. This was observed in the living room, and breakfast nook.

Living room: Loose spring

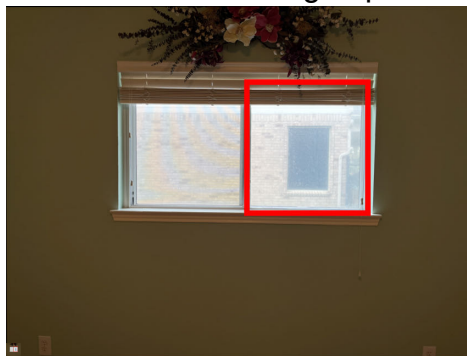
A window had lost its seal/experienced low-E failure. This had resulted in condensation/discoloration developing between the panes of glass, and can cause the glass to lose some of its insulating properties. We recommend having the glass repaired or replaced. This was observed in bedroom 2.

Bedroom 2: Lost seal

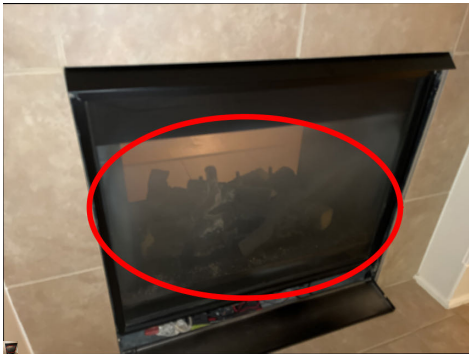
The fireplace had some fog on its inside glass panel, which I recommend cleaning. It is necessary to clean the glass periodically. During initial start-up, condensation, which is normal, forms on the inside of the glass and causes lint, dust and other airborne particles to cling to the glass surface. Also, initial paint curing may deposit a slight film on the glass. All glass should be cleaned after the first 4 to 6 hours of initial burning to remove deposits before they become baked on through further use. After the initial cleaning, glass should be cleaned two or three times during the heating season. For more information, you can go to <http://www.americanheritagefireplace.com/faqs.html>

Fog on glass

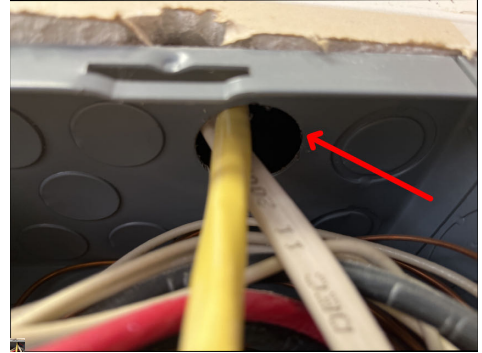
Missing grommet/bushing

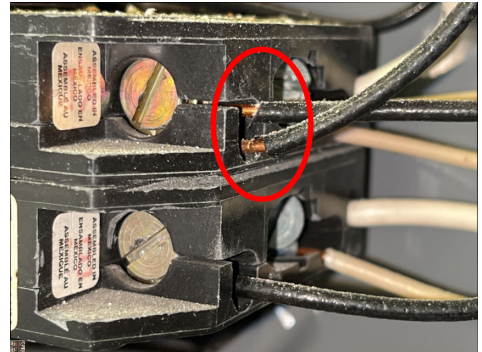
Two wires were connected to a breaker designed for only one wire. This is known as a "double-tap" and is a defective condition. We recommend repair.

Double tapped breaker

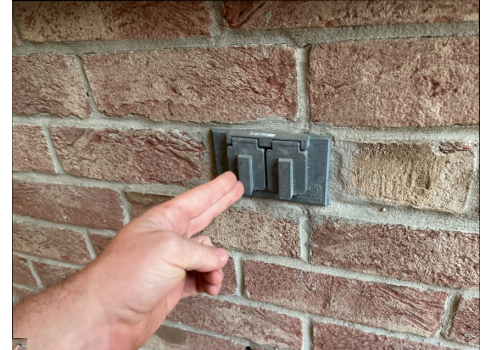
Exterior: Bubble cover recommended

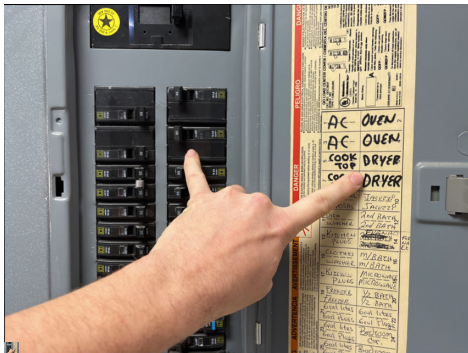
Dryer outlet: Not GFCI protected

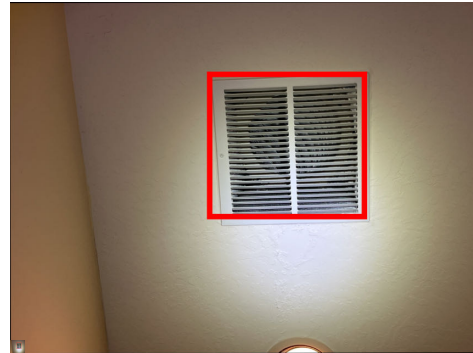
Missing filter at supplemental air returns

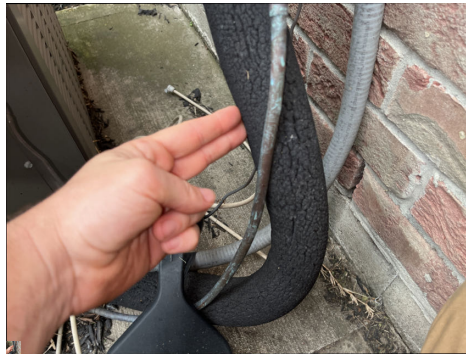
Old and deteriorated refrigerant line insulation

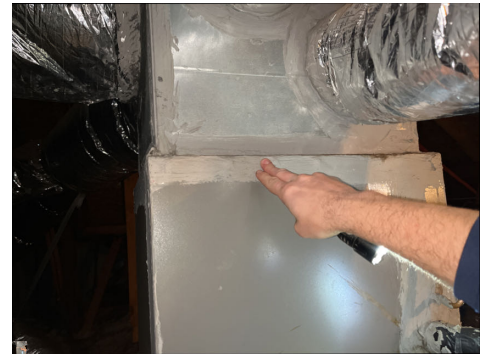
Attic: Evaporating coils sealed/unable to view coils

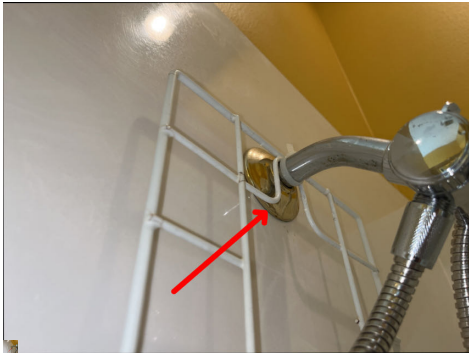
Bathroom 2: Caulk needed at escutcheon plate

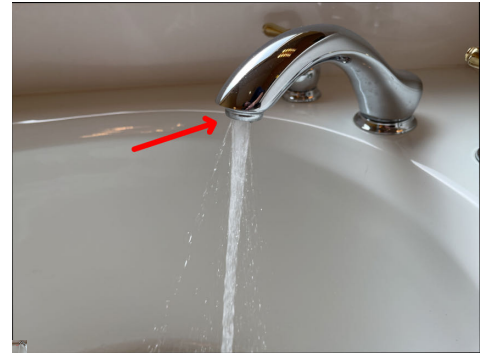
Bathroom 2: Blocked/dirty aerator

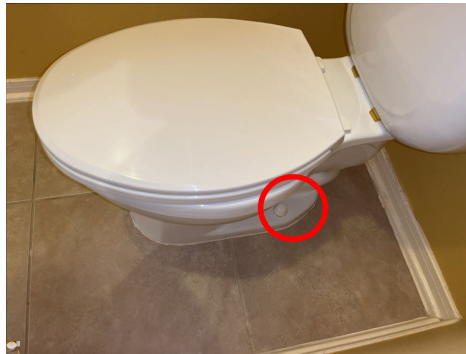
A loose toilet was noted. If the subfloor is wood there is the possibility for water damage. We recommend having the necessary repairs made. This was observed in bathroom 2.

Bathroom 2: Loose toilet

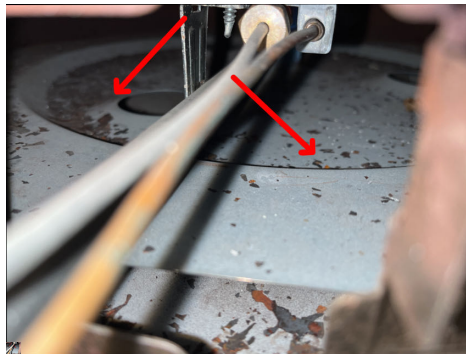
Rust flakes in burn chamber

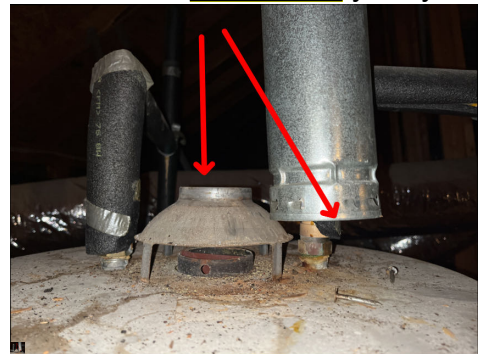
Flue disconnected

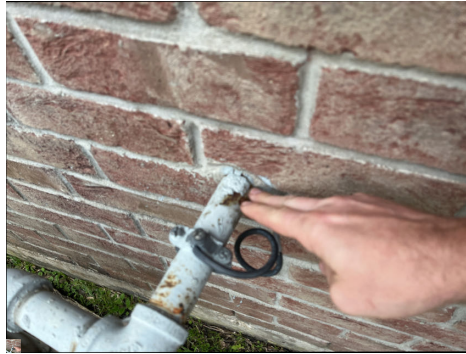
Gas meter: Rust on gas line

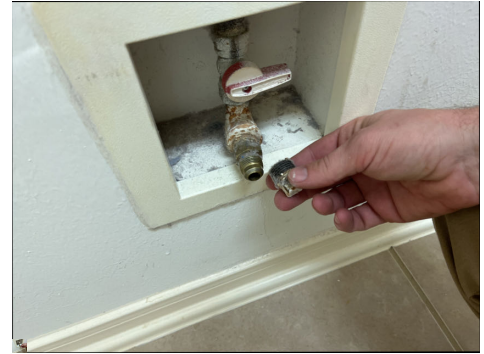
Laundry room: Uncapped gas line, wrong size cap

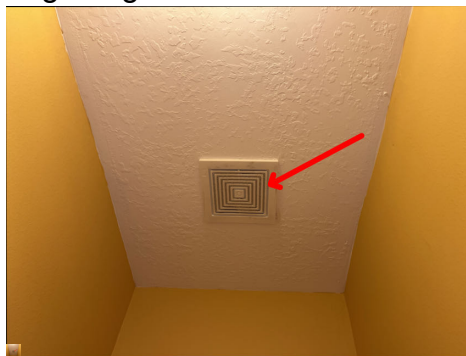
The bathroom exhaust fan was excessively noisy at the time of the inspection and may need to be replaced soon. We recommend budgeting for replacement. This was observed in bathroom 2.

A bathroom exhaust fan was excessively dirty at the time of the inspection. We recommend having the grill cleaned.

Bathroom 2: Dirty grill, noisy fan

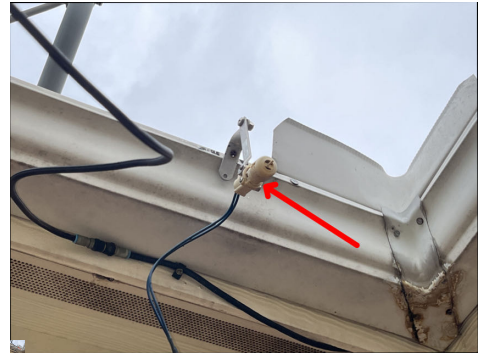
Left: Loose rain sensor

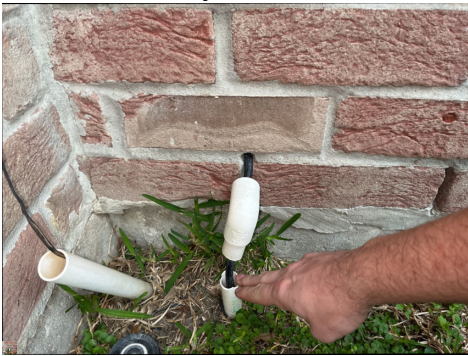
Left: Damaged conduit

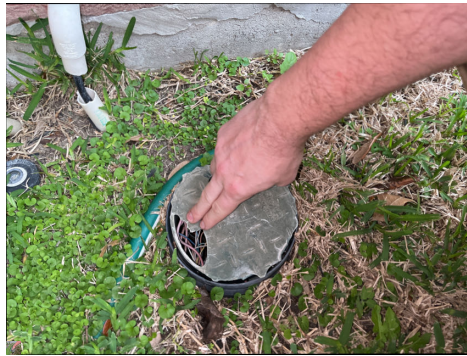
Left: Damaged valve cover
