Total Home Inspection

Property Inspection Report

2716 S Millbend Dr, Spring, TX 77380
Inspection prepared for: Eliazbeth Shaw
Real Estate Agent: -

Date of Inspection: 1/30/2023 Time: 9:00-11:00AM
Age of Home: 1977 Size: 1276
Weather: 40's intermitten rain
Order ID: 3314

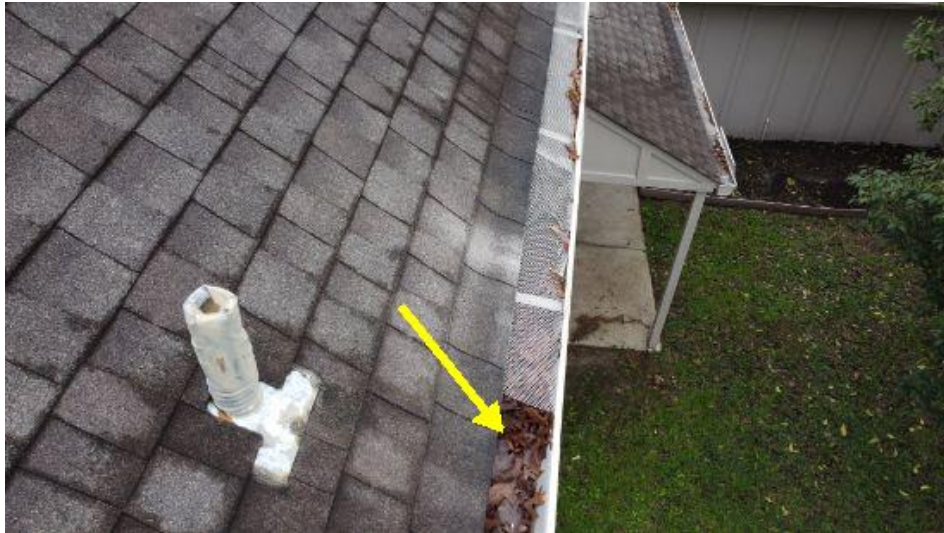
Gutters should be cleared to allow for proper drainage of rain water.

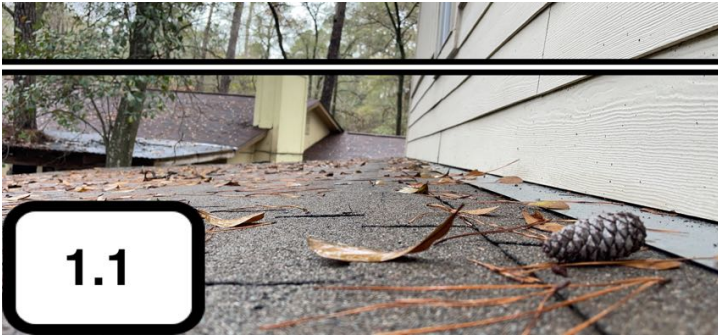
It appeared that improper roofing material was being used over the back patio cover. The slope of this roof area requires flat roofing material such as Modified Bitumen or single ply.

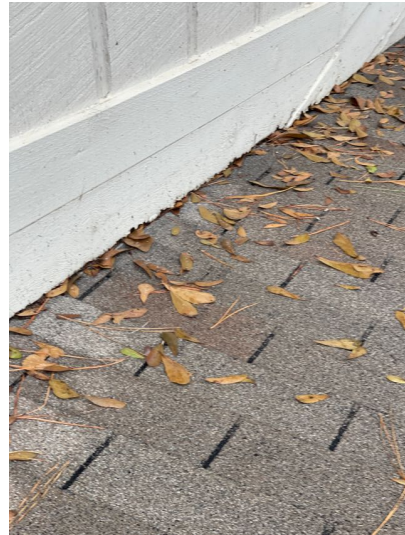
Siding was touching the roof surface at the left side of the home. In our opinion, siding should be at least 1" from the roof surface.

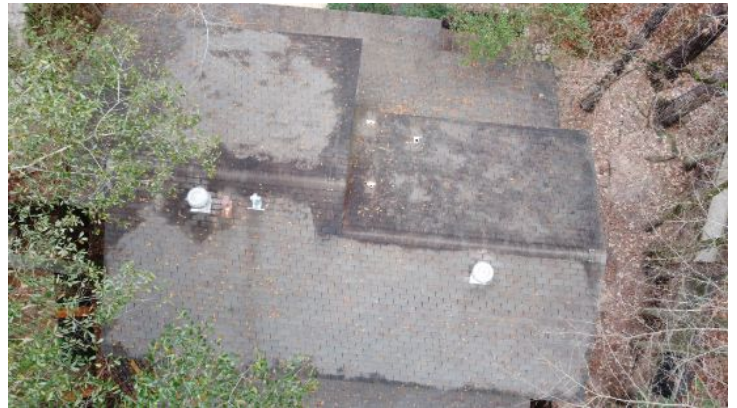
Flashing was lifted at the bottom of the vertical wall on the left side.

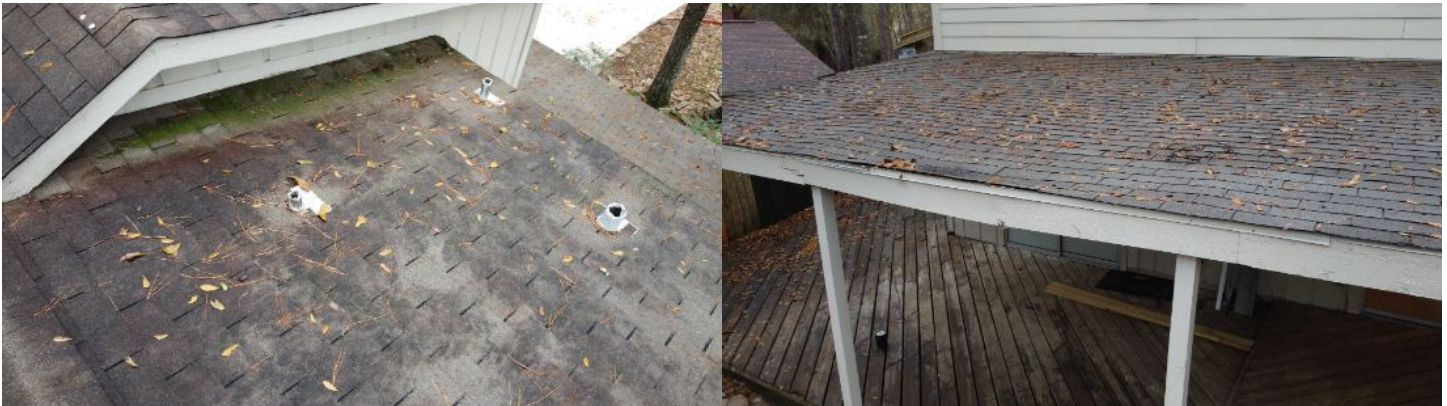
Rotted eave at the back deck cover.

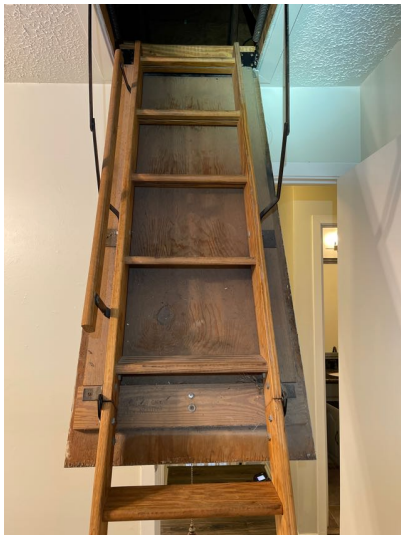
Attic access door was inadequately sealed and insulated.

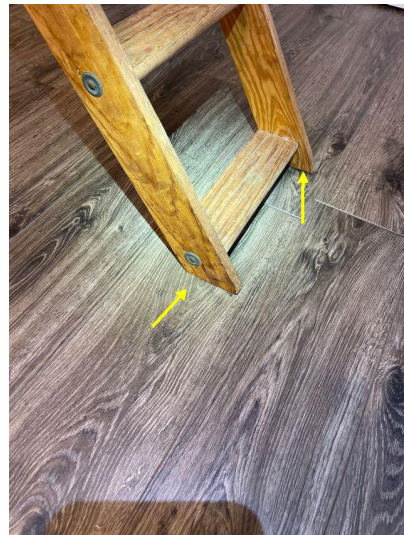
Pull down stair legs should be padded to avoid floor damage.

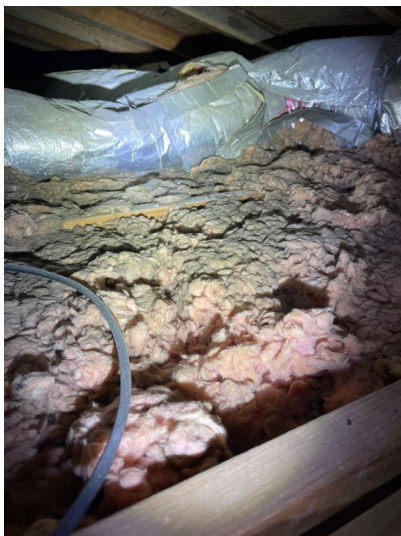
Low level of insulation and in need of improvement for better efficiency. Current efficiency standards are R38, and previously R30.

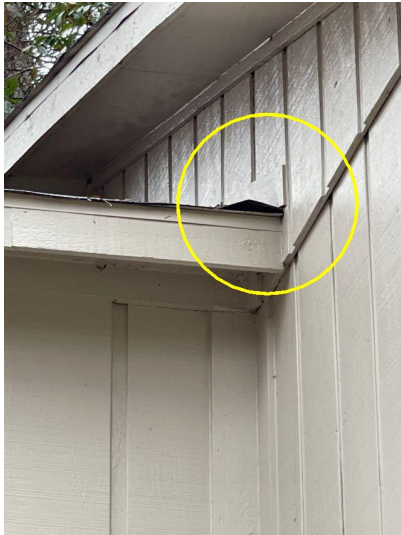
Kick out flashing were not observed a vertical wall and roof junctions.

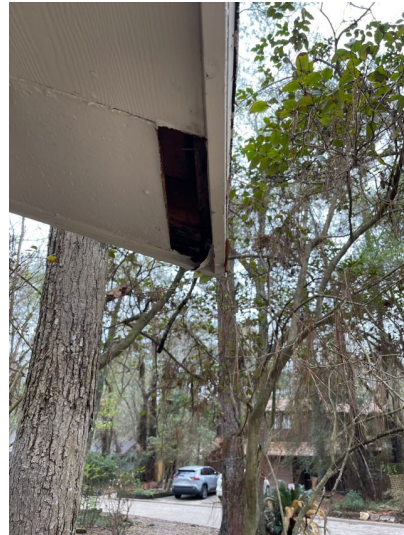
Soffit material was missing from the right front corner of the home.

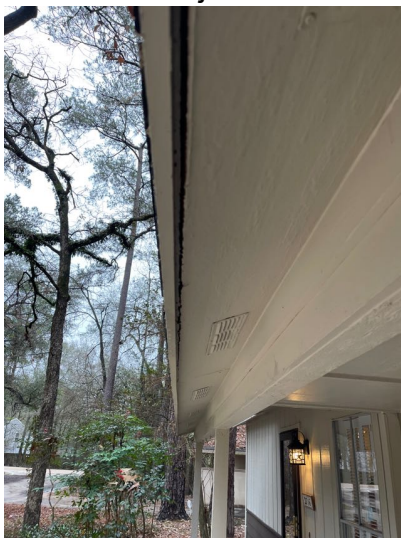
Soffit material was separated from the fascia in the front of the home.

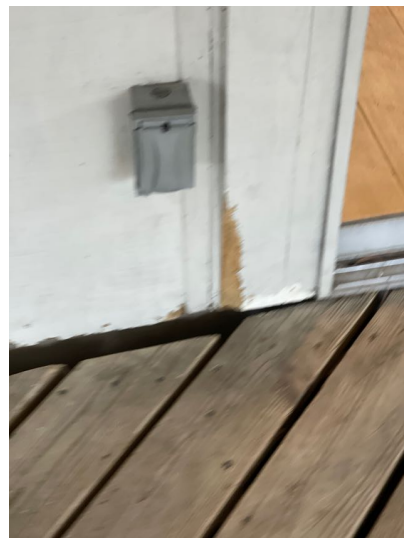
Damaged trim was noted at the back deck.

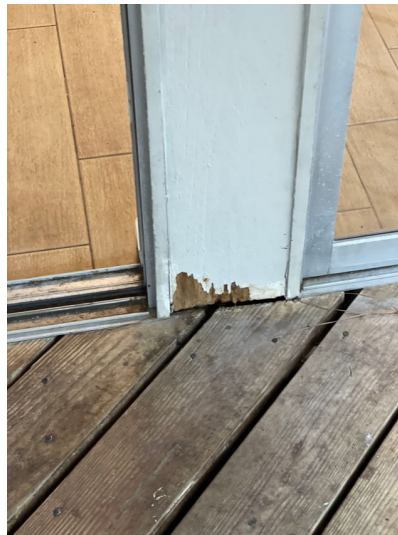
Damaged trim was noted at the back deck.

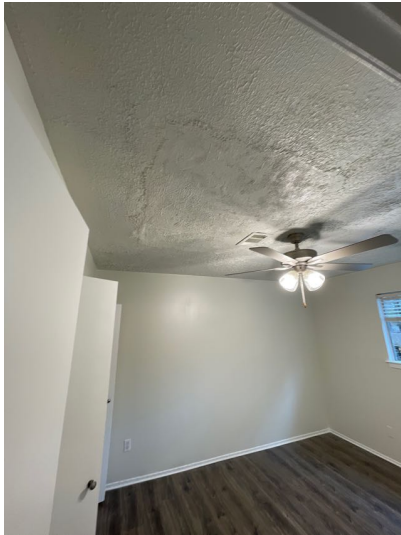
Evidence of drywall repairs were noted at the right front bedroom.

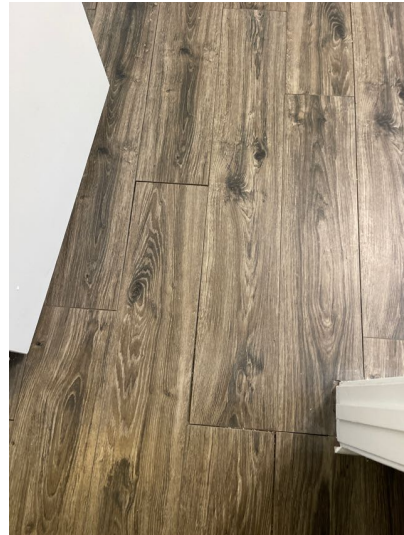
The flooring in the upper right bedroom was separated at the joints.

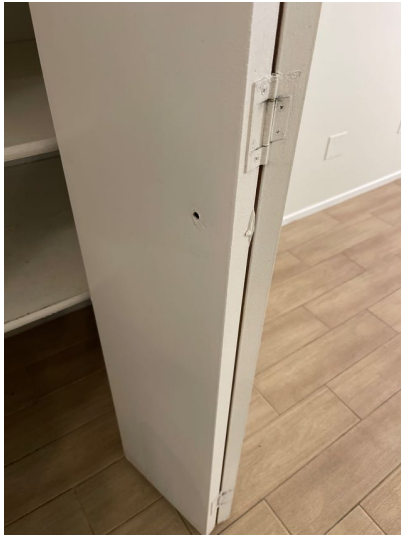
The pantry door and the upper bedroom closet bi-fold doors were missing a door handle.

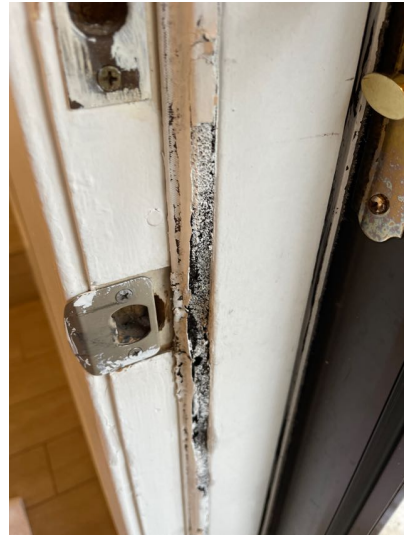
Weatherstrip was missing or worn at the front entry door.

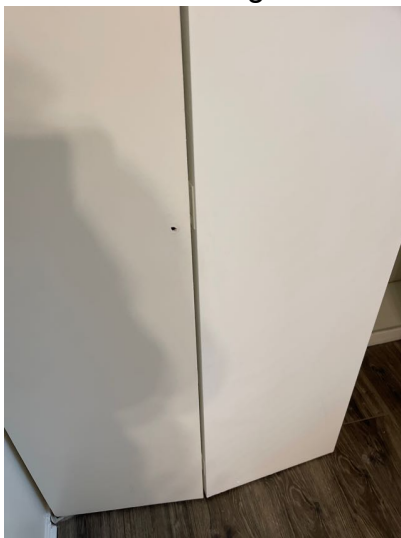
The pantry door and the upper bedroom closet bi-fold doors were missing a door handle.

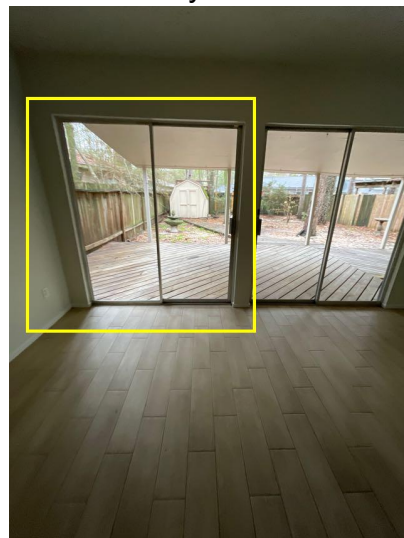
The left side living room sliding door would not open.

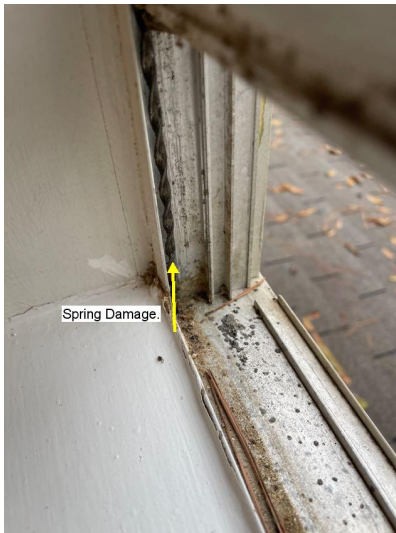
Several windows springs were stiff ,noisy and damaged. Maintenance and repair, including cleaning, lubrication and replacement of springs may be required.

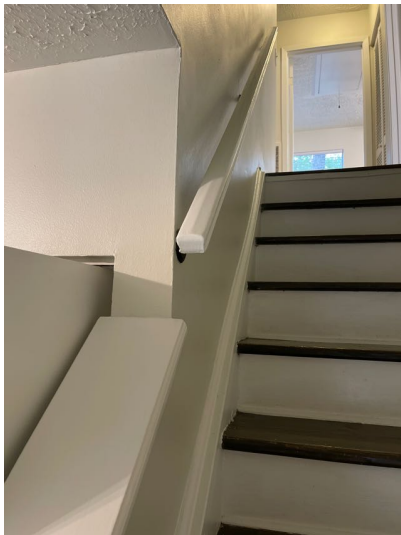
Handrails were not continuous to the walls and open ended handrails may catch clothing or other items on a person resulting in trips or falls.

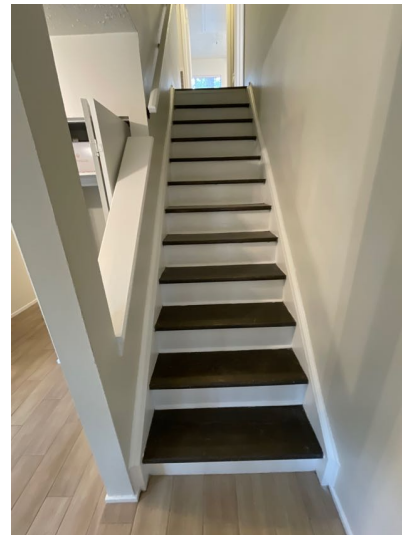
The lower portion of the stairway did not have a graspable handrail.

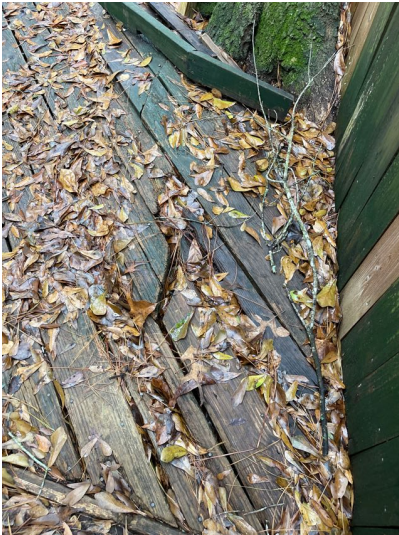
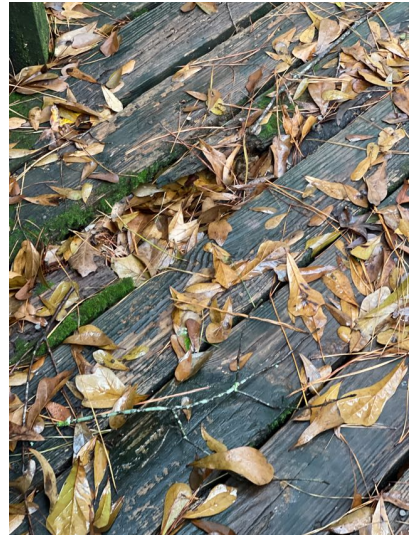
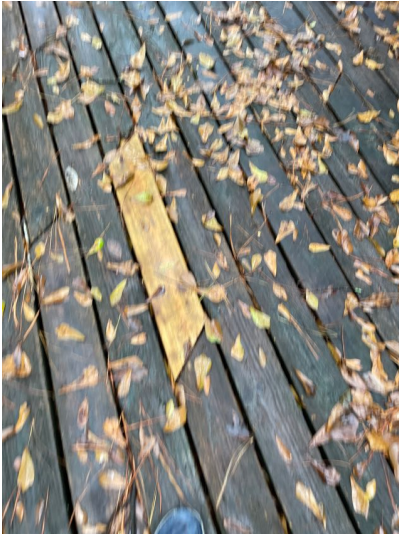
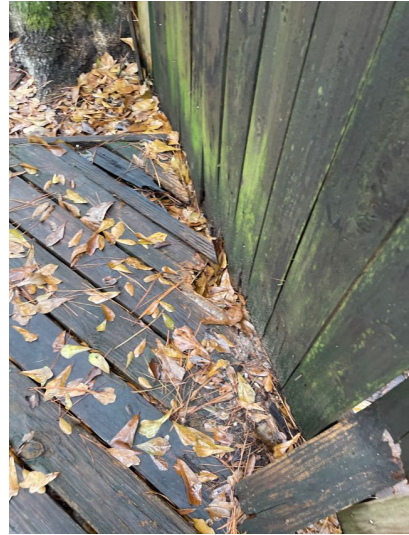
Rotten deck boards were noted in multiple areas.

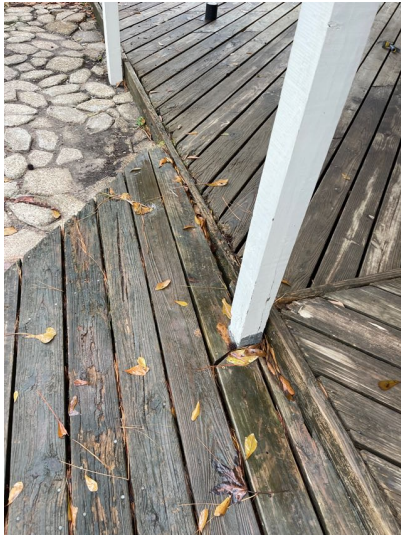
Rotten deck boards were noted in multiple areas.

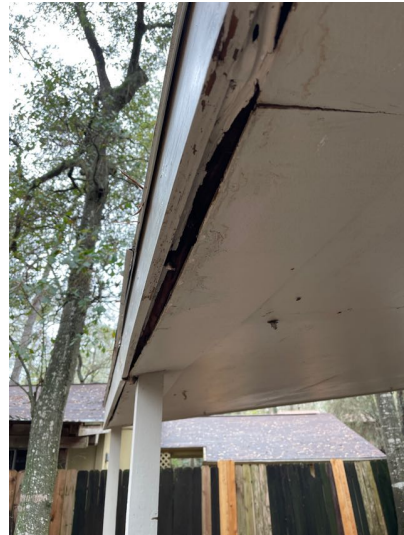
Fascia and soffit was rotted on the back deck cover. These areas are likely leaking from the roofing material on the deck cover.

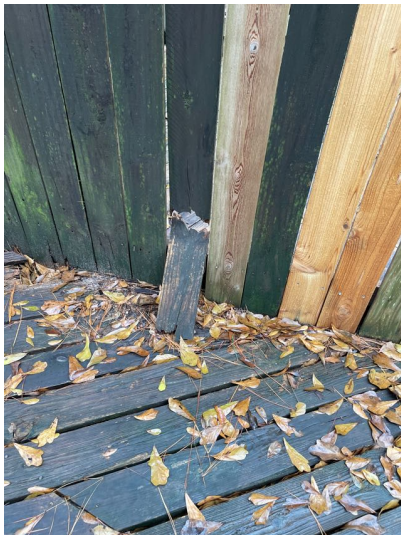
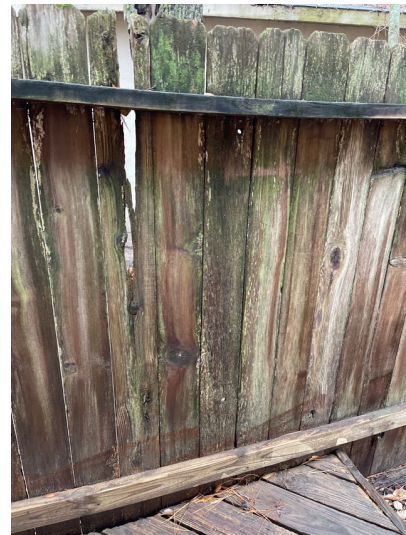
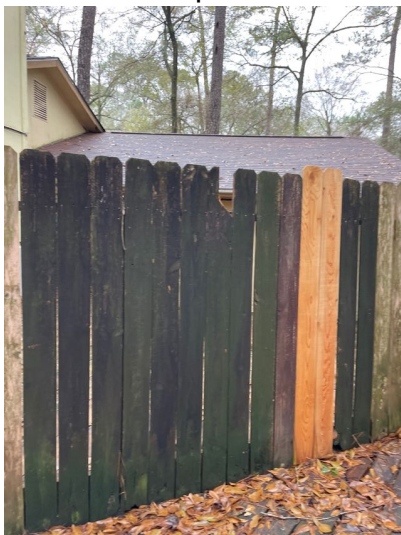
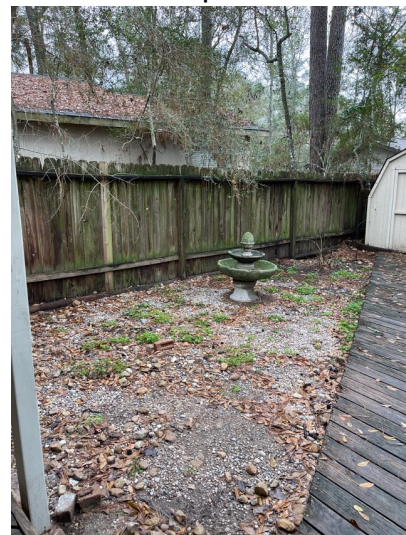
Fence in the back yard appeared to be weathered with damaged and rotted pickets, loose posts and loose panels.

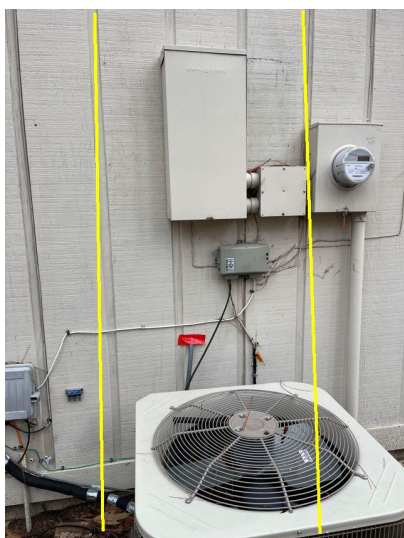
Access to electrical panel was obstructed. Working space in front of the panel should be 30" wide by 36" deep.

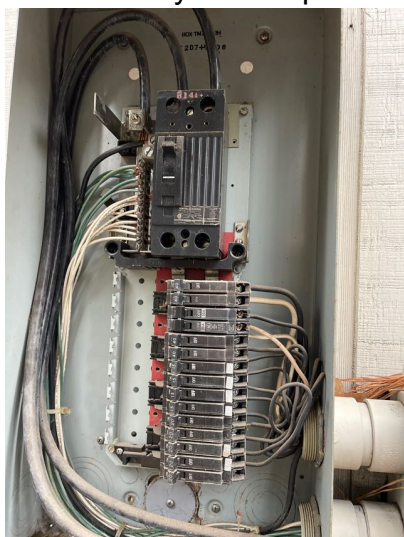
All breakers for the panel boxes and/or sub panels must be clearly and permanently labeled for identification of particular circuit.

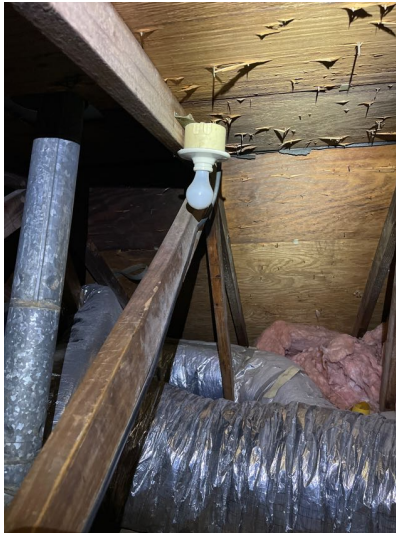
Fixture was not functioning at attic light, the upper left closet light. Light bulbs were not tested.

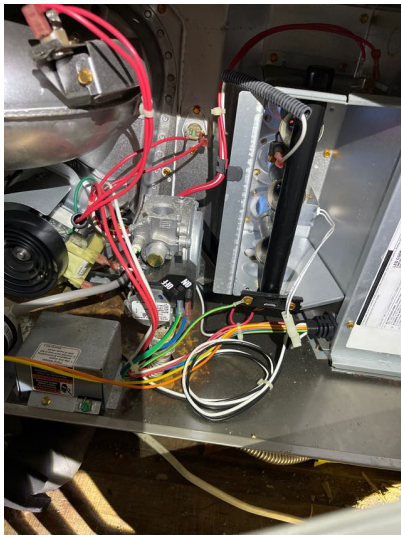
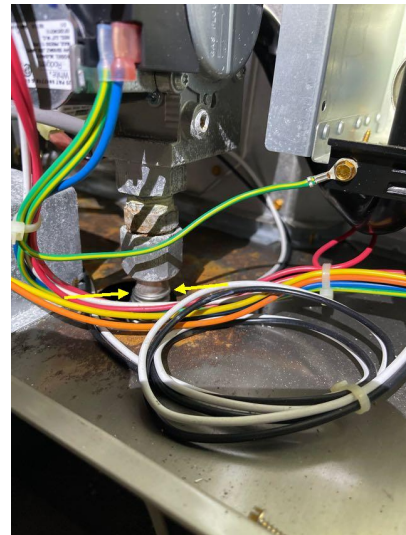
Flex gas line was entering the furnace and is not rated for this application. This connection should be hard piped.

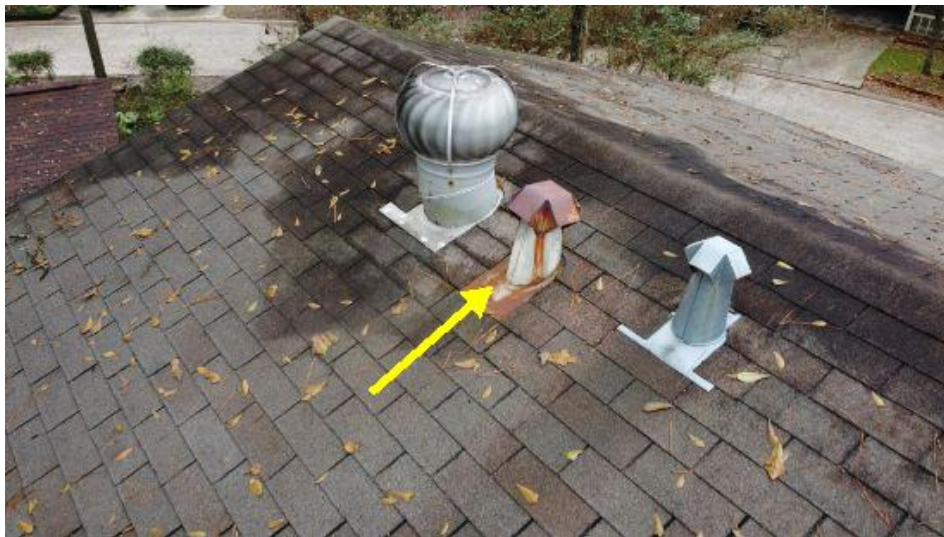
Flue vent did not fully penetrate the roof deck and was not terminated with a B type vent.

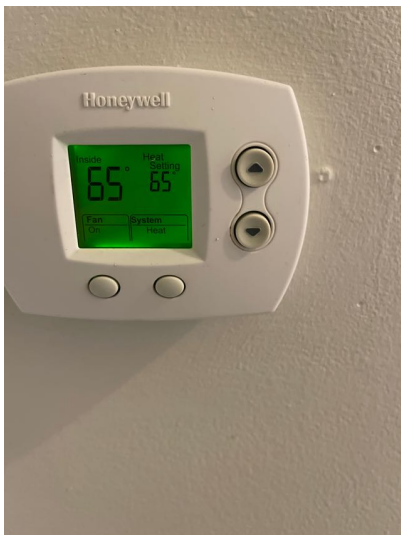
Thermostat was a Honeywell type digital non-programmable located in the stairway. This should be updated to meet current energy codes.

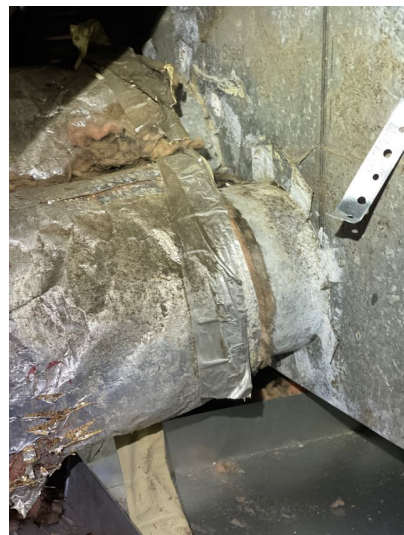
Duct work was aged and insulation exposed or missing in some spots.

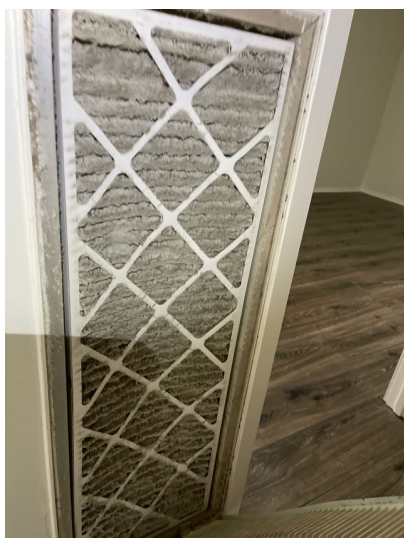
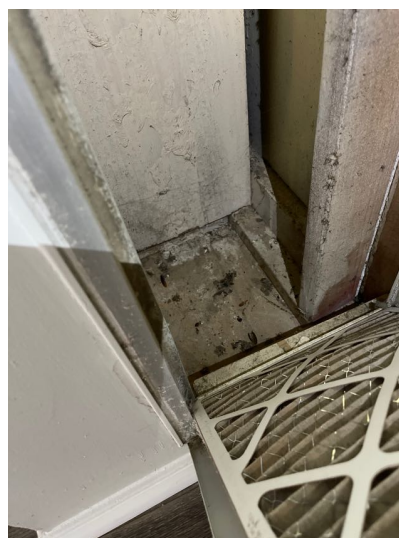
Air filters and chase were dirty. Advise to check records for service of these units. If records are not available we recommend cleaning and service by an HVAC professional.

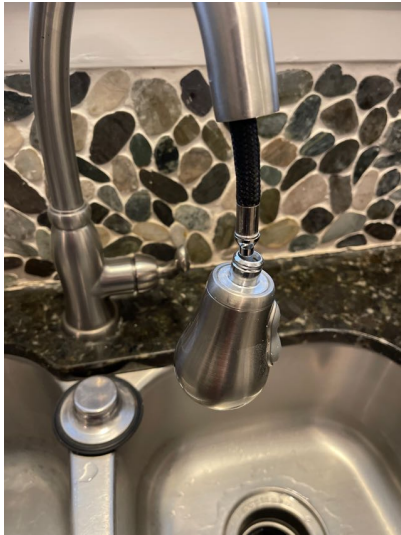
The kitchen sink fixture vegetable sprayer would not return to the stem.

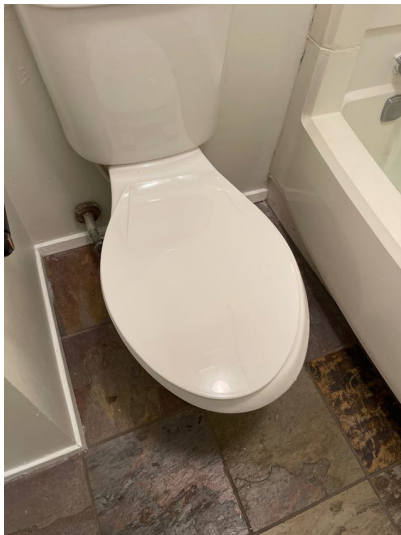
The toilet seat in the upper bathroom was loose.

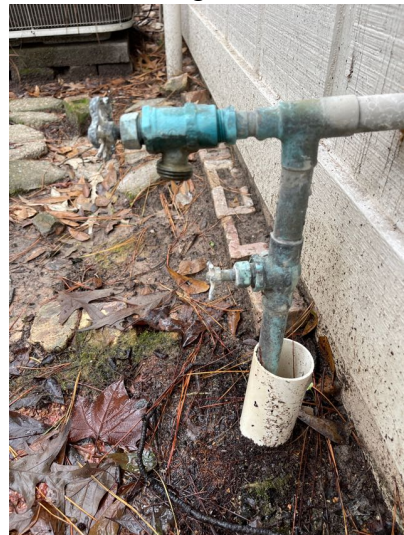
The left side hose bib was leaking.

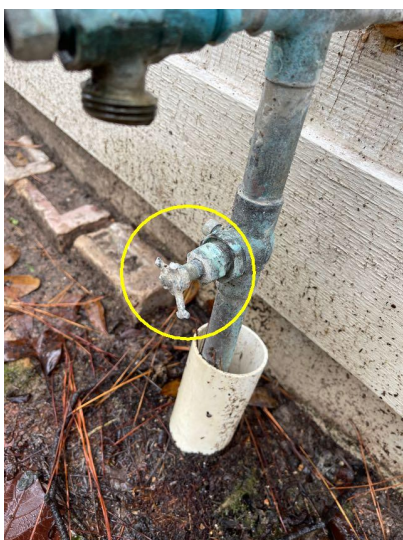
Main water valve handle was broken and unable to turn.

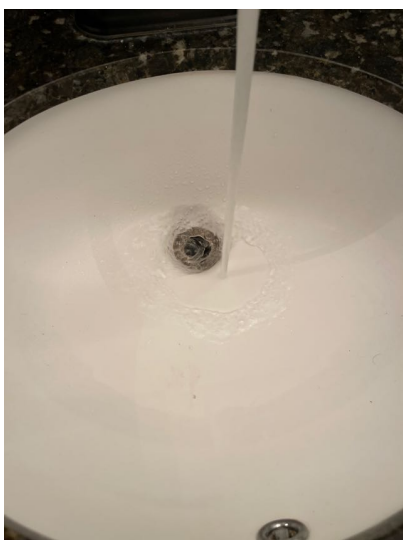
Sink stopper was not present in the upper bathroom.

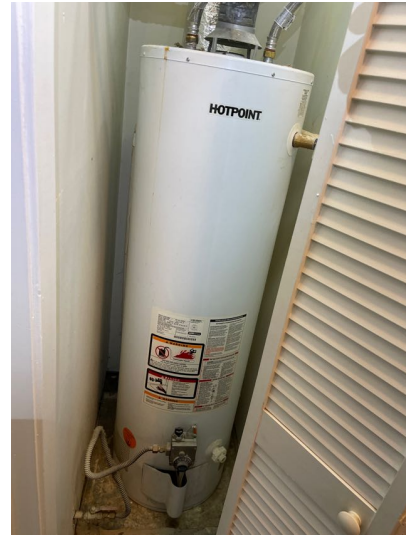
Gas fired water heater was located in the space adjacent to the upper bedroom and should be separated from the living space by a weather stripped self-closing exterior door and combustion air should be available from the exterior or attic.

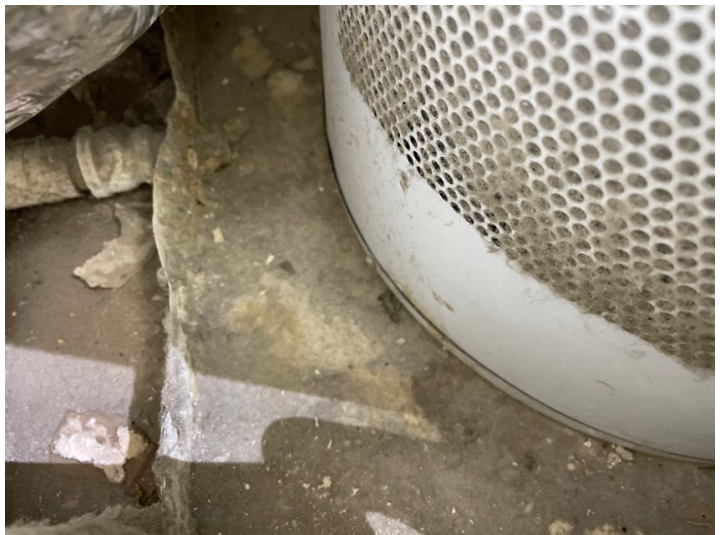
There was debris in water heater drain pan. This should be cleared to allow for proper drainage in the event of a leak.

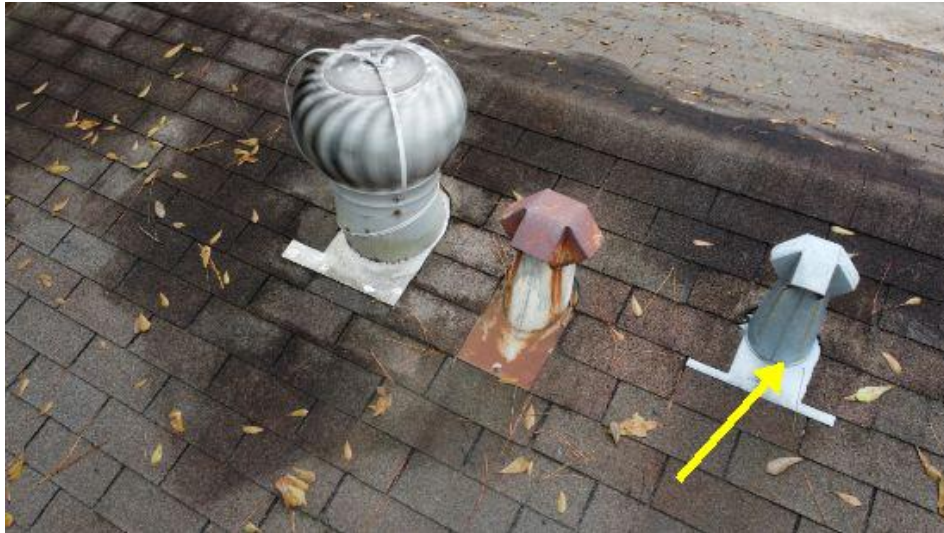
Flue vent did not fully penetrate the roof deck and was not terminated with a B type vent.

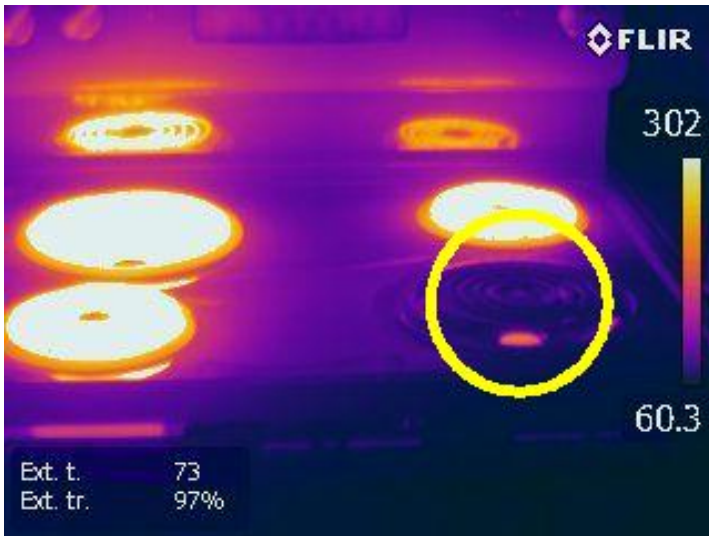
Right front burner was not functioning.

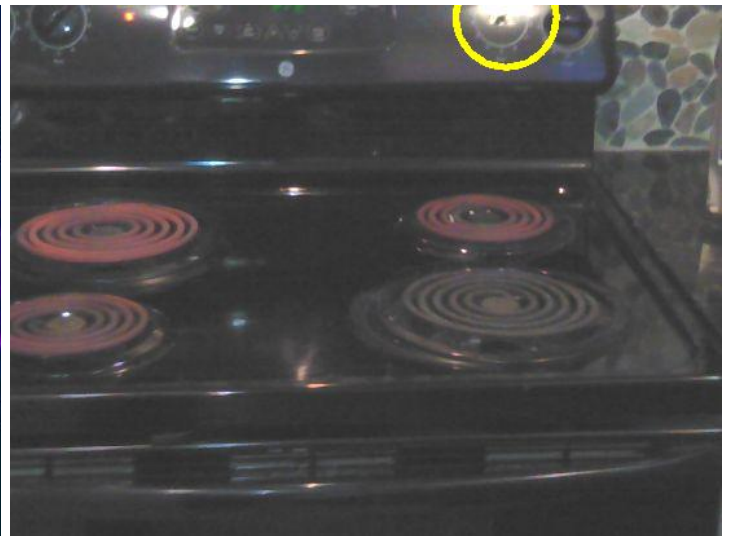
Temperature control knob was missing.

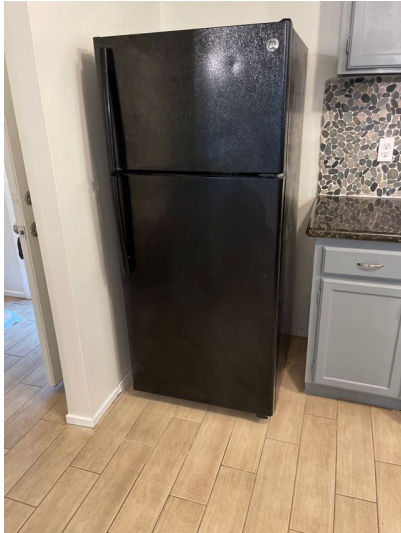
GE refrigerator with non-functioning ice maker was observed in the kitchen.

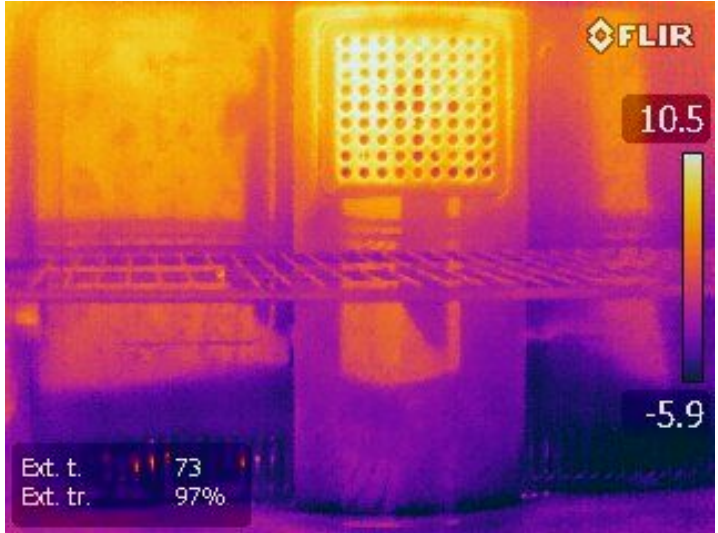
GE refrigerator with non-functioning ice maker was observed in the kitchen.

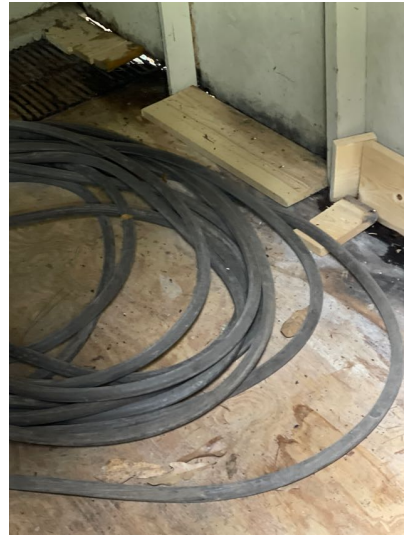
The rear storage shed had several areas of rotted flooring along with some siding damage.

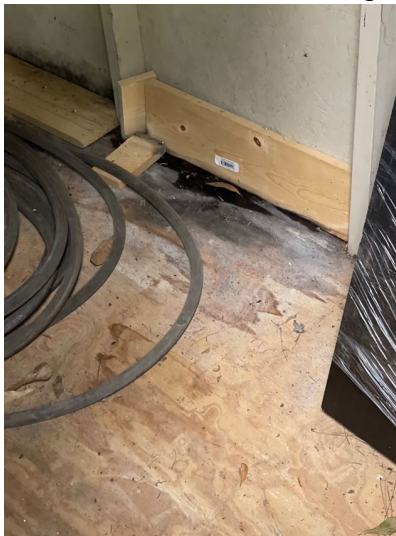
The rear storage shed had several areas of rotted flooring along with some siding damage.

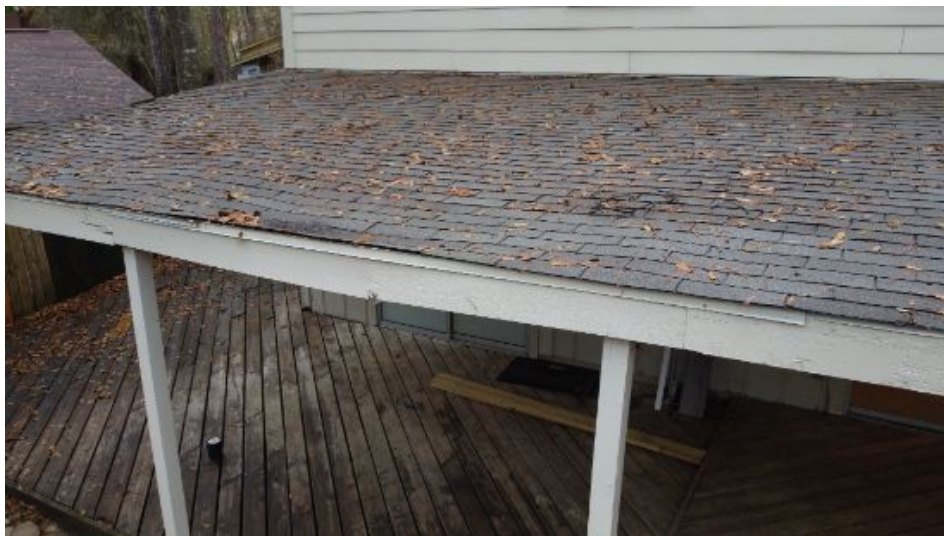
Rotted eave at the back deck cover.
