PROPERTY INSPECTION REPORT FORM

| RAUL & VELMA RODRIGUEZ <i>Name of Client</i> | 03/13/2023 <i>Date of Inspection</i> |
| 5822 PINELLAS PARK, SPRING, TX 77379 <i>Address of Inspected Property</i> | |
| Stephen Perry <i>Name of Inspector</i> | 7854 <i>TREC License #</i> |

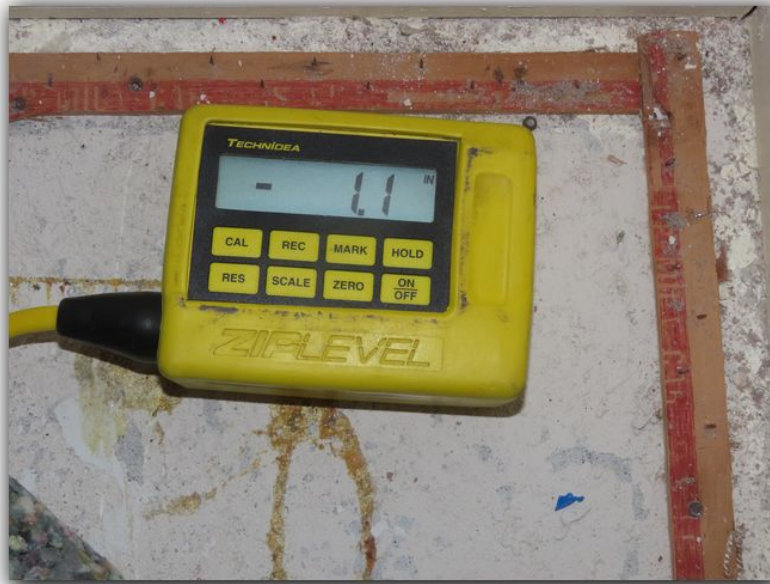
AS PART OF THE FOUNDATION INSPECTION THE ELEVATION OF THE FLOOR WAS CHECKED FOR EXCESSIVE SLOPE WITH A "ZIP LEVEL/ PRO-2000"- ("HIGH PRECISION ALTIMETER"). A REFERENCE POINT WAS SELECTED IN THE MIDDLE OF HOUSE AND ELEVATION MEASUREMENTS WERE TAKEN IN EACH ROOM. IT WAS DETERMINED AFTER CAREFUL EVALUATION OF THE DATA OBTAINED THAT THE FOUNDATION ELEVATION/SLOPE IS WITHIN ACCEPTABLE TOLERANCES. THE FRONT SECONDARY BEDROOM WAS SHOWING -1.1 INCHES LOW. THIS DOES SHOW SOME SETTLEMENT BUT IS NOT CONSIDERED EXCESSIVE. HOWEVER, DUE TO MANY SIGNS OF

STRUCTURAL SETTLEMENT I DO RECOMMENDEVALUATION OF THE HOME BY A STRUCTURAL ENGINEER.

RECOMMEND PROPER MOISTURE MAINTENANCE OF THE SOIL SURROUNDING THE HOMES PERIMETER AND THE LARGE TREE IN THE FRONT YARD HAVE A ROOF BARRIER SYSTEM INSTALLED AS WELL.

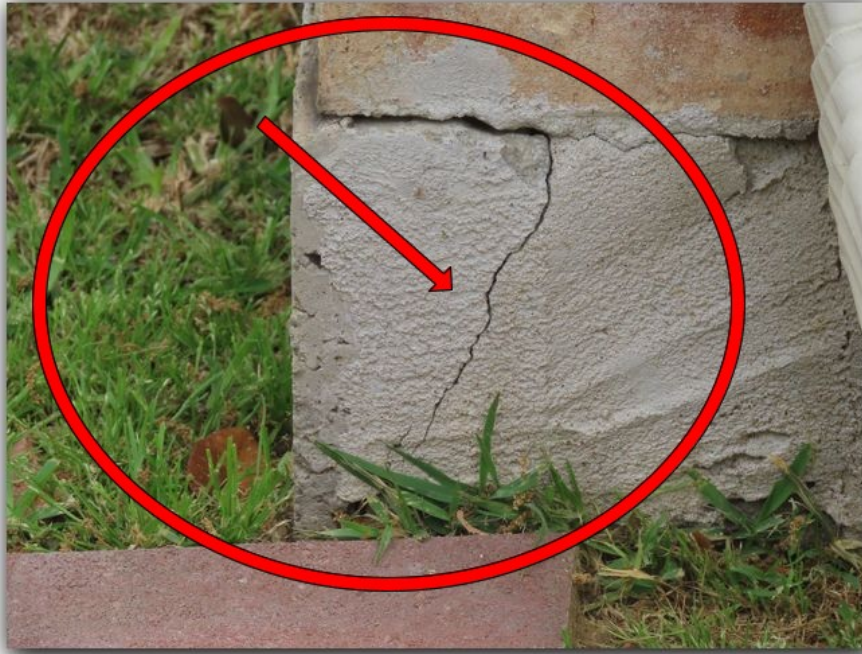
☑ DEFICIENCY-(MINOR COSMETIC DEFICIENCY- "CORNER POP" ON THE OUTSIDE CORNERS OF THE SLAB THAT IS RECOMMENDED TO BE POINTED WITH MORTAR (Deficiency)****

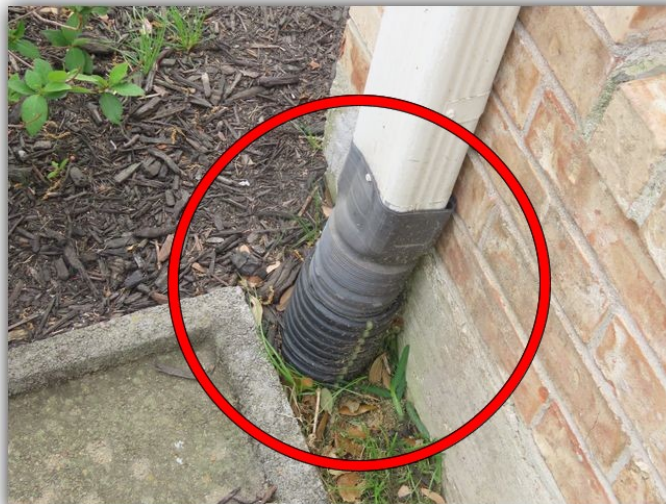
- **THE GUTTER DOWN SPOUTS HAVE FLEX TUBING CONNECTIONS TO THE FRENCH DRAINS BELOW SURFACE THAT ARE NOT RECOMMENDED DUE TO POTENTIAL LEAKS WITH THESE TYPE TUBES. IT IS RECOMMENDED TO HAVE A SOLID PVC TYPE DRAINS THAT TERMINATE TO FRENCH DRAIN BELOW SURFACE **** (Deficiency) ******

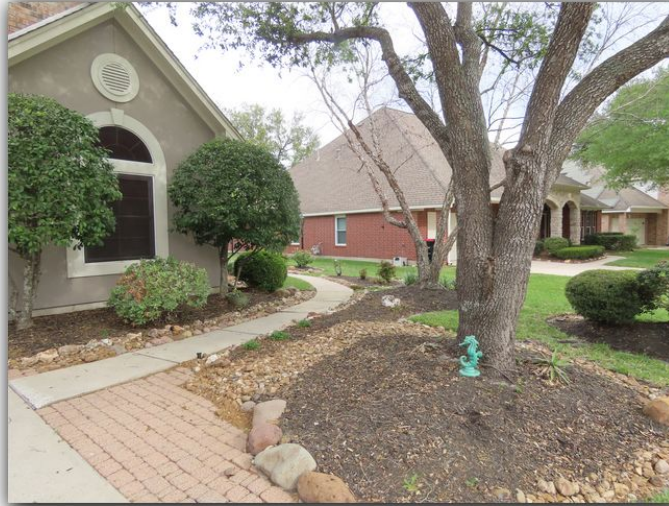
- ☑ **Trees/heavy foliage close to structure; recommend that the trees and shrubs close to the home have a root barrier system installed or roots pruned back between the home and tree. trees close to the home and large roots from trees and shrubs growing underneath the home can affect foundation performance. **** (Deficiency) ******

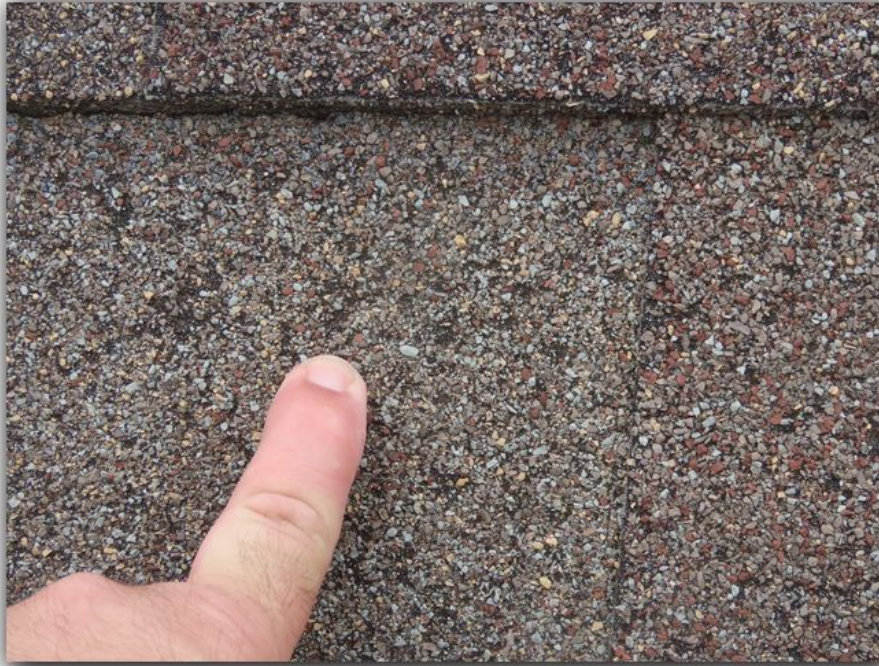
Comments: **The roof appears to be approx. 12 years old and does have deficiencies detailed below and active roof leaks as well. In need of repairs by a roofing expert.**

- **There is hail damage present; recommend overall evaluation and repairs or potential roof replacement by a roofing expert.**(Deficiency)****

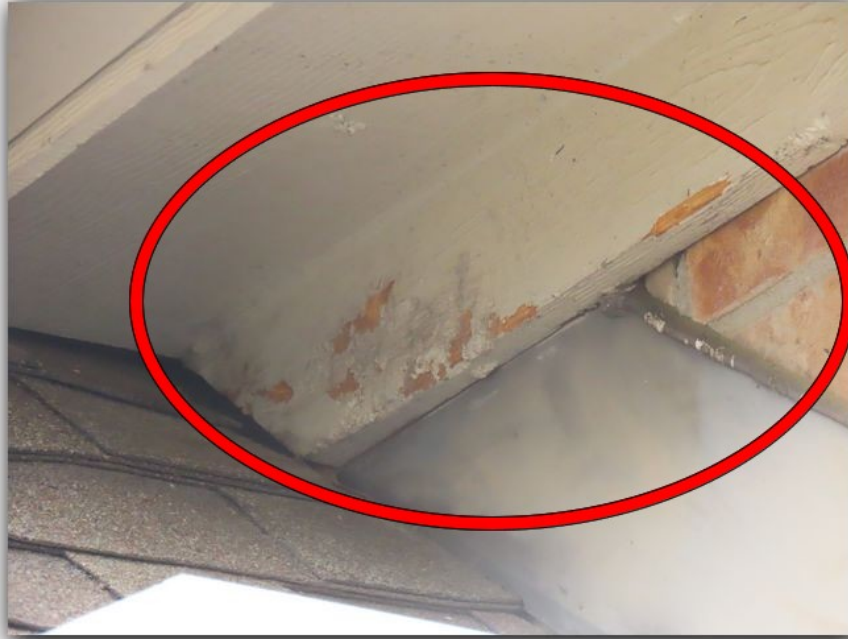
Flashing is lifting, ill configured, or missing; and active roof leaks with water stains/patchwork on the master closet below. In need of repairs by a roofing expert. **** (Deficiency) ****

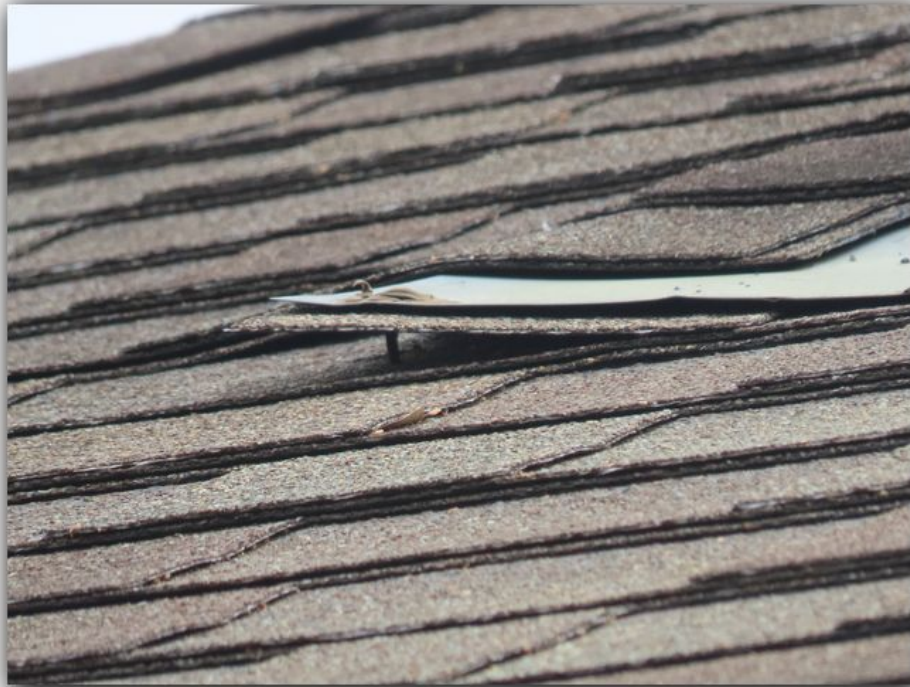
- **THERE IS VENTS AND FLUES WITH RAISED FLASHING THAT NEEDS TO BE PROPERLY SEALED DOWN BY A ROOFING EXPERT.**(Deficiency)****

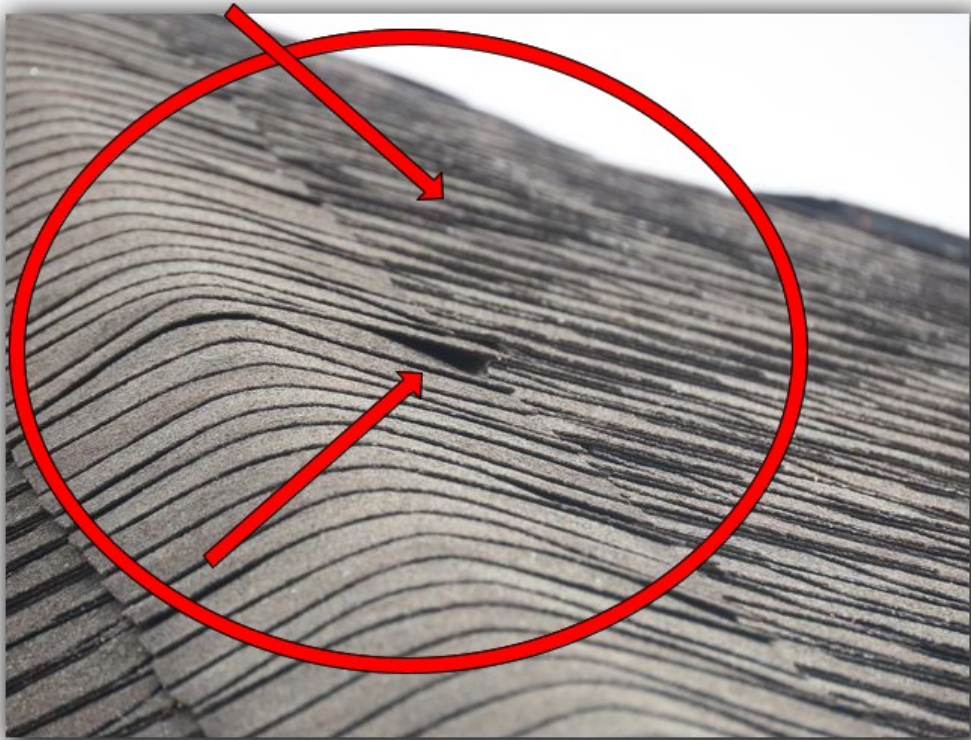
- **THERE IS SEVERAL RAISED SHINGLES IN VARIOUS LOCATIONS THAT NEEDS TO BE REPAIRED AND PROPERLY SEALED DOWN BY A ROOFING EXPERT** **** (Deficiency)****

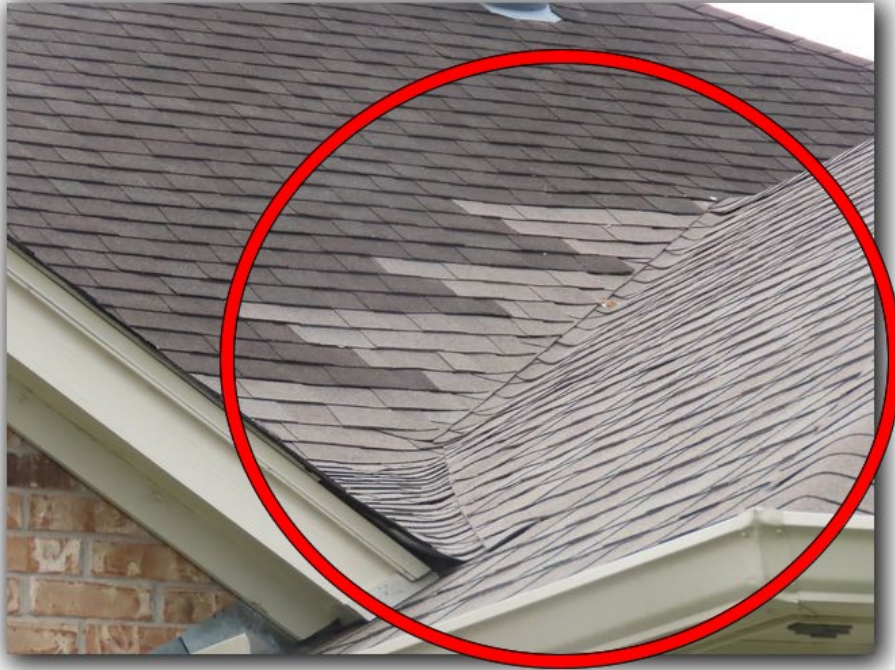
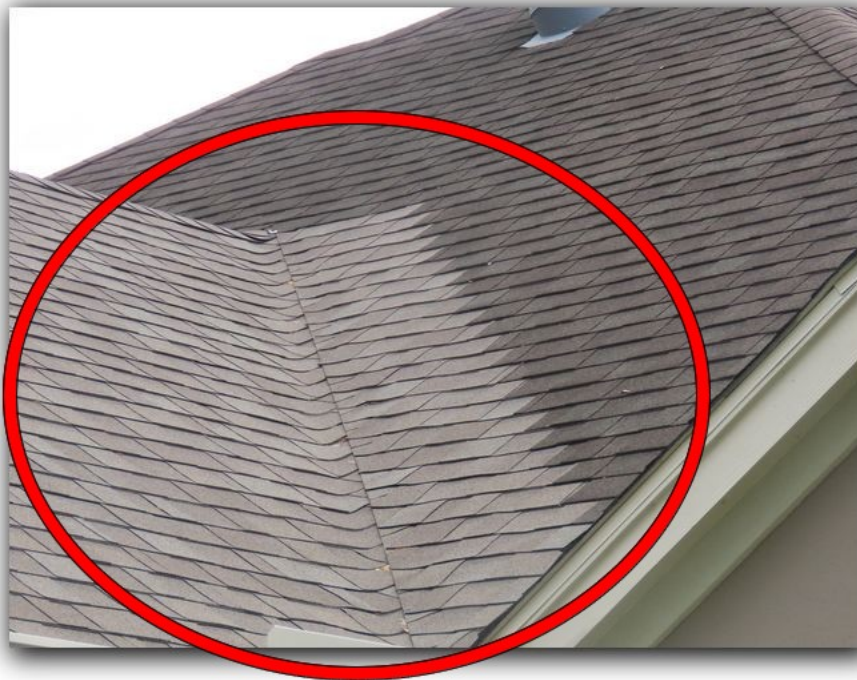
Previous Repairs to Roof At: BACK PORCH

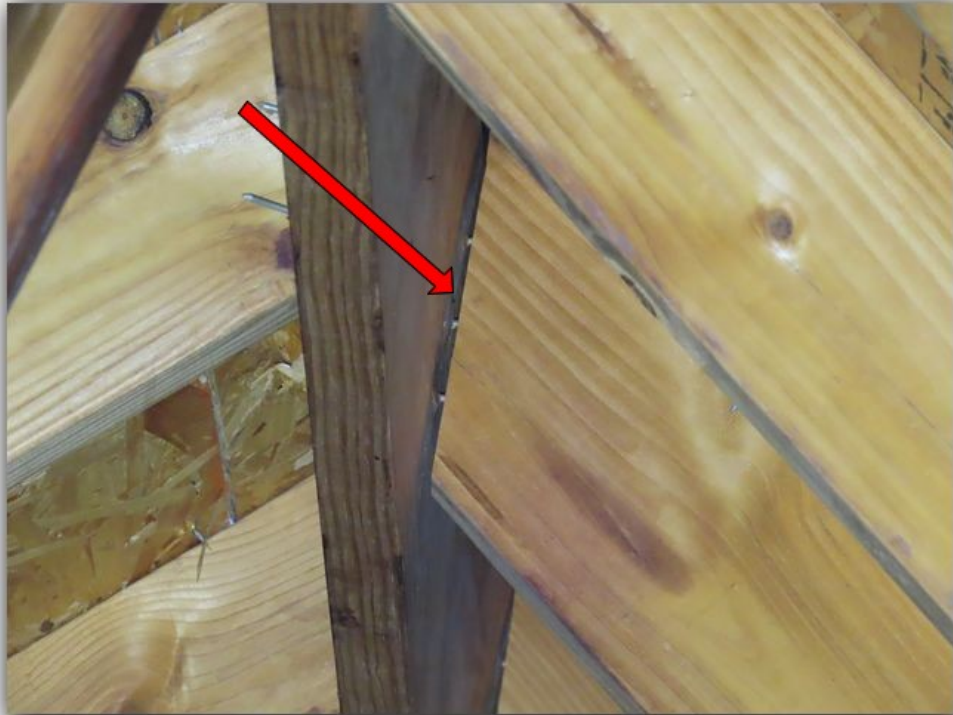
Evidence of moisture penetration **** (Deficiency) ** (above the master closet); in need of repair by a roofing expert)**

THERE IS SOME RAFTERS WITH SEPARATION FROM THE RIDGE BEAM THAT IS ALSO COMMON WITH STRUCTURAL SETTLEMENT AND IN NEED OF EVALUATION AND REPAIRS BY A FRAMING EXPERT. ** (Deficiency) **

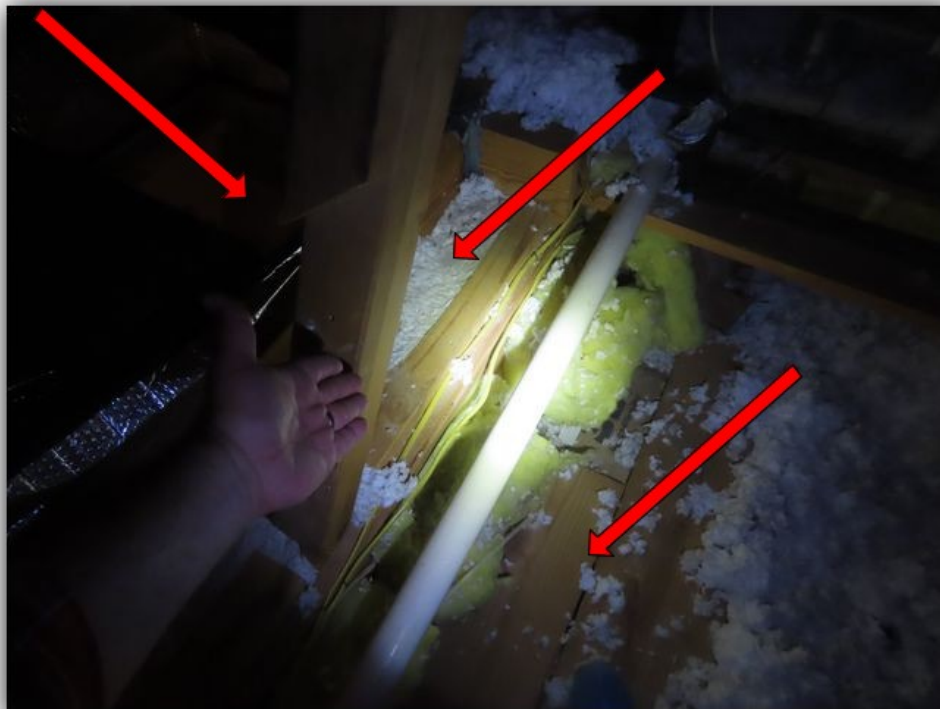
Damaged access ladder; LOOSE HARDWARE, SAFETY HAZARD AND IN NEED OF REPAIRS OR REPLACEMENT. (Deficiency)****

There is not a clear continuous solid pathway leading to the hvac equipment from the attic entrance as is required for safety and also needs a step down to the sharp drop down from the attic entry down to the pathway to the equipment. (Deficiency)****

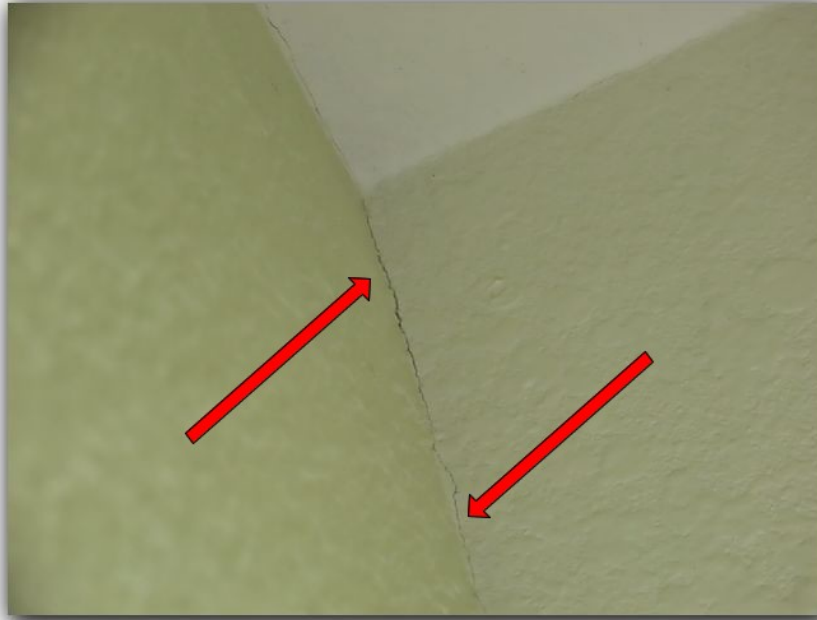
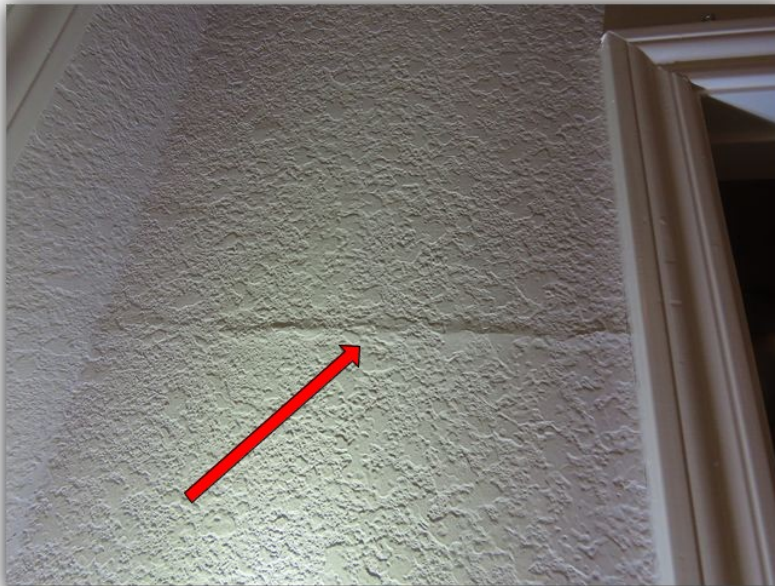
- **THERE IS SOME CRACKS/PATCHED CRACKS ON THE WALLS, SEPARATIONS BETWEEN TRIM THAT INDICATES SOME STRUCTURAL SETTLEMENT. ** (Deficiency) ****
- **INDICATING STRUCTURAL SETTLEMENT THAT NEEDS TO BE PATCHED/FINISHED/TEXTURED AND MONITORED FOR ANY FURTHER CRACKING**

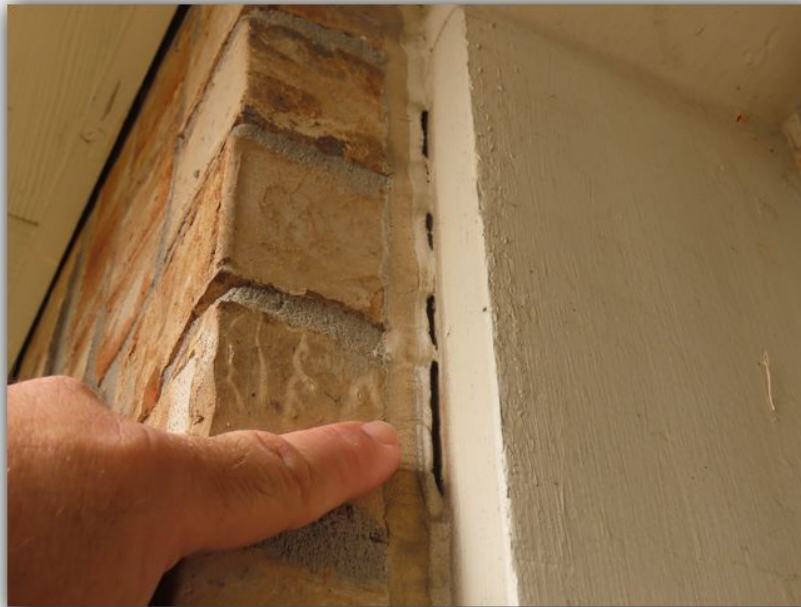
Rusted steel lintels that need repairs and paint **** (Deficiency)****

Caulking / sealant is separated or missing in some areas **** (Deficiency)** (Separations in trim and calking at the brick can also be a sign of structural settlement as well)**

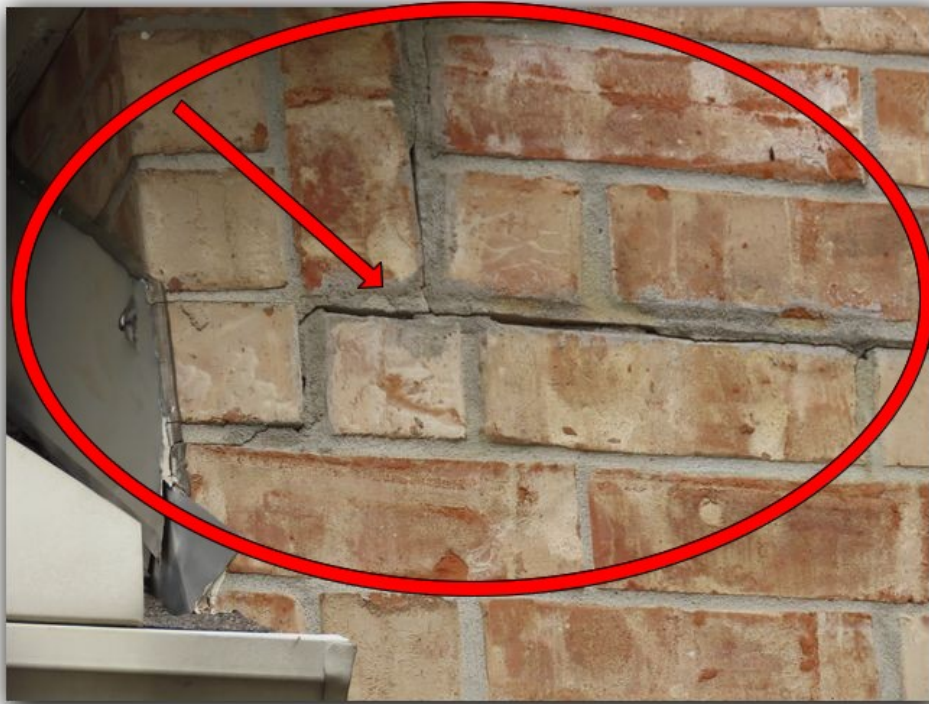
Some cracks at the brick; SIGNS OF STRUCTURAL SETTLEMENT ABOVE

THE GARAGE THAT NEEDS TO BE REPAIRED/POINTED BY A MASONRY REPAIR EXPERT AND ALSO MONITORED FOR ANY FURTHER SIGNS OF STRUCTURAL SETTLEMENT.(Deficiency)****

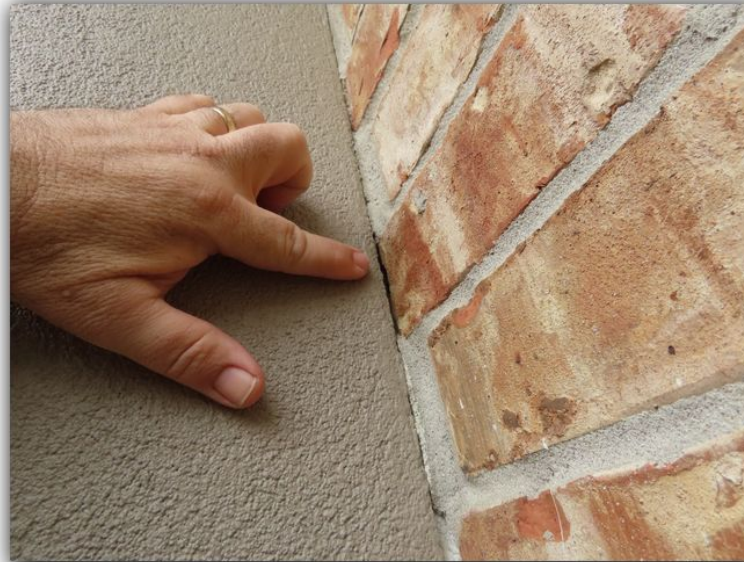
STUCCO IF NOT SEALED PROPERLY DUE TO CRACKS OR OPENINGS AND SEPARATIONS CAN ALLOW MOISTURE TO BECOME TRAPPED INSIDE THE WALL THAT IS SOMETIMES NOT VISIBLE FROM THE INSIDE WALLS OR EXTERIOR WALLS AND CAN CAUSE ROTTED FRAMING AND MOLD INSIDE THE WALLS UNDETECTED FOR A LONG PERIOD OF TIME IF NOT PROPERLY SEALED. ANY AREAS OF STUCCO THAT ARE NOT PROPERLY SEALED OR CRACKS AND SEPARATIONS SHOULD BE PROPERLY REPAIRED AND SEALED. I DO RECOMMEND FURTHER EVALUATION AND REPAIRS BY A STUCCO EXPERT.

There is a lack of caulking in several locations of trim, accent molding and a lack of weep screed/drainage system in some locations that can result in water penetrations with stucco if not properly sealed. In addition, there is other locations shown below that does also need caulking (high performance caulking recommended) in various locations of the stucco

I do recommend an evaluation for "invasive stucco inspection" by a stucco expert that includes probing the walls with a moisture meter to determine if there may be potential high levels of moisture inside the wall in these locations that can remain trapped inside the wall and result in moisture related damage such as rotted

framing/mold/insulation and wall damage.

RECOMMEND FURTHER EVALUATION BY A STUCCO

EXPERT. * (Deficiency) *****

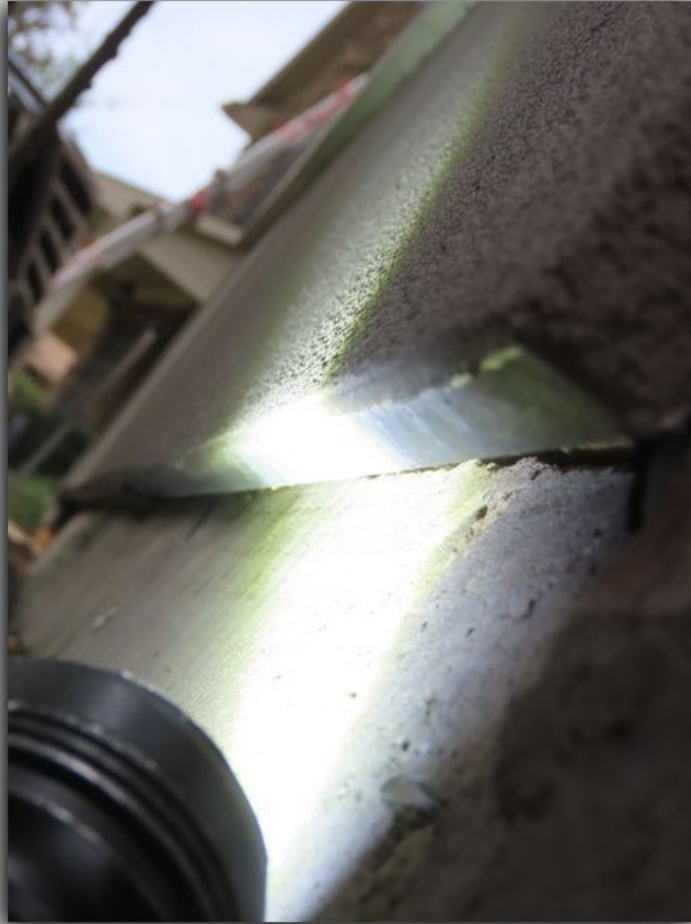
- **The bottom of the stucco wall terminations does not have weep screed or drainage system present; in need of evaluation and repairs by a stucco expert.**

**** (Deficiency) ****

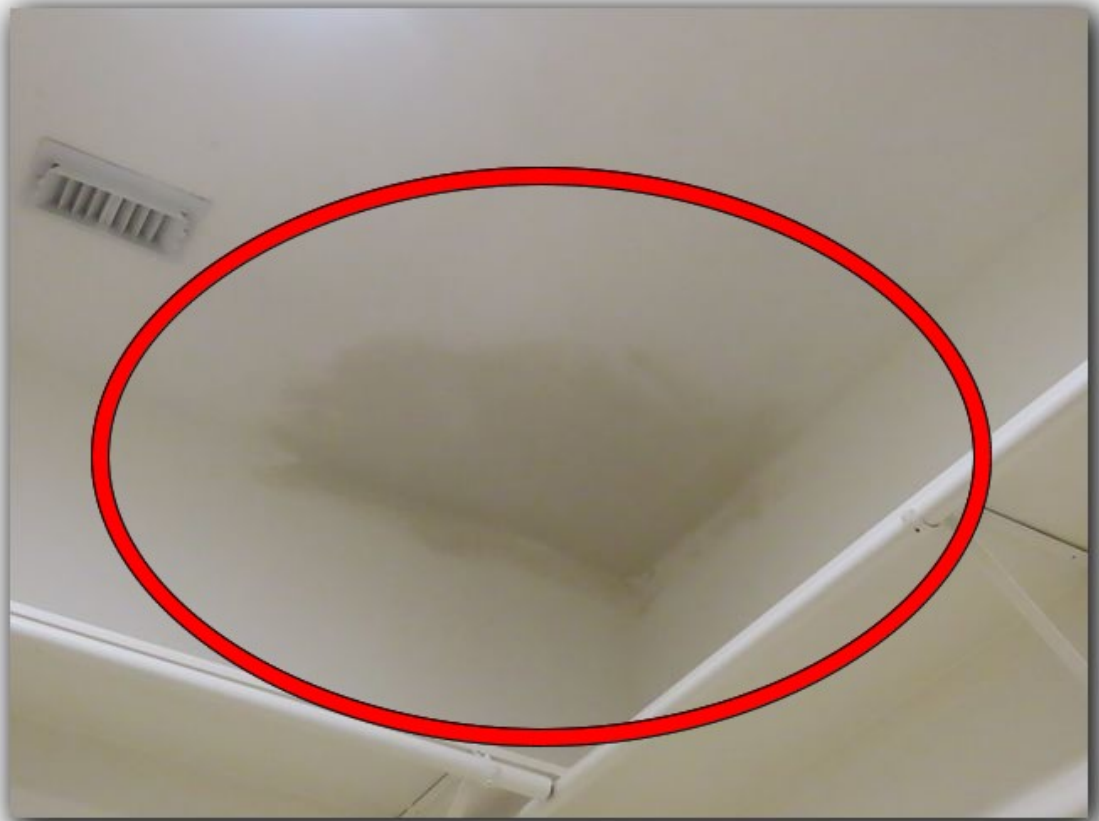
Water stain/water damage previously painted over in the master closet; active roof leak with a vent located in the attic directly above this location and has raised flashing at the roof level. In need of repairs by a drywall repair expert, roofing expert, and a mold inspection by a licensed mold inspector as well. ** (Deficiency) **

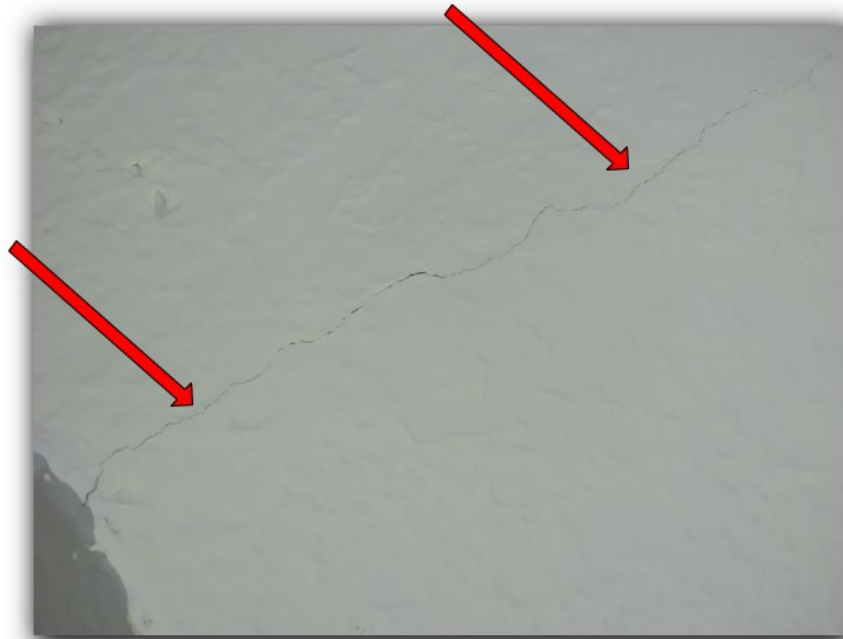
- Ceiling cracks in some areas** (Deficiency)****
- Signs of structural settling**
 - **INDICATING STRUCTURAL SETTLEMENT THAT NEEDS TO BE PATCHED/FINISHED/TEXTURED AND MONITORED FOR ANY FURTHER CRACKING**

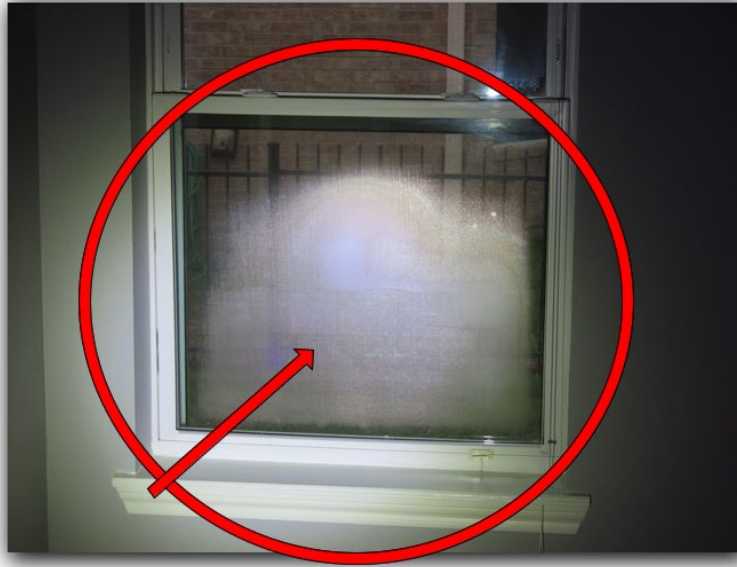
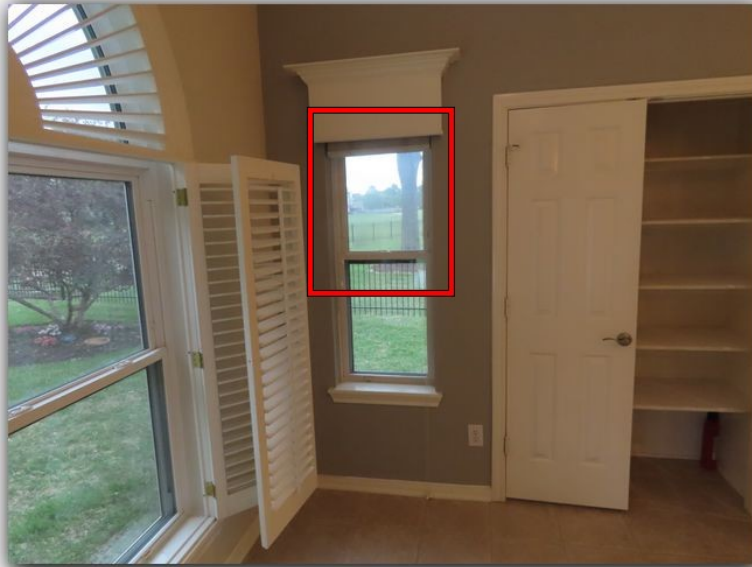
- Some window / door screens are damaged or missing
- Thermal pane window seals have failed, moisture is present **** (Deficiency)**** (SOME WINDOW HAVE A BROKEN SEAL, CAN BE A SIGN OF STRUCTURAL SETTLEMENT AND DOES REQUIRE WINDOW SASH REPLACEMENT AS WELL)

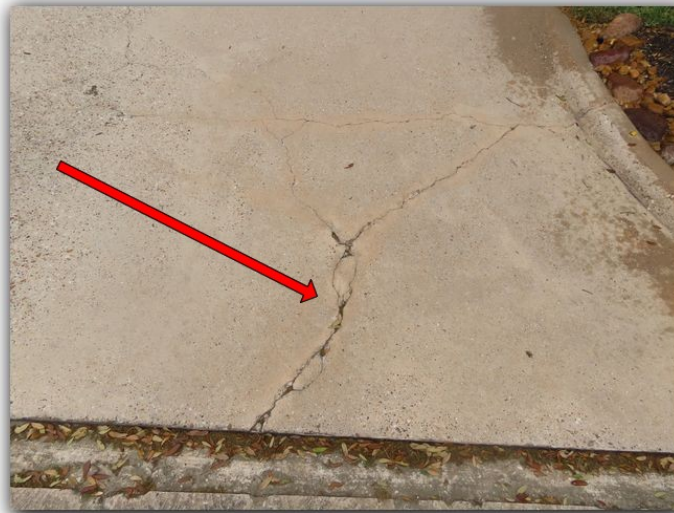
Structural deficiencies **** (Deficiency) **; DRIVE WAY CRACKS/SETTLEMENT THAT NEEDS REPAIRS.**

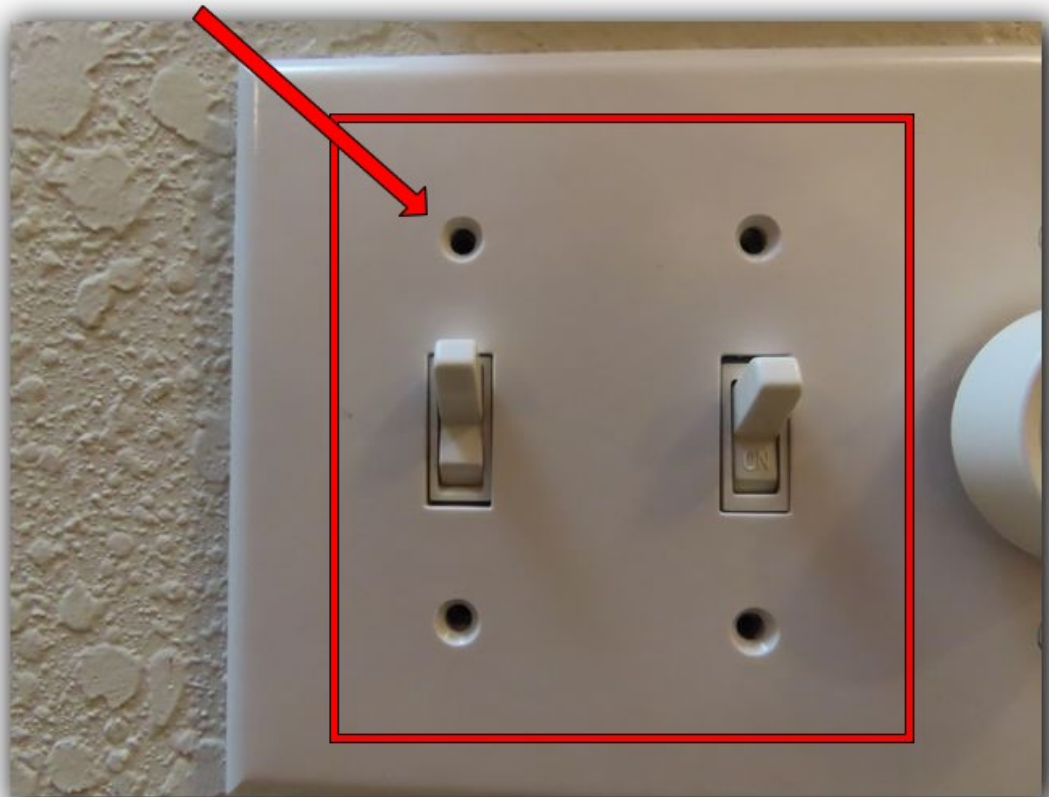
Loose, damaged, missing outlets / switches / covers **** (Deficiency)****

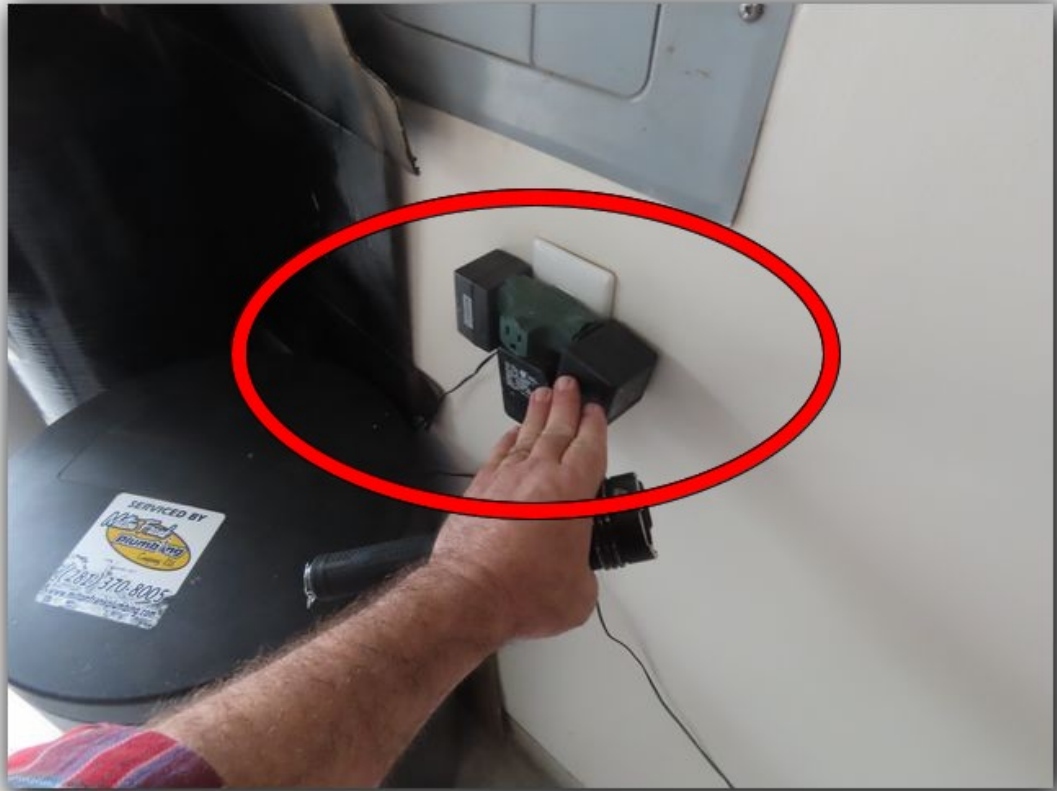
Due to the irrigation sprinkler system and the water softener plugs and other needing to be plugged into the same outlet there should be another outlet installed by a licensed electrician. Too many plugs for one outlet (Deficiency)****

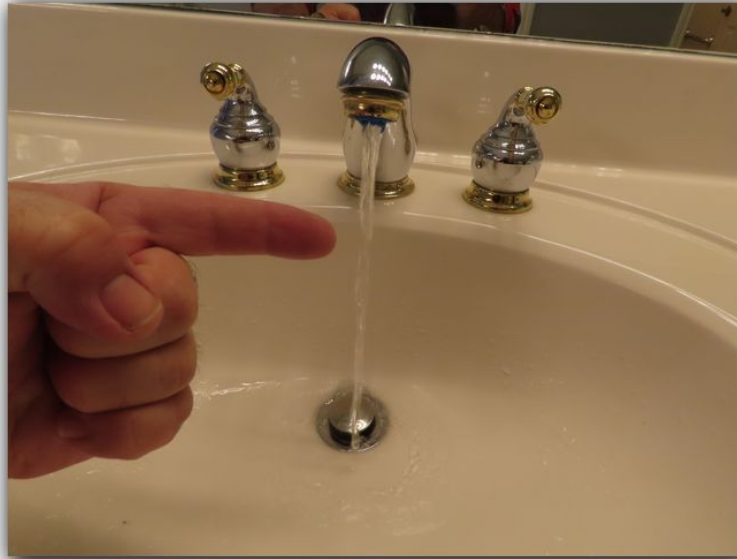
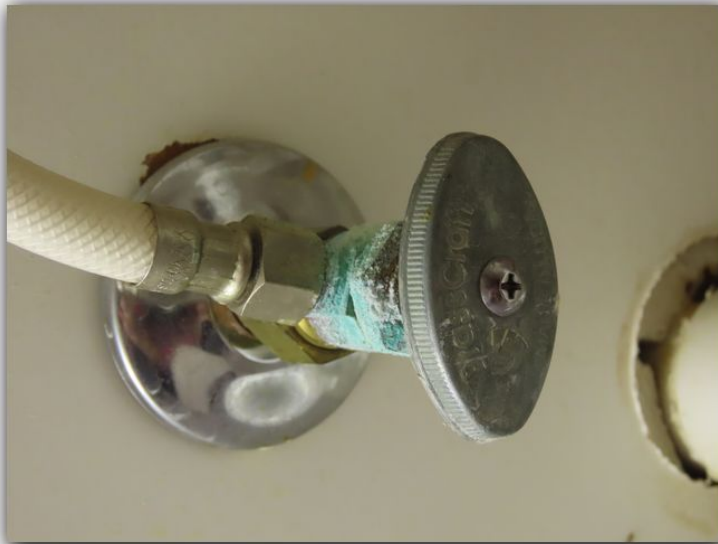
The master right side sink has low water pressure and corrosion at the valves under the sink that needs repairs by a plumber. ** (Deficiency) **

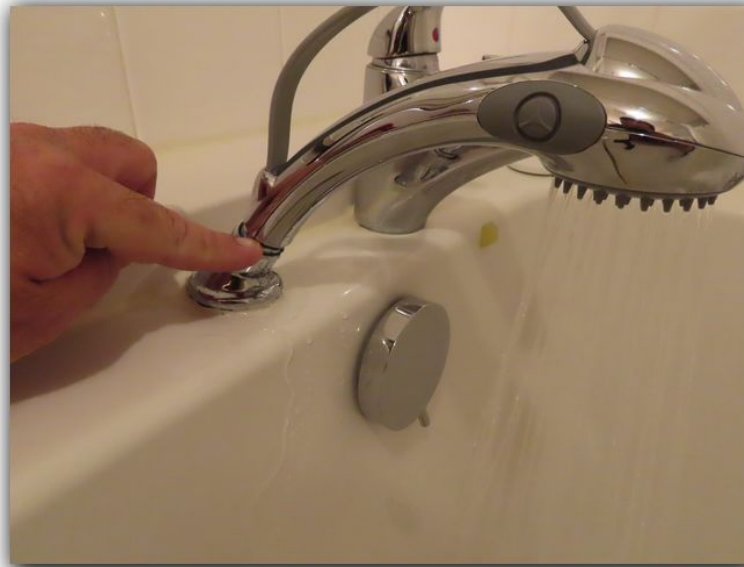
The master tub shower sprayer head is leaking and in need of repair by a plumber. (Deficiency)****

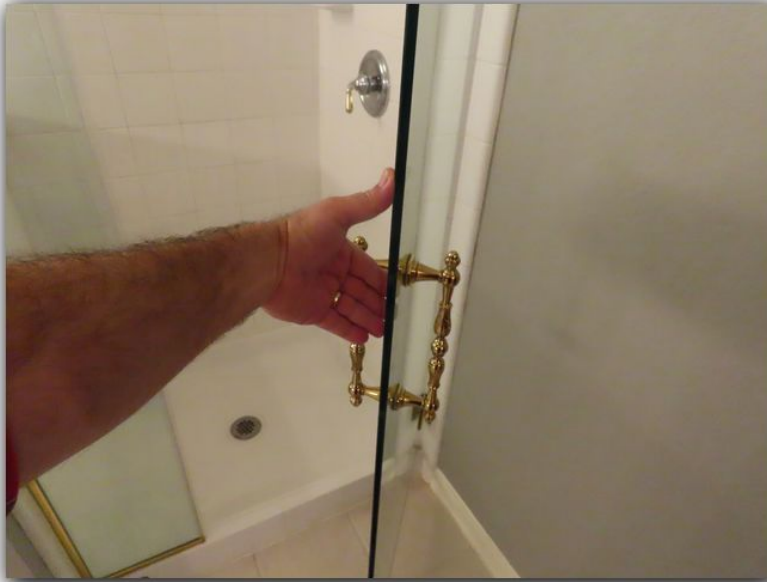
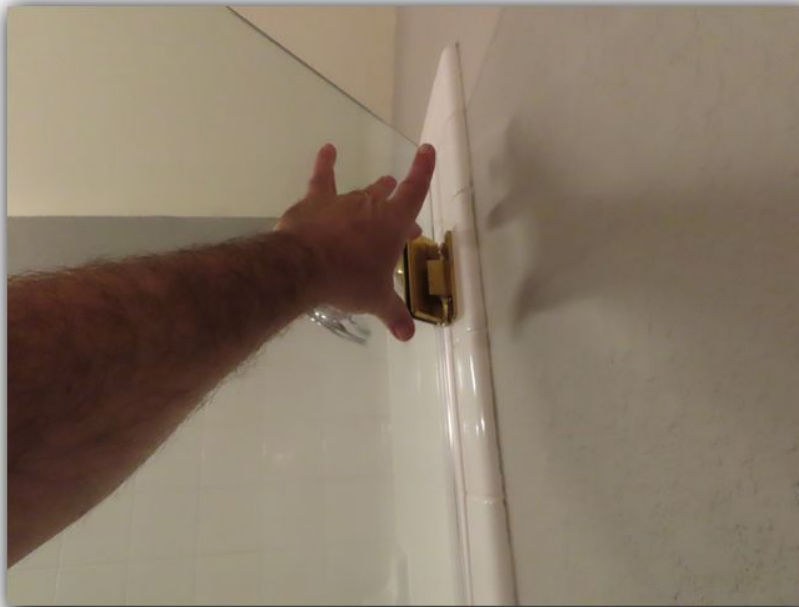
The master bath shower door is not able to open fully; damaged or improperly installed hinges; very small space to gain access into the shower. In need of repair or replacement of the shower door by a repair expert. (Deficiency)****

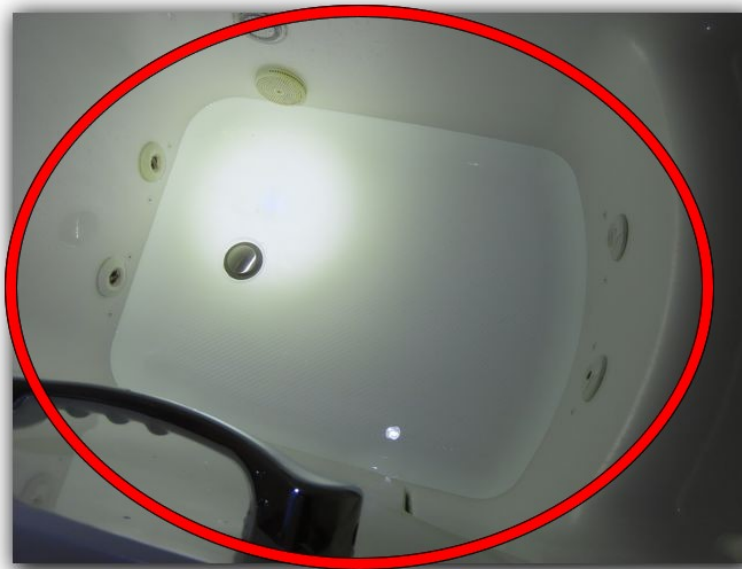
- **The hall spa tub has a slow drain; in need of repairs by a plumber.** (Deficiency)****
