FIG Services LLC d/b/a FOX INSPECTION GROUP
Property Inspection Report #210607RB-2135 Quenby Street
8616 Daffodil St. Houston, TX 77063
(Office)713.723-3330 (Email) office@foxinspectiongroup.com

Stucco Moisture Inspection Report Prepared For: Erick & Mara Calderon

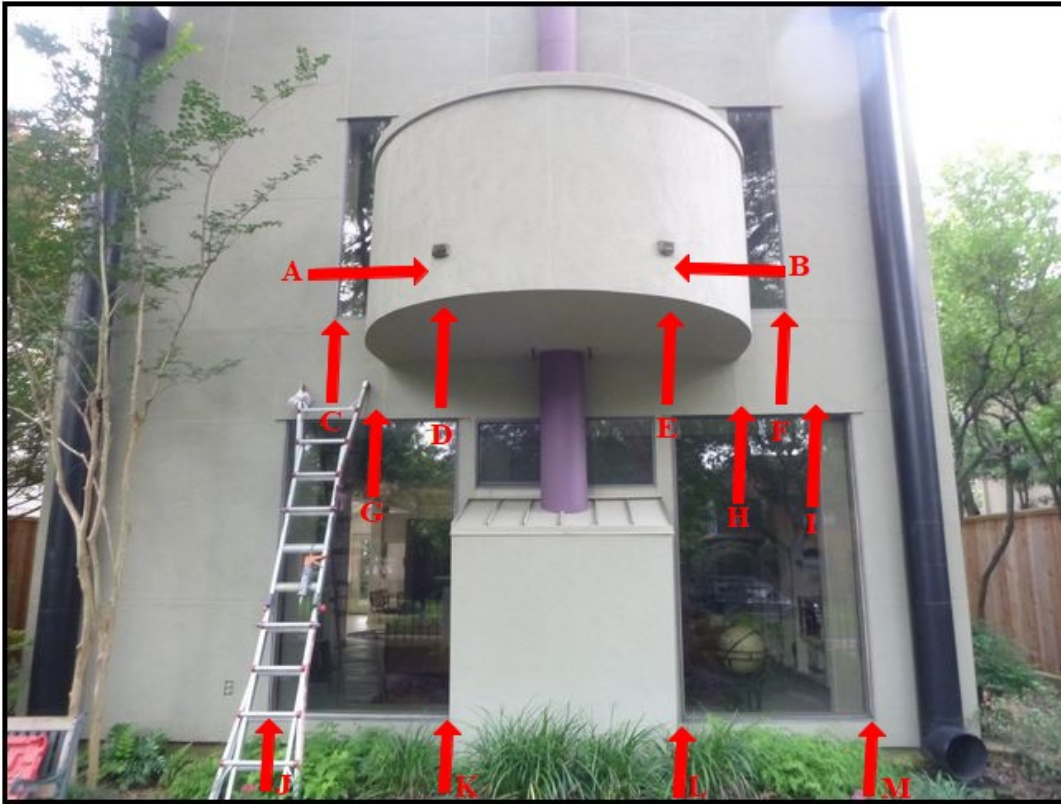
Front Elevation

Location	Item Description	Moisture Readings	Observations
A	Scupper	11.4	Substrate observed to be soft
B	Scupper	9.2	Substrate observed to be soft
C	Window	17.2	
D	Soffit	19.1	Substrate observed to be soft
E	Soffit	10.1	Substrate observed to be soft
F	Window	8.2	Substrate observed to be soft
G	Wall above window	19.2	
H	Wall above window	24.4	Substrate observed to be soft
I	Wall above window	20.1	Substrate observed to be soft
J	Window	13.9	Substrate observed to be soft
K	Window	14.2	Substrate observed to be soft
L	Window	18.3	Substrate observed to be soft
M	Window	9.2	Substrate observed to be semi-soft.

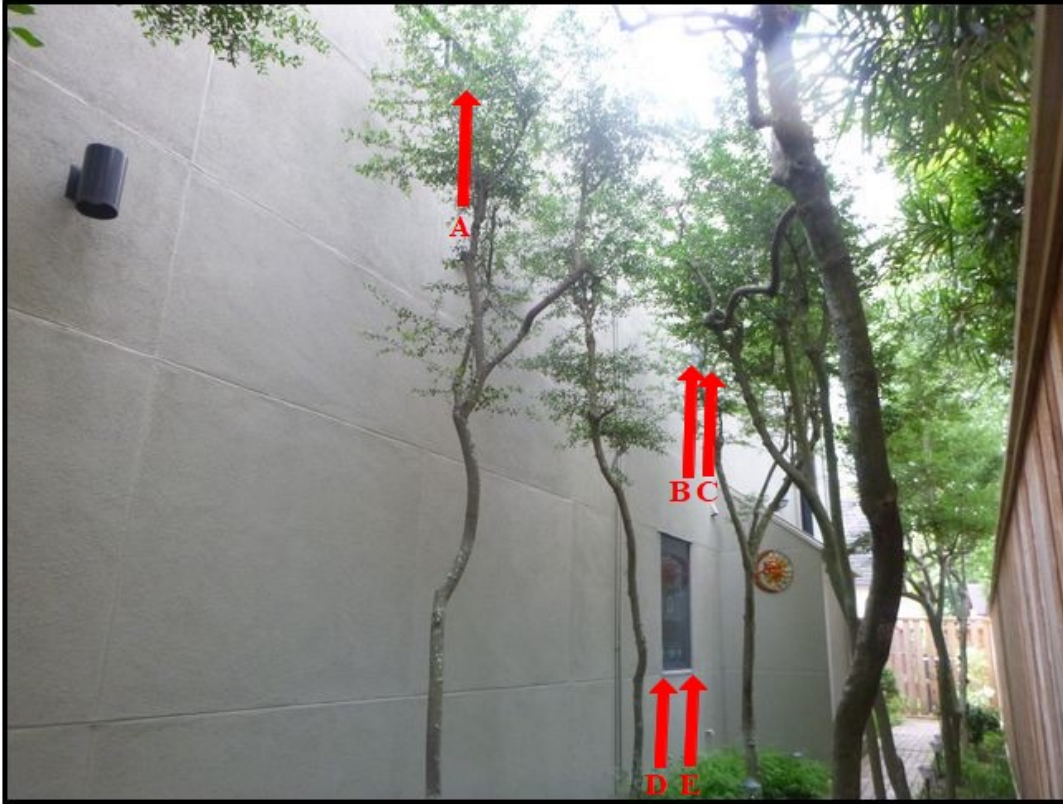
Right Elevation

Location	Item Description	Moisture Readings	Observations
A	Window	36.9	
B	Window	17.3	Substrate observed to be semi-soft.
C	Window	11.6	
D	Window	17.6	
E	Window	14.4

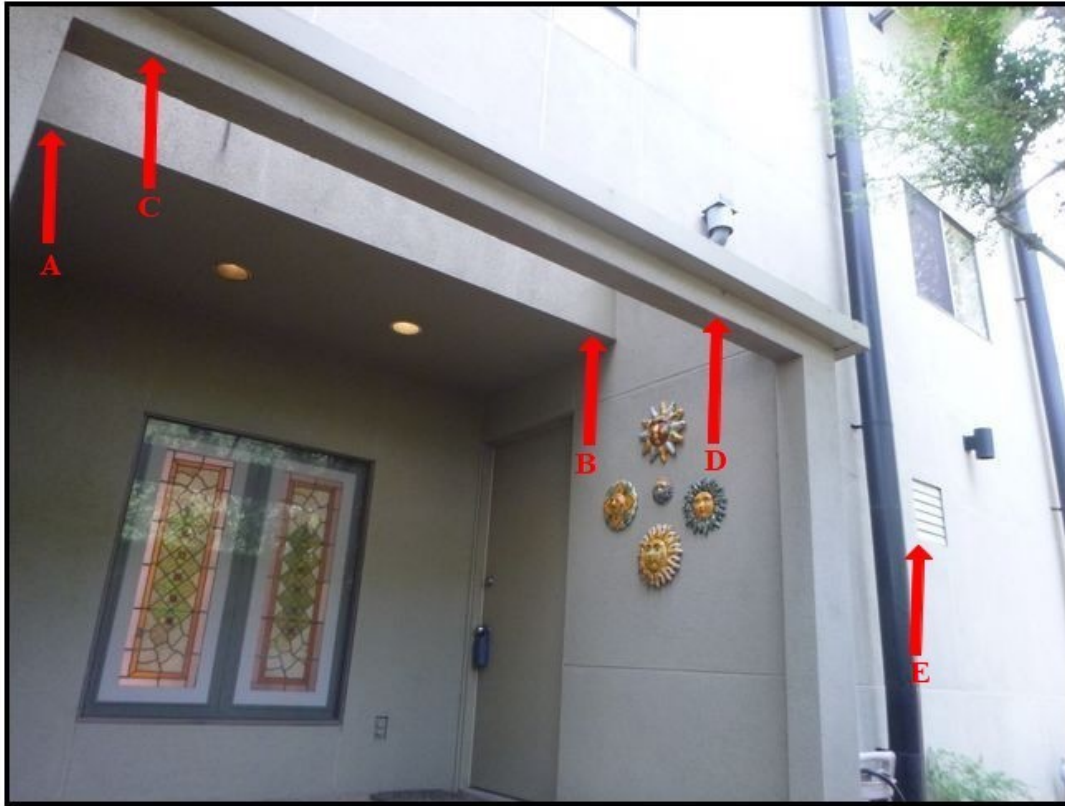
Right Elevation

Location	Item Description	Moisture Readings	Observations
A	Front entry soffit	10.5	
B	Front entry soffit	12.2	No substrate observed.
C	Front overhand soffit	22.6	Substrate observed to be soft
D	Front overhand soffit	32.3	Substrate observed to be soft
E	Vent	9.6	Substrate observed to be semi-soft.

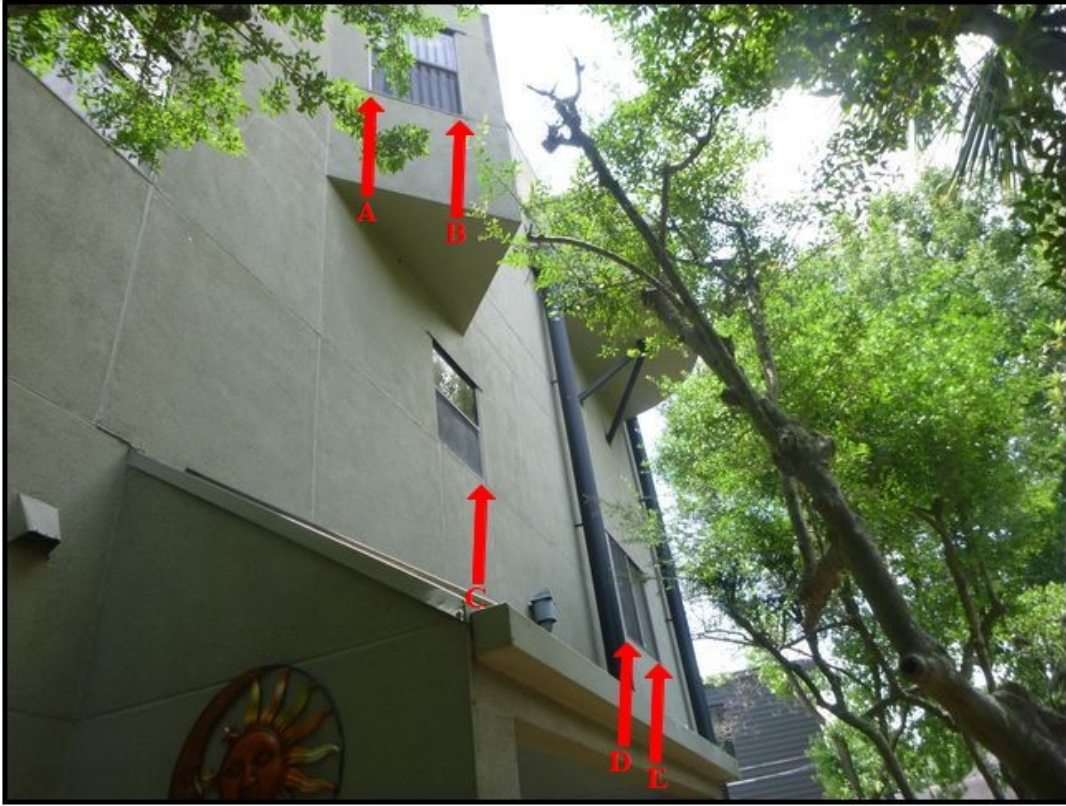
Right Elevation

Location	Item Description	Moisture Readings	Observations
A	Window	12.4	
B	Window	15.7	
C	Window	8.8	
D	Window	13.5	
E	Window	8.3

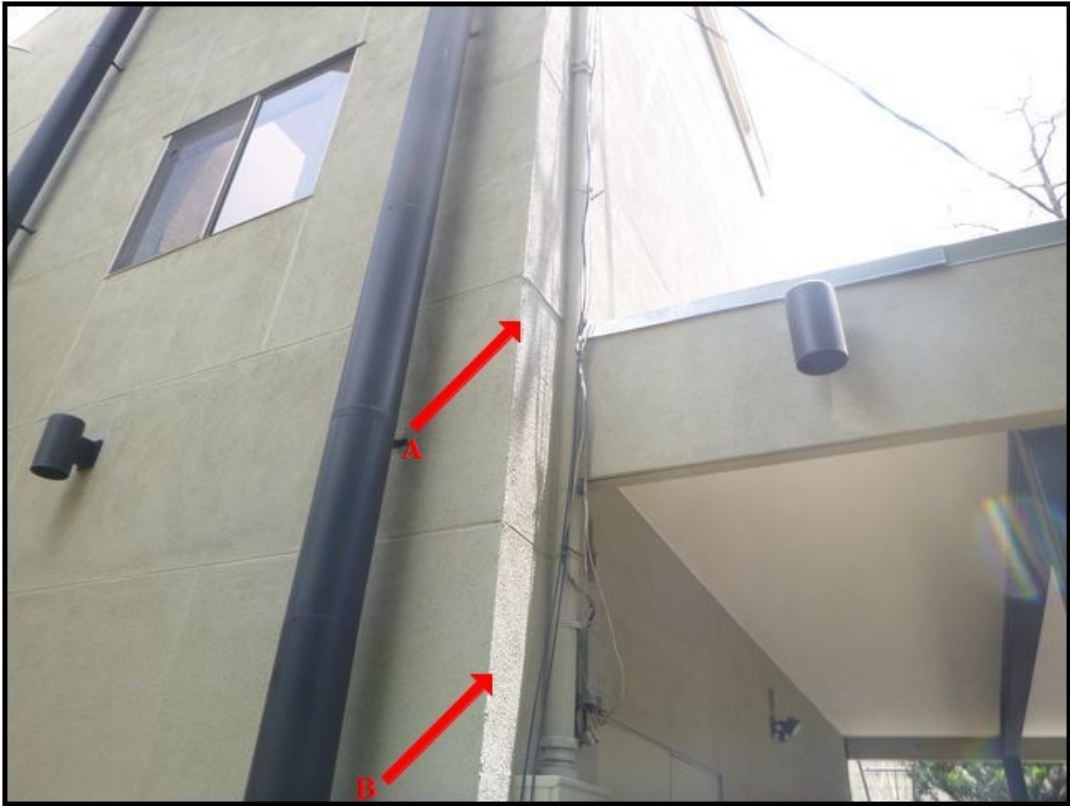
Back Elevation

Location	Item Description	Moisture Readings	Observations
A	Wall at corner	17.3	Substrate observed to be soft
B	Wall at corner	22.9	Substrate observed to be soft

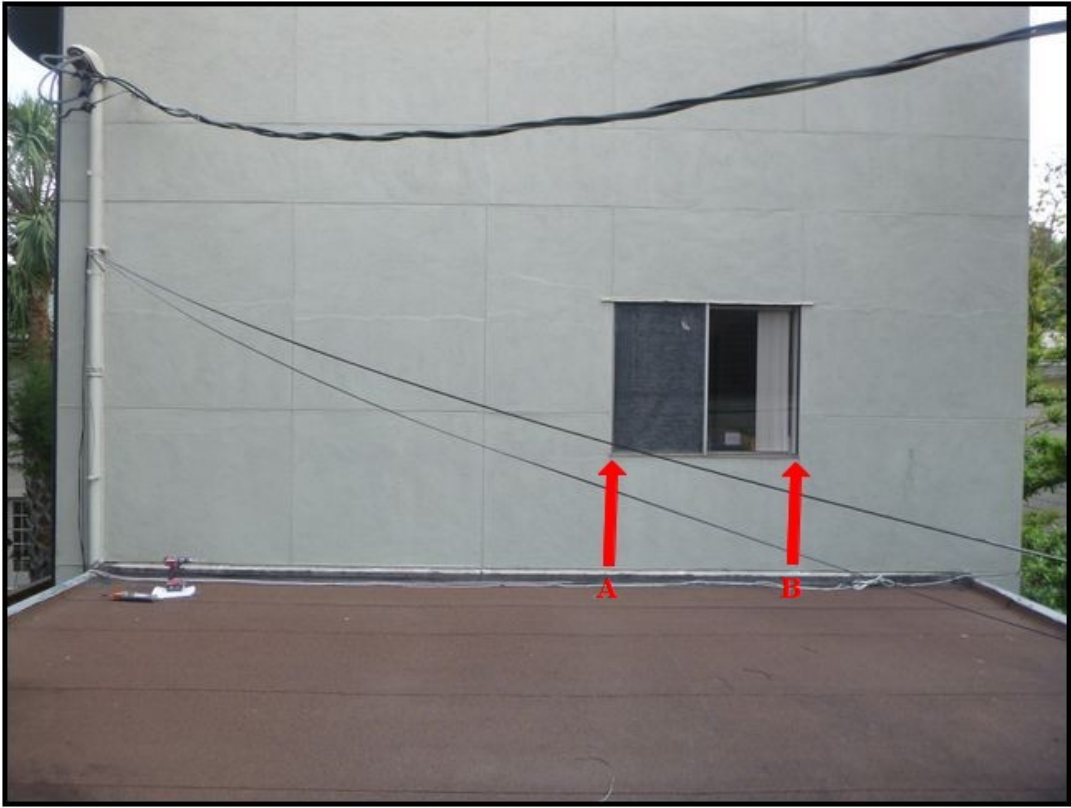
Back Elevation

Location	Item Description	Moisture Readings	Observations
A	Window	18.5	
B	Window	16.2

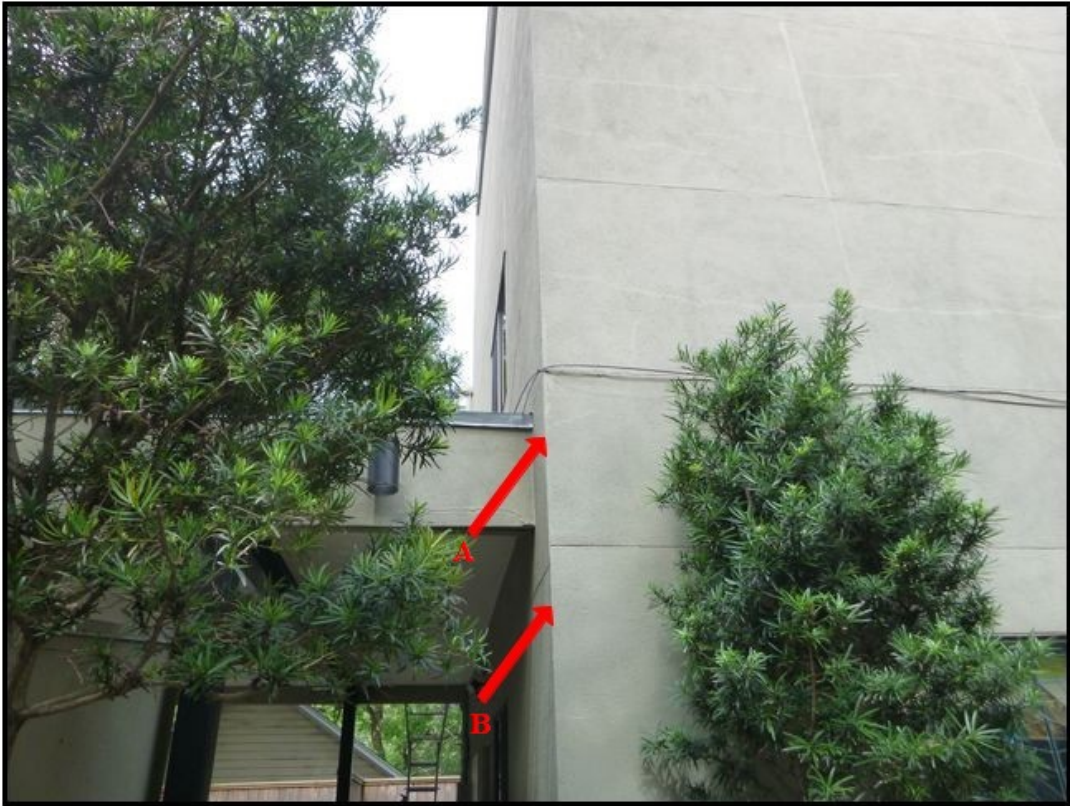
Back Elevation

Location	Item Description	Moisture Readings	Observations
A	Wall at corner	20.2	Substrate observed to be soft
B	Wall at corner	29.1	Substrate observed to be soft

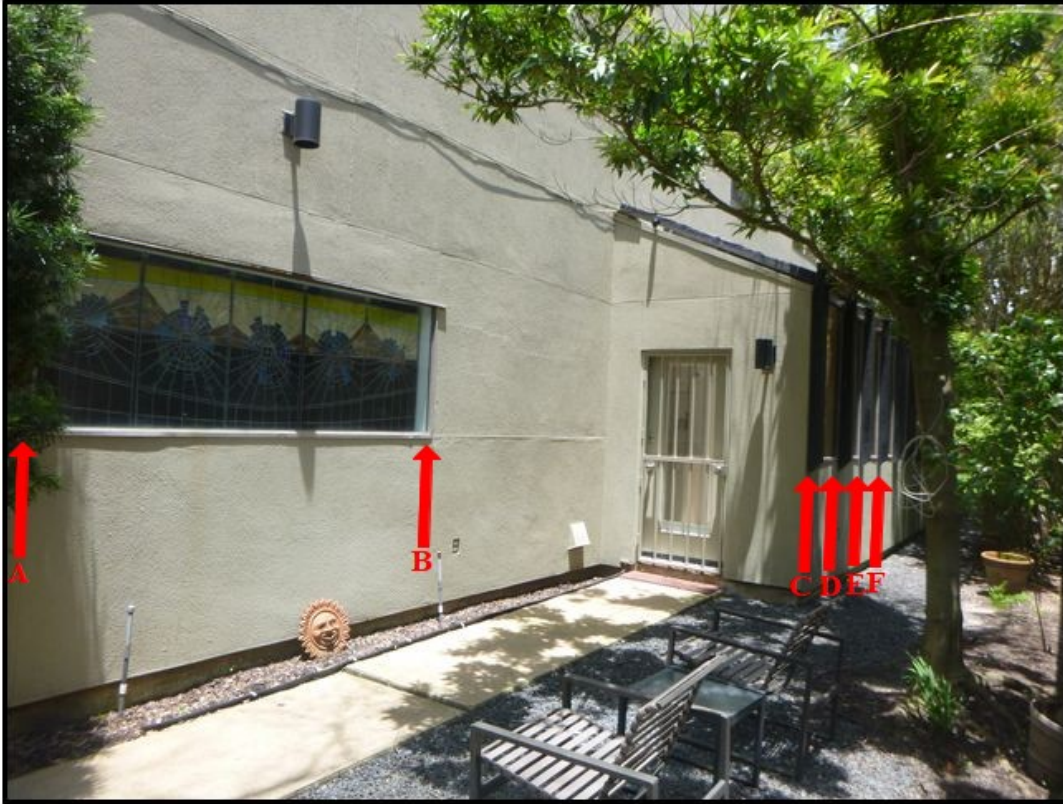
Left Elevation

Location	Item Description	Moisture Readings	Observations
A	Window	16.9	
B	Window	28.0	
C	Window	10.9	
D	Window	14.3	Substrate observed to be soft
E	Window	16.8	
F	Window	21.4	Substrate observed to be soft

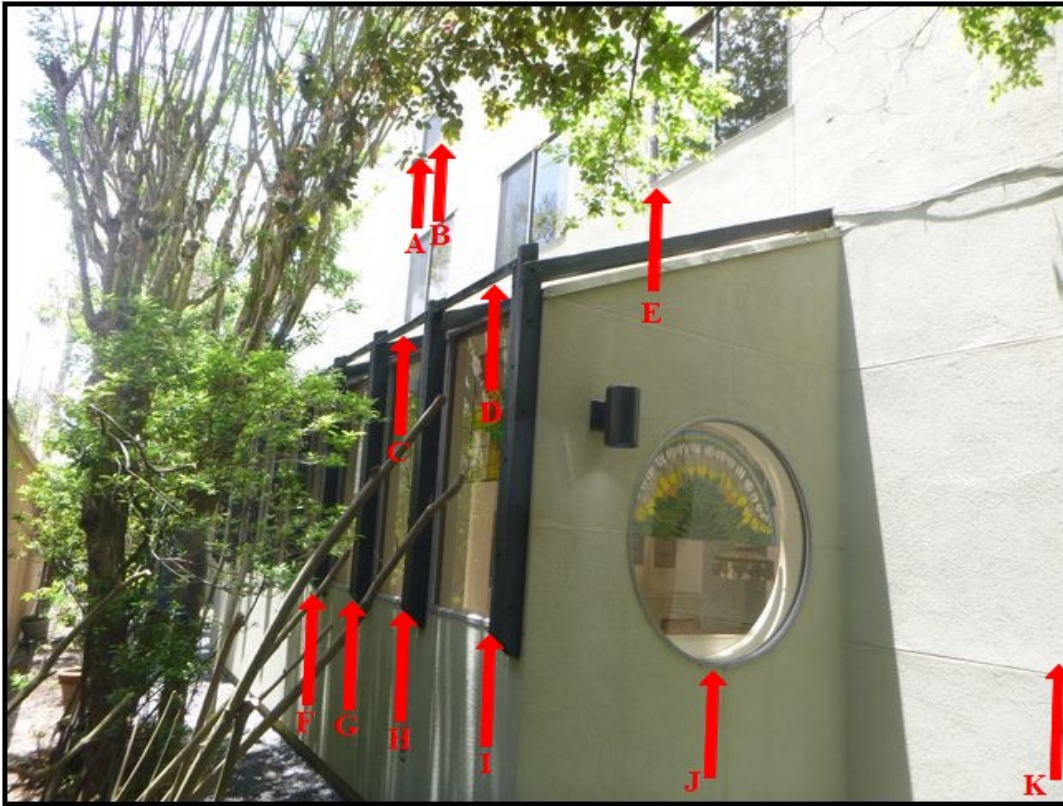
Left Elevation

Location	Item Description	Moisture Readings	Observations
A	Window	8.2	
B	Window	10.7	
C	Window	16.6	
D	Window	18.7	
E	Window	16.4	
F	Window	21.9	Substrate observed to be soft
G	Window	27.7	Substrate observed to be soft
H	Window	21.4	
I	Window	9.6	
J	Round window	8.1	
K	Wall at right above stains at base of wall	22.0	Substrate observed to be semi-soft.

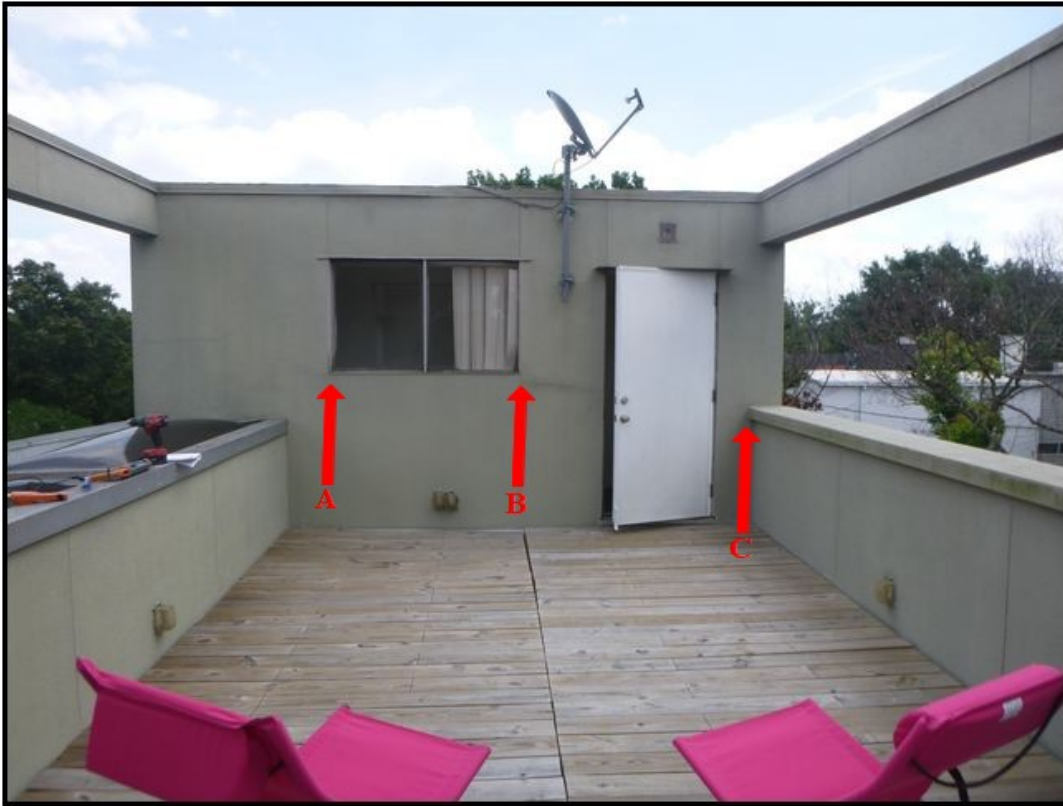
4th Floor Patio Elevation

Location	Item Description	Moisture Readings	Observations
A	Window	9.2	
B	Window	11.1	
C	Wall	9.3

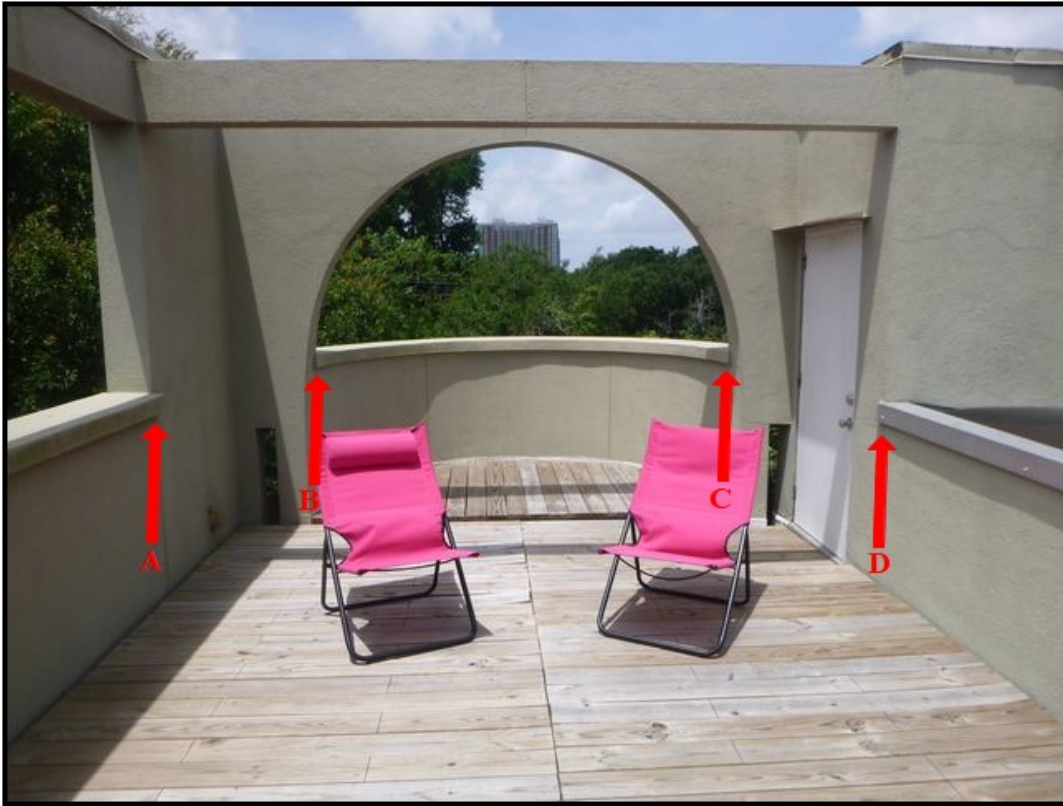
4th Floor Patio Elevation

Location	Item Description	Moisture Readings	Observations
A	Wall	9.0	
B	Wall	9.6	
C	Wall	11.1	
D	Wall	8.5

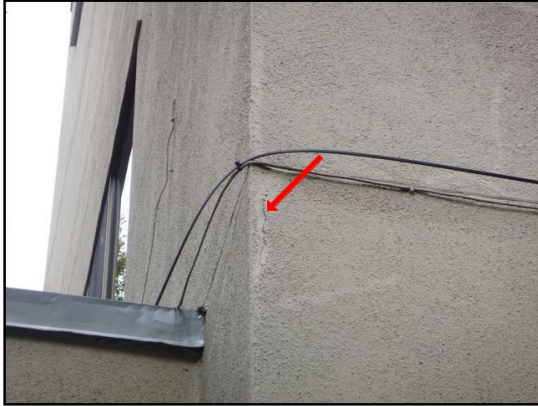
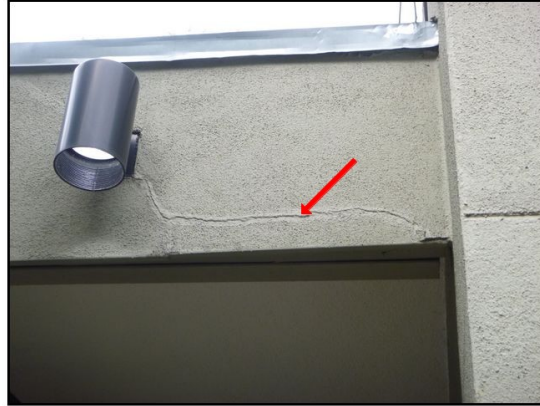
Multiple cracks observed around the structure. It is the inspector's opinion that the larger (thicker) cracks be sealed to prevent the expansion of the crack and/or potential water entry.

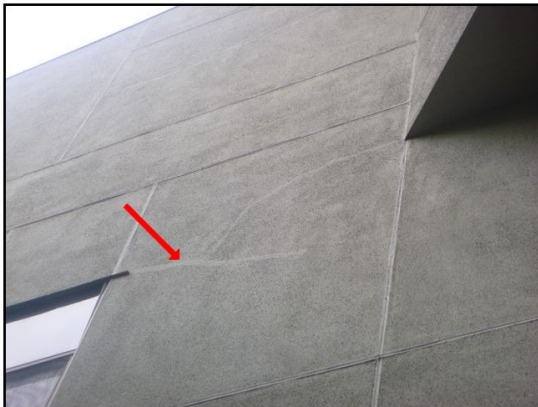
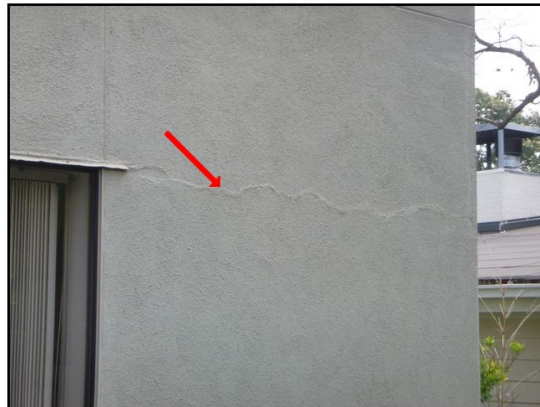
Previous patches / repairs were observed on multiple areas of the stucco surface. Recommend consulting with the owner as to and documentation concerning the repairs.

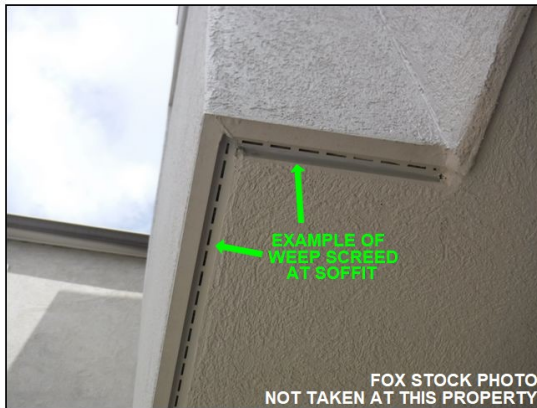
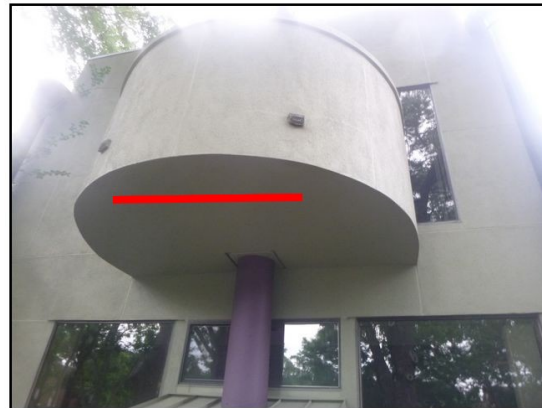
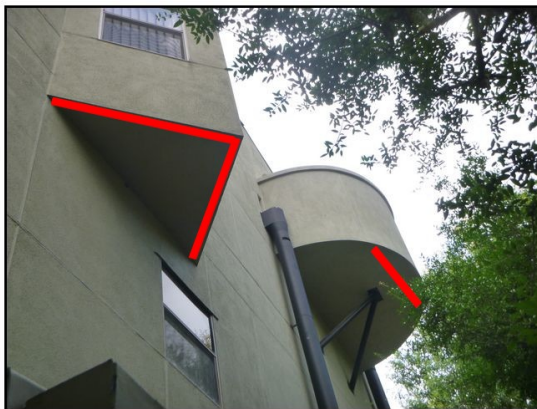
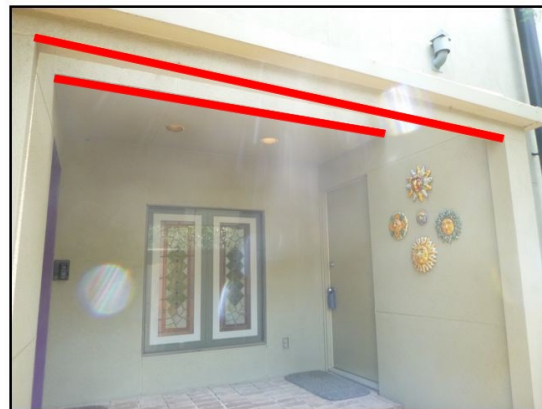
Did not observe weep screed at bottom of the stucco wall, where it intersects with the soffit. The following diagram depicts a “best practice” procedure as defined in the Texas Lathing and Plastering Contractor's Association (TLPCA) Stucco Resource Guide. This detail provide a means for moisture to exit from behind the stucco if the wall assembly leaks (we seldom see a weep screed at these locations on most stucco homes / buildings). Due to moisture / soft substrate observed in these areas (see page 6 & 8 above), installation of a weep screed is recommended.

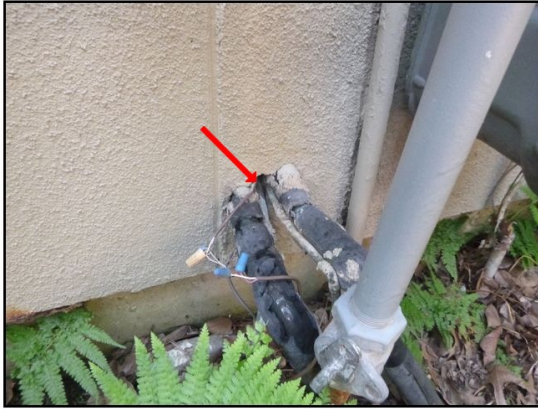
Recommend sealing all exterior penetrations to prevent potential water entry.

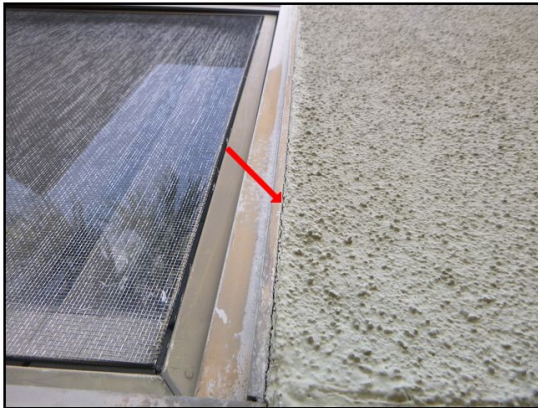
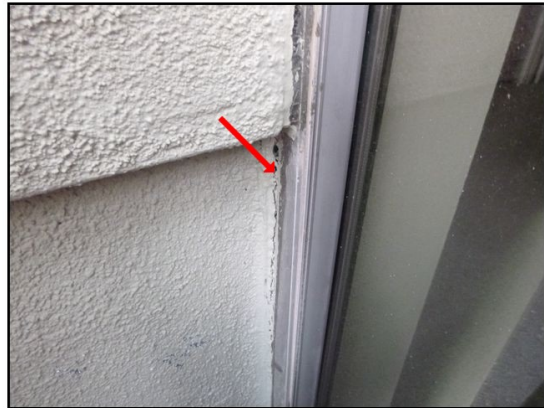
Recommend sealing around the exterior edges of all doors and windows to prevent potential water entry.

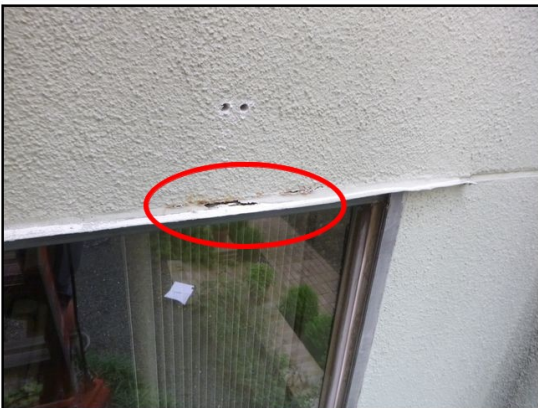
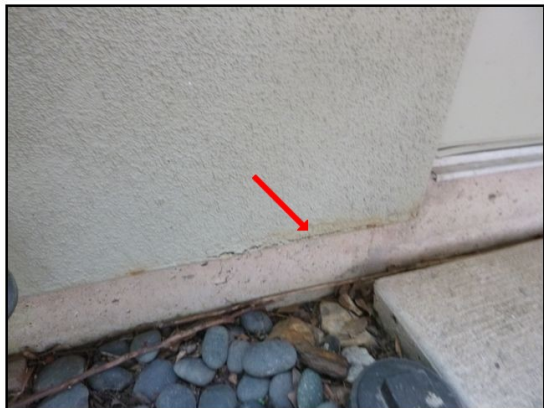
Observed one or more areas of staining on stucco veneer. Staining indicative of water moving persistently across stucco and / or exiting from behind wall which is conducive to water penetration to structure beneath.

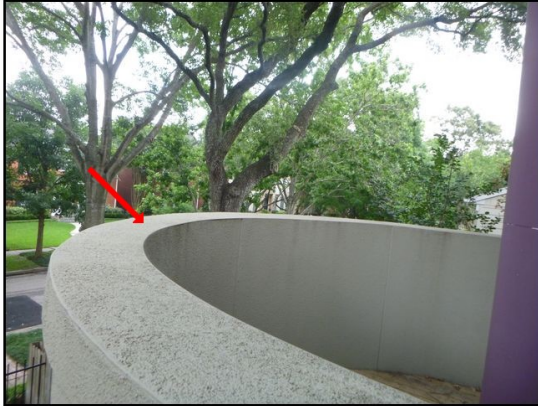
Did not observe cap flashing on flat areas of the stucco wall to prevent standing water and/or potential water penetration.

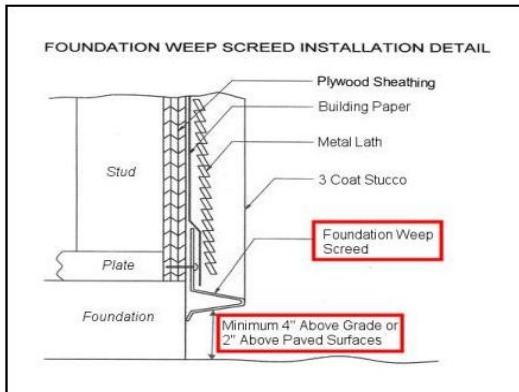
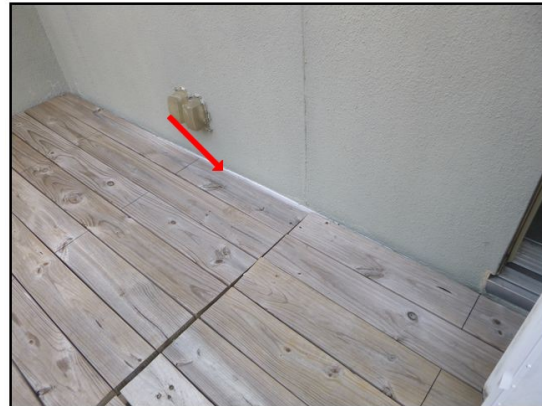
Inadequate space and / or missing weep screed at base of stucco. “Corrosion-resistant weep screed or plastic weep screed, with a minimum vertical attachment flange of 3 ½ inches shall be provided at or below the foundation plate line on exterior stud walls in accordance with ASTM C 926. The weep screed shall be placed a minimum of 4 inches above the earth or 2 inches above paved areas and shall be of a type that will allow trapped water to drain to the exterior of the building.” (Ref: IRC 2003 Section R703.6.2.1 Weep screeds).

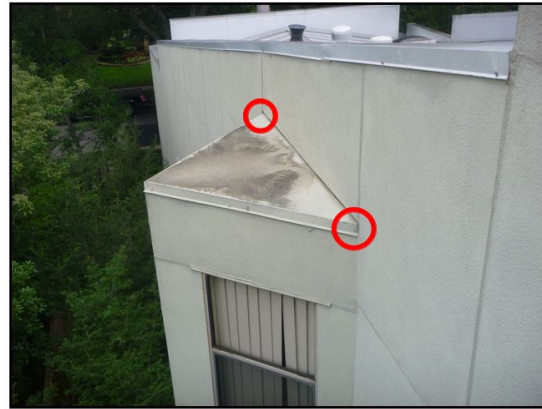
Did not observe "kick out" flashing where a roof / balcony terminates along a vertical wall. This flashing encourages rain water running down roof / balcony to be diverted / "kicked out" away from wall and reduce chance of water penetration behind wall.

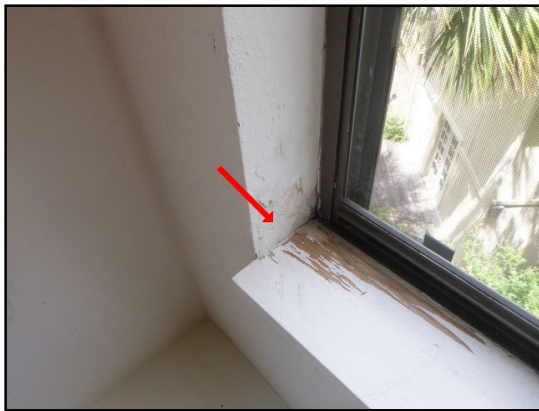
Water stains observed at multiple interior window jambs.

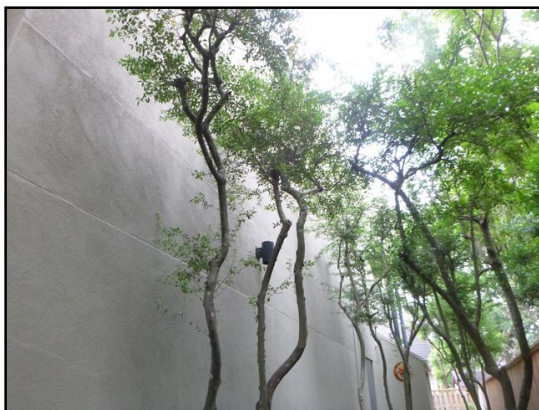
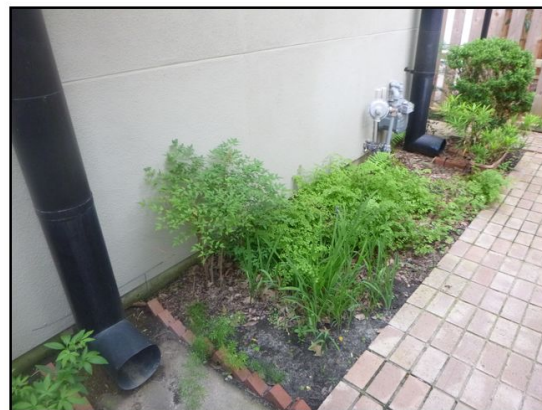
Bushes / trees / vines / foliage should not contact the stucco, holds moisture / insects against siding and can damage the protective stucco finish.

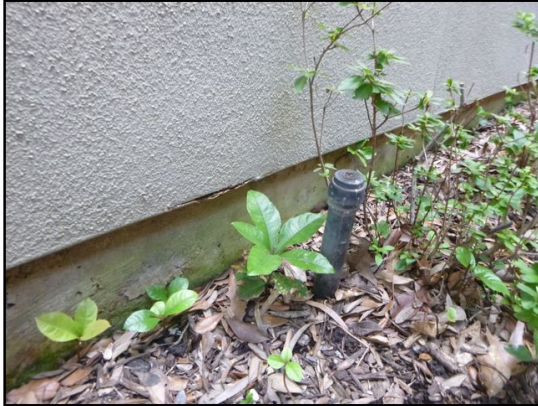
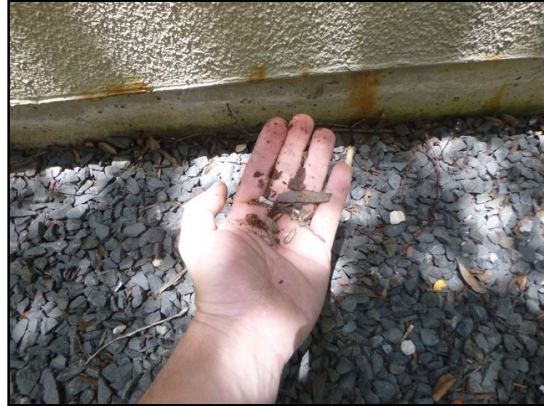
Recommend adjusting sprinkler heads away from spraying onto house and below stucco wall. Some deteriorated/soft substrate could be felt at the base of the stucco.

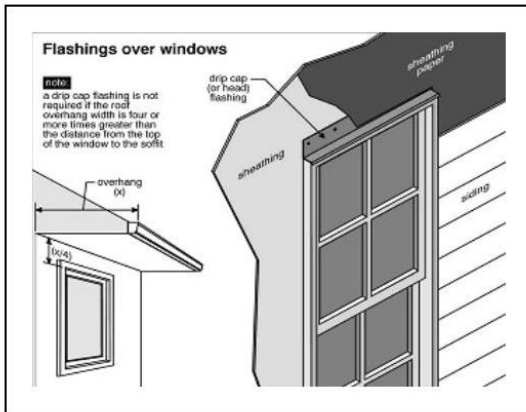
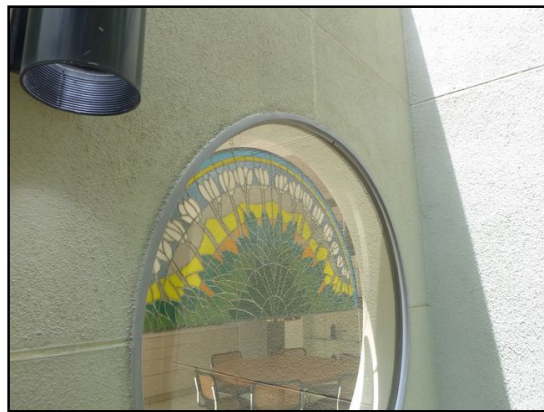
Did not observe head flashing over some windows / doors. Head flashing helps prevent water penetration. Without head flashing windows/ sealing must be maintained as the only defense against water penetration.
