## ***PROPERTY INSPECTION REPORT***

**Prepared For:** Erick & Mara Calderon  
(Name of Client)

**Concerning:** 2135 Quenby Street, Houston, TX 77005  
(Address of Inspected Property)

**By:** Jason Fielding, TREC; PI 21810 05/27/2021  
(Name and License Number of Inspector) (Date)

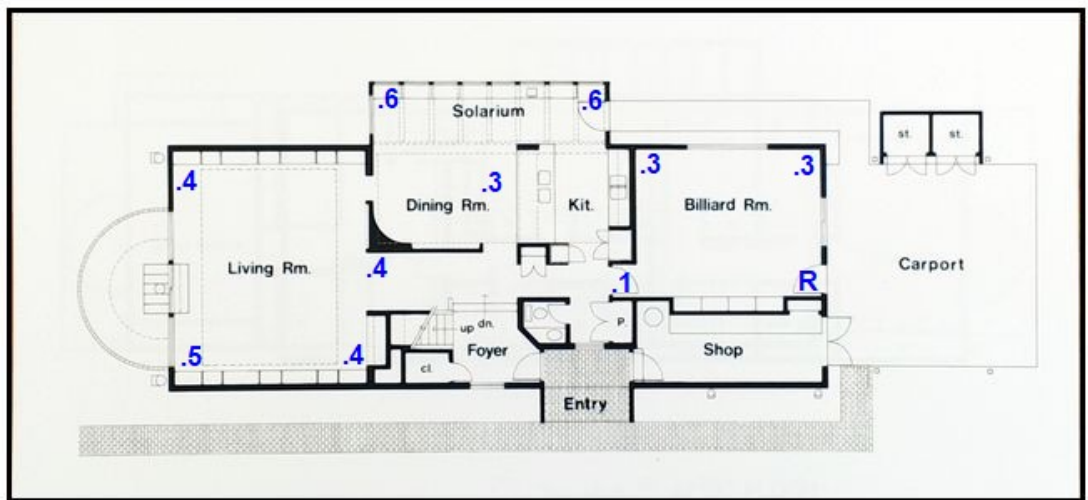
A foundation elevation survey was conducted during the inspection. The floorplan below represents data gathered using a Zip Level or similar instrument and adjusting for floor covering height differences. i.e. differences between tile, carpet and wood flooring(except step down to garage). Measurements are listed to the nearest 1/10th of an inch. Greatest variance was .6 "

*Performing intended function. No evidence suggesting significant foundation movement at time of inspection.*

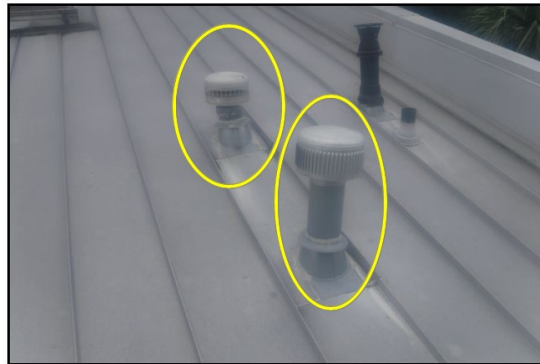
Flashing needs to be sealed/caulked at the following location(s): paint exposed metal flashing at roof level to prevent future corrosion.

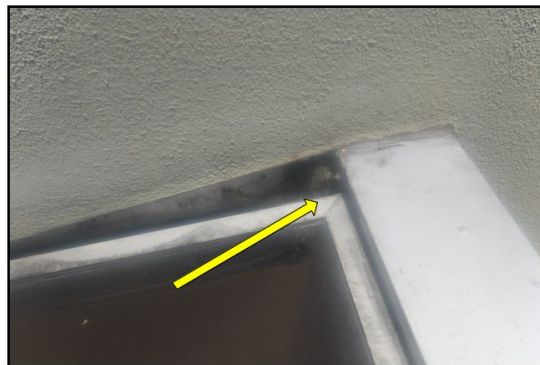
**Roof water penetration observed at the following location(s): near large skylights above loft room and near roof deck access door.**

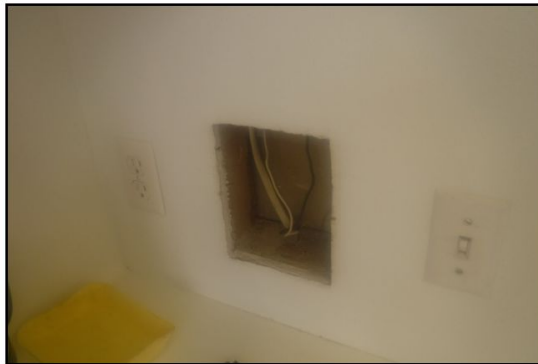
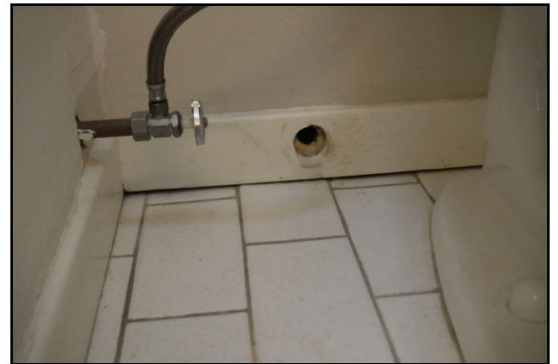
Water stains, damage or repairs observed, moisture detection equipment indicated that stains are not active (wet) at the time of inspection; solarium counter.

Recommend sealing all holes in interior walls to reduce air and water infiltration; kitchen counter, master bath.

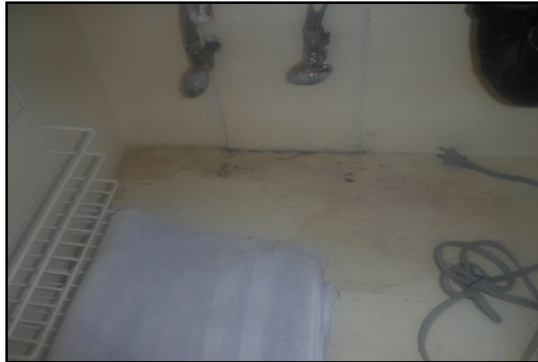
*Water damage to the base of the cabinet below the sink.*

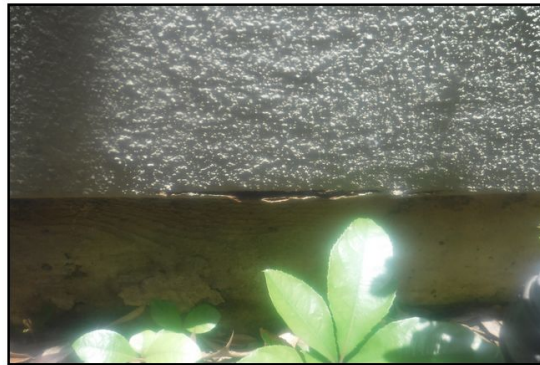
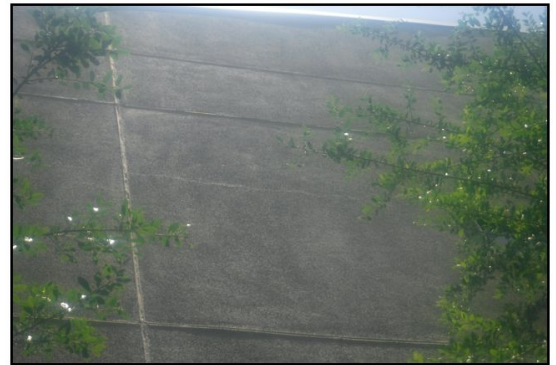
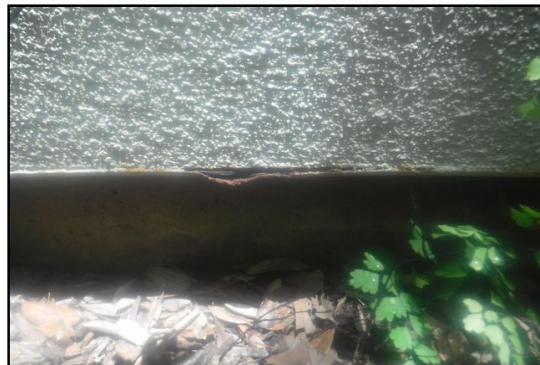
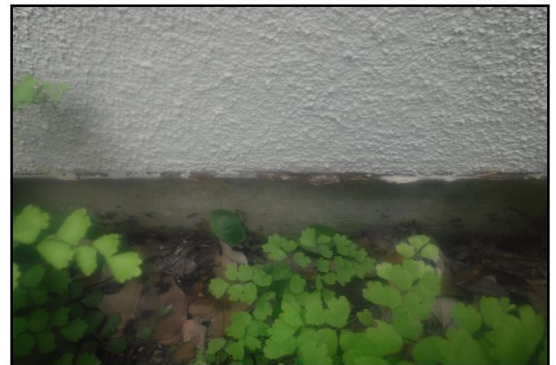
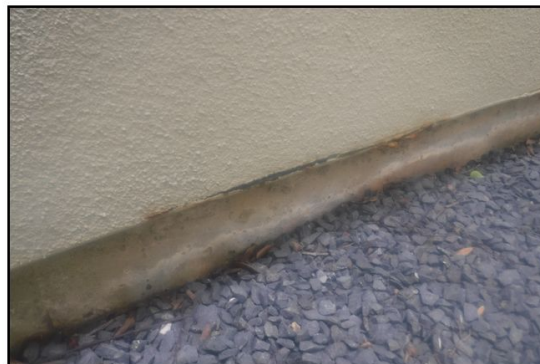
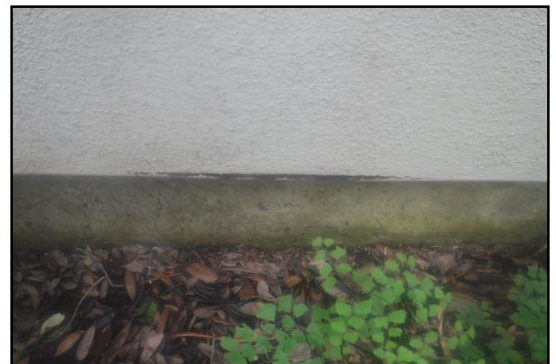
**Recommend additional stucco intrusive inspection be conducted to rule out the possibility of unseen/undetected/latent/hidden water damage behind areas of the stucco exterior. Sections of the exterior appear to be traditional hard coat / cement-based stucco. A limited visual inspection by this inspector has created concerns regarding the possibility of latent damage from water penetration behind the stucco at one or more locations that can only be verified by drilling / intrusive testing. Recommend the client contact our office or another third party stucco inspector of your choice before the expiration of any option period to conduct an intrusive stucco inspection.**

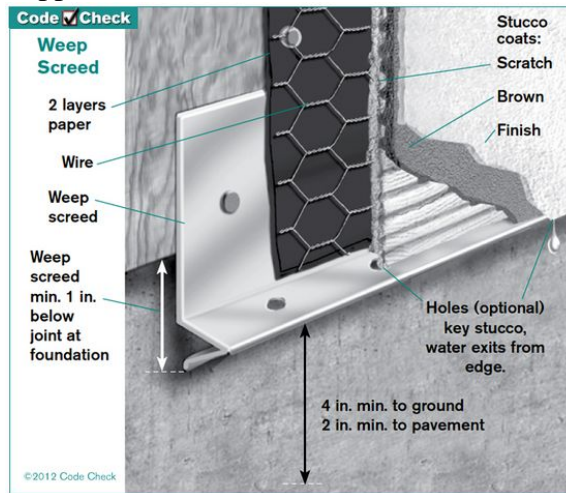
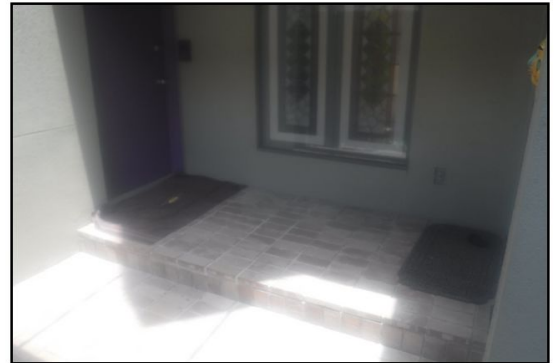
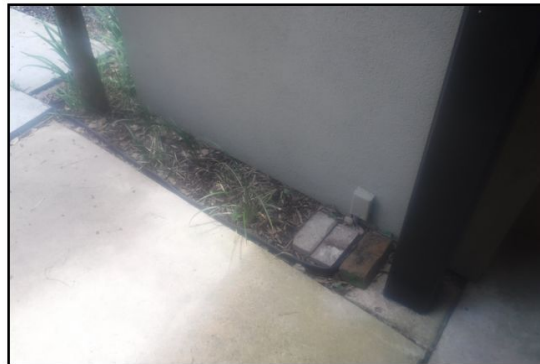
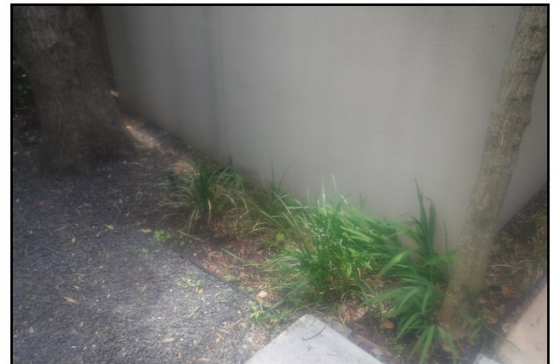
Inadequate space and/or missing weep screed at the base of the stucco. “Corrosion-resistant weep screed or plastic weep screed, with a minimum vertical attachment flange of 3 ½ inches shall be provided at or below the foundation plate line on exterior stud walls per the ASTM C 926. The weep screed shall be placed a minimum of 4 inches above the earth or 2 inches above paved areas and shall be of a type that will allow trapped water to drain to the exterior of the building.” Per IRC R703.6.2.1.

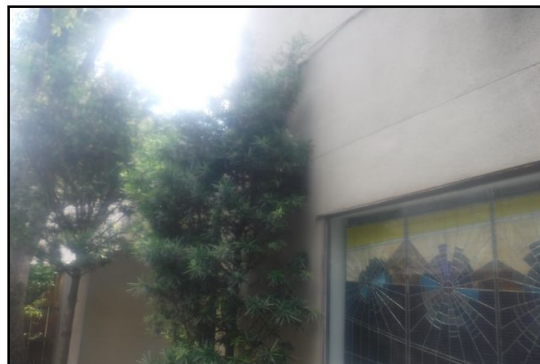
Bushes/trees/foliage should not contact the stucco siding of the house which can and will damage the protective stucco finish.

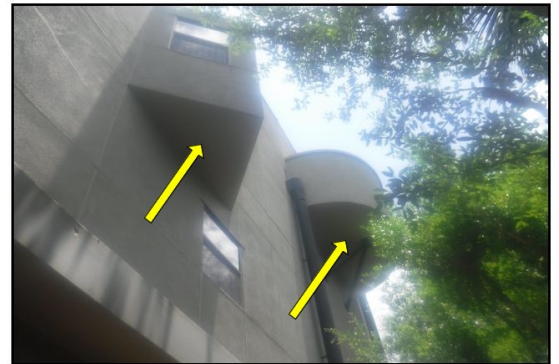
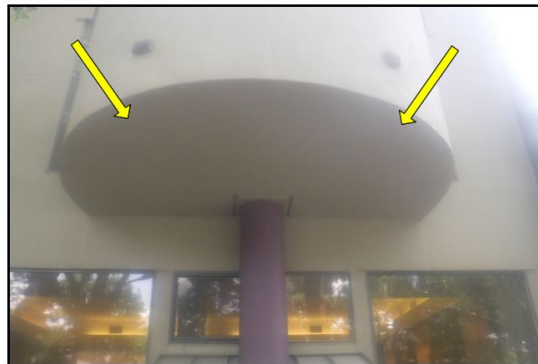
Did not observe weep screed at bottom of the stucco wall, where it intersects with the soffit. The following diagram depicts a “best practice” procedure as defined in the Texas Lathing and Plastering Contractors Association (TLPCA) Stucco Resource Guide. This detail provides a means for moisture to exit from behind the stucco if the wall assembly leaks (we seldom see a weep screed at these locations on most stucco homes/buildings). If this exhibits a problem with moisture collecting in this area, a weep screed should be installed.

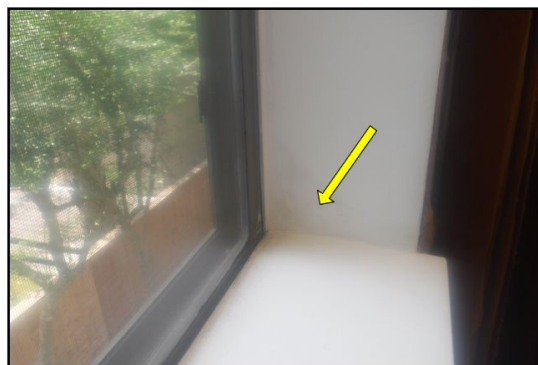
Water stains/damage to the interior of one or more window jambs. Moisture meter indicated that the stains were not active (wet) at the time of inspection.

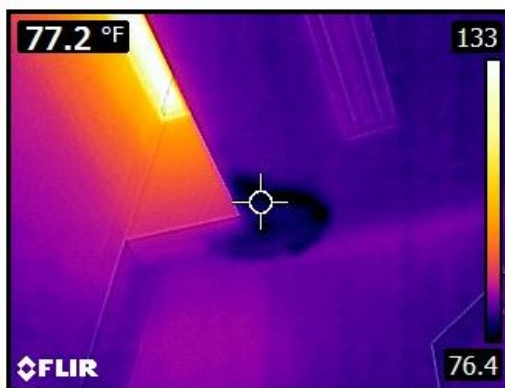
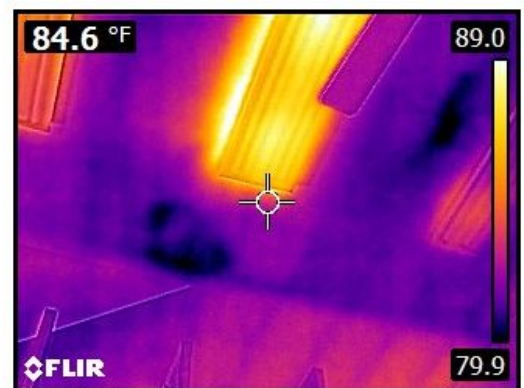
**Moisture meter registers water stains as active (wet); under skylights in loft room, under terrace door in loft room.**

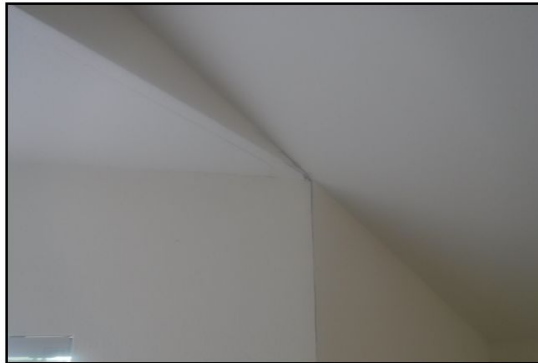
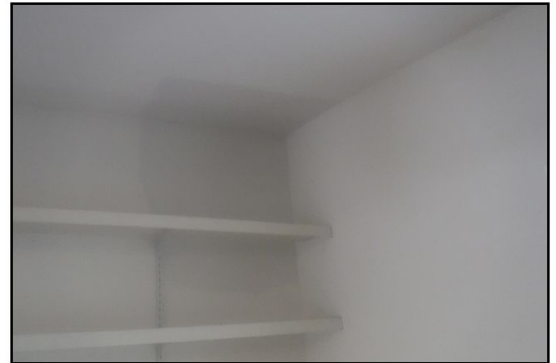
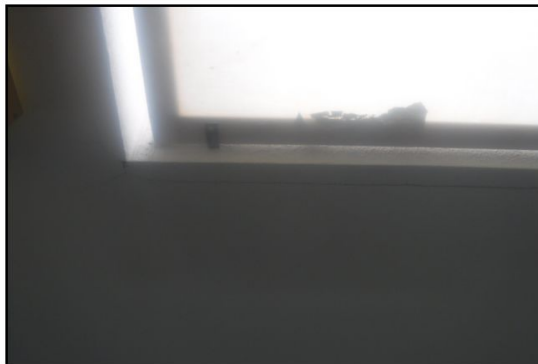
Water stains, damage or repairs observed, moisture detection equipment indicated that stains are not active (wet) at the time of inspection; multiple areas on 3rd floor, in shop area, 2nd floor master bedroom.

Observed cosmetic cracks and/or repaired cracks in sheetrock observed in ceiling at one or more areas of house.

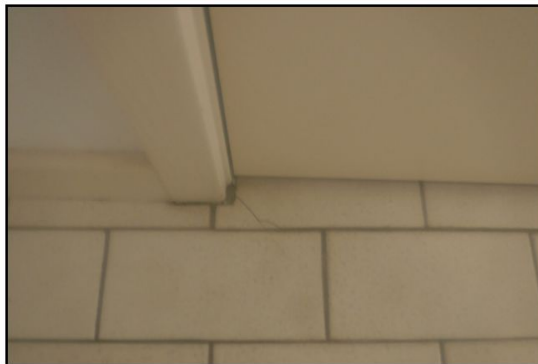
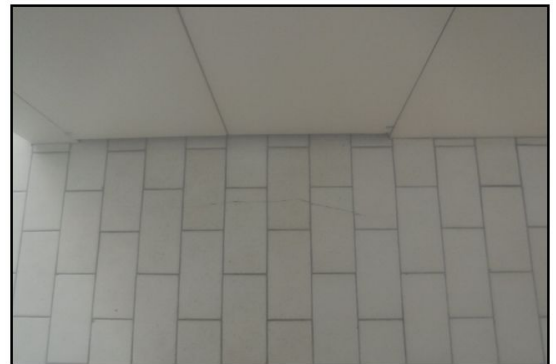
Cracked/chipped and/or loose floor tile observed; 1st floor tile.

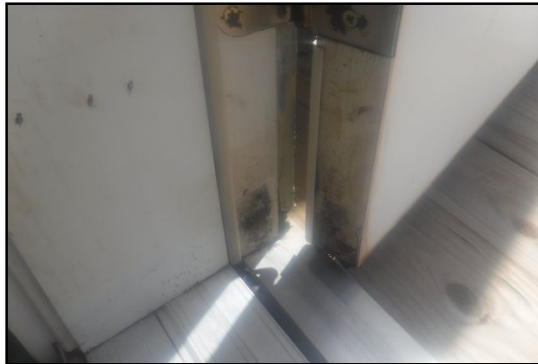
Wood rot of lower door and/or jamb; roof deck access door.

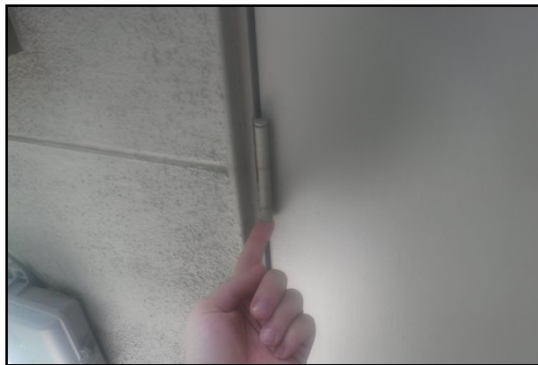
Security consideration; hinges mounted on the outside of the exterior door(s), makes an easy target for removal of the door for unauthorized entry.

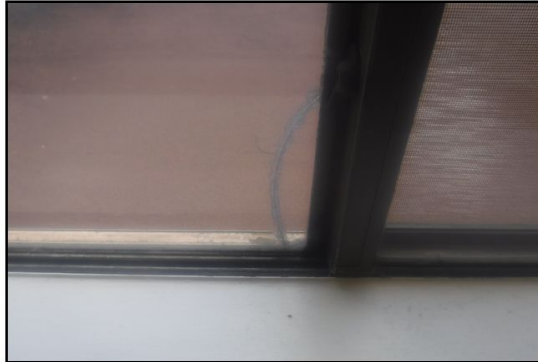
One or more windows had cracked/broken glass pane(s); loft room window.

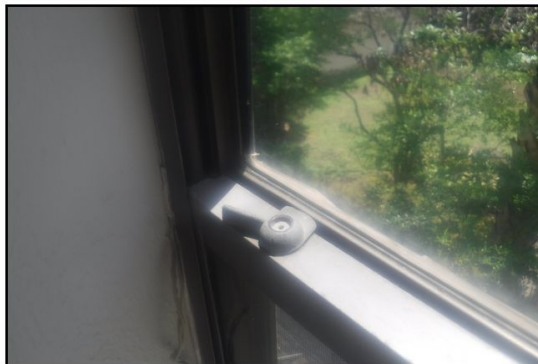
One or more window locking latches were broken and/or difficult to operate.

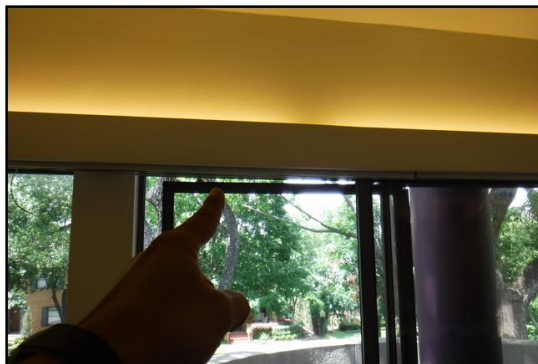
Sliding screen door damaged.

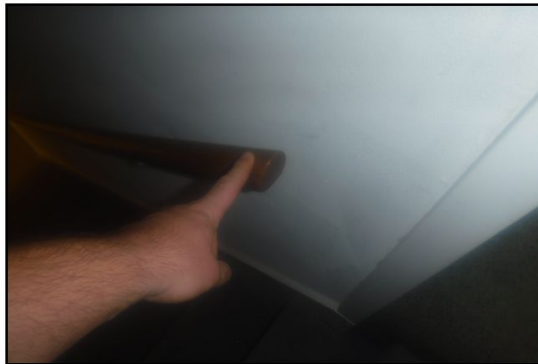
The ends of the handrail(s) do not return to the wall. This condition may allow loose articles of clothing to catch on ends of handrail while using stairs and result in a trip/fall mishap.

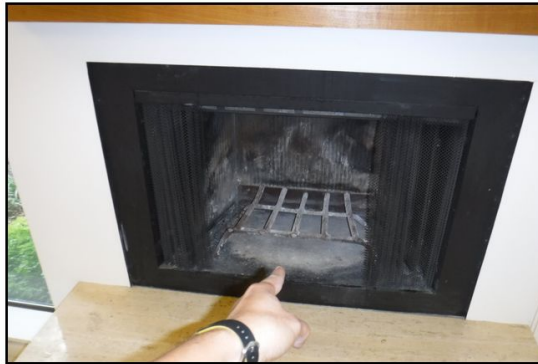
Voids or cracks observed in firebox, recommend repair before use.

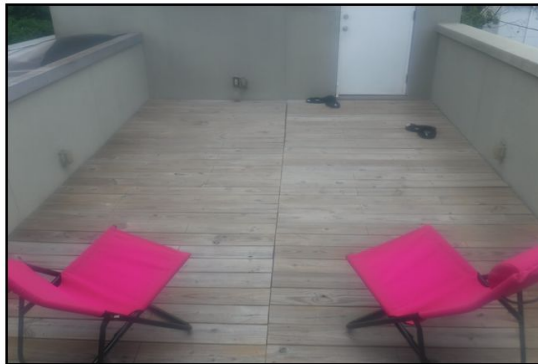
Paint or seal exposed wood at terrace.

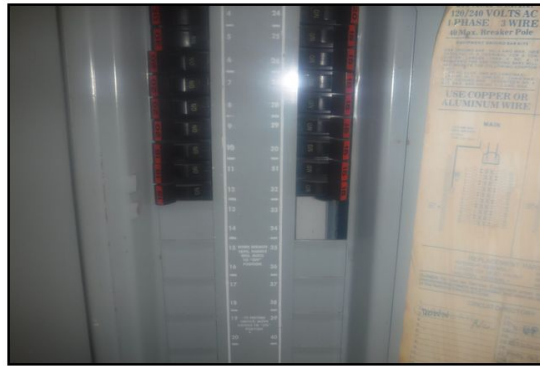
Missing one or more knockout cover(s).

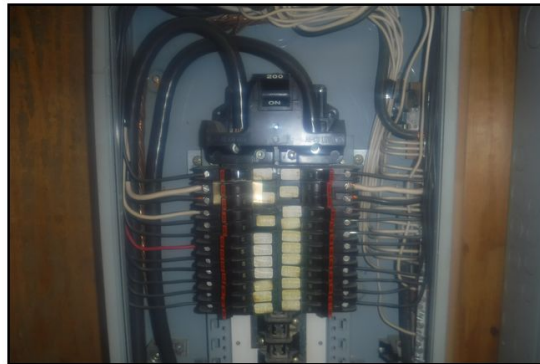
The brand of the electrical service panel is Federal Pacific. This make of panel is known for difficult to find and more costly to replace breakers. Also, this panel is associated with a higher incidence of failures/safety problems. If additional information is needed, recommend a qualified electrician be consulted. Replacement of panel recommended as an upgrade/safety improvement.

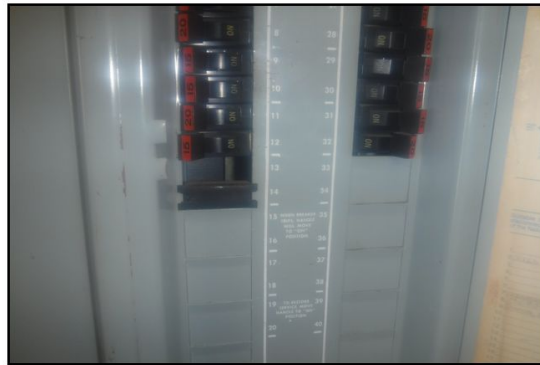
**Missing one or more knockout cover(s).**

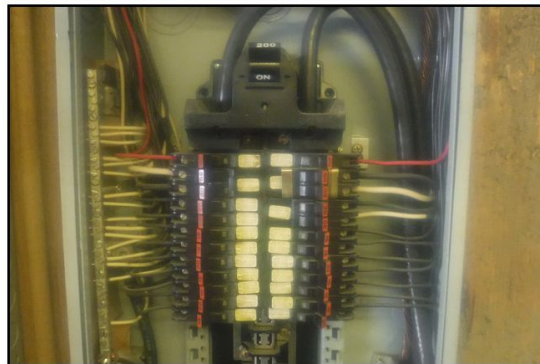
The brand of the electrical service panel is Federal Pacific. This make of panel is known for difficult to find and more costly to replace breakers. Also, this panel is associated with a higher incidence of failures/safety problems. If additional information is needed, recommend a qualified electrician be consulted. Replacement of panel recommended as an upgrade/safety improvement.

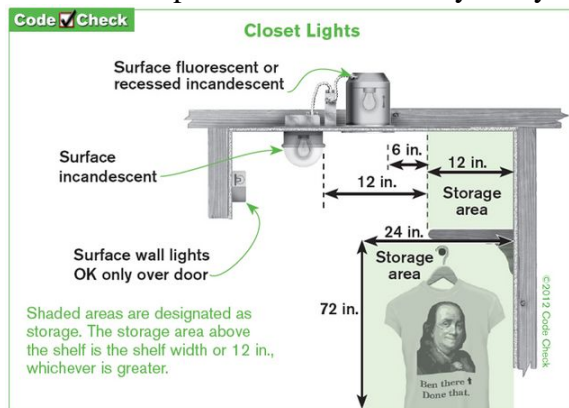
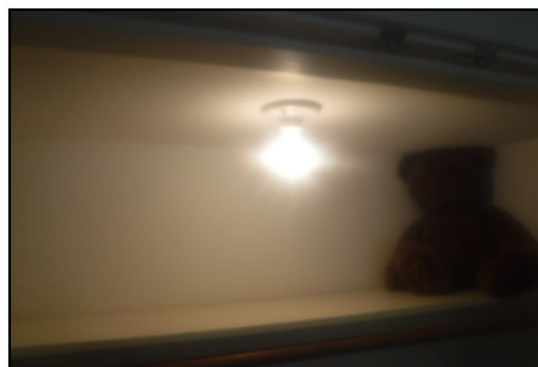
Observed open incandescent type light fixtures in one or more closets which are considered a potential fire hazard by today's standards. Per IRC 3903.11.

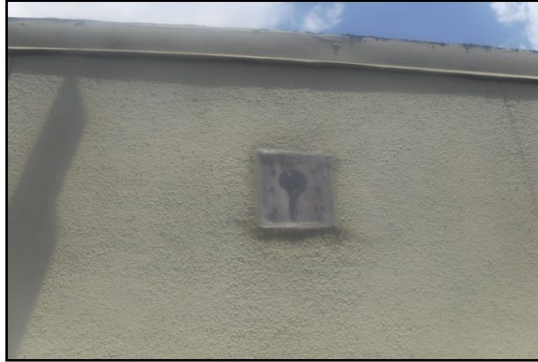
One or more light fixtures not present; roof top terrace.

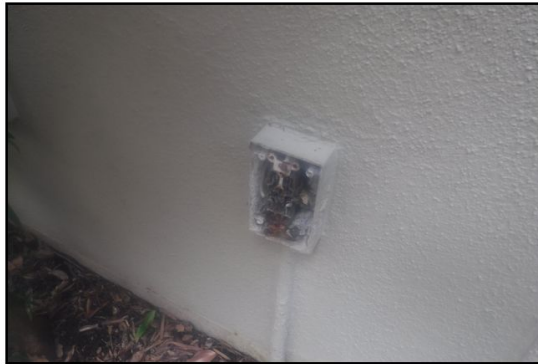
Exterior outlet damaged, missing weatherproof cover; E exterior wall.

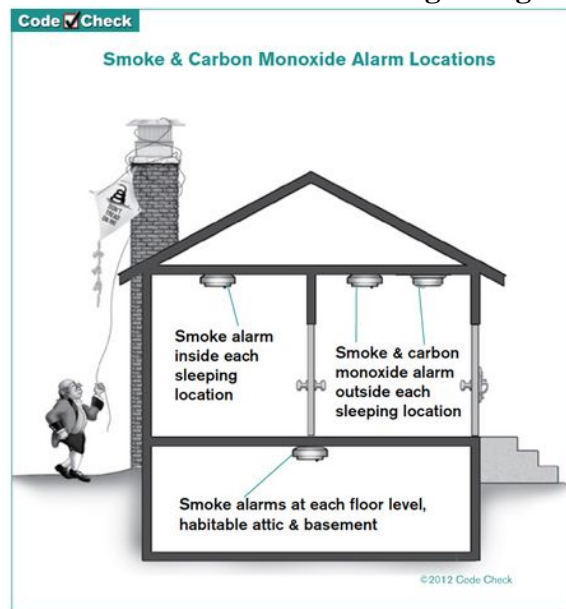
**There appears to be an inadequate number and/or improper location of smoke detectors in the home. Smoke detectors should be located on each level of the home as well as inside AND outside of all sleeping rooms. Consult the smoke detector manufacturer's instructions regarding the specific placement of detectors.**

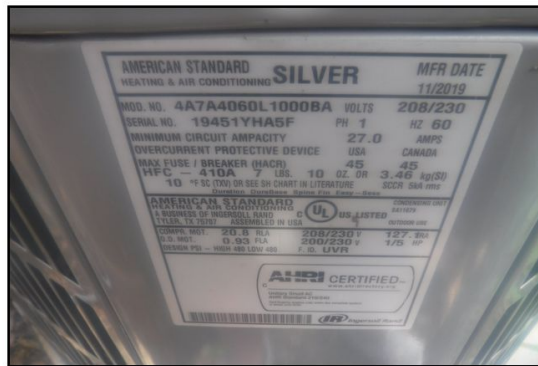
**CONDENSING UNIT: 1ST FLOOR AMERICAN STANDARD 5 TON**

**Recommend qualified/licensed HVAC technician service/repair/replace as needed. Not cooling well.**

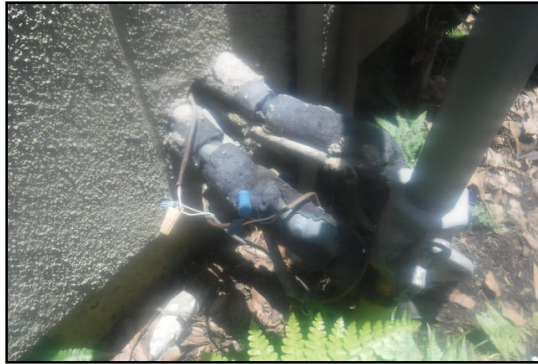
Section of suction line insulation missing or deteriorated near the condenser.

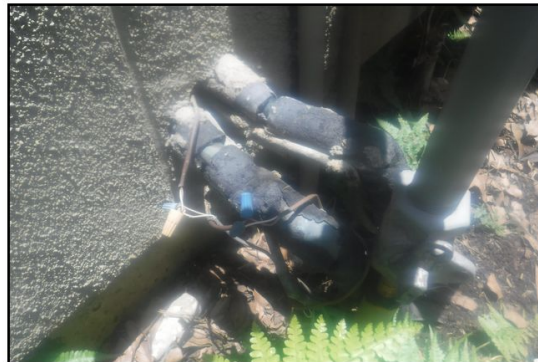
Section of suction line insulation missing or deteriorated near the condenser.

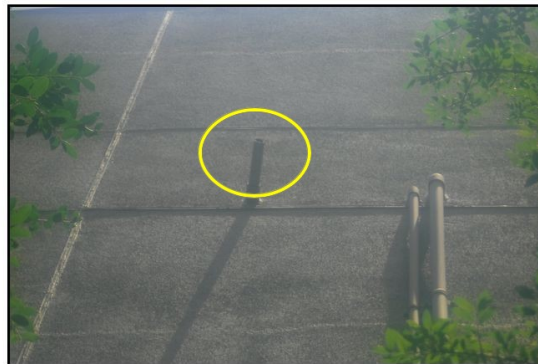
Missing 90-degree elbow fitting on end of emergency drain line to prevent condensation dripping back onto the exterior wall.

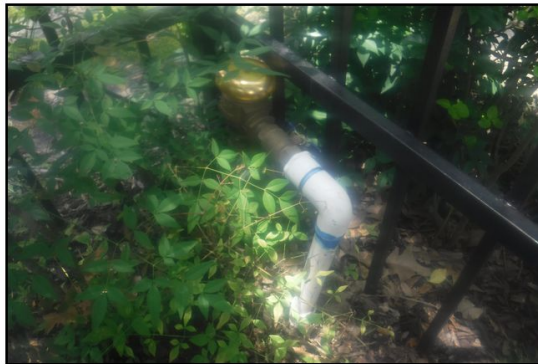
Recommend insulating exterior water line(s) to prevent freeze damage.

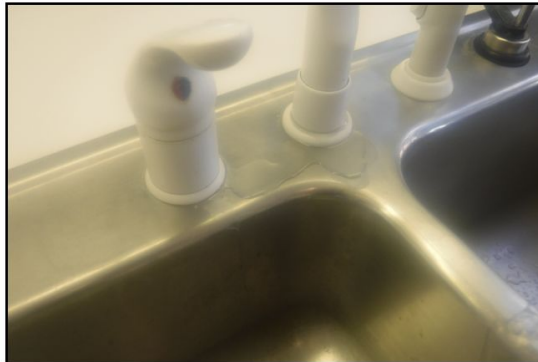
Leaks at base "O" rings, and/or stem washers; kitchen sink.

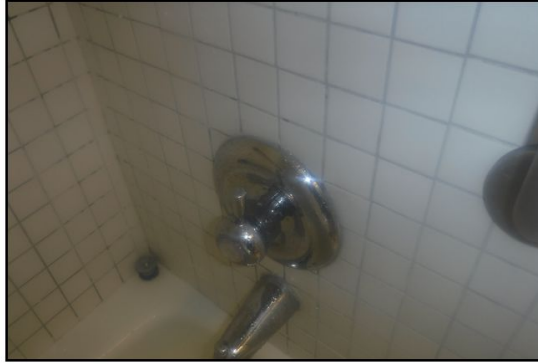
Recommend caulking around all tub/shower faucets and spouts to prevent water entry behind the wall.

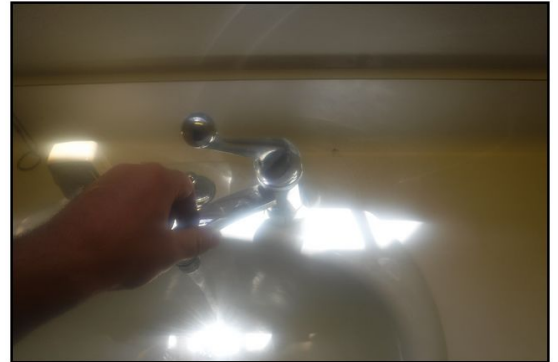
Handle(s) loose; laundry sink, 2nd floor guest bath.

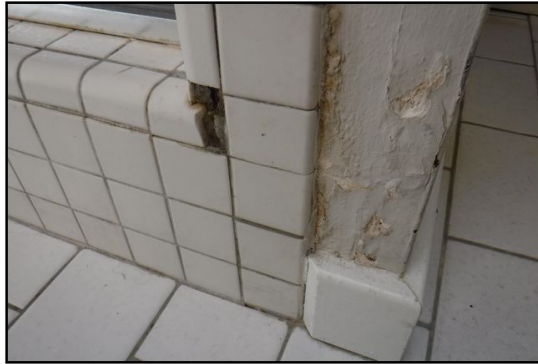
Observed cracked tiles; master bath.

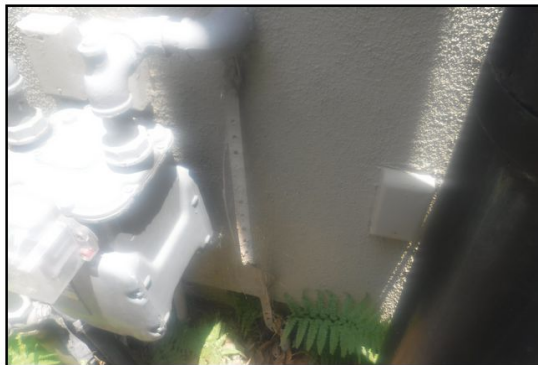
Ground rod/wire missing or damaged at the gas meter.

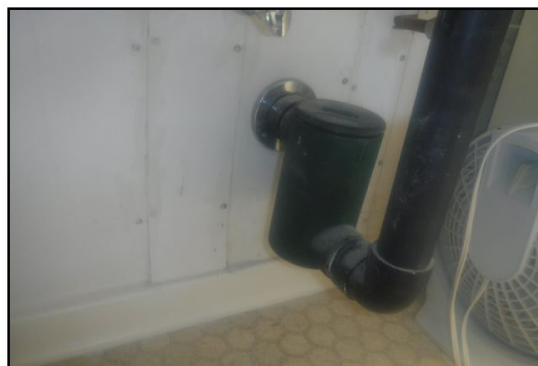
Improper trap observed; at loft room deep sink.

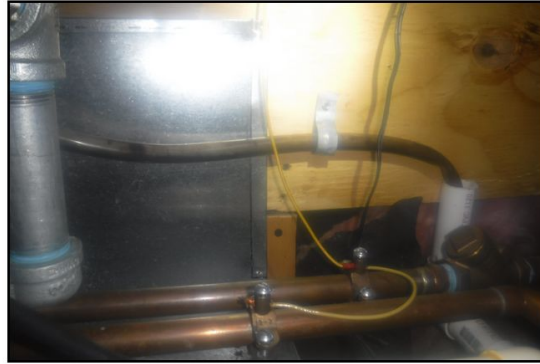
Missing condensate neutralizer at drain line.

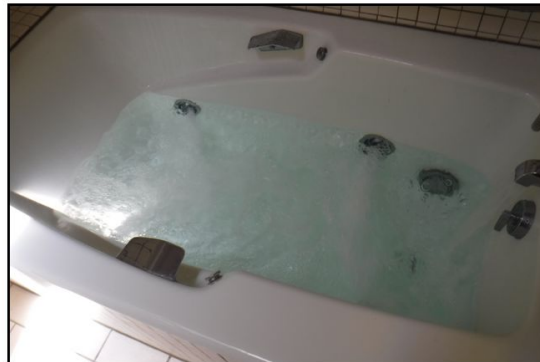
The motor was not accessible for visual inspection. Inaccessibility does not fully comply with the National Electric Code (Reference NEC 680-72. Accessibility. "hydromassage bathtub electrical equipment shall be accessible for repair/replacement without damaging the building structure or building finish".) Should have access panel installed for servicing/access to pump motor IRC 4109.3.

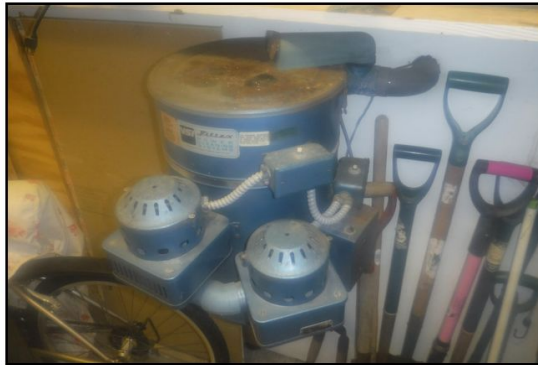
**The unit has exceeded its normal serviceable life; budget for repair or replacement.**

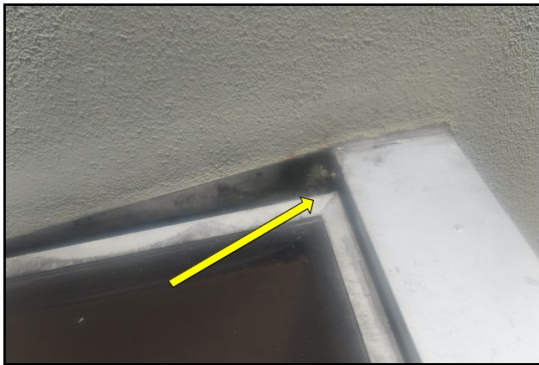
**Roof water penetration observed at the following location(s): near large skylights above loft room and near roof deck access door.**
