Inspection Report

PROPERTY INSPECTION REPORT

16211 Townes Rd, Friendswood, TX 77546

Tony Ngo - TREC License # 22826 8/6/2020

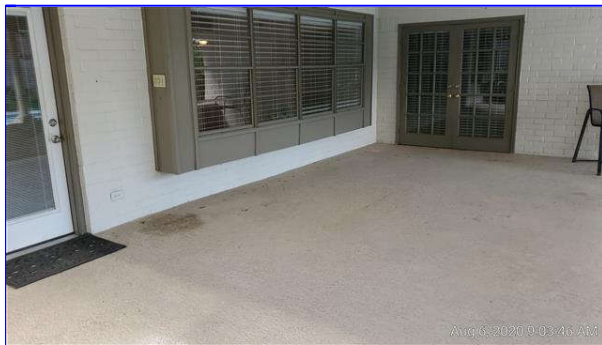
A. Item 1(Picture)

- The home was observed to have concrete flatwork (porches, driveways, pool deck and sidewalks) that is comparatively higher than normal in relation to the floor level of the home. These conditions can be a water penetration hazard to the home in heavy rains. It is important to provide clear and adequate drainage from these areas. Consideration to these conditions should be given when installing landscaping near the concrete flatwork. Installing gutter to direct roof run off away from this area may also be helpful.

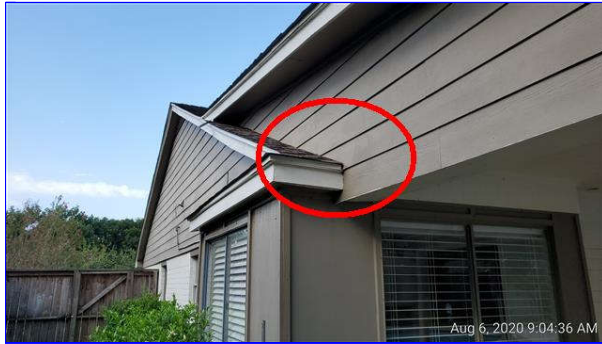
C. Item 14(Picture)

- Kick out flashings were observed to be missing. Kick out flashings should be installed to help direct the water away from the home. Bent counter flashing is not a substitute for proper kickout flashings. A qualified, verified roofing contractor should be consulted regarding repairs.

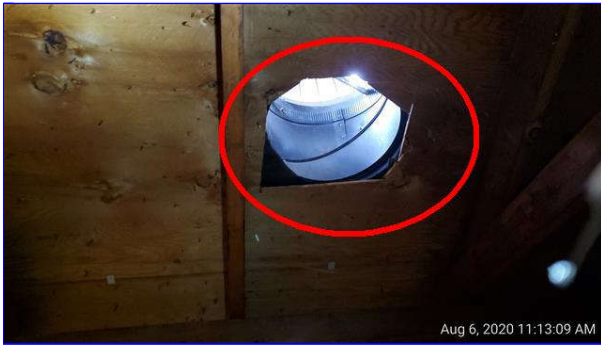
D. Item 8(Picture)

- The turbine fan operates, but was/were observed to have the following defect(s): noisy.

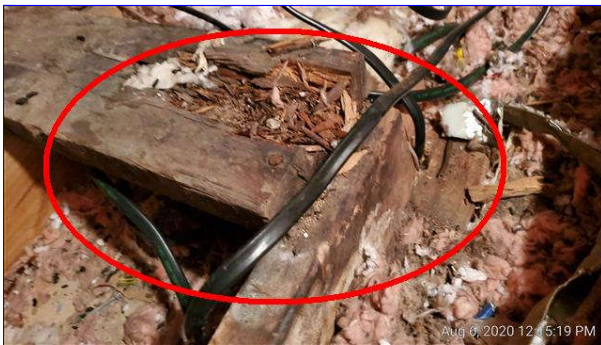
D. Item 20(Picture)

- Ceiling joists were observed to be damaged or deteriorated. The inspector recommends that the structural supports be further evaluated and repaired as needed by a certified, licensed foundation specialist.

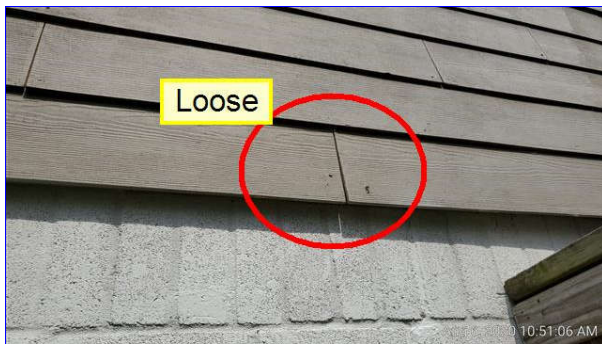
E. Item 6(Picture)

- The siding and trim, in various locations, were observed to have the following defects: damaged, detached, in poor condition and needs improvement. This condition could lead to moisture intrusion into the home. While it could not be verified, there may be concealed damage to the underlying structure. A qualified exterior contractor should be consulted regarding repairs.

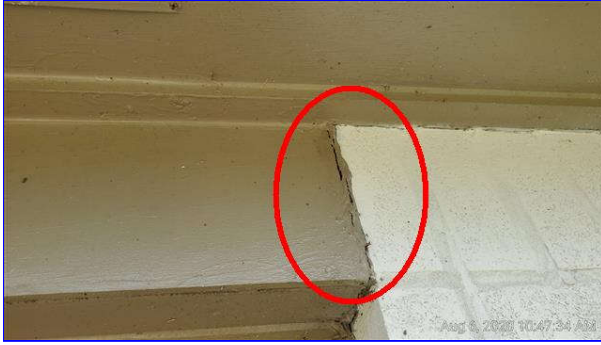
E. Item 7(Picture)

- Caulking at the exterior penetrations into home, in various locations, was/were observed to be in poor condition and needs improvement.

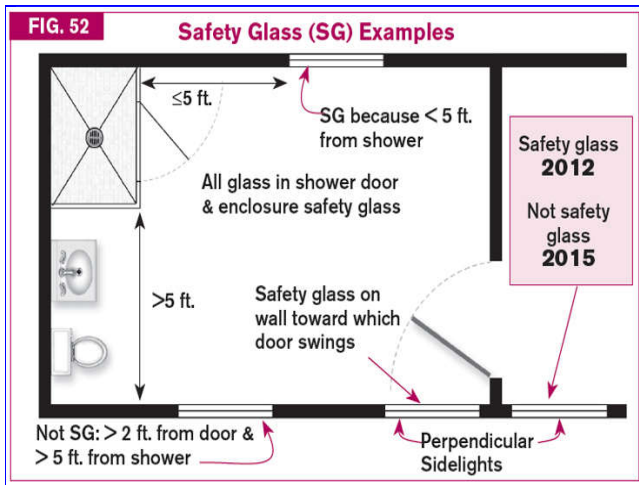
H. Item 3(Picture) Bathroom Safety Glass

- Safety glass is needed at the shower. Proper glazing should be installed to prevent potential safety hazards.

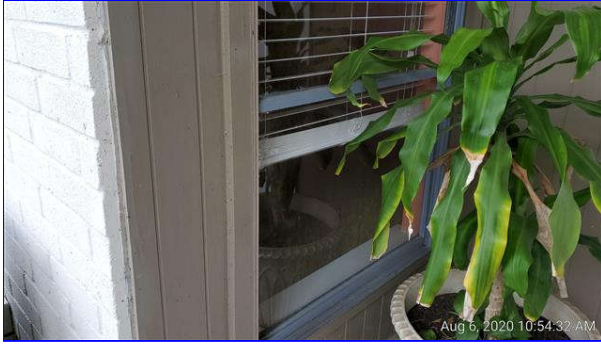
H. Item 4(Picture)

- One or more window screens were observed to be missing or damaged. Repair or replacement is needed.

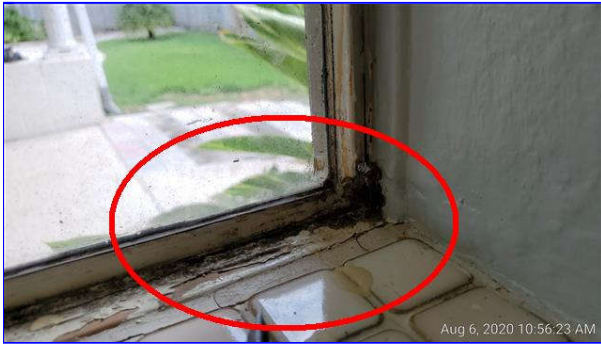
H. Item 5(Picture)

- Several windows in various locations were observed to have the following defect: evidence of leaks. The windows should be repaired as needed.

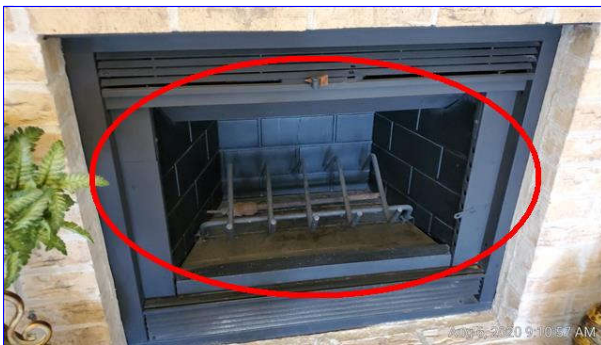
J. Item 5(Picture)

- The fire screen was observed to be missing. This is a safety concern and is a potential fire hazard. Screens are used to keep organic materials from leaving the fire box area and causing burns or fires. Fire screen should be replaced prior to using the fire place.

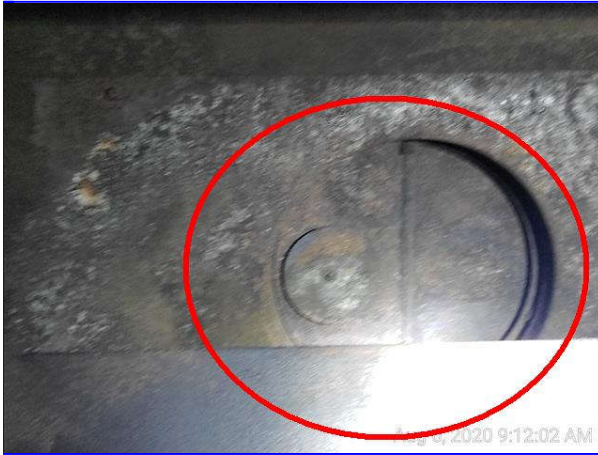
J. Item 6(Picture)

- The fireplace does not have damper stop installed. Damper stops are needed for fireplace burning hydrocarbon fuels to assure carbon monoxide fumes are vented out of the home.

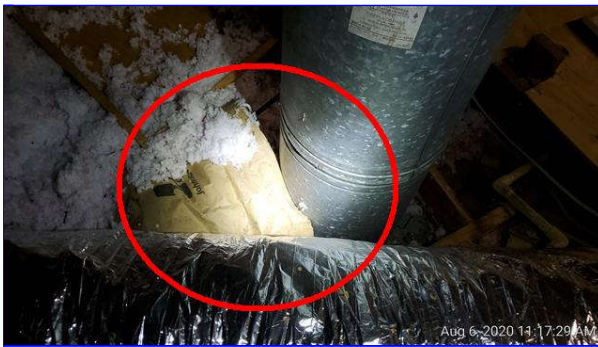
J. Item 8(Picture)

- One or more flue vents are in contact with or does not have adequate clearance from combustibles. A minimum of 1" clearance is required per manufacturer instructions. Adjustment is needed to prevent possible safety hazards such as fire.

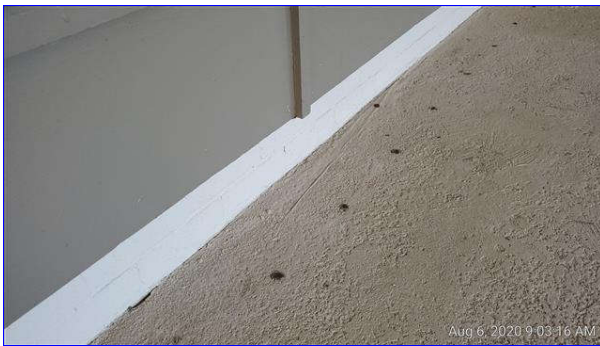
L. Item 17(Picture)

- Evidence of possible active, previous activity and/or evidence of previous treatment of a wood-destroying insect was detected at the time of this inspection. Full evaluation of the amount of damage caused by the insects cannot be detected within the wall voids or other hidden areas without defacing the property and cannot be addressed in this inspection report. With the detection of active or previous activity of a wood destroying insect, it should be assumed that some degree of damage is present. A licensed pest control specialist should be consulted for further investigation of this condition.

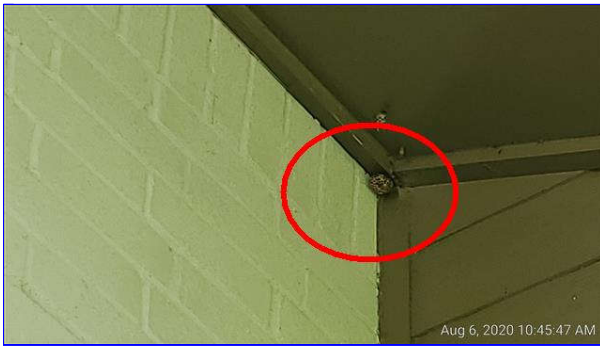
L. Item 20(Picture)

- Excessive number of a wasp like insect was observed in various locations of the home. A qualified, verified, licensed pest control specialist should be consulted regarding this condition and possible treatment.

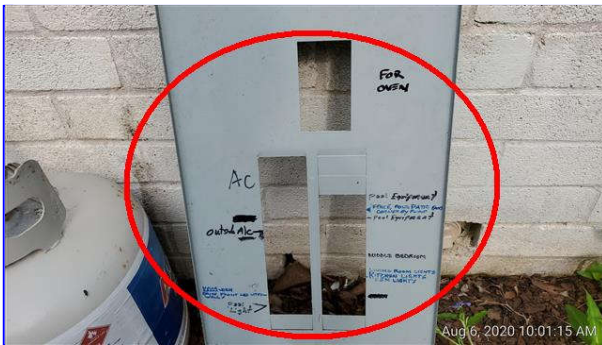
A. Item 10(Picture)

- Some labels are present, but are illegible or confusing. Without proper labelling the inspector cannot determine the proper amperage for appliances such as the HVAC condensing unit(s). I recommend correcting for safety reasons.

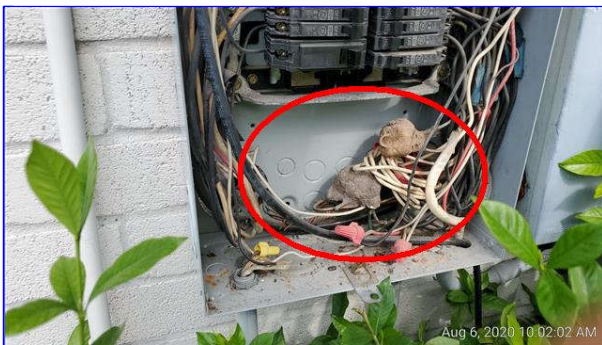
A. Item 11(Picture)

- Wasp's nest was observed in the panel. When debris is present, it is mostly likely due to excessive openings in the panel. Excessive openings should be sealed to prevent further intrusion into the panel. The panel enclosure may also need to be caulked at the wall, top and sides, while leaving the bottom open for moisture relief. Repairs should be made.

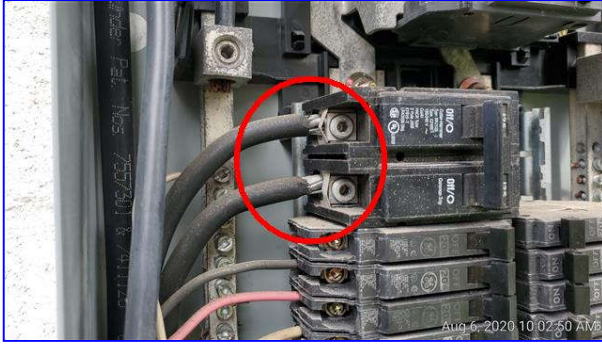
A. Item 13(Picture)

- Cable was observed to have the sheathing cut back too far, over exposing the conductor. Sheathing should not be cut more than a 1/4" from the connection to the breaker.

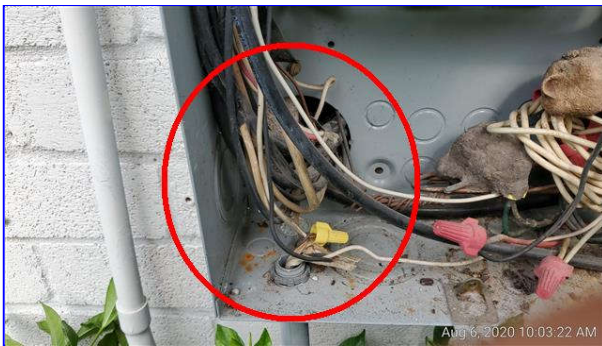
A. Item 15(Picture)

- Missing bushings to protect wiring were observed at the main panel enclosure. Bushings should be installed to prevent damage to the wiring.

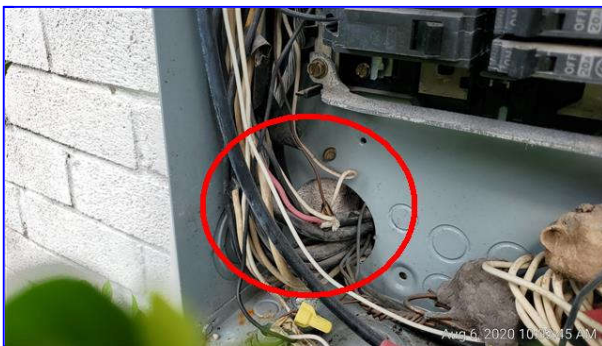
A. Item 17(Picture)

- Excessive openings were observed at the electrical panel. This condition is a safety hazard. These openings should be sealed or adjustments made to close them.

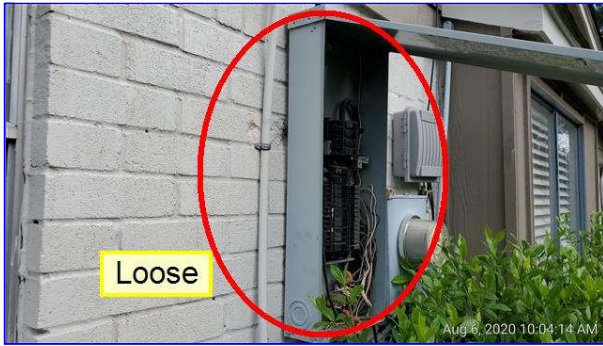
A. Item 18(Picture)

- The main panel enclosure is loose on the wall. The enclosure should be properly secured.

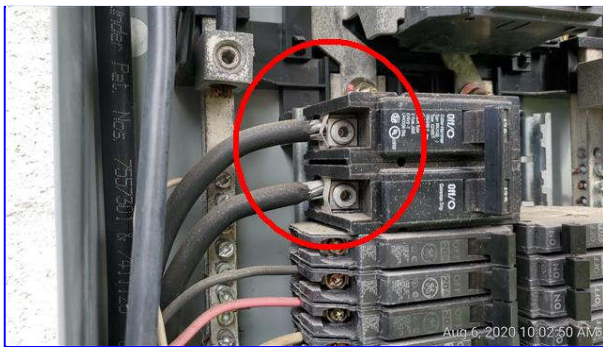
A. Item 19(Picture)

- The aluminum feeder wires are not coated with anti-oxidant paste to prevent corrosion.

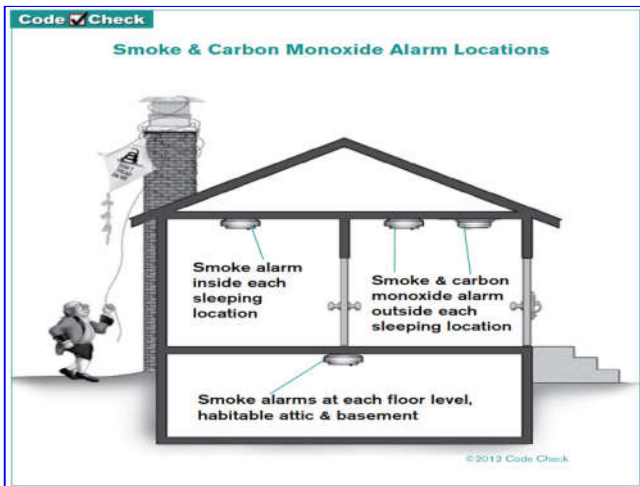
B. Item 5(Picture) Alarm Required Locations

- Smoke detectors were observed to have the following defect: are not installed in all of the bedrooms. Smoke detectors are critical to occupant safety and should be repaired as needed. By current standards smoke detector are required in each sleeping area, in the vicinity outside the sleeping area, and one each inhabitable level of the home. Smoke detectors in newer homes are required to be hard wired to the electrical system, have battery backup, and be interlinked to activate all smoke detectors in the home if one is activated. All smoke detectors should have batteries replaced upon moving into the home. This ensures all batteries are new and in working order.

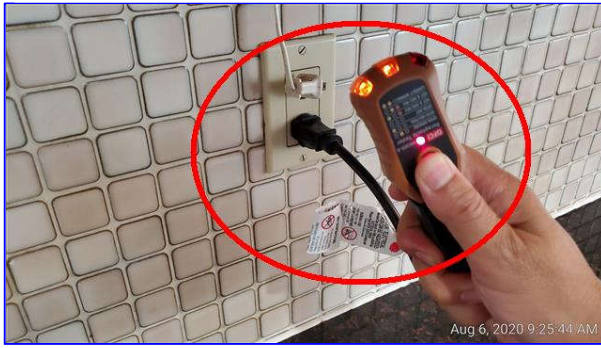
B. Item 6(Picture)

- Numerous receptacles in required locations, kitchen countertops, kitchen island, bathrooms, exterior, garage and/or within six feet of a sink, are not ground fault circuit interrupt (GFCI) protected. This condition is a safety hazard that should be repaired.

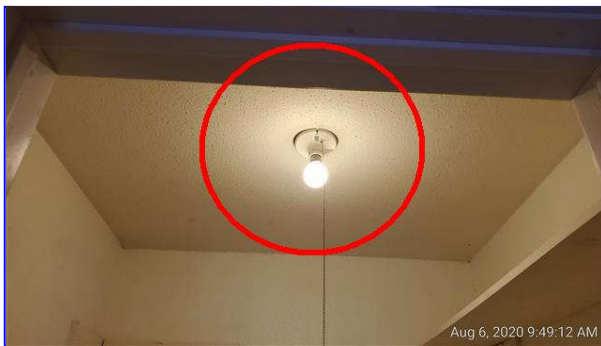
B. Item 10(Picture)

- Light fixtures at closets in various locations should have shade or globe installed. This condition is a potential fire hazard.

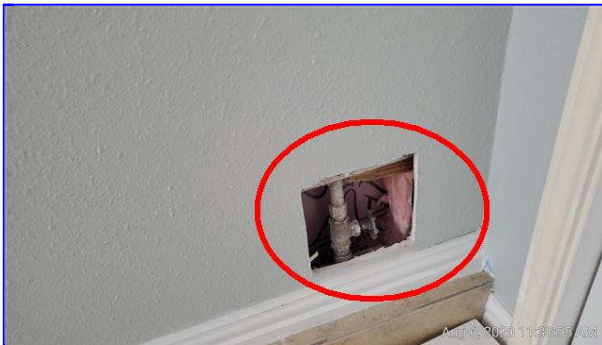
A. Item 2(Picture)

- The supply valve to the home is located in the formal garage. This is the main shut off to the home. In the event of a plumbing emergency this is where you will shut off the supply of water to the home.

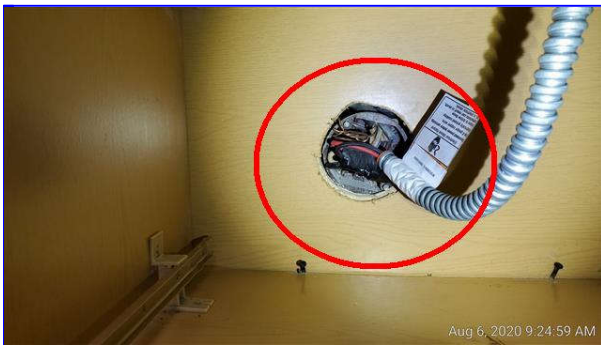
D. Item 5(Picture)

- The cooktop electrical splice that is not placed in a box with cover. I recommend repair as needed.
