SEALY ENGINEERING

September 14, 2018

FOUNDATION INSPECTION REPORT

The residence inspected was located at 2711 Everest Ln., Houston, Texas. The clients for this inspection were Regina and Casey Woods. The residence was not occupied and Casey Woods was present.

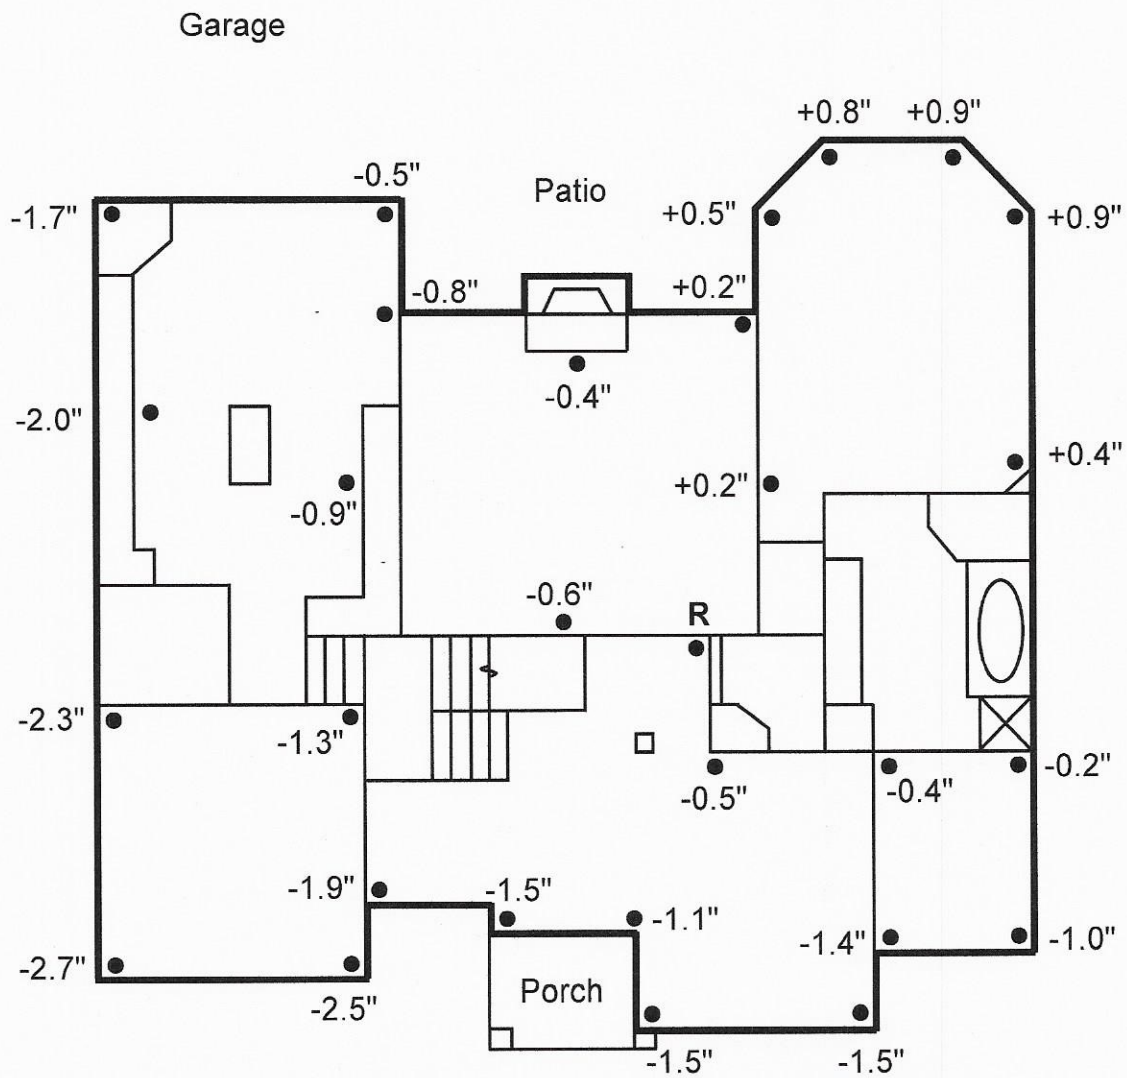
Levels Adjusted For Floor Coverings

The foundation of this residence was observed to be more unlevel than would normally be expected and there was foundation-related damage. The level deviations were measured using an electronic version of a waterlevel, a Ziplevel by Technidea in this case, and the results have been superimposed upon an attached sketch. Compensation was made for variations in the height of the floor coverings so that the measurements shown should reflect the relative height of the top of the concrete slab. From this sketch, it can be seen that the slab was measured to be level within approximately 3.6 inches from the high point to the low point. Based upon my experience, this is more than would normally be expected, with a more typical average usually being in the range of about 1.5". That also is the recommended slab construction tolerance given by the American Concrete Institute. The high area was located in the master bedroom at the north corner of the house and the low area was in the dining room at the south corner. Brick cracks or separations to about $\frac{1}{4}$ inch were noted. Brick lines which could be observed were generally straight within normal limits. Significant sheetrock cracks were not seen. The front door and master bedroom door were slightly misaligned. Almost all of the walls that were checked were tilting in the direction of the foundation slope, which indicates to me that the house was not built in this unlevel condition but has moved since construction.

The drawing at the end of this report is provided to aid in determining the condition of the foundation. "R" on the drawing represents the reference point from which all other level readings are taken and it is arbitrary. Changes in floor coverings such as the transition from carpet to tile etc. are taken into consideration when taking level readings. Taking the largest positive reading and adding the largest negative reading will give the overall levelness of the structure. Generally, when new houses are finished, a certain amount of slope is built in. This slope is generally in the range of 1.5 inches for the average size house. Level readings are valuable not only as a diagnostic tool but can be used as a reference for any suspected foundation movement that may occur in the future. Readings can also verify the stability of a house. Please note that the scale of the drawings can change with faxing or copying of the original sketches.
