Gerard J. Duhan, P.E., #59832
Engineered Foundation Solutions, #F-12259
281-788-7393 gerard@texashomeengineer.com

ENGINEERING OPINION
INVESTIGATION OF FOUNDATION PERFORMANCE
RESIDENCE AT 14907 ALDERWICK DRIVE, SUGAR LAND, TEXAS, 77498
Date of Inspection: March 8, 2023
Date of Report: March 10, 2023

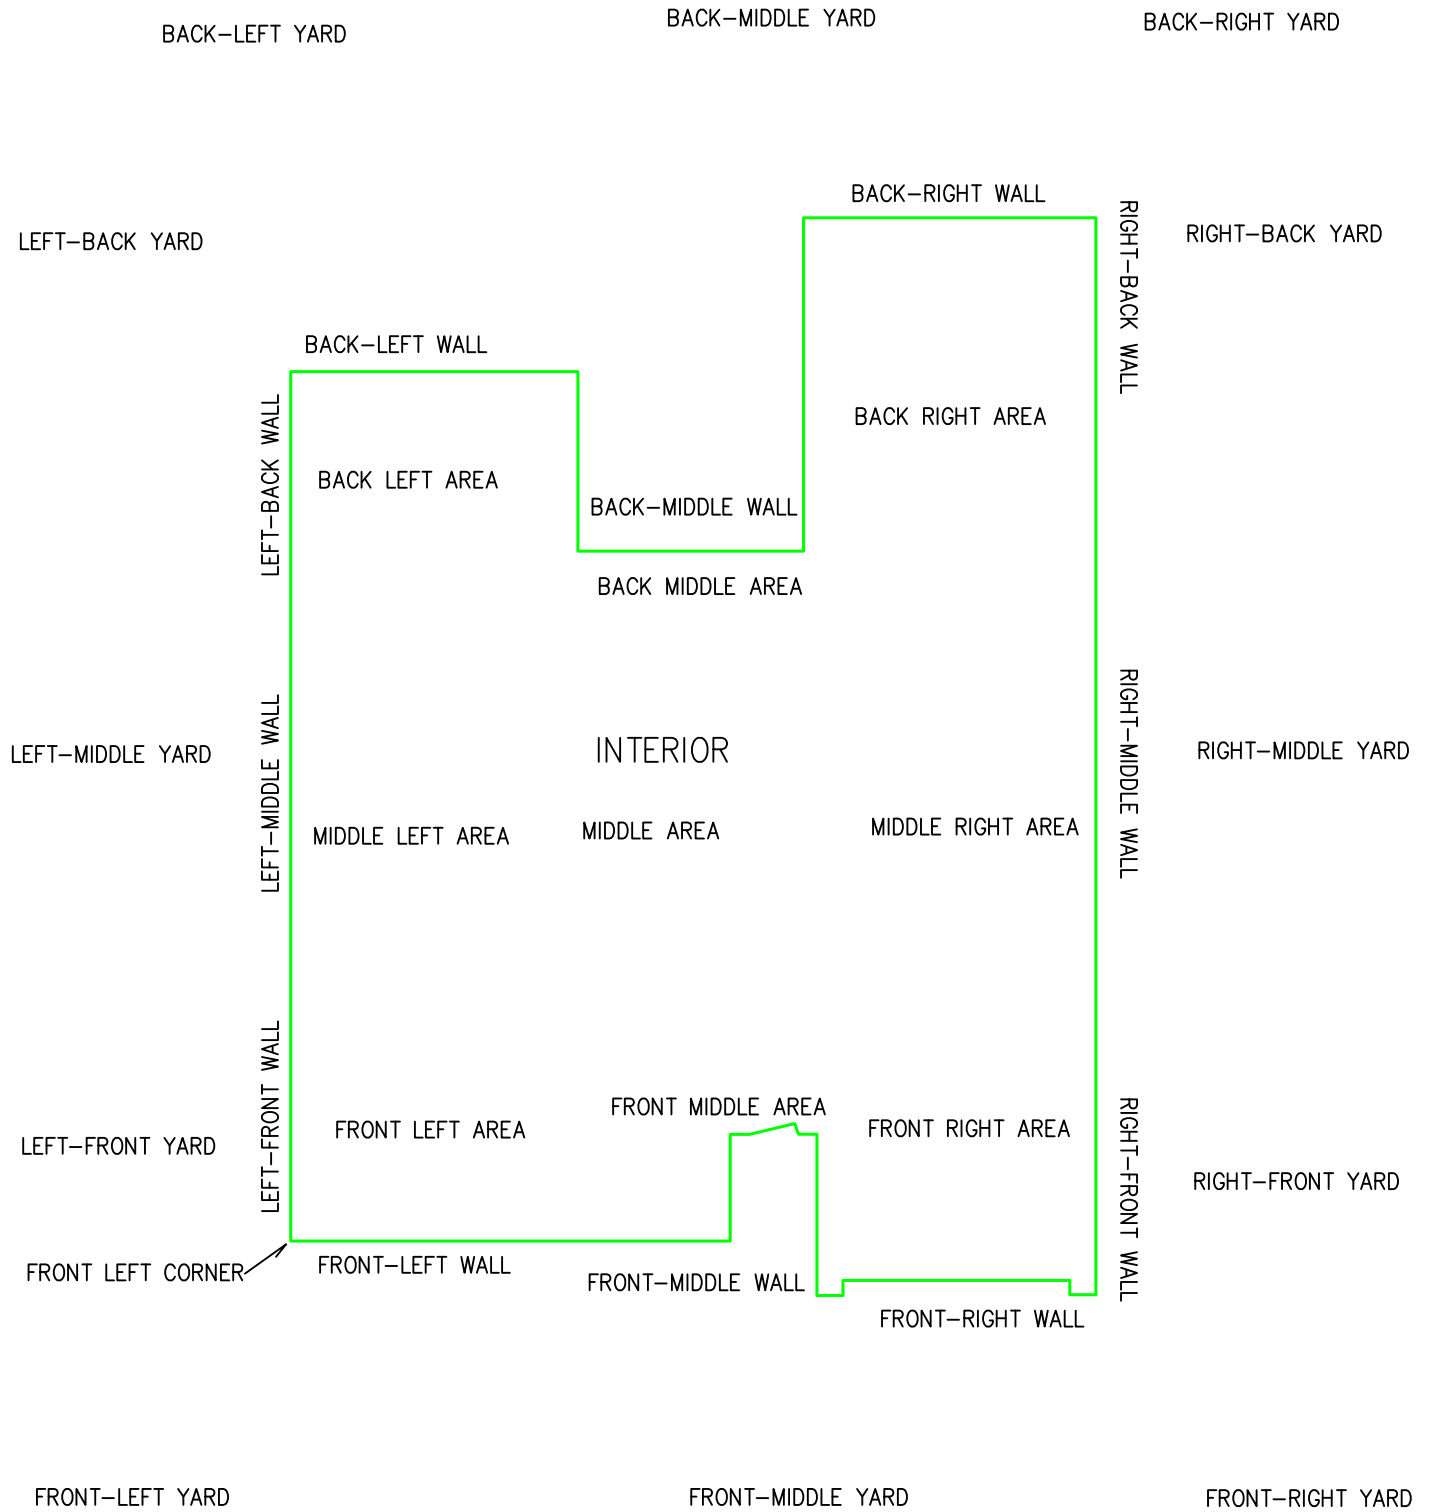
LOCATION KEY

Damages and conditions at the exterior are shown on the attached Elevation survey sheet. Damages were concentrated at the left wall and near the corners of the wall. The brick mortar line at the left wall was down in the middle.

Inspection of the exterior found clay cracks. Inspection also found deficient drainage and landscape conditions at the perimeter of the foundation, as shown on the attached Elevation survey sheet.

Damages and conditions at the interior are shown on the attached Elevation survey sheet. Damages are few and minor and distributed throughout the house.

An elevation survey throughout the house was performed using a Technidea Zipllevel. The reference zero was the target symbol. The elevations have a range of 2.6 inches, highest at the fireplace, lowest at the front wall of the master bathroom. The foundation generally drops to the front in the back half, and is almost flat and level in the front half.

The elevation deflections measured as bending of a straight line calculate to .66/360 (.70 inches in 32 feet, green line, worst case) which does not exceed the generally accepted criteria for foundation performance and repair of 1.00/360 (1 inch bend in 30 feet).

The elevations measured as tilting of a level line across the foundation calculate to .63% (2.2 inches in 29 feet, turquoise line, worst case) which does not exceed the generally accepted criteria for foundation performance (not repair) of 1.00% (2.4 inch difference across 20 feet).

The elevations measured as slope of floors calculate to 1.30% (.7 inches in 4.5 feet, red line, worst case), which does not exceed 2.00% (1.2 inch difference across 5 feet).

I recommend the installation of root barriers between the trees and the foundation. Removal of the trees will have the same effect. Large trees closer to the foundation than 12 feet should be barriered with caution. If nothing is done the problems will become worse.
