## RESIDENTIAL INSPECTION

14907 Alderwick Dr Sugar Land, TX 77498

# **PROPERTY INSPECTION REPORT FORM**

Charis Prendergast	02/27/2023 5:30 pm
Name of Client	Date of Inspection
14907 Alderwick Dr, Sugar Land, TX 77498	
Address of Inspected Property	
Joshua Brown	TREC 25631
Name of Inspector	TREC License #
Name of Sponsor (if applicable)	TREC License #

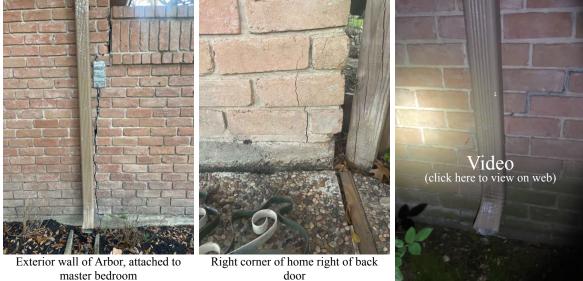
Previous repair, right side of home across from kitchen

#### 3: Brick Exterior: Cracking: step-cracking thru brick/mortar- SE ASafety Hazard

Exterior walls had severe localized step-cracking visible that were continuous through brick and mortar. This condition is a structural concern and can have a variety of causes, often connected with soil movement. 1. The Inspector recommends that before the expiration of your Inspection Objection Deadline you consult with a soils (geotechnical) engineer to gain a more accurate idea of the level of risk of continuing damage connected with this condition. 2. The Inspector recommends that before the expiration of your Inspection Objection Deadline you consult with a qualified contractor to gain an idea of options and costs for crack repair.

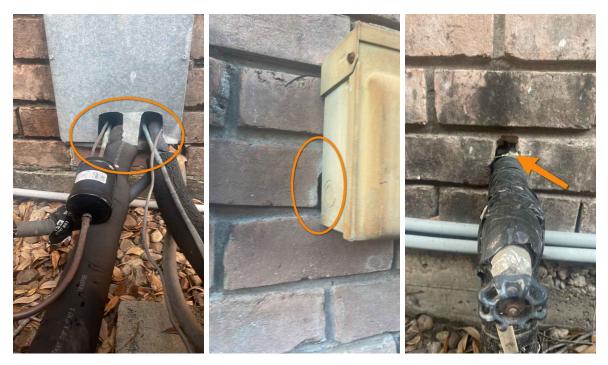
#### 4: Wall Exteriors: Seal penetrations- QC

Exterior wall penetrations had gaps that should to be sealed with an appropriate sealant to prevent moisture and insect entry.

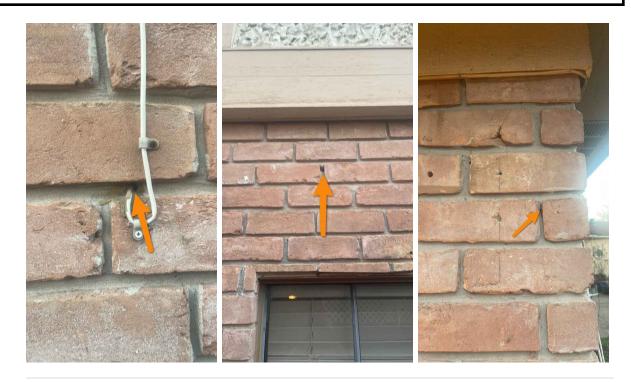
#### 5: Brick Exterior: Mortar deterioration: severe, widespread- QC

The brick exterior exhibited widespread severe mortar joint deterioration. Mortar joints should be re-pointed to prevent continued deterioration from freezing moisture. You should consult with a qualified masonry contractor before the expiration of your Inspection Objection Deadline to determine options and costs for repointing.

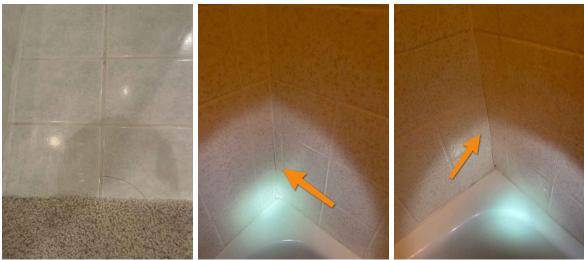
Master bathroom, shower

#### 2: Floors: Tile floors: cracked tiles- QC

This room had cracked floor tiles. You should ask the seller if spare tiles are available as matching replacements. You should consult with a qualified contractor to discuss options and costs for repairs.

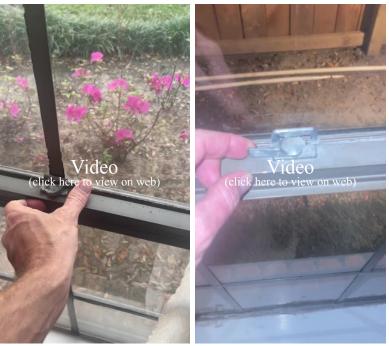
Formal dining

#### 1: Windows: inoperable- QC

A window was inoperable. It should be serviced by a qualified contractor.

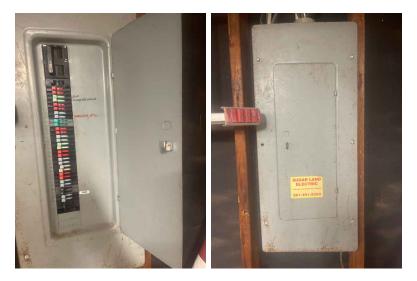
#### 1: Panel Missing Labels

Electrical panel does not have labels. Recommend a qualified electrician test and properly label all switches.

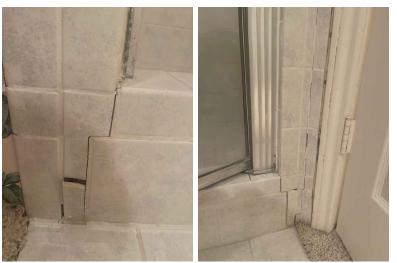
Master bath, shower

#### 1: Bathroom: Shower: grout missing- QC

The shower tiles had areas of missing grout that may allow moisture to penetrate the walls. The inspector recommends service by a qualified plumbing contactor.

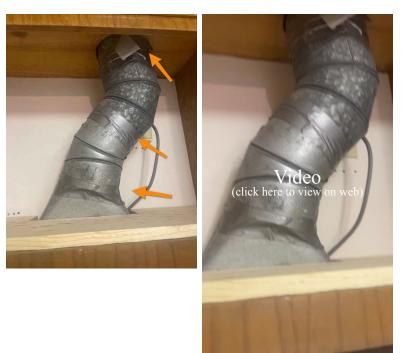
#### 1: Not sealed properly

Kitchen range, hood, exhaust duct taped together and leaking back into the cabinet above microwave. Recommend properly sealing range exhaust.
