KELLY INSPECTION SERVICES

TREC REI 7-6

204 Yaupon Dr Baytown, Tx 77521

PROPERTY INSPECTION REPORT FORM

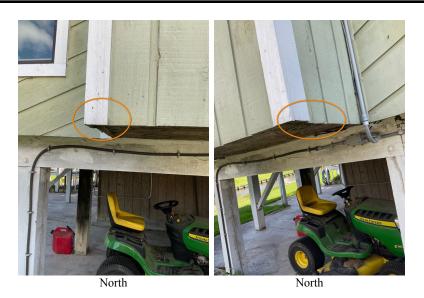
2: Exterior wood siding shows signs of rot

The wood siding shows signs of wood rot. I recommend a qualified professional evaluates and replaces as needed.

Recommendation: Contact a qualified professional.

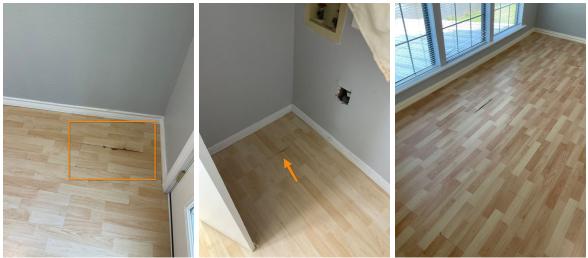
Front Door 3rd Floor Master Bedroom

1: Flooring - Damaged

The home flooring had general moderate damage visible at the time of the inspection. Recommend evaluation by a qualified flooring contractor.

Recommendation: Contact a qualified professional.

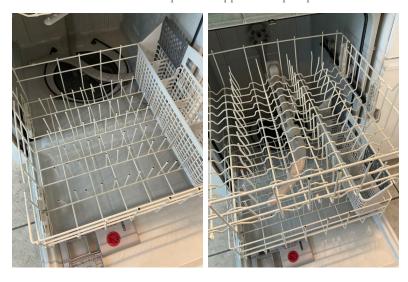
1: Racks rusted Recommendation

Dishwasher racks show rusting

Recommendation: Contact a qualified appliance repair professional.
