FOUNDATION INSPECTION

14418 Ardwell Dr
Sugar Land, TX 77498

MARCH 13, 2023

REF: CONDITION OF PROPERTY SURVEY

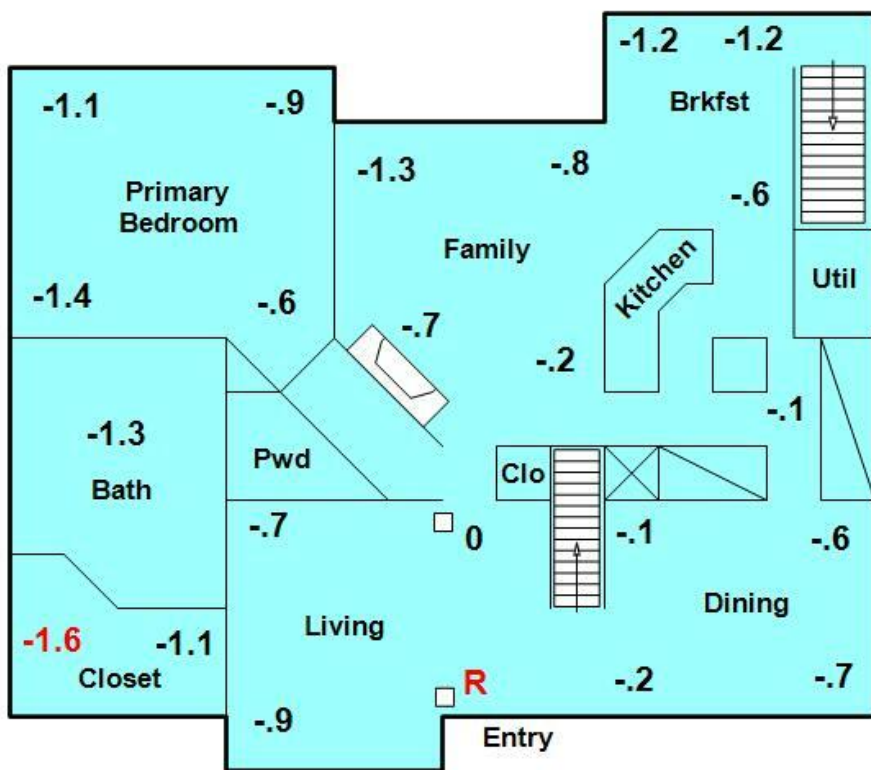
Elevations Readings 14418 Ardwell Drive

The floors were checked with an electronic level, and were observed to be sloping towards the west side of the house. The difference in elevation between the high point and low point was 1.6 inches. The high point was located at the entry, and the low point was located at the primary closet. The unlevelness takes place over a horizontal distance of approximately 30 feet.

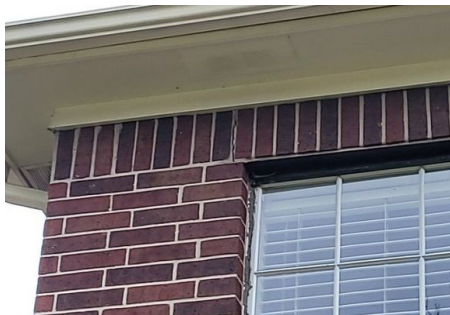
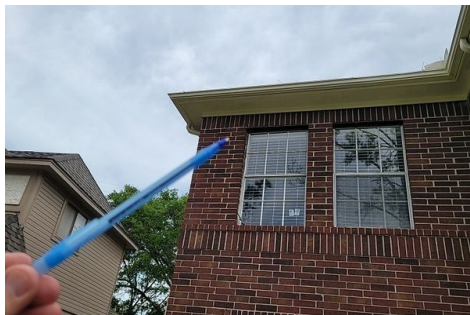
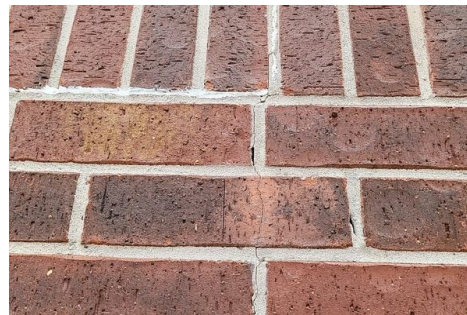
East Front

Cracks and/or patches were observed in the exterior veneer at the time of the inspection, including at the locations shown in the photos.

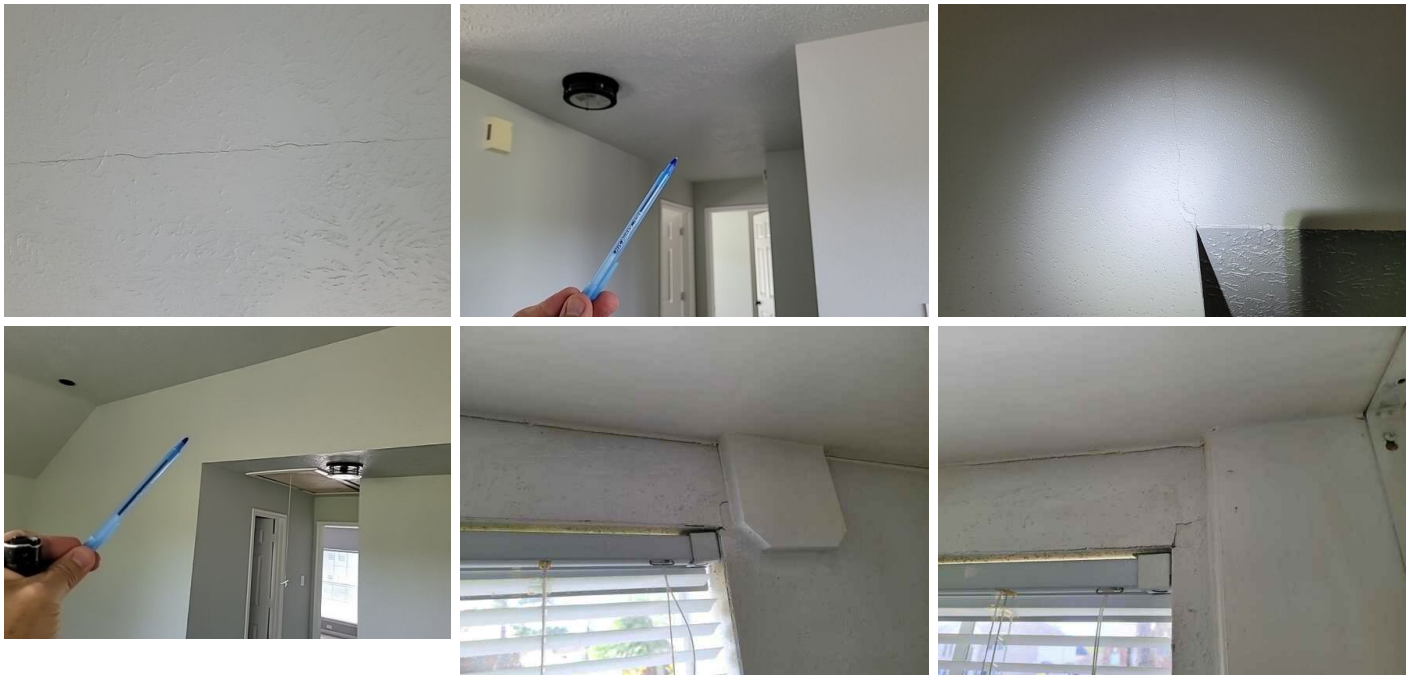
Game Room

The sheetrock tape was observed to be wrinkled at some locations during the inspection including at the above locations.

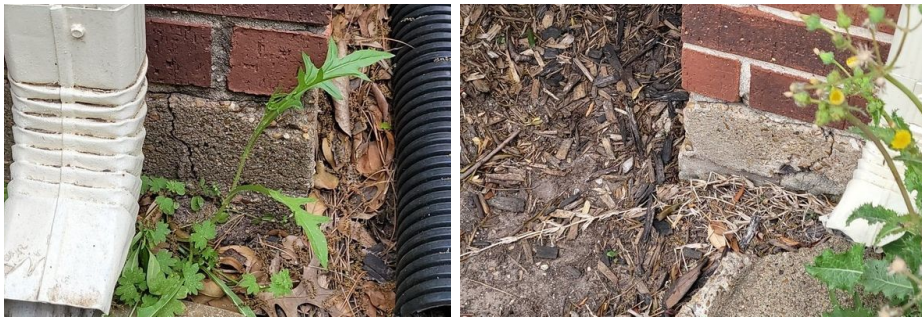
Southwest Southeast

The corner of the foundation was observed to be chipped at the above locations. This condition is typically caused by differences in thermal expansion between the brick veneer and the concrete foundation. Also, this condition can be caused by a lack of reinforcement in the corner of the foundation during original construction. In our opinion, this condition does not affect the overall structural integrity of the foundation.

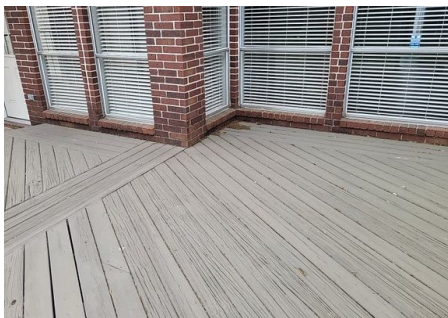
It is pointed out that a portion of the foundation concrete could not be viewed at the rear of the house due to the wood deck that adjoined the foundation.

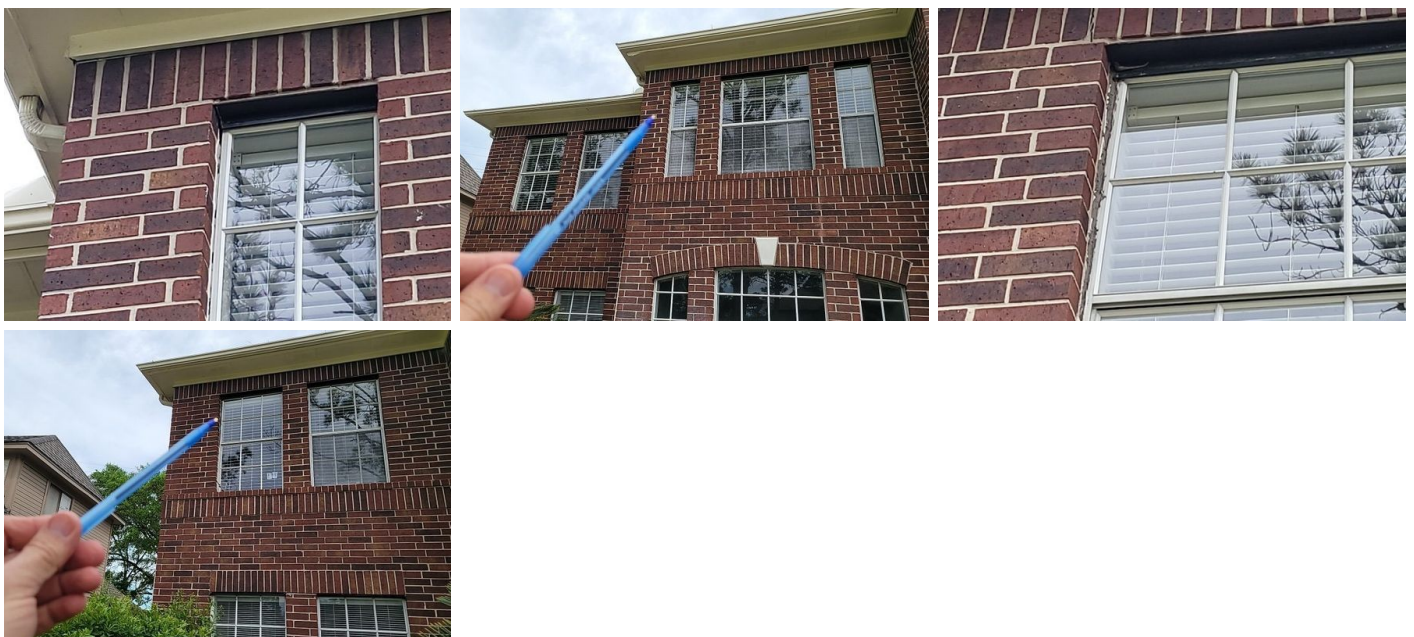
Front

The window frame was separated from the exterior brick veneer apparently due to movement.

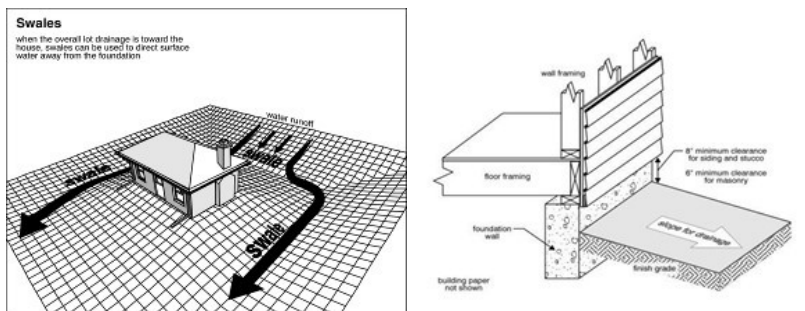
The flower bed and/or perimeter grading was too high at some areas, and was graded near or above the top of the foundation. It is recommended that the beds/soil be regraded as needed to prevent water penetration into the house, and to allow for proper drainage.

Contact a qualified landscaping contractor

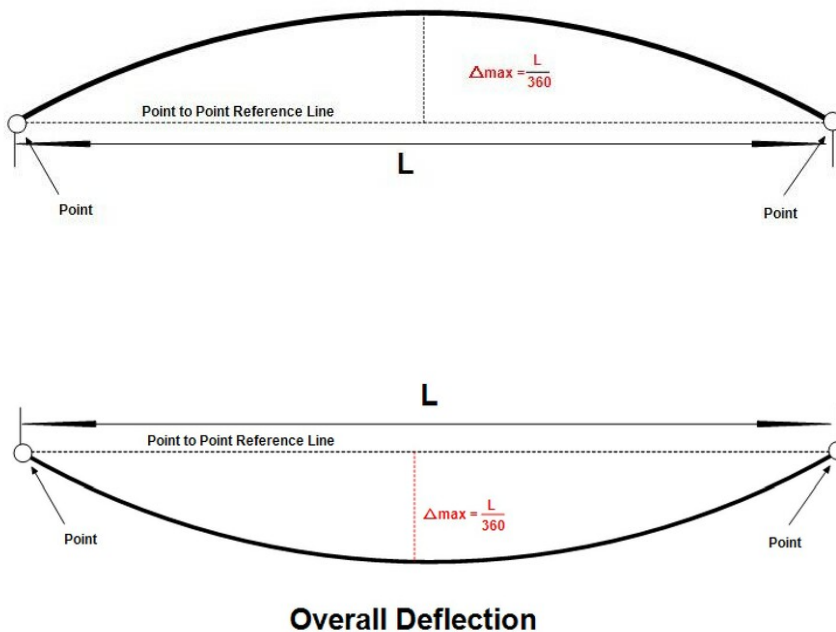
From the master closet, to the dining room ($L = 48$ feet), the maximum allowable deflection is 1.6 inches. We measured a deflection of 1.15 inches at the time of inspection across this span, which is less than the maximum allowable deflection, and is acceptable. This observation can be observed along the red line in the sketch below.

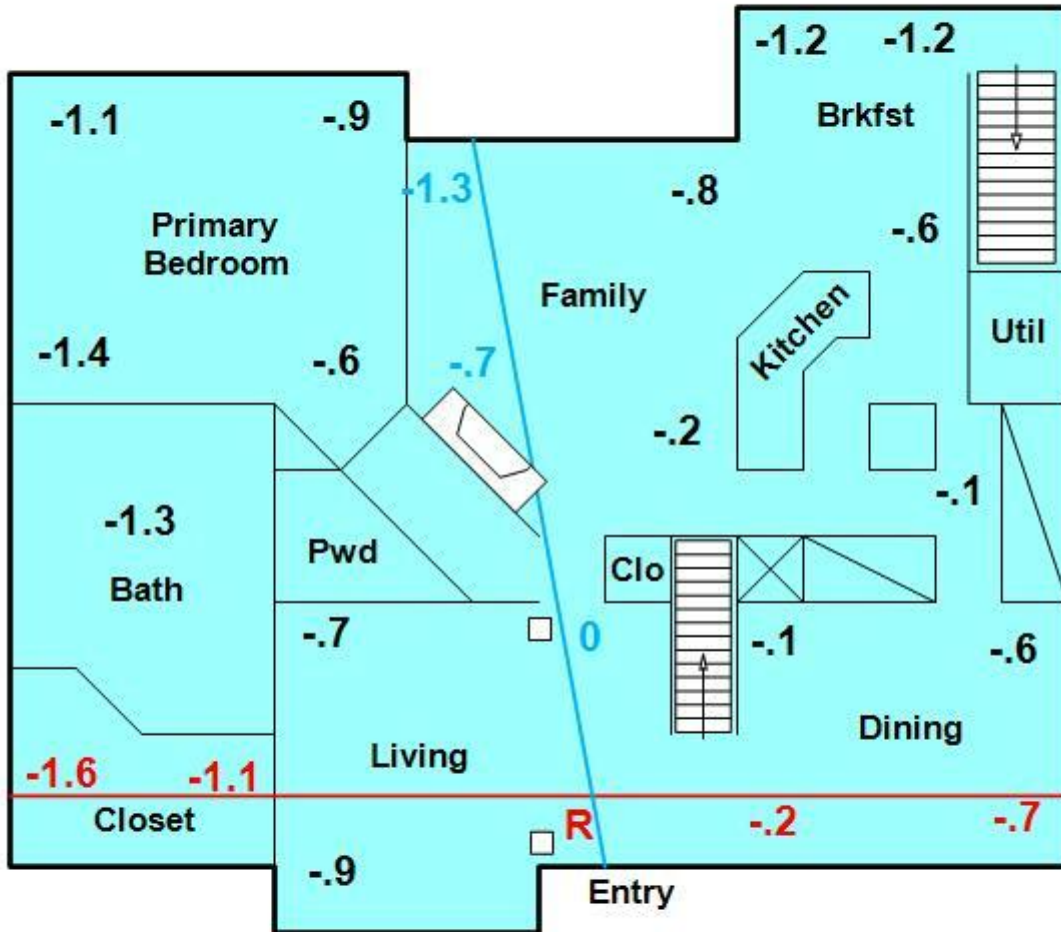
Elevations Readings 14418 Ardwell Drive

From the point of curvature located at the entryway, to the north wall of the family room ($L' = 22.5$ feet), the maximum allowable deflection is 1.5 inches. We measured a deflection of 1.3 inches at the time of inspection across this span, which is less than the maximum allowable deflection, and is acceptable. This observation can be observed along the **blue line** in the sketch below.
