Smith Group Property Inspections

Property Inspection Report

4613 Knoxville Street, Houston, TX 77051
Inspection prepared for: Michael Jolivet and Dwight Bazile

Date of Inspection: 12/30/2021 Time: 7:00AM
Age of Home: 2006 Size: 4000 sqft

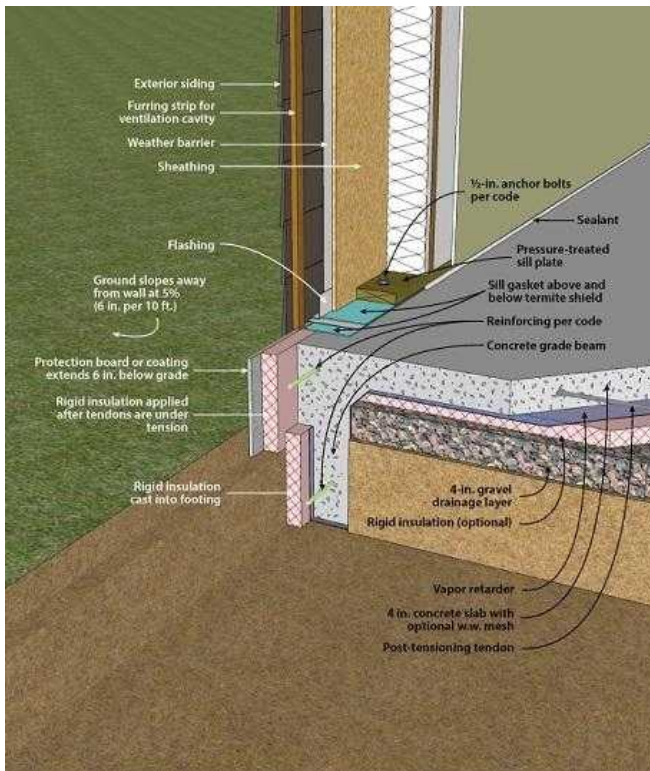
Structural movement and/or settling noted; however, the foundation is supporting the structure at this time.

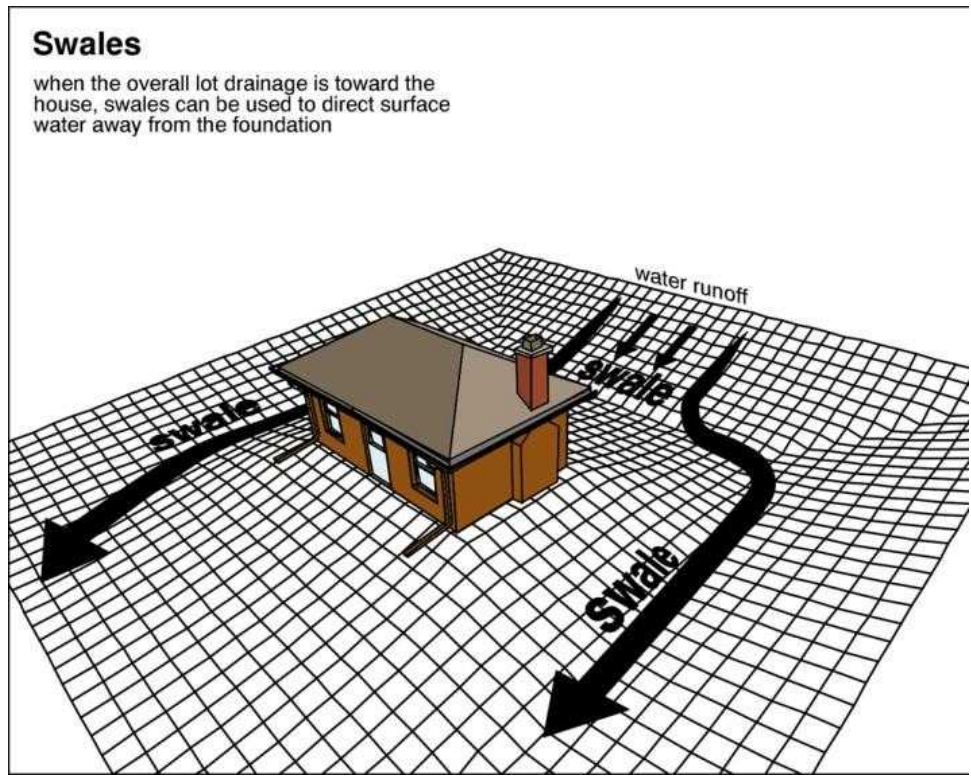
Soil / mulch too high at foundation.

Soil (or mulch) too high at foundation can potentially promote pest intrusion.

It is recommended that at least 4 of foundation be visible.

Correction recommended by qualified contractor.

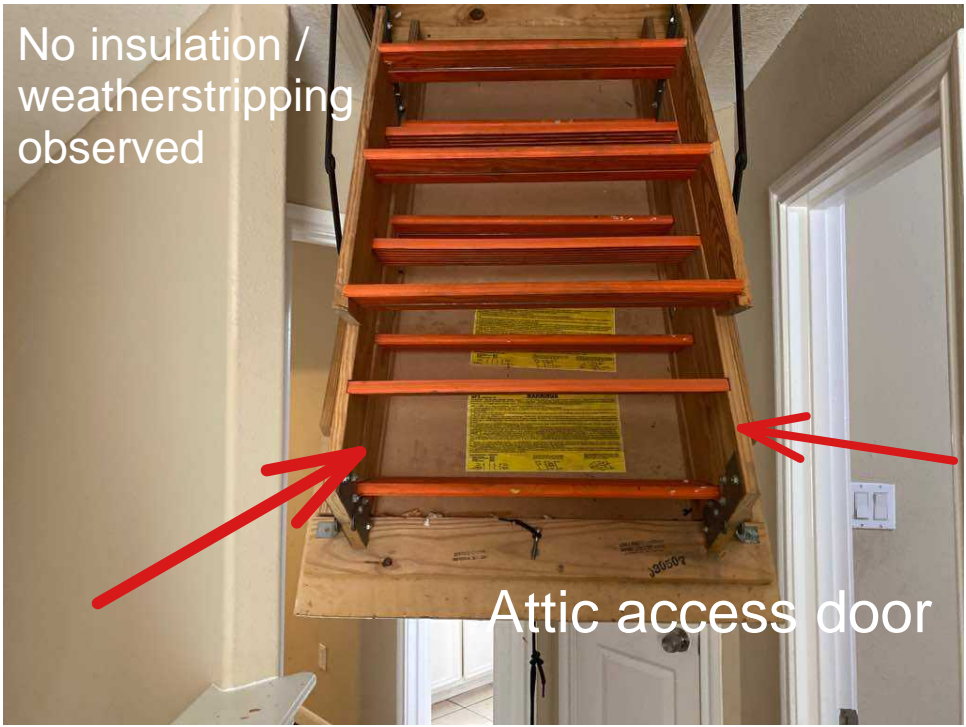
Observed no insulation / weatherstripping at attic access door.

Correction recommended by qualified contractor to minimize opportunity for heating / cooling loss at attic access door.

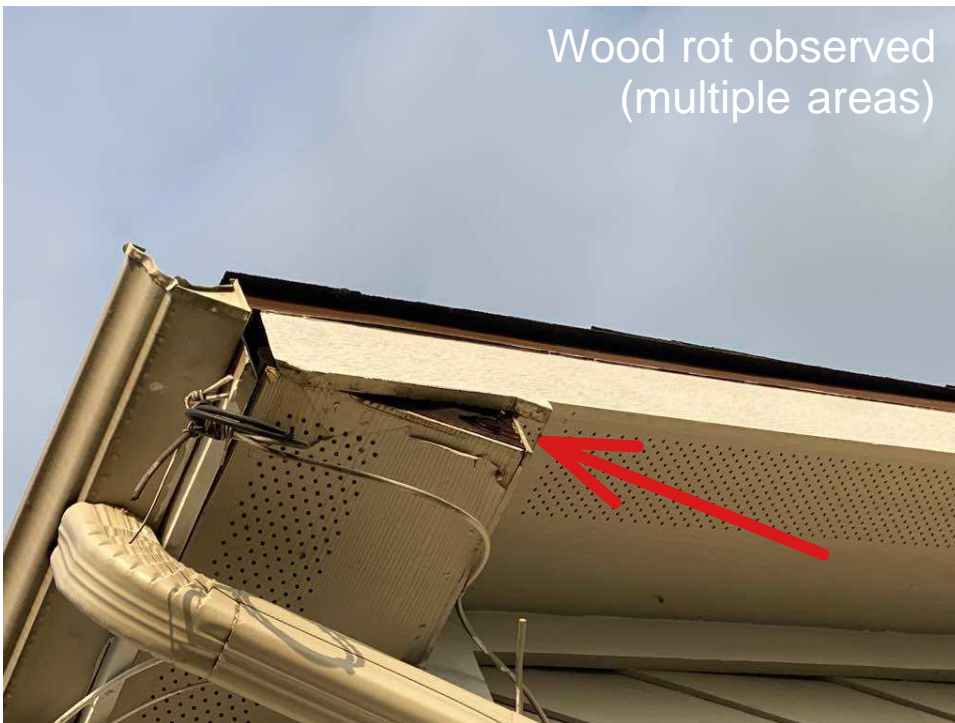
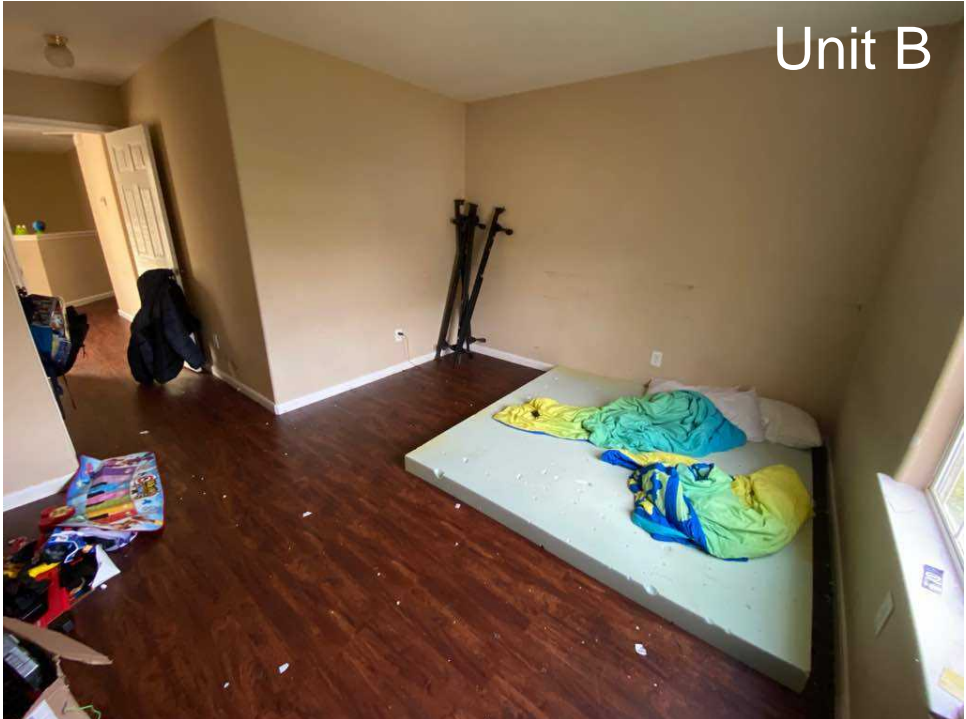
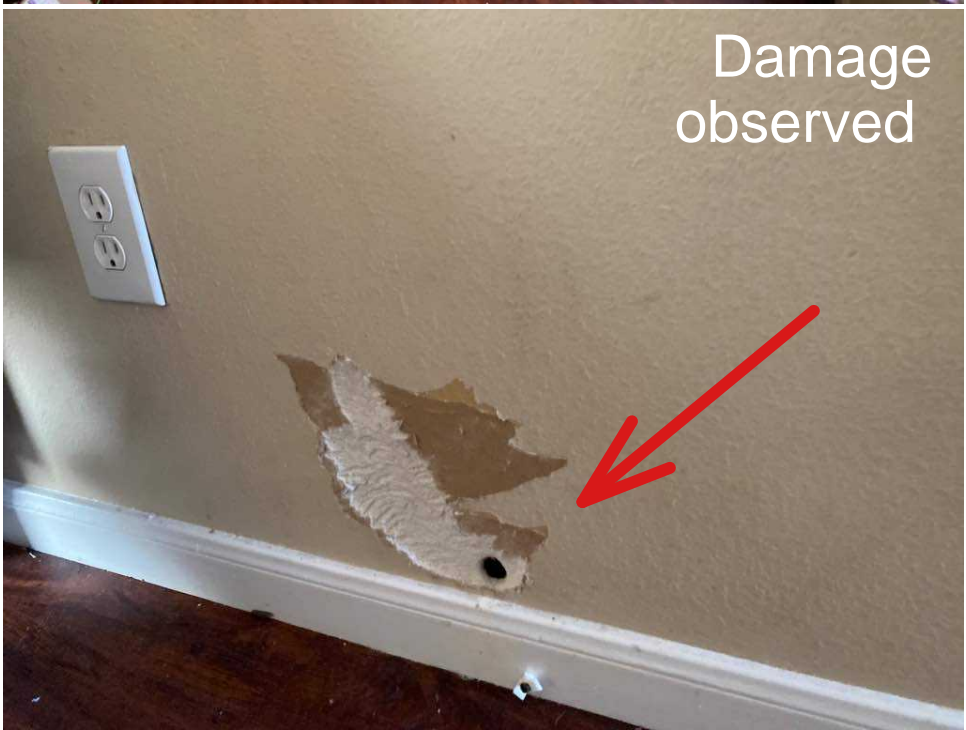
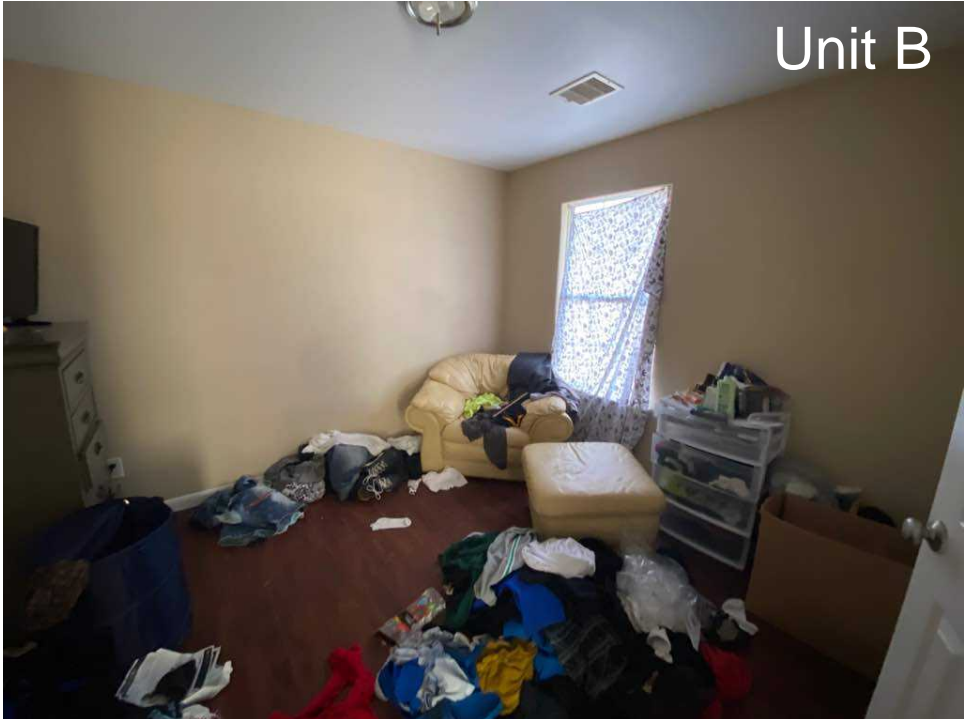
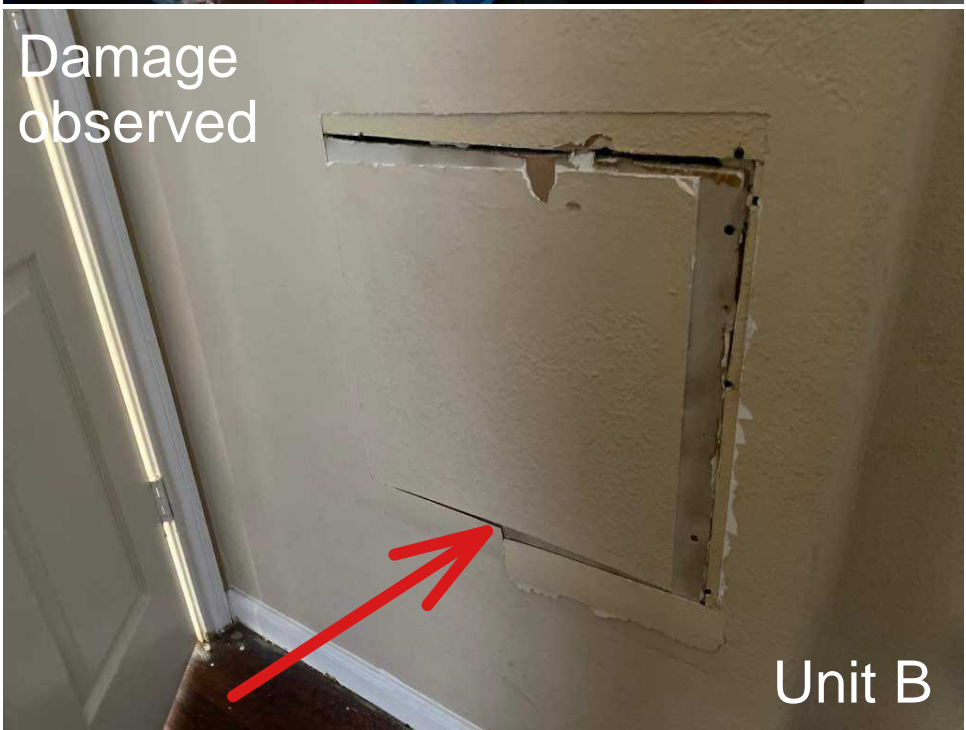
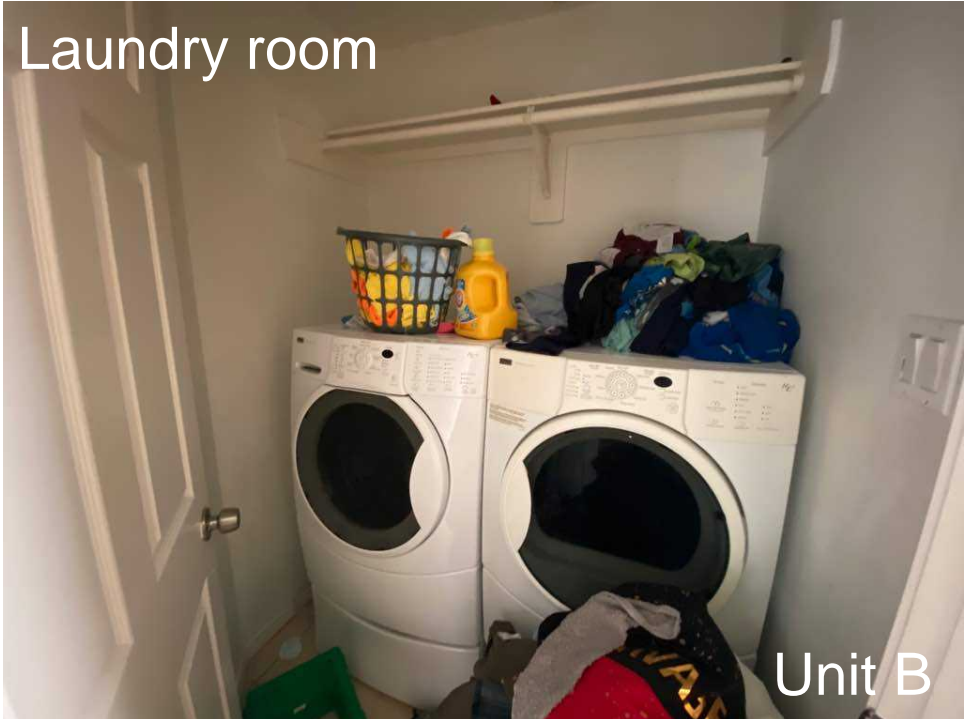
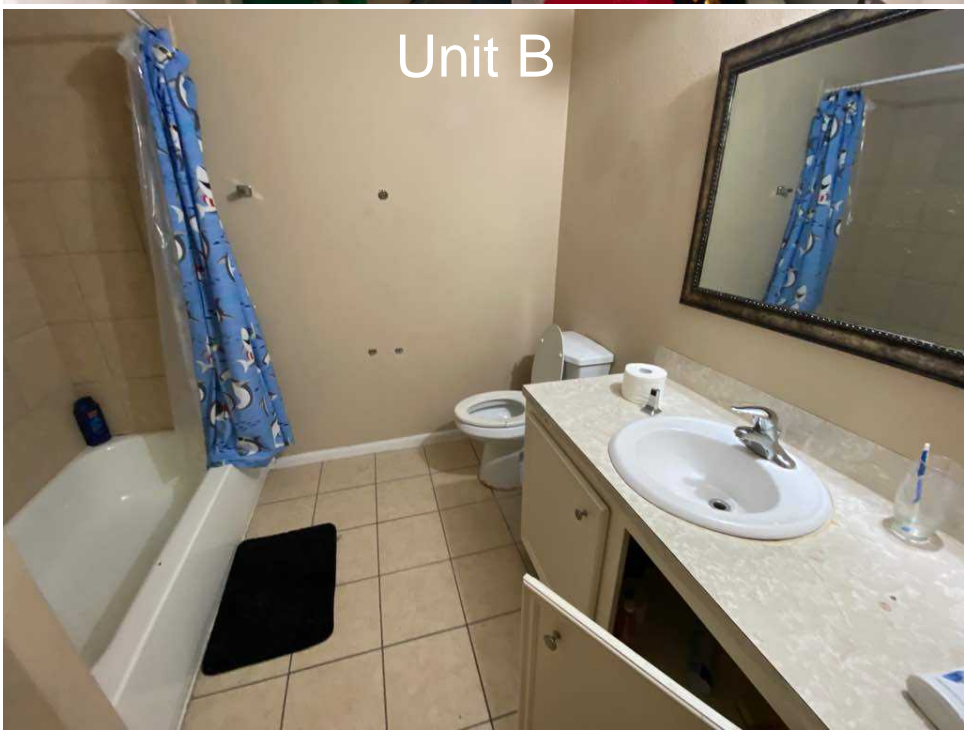
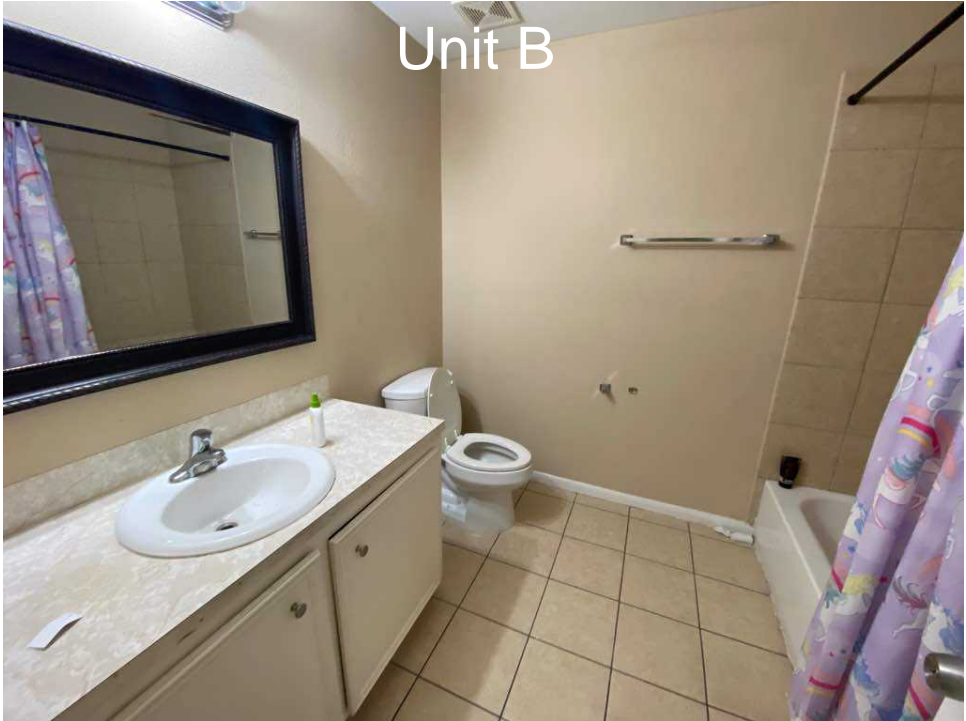
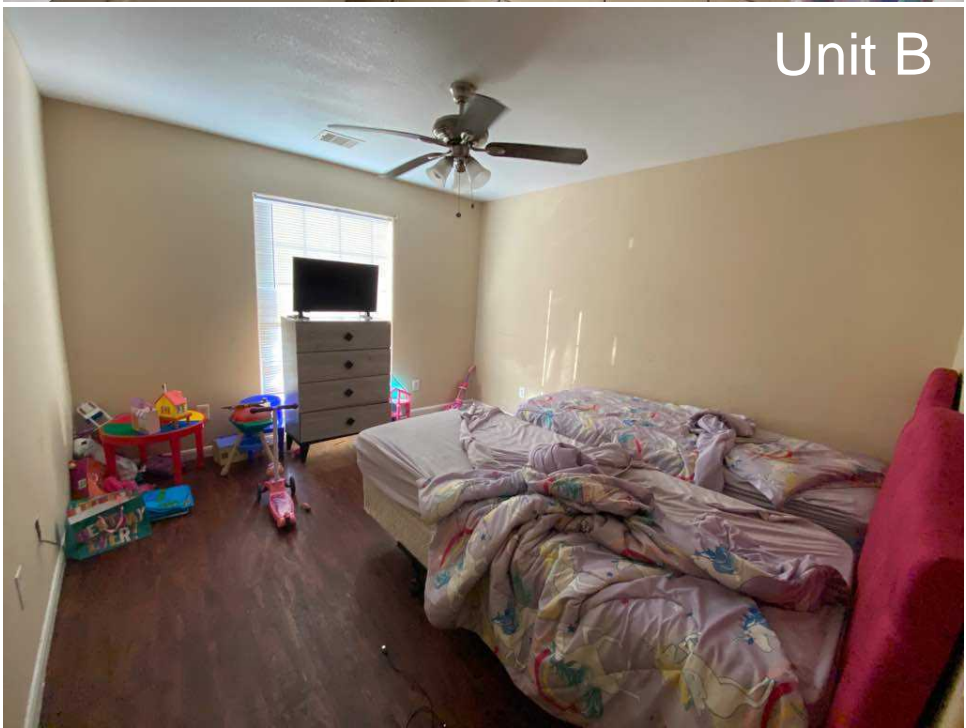
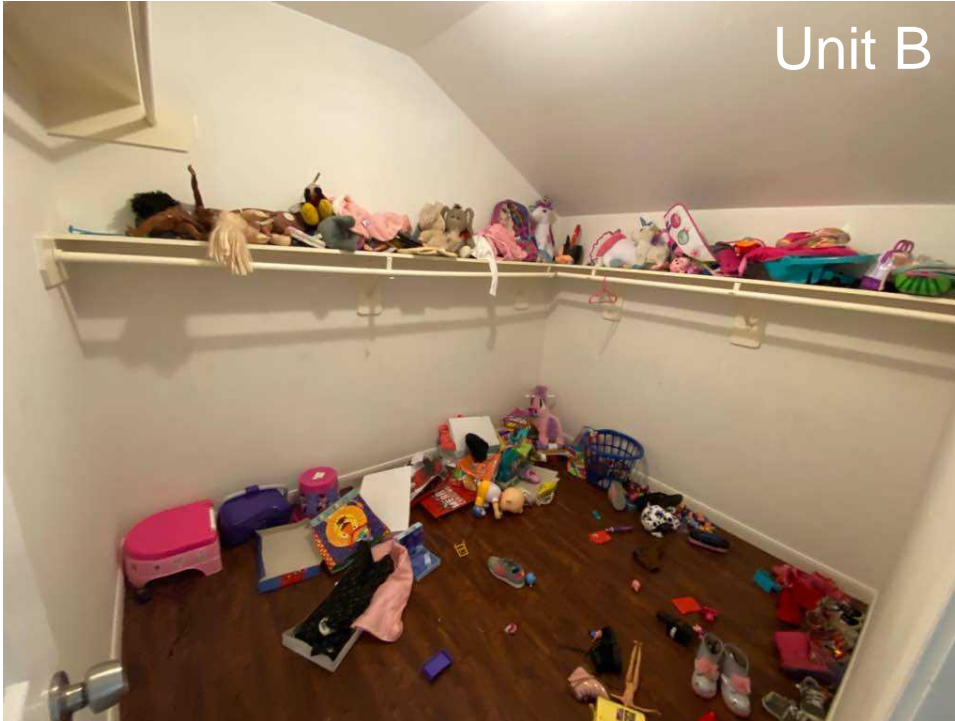
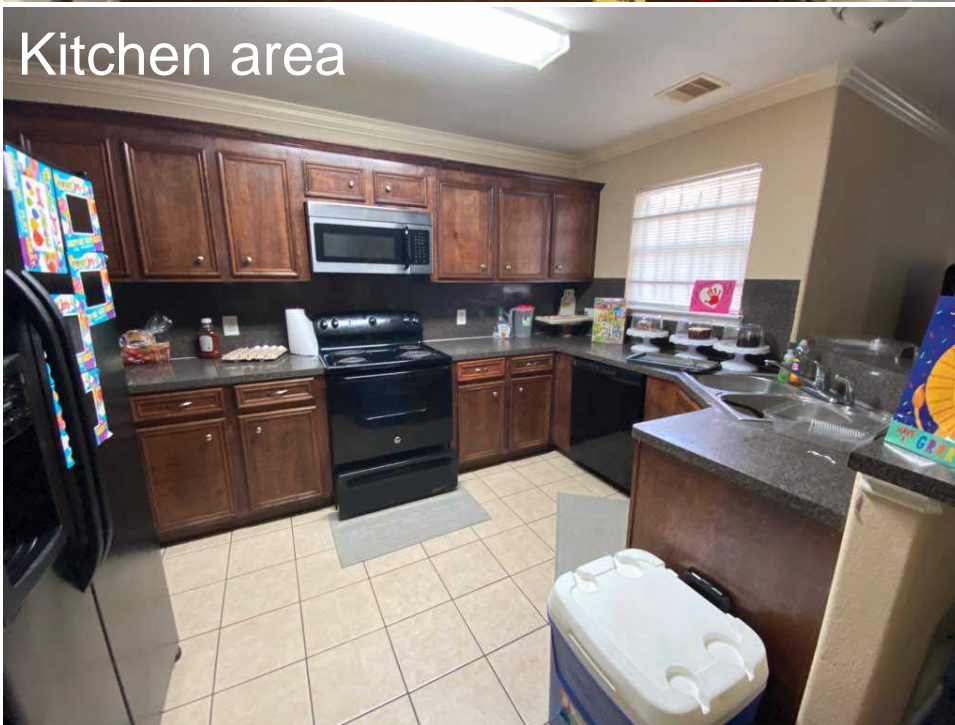
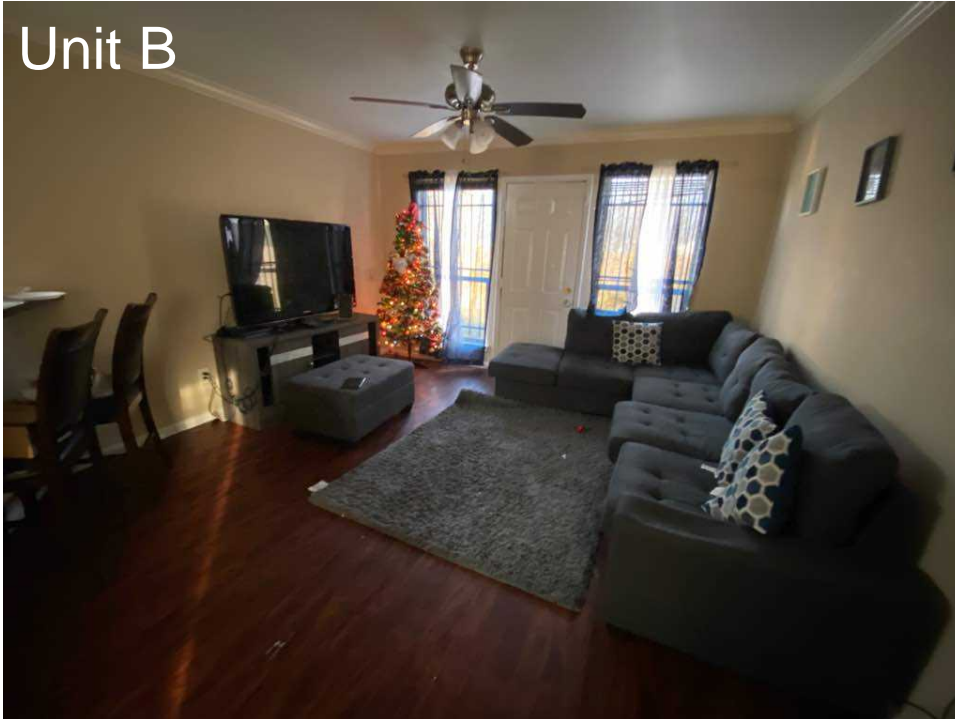
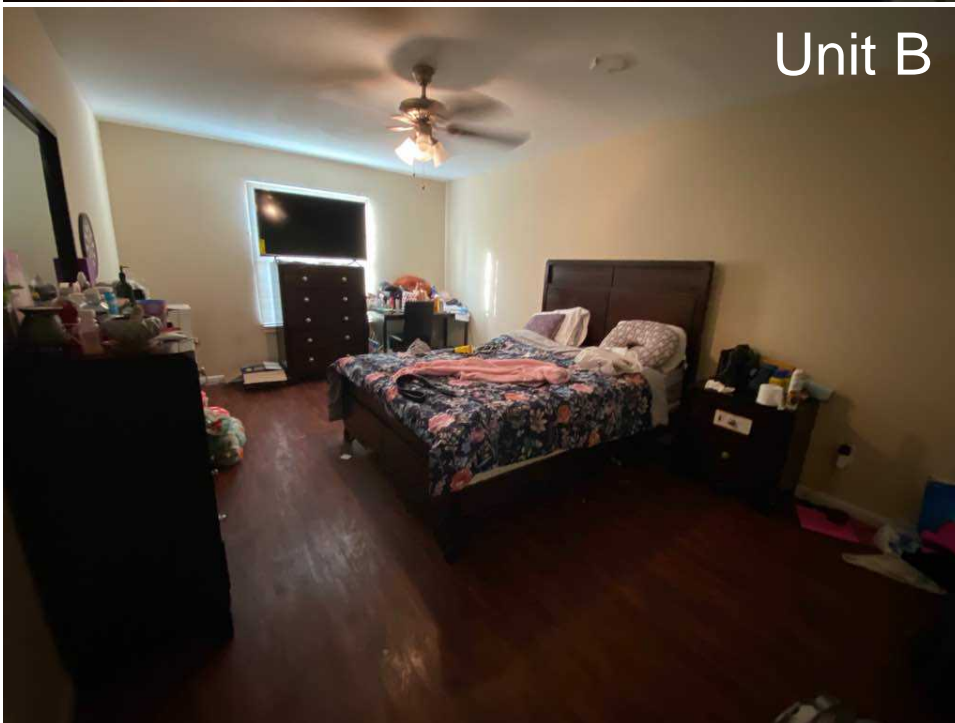
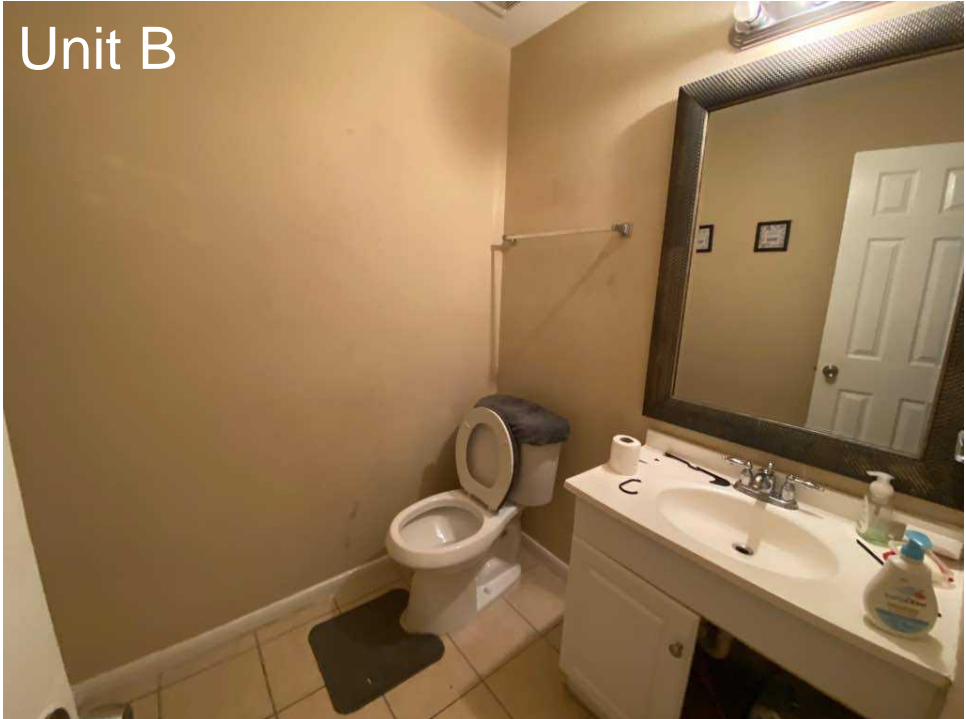
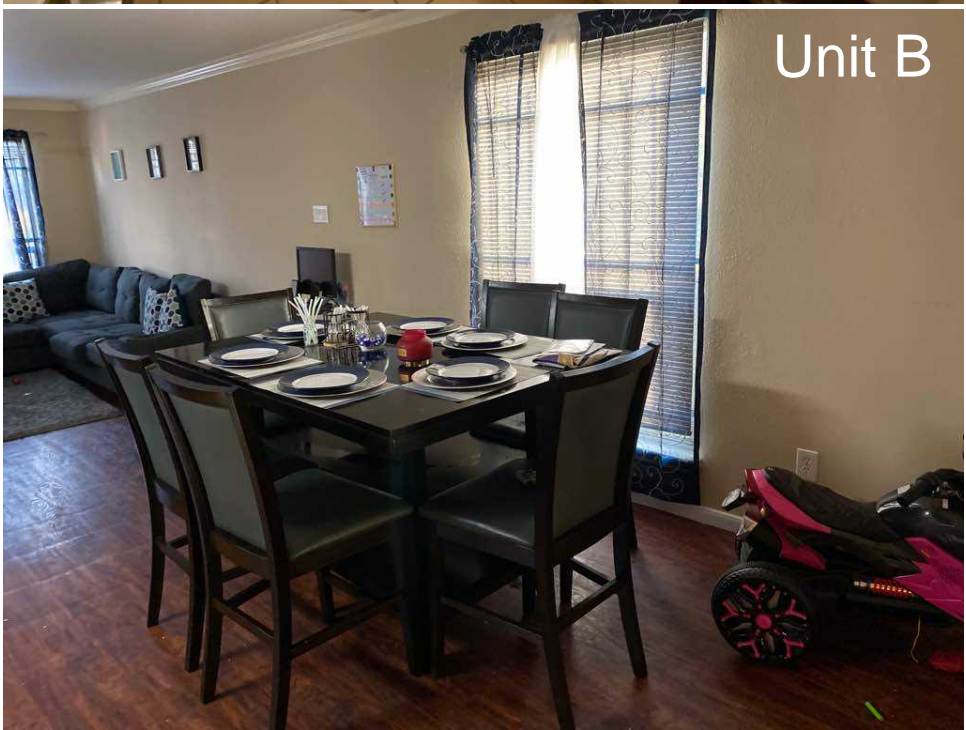
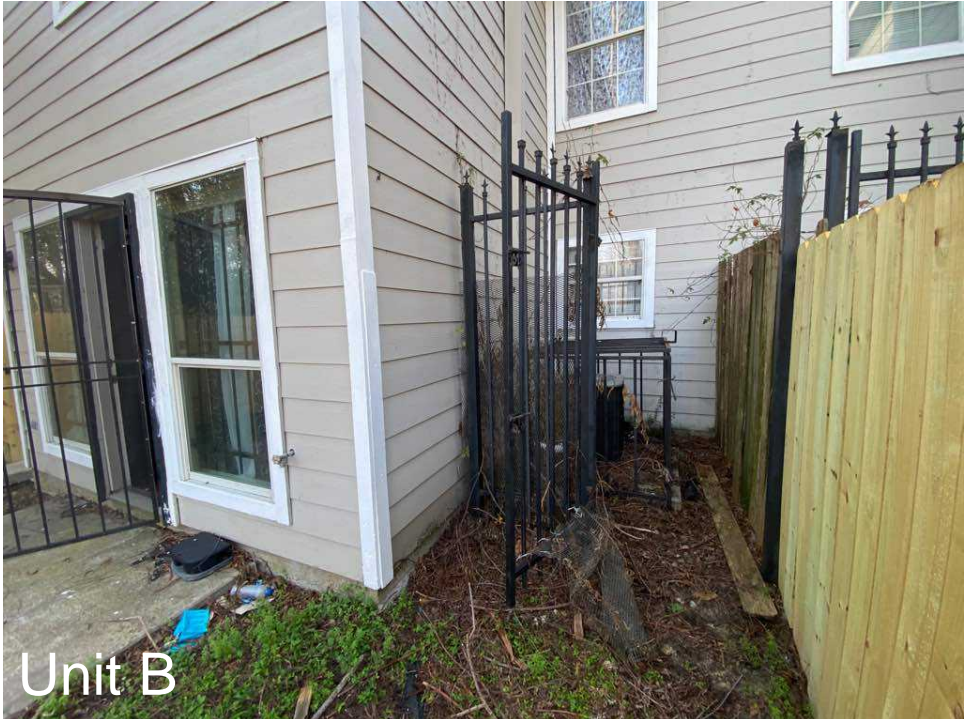
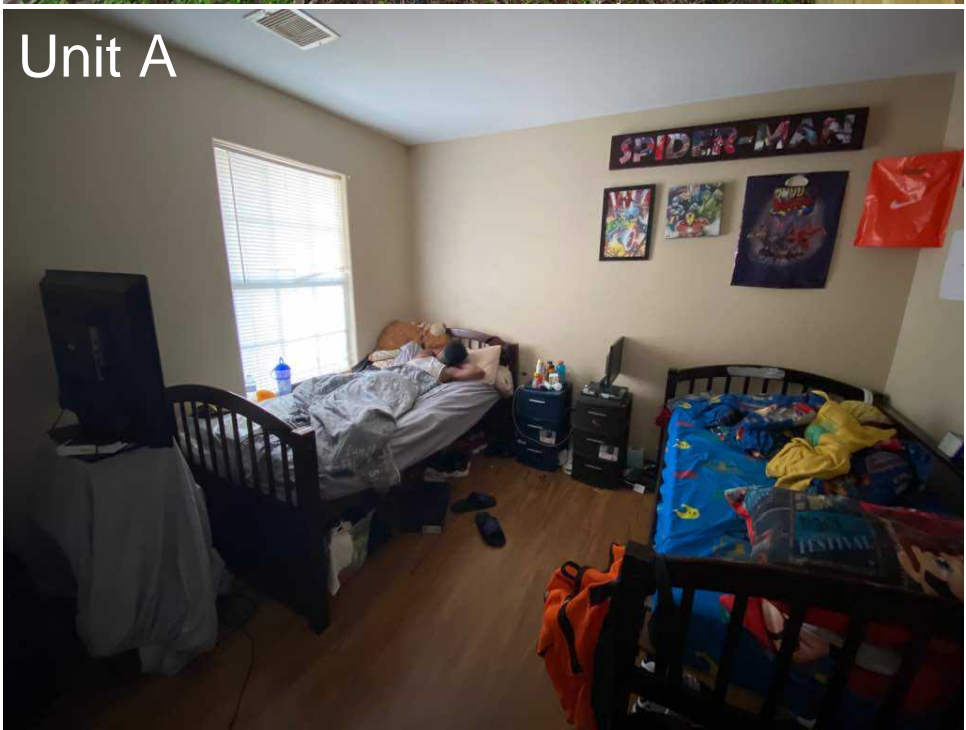
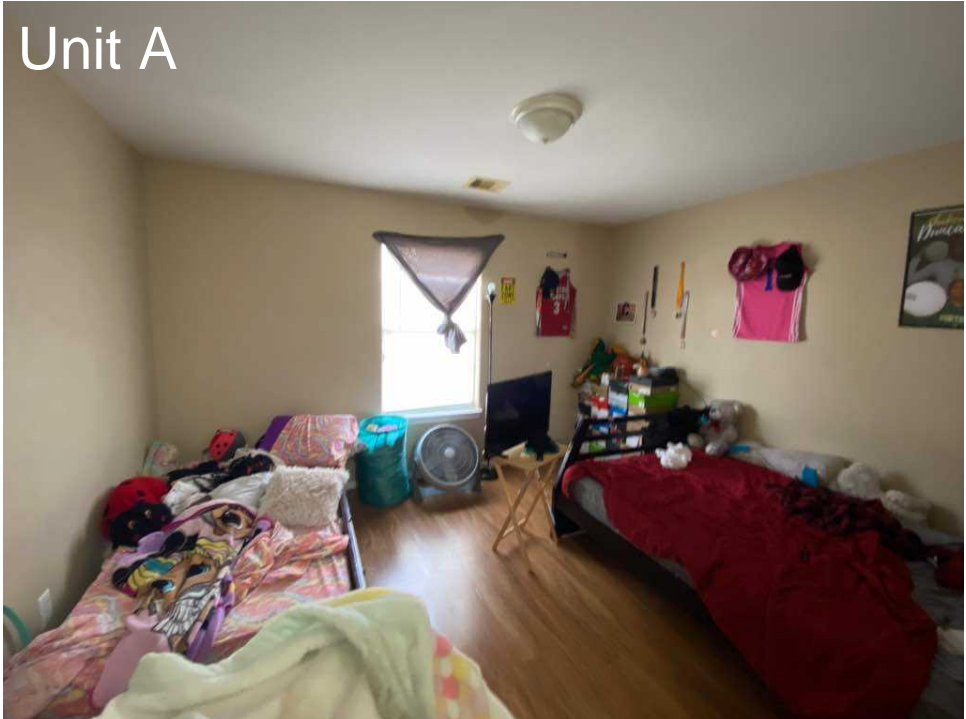
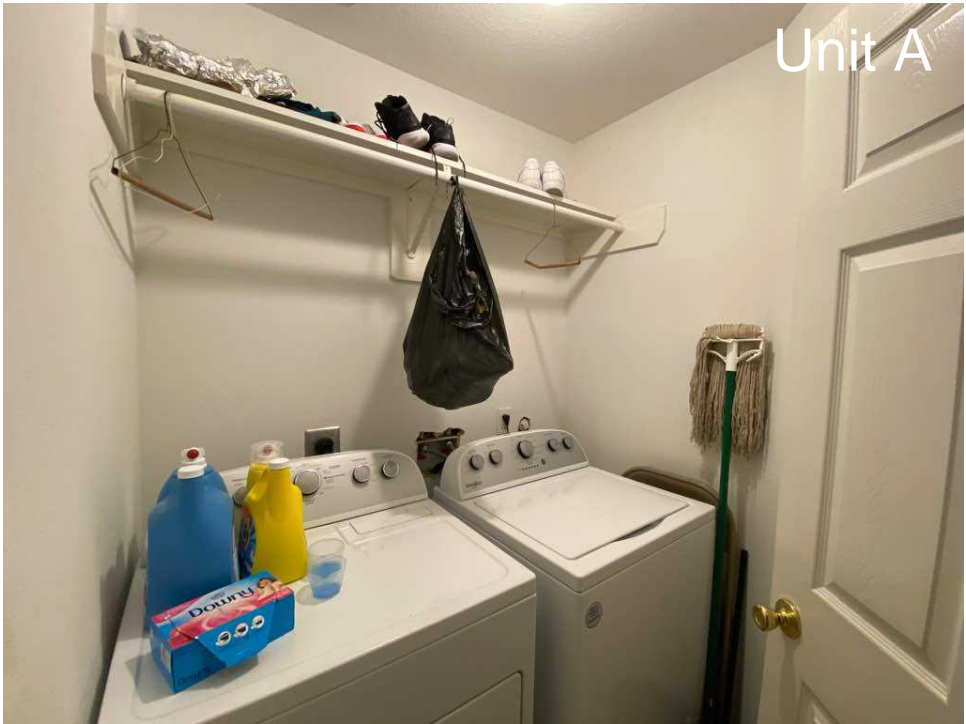
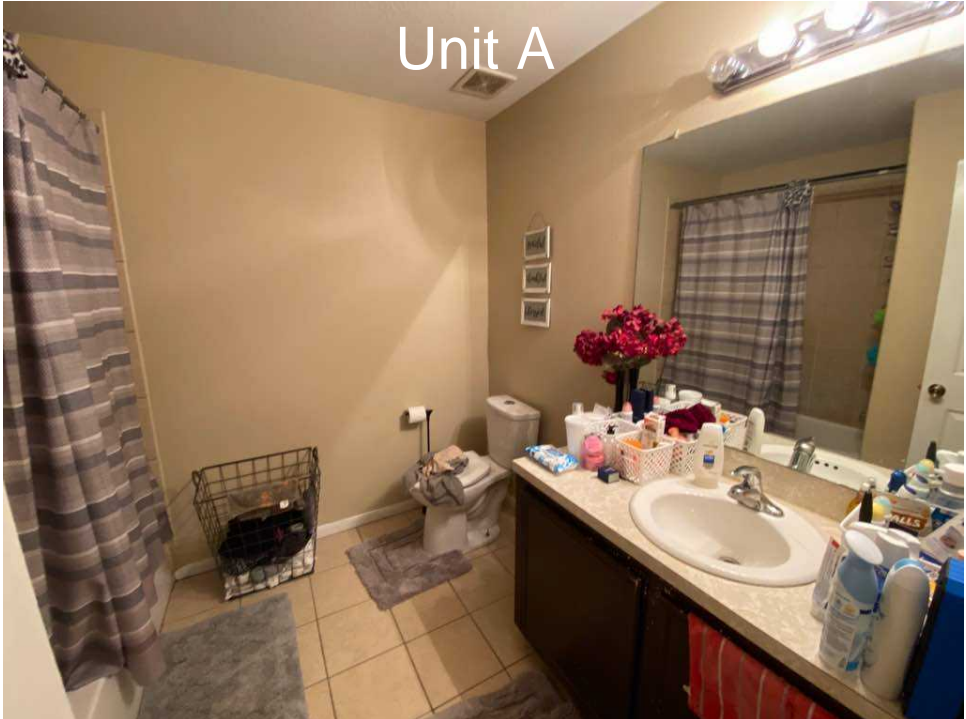
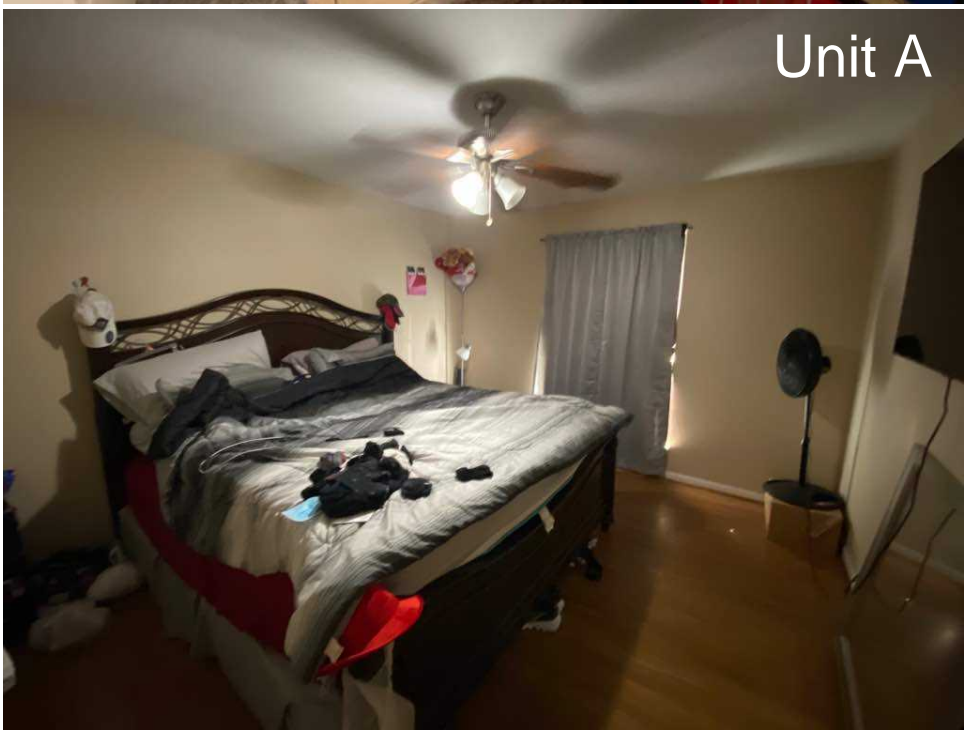
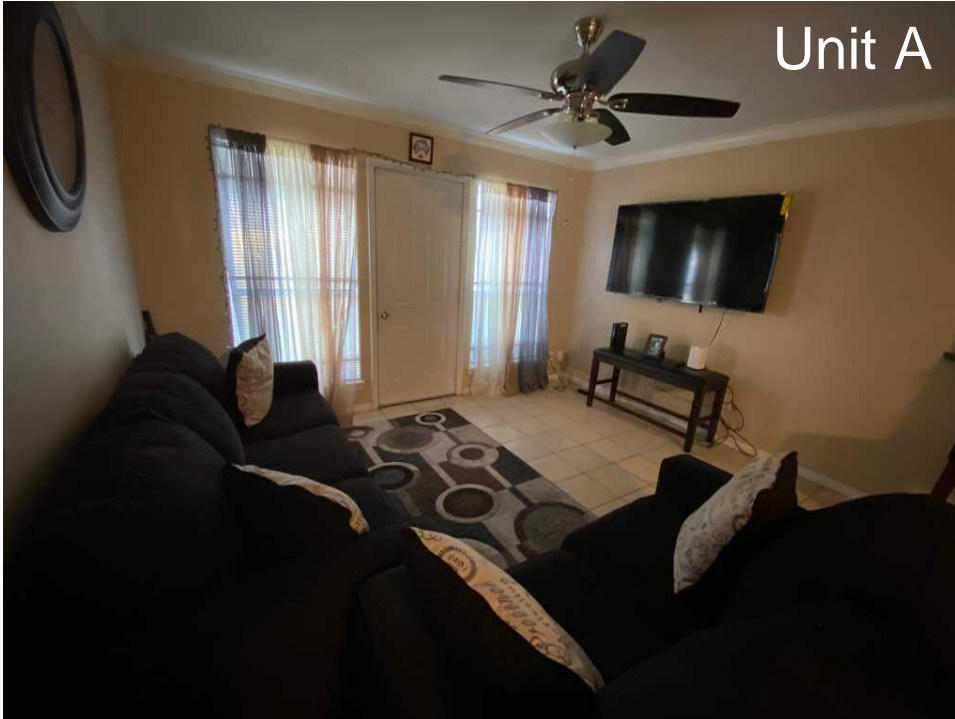
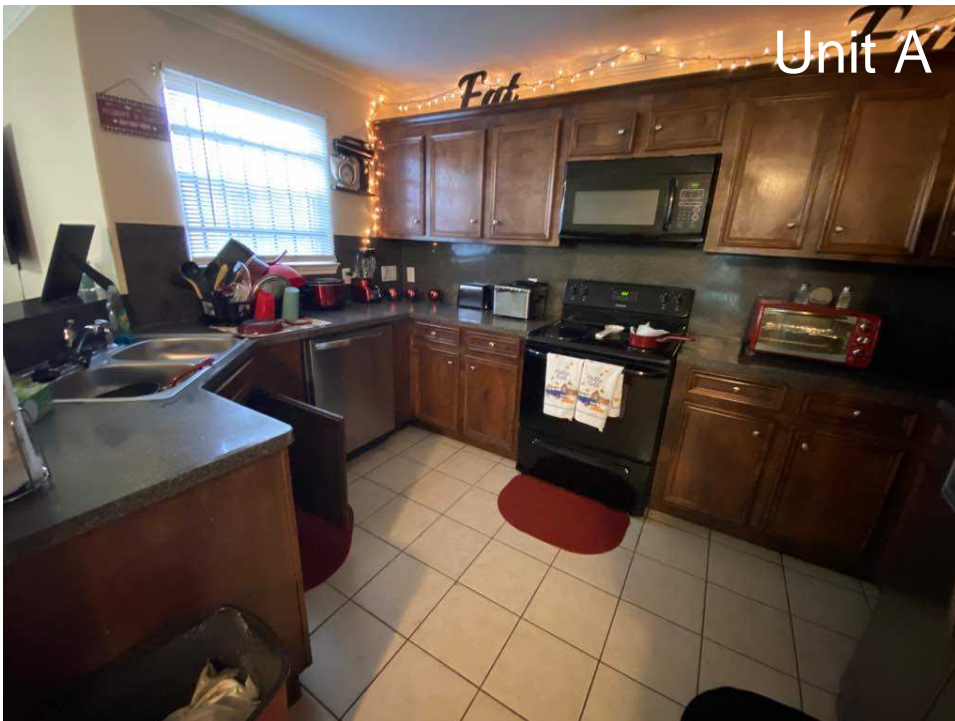
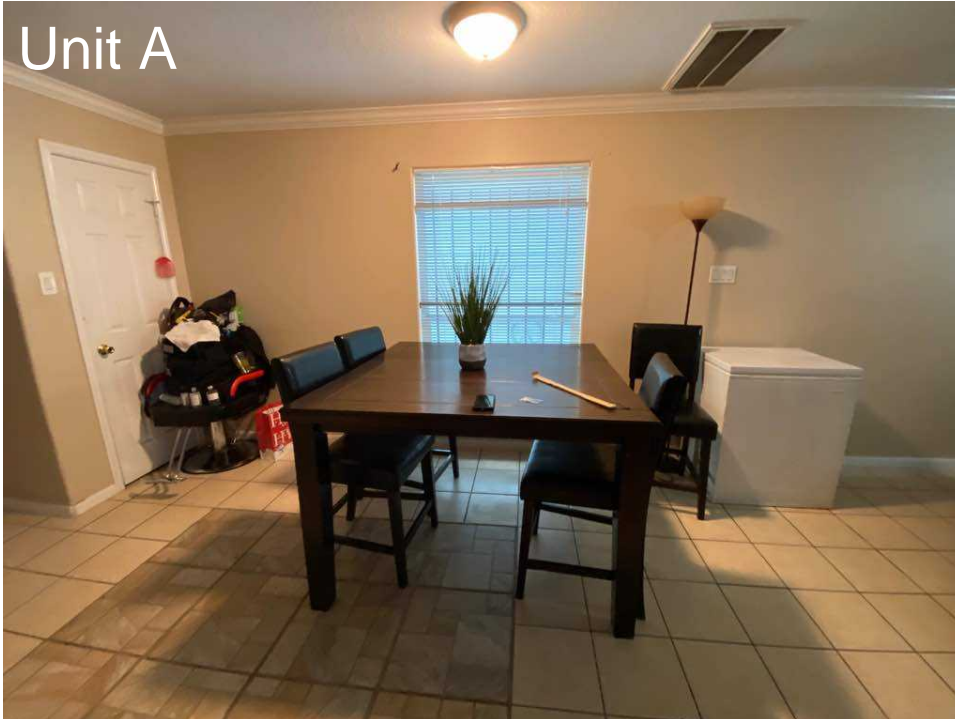
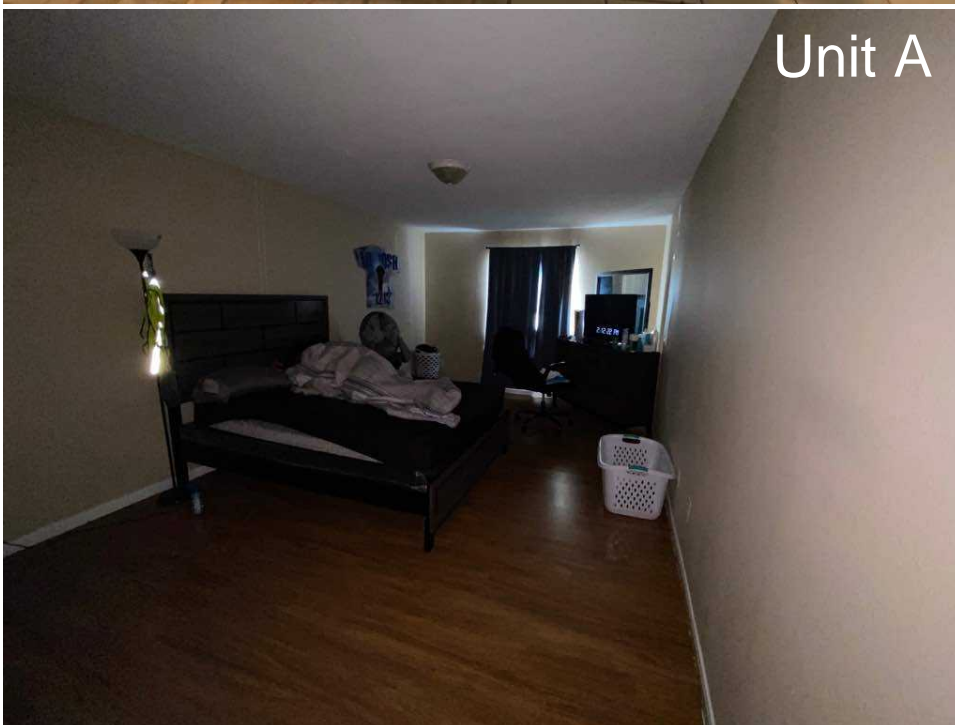
Damaged wall covering (exterior) observed.

a. Wood rot observed (multiple areas).

Correction recommended to minimize possibility of moisture / pest intrusion.

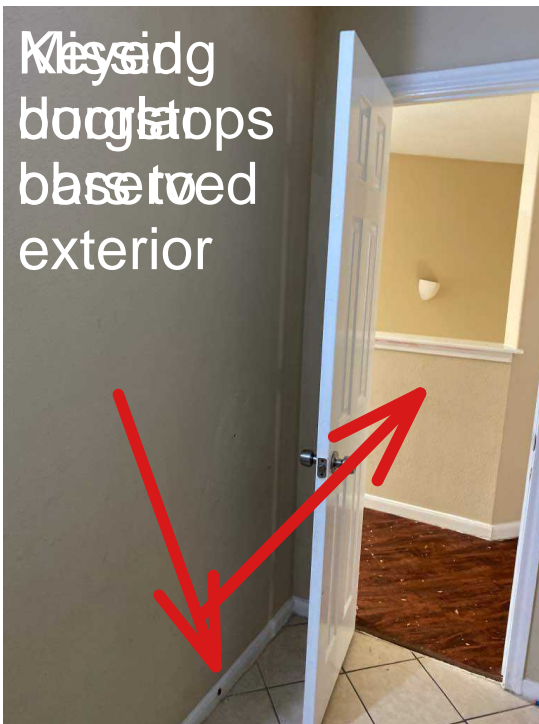
1. Burglar bars (keyed) observed at doors.

2. Missing doorstop observed.

Further evaluation and correction recommended by qualified contractor.

Correction recommended by qualified contractor to avoid wall damage.

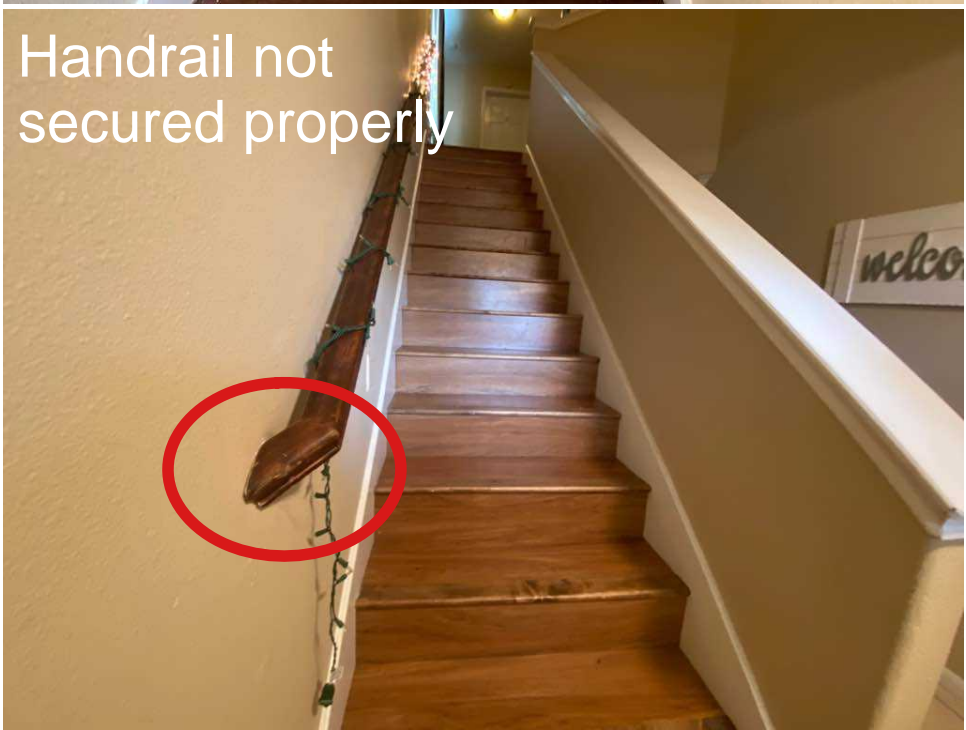
Stair handrails loose (moves unsteadily from side to side).

Correction recommended by qualified contractor.

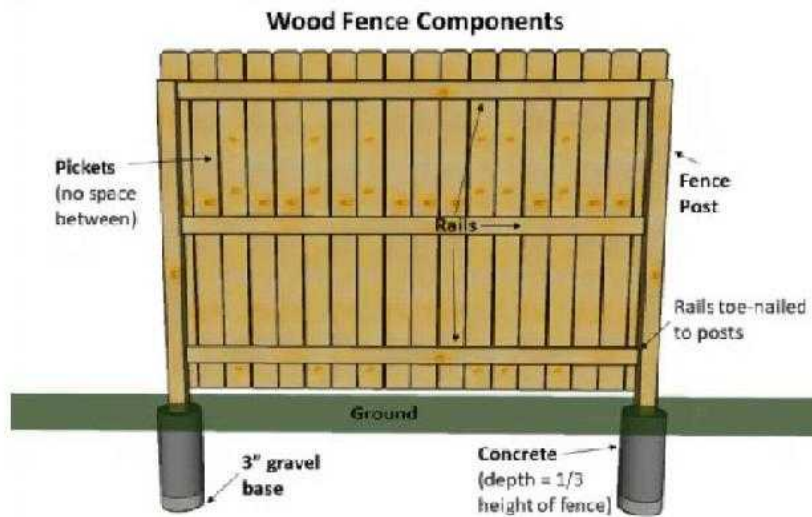
Observed damaged fence pickets / posts.

Damaged fence pickets / posts can be safety issue.

Recommend further evaluation & correction by qualified contractor.
