Smith Group Property Inspections

Property Inspection Report

4613 Knoxville Street, Houston, TX 77051
Inspection prepared for: Michael Jolivet and Dwight Bazile

Date of Inspection: 12/30/2021 Time: 7:00AM
Age of Home: 2006 Size: 4000 sqft

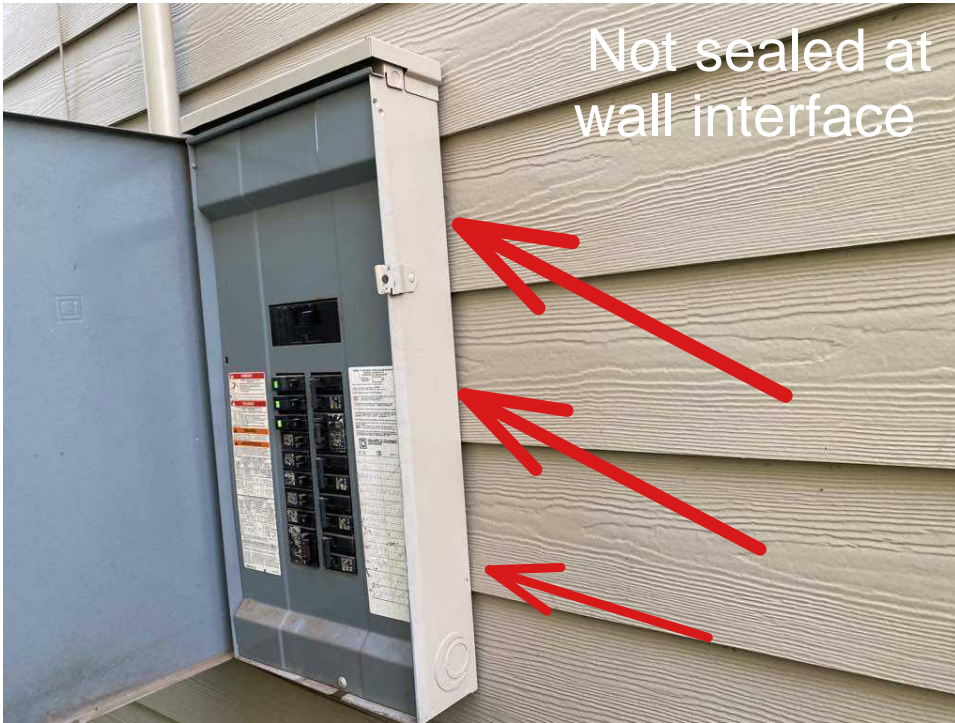
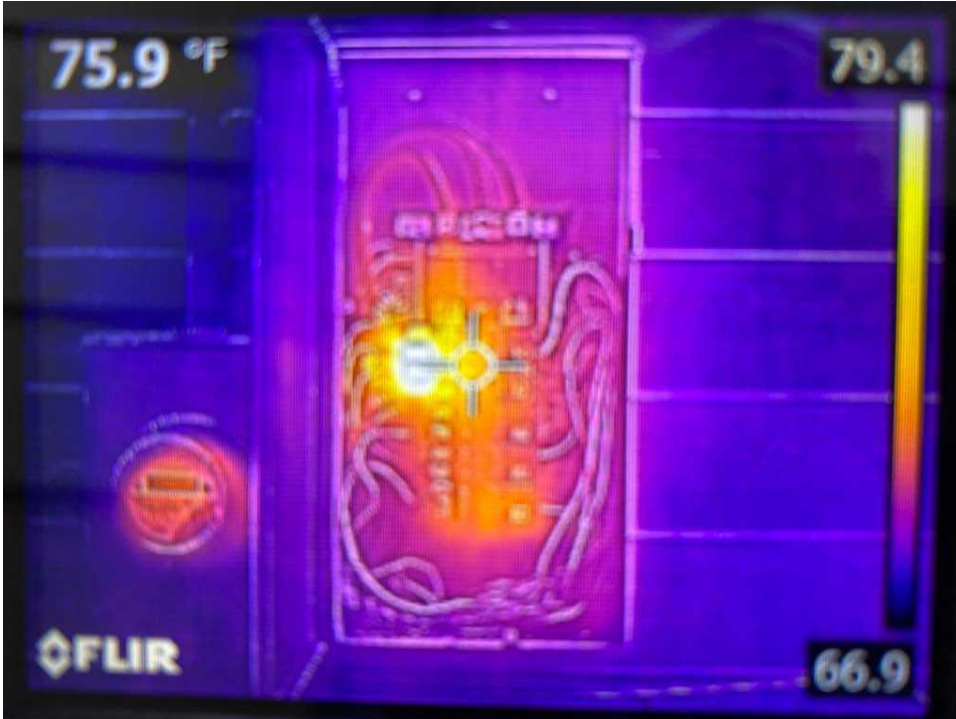
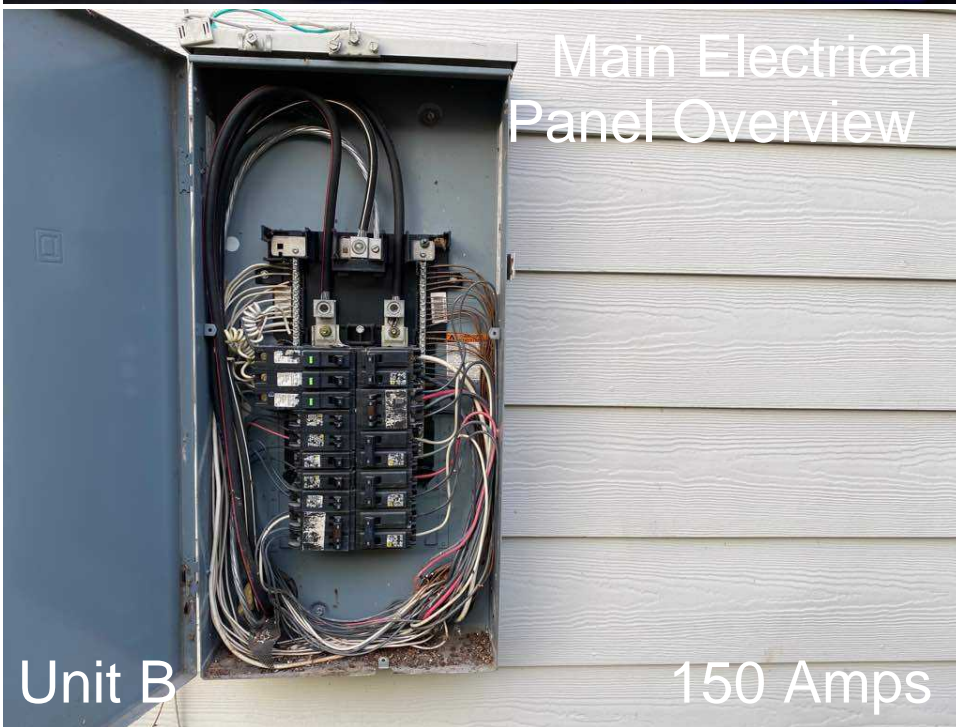
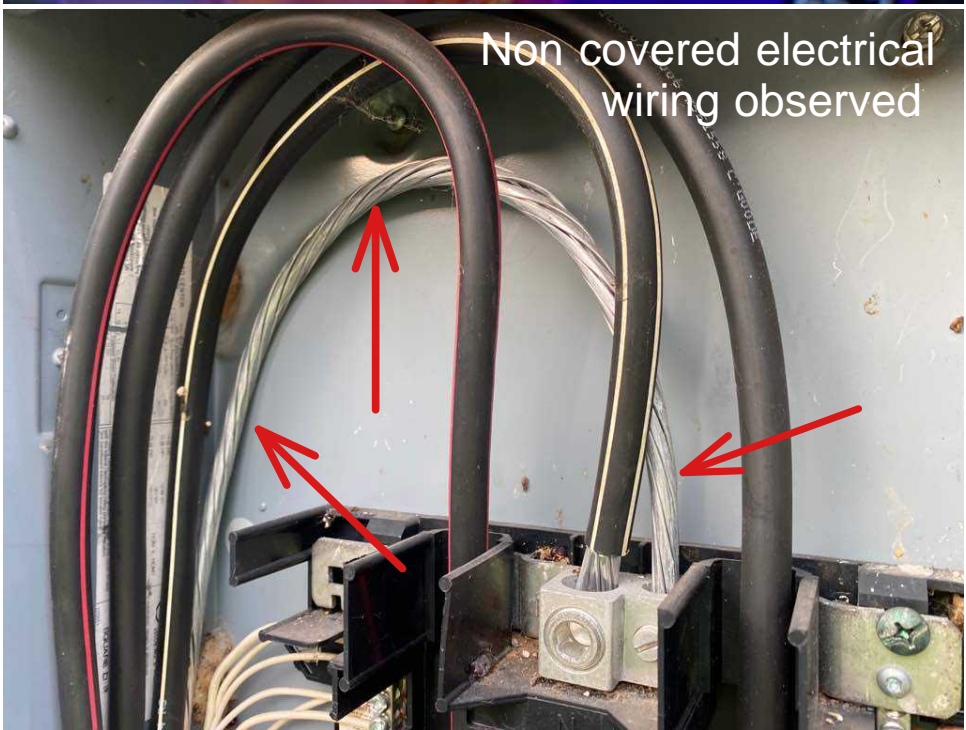
1. No anti-oxidant paste observed at main electrical aluminum cables in panel.

Anti oxidant paste is recommended for aluminum cables because (without the paste) aluminum can overheat & become fire hazard.

3. Non covered electrical wiring observed (Unit B).

Further evaluation & correction recommended by qualified contractor.

Correction recommended by qualified contractor

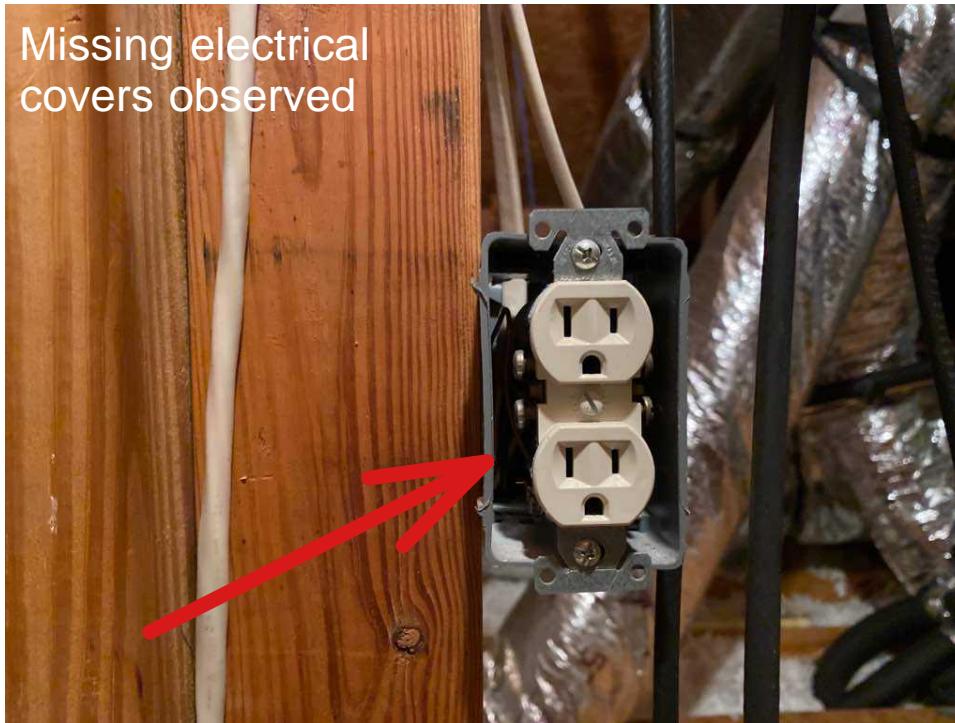
Electrical covers missing from outlets (multiple).

Correction recommended by qualified contractor.

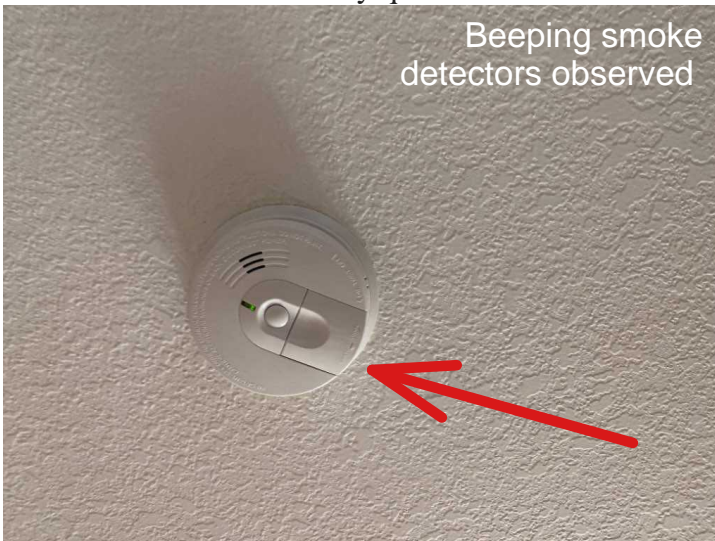
Observed batteries needing replacement in smoke detectors (multiple).

Correction recommended by qualified contractor to ensure proper safety.

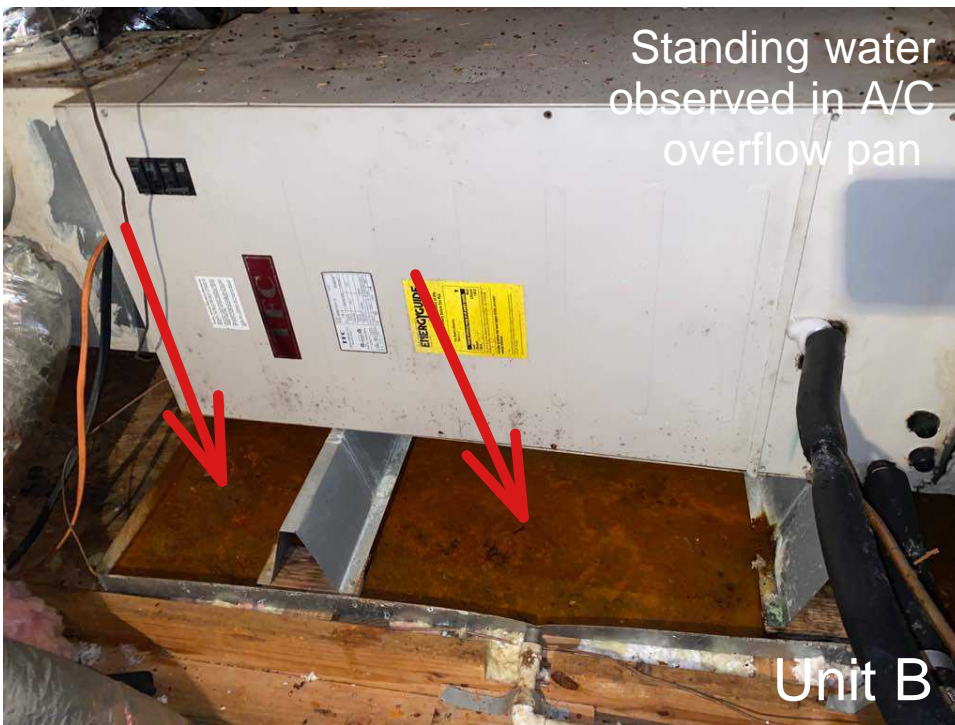
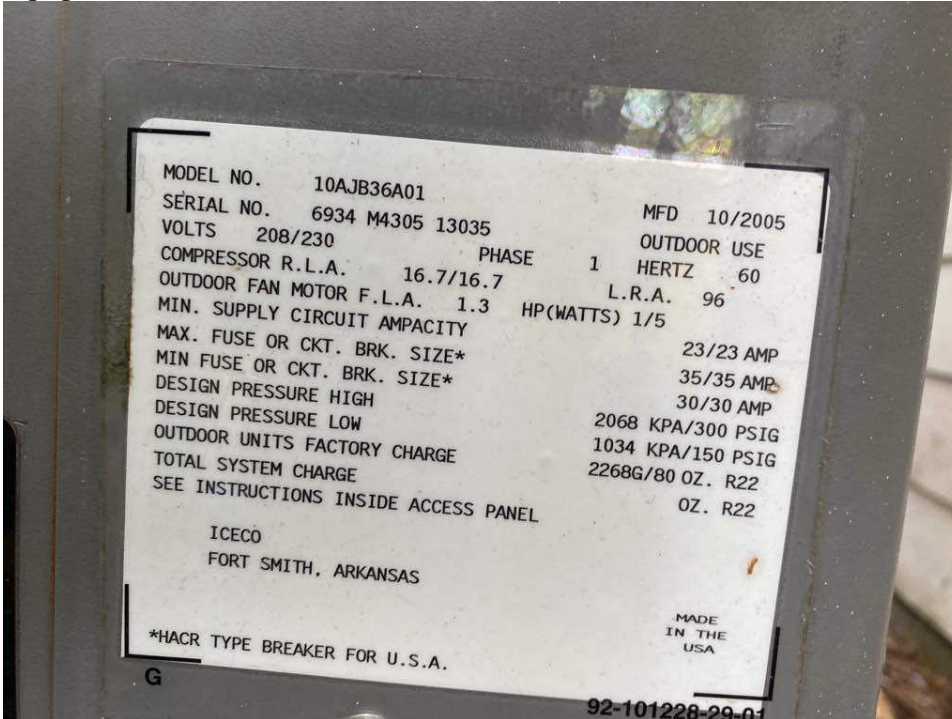
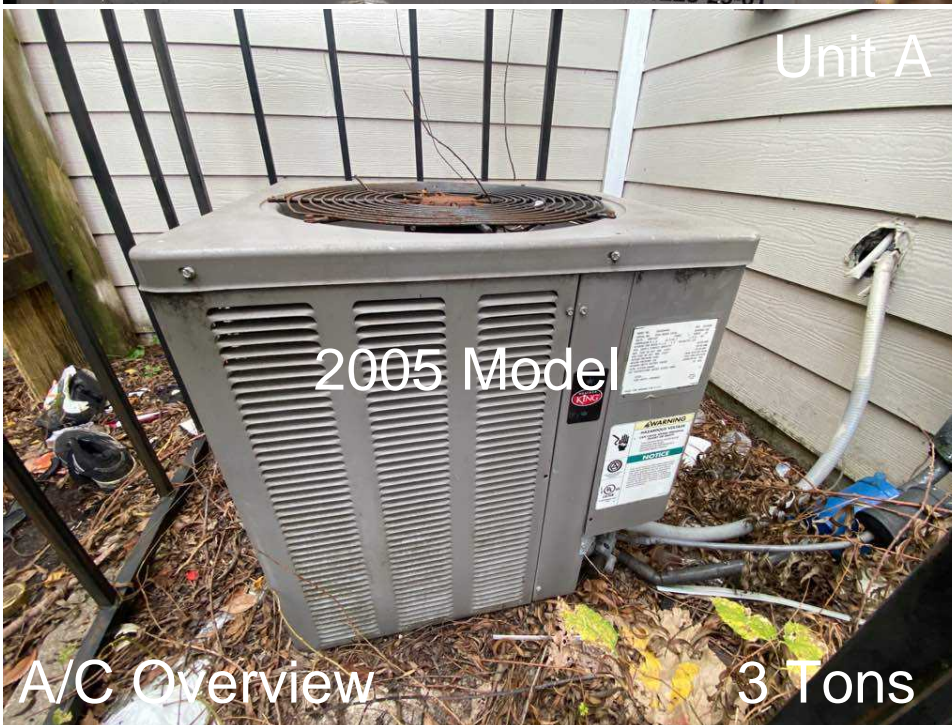
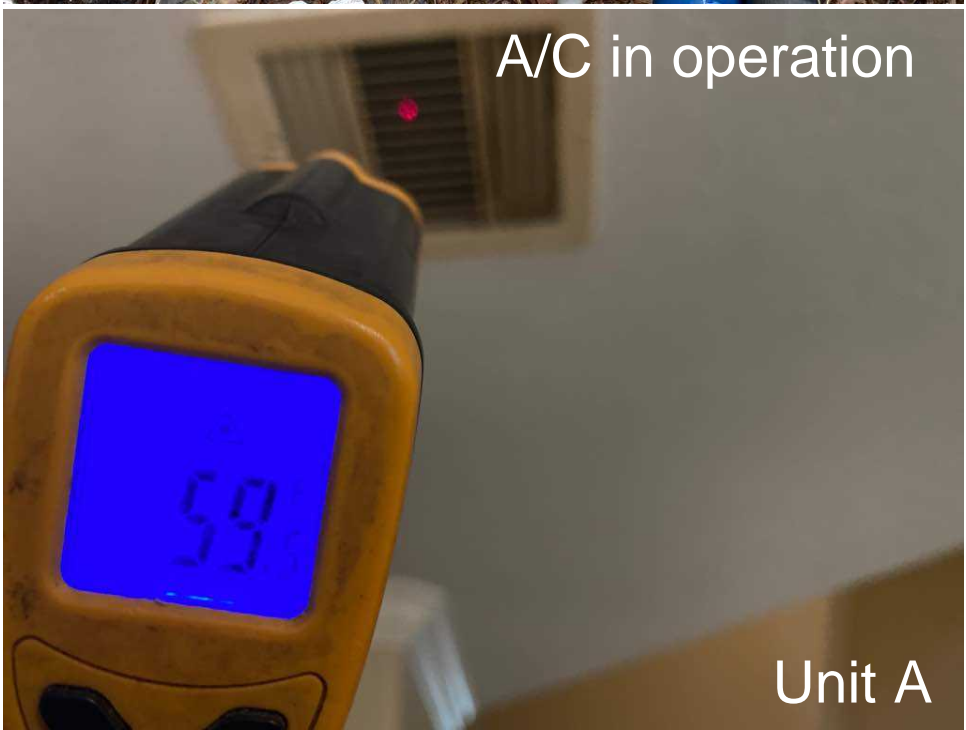
1. Standing water observed in A/C overflow pan & water dripping from secondary condensation drain.

Moisture in A/C overflow pan often indicates blockage of primary condensation drain line.

2. Observed no cap flashing (& not weathertight) where the A/C lines enter the structure.

Further evaluation and correction recommended by qualified contractor.,

Correction recommended by qualified contractor to avoid moisture / pest intrusion.

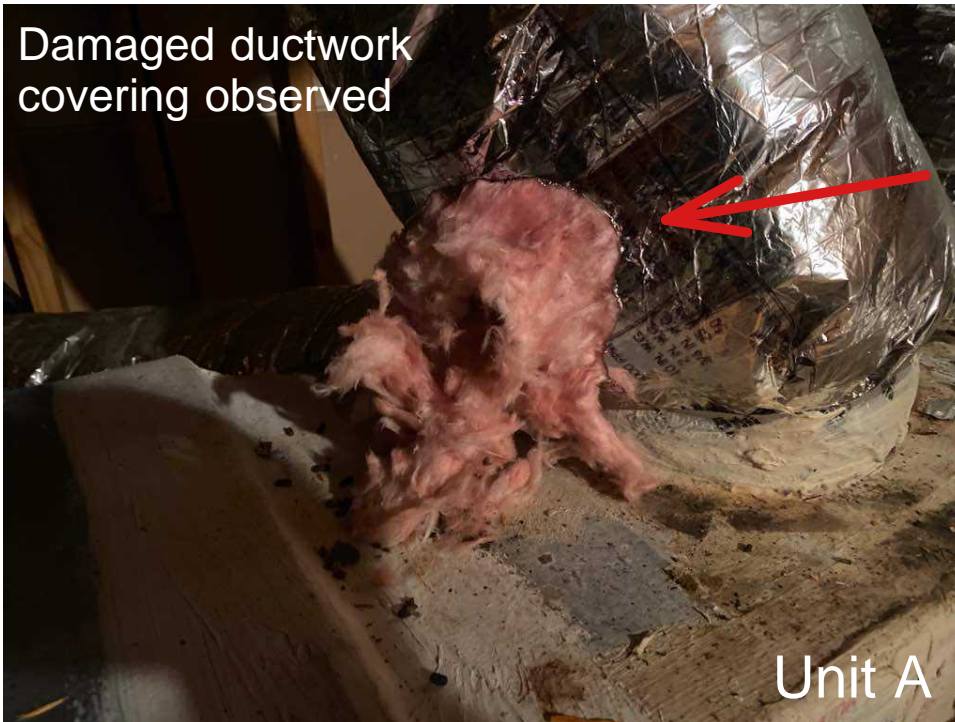
Damage observed at air supply duct in the attic.

Correction recommended by qualified contractor.

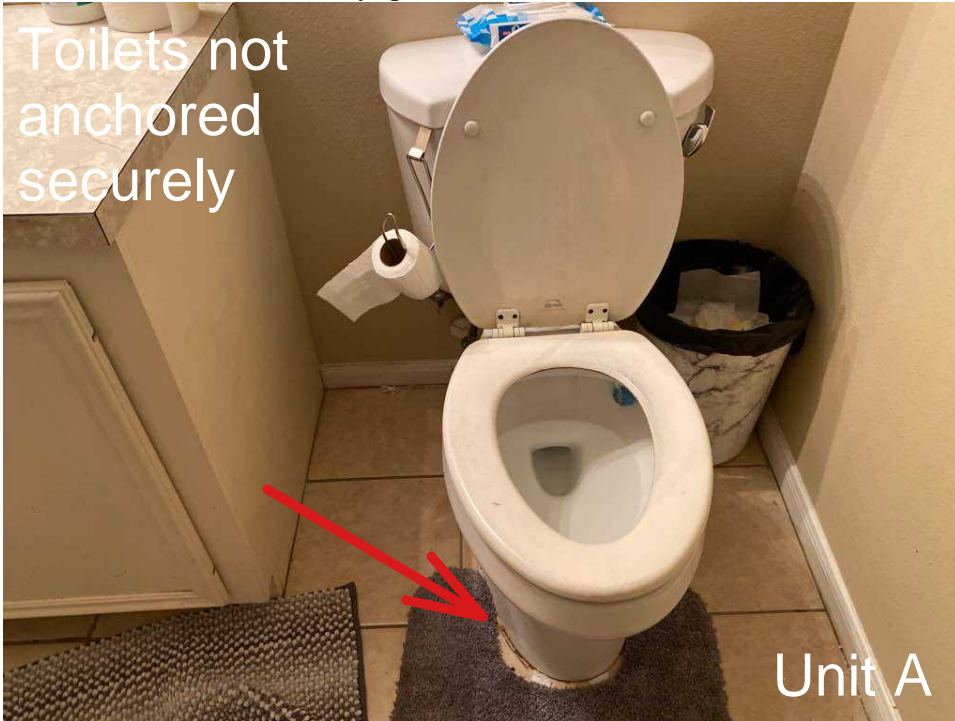
Observed toilet loose at floor mounting.

Correction recommended by qualified contractor.

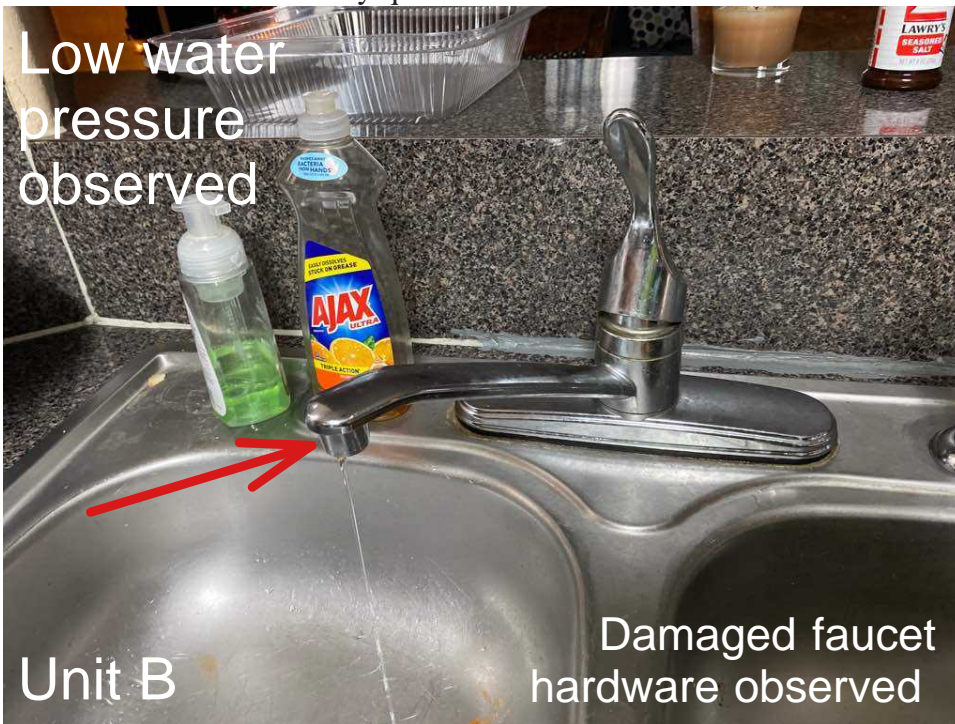
1. Observed loose or damaged kitchen faucet hardware (Unit B).

2. Observed sink leaked into cabinet below (Unit A)

Correction recommended by qualified contractor.

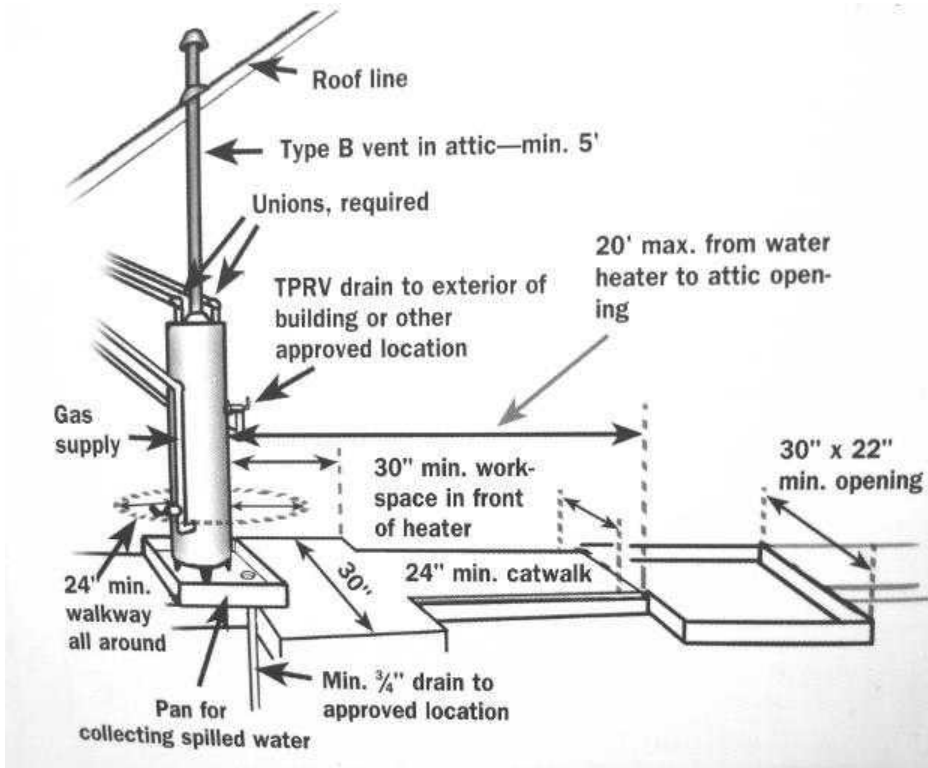
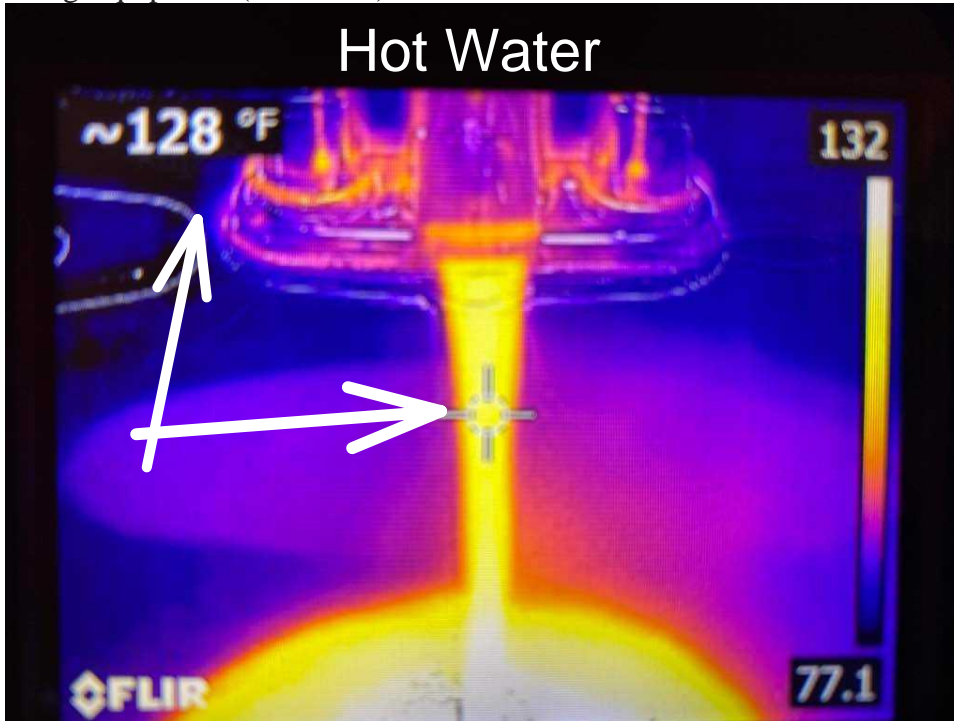
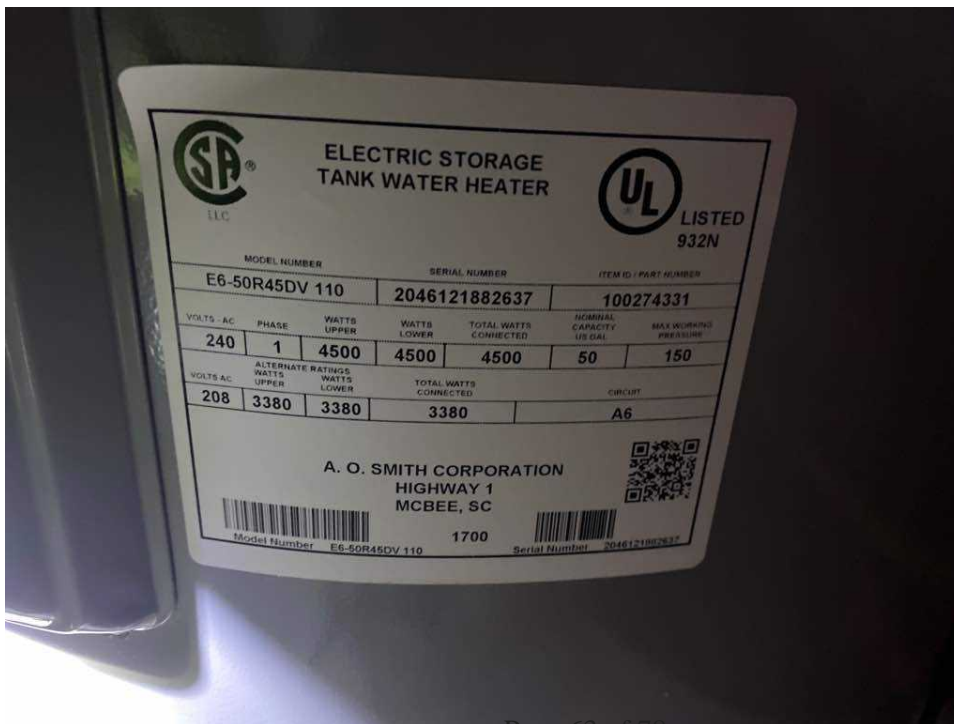
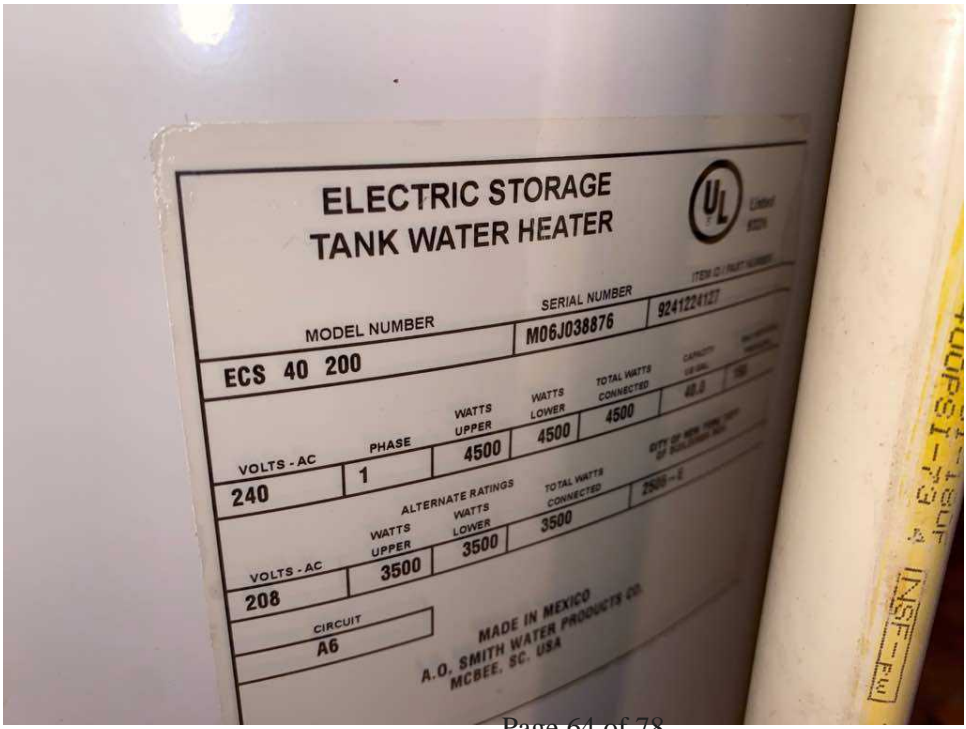
No TPR (Temperature Pressure Relief) drain pipe observed / installed at time of inspection.

The purpose of the TPR (Temperature Pressure Relief) drain pipe is to discharge water / steam if the water heater were to become overheated / over pressurized.

Correction recommended by qualified contractor.

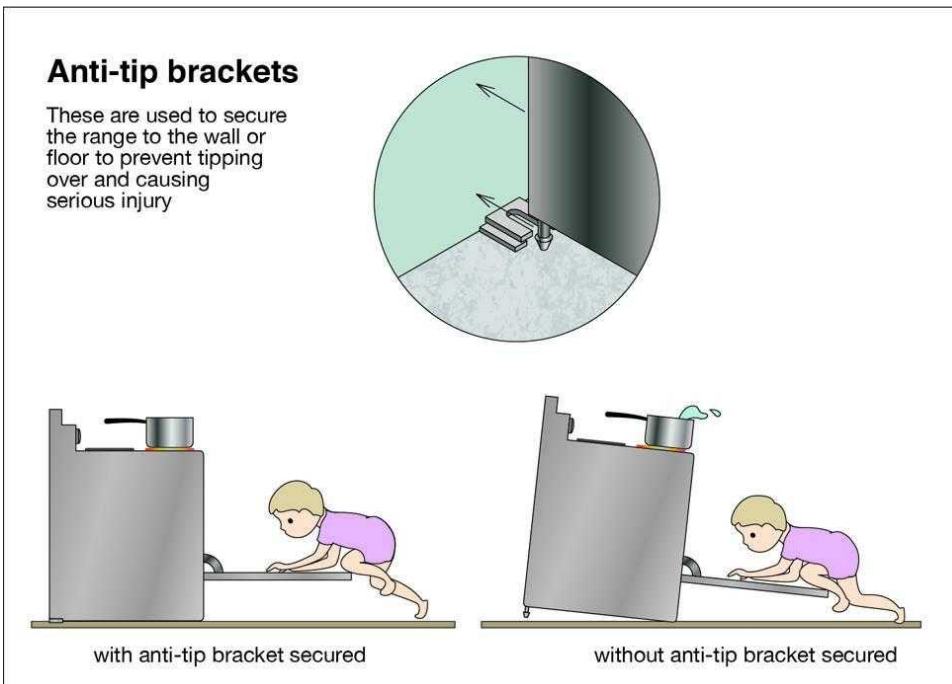
No anti-tip brackets installed on oven (safety).

Correction recommended by qualified contractor.
