PROPERTY INSPECTION REPORT

Report # 21187

Concerning: 114 Mango Lake Jackson, TX 77566
(Address or Other Identification of Inspected Property)

By: Kenny Boulton **July 21, 2021**
TREC Professional Inspector Lic.# 698 (Date)

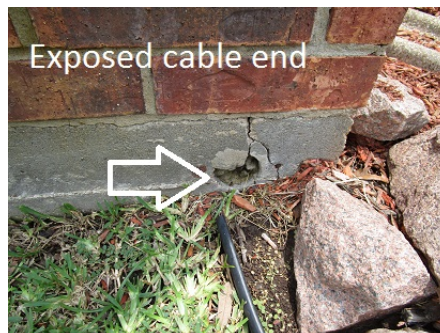
The exposed post tension cable end on the living room left side front corner should be sealed to prevent rust and corrosion in the exposed cable end.

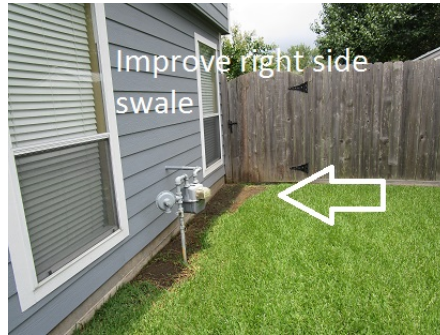
The right side drainage swale (in effect, a wide and shallow ditch) at the right rear corner area of the house should be improved. Drainage swales are intended to divert storm water away from the house and ultimately off the lot.

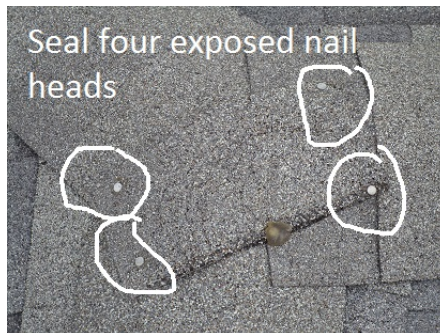
The four exposed nail heads at the EI intersection of the peaks of the roof should be sealed.

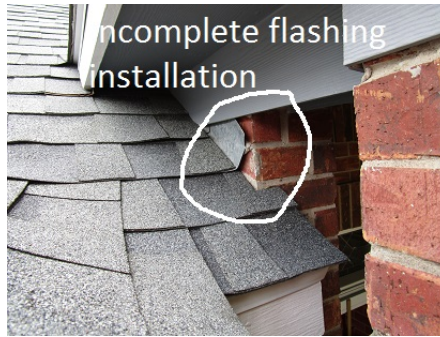
The incomplete flashing on the front entry upper left corner should be completed.

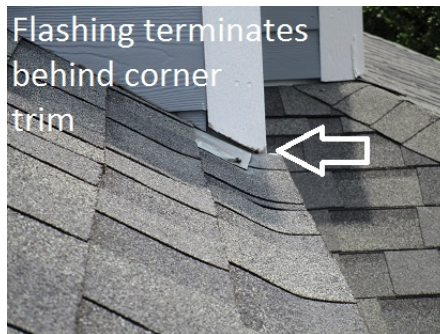
The master bedroom left front corner flashing terminates behind the corner trim and should be repaired to kick out from behind the corner trim. This will prevent any water from running behind the corner trim.

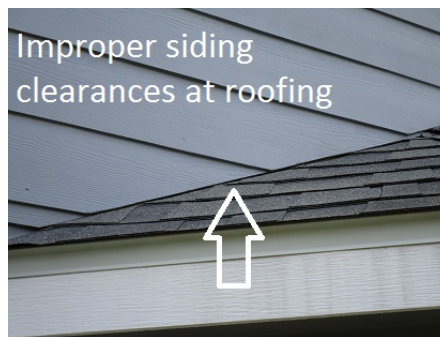
The fibered cement board manufacturer recommends a minimum siding bottom clearance of one inch from the roofing.

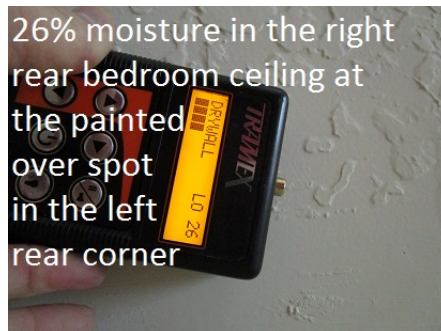
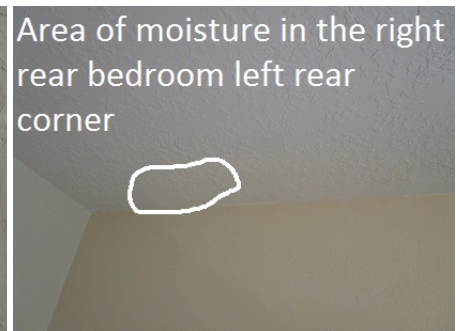
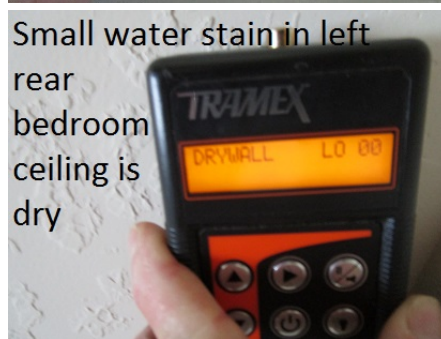
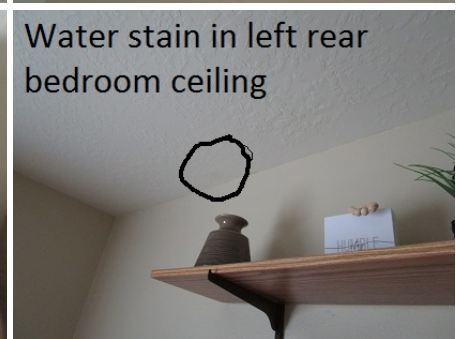
Water staining was noted in the left rear bedroom ceiling on the right side with a painted over area in the right rear bedroom ceiling left rear corner. These areas were tested with a Tramex MRH III moisture meter and found excessive moisture up to 26% in the right rear bedroom ceiling and the left rear bedroom ceiling to be dry at the time of the inspection. Although no visible signs of leakage were found around the chimney from the attic, it appears there may be some slight seepage at the chimney causing the moisture in the right rear bedroom ceiling. This should be investigated further to determine the source of moisture and repairs made as necessary.

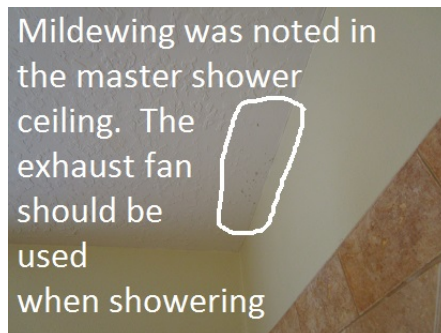
Several small mildew spots were noted above the master shower. The bathroom exhaust fan should be used when showering.

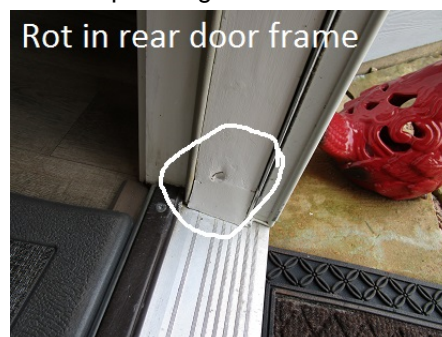
Rot and patching was found in the rear exterior door frame.

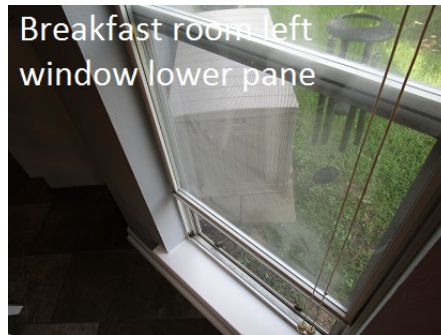
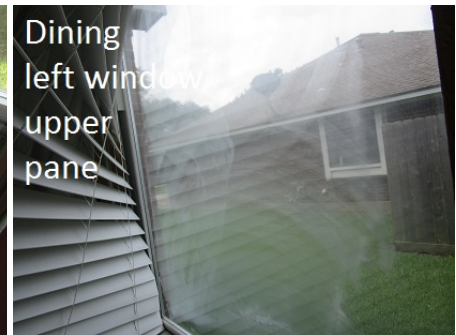
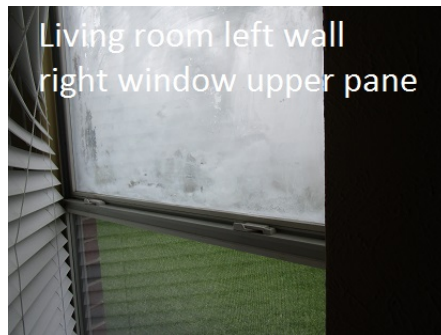
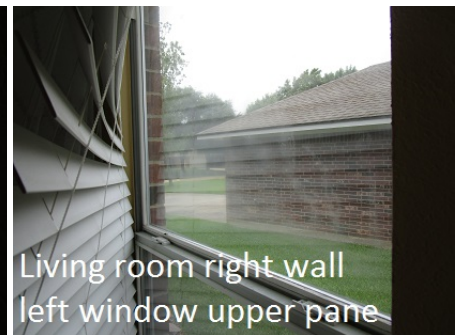
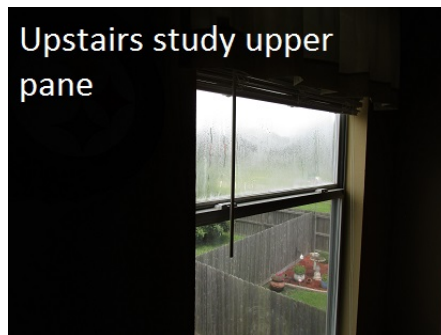
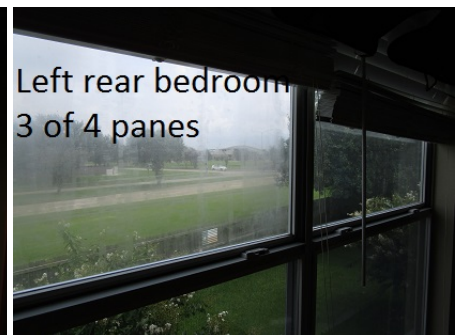
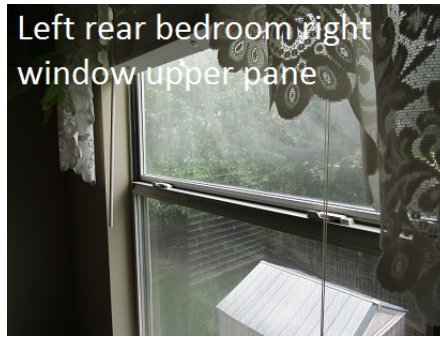
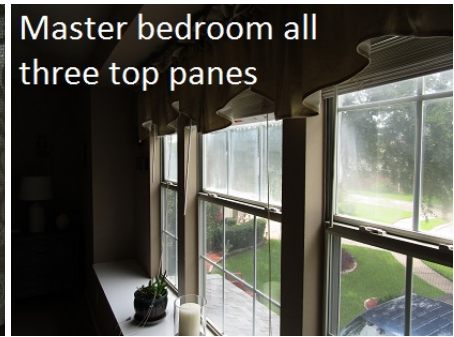
At least eleven window panes have lost their seal. This has resulted in condensation developing between the panes of glass and can cause the glass to lose its insulating properties. The glass should be replaced.

The windows should be cleaned and re-inspected to determine if additional panes have lost their seal.

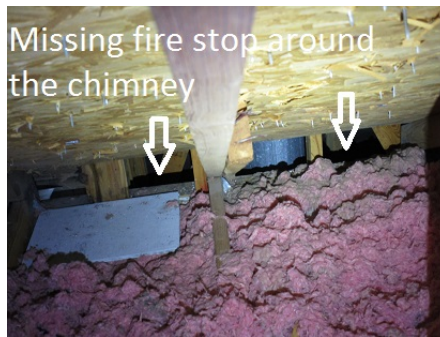
Fire stop (fire rated material ie. drywall, metal, etc. that will stop the spread of fire to the attic space) should be installed around the chimney at the second story top place as seen from the attic.

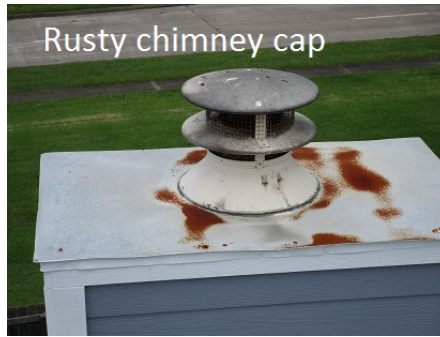
The metal chimney cap is rusty.

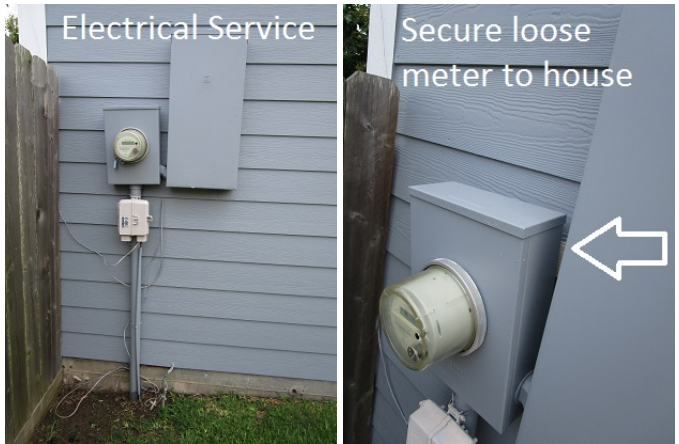
The loose meter panel should be better secured to the side of the house.

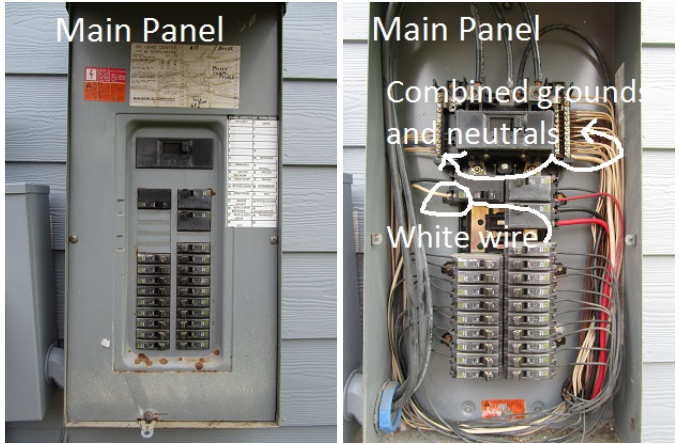
All circuits should be properly identified.
The white wire used as line or hot wire for the AC should be identified as such by wrapping the wire with black or red electrical tape or marking the wire with marker at the breaker.
The neutral and ground wires are combined on the neutral and ground terminals.
The Arc Fault Interrupter (AFI) breaker protection is not present for the bedroom and living areas. An arc-fault circuit interrupter is device intended to provide protection from the effects of arc faults by recognizing characteristics unique to arcing and by functioning to de-energize the circuit when an arc fault is detected.

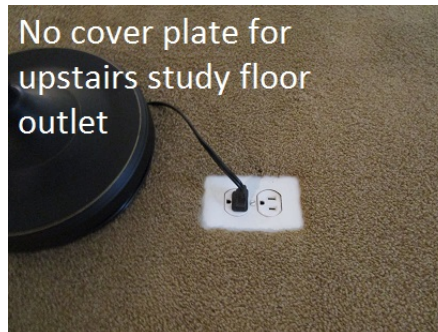
The upstairs study floor mounted outlet should have a protective cover plate installed to protect the exposed outlets facing up when not in use.

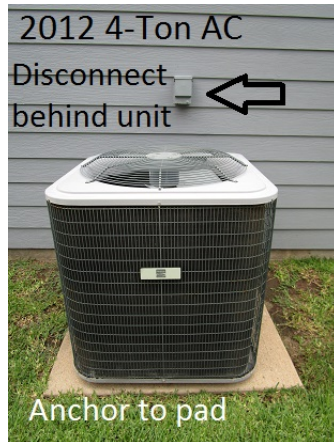
The electrical disconnect for the outdoor unit of the central air conditioning system should not be installed behind the unit.

The outdoor unit of the central air conditioning system should be properly anchored to the pad.

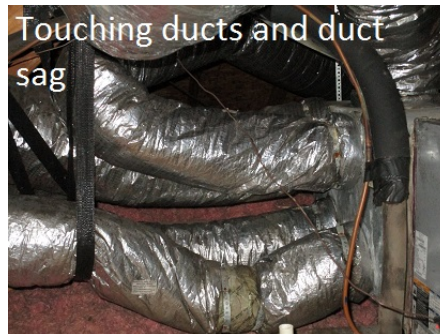
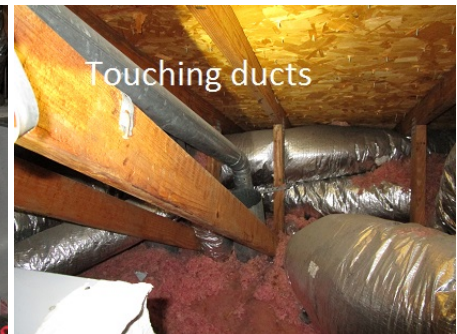
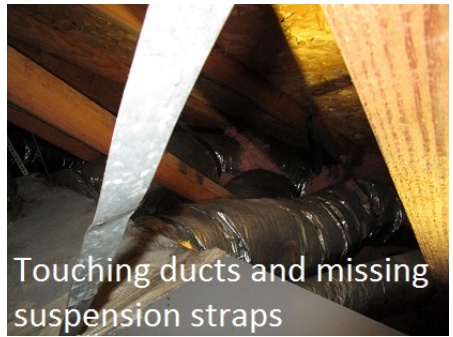
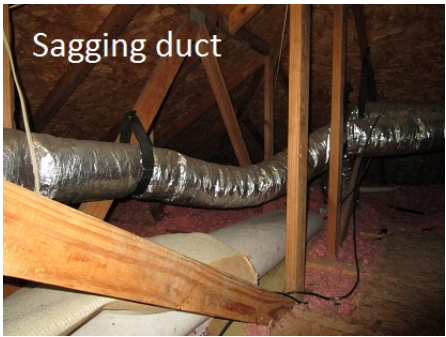
Touching ducts on top of the plenum should be suspended so the ducts do not touch. This can create a moisture/condensation issue between the two ducts. Isolation insulation should be installed between touching ducts or the ducts should be separated by re-configuration of the current ductwork suspension.

All ductwork should be properly suspended every four to five feet with no more than 1/2" of sag per foot.

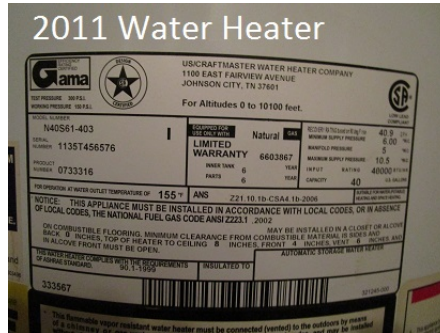
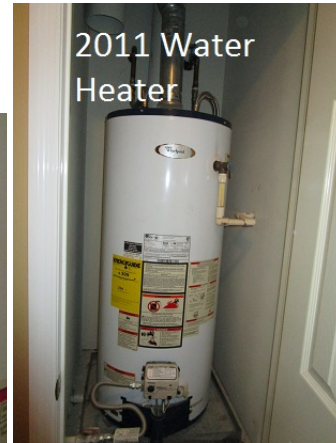
Water heaters have a typical life expectancy of 10 to 12 years. The existing unit 10 years old. One cannot predict with certainty when replacement will become necessary.

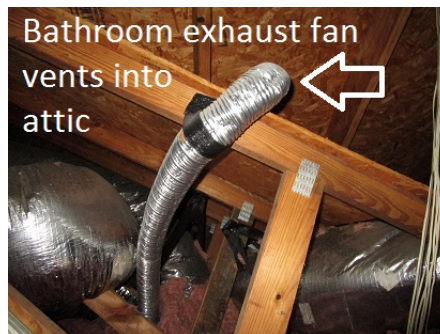
The bathroom exhaust fans should be vented to the building exterior instead of the attic.
