Inspection Report

Property Address:
1710 Westmere Ct
Houston TX 77077

PROPERTY INSPECTION REPORT

By: Sean Kennedy #22935 and Warren Sturges #24574 4/19/
2021
(Name and License Number of Inspector) (Date)

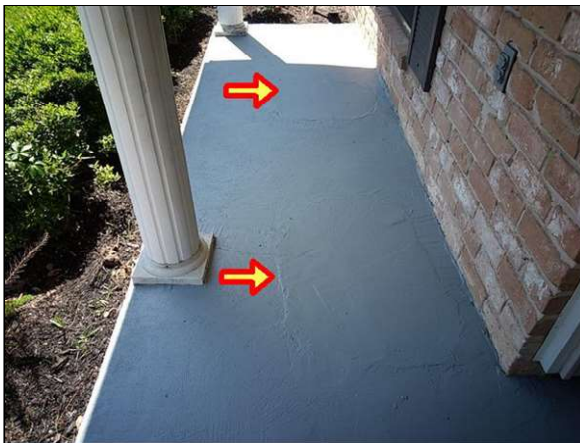
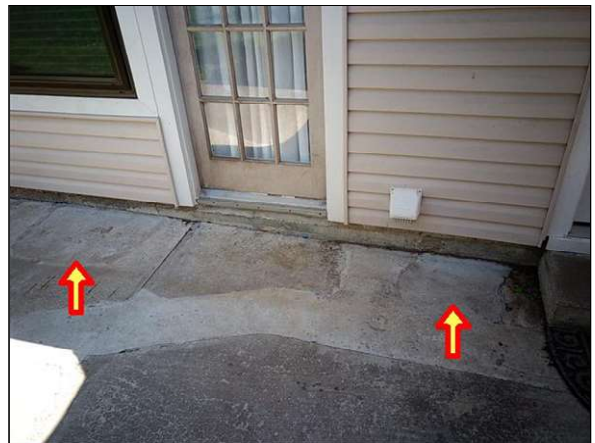
- Evidence of previous foundation repairs was observed. This inspection was performed without any data regarding the extent or final results of these repairs. Foundations repairs may not leave the foundation completely level and often the indications of excess movement before the repairs are still visible. In my opinion this foundation is not currently demonstrating evidence of defects that will adversely affect the overall performance of the foundation or evidence that suggests recent excessive movement. I do recommend that prospective buyers obtain as much documentation as possible regarding previous repairs and warranty information. The future performance of foundation is difficult to predict and other foundation inspectors or foundation experts may form a different opinion when evaluating this foundation. It may be advisable to consult with a foundation specialist before purchasing the home, regarding both its current condition, and the best measures to prevent further movement in the future.

concrete patches from foundation work

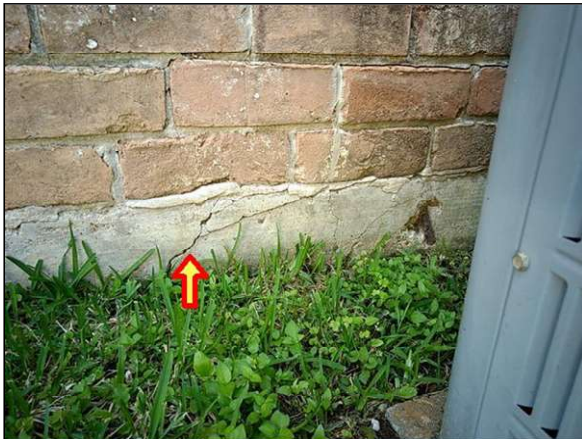
crack at foundation wall

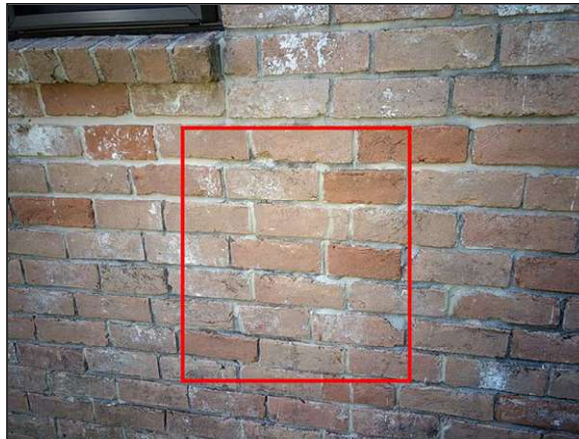
repaired veneer cracks

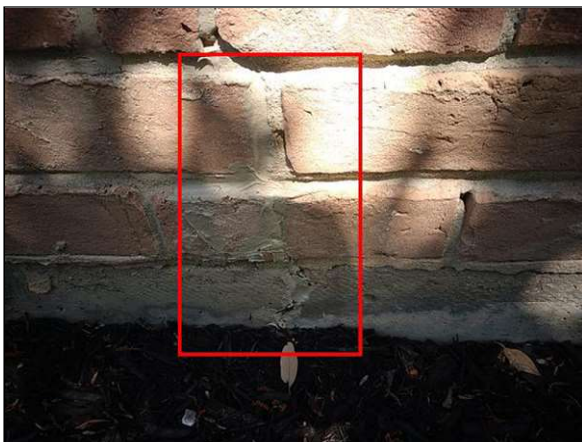
repaired veneer cracks

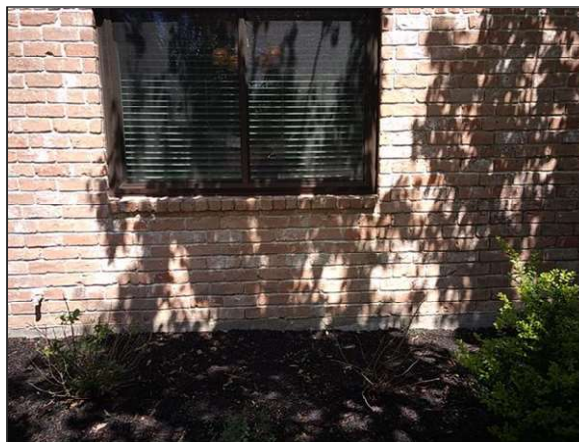
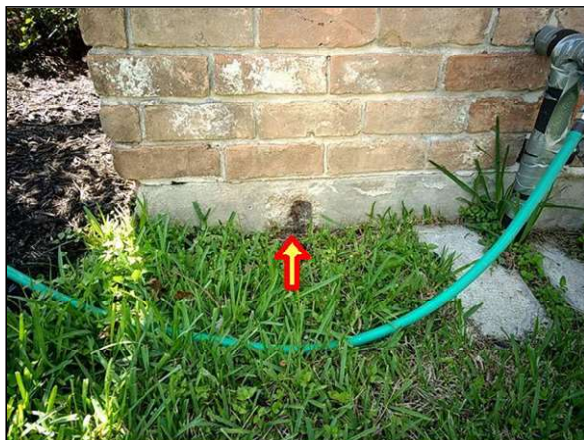
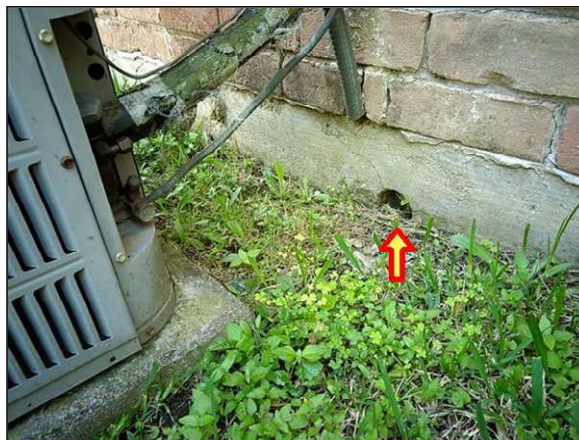
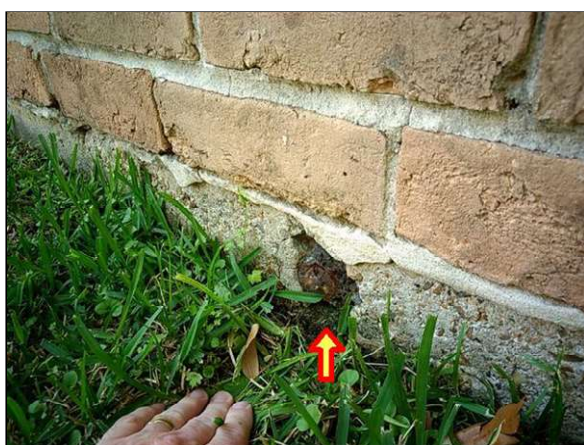
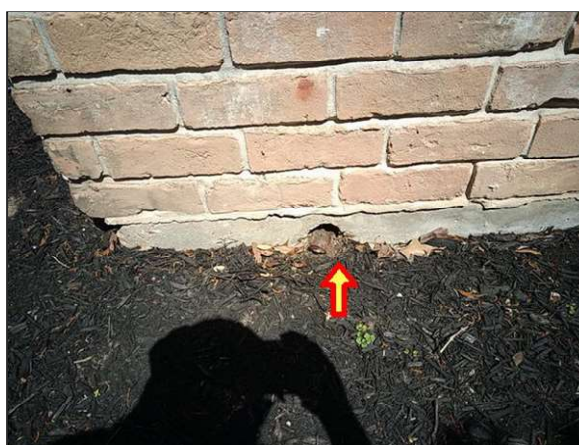
- Exposed post tension cable ends were observed on the exterior wall of the foundation. This should be repaired to prevent corrosion. Deterioration from corrosion causing release of tension on the cable is the primary concern. Consulting a foundation specialist is advisable

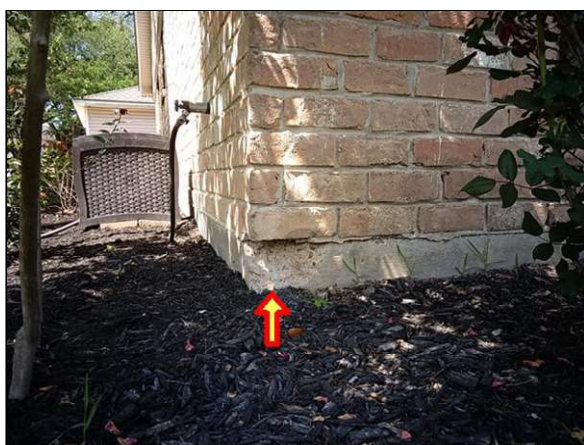
- The base for the brick veneer at the left front corner of the home is missing.

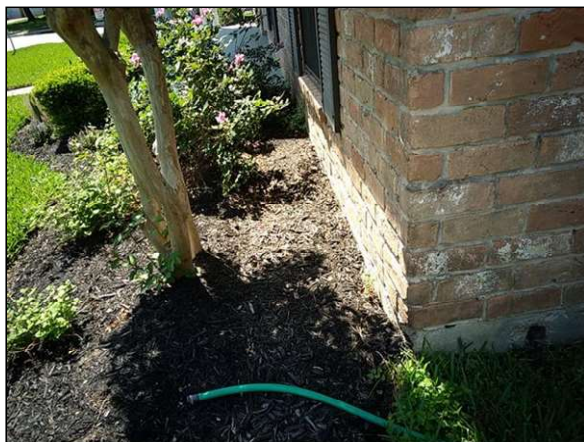
- High soil and mulch levels were observed in the planing bed at the front of the home. A minimum of four inches of foundation wall should be exposed under the brick veneer and a minimum of six inches of foundation wall should be exposed under the wood surfaces. High soil levels are conducive to wood destroying insect infestation, and possible water penetration into the home. When repaired, the grade should slope downward away from the home directing runoff away from the foundation. Improvements should be undertaken by professional landscaper.

- High soil and mulch levels were observed in the planing bed at the front of the home. A minimum of four inches of foundation wall should be exposed under the brick veneer and a minimum of six inches of foundation wall should be exposed under the wood surfaces. High soil levels are conducive to wood destroying insect infestation, and possible water penetration into the home. When repaired, the grade should slope downward away from the home directing runoff away from the foundation. Improvements should be undertaken by professional landscaper.
- The downspout is missing at the garage. Defective downspouts have the potential to erode the soil near the foundation, or saturate the soil are near the foundation. These conditions are detrimental to foundation stability.

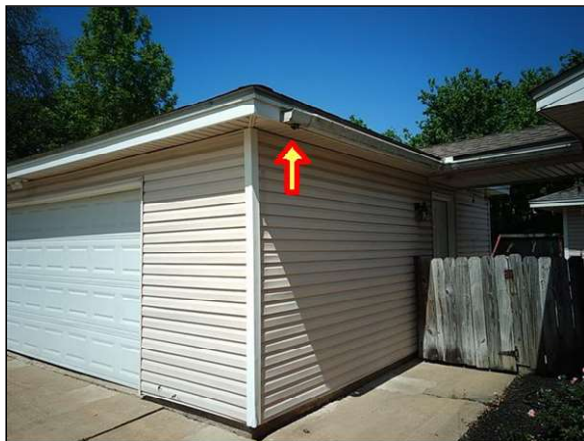
- The downspout is missing at the garage. Defective downspouts have the potential to erode the soil near the foundation, or saturate the soil are near the foundation. These conditions are detrimental to foundation stability.

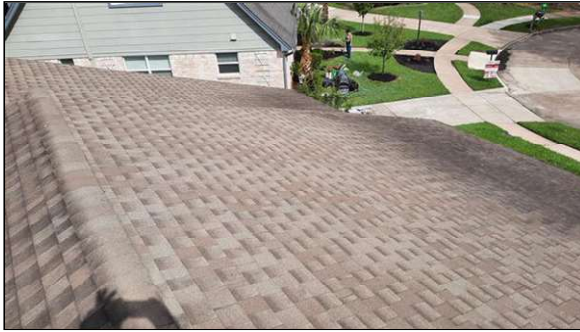
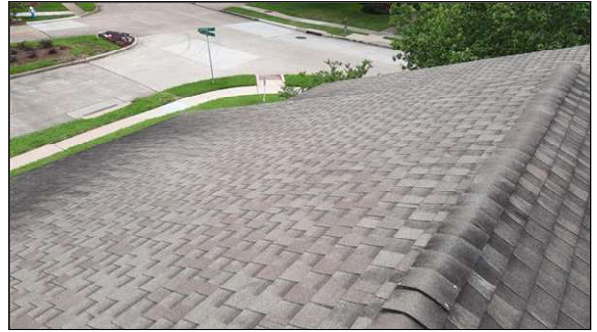
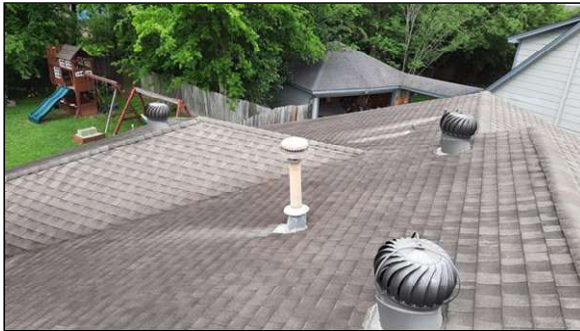
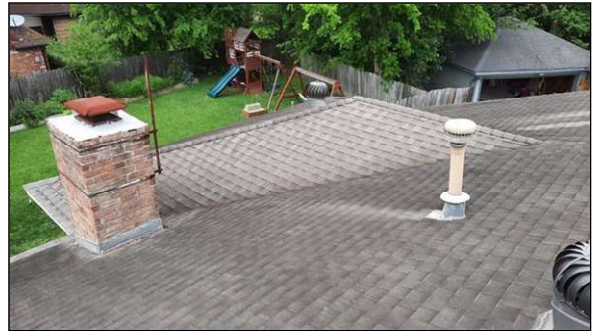
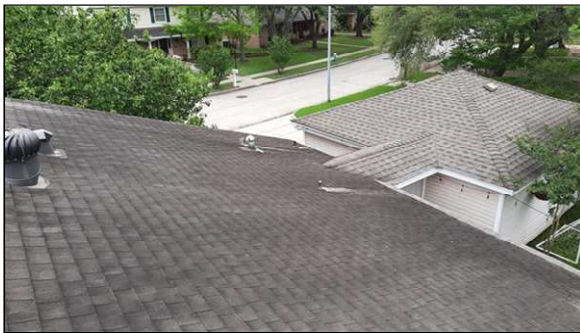
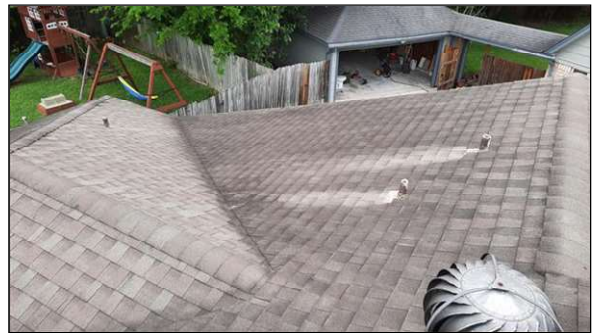
- Raised shingles were noted on the front of the roof. This condition is caused by protruding nail heads below the shingle. This condition makes the shingle susceptible to wind damage. In the long term the nail will penetrate through the raised shingle. Repairs should be undertaken.

- Raised shingles were noted on the front of the roof. This condition is caused by protruding nail heads below the shingle. This condition makes the shingle susceptible to wind damage, In the long term the nail will penetrate through the raised shingle. Repairs should be undertaken.

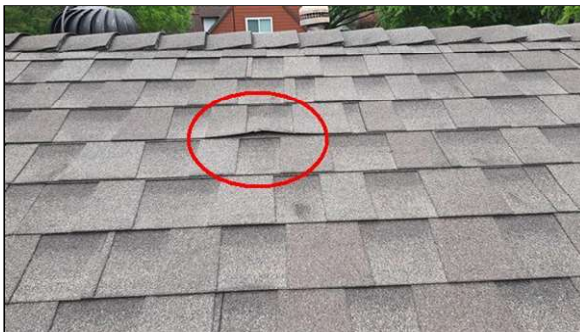
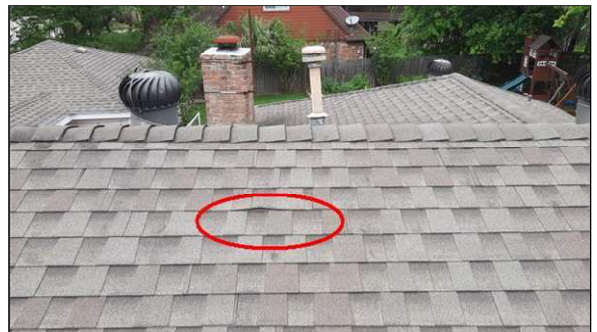
- What appears to be evidence of previous repairs was observed at the rear patio. If possible further information regarding this condition should be obtained from the current owners. It is not possible to determine the effectiveness or longevity of repairs.

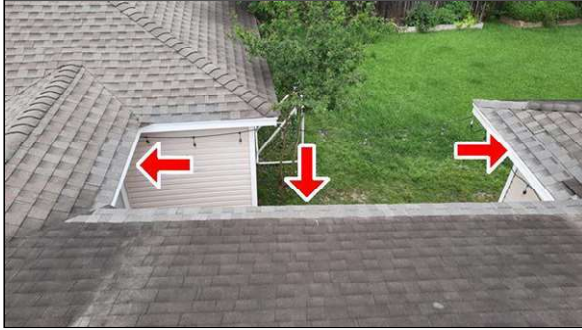
- Exposed nail heads at the rear of the roof should be sealed to prevent water intrusion.

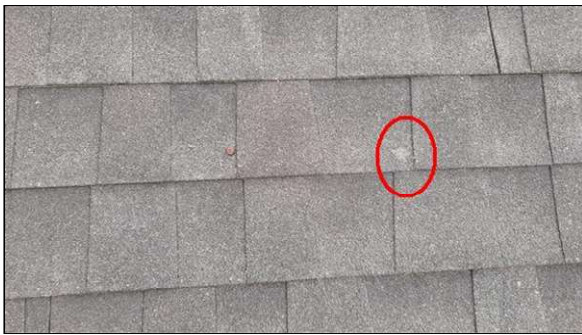
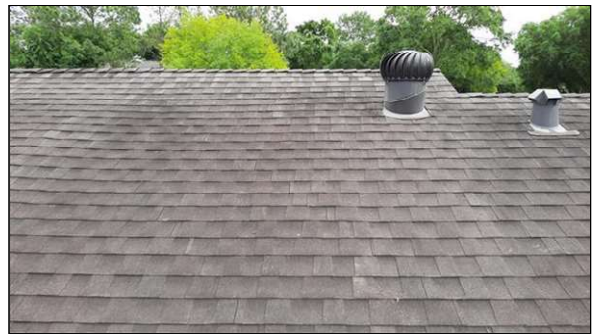
- Exposed nail heads at the ridges should be sealed to prevent water intrusion.

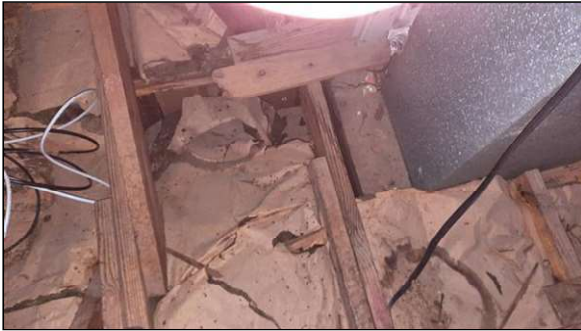
- The attic insulation is damaged. Insulation should be installed as specified by the manufacture to achieve an R value of no less than R30 .

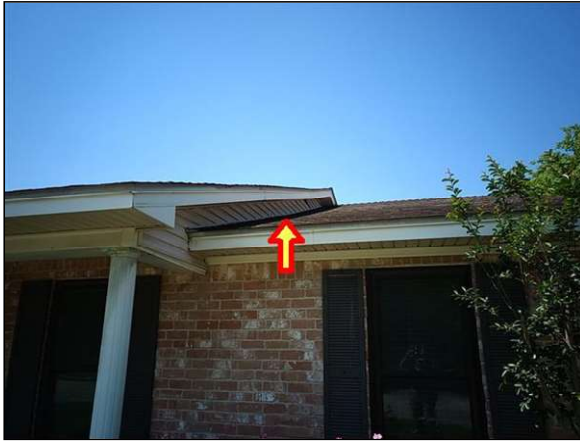
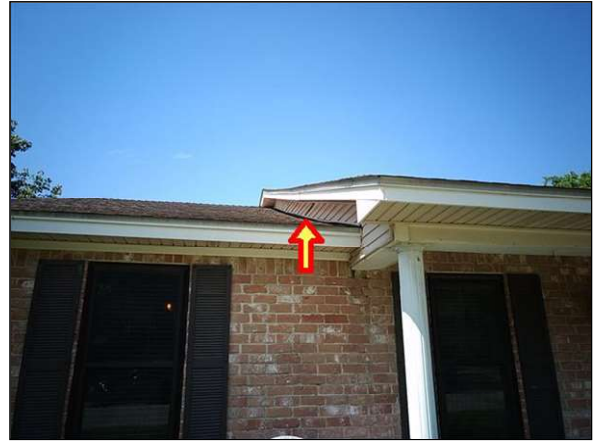
- Loose siding panel was observed at right and left side of the roof.

14. • Loose siding panel was observed at right and left side of the roof.

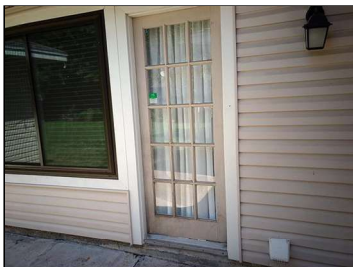
- The interior door at the powder room has the following defects: door does not latch.
- Note: the exterior door in the family room is no longer a functioning doorway.

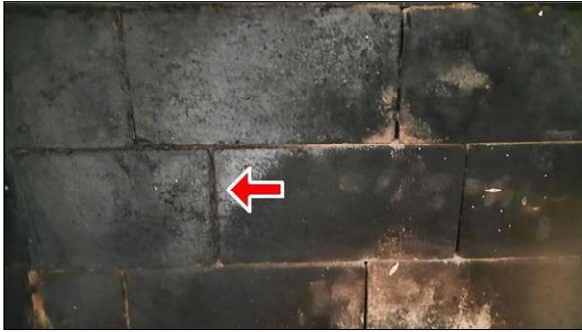
- Gaps in fire brick were observed in the rear of fireplace

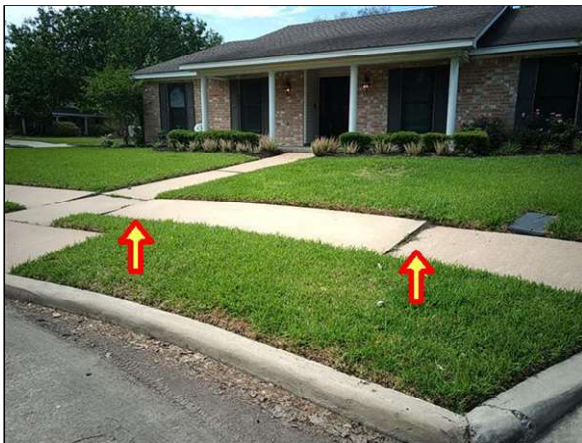
- The concrete walkway at the front of the home is uneven, and can be a tripping hazard. A fall or injury can occur if not corrected. .

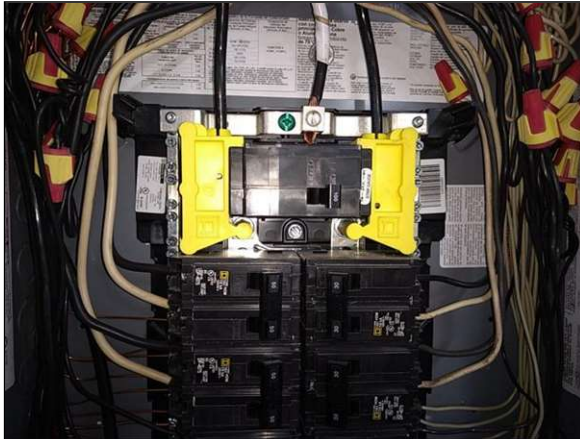
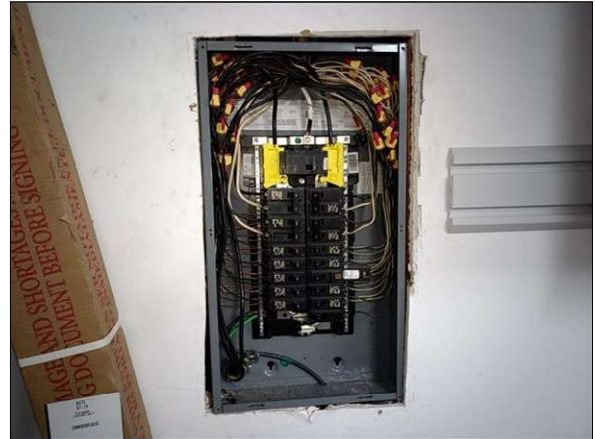
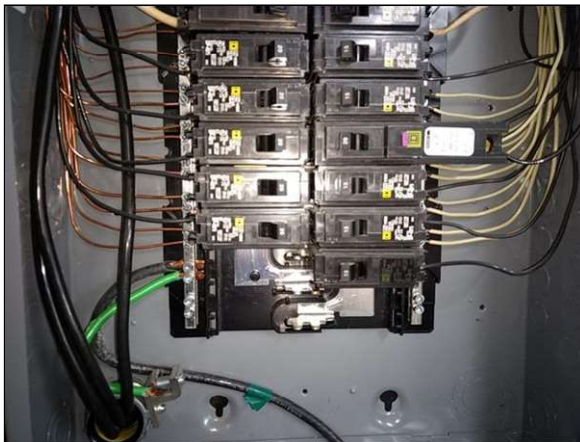
- The main panel enclosure was inspected with the deadfront removed. Conditions needing repair were observed. These repairs should be performed by a licensed electrician. Additional defects may be discovered when inspected by the licensed electrician.

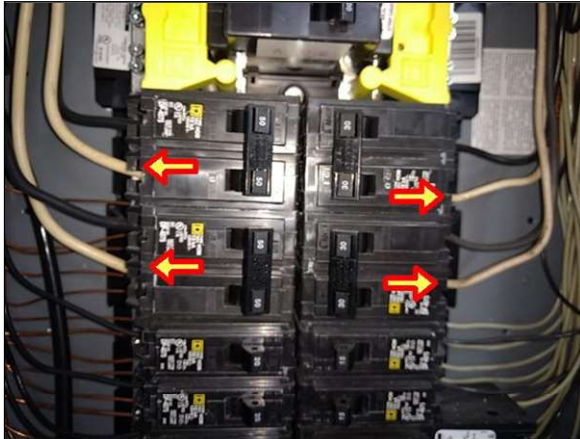
- "Hot" wires terminating at breakers in the main panel enclosure are improperly colored. These wires should be red or black in color. Marking the wires with a marker is acceptable.

18. • "Hot" wires terminating at breakers in the main panel enclosure are improperly colored. These wires should be red or black in color. Marking the wires with a marker is acceptable.

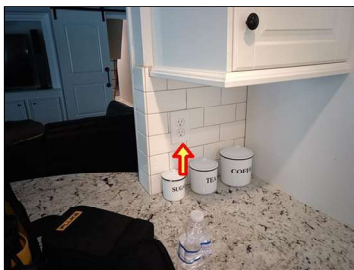
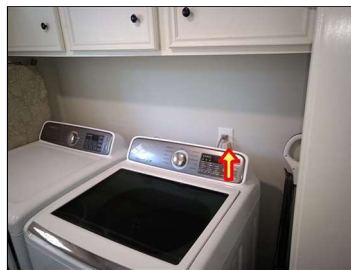
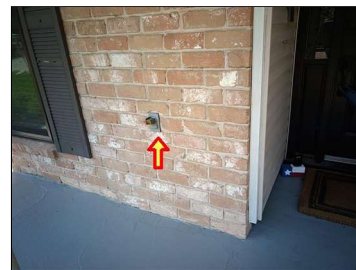
- Several receptacle(s) at the laundry room, kitchen counter and exterior of the home are not ground fault circuit interrupt (GFCI) protected. This condition is safety hazard that should be repaired.

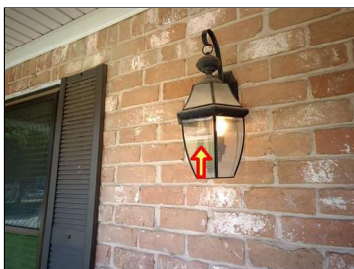
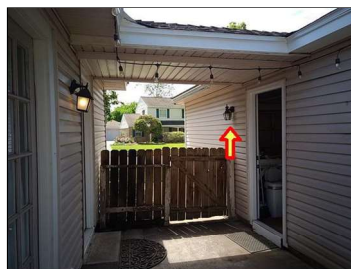
- Two light fixture(s) at the front of the home and garage have miscellaneous inoperative bulbs. If the fixture does not work after replacing the bulbs, a licensed electrician should be consulted.

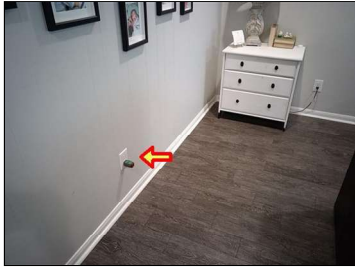
- One light fixture(s) in the hall bathroom is inoperative. If the fixture does not work after replacing the bulbs, a licensed electrician should be consulted.
- One receptacle(s) in the family room is(are) inoperative. Repairs should be performed by licensed electrician.

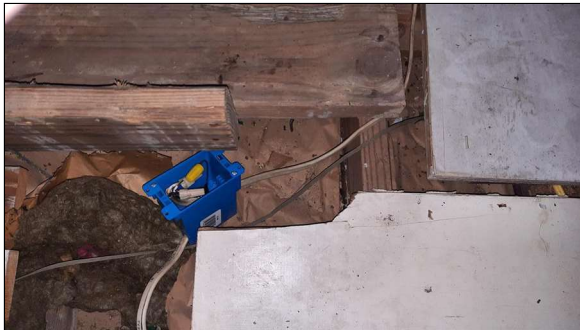
- Several electrical junction box(s) in the attic are missing a cover.

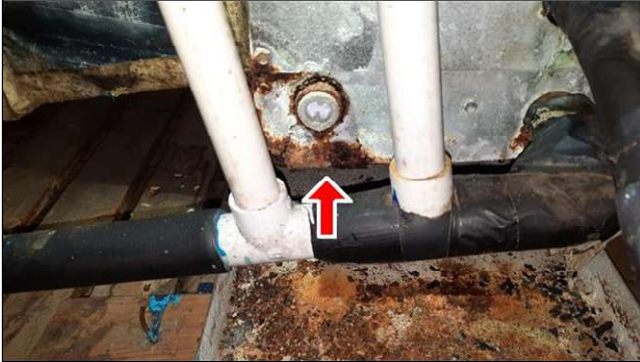
- The temperature drop across the coil for the cooling system The entire house has one unit is less than considered normal. This is an indication repairs are needed. A licensed HVAC technician should be consulted.
- Corrosion/rust on the coil side of the attic unit were noted.

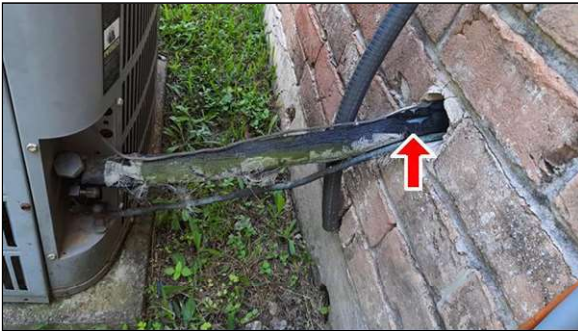
- The insulation at the condensing unit(s) refrigerant line(s) are damaged and they should be replaced.

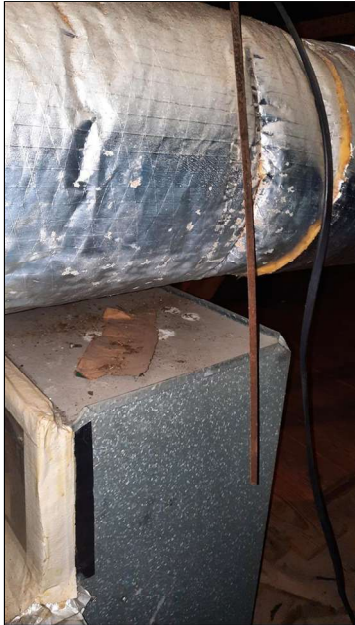
- Broken strapping supporting the ducts was observed. Repairs are needed.

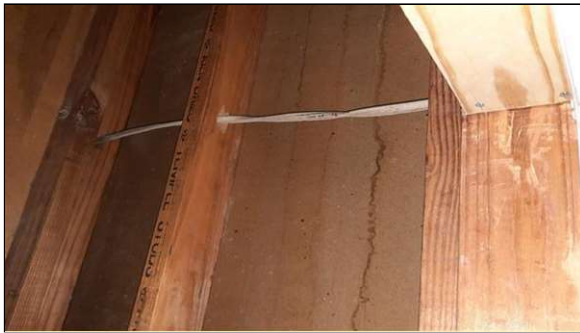
- The the return air chase hallway has electrical wiring inside the chase. This condition is a safety hazard.

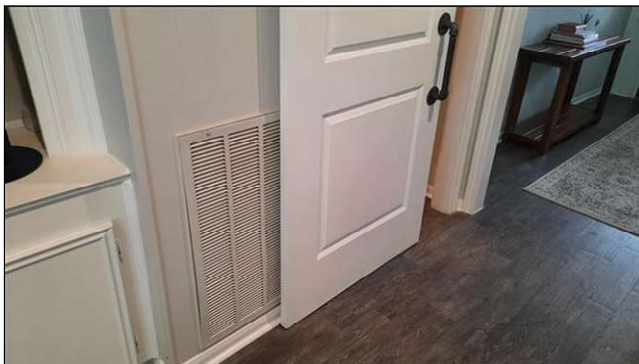
- The hallway barn door obstructs the AC return air grille when open.

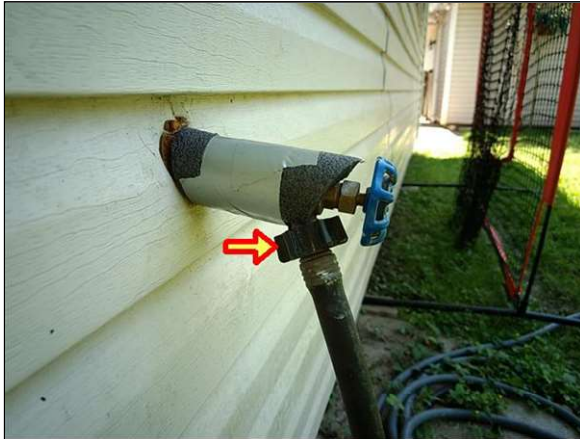
- The hose bib(s) at all exterior locations are missing anti siphoning devices.

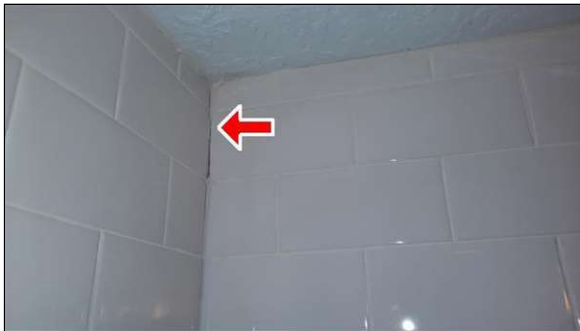
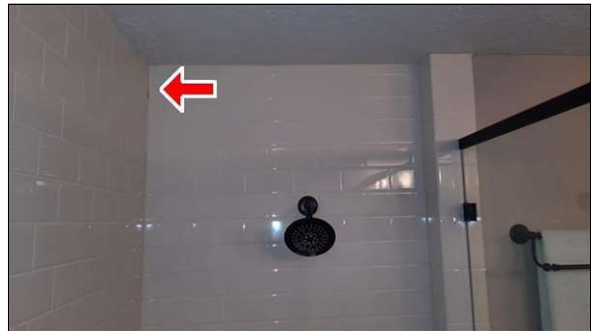
- Caulk / grout improvements are needed at the shower.

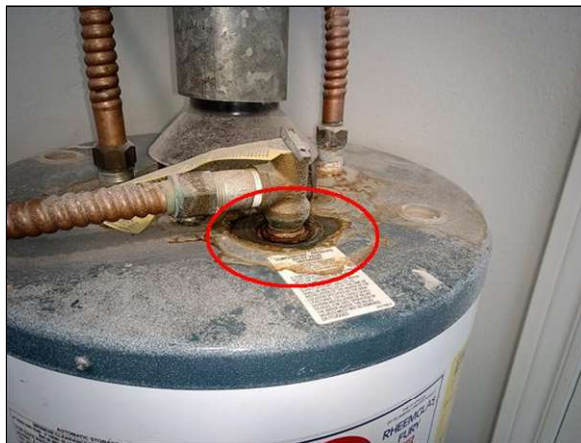
- The water heater appears to be leaking at TPR valve connection. A more thorough inspection by a qualified contractor is needed. A qualified licensed plumber should repair or correct as needed.

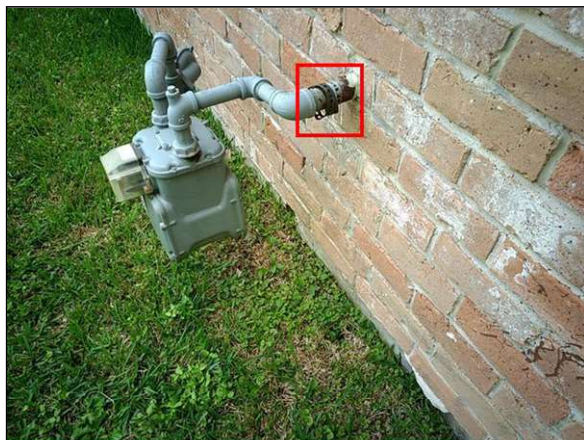
- Grounding or bonding of the natural gas system could not be verified. Evidence of a prior grounding point at the meter was observed.

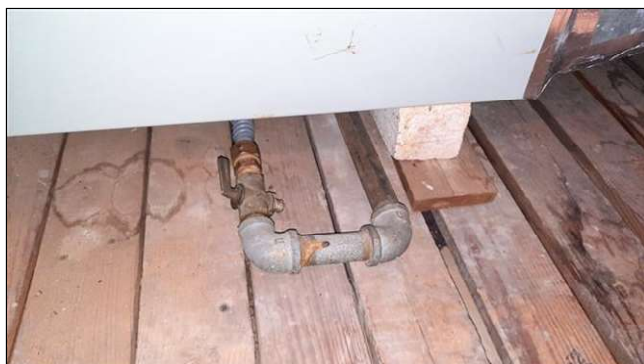
- The gas valve for the furnace is a type that is considered out dated and a safety hazard. The gas valve should be replaced.
- Furnace gas line does not have a sediment trap.
