FIG Services LLC d/b/a FOX INSPECTION GROUP
 Property Inspection Report #220119JB-23 Misty Grove Circle
 8616 Daffodil St. Houston, TX 77063
 (Office)713.723-3330 (Email) office@foxinspectiongroup.com

PROPERTY INSPECTION REPORT

Concerning: 23 Misty Grove Circle, The Woodlands, TX 77380
(Address of Inspected Property)

By: Josh Burk, TREC PI: 22850 01/19/2022
(Name and License Number of Inspector) (Date)

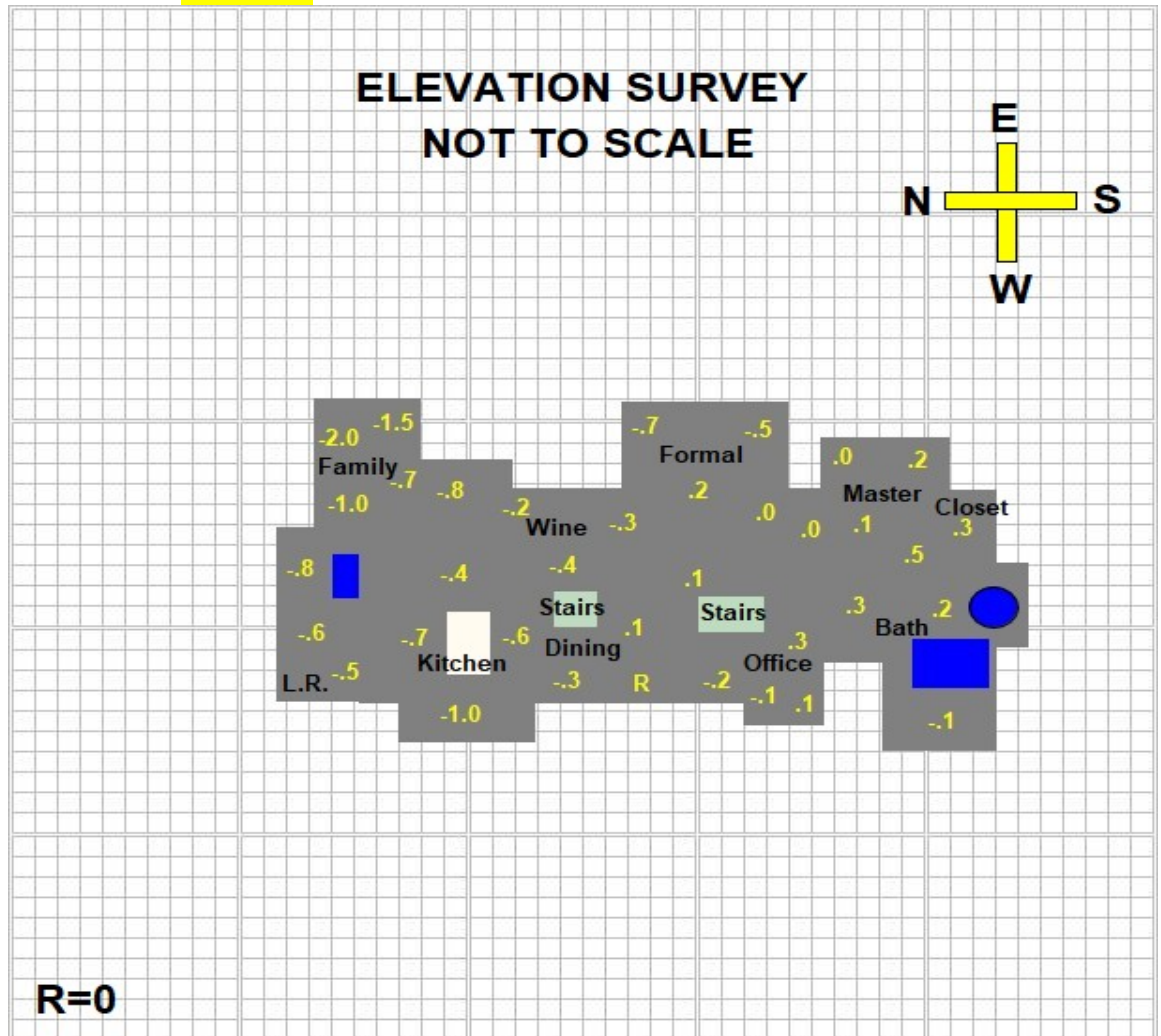
Differential movement/settlement observed; indicated by one or more of the following observed conditions; Elevation readings, cracks in brick veneer and/or foundation, cracks in sheetrock over doors and windows, doors that are not square in the jamb etc. In my opinion, the distress patterns observed at the time of inspection were not severe enough to recommend repair. Acceptance of present and future condition/performance/maintenance rests solely with the buyer/client.

A foundation elevation survey was conducted during the inspection. The floor plan below represents data gathered using a Zip Level and adjusting for floor covering height differences. i.e. differences between tile, carpet and wood flooring (except step down to the garage). Measurements are listed to the nearest 1/10th of an inch. The greatest variance was 0.5 to -2.0

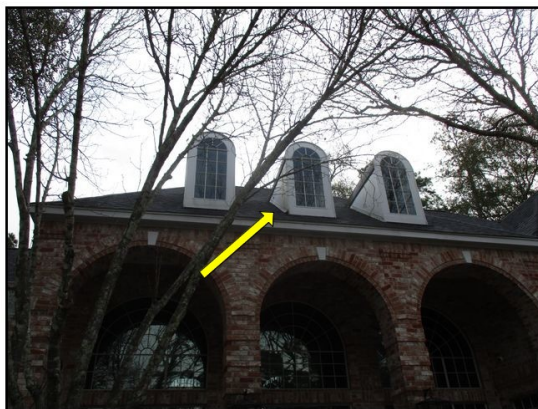
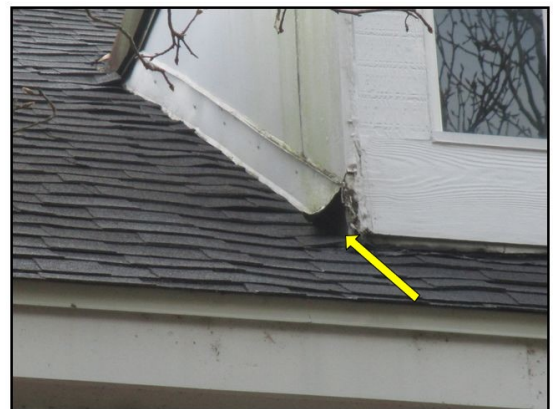
Lower side of flashing is not sealed down, wind-driven rains can cause water penetration.

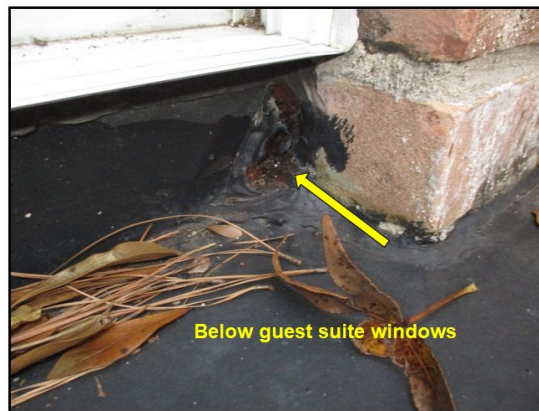
Flashing needs to be sealed/caulked at the following location(s): Above portica shea, and front dormer.

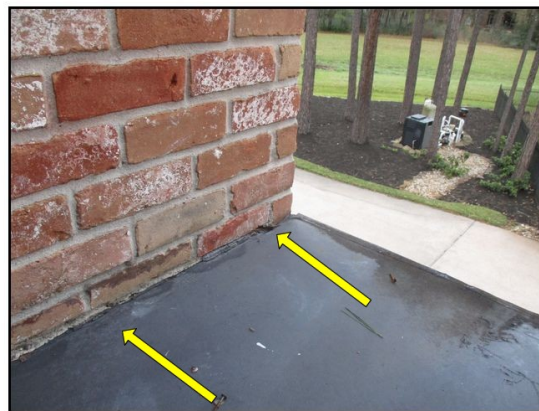
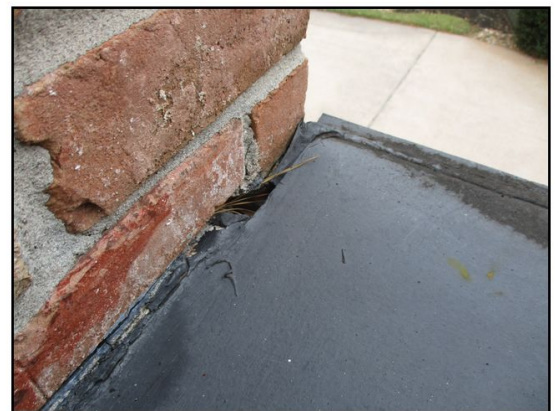
Observed masonry counter flashing missing or improperly installed Above portica shea. May allow water penetration to occur between the masonry and flashing

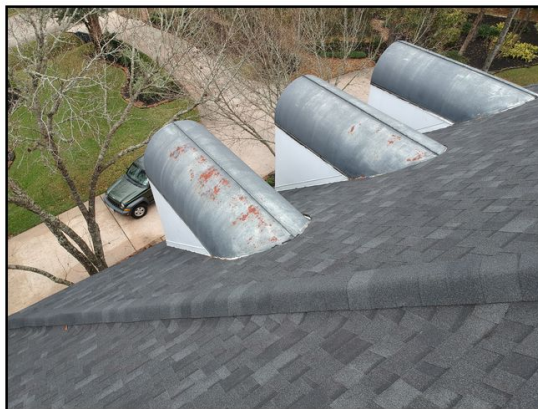
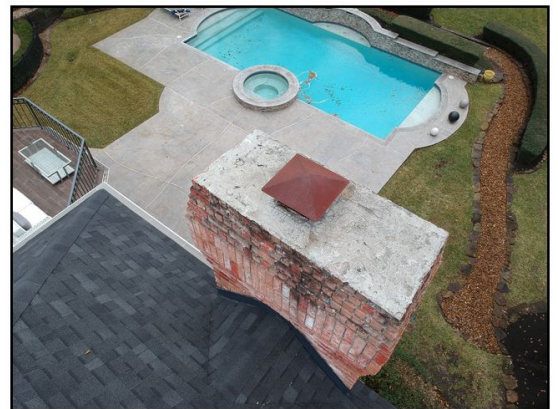
Improperly vented; vents shall terminate not less than 6" above the roof, and not less than 12" from any vertical surface of the building, Ref IRC 3102.

Recommend painting all exposed metal above roof line to prevent rusting and extend service life.

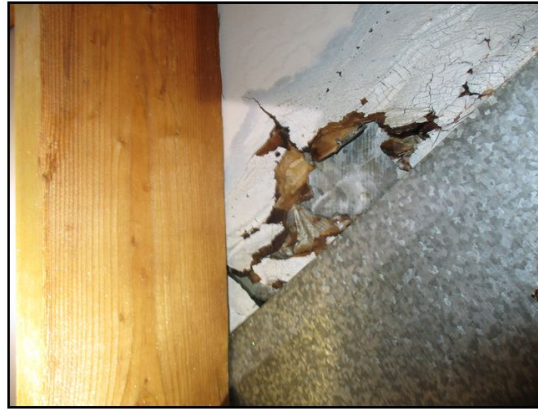
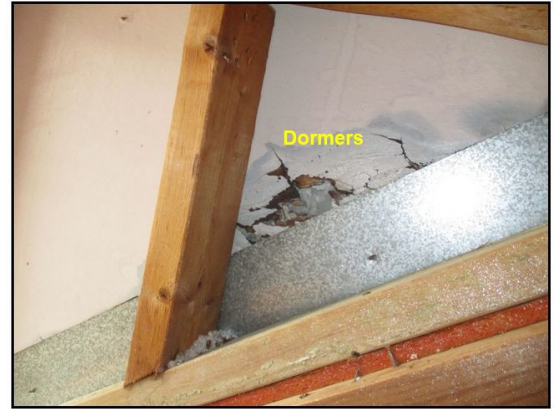
Area(s) of water-stained and/or rotted siding and or roof decking observed in the attic.

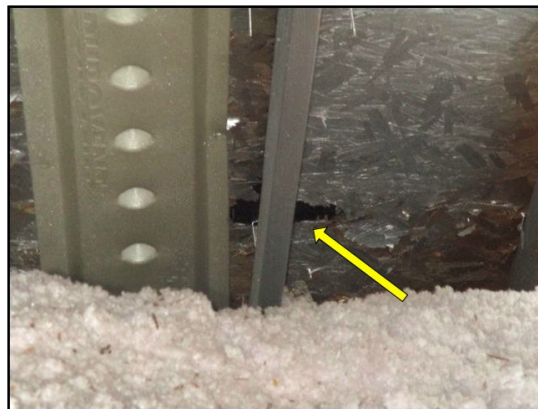
Hole and/or damaged roof decking observed in the attic, recommend repair to prevent damage/injury from a person walking on the roof; **Near South dormer.**

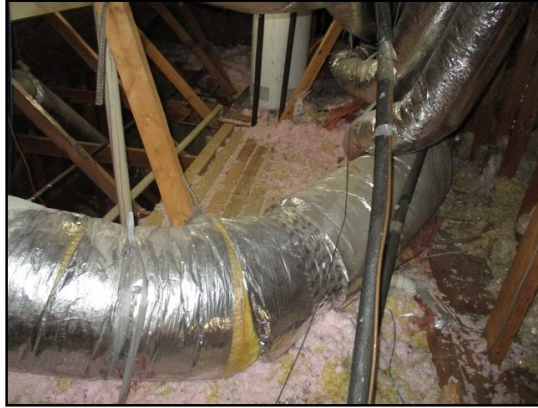
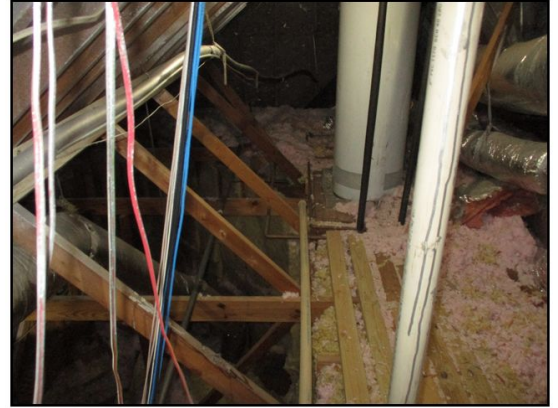
The passageway to the water heater must be a minimum of 24" wide solid floor, a maximum of 20' long. Ref: IRC: 1305.1.3,4.

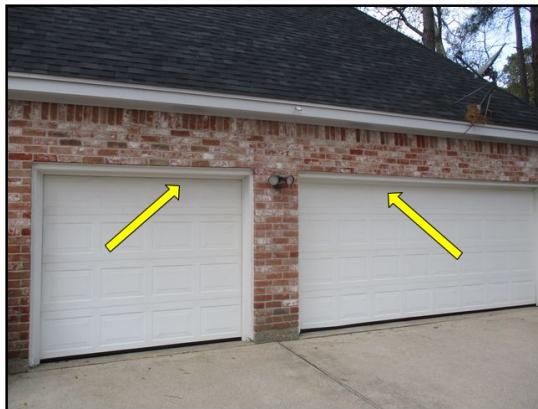
Sag in the double header over garage door. Possible indication of improper/inadequate framing and/or foundation settlement.

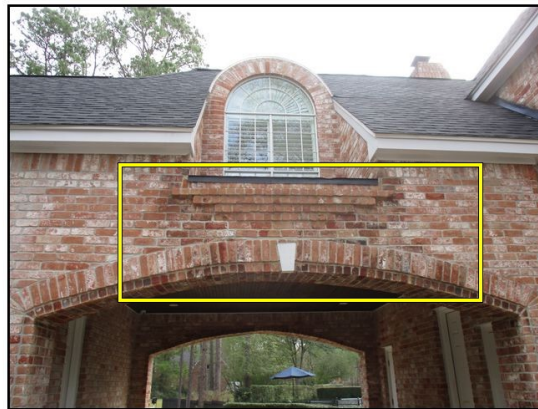
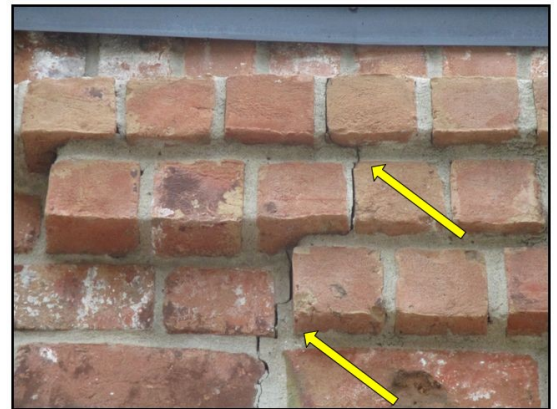
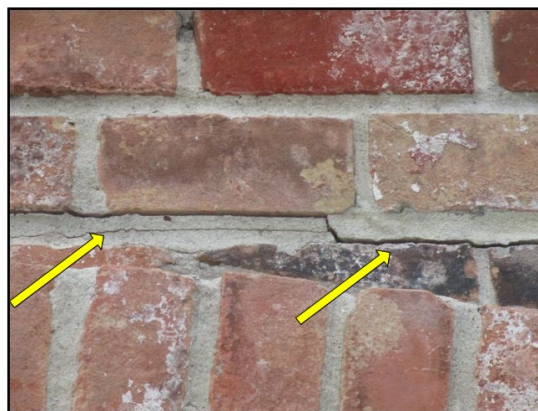
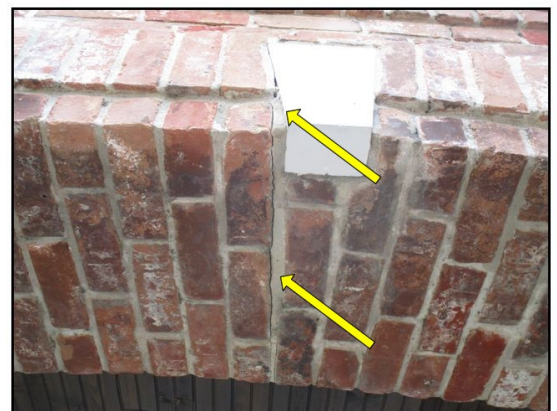
The brick arch has multiple cracks, repairs and appears to have settled/ lowered, recommend further evaluation and repair to prevent serious injury from potential collapse.

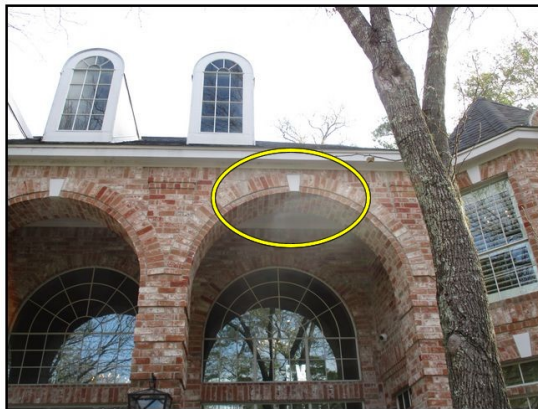
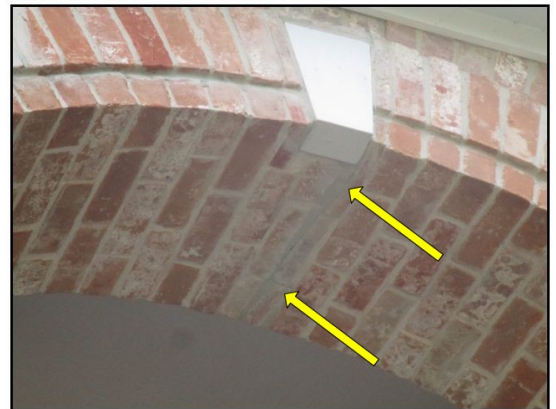
Cracks and or repairs in the brick arch were observed. Loose bricks are hazardous.

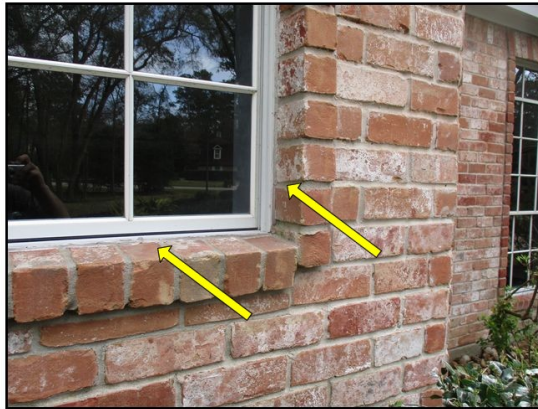
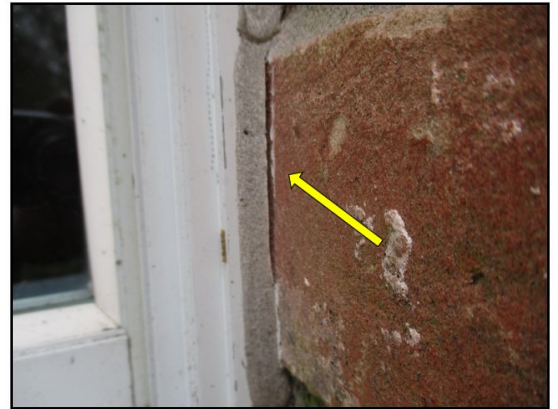
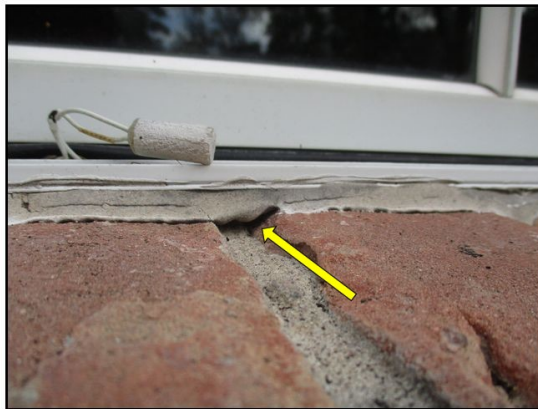
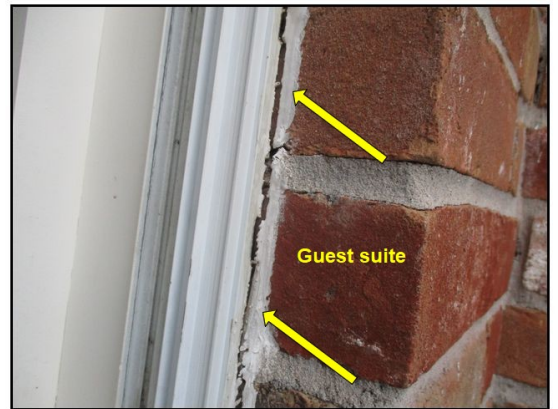
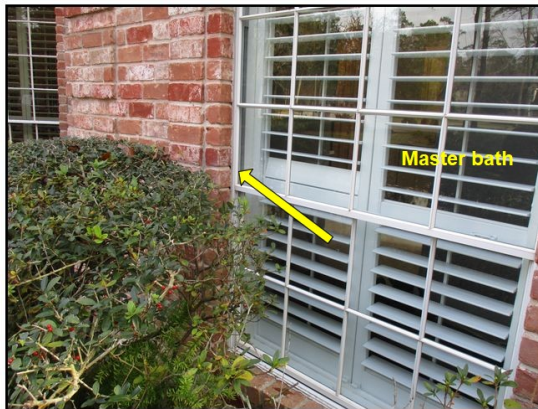
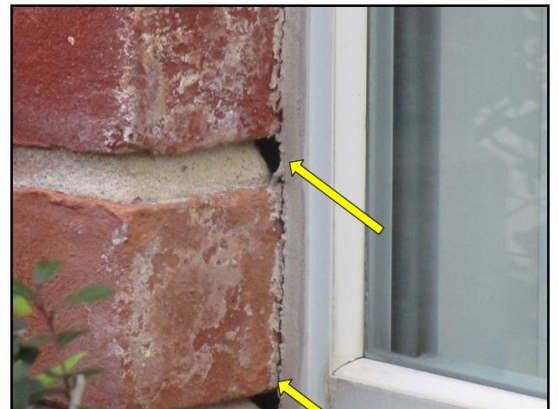
Caulking missing and/or deficient around windows / doors / vertical trim / joints in siding. May allow wind driven rain entry.

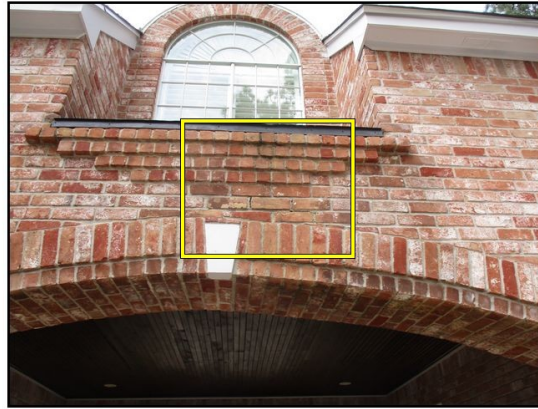
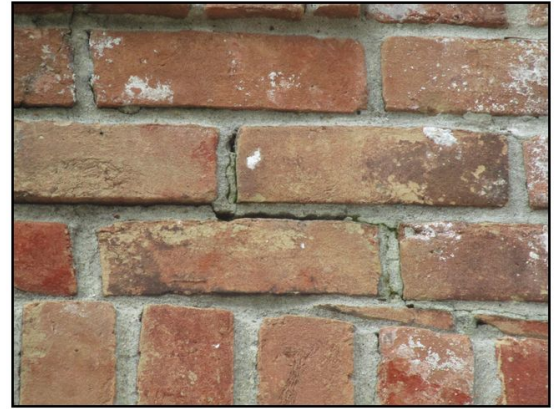
Mortar joints between brick ends are deficient in areas. This is an indication of cracking, settlement, and or the brick-layer might not have properly "struck" the bricks (used enough mortar) - recommend re-pointing areas where voids in mortar are present.

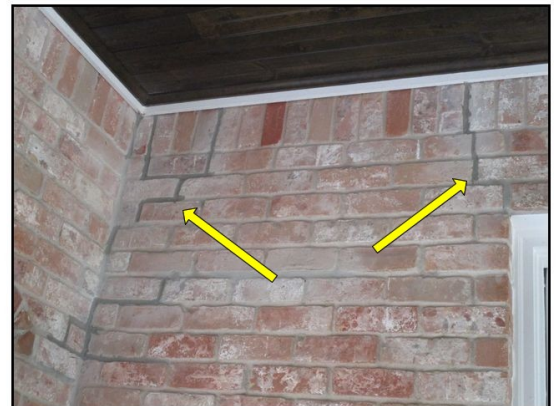
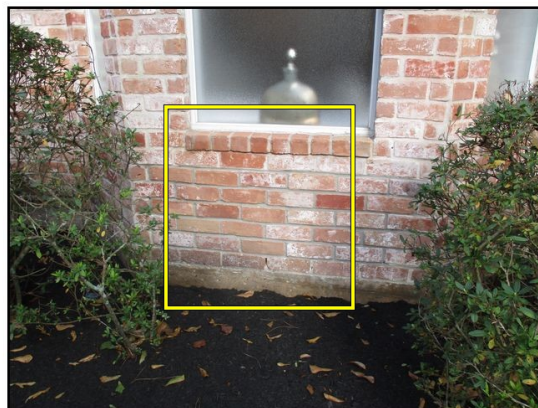
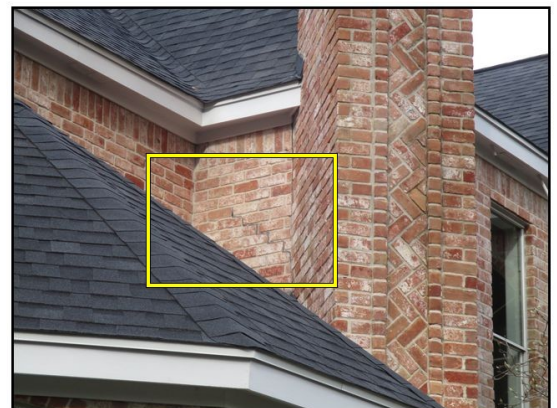
Cracks in brick / stone veneer and/or repairs, one or more locations, Recommend buyer take photographs of cracks, their location, and width [ruler across the crack] with a high-resolution camera that has a date stamp for future reference.

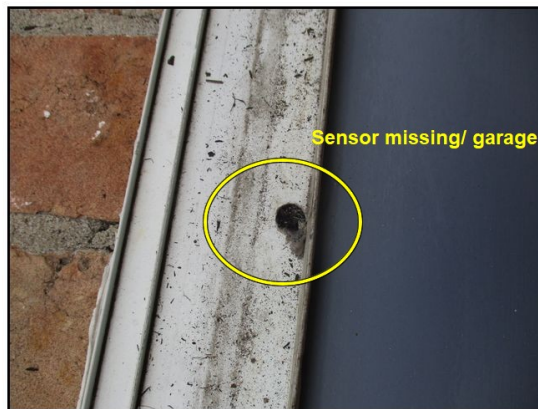
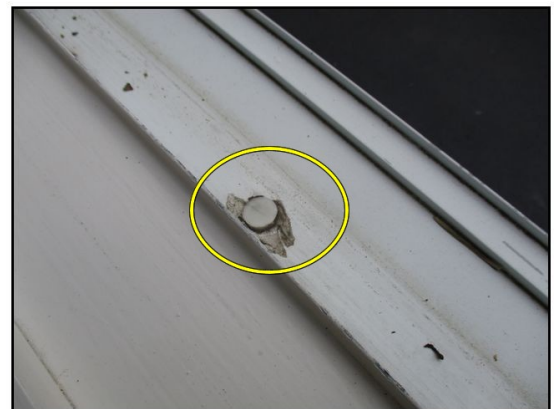
Window jamb alarm sensors need to be sealed with silicone seal to prevent water entry.

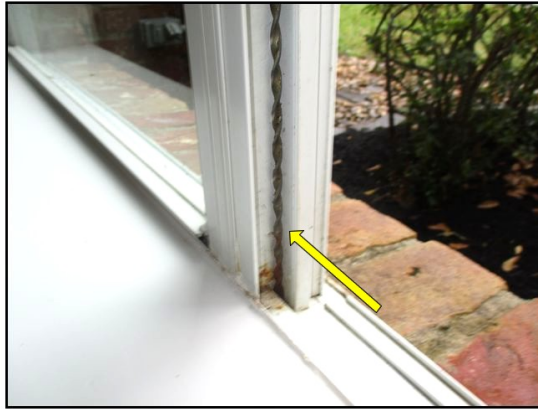
One or more window spring(s) were observed to be sprung/broken/detached.

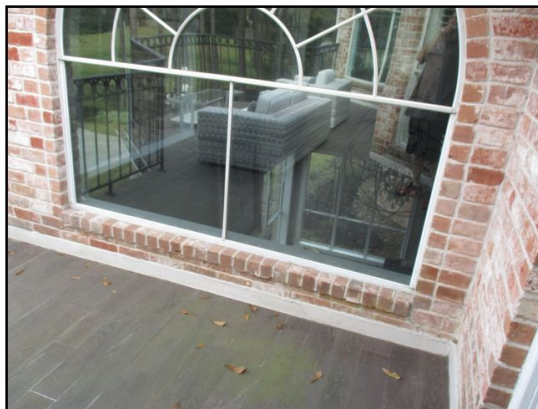
Large picture window(s) do not appear to be safety/tempered glass. Considered a recognized safety hazard. Per IRC 308.4.7; windows greater than 9 Sq. Ft., bottom less than 18" above the floor, top more than 36" above the floor, within 36" of traffic area; **Second floor patio.**

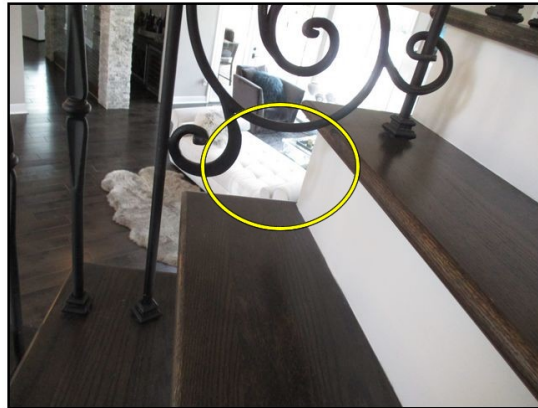
Space between lower treads and railing does not comply with IRC 312.2. Requires spacing between treads and lower edge of railing does not allow passage of an object 6 inches in diameter. Recommend covering large openings in stair rails with temporary type nylon netting if small children are present in the house to prevent injury.

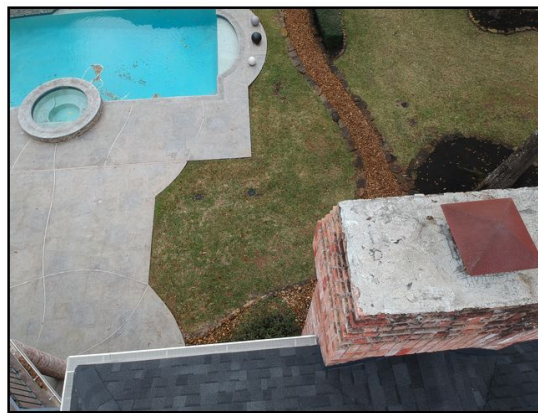
Masonry coping cracked or in need of improvements on top of the chimney.

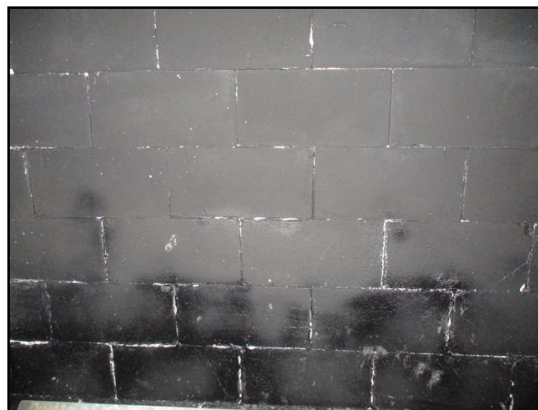
Voids in the mortar between bricks of the firebox were observed. Voids need to sealed/tuck pointed with mortar.

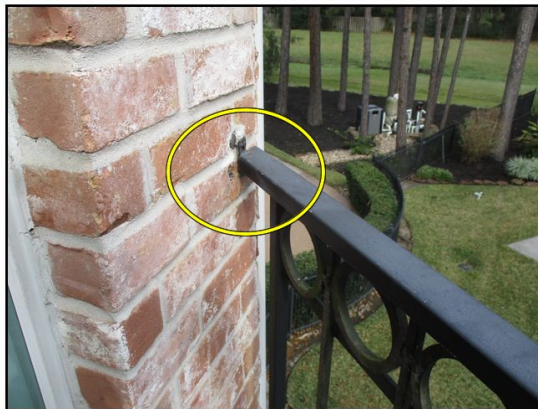
Section of handrail missing and/or loose.

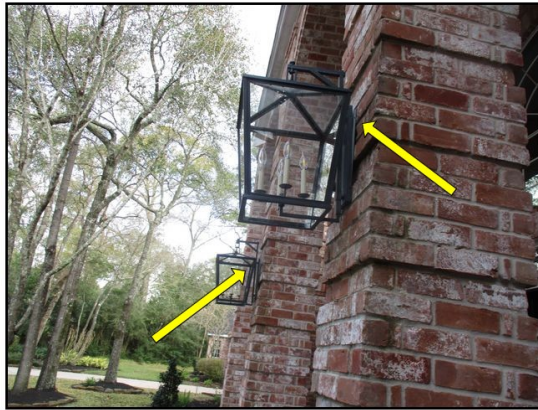
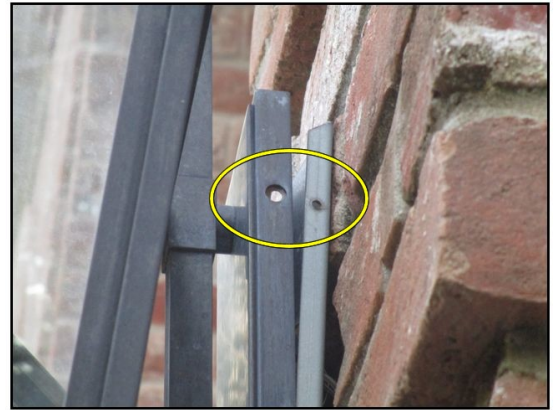
Light not secured; Front exterior.

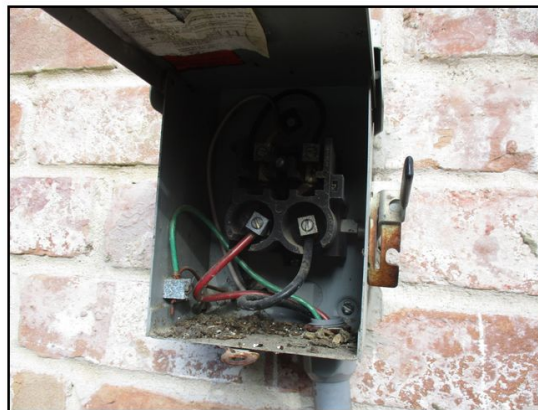
The electrical service disconnect is missing the dead front cover; All.

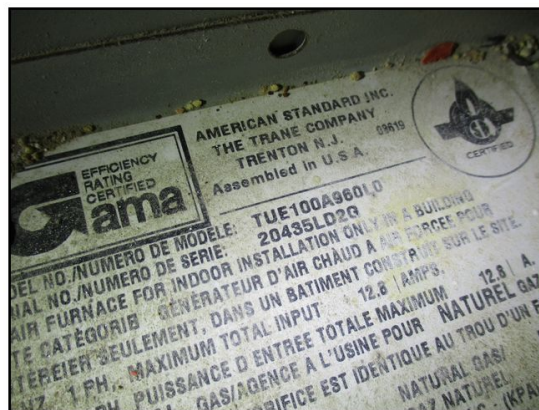
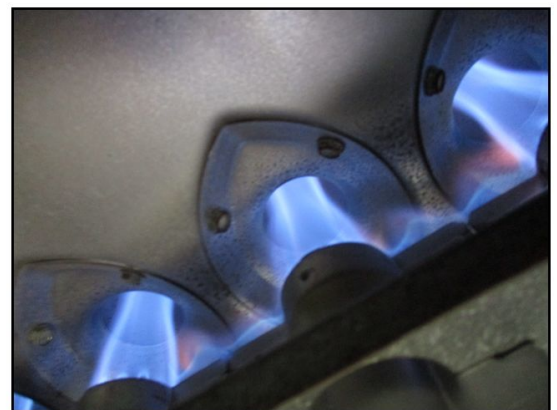
HEATING UNIT: 1ST FL 2002 TRANE

Older unit, limited service life remaining.

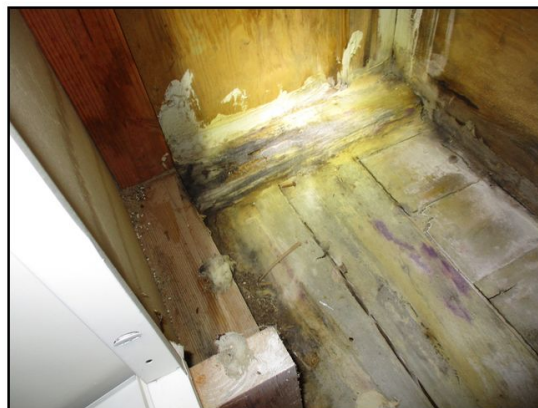
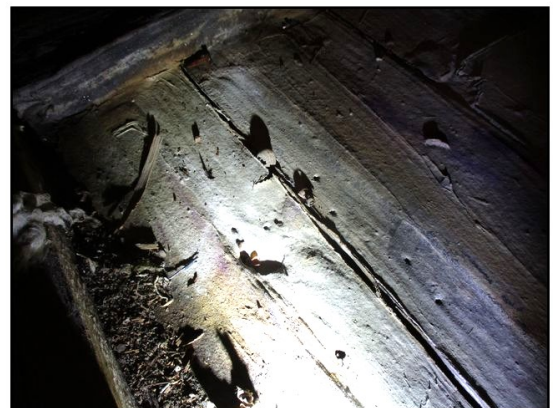
Observed wood rot/ water stains at guest suite return chase. Recommend repair.

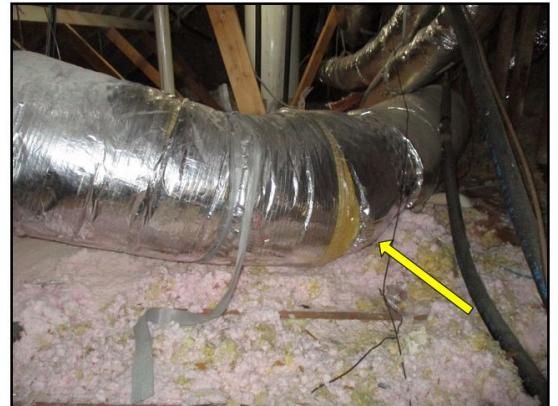
Observed multiple areas of damaged/ loose outer vapor seal on the flex duct in the attic.

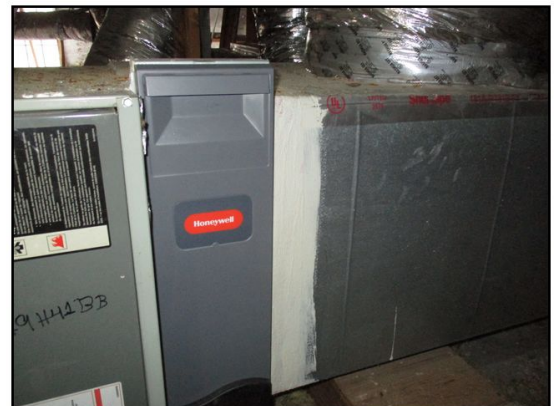
Media air filter(s) located in the attic that requires changing/cleaning every 6 months, recommend checking guide for proper maintenance information.

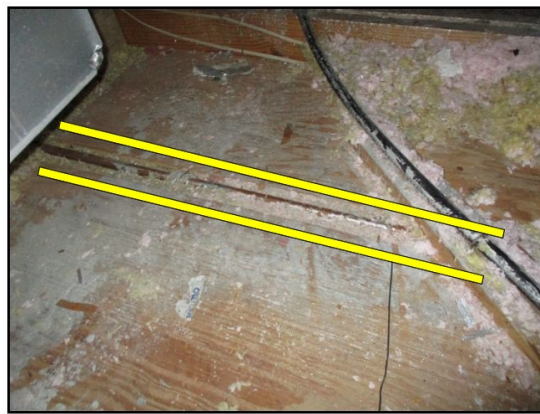
Recommend protecting water line(s) from foot traffic damage by securing 2x4 board along side to prevent stepping directly on the water line(s).

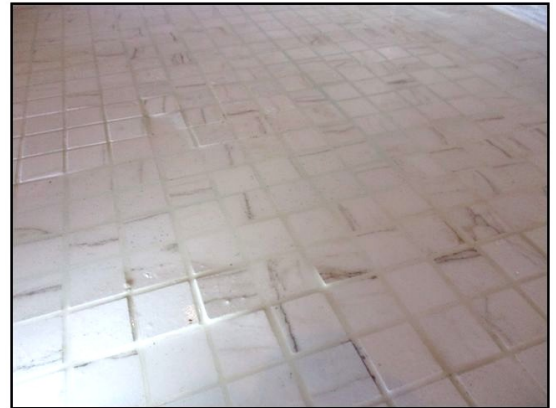
Master shower floor holds water, does not tilt towards center drain.

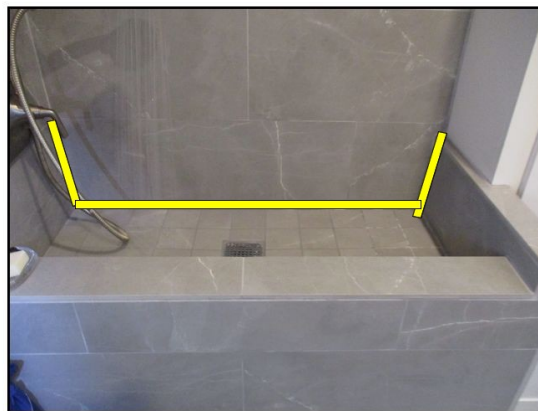
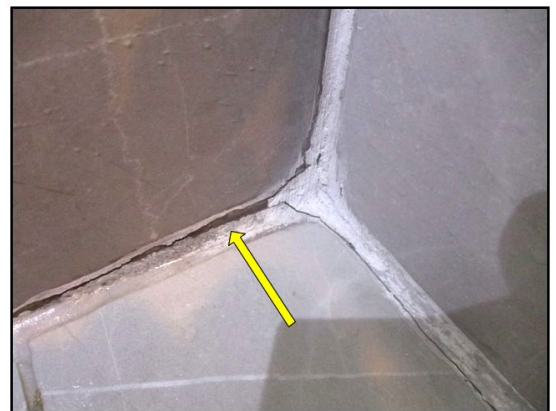
Grout/caulking needed at vertical tile corners, cracks in tile and/or mortar between tiles, to prevent water entry behind the wall; Pet bath/ shower

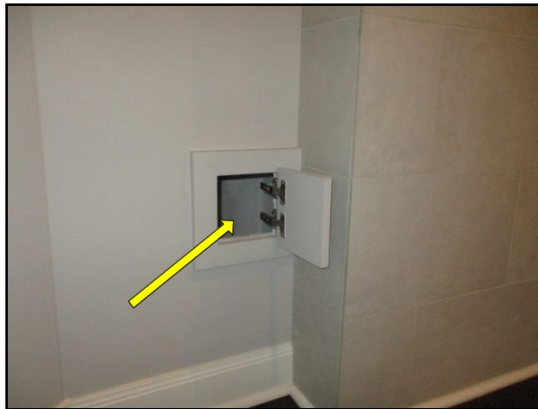
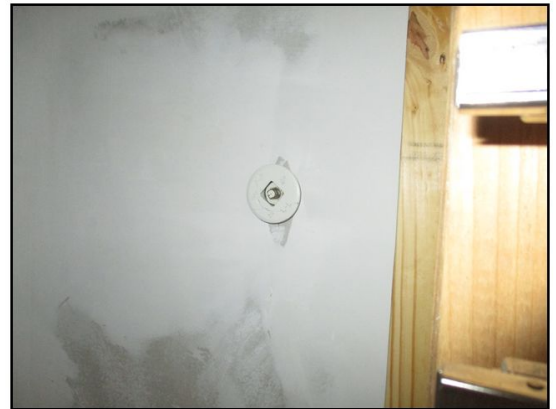
A possible odor of gas was observed at Master bedroom fireplace gas valve access.

Recommend further evaluation by a licensed/ qualified plumber.

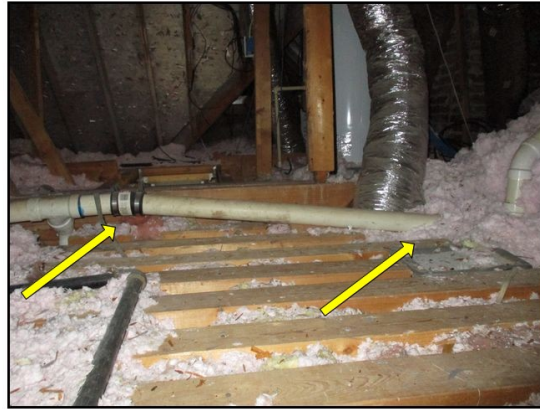
Improper slope of the drain waste vent line observed. The line does not tilt downhill for drainage of condensate, possibly blocking proper venting of sewer gas.

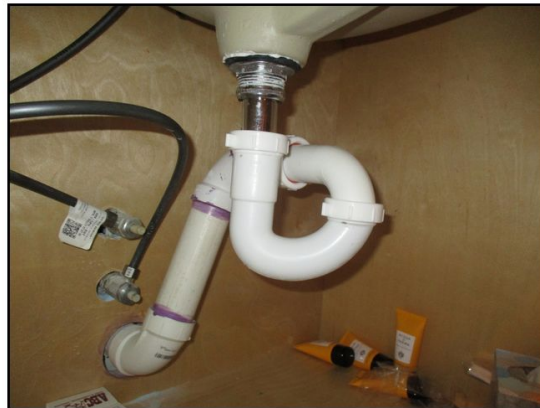
Improper trap observed; **First floor guest bath sink.**

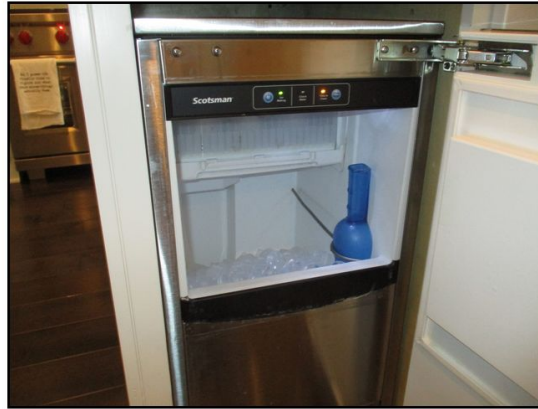
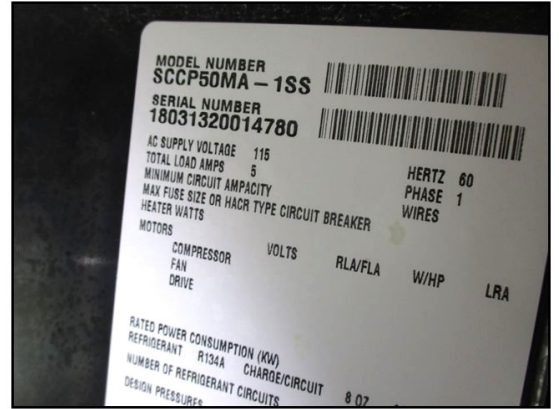
Lower coils are dirty, needs cleaning. Dirty coils reduce airflow through the system and create high head pressures at the compressor, thereby unduly stressing and reducing the life span of system components.

Recommend cleaning interior of unit.

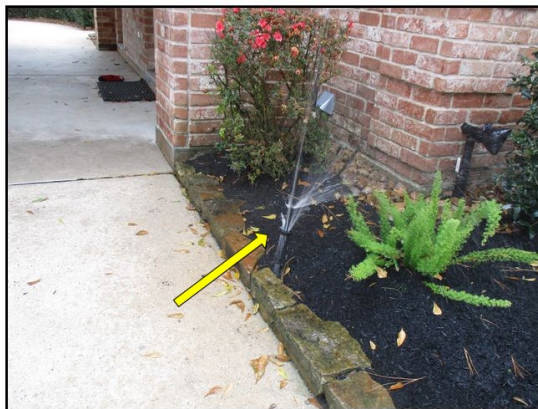
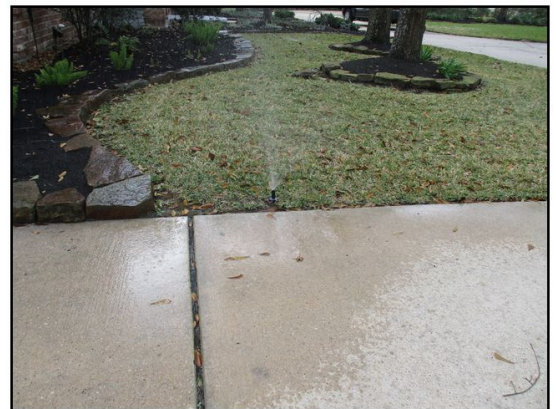
Observed one or more damaged heads.
