# **Inspection Report**

1115 W 15TH STREET Houston TX 77008

## PROPERTY INSPECTION REPORT

Prepared For:	Mr. Tim Davis			
	(Name of Client)			
Concerning: 1115 W 15TH STREET, Houston, TX 77008				
	(Address or Other Identification of Inspected Property)			
Ву:	Damien Stout. TREC#20374 / Prolook Home Inspections	8/6/2019		
	(Name and License Number of Inspector)	(Date)		
	(Name, License Number of Sponsoring Inspector)

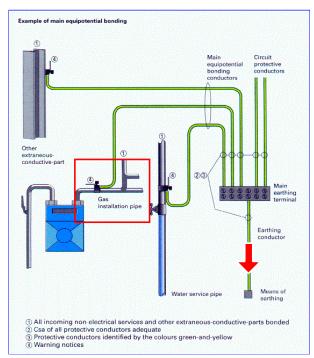
EQUIPOTENTIAL BONDING wire was found at this time (LOACTION - Gas supply line before entry to home) however, It is often not possible to tell during this type of inspection if <u>all</u> bonding has been properly done. The lack of bonding may allow metallic parts, in a home, to become electrically energized due to a number of electrical events not normal to an electrical system, such as a lightning event. Metal gas (including corrugated stainless steel tubing (CSST)) and water supply pipes & other equipment such as stoves, ovens, furnaces, air conditioners, water heaters, pool equipment & metallic electrical panel boards, that may become electrically energized, are required to be electrically bonded together. If, a bonding component has come loose, appears deficient or is missing/not visible, it will be noted as NOT INSPECTED in this report as required by the TEXAS REAL ESTATE CONSUMER NOTICE CONCERNING HAZARDS OR DEFICIENCIES (10/2015). A Master Electrician is recommended be consulted to verify all bonding has been installed in accordance with the proper current electrical standard.

referred to as "equipotential bonding." Keeping the electrical potential at the same level reduces the hazard created by stray currents. A copper bonding conductor #6 or larger should be attached using a listed clamp at the first length of hard pipe after the gas meter, or at the first CSST fitting. The bonding conductor should run to the grounding connection at the service equipment, the grounding electrode, or the grounding electrode conductor. This bonding is for lightning protection, not for personnel protection, which is the reason for bonding most other metal.

The bonding conductor should run to the grounding connection at the service equipment, this could not be verified during today's inspection.
