## INVASIVE STUCCO INSPECTION

1703 Hazard St  
Houston TX 77019

Jack Fletcher  
AUGUST 16, 2021

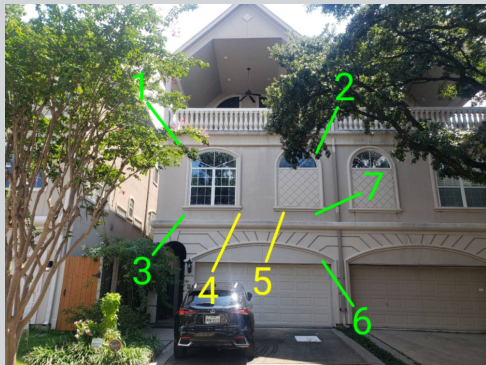
West Side

Probe	%	Moisture	Substrate	Note
1	11	Low	Firm	
2	10	Low	Firm	
3	12	Low	Firm	
4	21	High	Firm	
5	17	Elevated	Firm	
6	10	Low	Firm	
7	10	Low	Firm

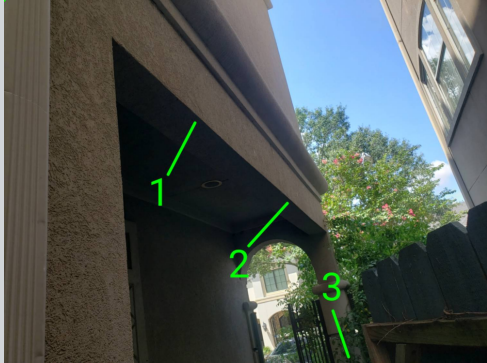
North Side

Probe	%	Moisture	Substrate	Note
1	10	Low	Firm	
2	9	Low	Firm	
3	14	Low	Firm	base of column, sitting on flatwork concrete, recommend sealing

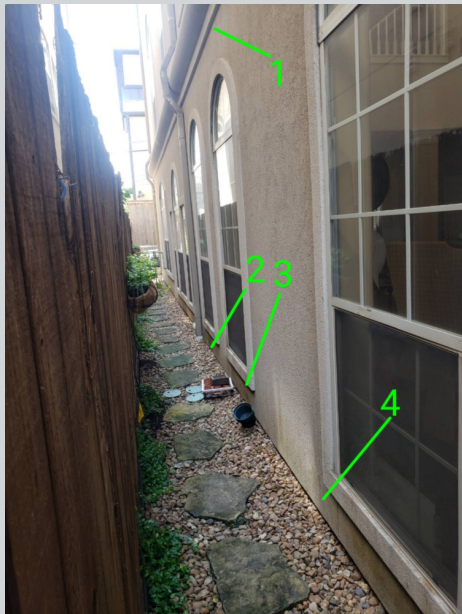
North Side

Probe	%	Moisture	Substrate	Note
1	11	Low	Firm	
2	10	Low	Firm	
3	10	Low	Firm	
4	11	Low	Firm

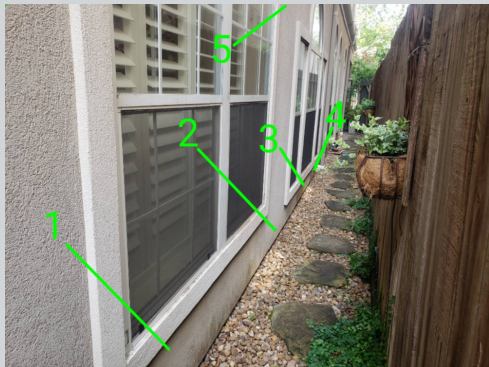
North Side

Probe	%	Moisture	Substrate	Note
1	8	Low	Firm	
2	10	Low	Firm	
3	10	Low	Firm	
4	10	Low	Firm	
5	11	Low	Firm

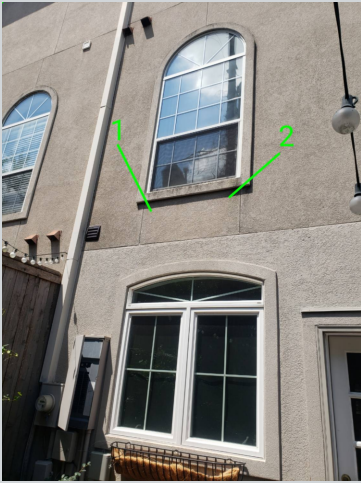
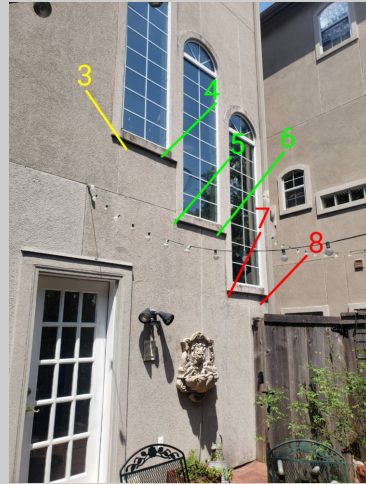
### General: Elevation 5

Probe	%	Moisture	Substrate	Note
1	10	Low	Firm	
2	11	Low	Firm	
3	17	Elevated	Firm	
4	13	Low	Firm	
5	11	Low	Firm	
6	14	Low	Firm	
7	12	Low	Deteriorated	reading taken in framing
8	17	High	Soft

Substrate damage was found on this house and further framing damage may be present beyond the substrate. It is recommended that all areas noted not to have "Firm" substrate (Including Semi-soft, Soft, or Deteriorated) be opened up to verify the extent of any damage. It is also recommended that the source(s) of the moisture intrusion be determined and repaired along with all damaged materials due to moisture intrusion. Typical sources of moisture intrusion can include, but are not limited to, damaged or missing sealants, damaged or missing flashings, balcony and terrace walls and columns, improper installation of stucco accessories, back-wrapped sheathing, etc. Refer to elevation photos for locations.

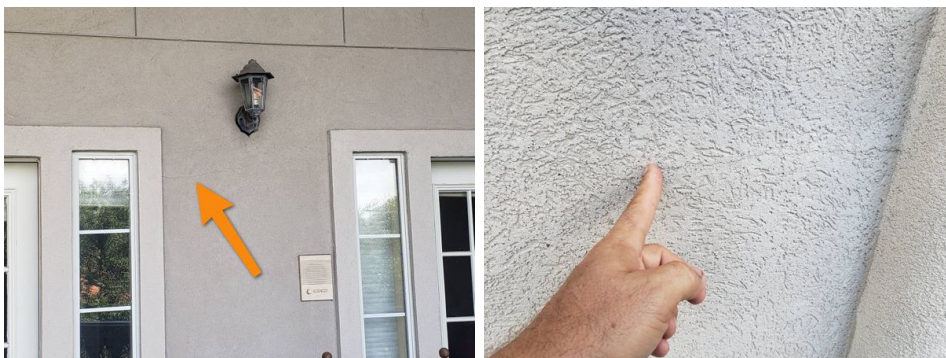
3rd Floor Balcony

#### HAIRLINE CRACKS OBSERVED

The presence of hairline cracks/cracking is noted in several locations. It is recommended to seal and paint all cracks throughout the exterior veneer. It is recommended that you contact a qualified stucco waterproofing contractor to seal these areas in an approved manner.

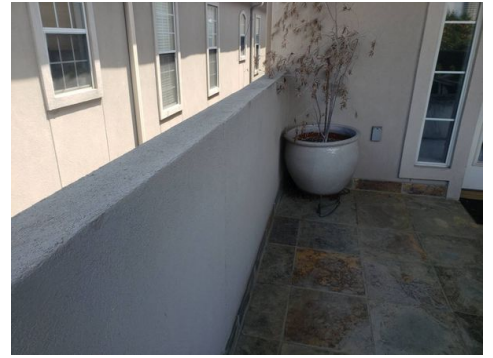
**CAP FLASHING - NOT PRESENT**

Cap flashing was not installed over the top of the flat surfaced wall. Cap flashing is intended to help prevent moisture from migrating through the stucco material at the flat top of the wall. No evidence of a elevated moisture was observed at the time of the inspection, however consideration should be given to installing this cap flashing and a minimum kept well painted with an elastomeric coating.

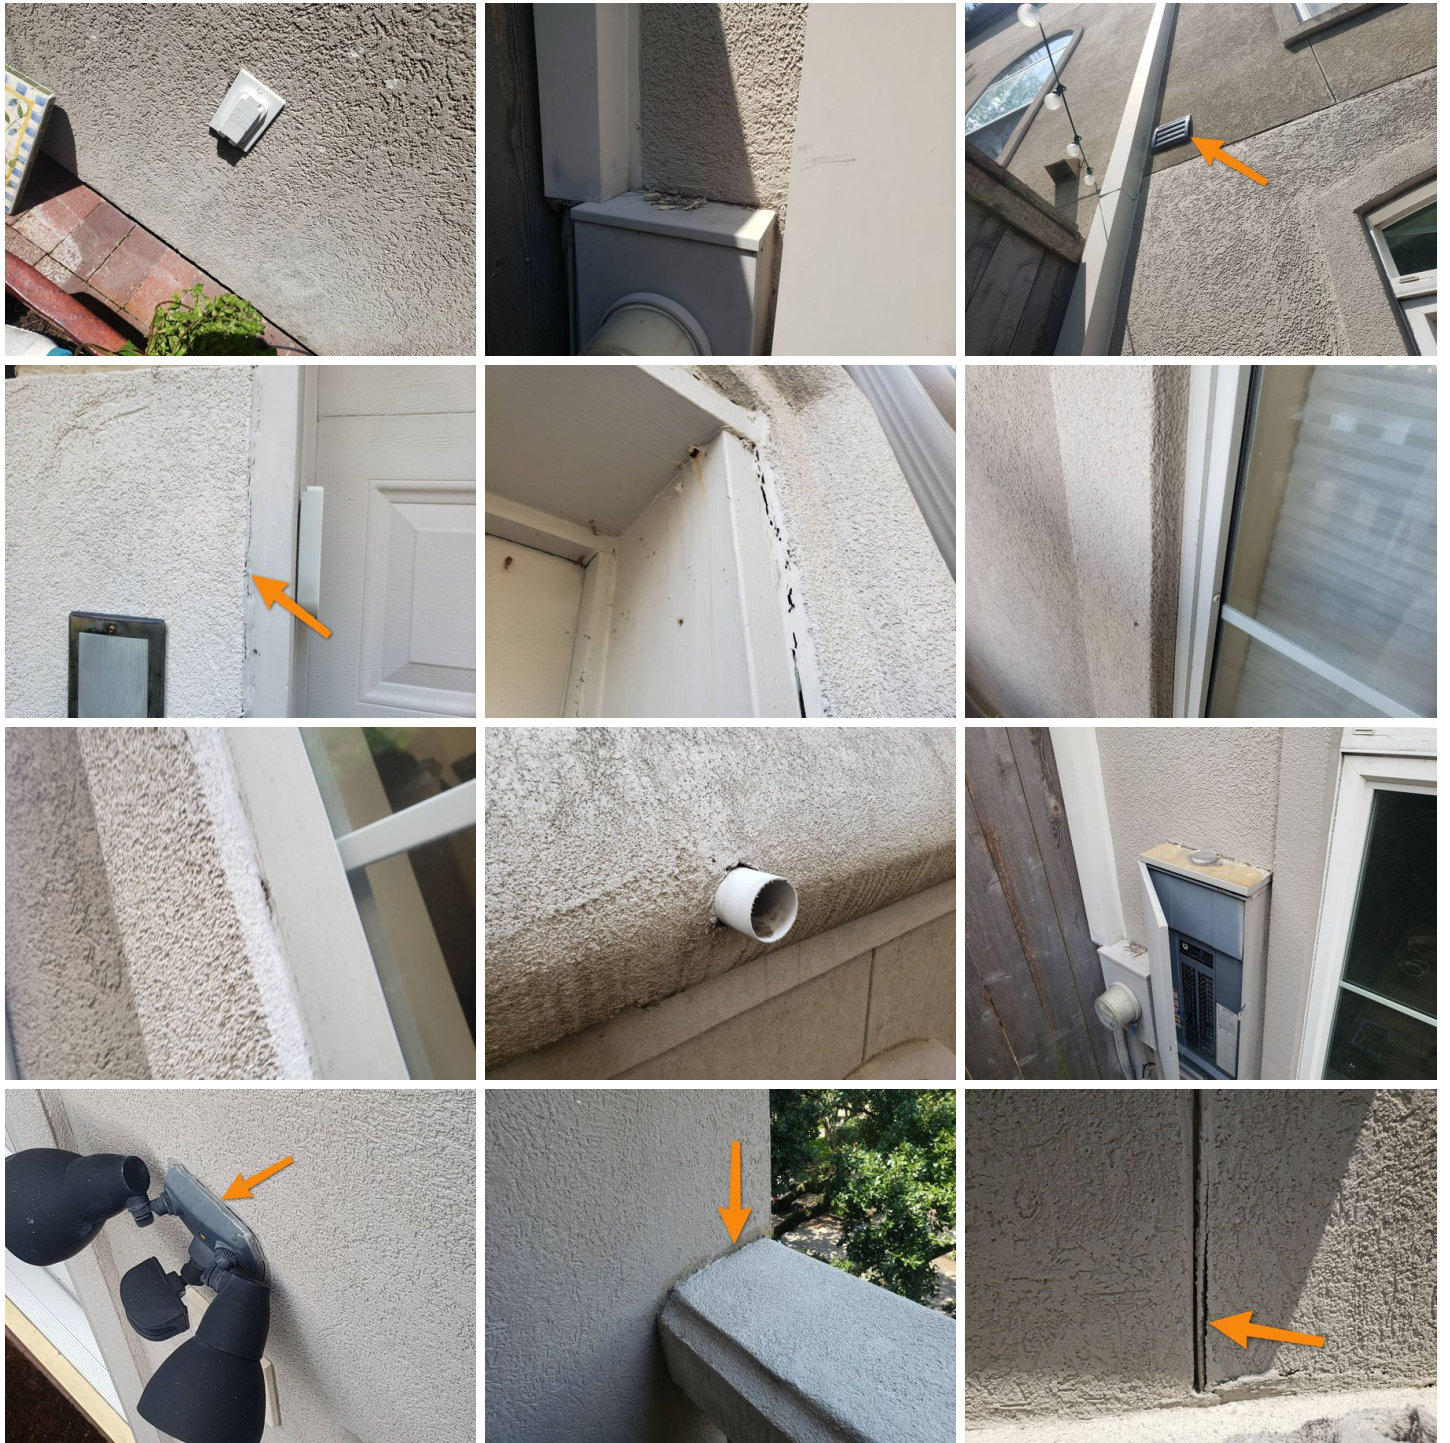
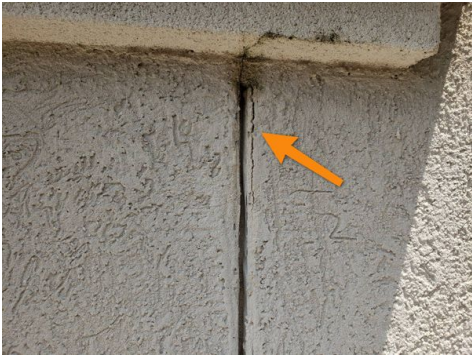
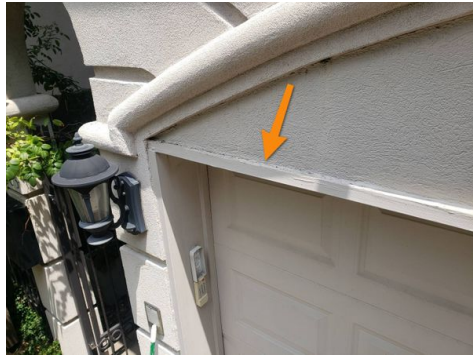
**VULNERABILITIES TO WATER INTRUSION**

Vent caps, Outlets, Doors, Balcony railings, Electric Meter, Vertical joints between materials, Accent details, Light fixtures, Electrical panels

A substantial vulnerability to water penetration was observed at openings through the exterior building envelope, and it is recommended that all penetrations/openings be sealed against water penetration. Below is a representative sample of photographs showing some, but not necessarily all, locations where there is a vulnerability to water penetration. Have a contractor provide a cost estimate to seal all vulnerable areas on the exterior building envelope against water penetration.

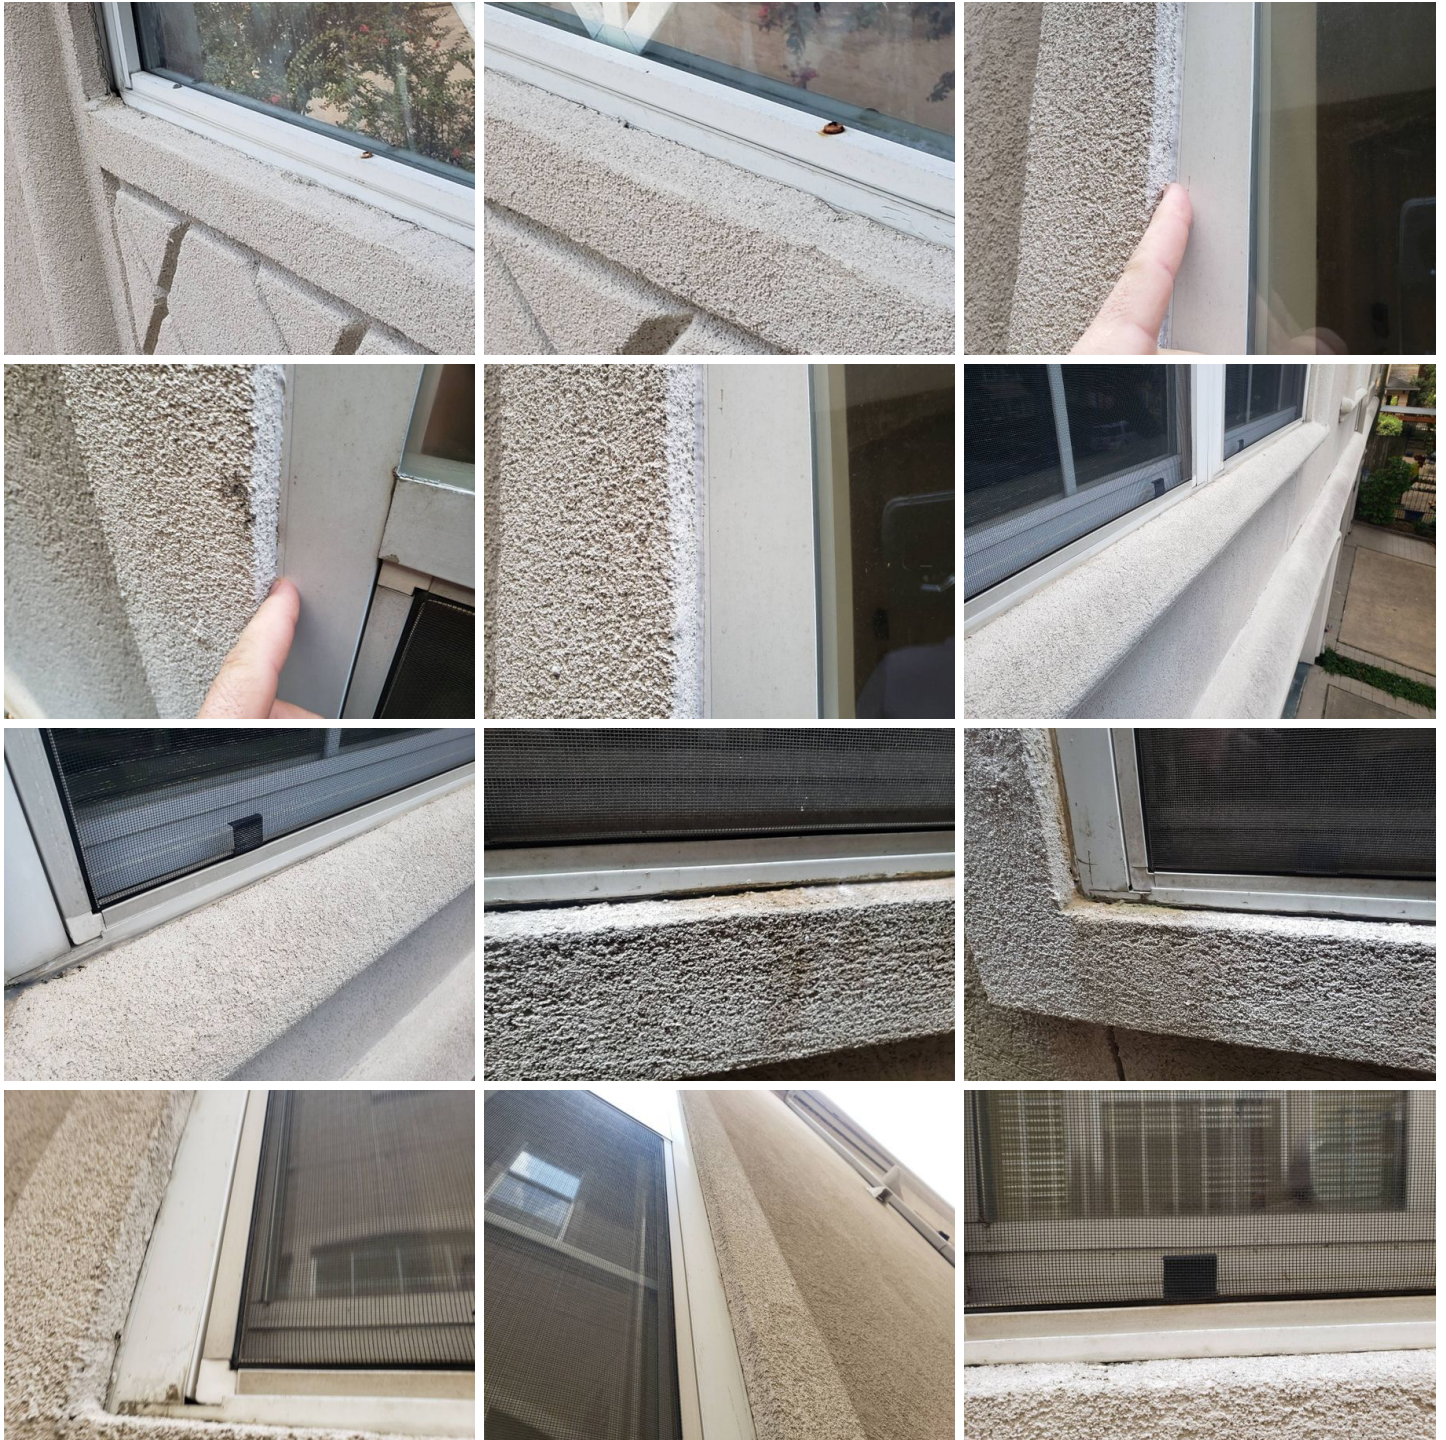
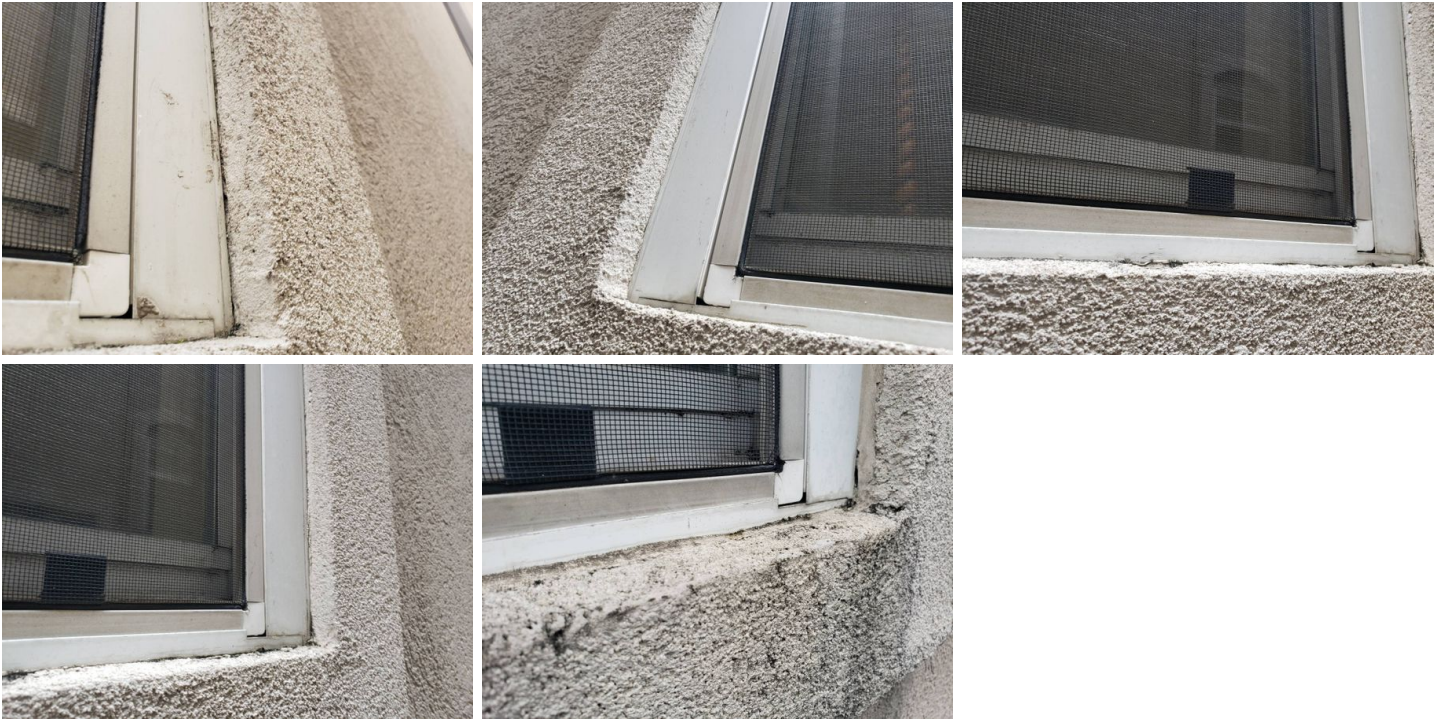
**SEAL ALL WINDOWS**

The sealants around the windows were inadequate. All of the windows need to be resealed to prevent moisture intrusion. It is recommended that you consult a qualified stucco waterproofing contractor to seal these areas with a high quality exterior sealant.

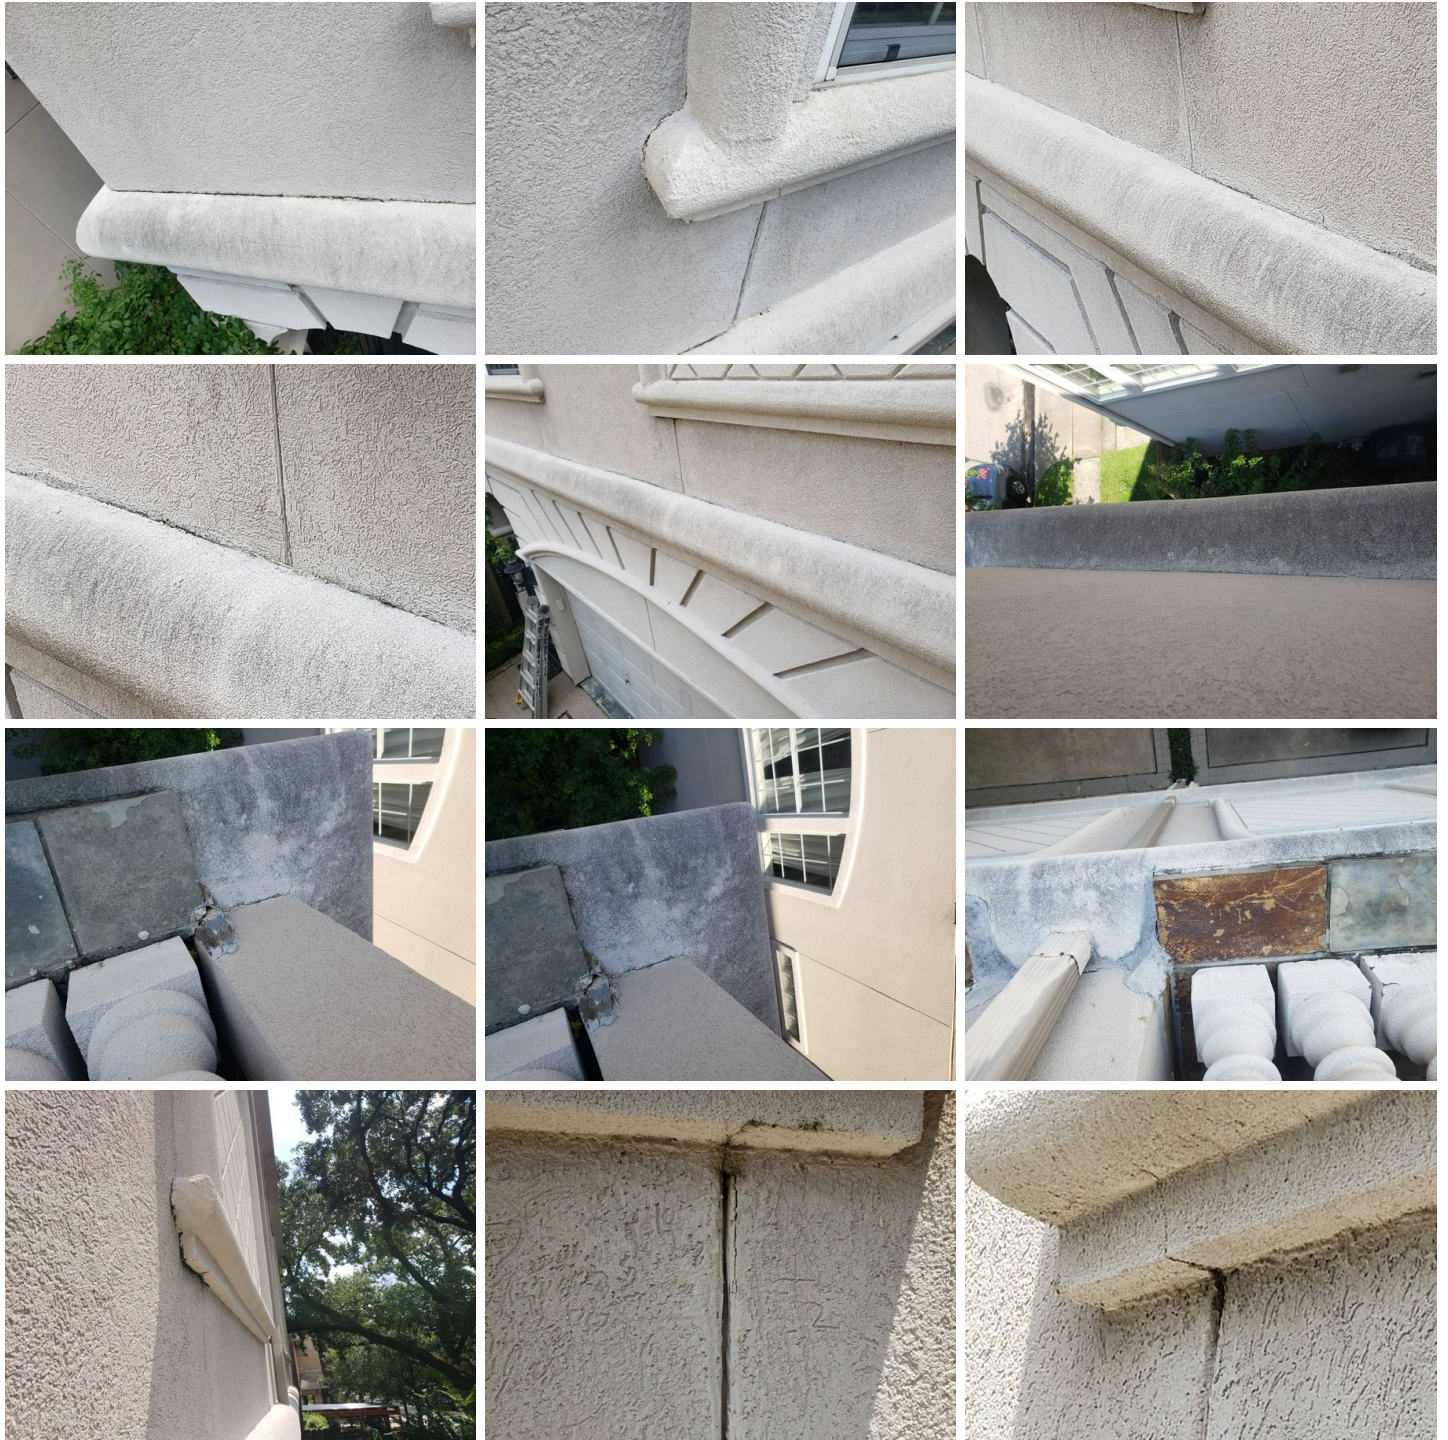
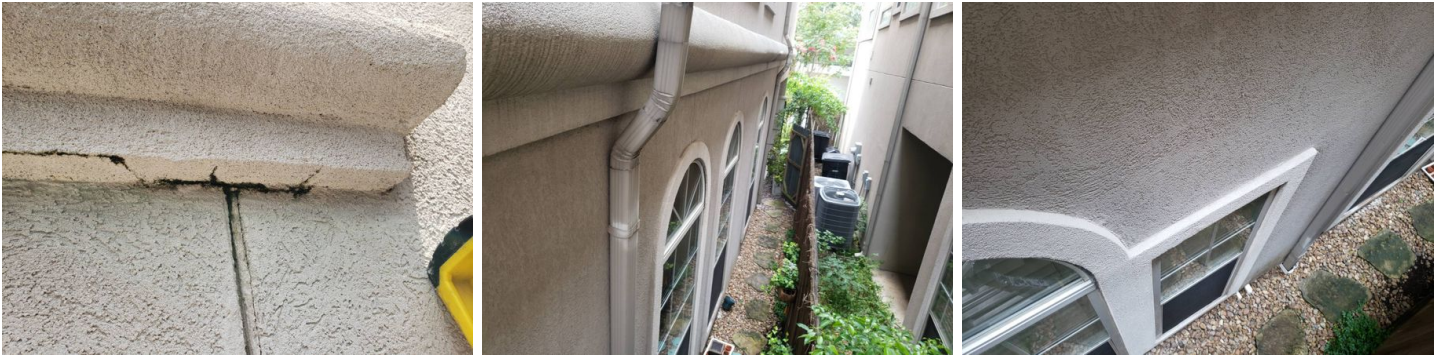
**SEAL ACCENT BANDS-NO SEALANTS**

No sealant was used at the accent bands. It is recommended that all of the accent bands be sealed with a high quality exterior sealant and the foam painted with an elastomeric coating by a qualified stucco waterproofing contractor to prevent moisture intrusion.

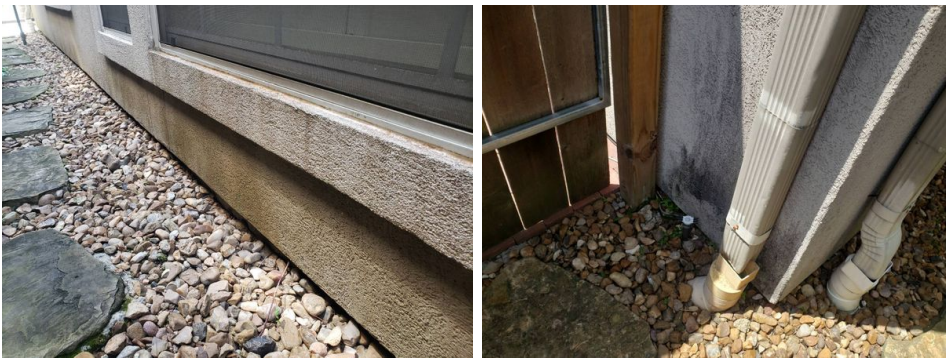
## **INADEQUATE CLEARANCE - 4-6 INCHES NEEDED**

The stucco veneer did not have adequate clearance along the bottom of the wall. It is currently required, for new construction, that there be a minimum clearance of four to six inches at the bottom of the stucco system to prevent water intrusion and to allow the stucco system to drain moisture properly.

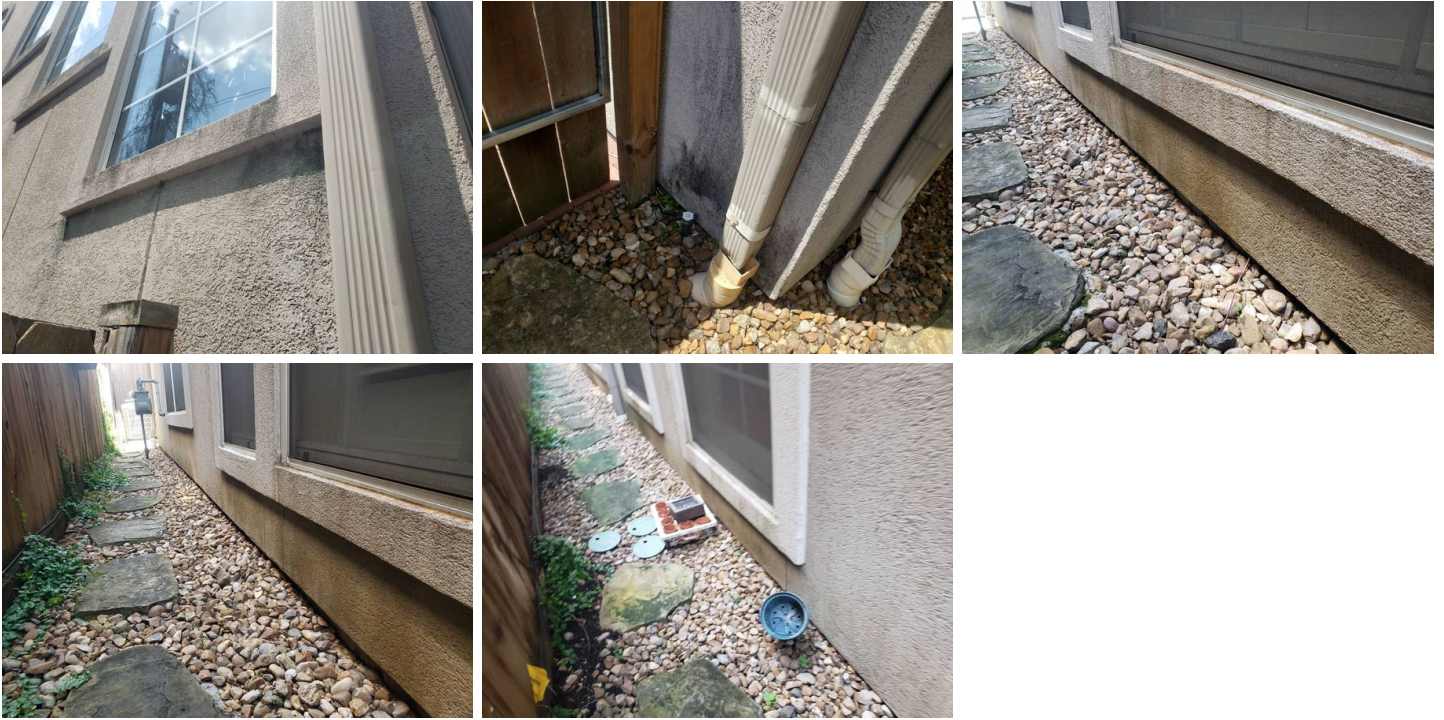
**MICROBIAL GROWTH PRESENT**

Microbial growth / mildew was observed on the stucco surface at many locations around the house. The substance should be removed and the stucco should be cleaned and painted as necessary.
