## Property Inspection Report

1109 Eugene St, Port Neches, TX 77651  
Inspection prepared for: Cynthia Lusignolo  
Real Estate Agent: Melissa White - Remax One

Date of Inspection: 4/28/2021 Time: 10:00 am  
Weather: Fair

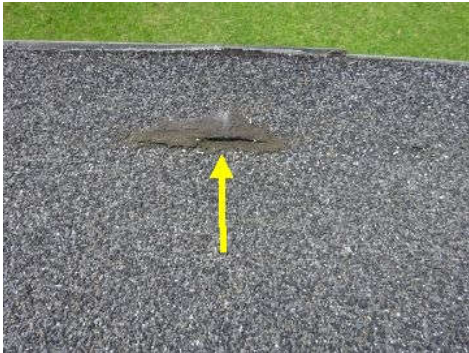
Observed a small are of separation to rolled roofing at tar patched area.

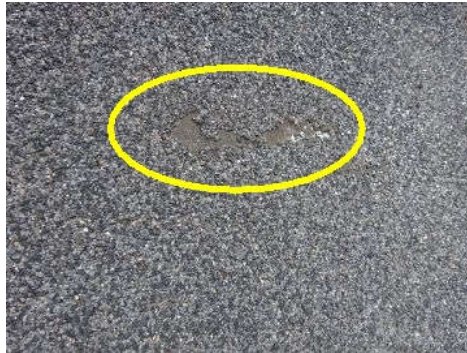
Observed mineral wear to surface of rolled roofing at rear enclosed porch in two locations.

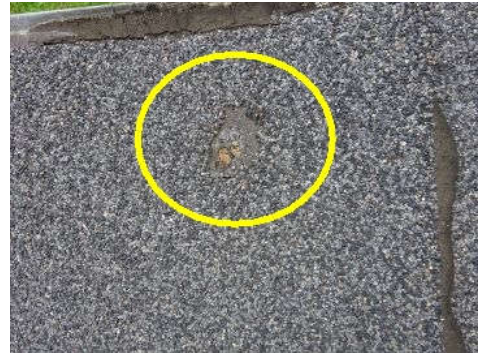
Observed mineral wear to surface of rolled roofing at rear enclosed porch in two locations.

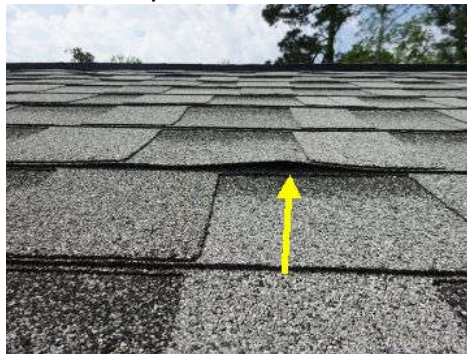
Observed a minor raised shingle on the front slope, generally a simple fix by a professional roofer.

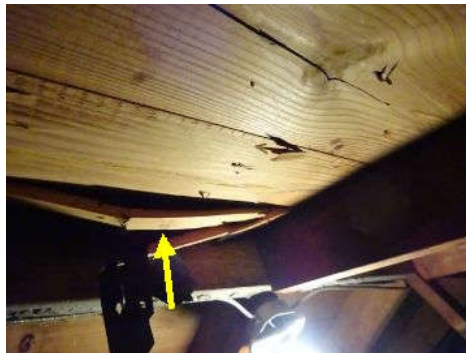
Observed several minor damaged decking boards, this is a common occurrence when installing a new roof on an older home and generally not a major concern

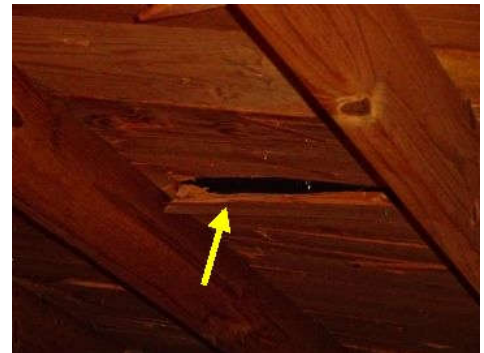
Observed several minor damaged decking boards, this is a common occurrence when installing a new roof on an older home and generally not a major concern

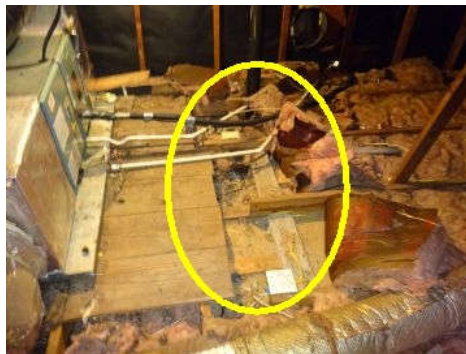
Missing insulation in the attic near furnace, recommend adding to reduce energy cost and provide added comfort.

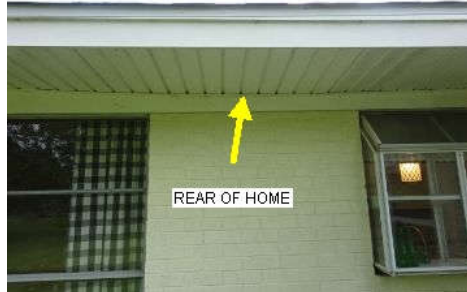
Sagging soffit vinyl in several locations.

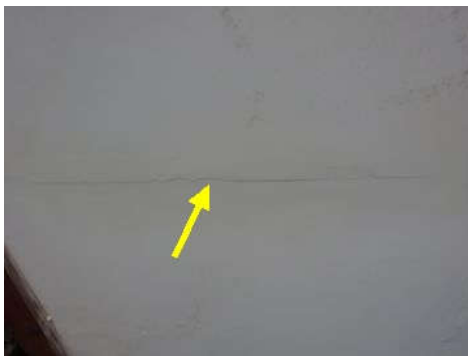
**F.5. Observed loose tape seams / hairline separation at sheetrock tape seams in the garage, this is generally common due to the garage is not climate controlled.**

Observed loose tape seams / hairline separation at sheetrock tape seams in the garage, this is generally common due to the garage is not climate controlled.

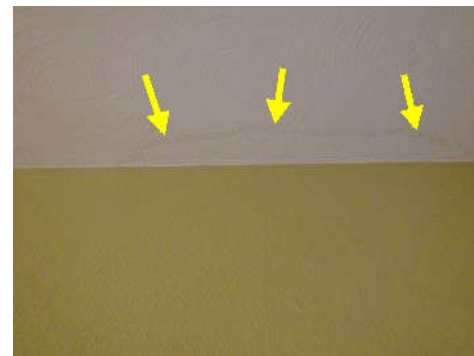
F.4. Observed a stain to ceiling in the hallway, however moisture levels are normal at time of inspection. Possible previous leak from drain pan under furnace.

Observed a stain to ceiling in the hallway, however moisture levels are normal at time of inspection. Possible previous leak from drain pan under furnace.

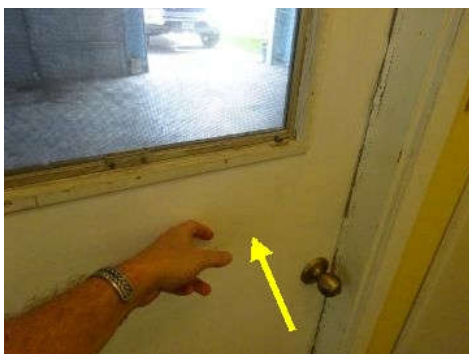
Door between garage and home is not a fire rated safety door. does not meet current industry standards.

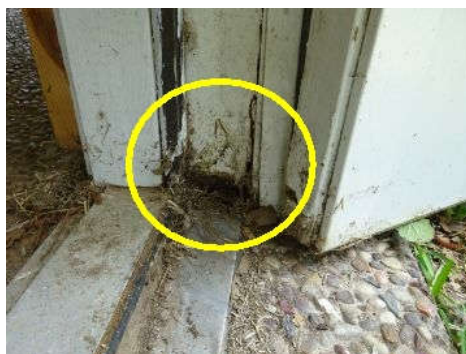
**G.7. Observed wood rot to lower area of door frame at rear exterior entrance door to porch.**

Observed wood rot to lower area of door frame at rear exterior entrance door to porch.

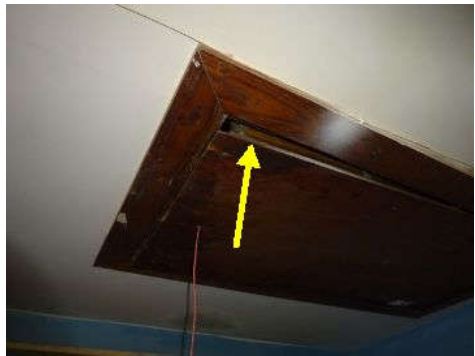
Pull down attic stairs do not completely close at time of inspection.

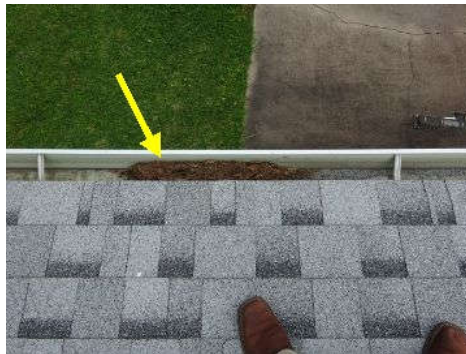
**L.2. Gutters have debris in them in several locations, recommend cleaning.**

Gutters have debris in them in several locations, recommend cleaning.

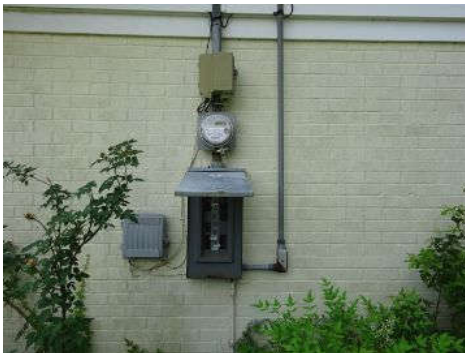
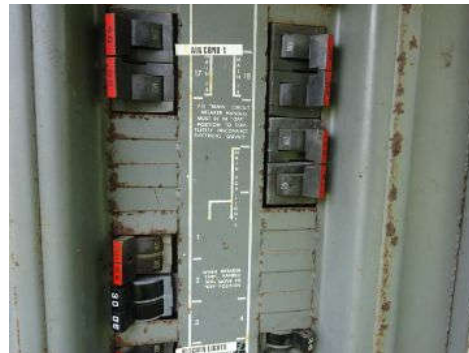
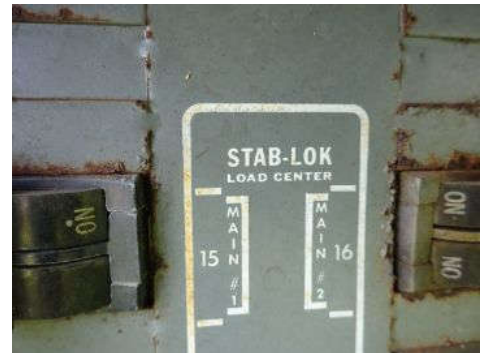
ELECTRICAL SYSTEMS Service Entrance and Panels

**A.6. There is no one main disconnect to the electrical service. There is a series of disconnects in the panel on the right exterior wall of home. As a note, current industry standards require a minimum of 100 amp main disconnect, however this was approved at time of construction.**

**A.7. Recommend electrician to evaluate / correct.**

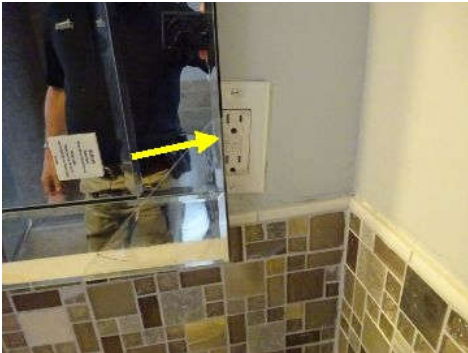
The right GFCI receptacle in the master bathroom is blocked by mirror.

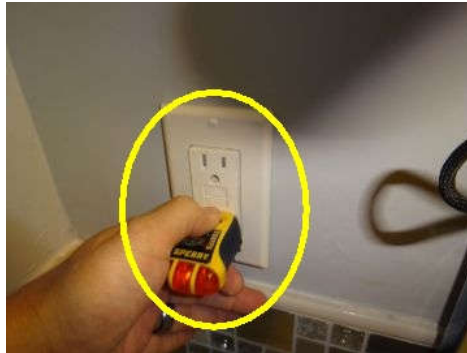
The GFCI receptacles in the master bathroom did not trip when tested with external tester.

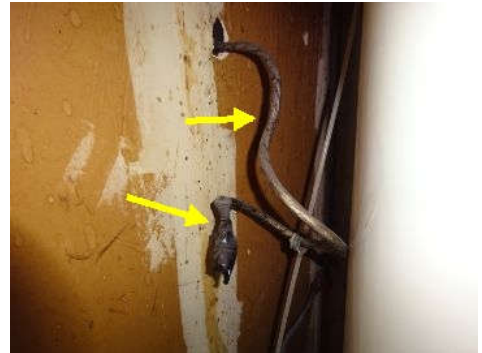
Non standard termination of romex in the water heater closet should be in protective junction box for safety reasons.

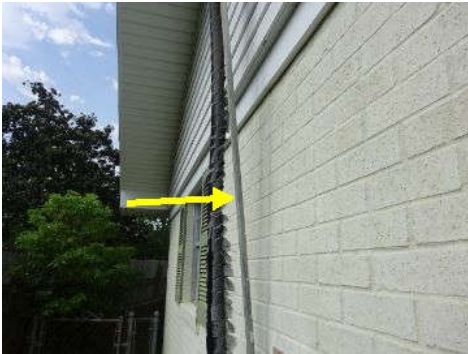
Conduit on the right and left side of home is not properly secured to wall and some areas have surface rust.

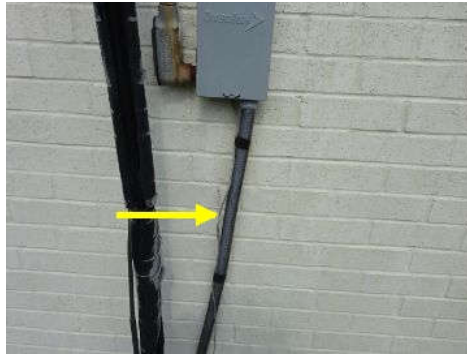
Flex conduit on the left wall of home below service disconnect for AC condensing unit is not properly secured to wall.

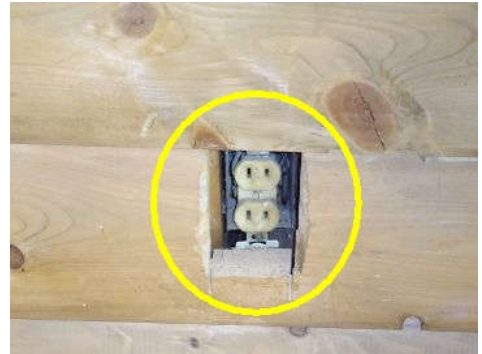
Replace all missing / damaged cover plates at receptacles and switches.

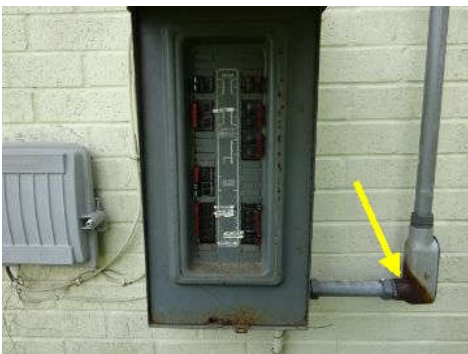
Conduit on the right and left side of home is not properly secured to wall and some areas have surface rust.

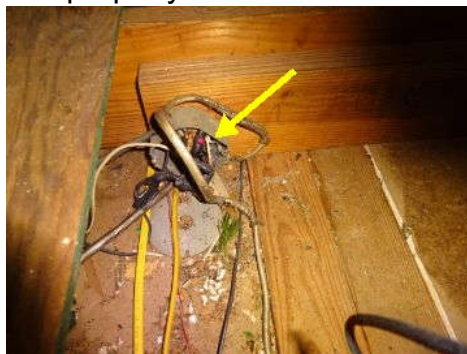
Missing junction box cover in the attic over garage, recommend installing cover for safety reasons.

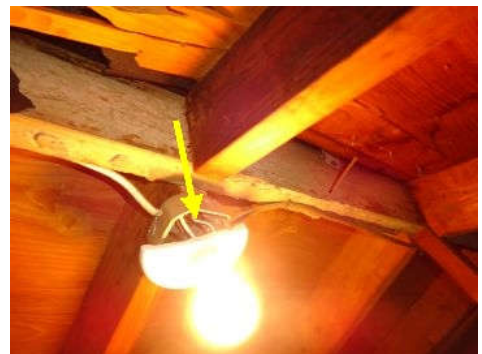
Damaged light fixture in the attic.

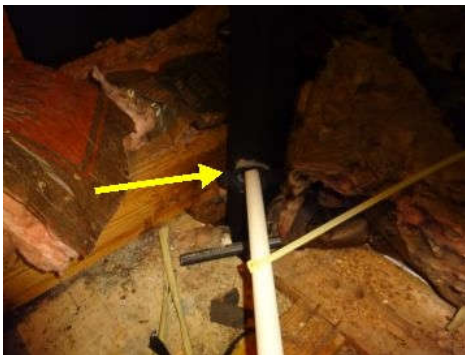
**A.6. The primary drain line from coils terminates through side of cast iron plumbing vent stack in the attic, its required to terminate to approved location.**

The primary drain line from coils terminates through side of cast iron plumbing vent stack in the attic, its required to terminate to approved location.

**A.7. Recommend HVAC technician to further evaluate / correct.**

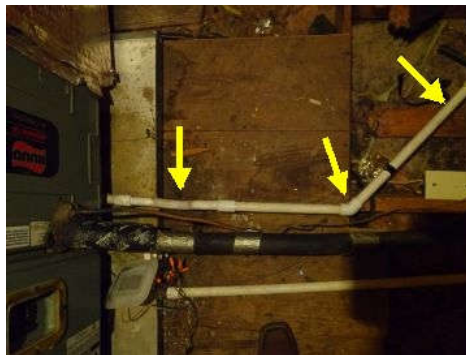
There is no insulation on the primary drain line in the attic from coils as required.

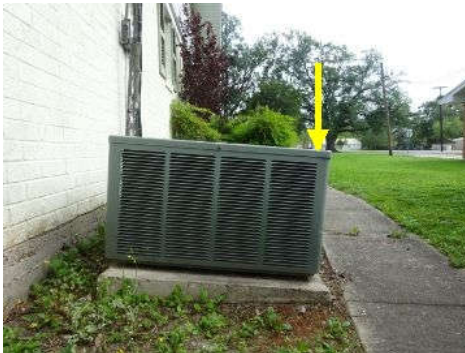
The exterior condensing unit is un level at time of inspection, unit should be level on its foundation / pad.

**B.8. Recommend HVAC tech to further evaluate / correct.**

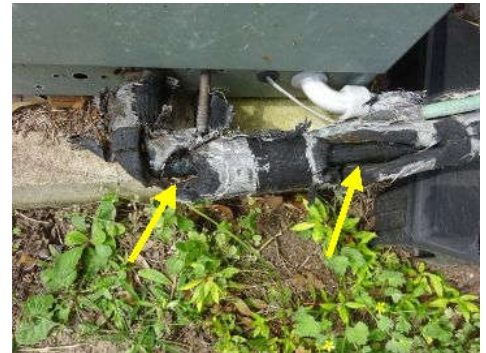
**B.7. Missing / worn insulation at suction line at exterior AC unit.**

Missing / worn insulation at suction line at exterior AC unit.

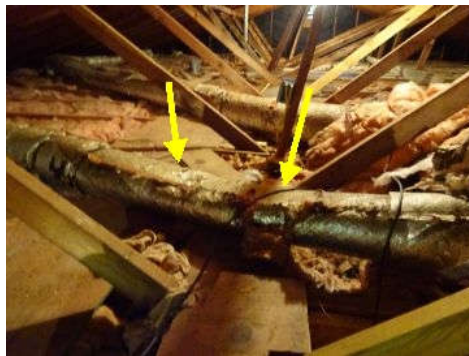
**C.4. Filter is dirty, recommend changing.**  
**C.5. Partially collapsed duct in the attic at pathway.**  
**C.6. Recommend HVAC tech to further evaluate.**

Partially collapsed duct in the attic at pathway.

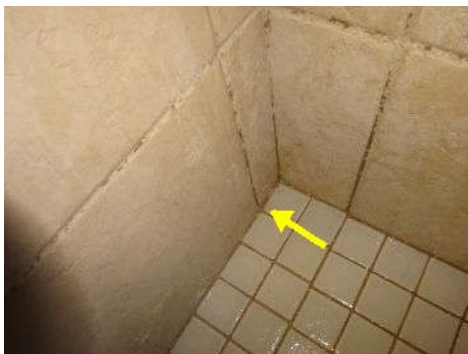
Observed separation to grout in several locations between tiles in the corners of shower surround in the master bathroom.

**A.8. Recommend plumber to evaluate**

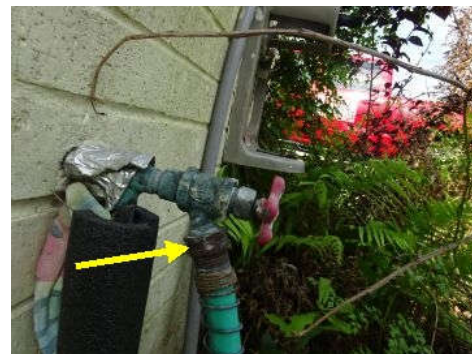
**A.7. There are no back flow prevention devices installed on the exterior hose bibs, does not meet "current industry standards".**

There are no back flow prevention devices installed on the exterior hose bibs, does not meet "current industry standards".

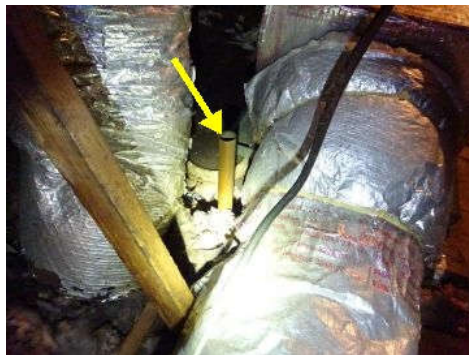
Observed an open ended copper drain line / plumbing vent in the attic near furnace, unable to determine use, possibly discontinued vent pipe. See sellers disclosure.

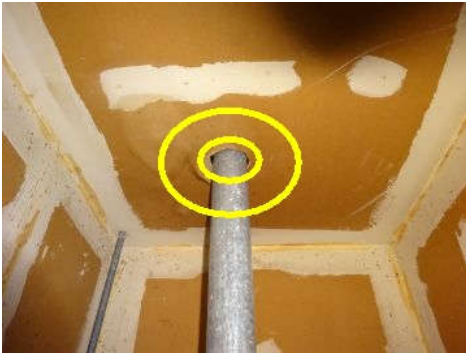
Missing heat shield at ceiling for gas vent stack.

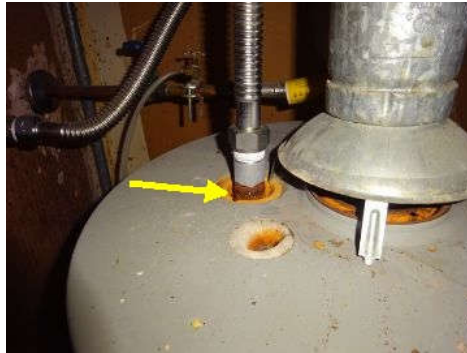
Observed surface rust to upper supply fitting atop water heater.

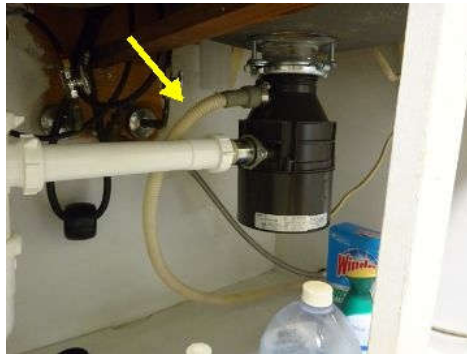
No air gap / anti siphon loop is present at drain line from dishwasher.

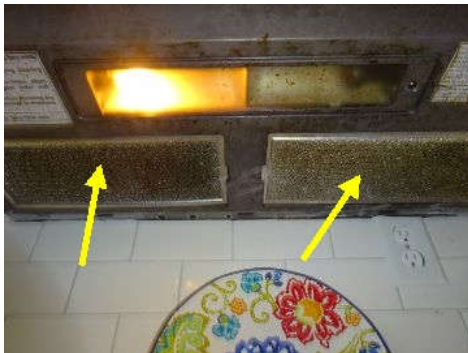
Filters are dirty and need cleaning.

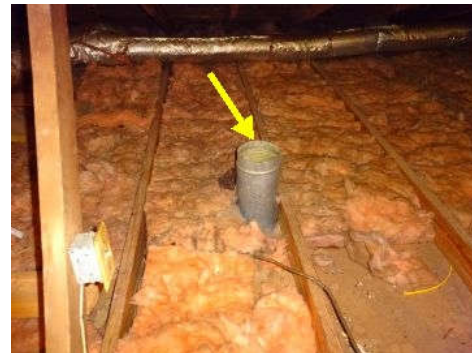
Vent hood terminates in the attic, this type should terminate to the exterior of home to meet "current industry standards".

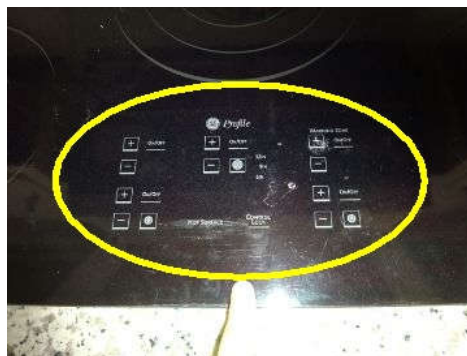
**D.3. Cook top did not respond to controls.**

Cook top did not respond to controls.

**D.4. Recommend a qualified appliance repair person further evaluate, determine cause and repair/replace as required.**

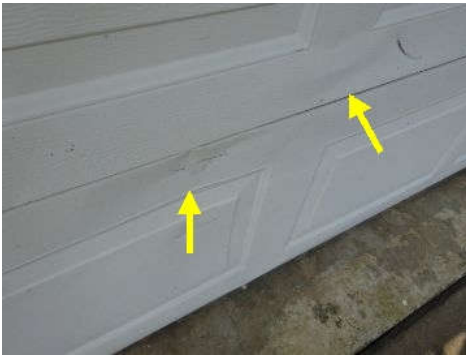
**G.4. Doors have dents in several locations.**

Doors have dents in several locations.

**G.5. Recommend further evaluation by a qualified overhead door technician.**

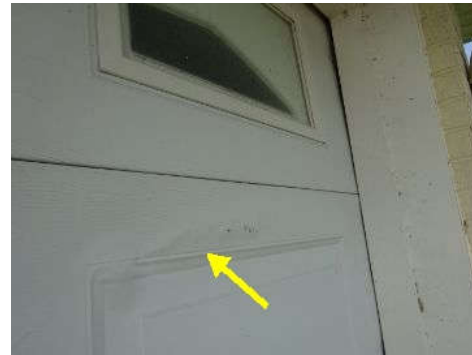
Doors have dents in several locations.
