# HOUSTON INSPECTIONS

**Clayton Carlson  
6130 Sugar Hill Dr  
Houston, TX 77057**

**March 21, 2019**

## PROPERTY INSPECTION REPORT

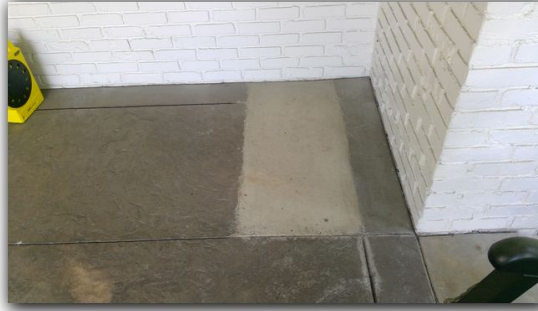
Signs of previous foundation repairs were noted around the perimeter of the foundation at the concrete flatwork as evident by pier caps. The seller / current owner should be consulted to determine the extent of repairs and any transferable warranties that apply to the foundation repairs.

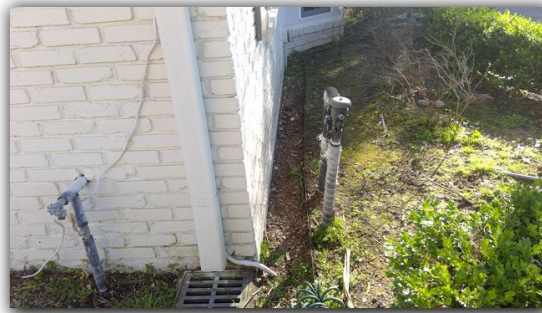
The existing grade at the slab perimeter is not adequate for shedding water away from the structure(s) on all sides. The ground should slope away from the structure at a rate 6" in the first ten feet. Where lot lines, walls, slopes or other physical barriers prohibit 6" of fall within the first 10', drains or swales should be provided to ensure drainage away from the structure. Ideally, at least eight (8) inches of clearance should be maintained between soil level and the top of the foundation walls.

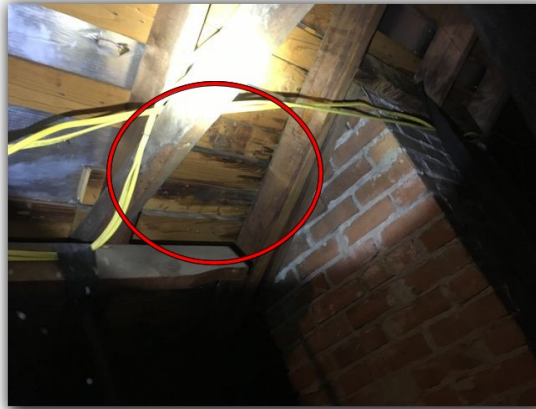
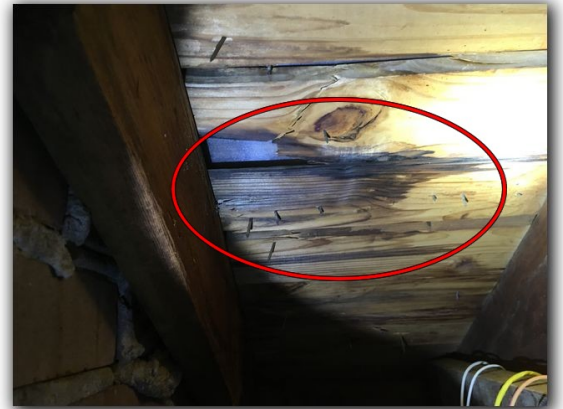
Staining was found at sections of the roof decking as evidence of active roof leaks. A qualified tradesman should further evaluate the roof and make the necessary repairs to repair the leaks.

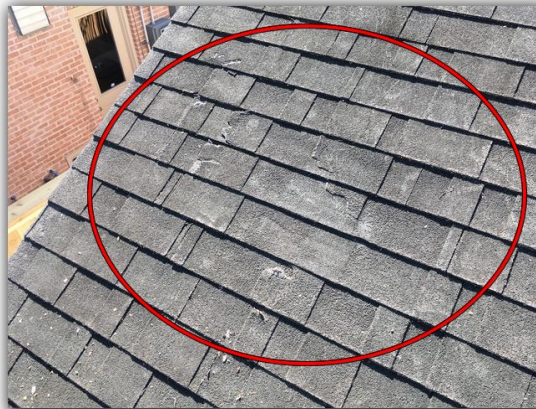
Damaged and / or missing shingles were found during the inspection of the roof covering. Recommend repairs by a qualified tradesman.

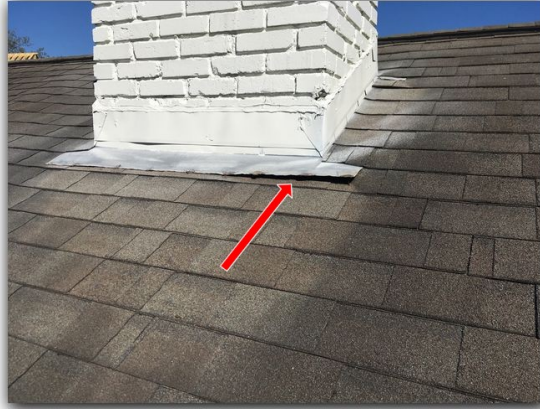
Sections of the roof flashing are raised which could lead to water penetrations. Recommend repairs.

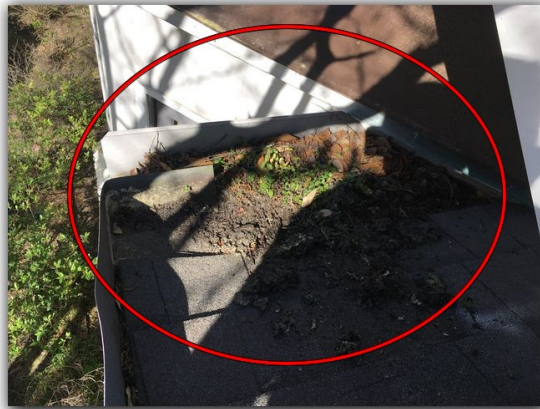
The debris should be cleaned from the gutters to allow proper drainage of rainwater from the roof covering.

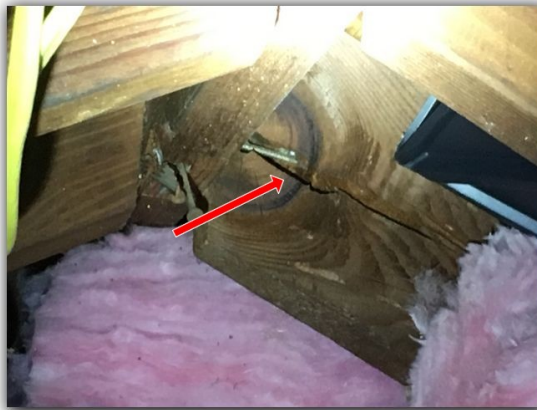
A damaged/split rafter was noted in the middle left of attic. Recommend repair by a qualified tradesman

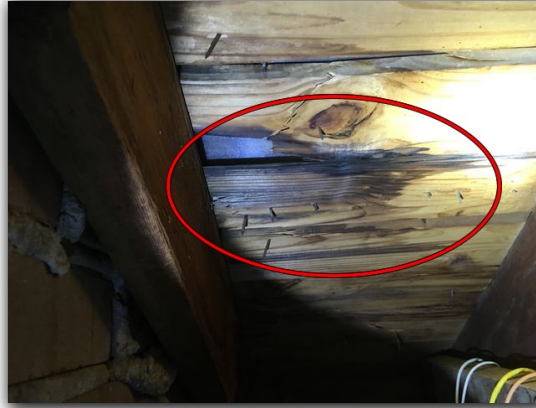
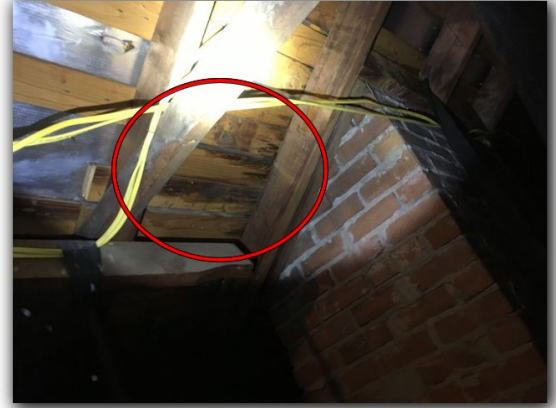
During the inspection of the roof covering active and / or previous water penetrations were observed. The client should advise the roofing tradesman to evaluate the roof decking during repairs to determine if hidden / concealed damage is present that is in need of repairs.

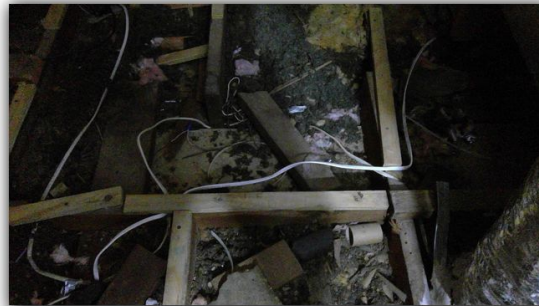
Missing insulation was found in the attic. Recommend installing insulation at the needed areas to improve the energy efficiency of the building.

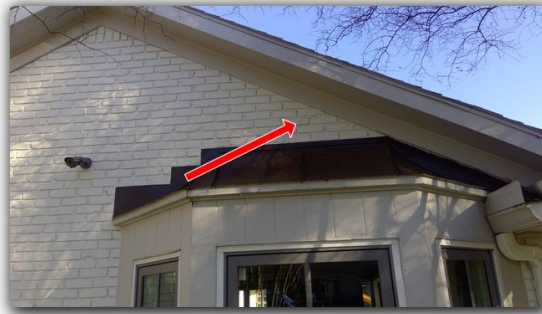
Brick / mortar cracks were found on the exterior of the structure as evidence of settlement of the structure.

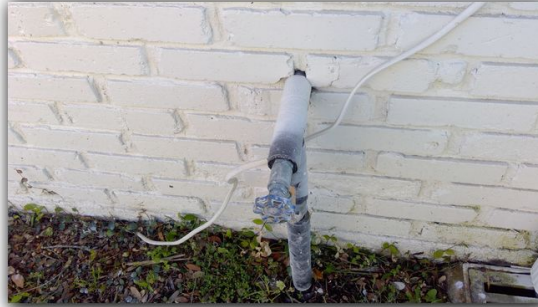
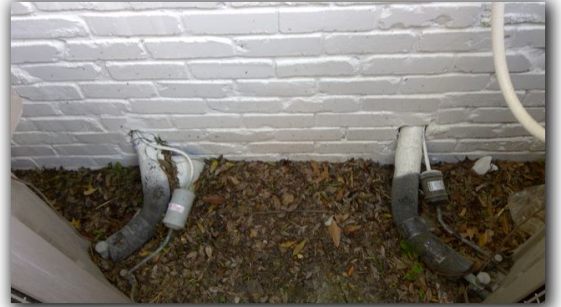
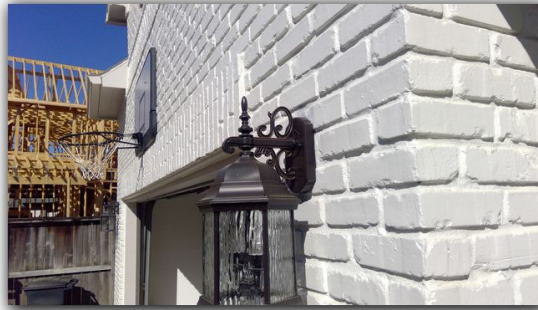
All exterior wall penetrations (electrical panels, electrical disconnects, light fixtures, etc. ) and openings (expansion joints, windows, door thresholds, etc. ) should be sealed with an approved material to prevent water penetrations into the wall cavities. Properly sealed exterior veneers help provide a barrier against the weather, insects, and enable environmental control of the interior spaces.

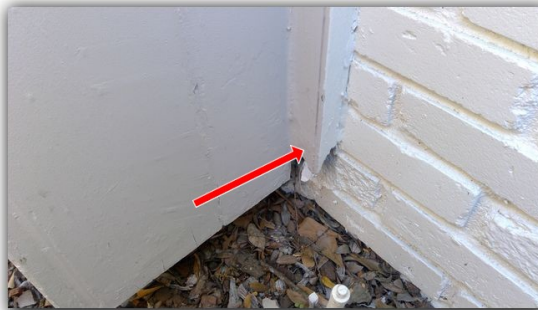
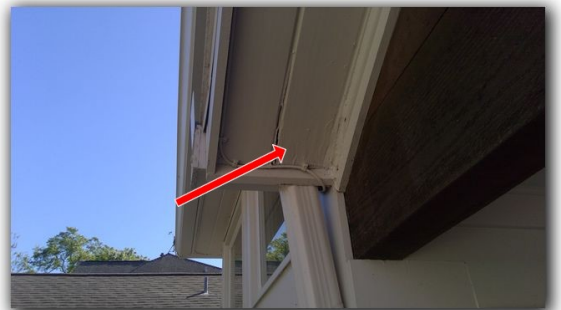
Damaged and / or missing trim, fascia boards, and / or soffits were found on the exterior of the property. The damage was found at the following locations: middle right, Middle Areas where decay is present should be removed, exposing underlying materials for inspection prior to repair.

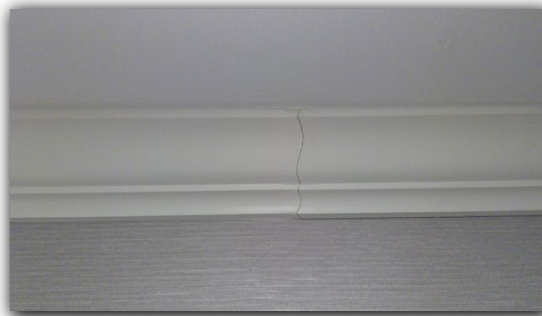
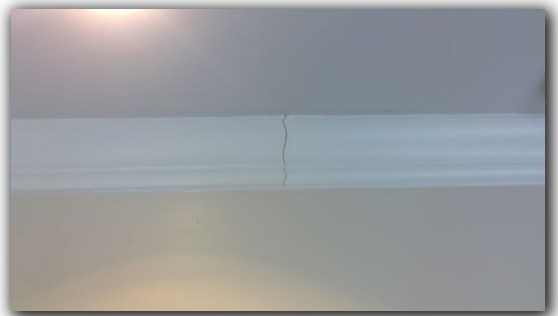
Separation was noted at sections of the interior trim and / or crown molding as evident of settlement of the structure.

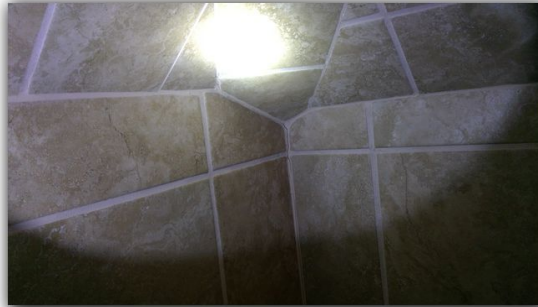
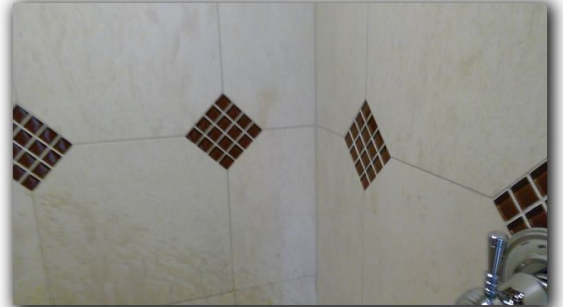
Damaged and missing grout/caulking was noted in the rear right guest bathroom, garage apartment bathroom shower/bathtub enclosure. It is recommended that the damaged or missing items be repaired/replaced.

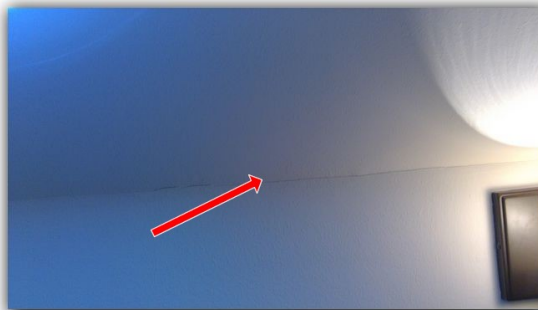
Hairline cracks were found on the interior of the property as evident of settlement. The cracks can be repaired if desired for cosmetic purposes.

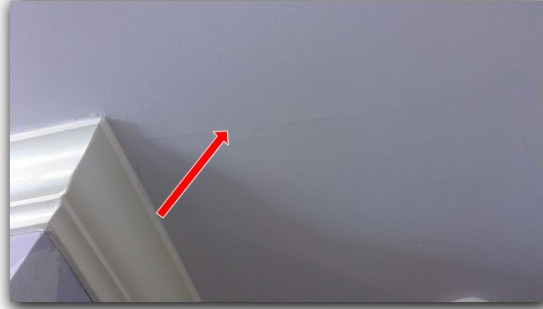
Cracking was noted on the interior ceiling of the property as evidence of settlement.

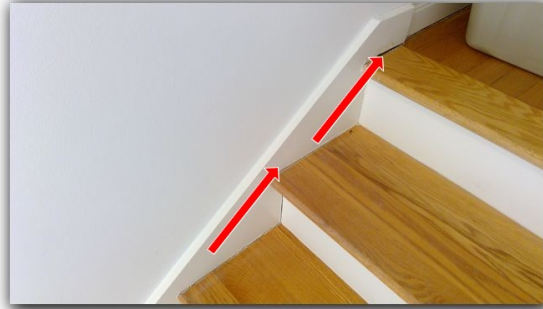
Damaged and missing grout/caulking was found at the floor garage apartment

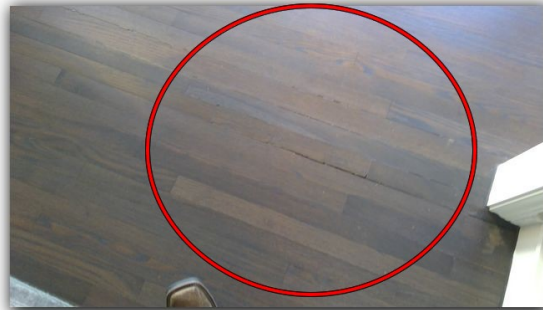
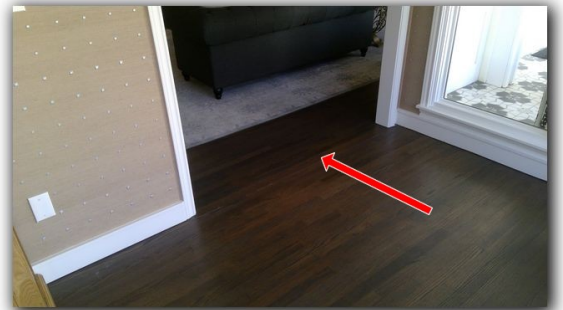
Damaged/Raised flooring was noted in living room hallway from possible moisture penetration . Recommend evaluation for repair

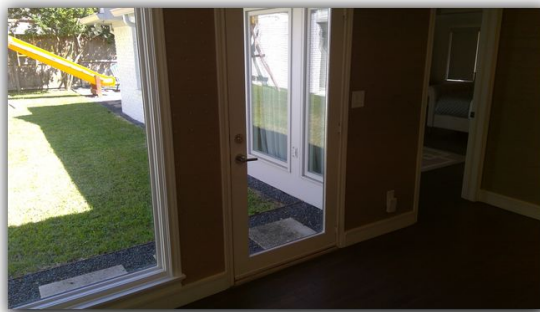
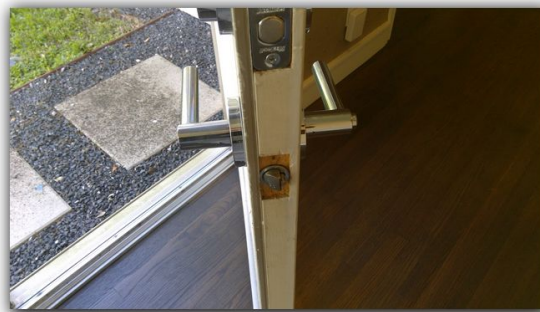
The door handle on the middle exterior door does not appear to be functioning properly and the striker plate is improperly installed. Recommend repair by a qualified tradesman

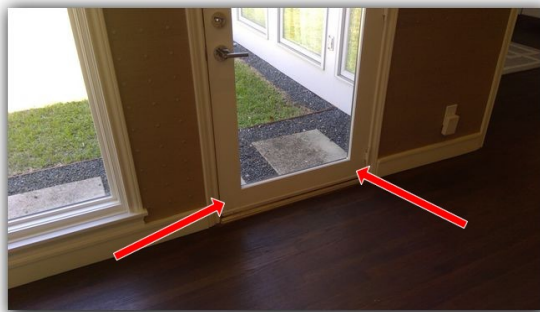
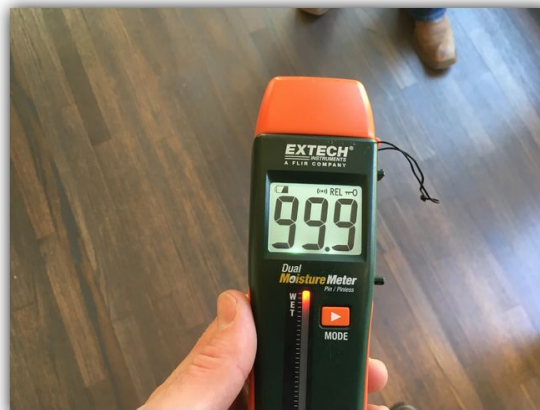
The middle rear exterior door shows signs of moisture penetration and elevated moisture meter readings (99.9%). Recommend evaluation for repair of all associated components by a qualified tradesman

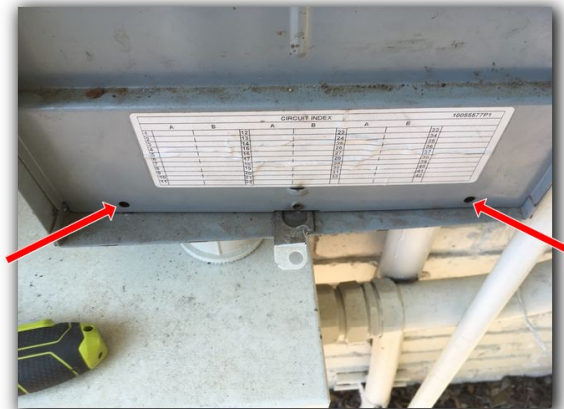
Missing screws were found at the dead front cover located at the main service panel. Approved screws should be installed at the dead front to properly secure the cover.

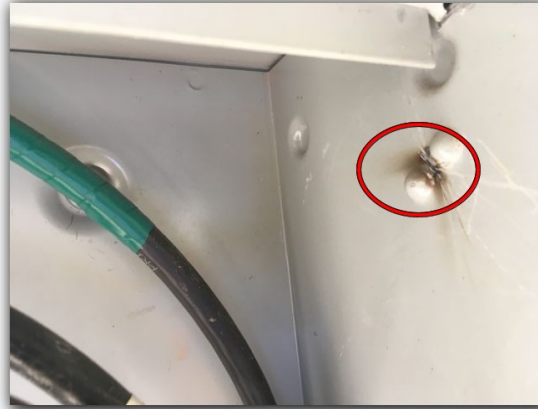
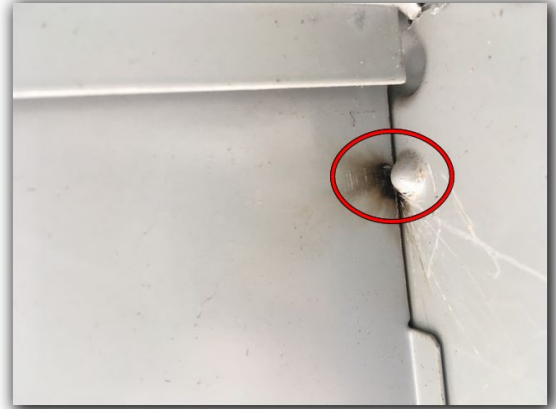
Evidence of previous overheating/arcing was noted on the panel as evident by discoloration on the interior of the box. Recommend evaluation by a licensed electrician

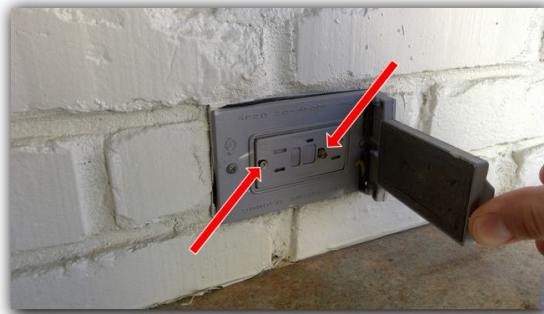
A metal prong is broken off in one leg of a receptacle in the Exterior. The prong should be removed or the receptacle should be replaced.

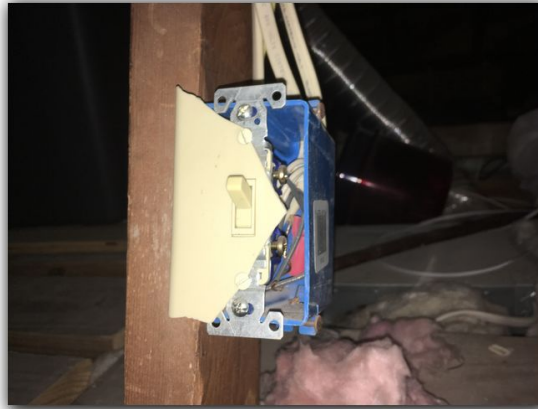
Damaged plate covers were noted in the attic

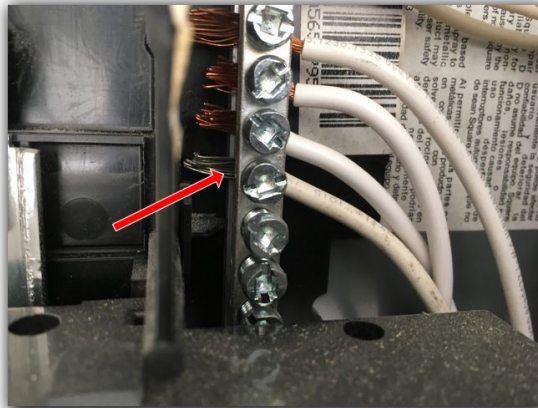
Aluminum neutral conductor was found at the neutral bar and i could not determine the what it went to. Recommend evaluation by a licensed electrician

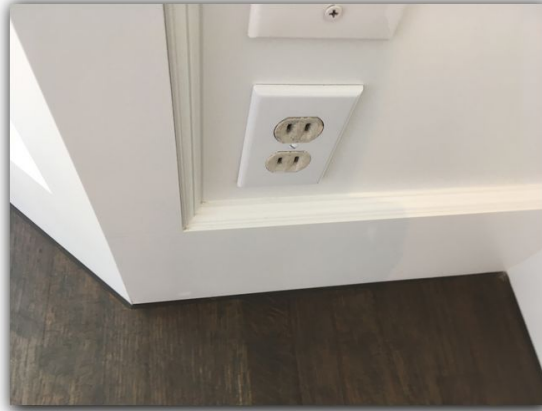
Two prong un-grounded receptacles were found at various locations in the property.

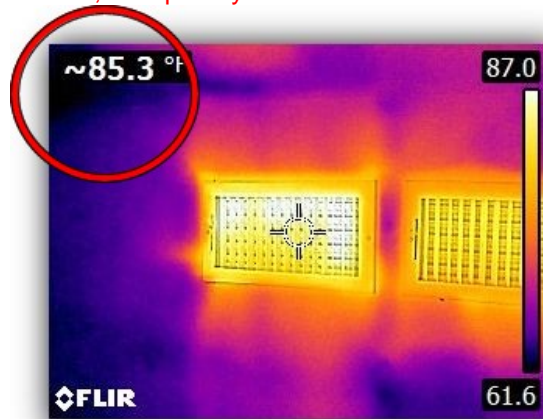
The electric heaters does not appear to be operating at maximum efficiency. After operating for 20 minutes the temperature at the registers was only 85 degrees. This may indicate a malfunction in one or more of the heating elements or control components. Recommend further inspection, service, & repair by a licensed A/C-Heat technician.

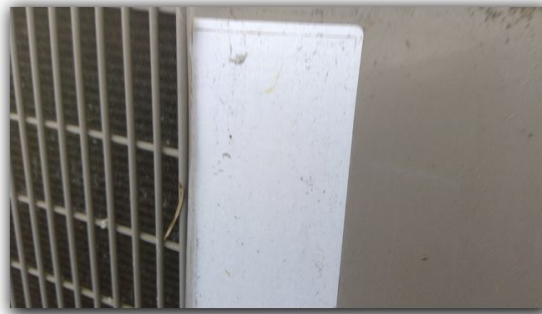
The data plate on the cooling system was not visible / legible at the time of the inspection.

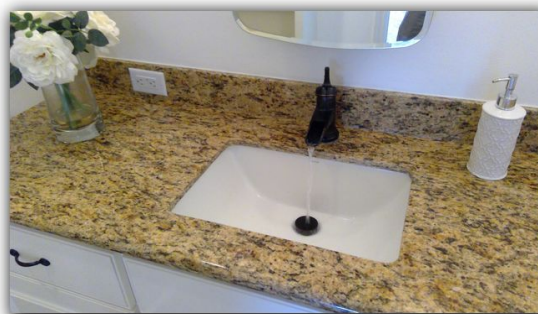
Low water pressure was noted during operation of the bathroom sink. Recommend further investigation and improvements if needed.

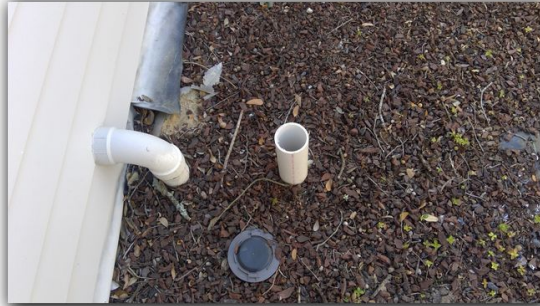
The cleanout for the garage apartment is missing the cap. Recommend replacement

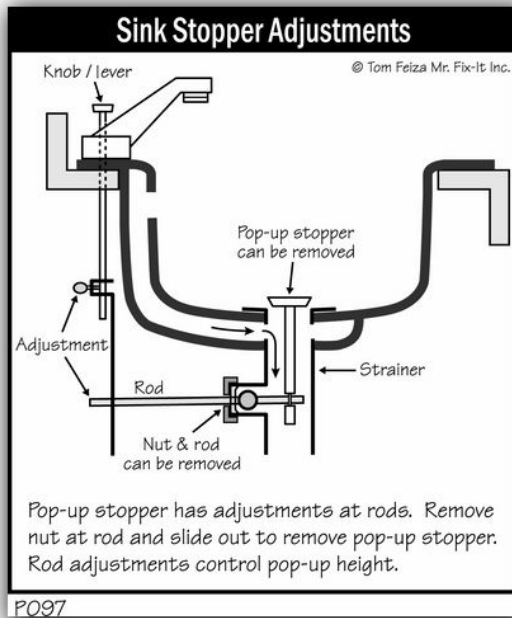
The stopper is not functioning properly at the bathroom left sink.

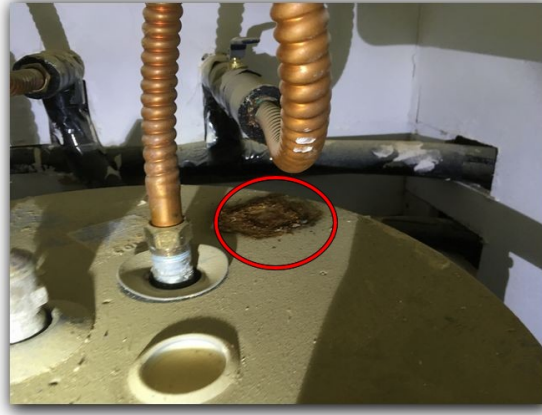
Corrosion/rust was noted on top of the electric water heater in garage attic. Recommend evaluation for repair by a qualified tradesman

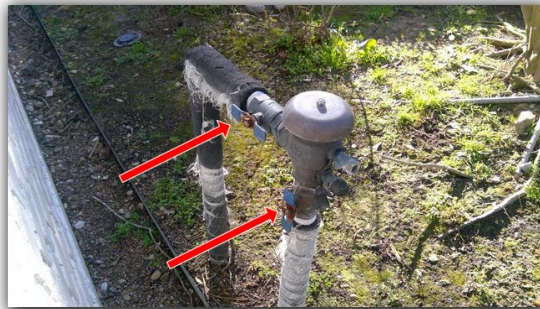
**Rust and corrosion were found at the valve handles installed at the backflow prevention device. The valve handles should be repaired as the rust will eventually cause the handles to become inoperative.**

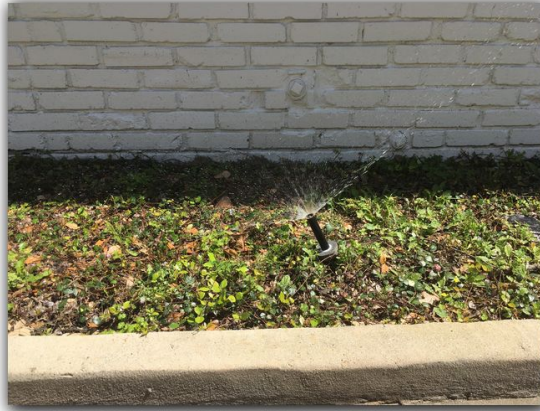
Several sprinkler heads are not level causing the heads to not provide proper coverage to the area intended. Recommend re-aligning the heads to insure proper watering and coverage.

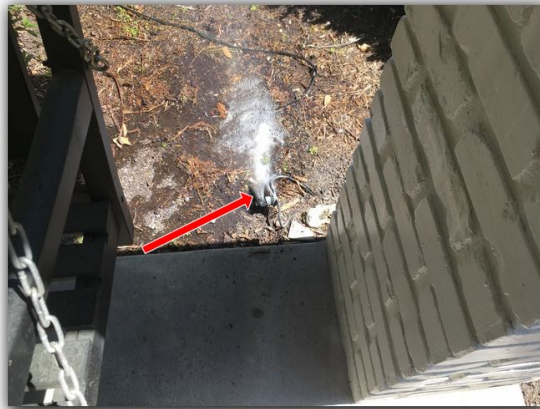
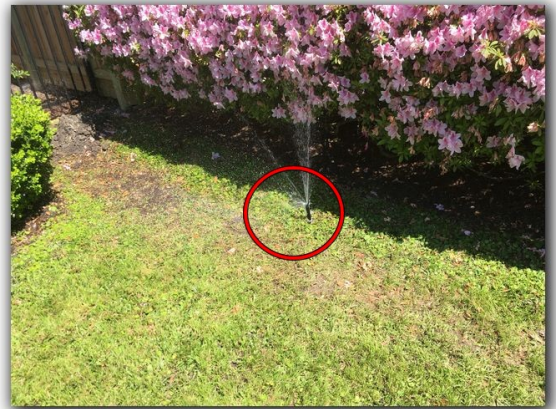
Broken sprinkler heads were found in zone(s) #\_\_1,2\_\_. A qualified tradesman should be consulted to perform all necessary repairs.
