SELLER'S DISCLOSURE NOTICE

CONCERNING THE PROPERTY AT 3311 Sunset Field Ln Missouri City TX 77459

Client: Alberto Bazan / 346-816-8149 / Email: 4bazans@comcast.net
Inspection Date: February 20, 2019
Project Address: 3311 Sunset Field Missouri City Texas 77459
Propose Repair: Installation of 34 Exterior Pilings and 20 Interior Pilings

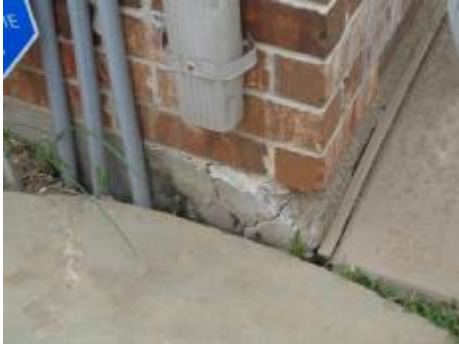
Comments: There are cracks/ popped in the corners of the foundation on the left front, right front, and right back. Seal/repair all cracked/popped corners

Popped corner back right

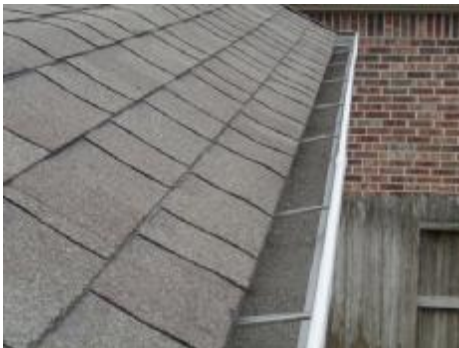
Comments: The gutters are full of roof aggregate debris. Clean out the gutters for proper drainage away from the foundation. The right back side of the house is missing the downspout elbow and extension. Install the downspout elbow and extension for proper drainage away from the foundation.

Gutter debris

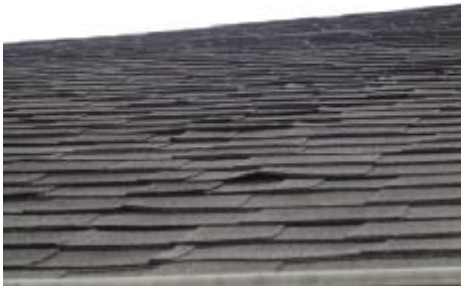
Roof raised shingle

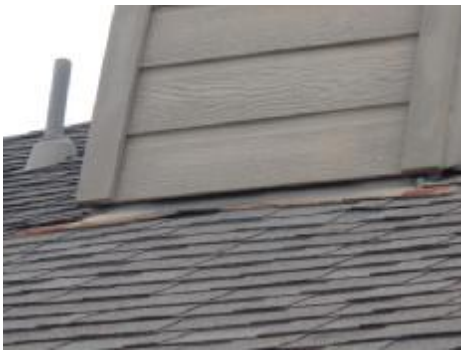
Rusted flashing

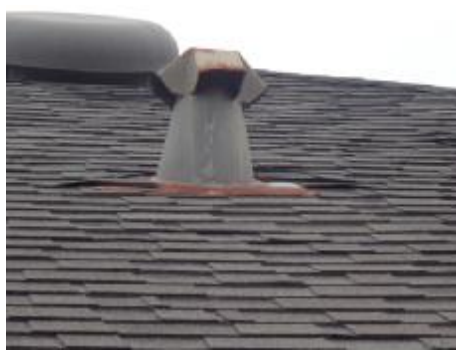
Rusted vent pipe

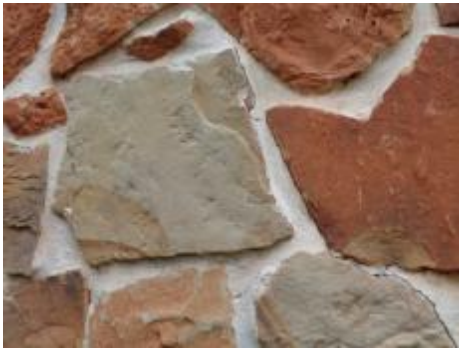
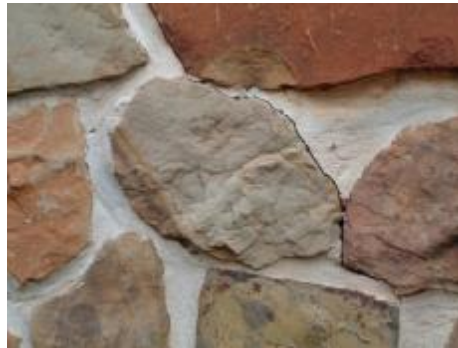
Comments: There are cracks through the mortar on the left side of the house. Repair the cracks to prevent moisture intrusion.

Crack in mortar

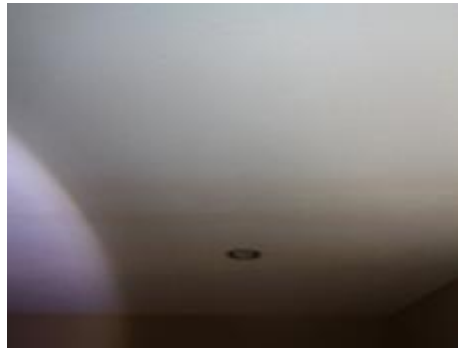
Comments: There is moisture damage to the ceiling in the upstairs hallway. Have a contractor evaluate and repair the ceiling.

Moisture damage

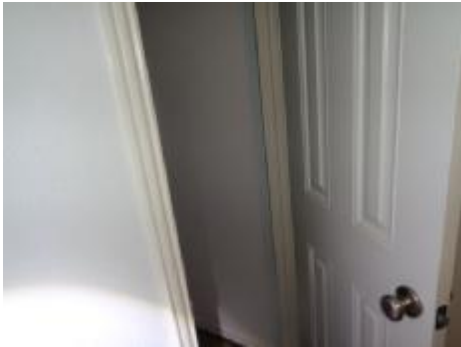
Closet door

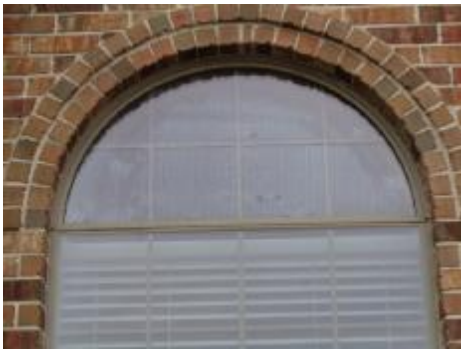
- H. Windows –**
Comments: There is a fogged window on the front exterior wall. Repair or replace fogged window.
Fogged windows yes no

Fogged window

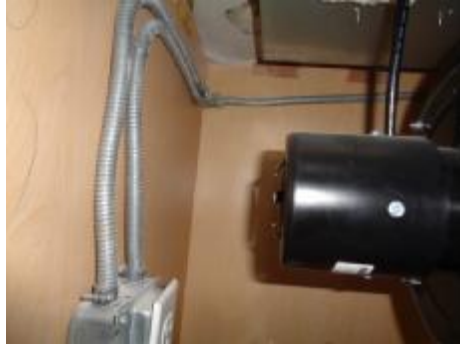
Fungal growth

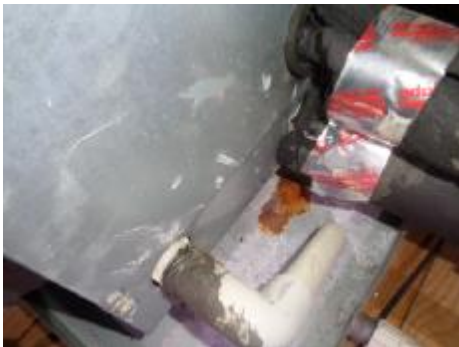
- Condensate Drain (s) There is rust in the drain/condensation pan.
- Piping Insulation
- Unit Clearances

Rust in pan

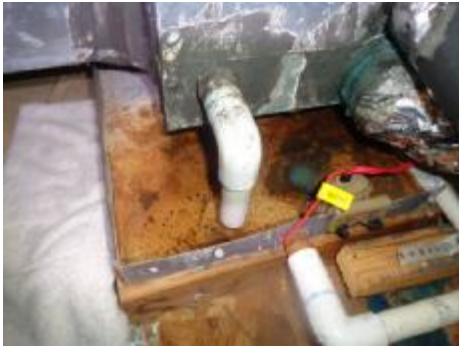
Rust in pan

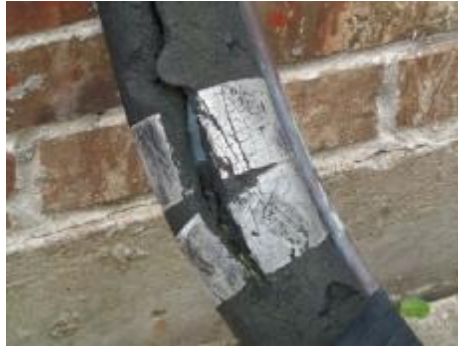
- Condensate Drain (s) There is rust in the drain/condensation pan.
- Piping Insulation The exterior piping insulation is damaged. Repair or replace the insulation.

AC insulation

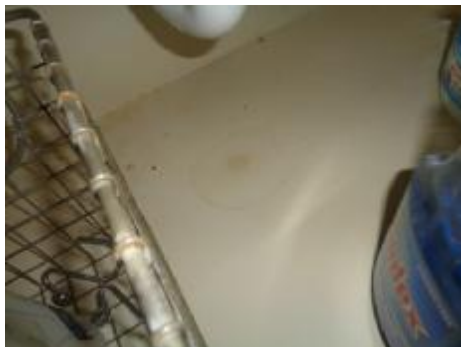
Leak under sink

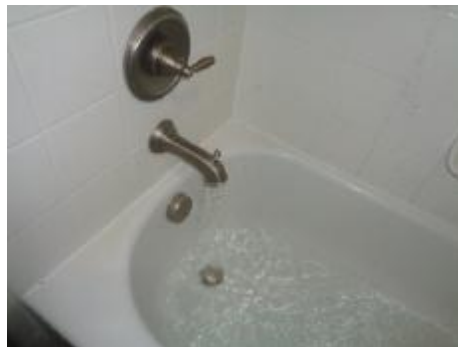
There is continuous water flow from the tub faucet when the shower diverter is in operation. Repair/replace the shower diverter for proper operation.

Diverter valve

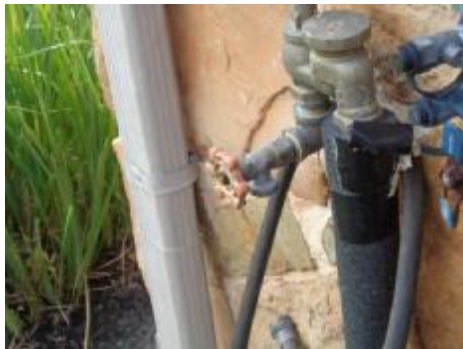
- Exterior Faucets/Fixtures* The exterior hose faucet on the right side lacks an anti-siphon device. Install anti-siphon device for safety.
- Backflow Prevention* present absent

Backflow missing

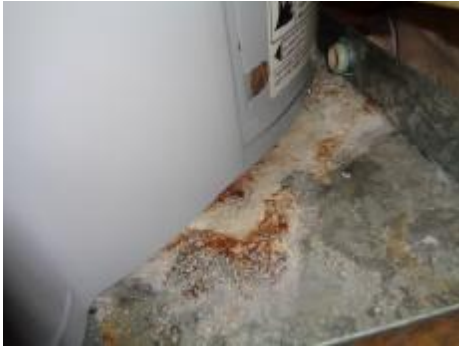
Rust in pan

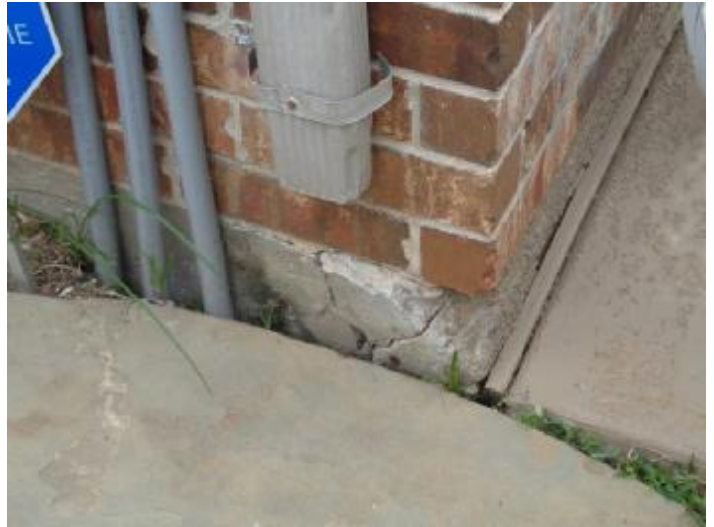
Rear right corner of concrete slab foundation cracked - Downspout lacks an elbow and extension

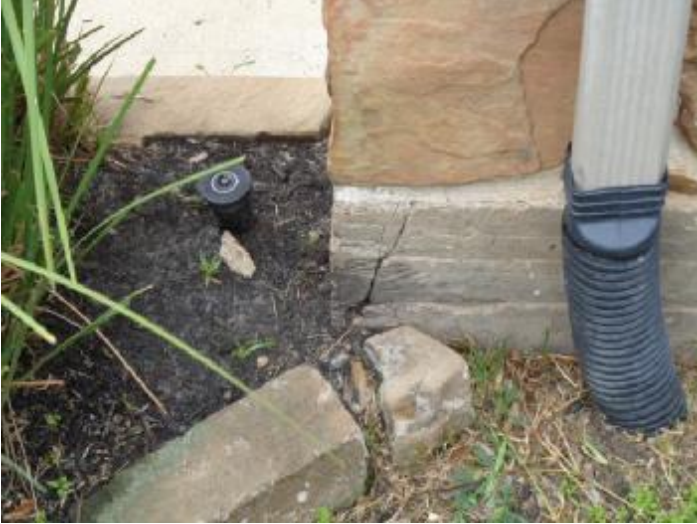
Front right corner of concrete slab foundation cracked

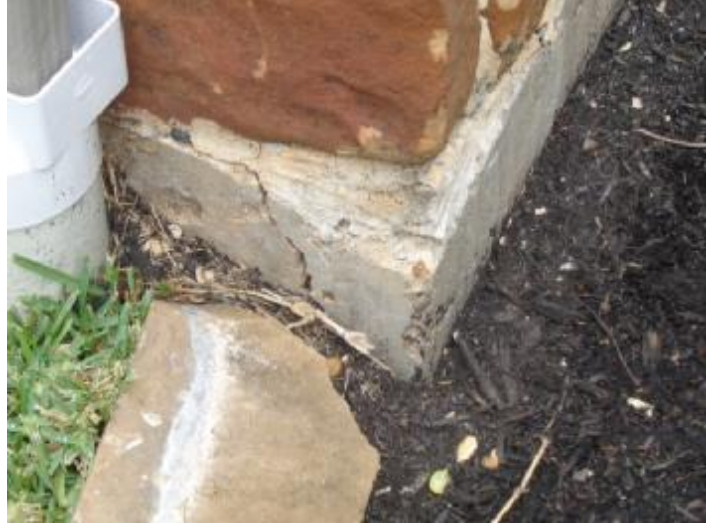
Left front corner of concrete slab foundation cracked

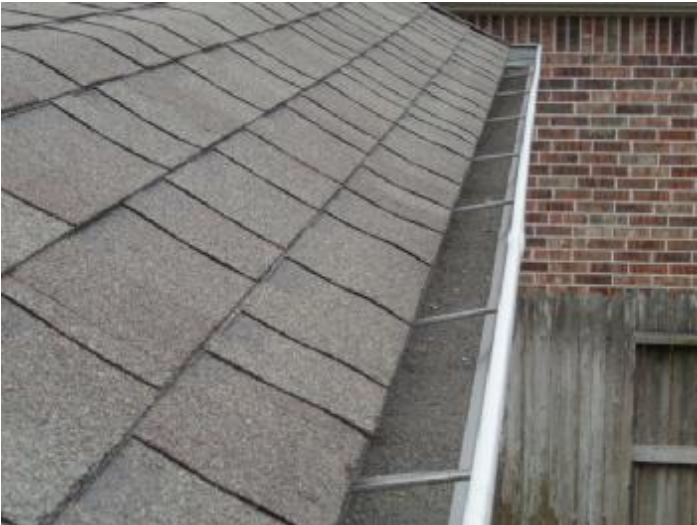
Gutter clogged with debris

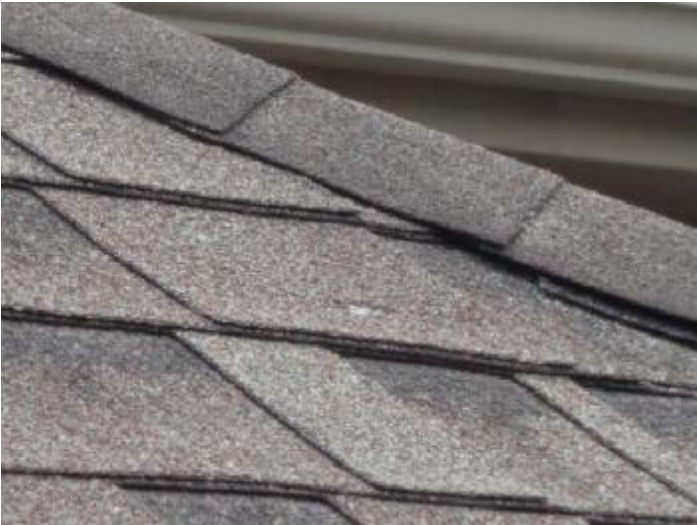
Granular/aggregate loss at roof surface - Damaged shingle

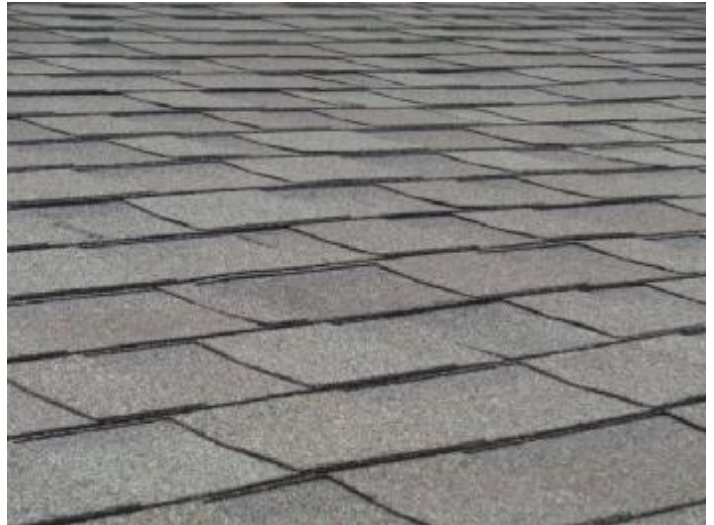
Granular/aggregate loss at roof surface

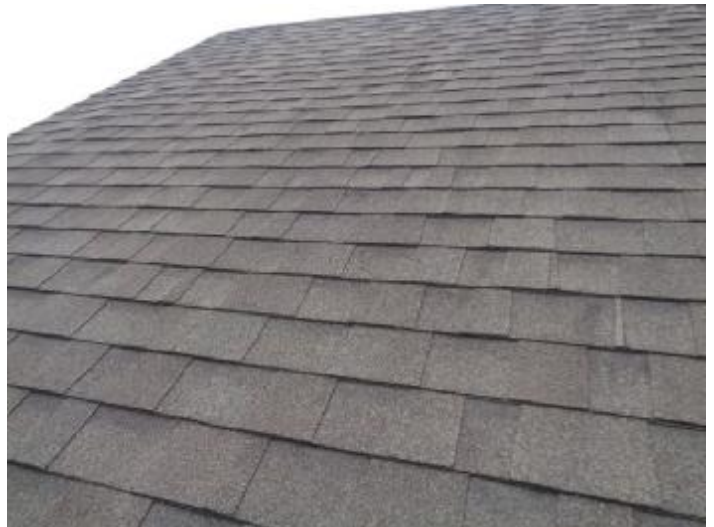
Granular/aggregate loss at roof surface

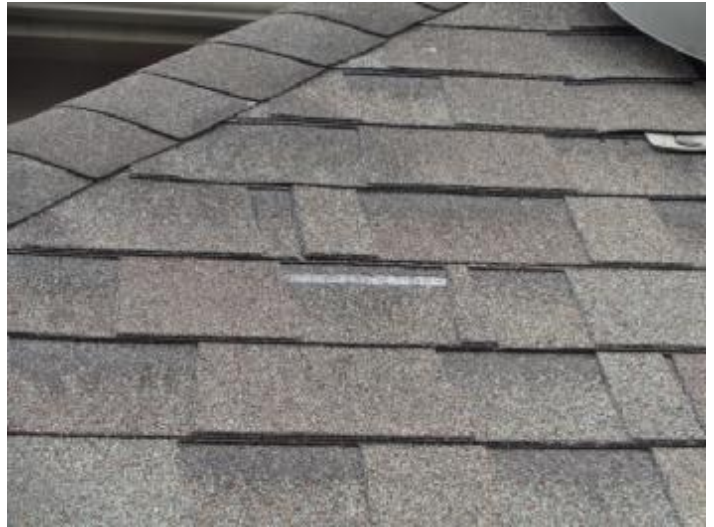
Granular/aggregate loss at roof surface - Damaged shingle

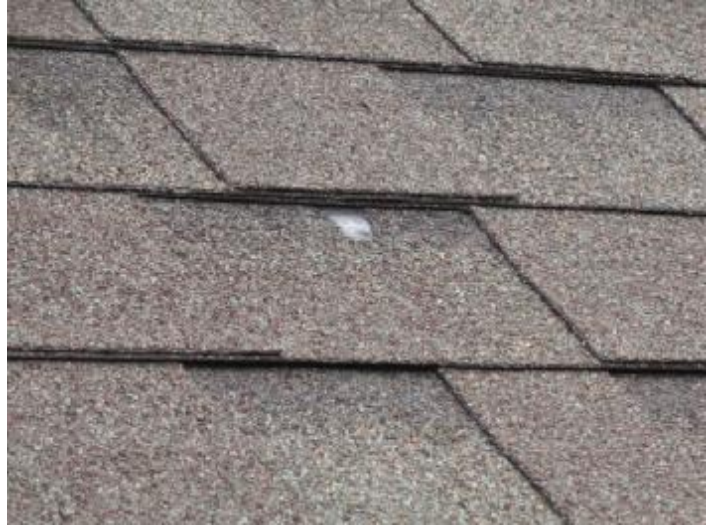
Granular/aggregate loss at roof surface - Damaged shingle

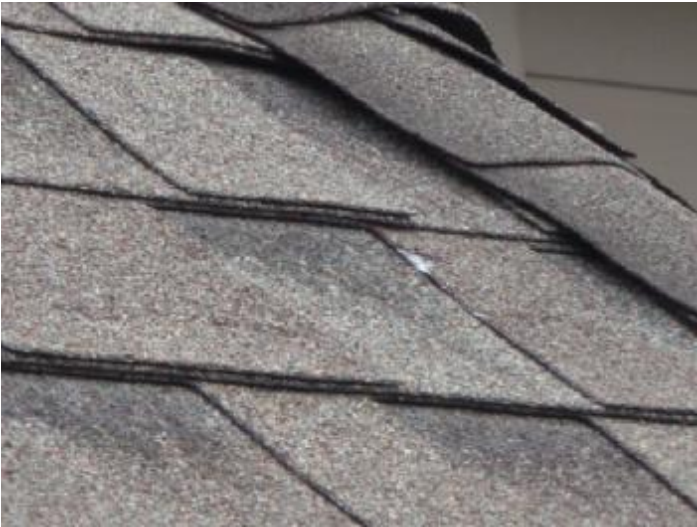
Granular/aggregate loss at roof surface - Damaged shingle

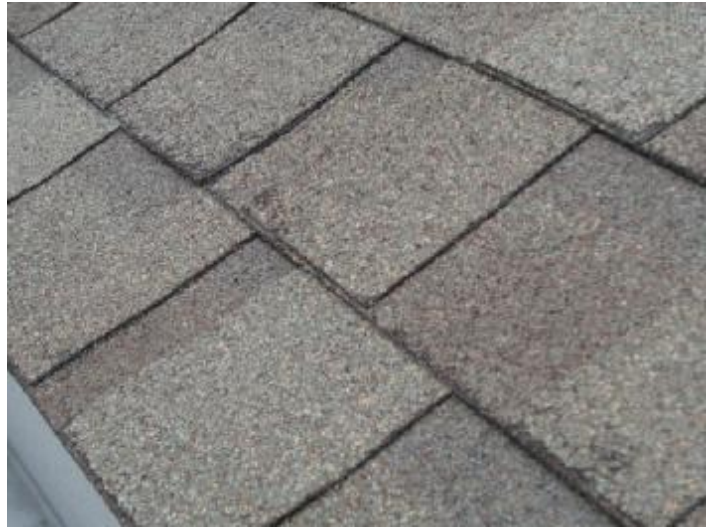
Granular/aggregate loss at roof surface

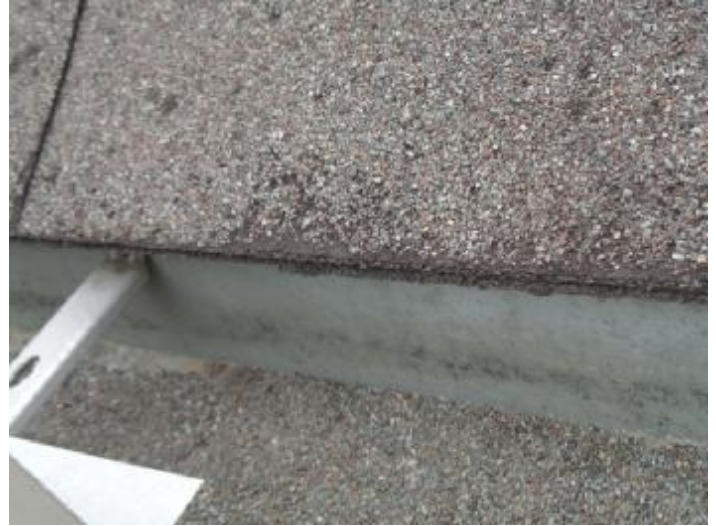
Granular/aggregate loss at roof surface

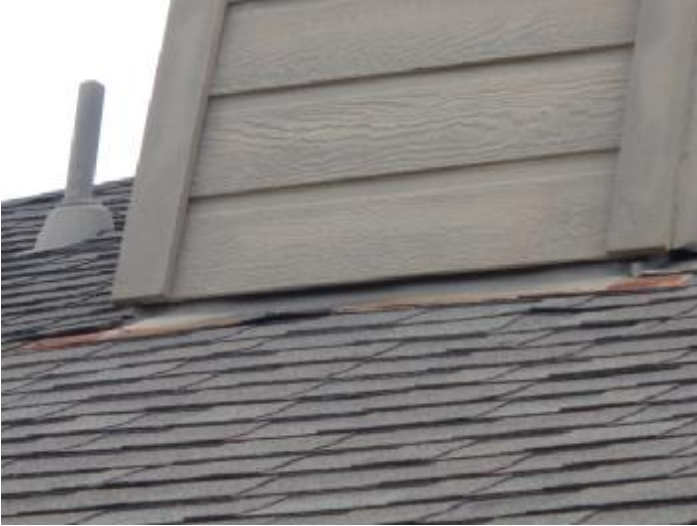
Damaged and rusted chimney flashing

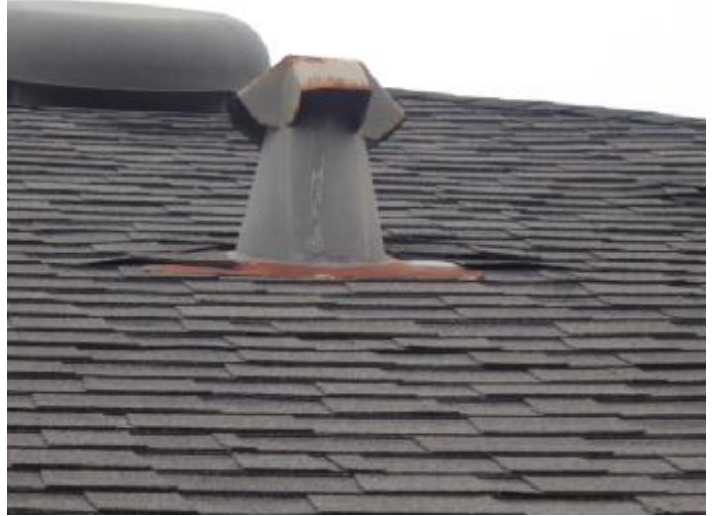
Rusted vent flashing

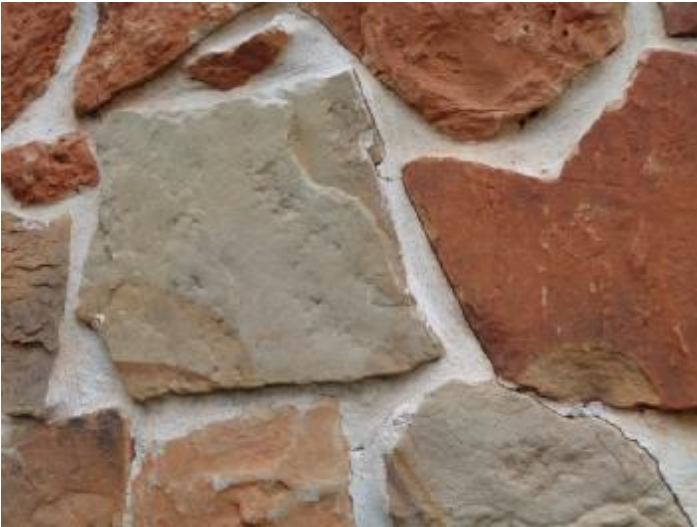
Cracks at stone mortar at left side

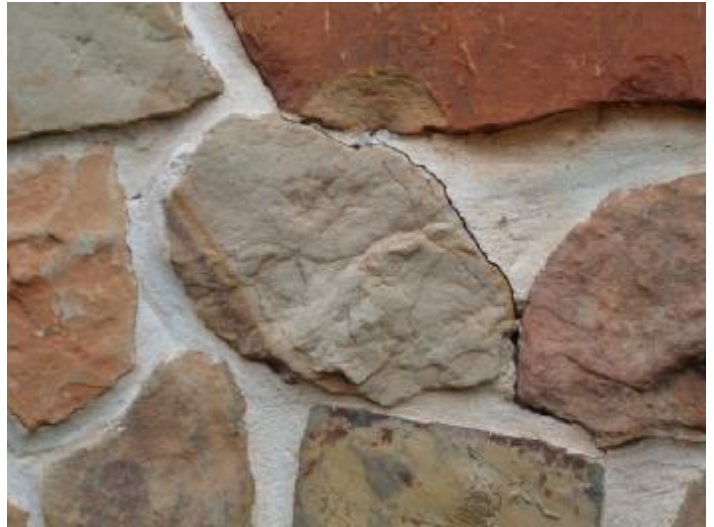
Cracks at stone mortar at left side

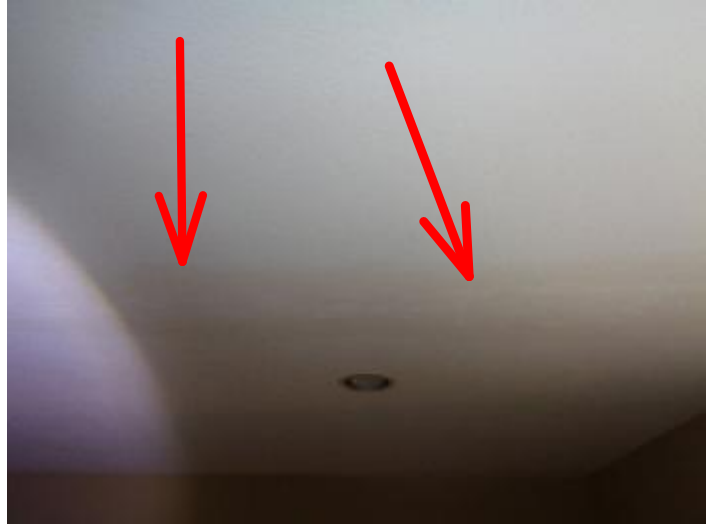
Water stains at upstairs hall ceiling

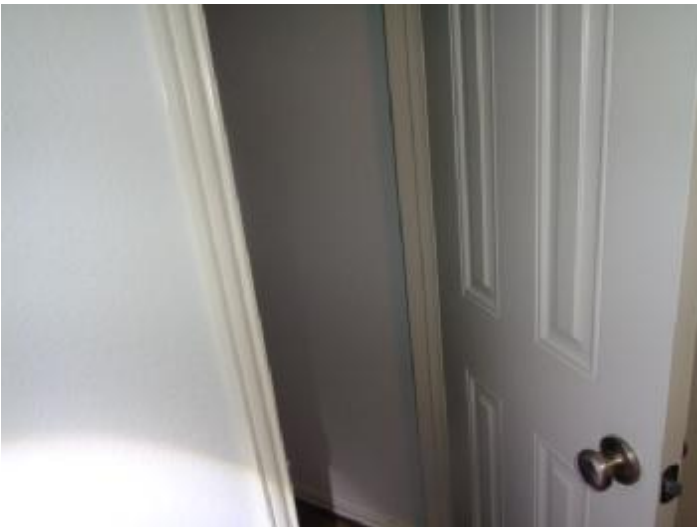
Closet door will not close in the upstairs left side bedroom

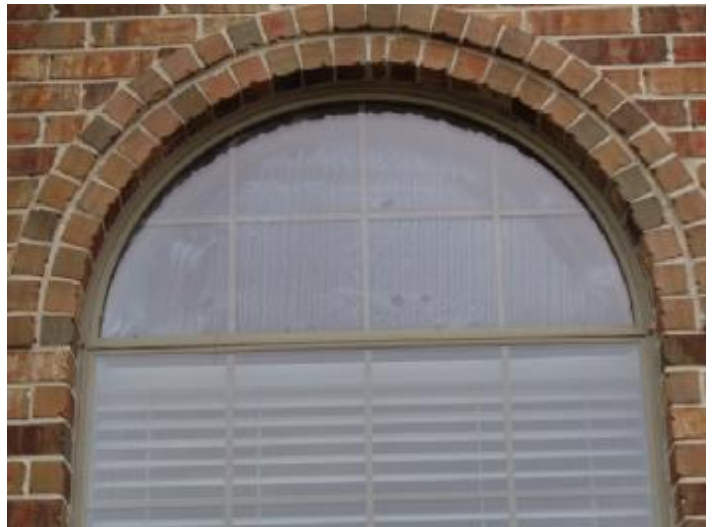
Breached thermopane window seal at front

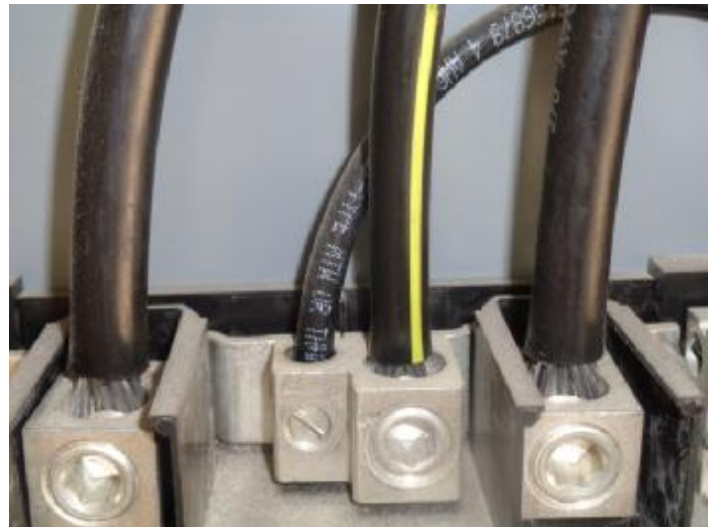
Aluminum service wire connections lack anti-oxidant paste in the electric panel

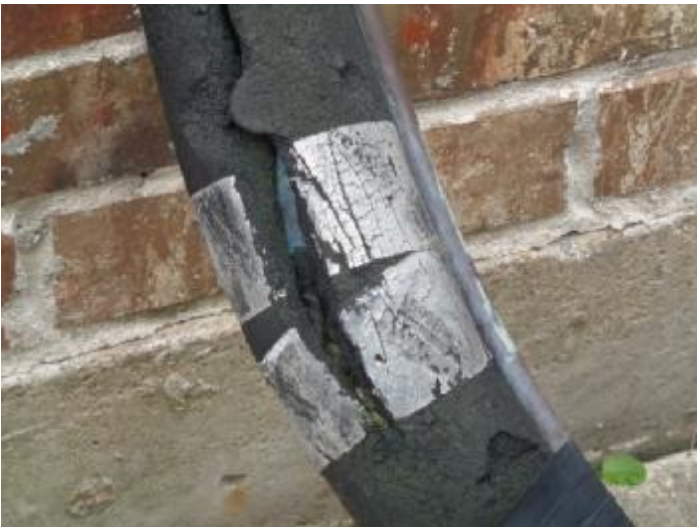
Damaged insulation on refrigerant line at air conditioner #2

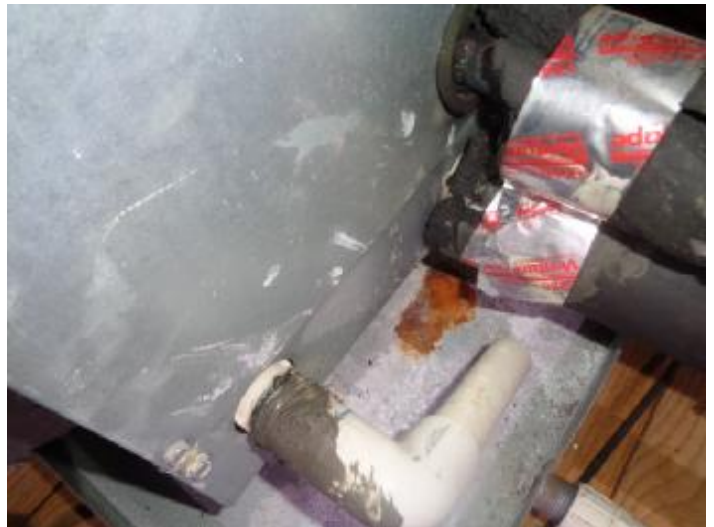
Rust in drain pan under furnace #1 in attic

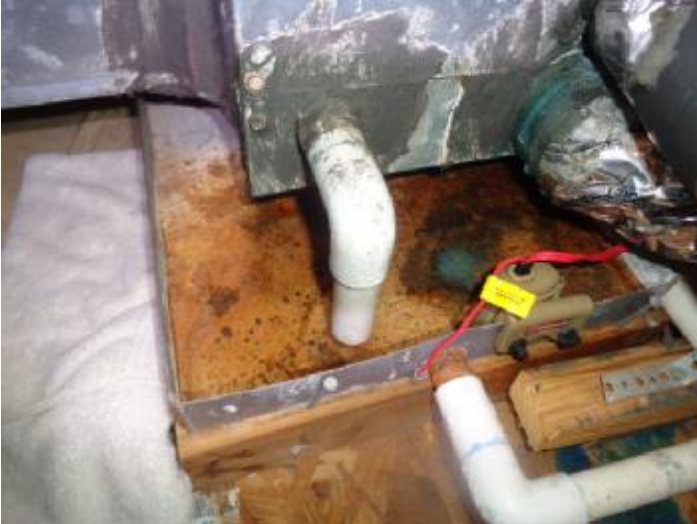
Rust in drain pan under furnace #2 in attic

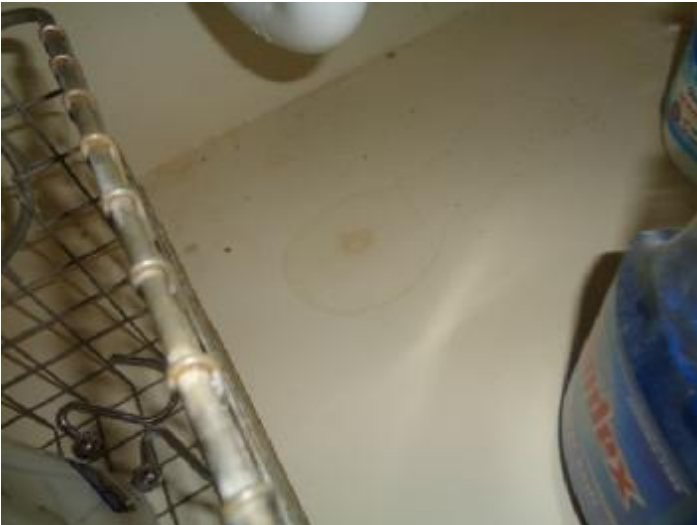
Evidence of leakage under sink in 2nd floor hall
bath

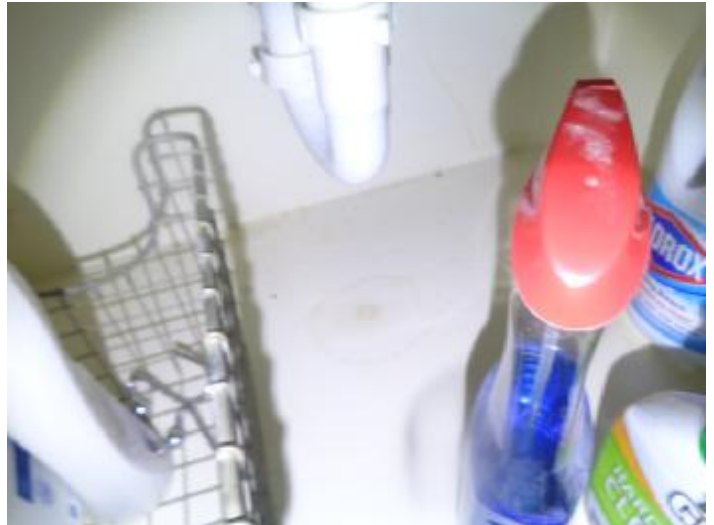
Evidence of leakage under sink in 2nd floor hall
bath

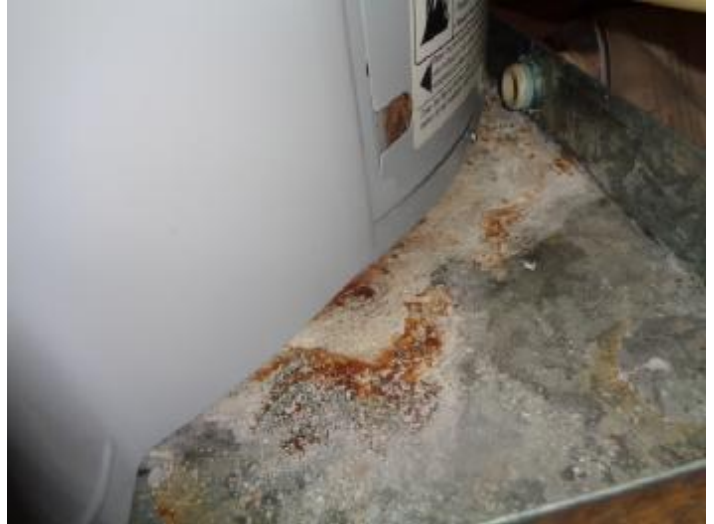
Rust in drain pan under water heater #2 in the attic

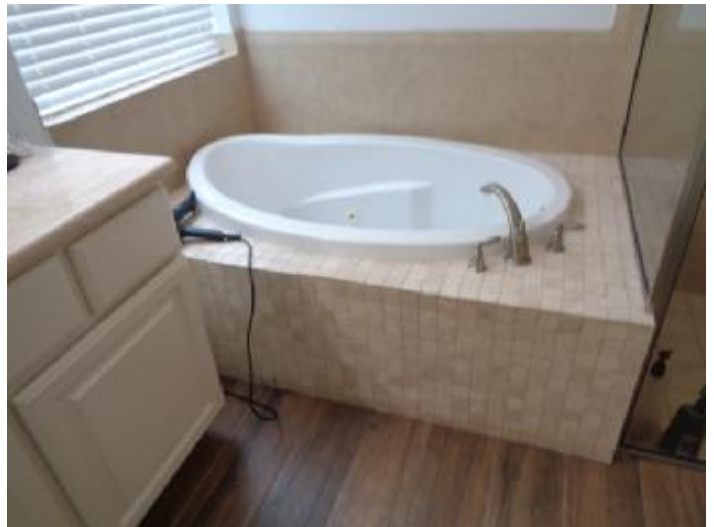
No visible access panel to whirlpool tub equipment

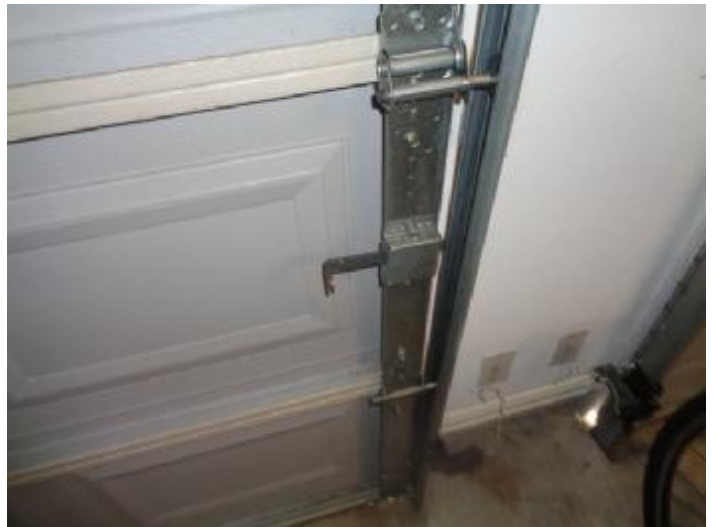
Manual lock not disabled with the presence of a garage door opener

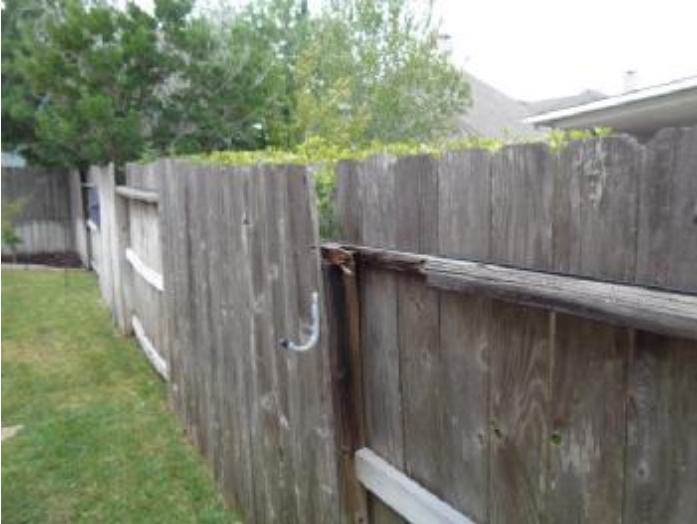
Yard fence is damaged/rotted
