**Town &
Country
Home
Inspection**

for the property located at:
**8726 Sanders Rd
Magnolia, Texas 77354**

Date of Inspection: **September 30, 2022**

PROPERTY INSPECTION REPORT FORM

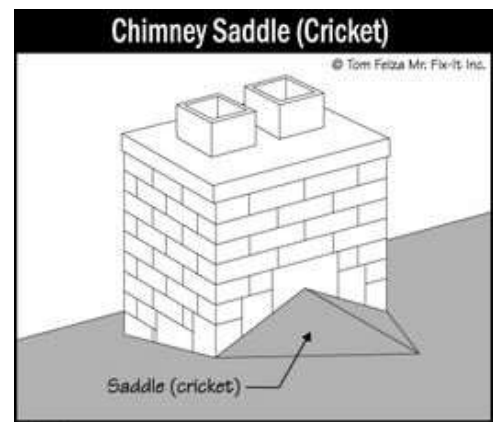
10. Chimneys 30 inches or wider are required to have a cricket at the upper side to deflect water.

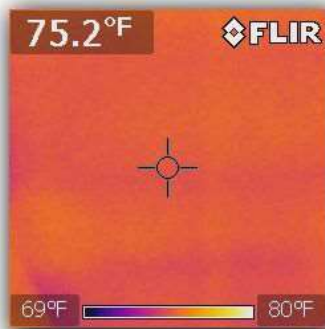
12. Infrared camera revealed heat transfer at attic access doors, Recommend installing insulation and weather stripping.

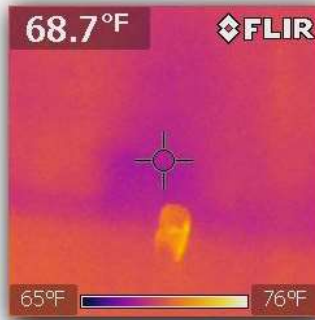
28. Evidence of moisture damage was noted at but may not be limited to this area in bedroom. Water damaged materials are considered a conducive condition for water penetration and insect infestation. Whenever water damaged materials are noted in this report, we recommend consulting a qualified contractor so a corrective course of action can be evaluated.

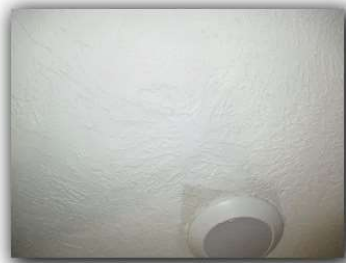
35. Evidence of moisture, stain or a foreign substance was detected in the ceiling. Moisture sensors are sometimes used to try to determine if the stain is active. There was no moisture detected at the time of the inspection. These areas should be cleaned, reconditioned and monitored for further activity as there are sometimes more than one obvious cause for water penetration.

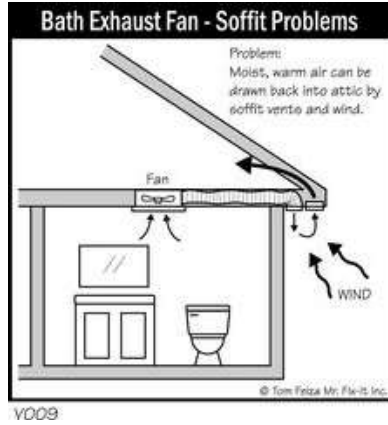
122. Observed exhaust vents routed to soffit. The problem is moist warm air can be drawn back into the attic by soffit vents and wind. Recommend rerouting the ducts to exhaust at a higher vent.
