Inspection Date:03/23/2023 Time 2:00 pm Compass Direction: South (220° compass)
Weather: Sunny Temperature: 70° (Fahrenheit)

PROPERTY INSPECTION REPORT FORM

| 13 Bewntwood Dr, Montgomery, TX 77356 <i>Address of Inspected Property</i> | |

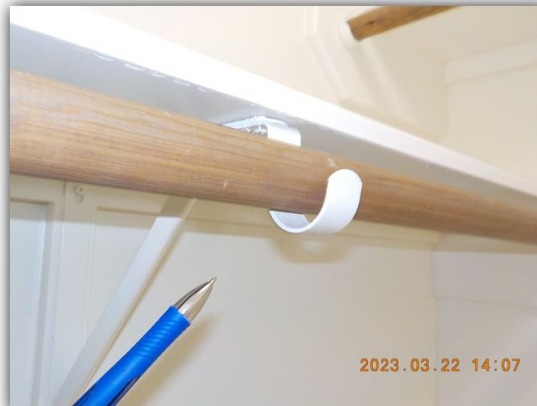
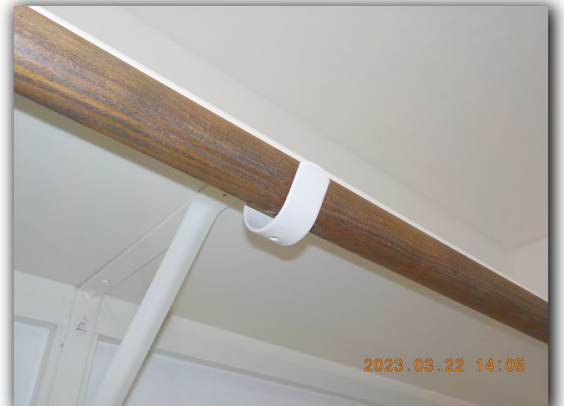
The wooden clothes bars are "not secured" to the support brackets with screws to prevent movement located in all of the interior closets.

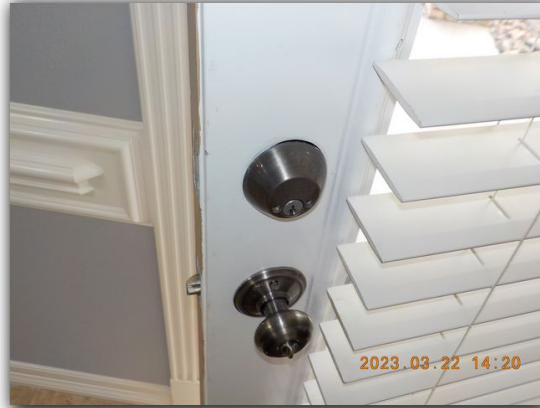
The back/entry exit door does not have keyless locks to exit in case of an emergency required by current code.

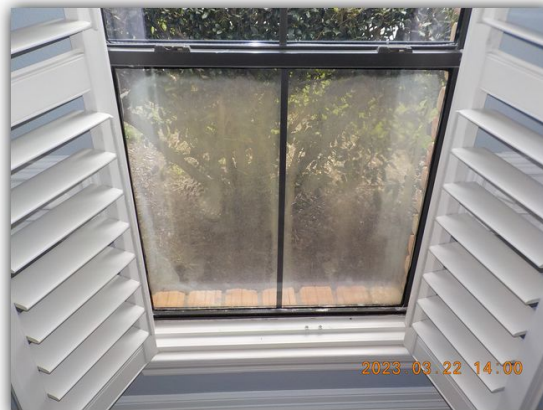
There are windows with leaking perimeter seals located at the dining room window, the window over the front door and the front office window. These windows have moisture stains present inside the glass panels. Replacement is the only option. Recommend all other windows inspected by a competent professional.

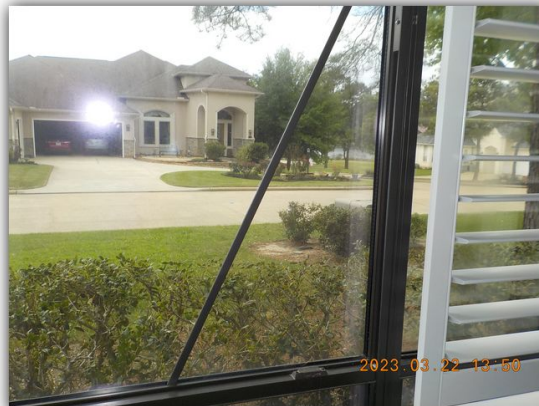
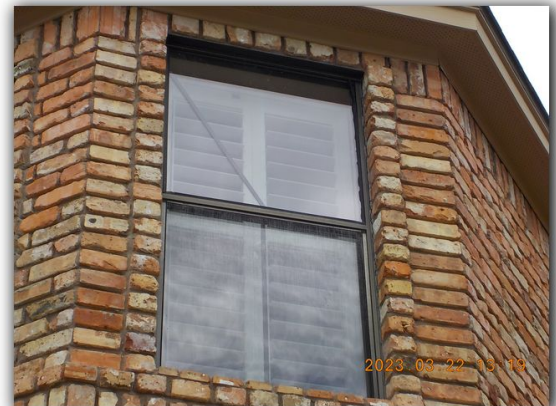
There are loose or shifted plastic grid pieces inside the window panes located at the front wall.

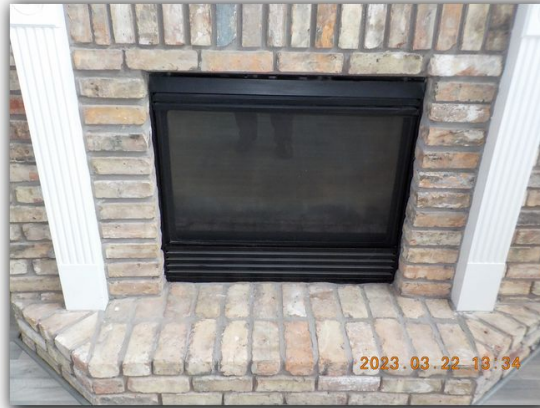
The glass sealed fireplace did not function at the time of inspection. The remote control was not present. The pilot light was not lit in order to operate.

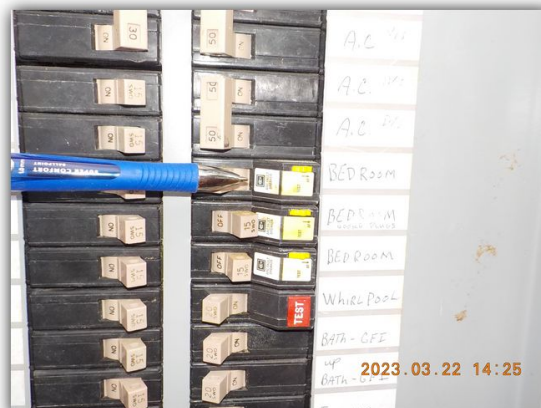
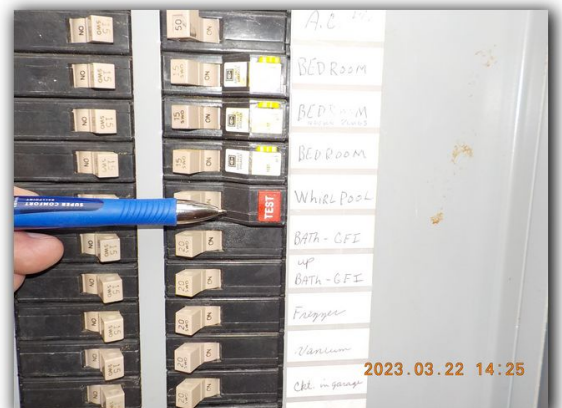
There are two defective circuit breakers that did not trip when tested. For safety reasons they should be replaced.

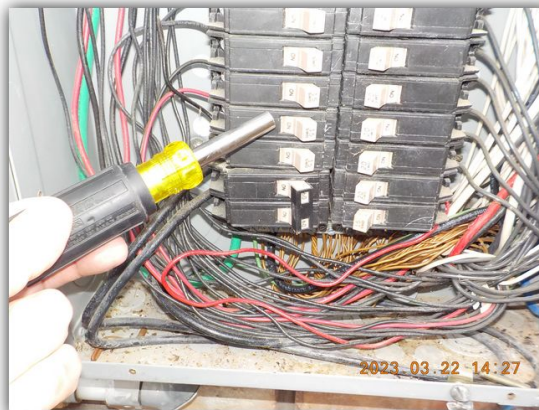
AC Breaker Oversized

The circuit breaker routed to the two AC compressor is “oversized at 50-amps”. The manufacturer’s maximum of 40 amps is required in order to avoid damage to the AC equipment from excessive electrical flow. Improper matching of the electrical breaker can “render void” any manufacturer’s warranties. Recommend replacing the circuit breakers.

“AFCI circuit breaker” (arc fault circuit breaker)

- Texas Real Estate Inspector are required to report as deficient any missing or damage safety devices regardless year built.
- AFCI devices were not observed in the panel box. AFCI (Arc Fault Circuit Interrupt) device protection, as required by current building standards, for all: family rooms, dining rooms, living rooms, parlor, libraries, dens, bedrooms, sunrooms, recreations rooms, closets, hallways, or similar rooms or areas. AFCI devices are intended to protect against fires caused by electrical arcing faults in the home's wiring. Arc faults are a common cause of residential electrical fires. Arc faults can be created by damaged, deteriorated, or worn electrical plugs, cords, and/or branch circuit conductors. As of September 1, 2008, the State of Texas has adopted the 2005 NEC, which includes this requirement, as the "minimum standard" for all non-exempt electrical work. Homes built prior to 2002, generally were not required to have arc fault protection. However, the current TREC standard of practice requires inspectors to indicate that a hazardous or deficient condition exists if any home does not have this protection, regardless of date the home was constructed.

The manufacture's maximum of 40 amps is required in order to avoid damage to the AC equipment from excessive electrical flow. Improper matching of the electrical breaker can "render void" any manufacture's warranties. Recommend replacing the circuit breakers.

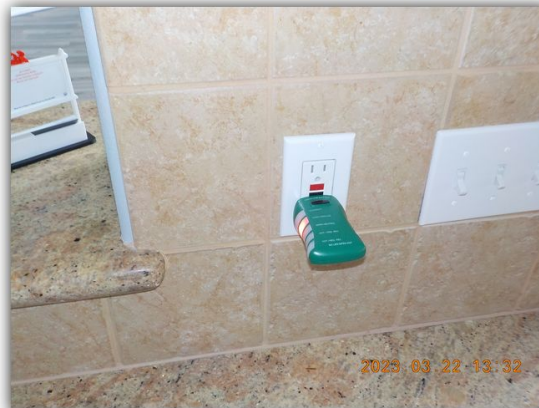
The electrical outlet is incorrectly wired located in the kitchen back splash. The outlet has an "open ground". Recommend repairs by a licensed electrician.

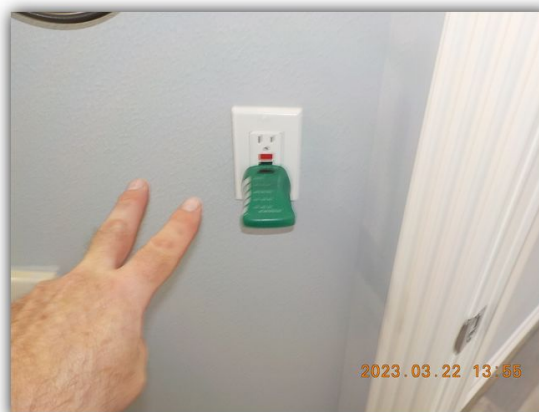
bathroom

2 GFCI Outlets

There are more than one GFCI electrical outlet (Ground Fault Circuit Interrupter) installed/located on the:

There only needs to be one GFCI electrical outlet (Ground Fault Circuit Interrupter) present in order to protect the circuit.

When the outlet trips it is a nuisance to reset the outlets in the correct electrical power order.

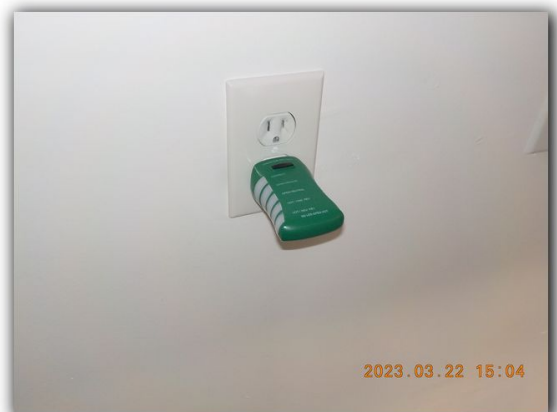
garage outlet

There is not any electrical power present at the electrical outlet located in the garage.

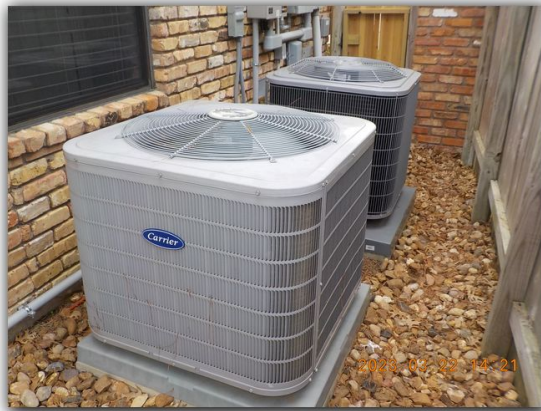
Not Cooling Properly

The air conditioning system downstairs "unit #2" is not cooling properly. The system had a temperature drop of only **12 degrees**. The differential temperature (Delta T) is below the normal operating efficiency that indicates a problem with the cooling system. Further evaluation and repairs by a licensed HVAC technician recommended. The operational delta "T" should be between 16 and 21 degrees.

The air conditioning system downstairs "unit #2" is not cooling properly. The system had a temperature drop of only 12 degrees. The differential temperature (Delta T) is below the normal operating efficiency that indicates a problem with the cooling system. Further evaluation and repairs by a licensed HVAC technician recommended. The operational delta "T" should be between 16 and 21 degrees.

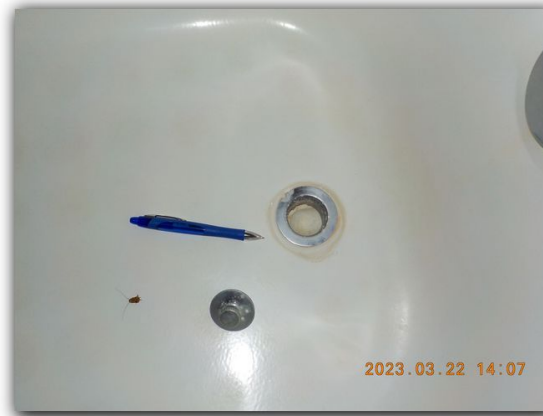
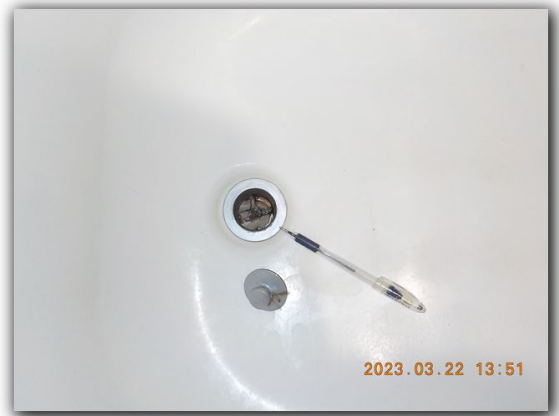
The drain stoppers are broken in two of the upstairs bathrooms. The interior threaded insert should be replaced.

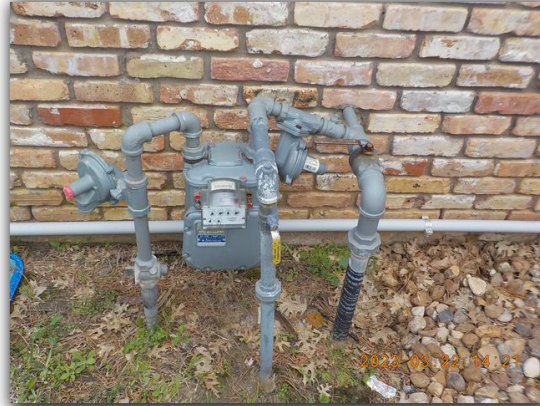
No Bond Wire Gas Pipe

Current building practices require a bonding wire in order to control static electricity build up and electrical charging during lightening episodes.

Each above ground portion of a gas piping system that is likely to become energized shall be electrically continuous and bonded to an effective ground-fault current path. Gas piping shall be considered to be bonded where it is connected to appliances that are connected to the equipment grounding conductor of the circuit supplying that appliance.

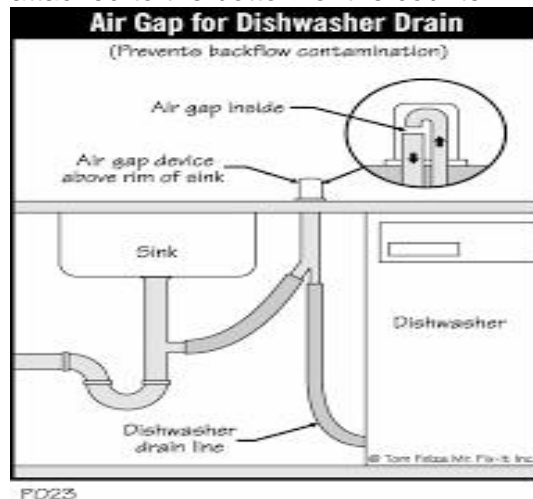
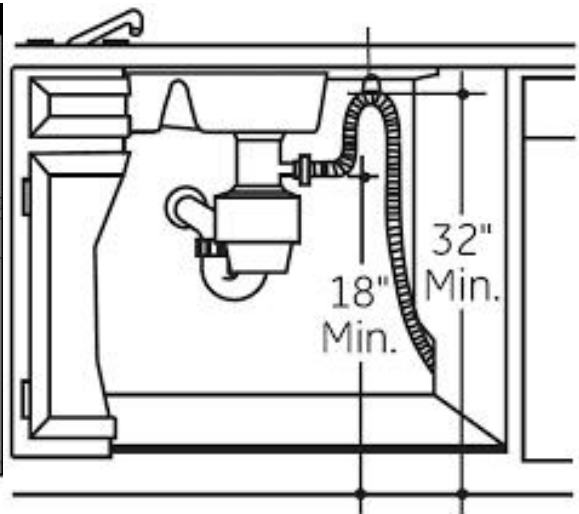
No Back Flow Prevention

The dishwasher drain line that terminates at the garbage disposal needs back flow prevention. A check valve could be installed or the drain line could be raised and attached to the bottom of the counter.
