117 Private Rd 5217 Buna, TX 77612

PROPERTY INSPECTION REPORT FORM

Don Novotney	03/20/2023 8:00 am
Name of Client	Date of Inspection
117 Private Rd 5217, Buna, TX 77612 Address of Inspected Property	
Sean Harper	Trec Certified Home Inspector
Name of Inspector	TREC License #
Name of Sponsor (if applicable)	TREC License #

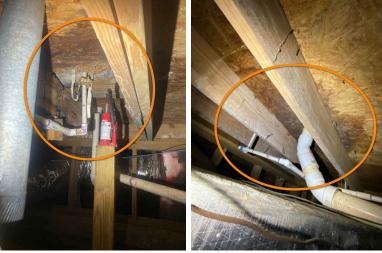
Beneath right side exterior door

The sub-floor material has some deterioration under the location(s) pictured.

Recommendation: Contact a qualified professional.

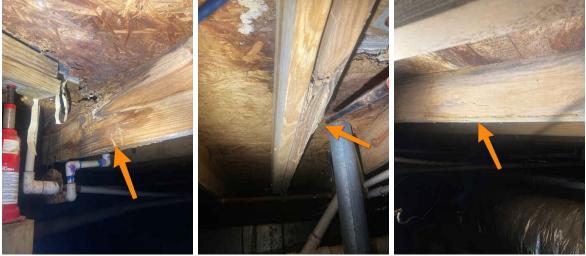
beneath laundry room

Beam deterioration and/or damage was observed from the crawl space under the locations pictured due to a previous termite infestation.

Recommendation: Contact a qualified professional.

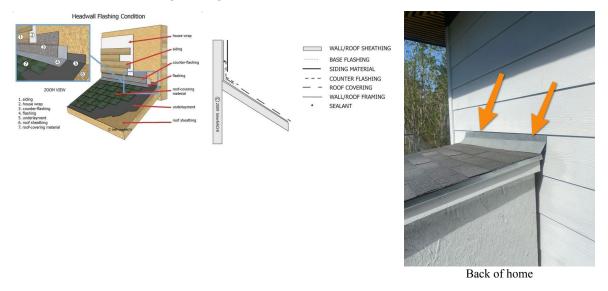
2: Head wall flashing improper install

The head wall flashing is improperly installed. This could allow water/moisture intrusion at this location.

Recommendation: Contact a qualified professional.

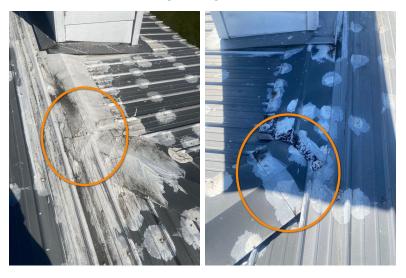
3: Ridge cap improper install Commendation

The ridge cap flashing in the pictured locations appears to be improperly installed.

Recommendation: Contact a qualified professional.

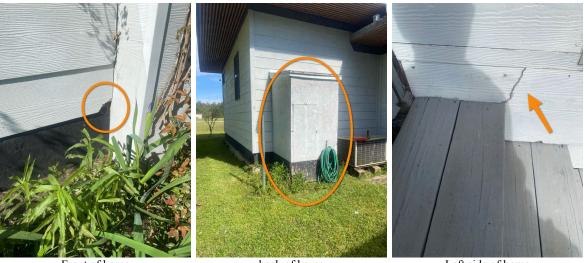
Front of home

The exterior veneer/cladding has some deterioration and/or damage on the locations of the structure pictured.

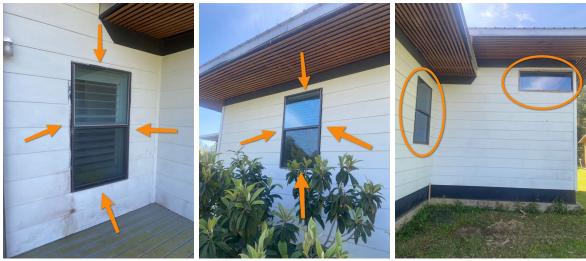
Front of home

One or more trim pieces are missing on the home in the pictured locations. This could allow water intrusion at this point.

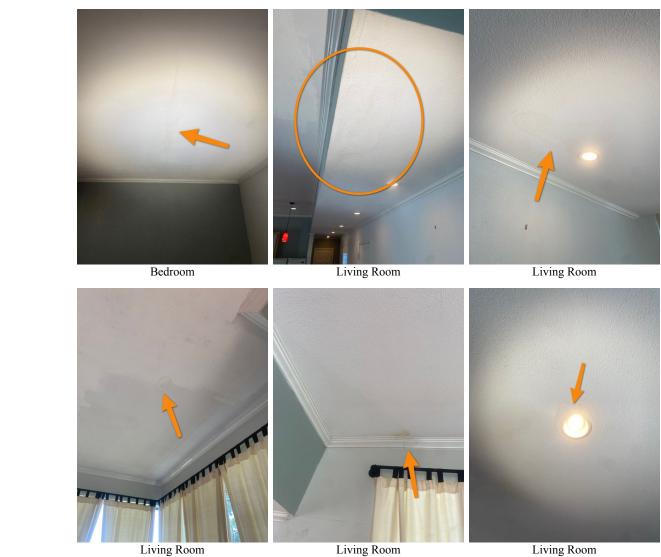
Bedroom

Moisture stains were observed on the ceiling finish in the room locations pictured. The cause and remedy should be further evaluated and corrected as necessary.

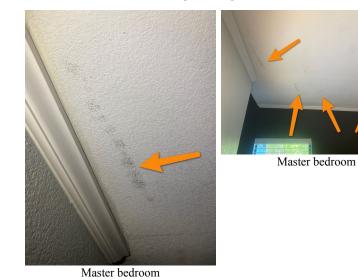
Master bedroom

There was an unknown substance observed. Evaluation of this substance is beyond the scope of this inspection. If any concerns exist on the type and/or nature of this substance, we recommend further evaluation by a professional and a remedy.

Recommendation: Contact a qualified professional.

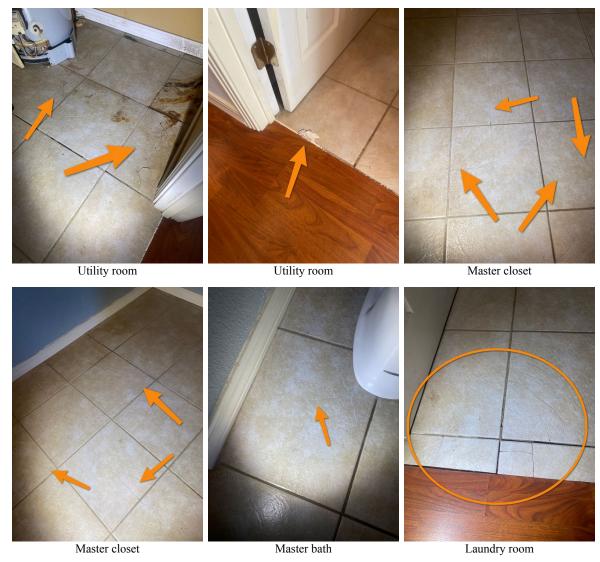
Laundry room

The floor tile(s) were observed to be cracked and/or damaged in locations pictured.

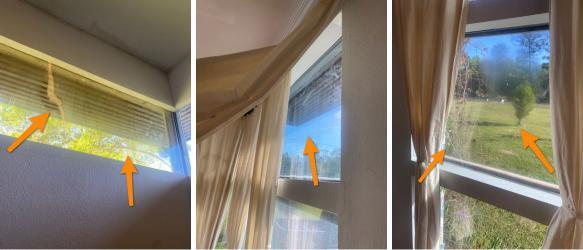
Cracked and/or broken window glass was observed in the locations pictured.

Recommendation: Contact a qualified professional.

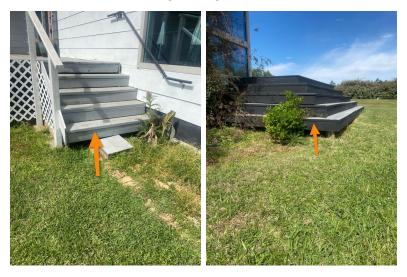
One or more of the stairway risers do not appear to meet current building standards. The stairway risers should not extend more than 7 3/4-inches and there should not be a difference more than 3/8- inch between any of the risers. This condition can cause a tripping hazard while traversing the stairway components.

Recommendation: Contact a qualified professional.

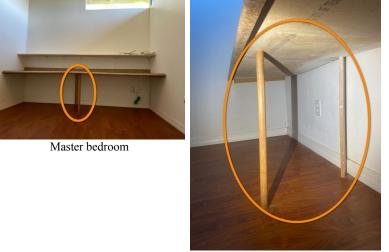
Master bedroom

The countertop material in the pictured locations is improperly supported.

Recommendation: Contact a qualified professional.

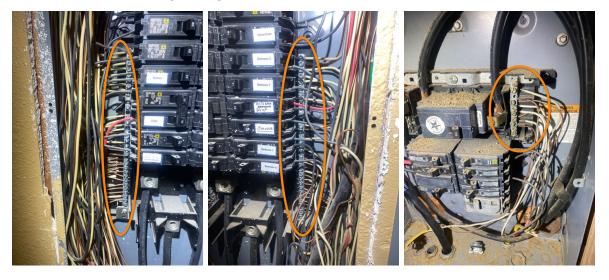
The ground wires and the neutral wires are not properly separated in the sub-panel electrical cabinet. The neutral wires should be on their own isolated bus bar and the ground wires should be connected to the sub-panel cabinet. Although the sub-panel is functional, it does not meet current National Electrical Code standards.

Recommendation: Contact a qualified professional.

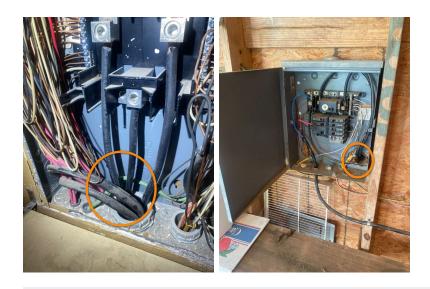
The sub-panel does not appear to have a four-wire service feed. Although the sub-panel is functional, it does not meet current National Electrical Code standards. This is an "as-built" condition but Per TREC standards of practice we are required to report this condition as a deficiency.

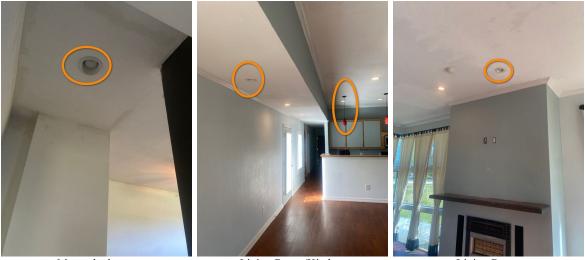
Master bedroom

One or more lights are not operating. <u>New light bulb possibly needed, switch could not be located or actually</u> <u>not functioning correctly.</u>

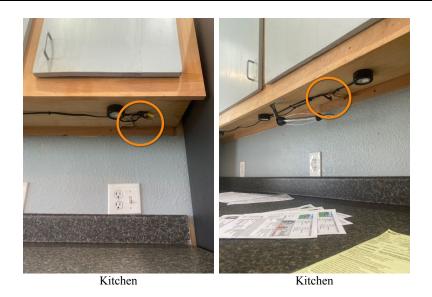
Spliced wires were observed in the pictured area(s). The spliced wires need to be properly enclosed in an electrical junction box for reasons of safety.

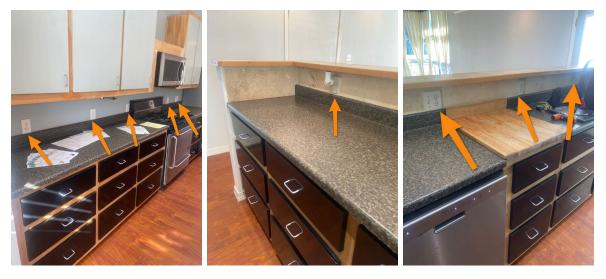
The kitchen counter top receptacles do not appear to be connected to a ground fault circuit interrupter (GFCI) device. Under current electrical standards, all of the kitchen counter top receptacles and any receptacle within 6-feet of the sink should have GFCI protection.

Recommendation: Contact a qualified professional.

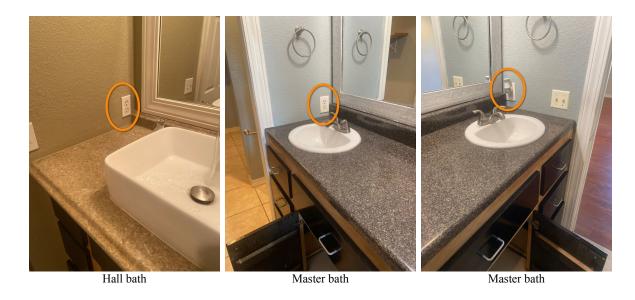
The bathroom receptacles do not appear to be connected to a ground fault circuit interrupter (GFCI) device. Under current electrical standards, all of the bathroom receptacles should have GFCI protection.

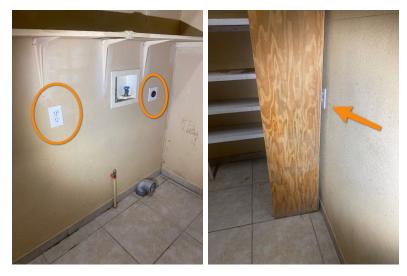
The laundry room area receptacles do not appear to be connected to a ground fault circuit interrupter (GFCI) device. Under current electrical standards, all of the receptacles in the laundry room area should have GFCI protection including dryer plug @ the main panel via a GFCI breaker.

Recommendation: Contact a qualified professional.

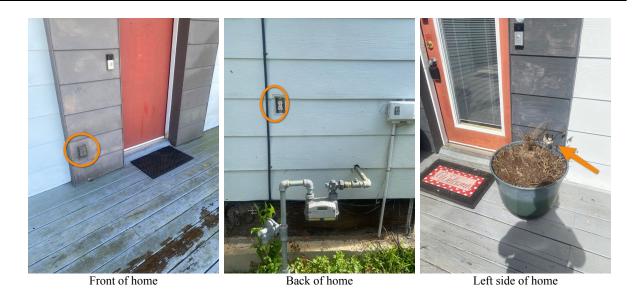
The exterior receptacles do not appear to be connected to a ground fault circuit interrupter (GFCI) device. Under current electrical standards, all of the exterior receptacles should have GFCI protection.

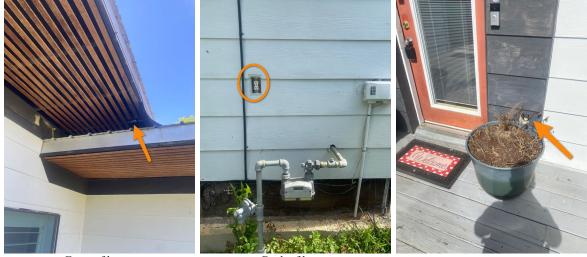
Front of home

All the pictured exterior receptacles should have weather tight covers. The current set up would allow water to enter the receptacle.

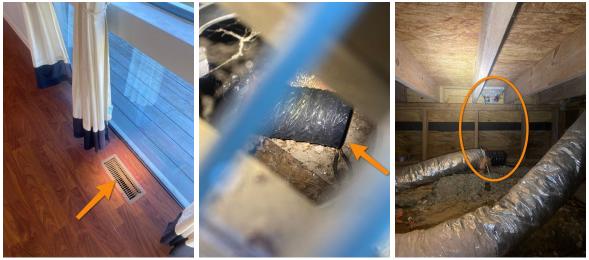
Living Room

This supply register pictured was not supplying air properly at the time of the inspection due to the duct being disconnected in the crawlspace.

Recommendation: Contact a qualified professional.

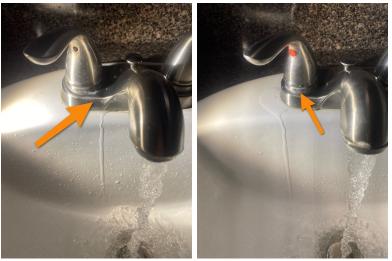
Master bath

The faucet leaks at the handle in the pictured area(s).

Recommendation: Contact a qualified professional.

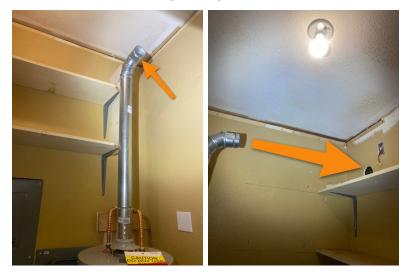
The gas water heater flue pipe is missing. All flues should be vented to the exterior of the home. The current set up emits fumes into the water heater closet/area and is a safety hazard.

Recommendation: Contact a qualified professional.

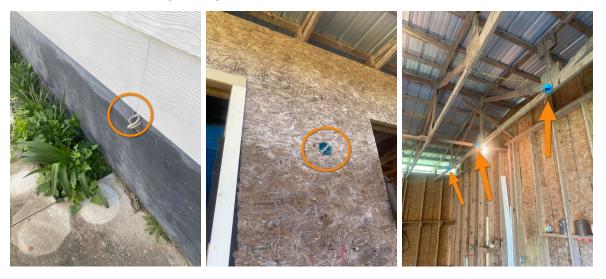
An open junction box was observed in the pictured locations. A junction box cover should be installed for reasons of safety.

Recommendation: Contact a qualified professional.

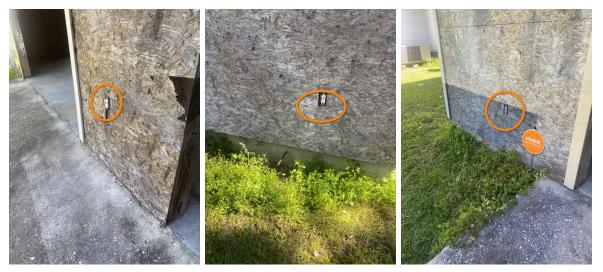
All exterior receptacles should have weather tight covers. The current set up would allow water to enter receptacle if cords were plugged in during a rain.

Recommendation: Contact a qualified professional.

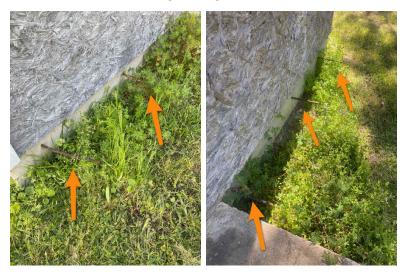
The foundation rebar is visible at the edge of the foundation beam in the pictured locations.

Recommendation: Contact a qualified professional.
