HEDDERMAN SERVICES

INVASIVE STUCCO INSPECTION

99 Lakeside Cove
The Woodlands, TX 77380

DECEMBER 2, 2022

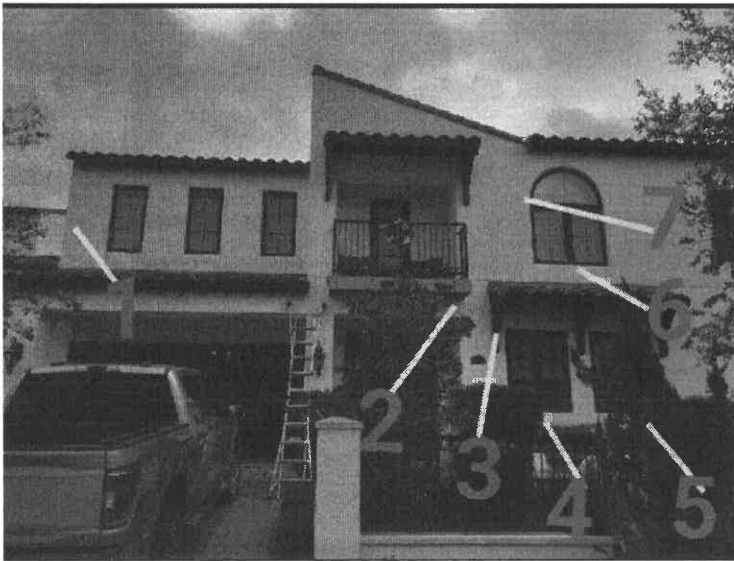
General: ELEVATION 1

#	%	Level	Substrate	Notes
1	12	Low	Firm	
2	10	Low	Firm	
3	12	Low	Firm	
4	14	Low	Firm	
5	12	Low	Firm	
6	11	Low	Firm	
7	13	Low	Firm

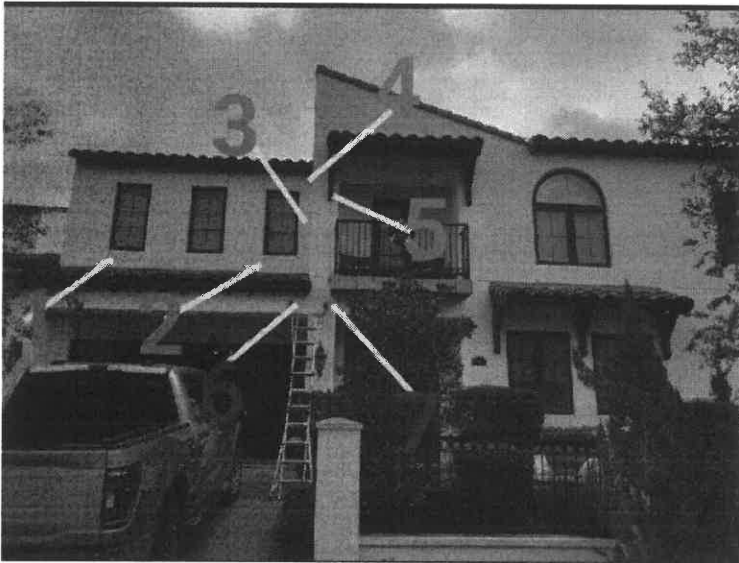
General: ELEVATION 2

#	%	Level	Substrate	Notes
1	11	Low	Firm	
2	13	Low	Firm	
3	12	Low	Firm	
4	9	Low	Firm	
5	12	Low	Firm	
6	N/A	N/A	Deteriorated	No resistance beyond stucco - Separation in flashing below corner tile
7	N/A	N/A	Deteriorated	No resistance beyond stucco

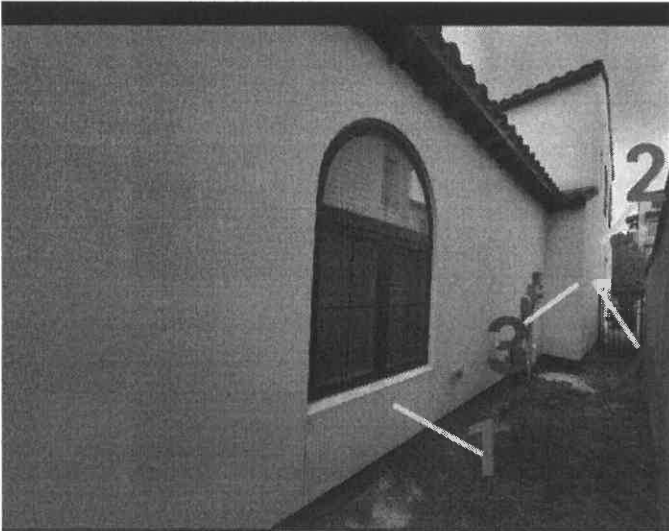
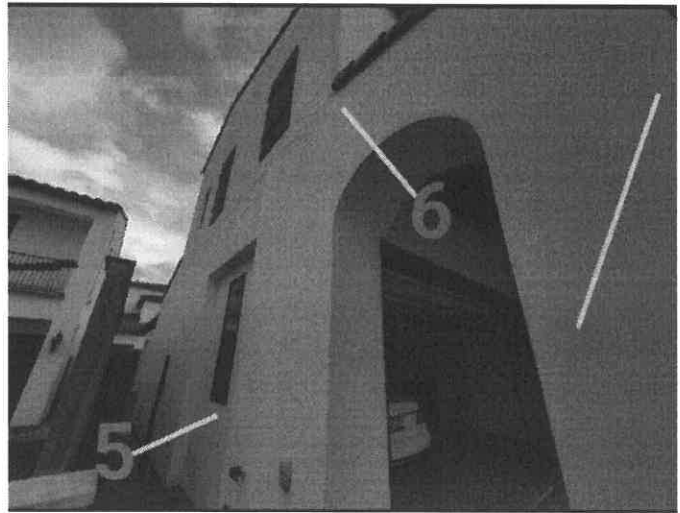
General: ELEVATION 3

#	%	Level	Substrate	Notes
1	11	Low	Firm	
2	12	Low	Firm	
3	N/A	N/A	Deteriorated	No resistance beyond stucco
4	N/A	N/A	Deteriorated	No resistance beyond stucco
5	12	Low	Firm	
6	12	Low	Firm	
7	10	Low	Firm

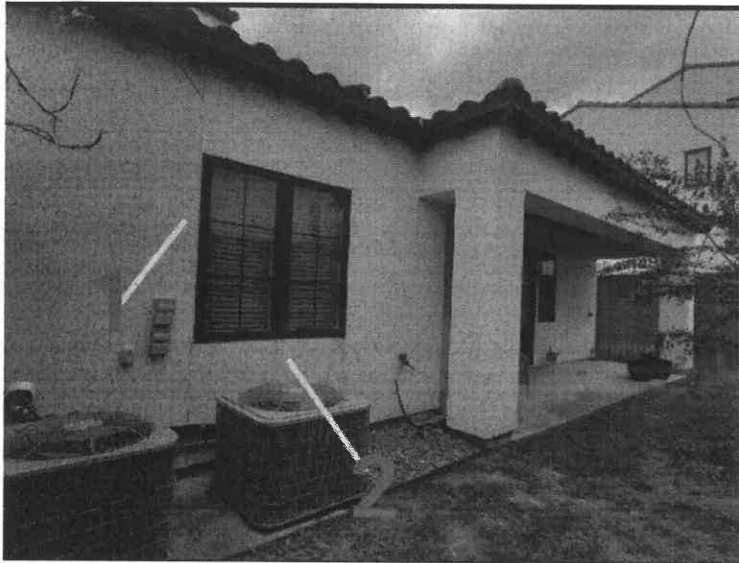
General: ELEVATION 4

#	%	Level	Substrate	Notes
1	12	Low	Firm	
2	10	Low	Firm

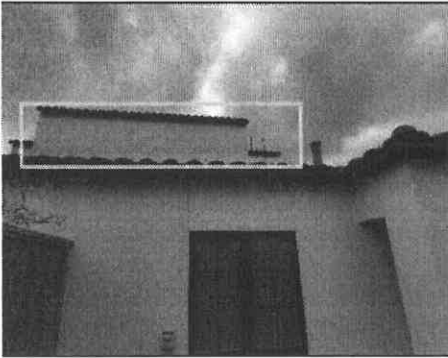
Due to the height of the structure some areas were inaccessible for inspection. If further investigation is desired, it is recommended that a means of access be provided and that a water proofing specialist or stucco contractor be contacted.

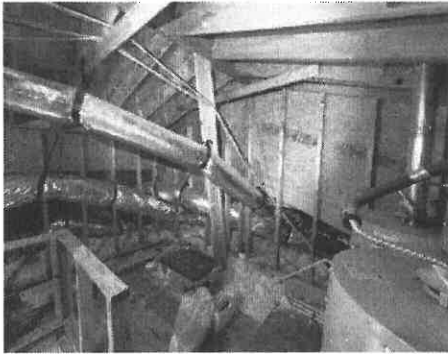
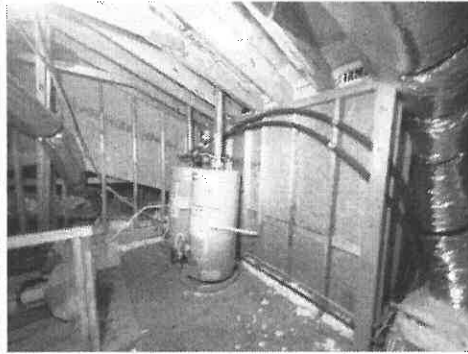
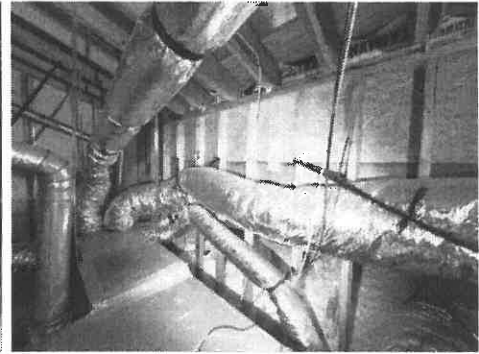
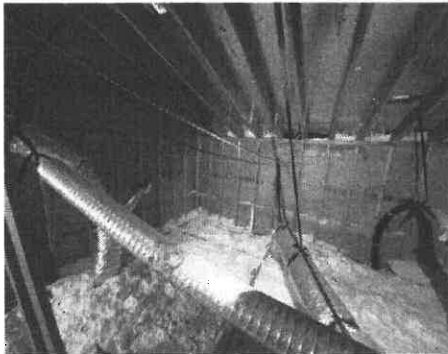
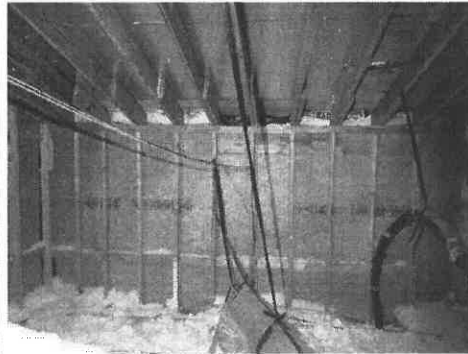
Substrate Integrity : Substrate visible from attic

Some of the substrate was visible from the attic for inspection. The substrate was observed to be firm and evidences of water intrusion were not visible at the visible substrate at the time of the inspection.

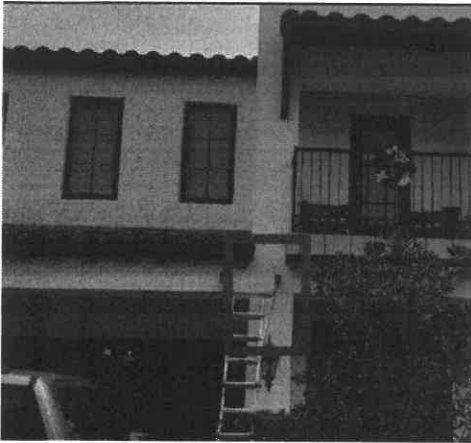
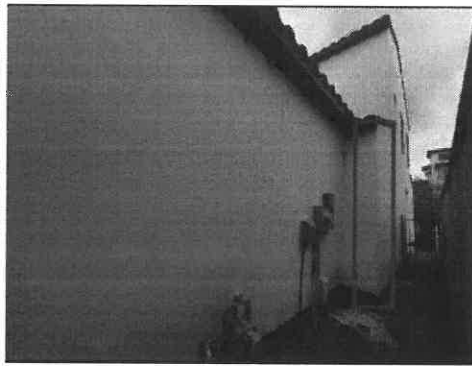
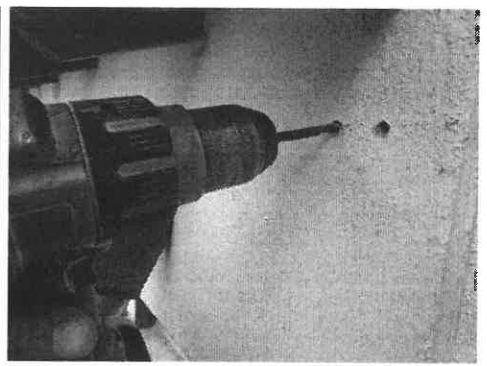
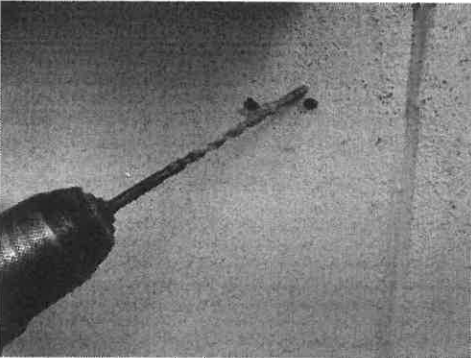
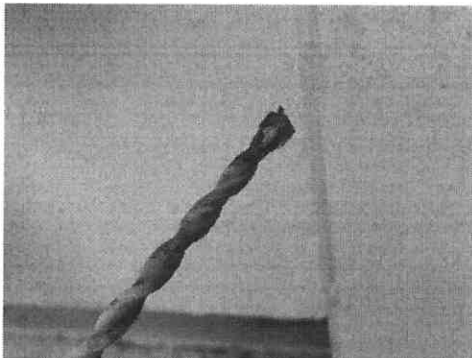
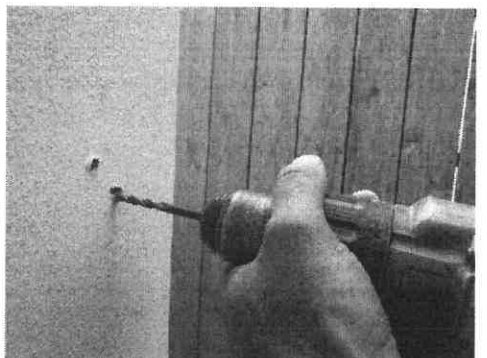
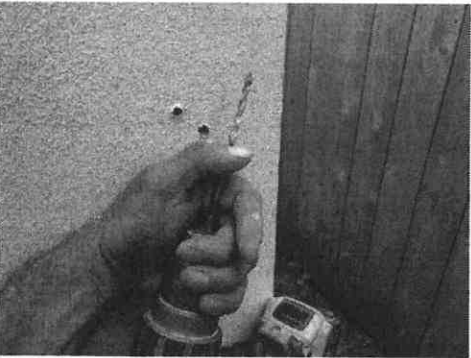
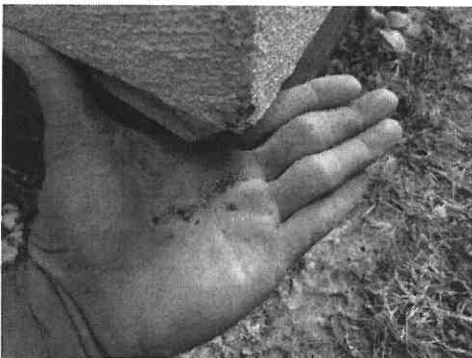
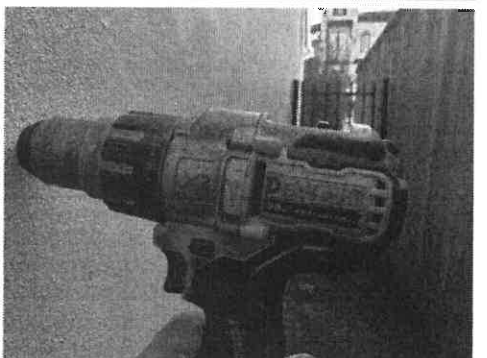
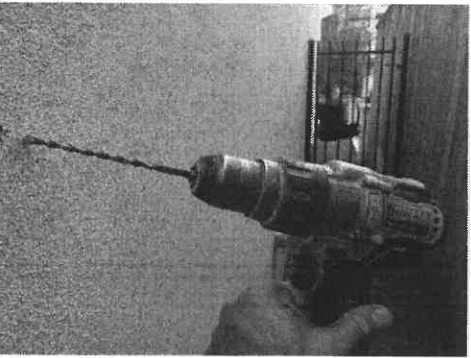
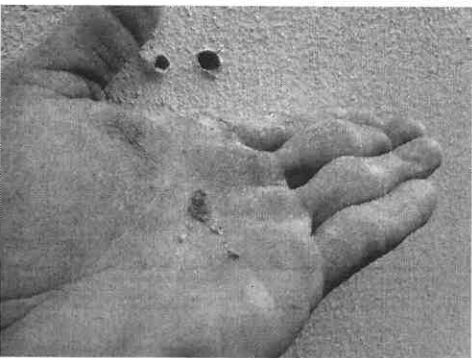
10.1.1 Substrate Integrity

SUBSTRATE INTEGRITY - DAMAGE OBSERVED

Substrate damage was found on this house and further framing damage may be present beyond the substrate. It is recommended that all areas noted not to have "Firm" substrate (Including Semi-soft, Soft, or Deteriorated) be opened up to verify the extent of any damage. It is also recommended that the source(s) of the moisture intrusion be determined and repaired along with all damaged materials due to moisture intrusion. Typical sources of moisture intrusion can include, but are not limited to, damaged or missing sealants, damaged or missing flashings, balcony and terrace walls and columns, improper installation of stucco accessories, back-wrapped sheathing, etc. Refer to elevation photos for locations.

Obtain Cost Estimate

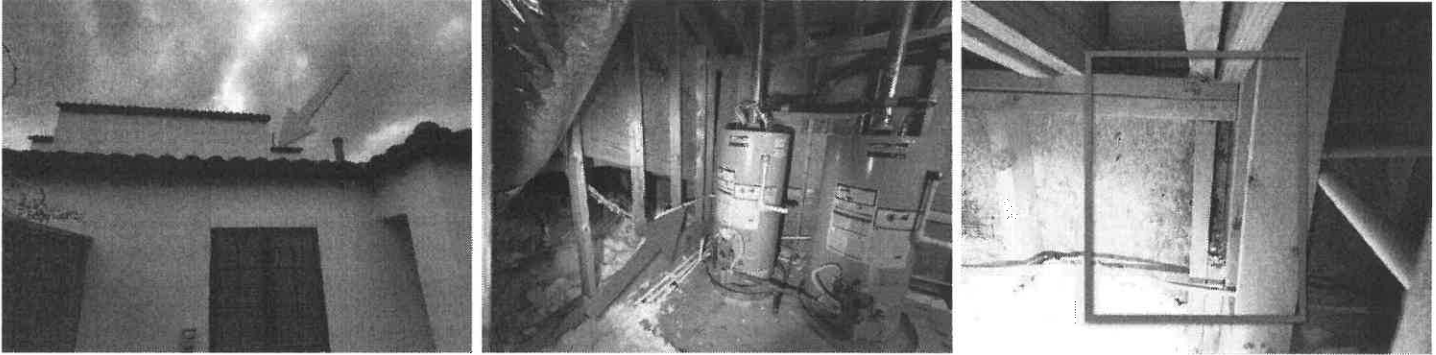
10.1.2 Substrate Integrity

SUBSTRATE VISIBLE FROM ATTIC - WATER INTRUSION OBSERVED

Some of the substrate was visible from the attic for inspection. The substrate was observed to be water stained/damaged apparently due to water intrusion. It is recommended that a stucco contractor be contacted for further investigation and to provide cost estimates to make all of the needed repairs.

Obtain cost estimate

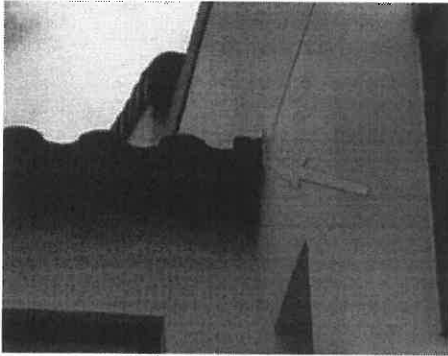
Kickout flashing

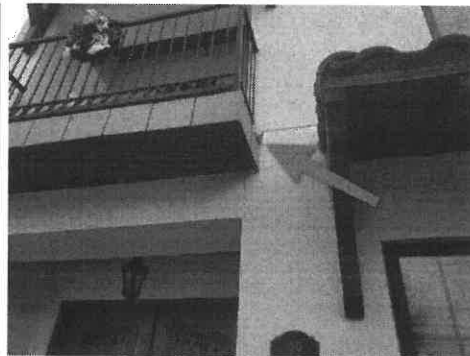
Corner flashing

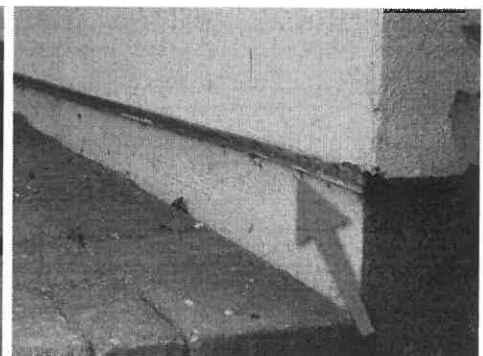
Weepscreed flashing

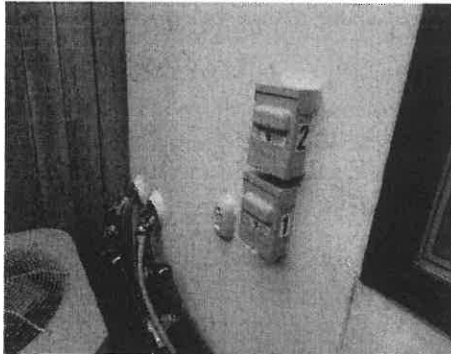
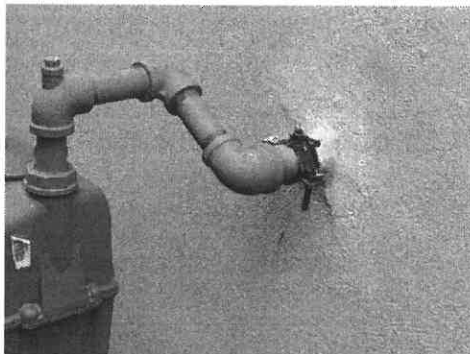
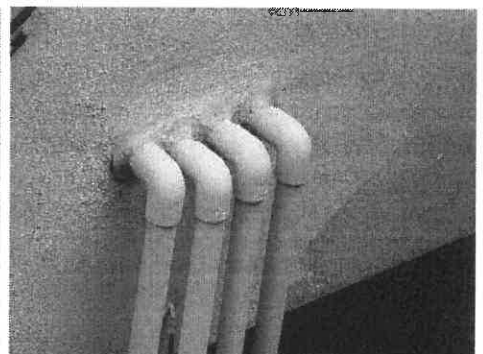
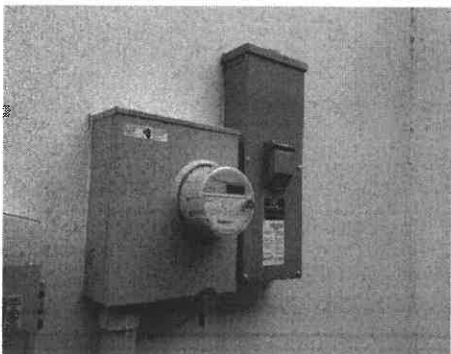
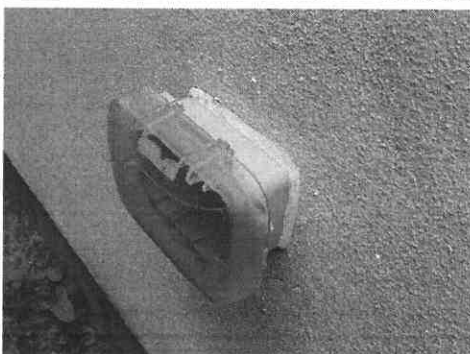
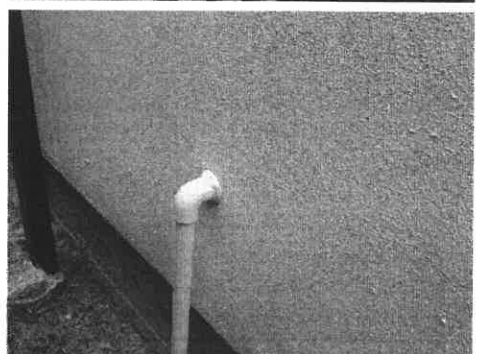
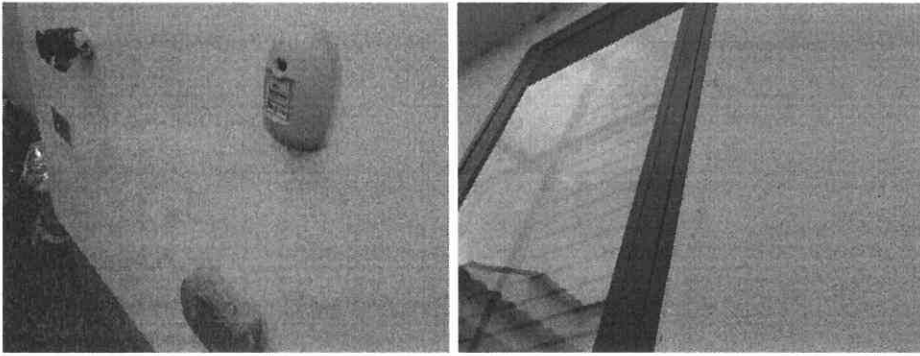
Sealants: Sealants - Generally good condition

The sealants in the stucco appeared to be in generally good condition at the time of the inspection, including at windows, doors, accents, flashings, and wall penetrations. It is stressed that exterior sealants play a key role in preventing water intrusion, and it is recommended that all sealants be maintained routinely.

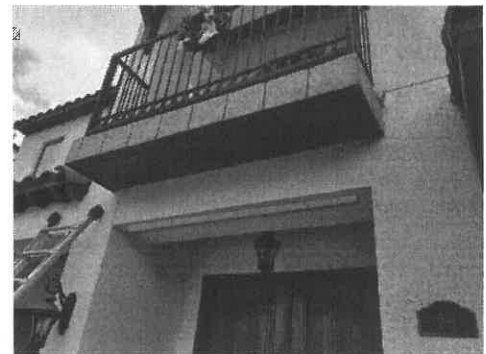
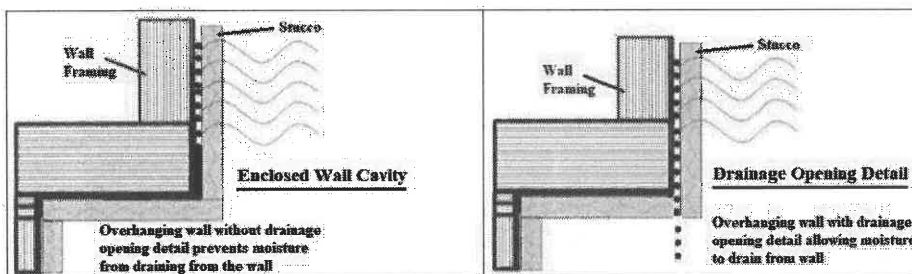
11.2.1 Flashings

MOISTURE RELIEF DETAIL - NOT PRESENT AT OVERHANG

The bottom of the overhanging wall was enclosed with stucco and a means for moisture that enters the cavity to drain out was not present. The lack of adequate drainage relief below an overhanging wall can allow moisture to be trapped inside the wall cavity and lead to wood damage, mold growth, and/or other moisture related conditions. It is recommended that a water proofing/stucco contractor be contacted to install the moisture relief detail in an approved manner to allow moisture to properly drain.

Obtain Cost Estimate
