### HOME INSPECTION REPORT

# PROPERTY INSPECTION REPORT

**Concerning:** 275 County Rd 3015, Dayton, TX, 77535  
 (Address or Other Identification of Inspected Property)

**By:** Charles Rowden 22155 Tina Paz 24081 Bertrand Lemelle 24610 5-26-2021  
 (Name and License Number of Inspector) (Date)

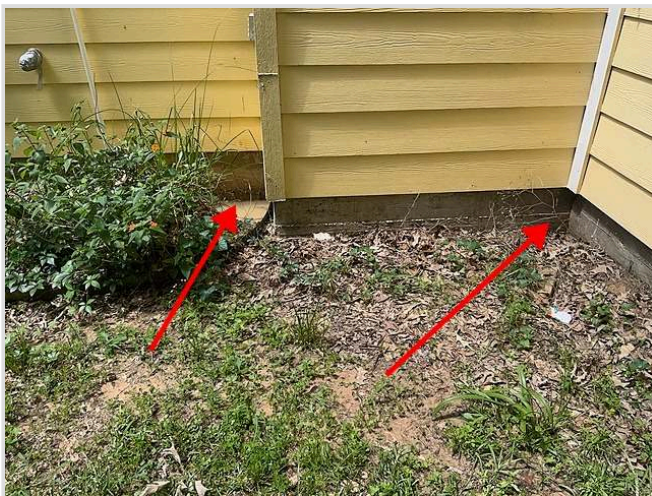
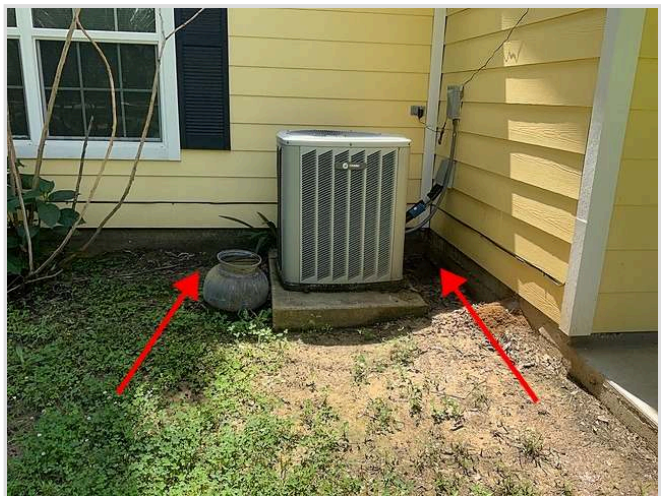
Soil grade and drainage patterns around the structure would not properly direct water away from the house and foundation system (low areas), which have allowed water to saturate the soil near the slab, which can affect foundation performance. Lots should be graded to drain surface water away from the foundation at a minimum slope of 6 inches within the first 10 feet. Where lot lines or other physical barriers prohibit this, drains, swales, and/or rain gardens shall be constructed to ensure drainage away from the structure.

Low areas

- Soil grade and drainage patterns around the structure would not properly direct water away from the house and foundation system (low areas), which have allowed water to saturate the soil near the slab, which can affect foundation performance. Lots should be graded to drain surface water away from the foundation at a minimum slope of 6 inches within the first 10 feet. Where lot lines or other physical barriers prohibit this, drains, swales, and/or rain gardens shall be constructed to ensure drainage away from the structure.

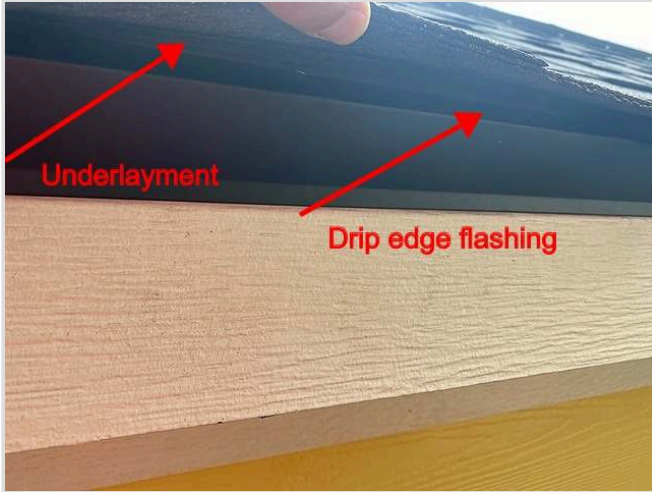
Underlayment was improperly installed beneath the drip edge flashing at the eaves. The underlayment should be installed over the drip edge flashing at the eaves and under the flashing at the rakes (sloped sides)

Underlayment installed under the drip edge flashing

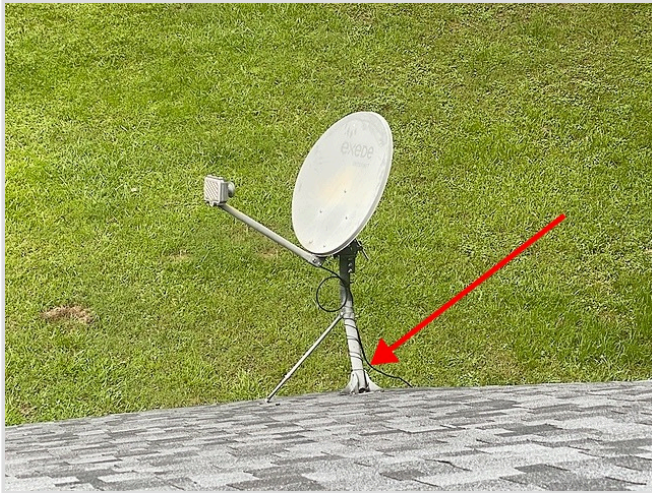
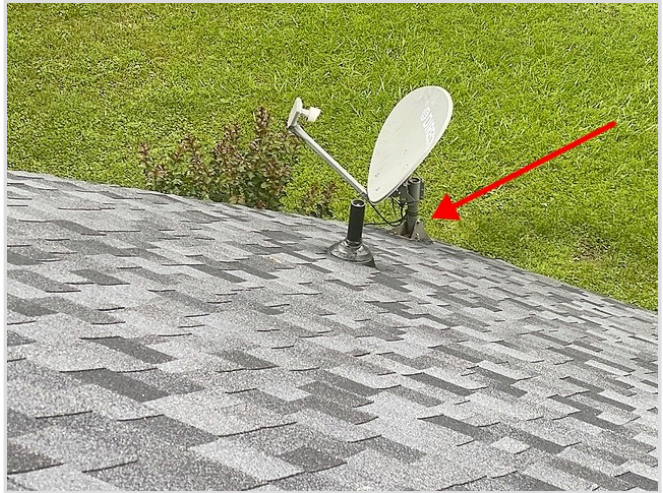
Satellite receivers were installed over the shingles at the roof decking. These have been known to cause roof damage due to poor installation or unexpected weather conditions (high wind).

Installed over shingles

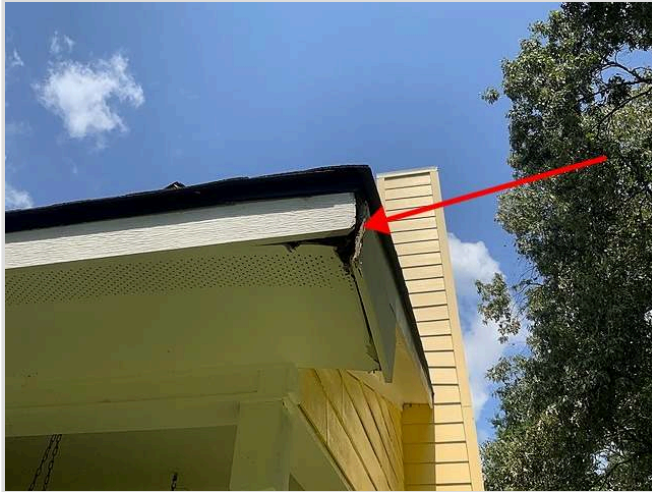
There was wood rot/water damage to portions of the soffit and/or fascia boards.

Wood/water damage (right corner-front porch)

- There was wood rot/water damage to portions of the soffit and/or fascia boards.

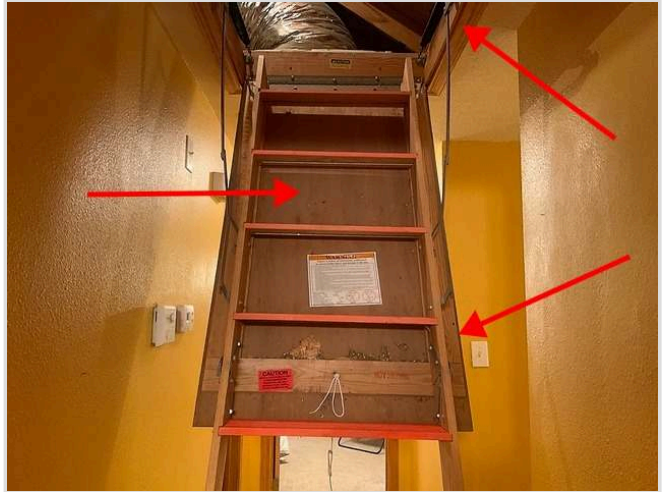
Not insulated/no weather stripping

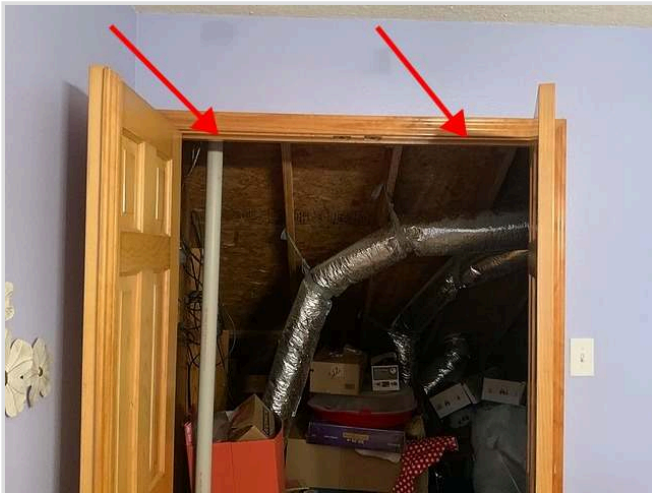
No weather stripping installed (left side access doors)

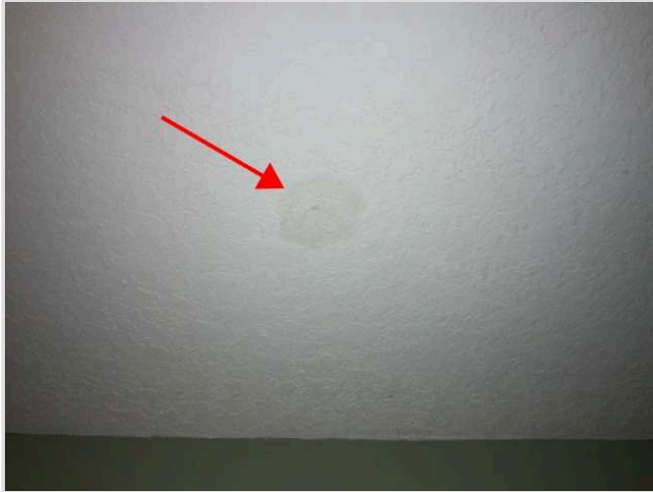
There were signs of previous leaks (staining/blistering) to the sheetrock ceiling in the master and left bedroom.

Signs of previous leaks (master bedroom)

- There were signs of previous leaks (staining/blistering) to the sheetrock ceiling in the master and left bedroom.

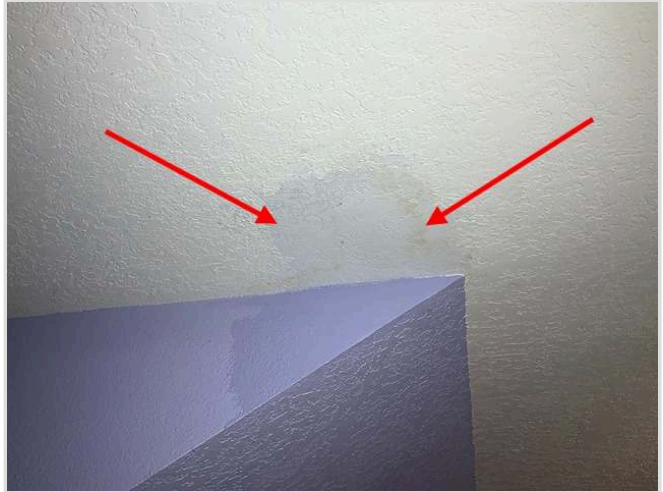
Signs of previous leaks (left bedroom)

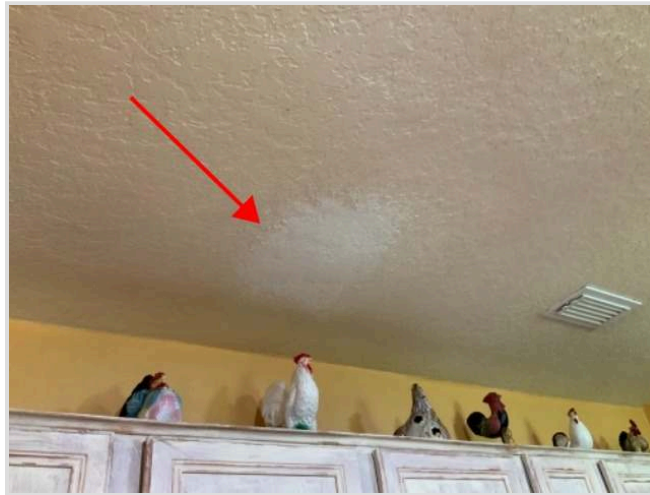
**Note:** Previous repairs had been made to the sheetrock ceiling in the kitchen.

Signs of previous repairs (kitchen)

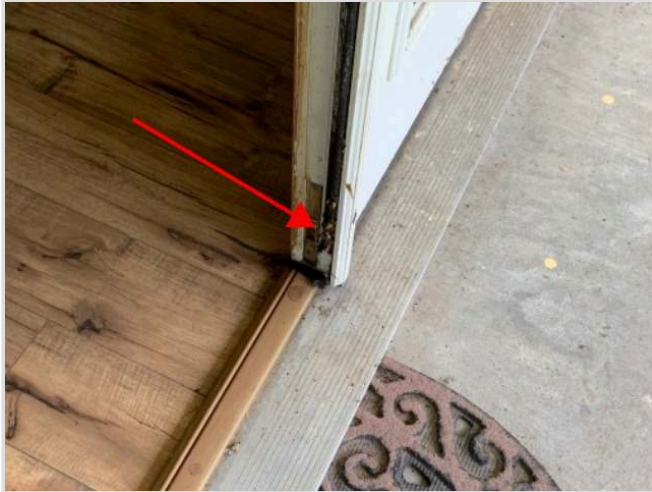
Weather stripping was torn/damaged and/or missing on one or more exterior door(s).  
Screen on the front exterior storm door was damaged.

Torn/damaged weather stripping (rear exterior door)

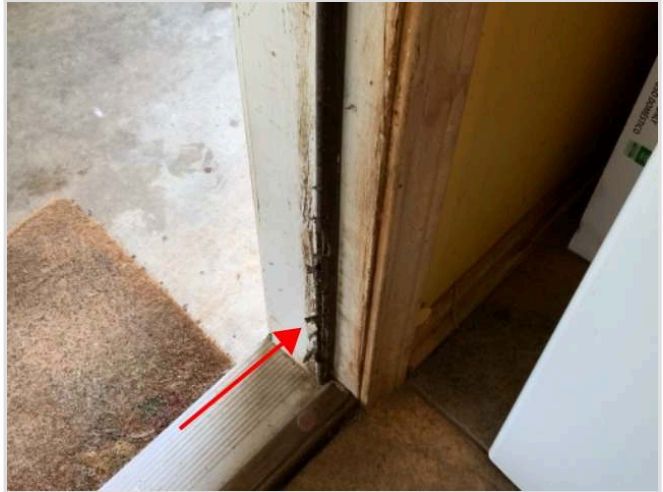
Torn/damaged weather stripping (exterior utility room door)

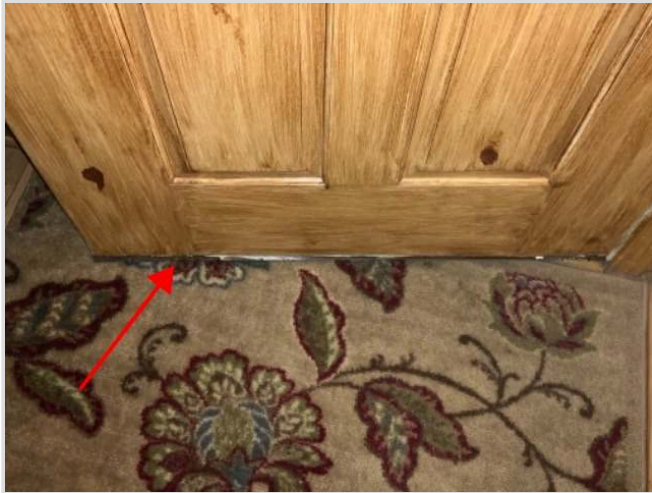
Torn/damaged weather stripping (front exterior door)

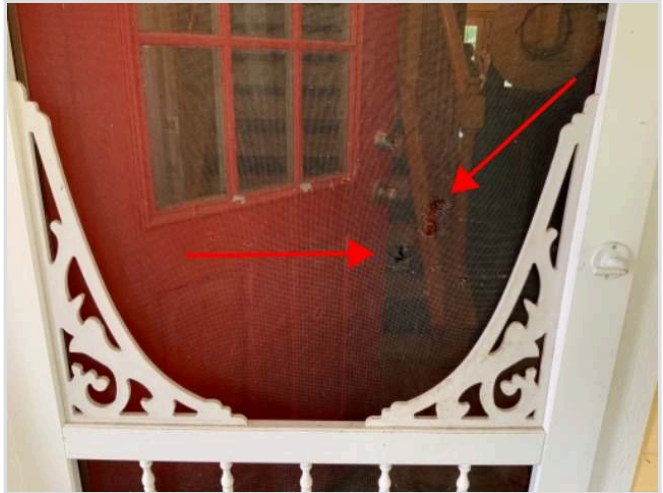
Damaged screen (front exterior-storm door)

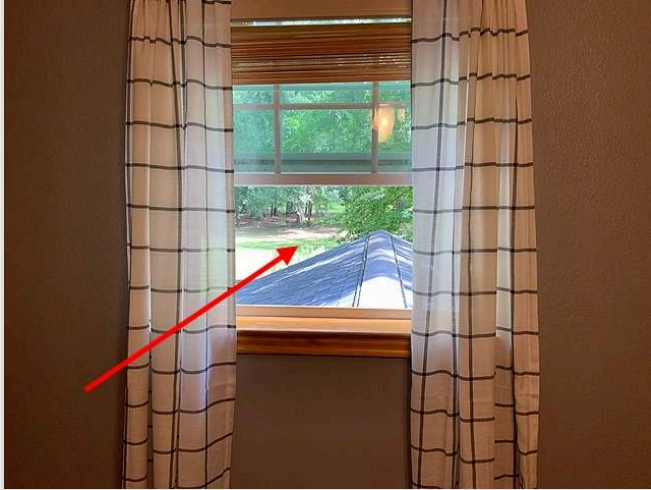
Not all of the windows had screens. In addition, some of the screens were damaged. The Texas Real Estate Commission (TREC) considers this to be a deficiency according to the standards of practice (SOP).

Missing screen (right bedroom)

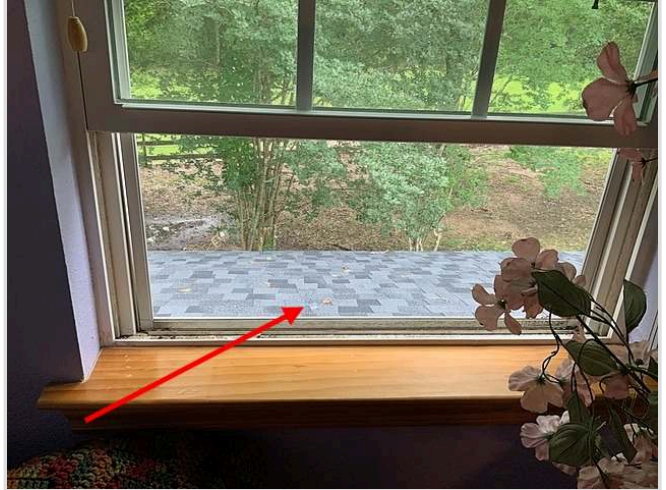
Damaged screen (left bedroom)

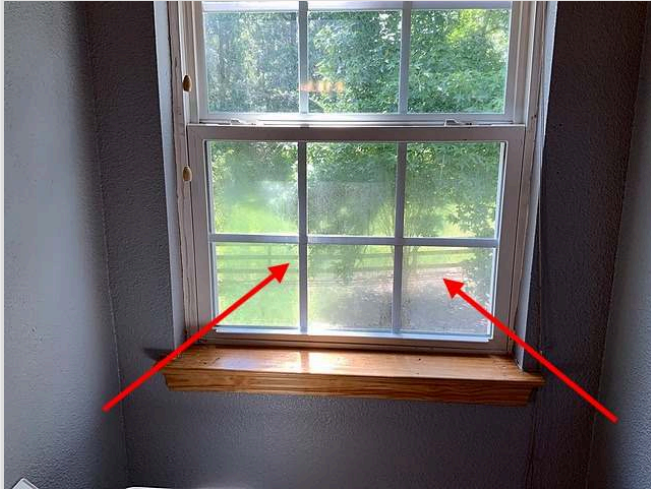
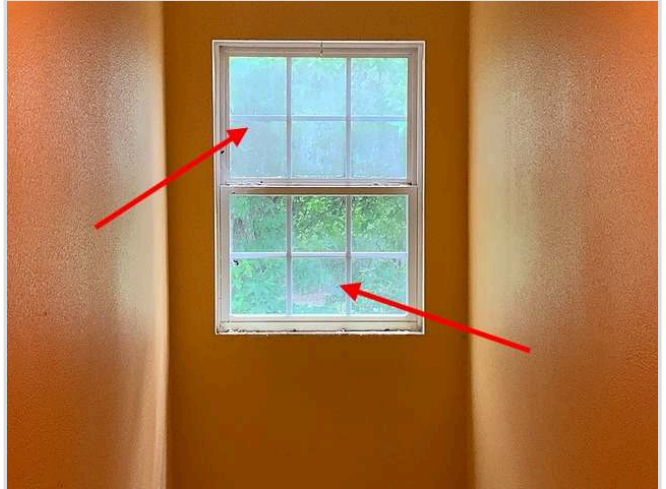
Windows had lost their seals (condensation between the panes of glass) in one or more locations throughout the house. **Note:** Lost seals are subject to change with variation in temperature and humidity.

Lost seal (right wall-left bedroom)

Lost seal (window above stairway)

- Windows had lost their seals (condensation between the panes of glass) in one or more locations throughout the house.  
**Note:** Lost seals are subject to change with variation in temperature and humidity.

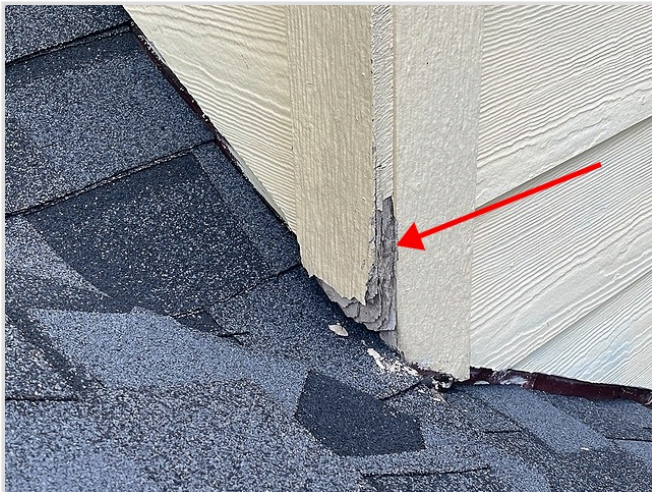
A portion of the trim on the chimney chase was damaged.

Trim damaged (chimney chase)

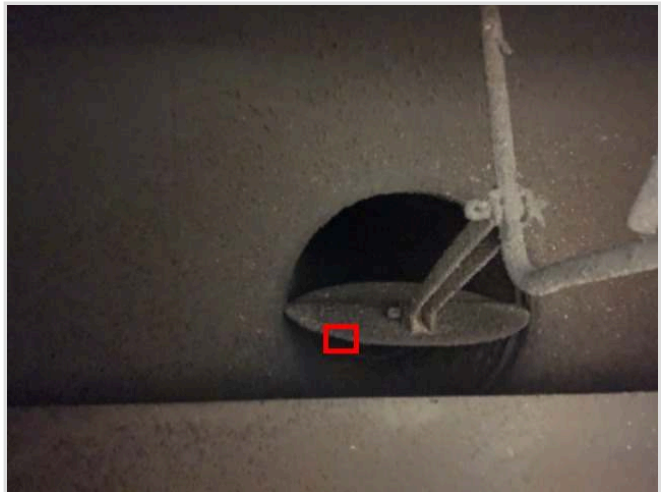
An artificial gas log insert was installed in the firebox and no damper clamp present. Having a properly installed damper clamp will prevent carbon monoxide from a pilot light or other sources, from exiting into the room where the fireplace is located.

No damper clamp

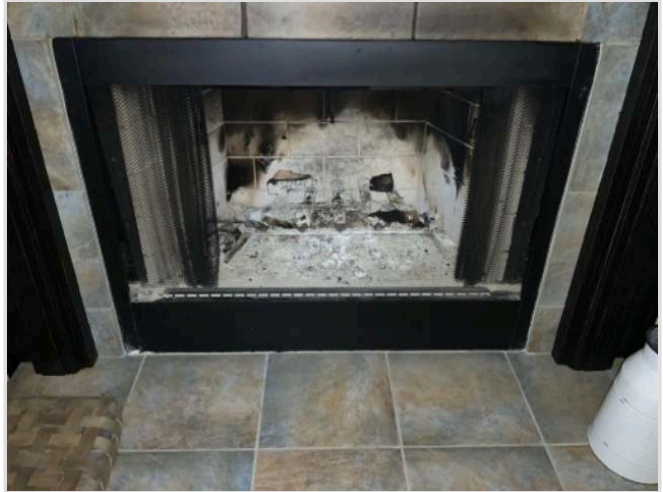
The fire box needed to be cleaned.

Needed to be cleaned

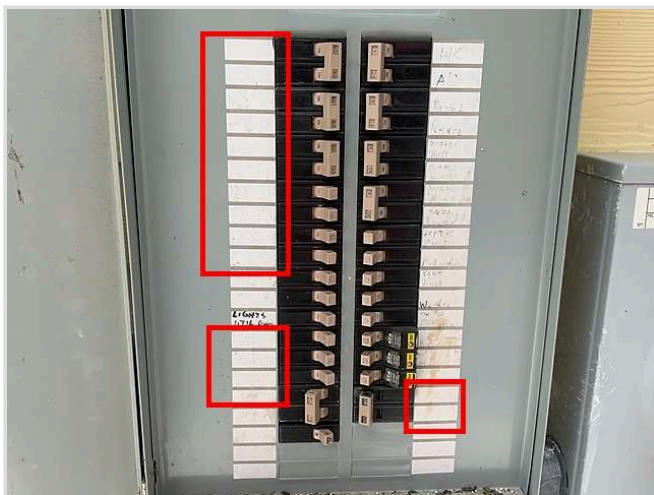
Not all breakers clearly labeled

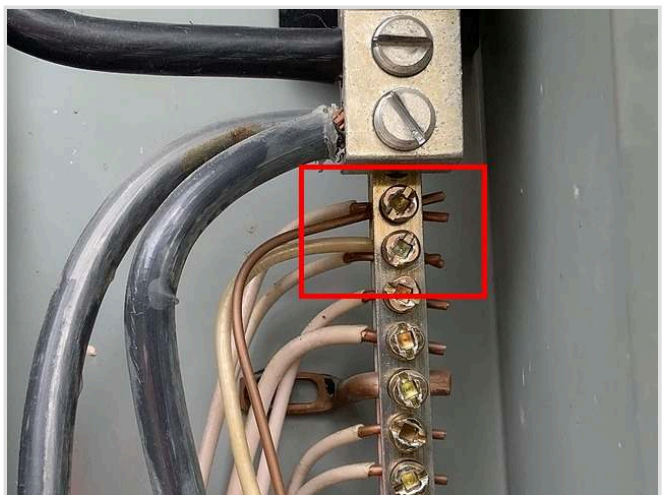
Neutral wires were improperly connected with ground wires/other neutrals at the bus bar under shared tension (set) screws. Only one neutral wire (alone) should be installed beneath a single tension screw at the bus bar.

Grounds/neutrals double lugged

- Neutral wires were improperly connected with ground wires/other neutrals at the bus bar under shared tension (set) screws. Only one neutral wire (alone) should be installed beneath a single tension screw at the bus bar.

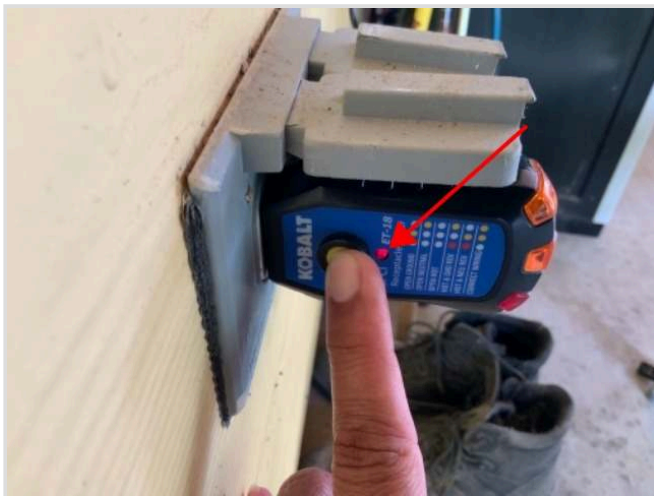
Not all receptacles on the exterior were on GFCI (ground fault circuit interrupter). Though the receptacle may not be within the six feet of a plumbing fixture, the Texas Real Estate Commission (TREC) considers this to be a deficiency according to the standards of practice (SOP).

Tester showing receptacle not GFCI protected (exterior)

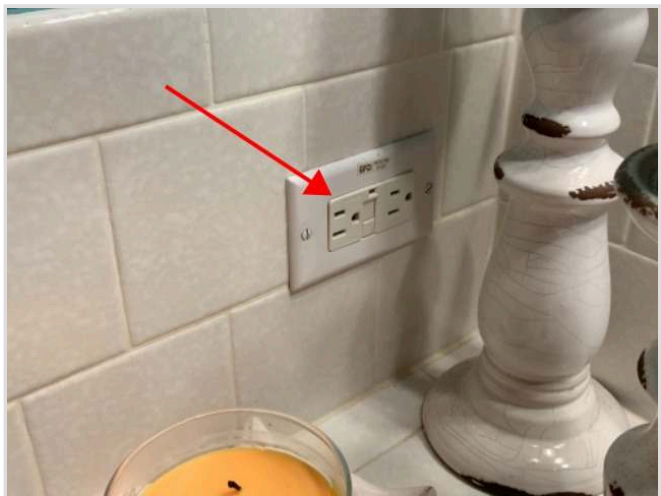
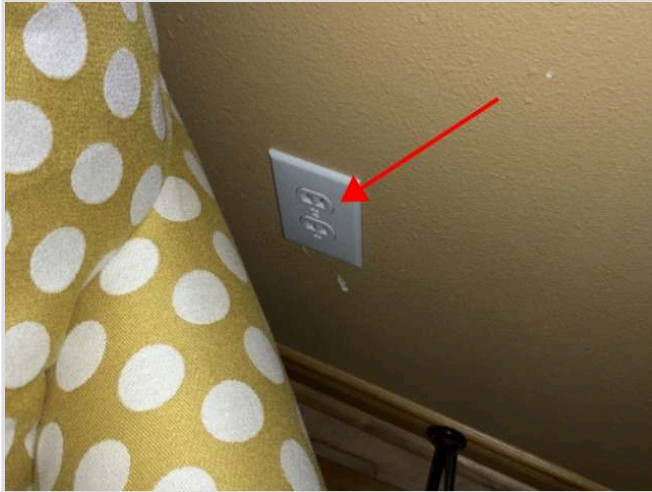
One or more receptacles/outlets were not properly installed in the gang box (loose), which can possibly lead to electrical faults such as loose or disconnected wires, and/or increased resistance in the circuit.

Loose (half bathroom)

Loose (living room)

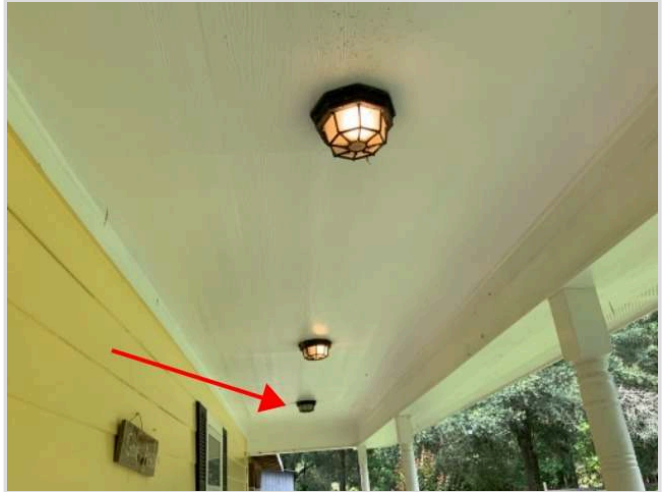
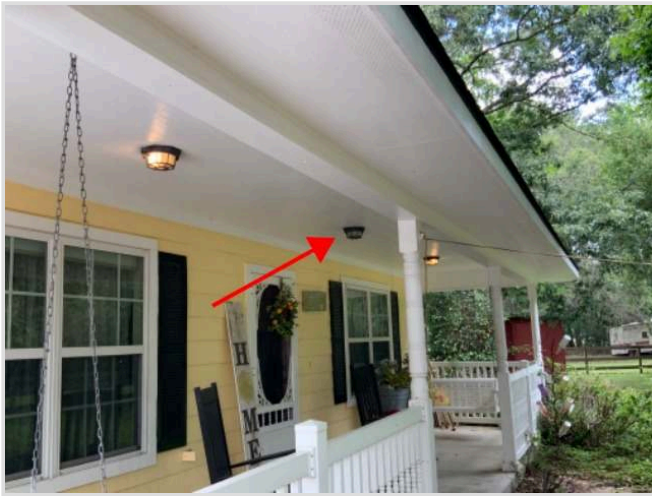
Some of the lights would not illuminate when placed into the on position, possibly due to burned out bulbs.

Would not illuminate (rear porch)

Would not illuminate (front porch)

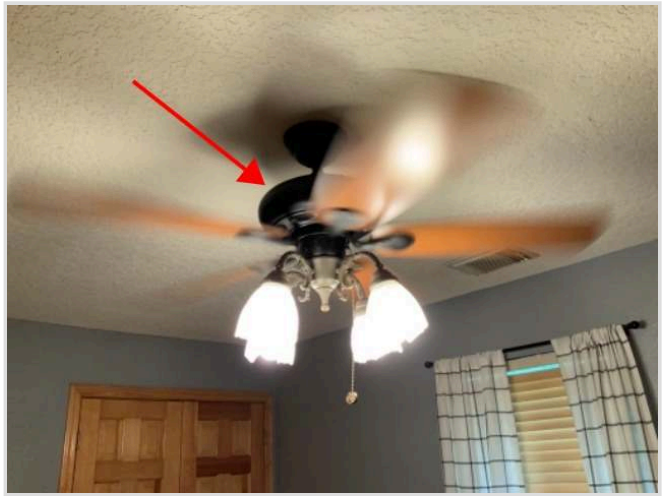
Ceiling fan in the right bedroom was not properly installed (loose).

Not properly installed/loose (right bedroom)

- Ceiling fan in the right bedroom was not properly installed (loose).

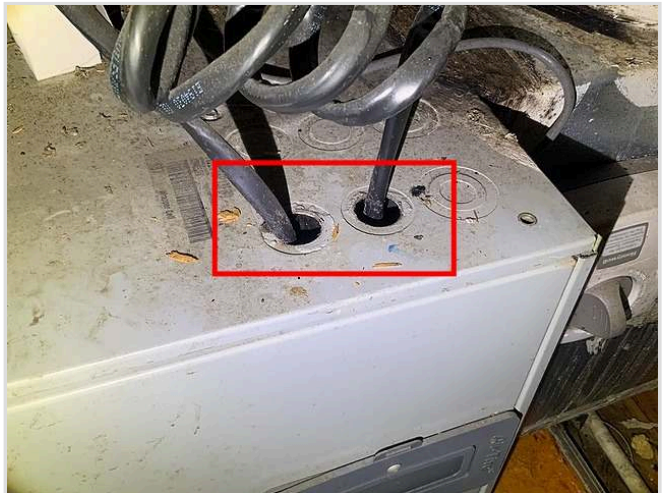
Wires entering the heating unit were not protected from abrasion (no grommet/bushing).

Wires not protected from abrasion

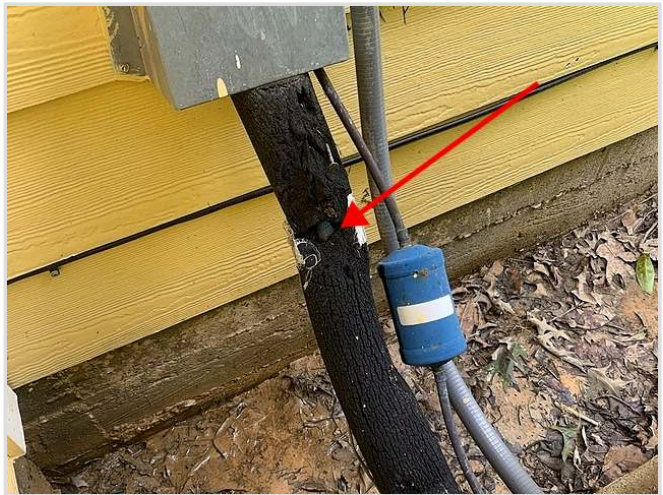
Needed additional insulation (outside unit)

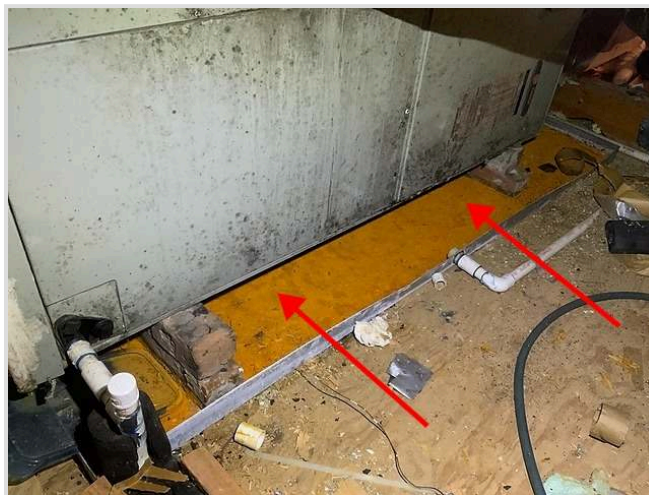
Secondary drain pan had significant rust corrosion. Once the galvanized coating is used up and rust sets in, it will continue to rust even without liquid water present.

Significant rust corrosion

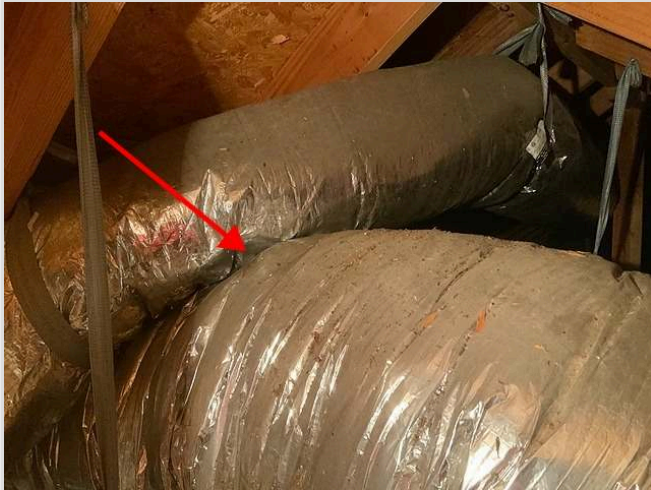
Ducts in the attic space were in contact with other duct. Points of contact between these items has been known to create condensation (sweating) in the attic space. Manufacturers recommend at least a 1” clearance around flex ducts.

In contact with other duct

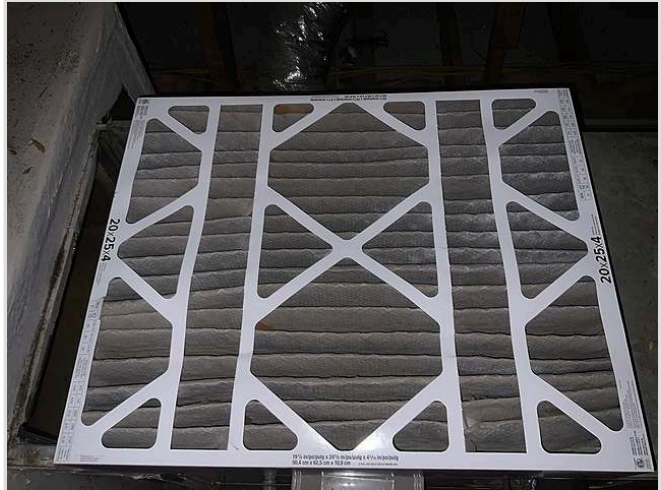
The media filter was dirty and needed to be replaced. Dirty filter(s) indicate that the system had not been properly maintained and may require the need for cleaning/service.

Dirty media filter

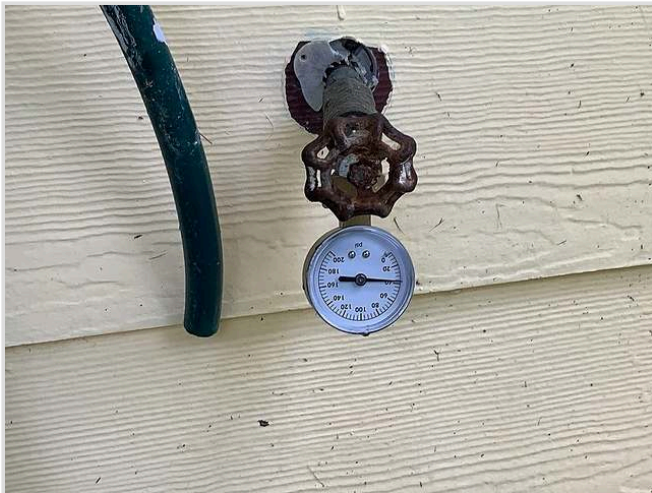
Static water pressure was measured below 40 psi. Water pressure below 40 psi will likely lead to poor performance of devices that use water.

Static water pressure (30-40 psi)

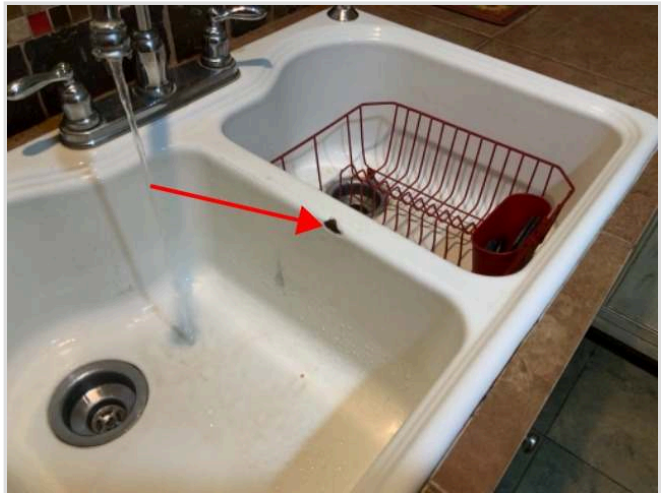
The finish for the kitchen sink was chipped/damaged.

Chipped/damaged finish (kitchen sink)

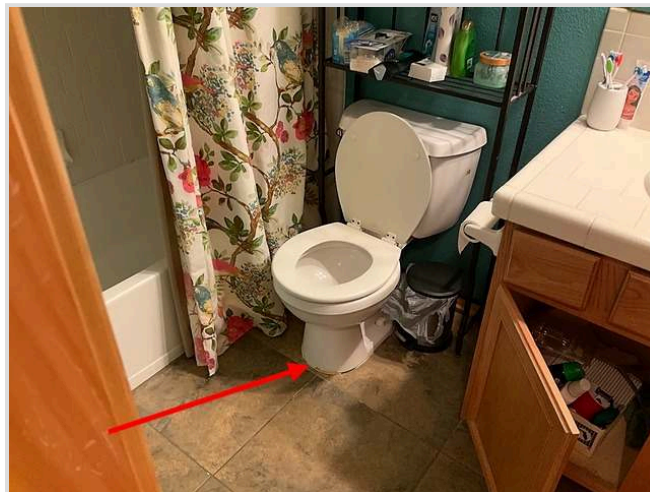
Commode located in the upstairs bathroom was loose at the floor. Unable to determine if the wax seal was intact.

Loose at floor (upstairs bedroom)

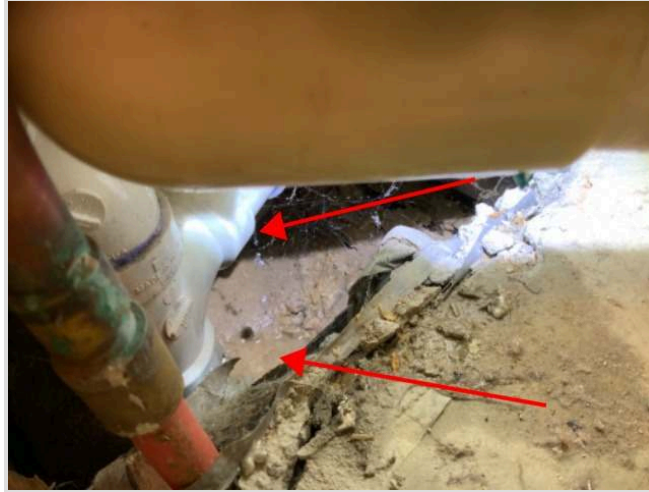
A leak was found beneath the master bathtub.

Leak point (master bathtub)

- A leak was found beneath the master bathtub.

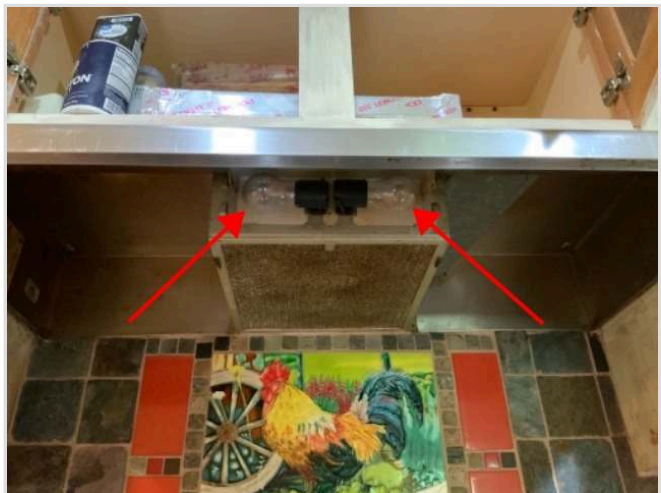
Lights for the range exhaust would not illuminate when placed into the on position.

Would not illuminate

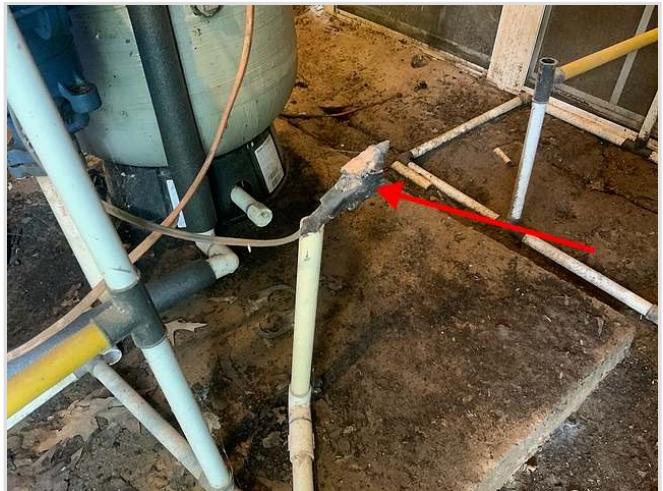
Wire connections not in a junction box
