PROPERTY INSPECTION REPORT

3618 Appalachian Trail , Kingwood , TX 77345
Inspection prepared for: Matt Messer
Real Estate Agent: Open House - Open House

Date of Inspection: 3/17/2023 Time: 3:30 PM
Age of Home: 1990 Size: 1,778
Weather: Clear 53 Degs F
Structure Type: Structure is a wood framed structure
on a concrete slab foundation.

Inspector: Steve McElwee
License 21679
Deer Park, TX 77536

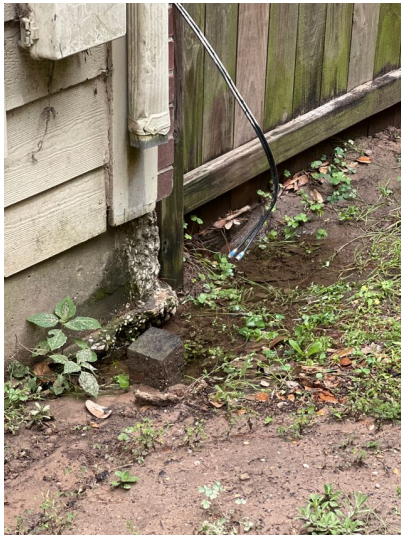
- Gutters downspouts should extend out beyond 5' from foundation to allow for proper runoff. All gutter downspouts should have splash blocks or diverters to control erosion and direct the roof water away from the foundation
- **One or more gutter downspout (s) are discharging too close to foundation.**
- **Low soil observed at one or more sides of the structure and recommend additional backfill.**

Gutter downspout discharging too close to the foundation.

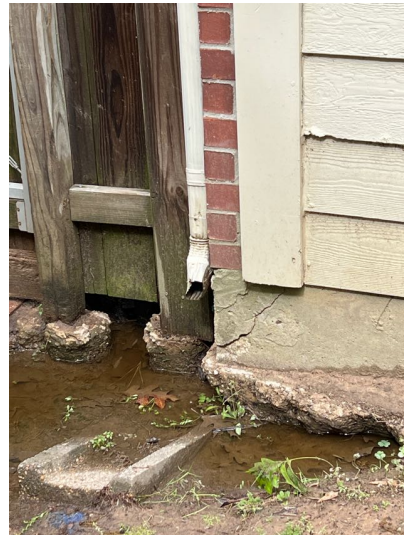
Gutter downspout discharging too close to the foundation.

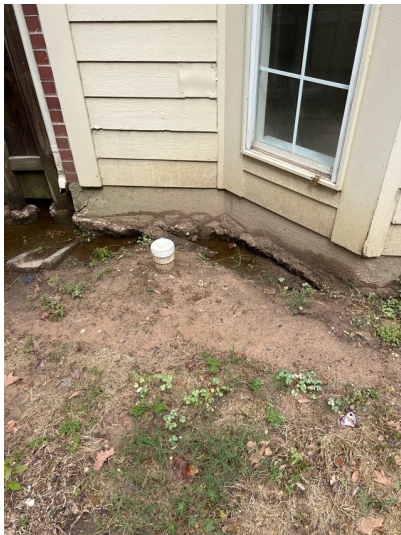
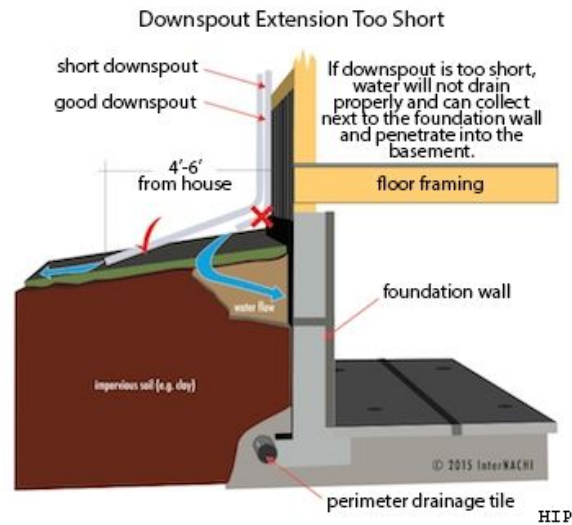
Low soil observed at one or more sides of the structure and recommend additional backfill.

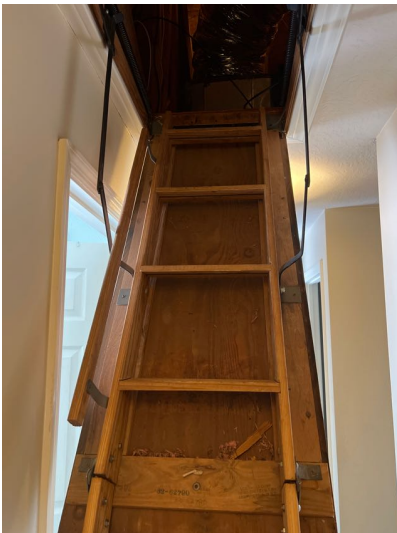
- The attic structure was observed to be framed using a truss system.
- **There is no insulation installed on the attic access cover as required by current standards.**

Attic access missing insulation.

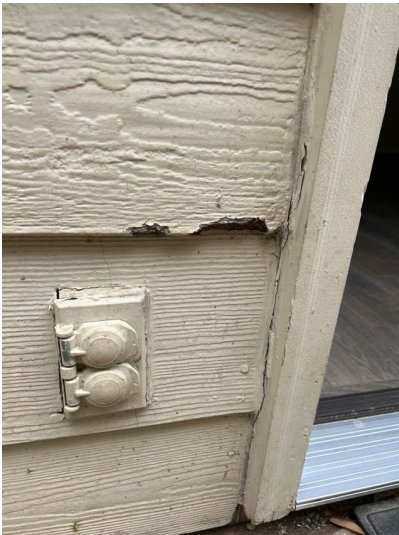
Damaged siding back side of house.

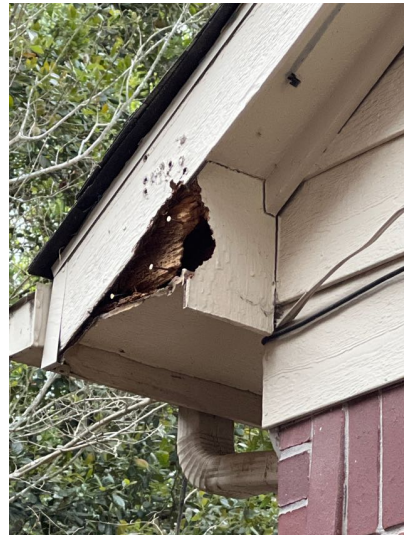
Damaged fascia board left side of house

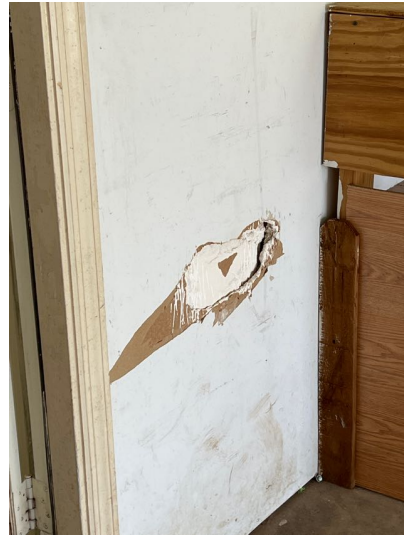
Damaged drywall

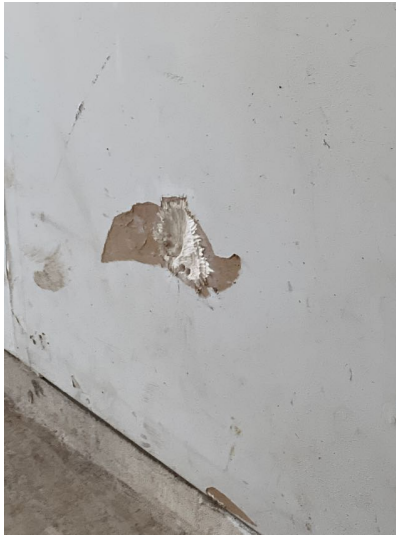
Damaged drywall

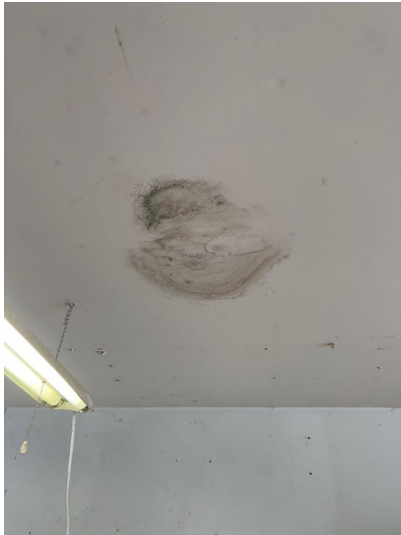
Moisture stain on ceiling.

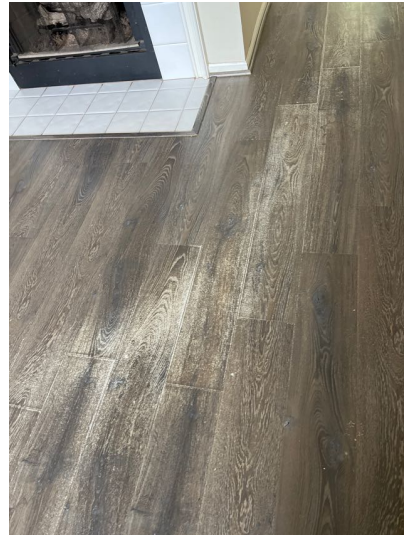
Damaged wood floor.

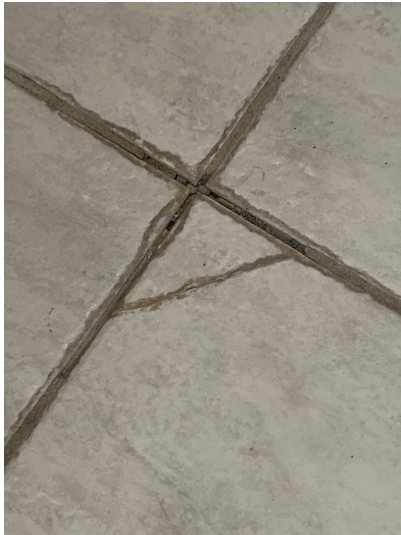
Damaged floor tile.

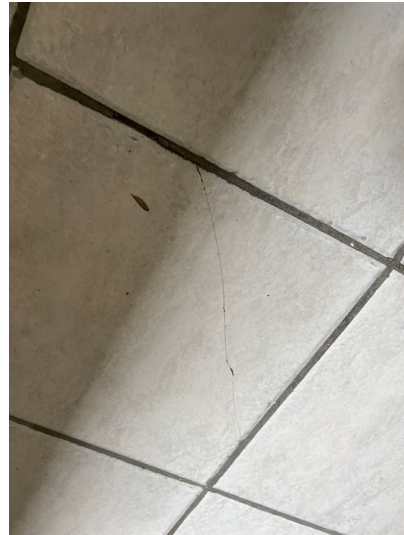
Damaged floor tile.

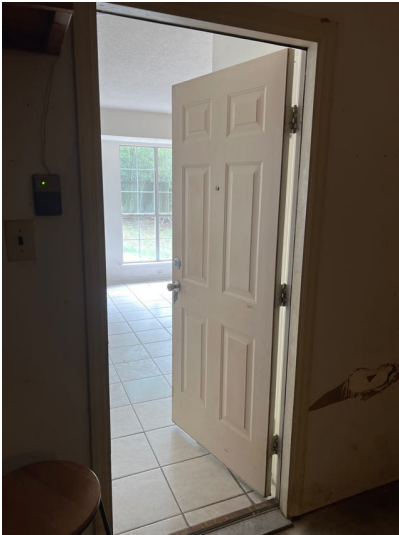
The garage entry door was not equipped with a self closing device.

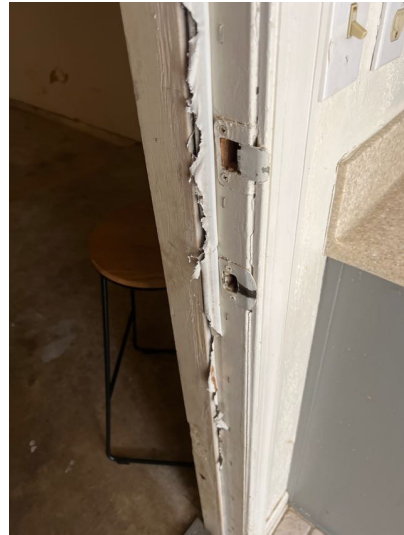
Garage door noted with Damaged weatherstripping

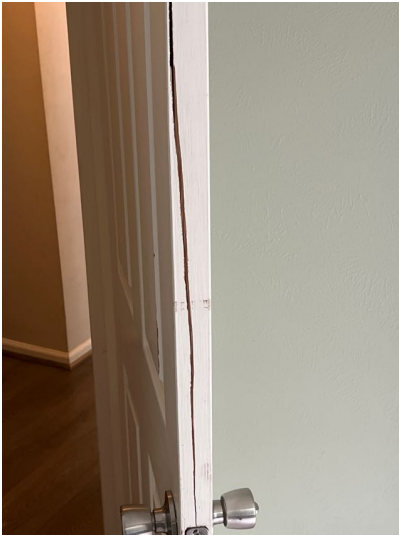
Bedroom door noted with damage

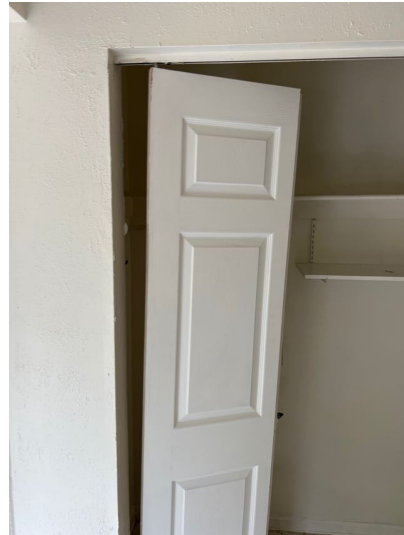
Utility room folding door not installed correctly

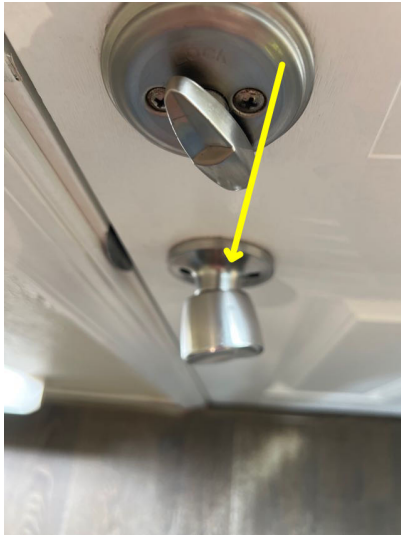
Back door noted with damaged door knob

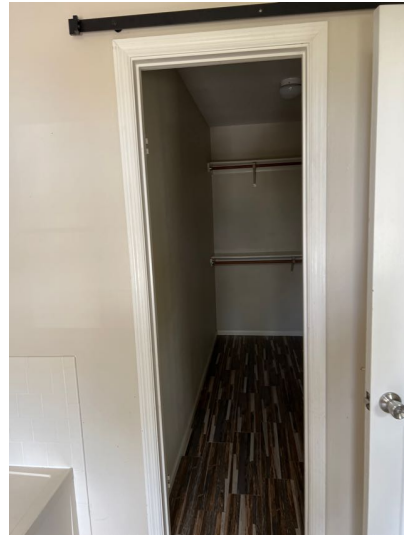
Master bedroom closet door missing

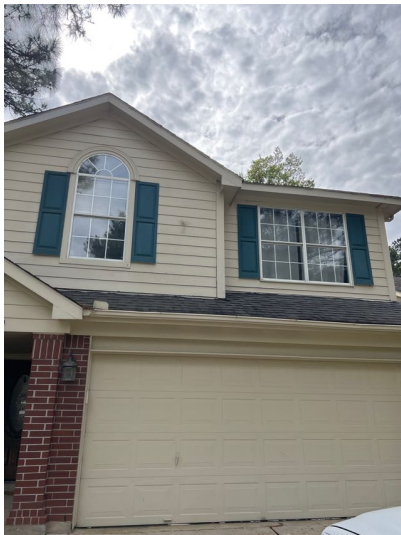
Windows missing screens.

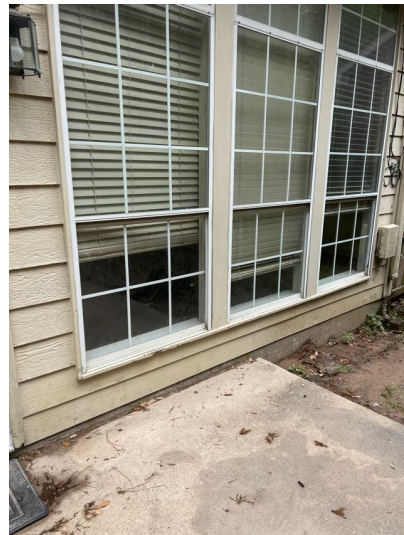
Windows missing screens.

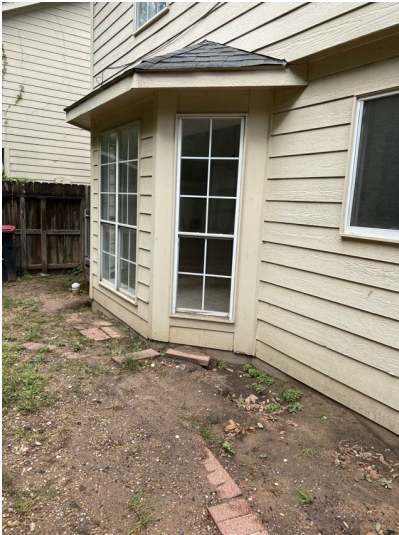
Windows missing screens.

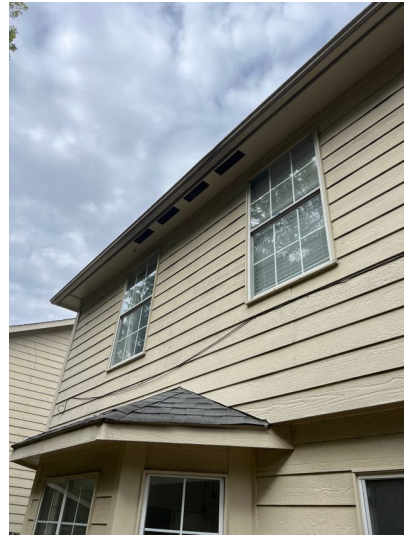
Windows missing screens.

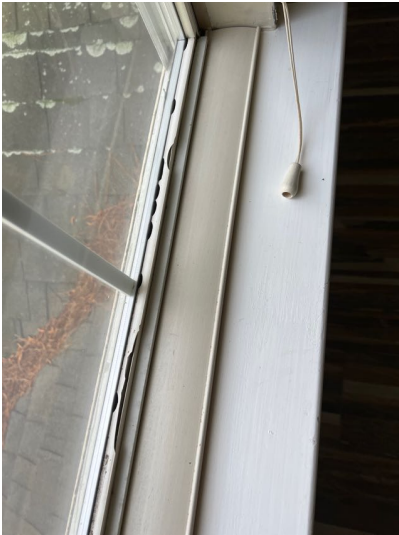
Several windows noted with damage

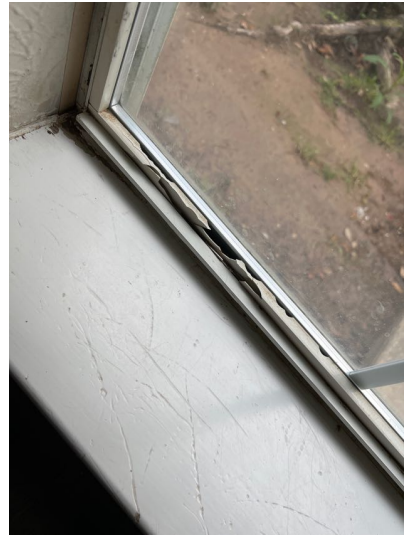
Several windows noted with damage

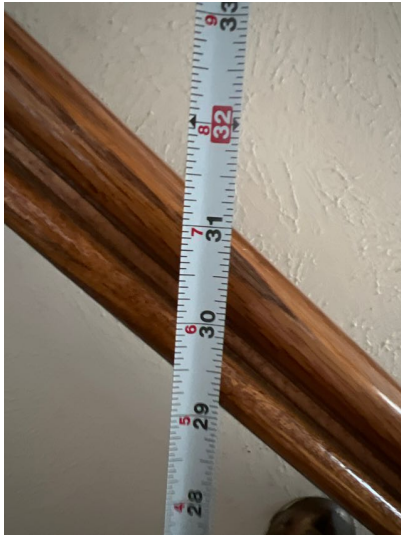
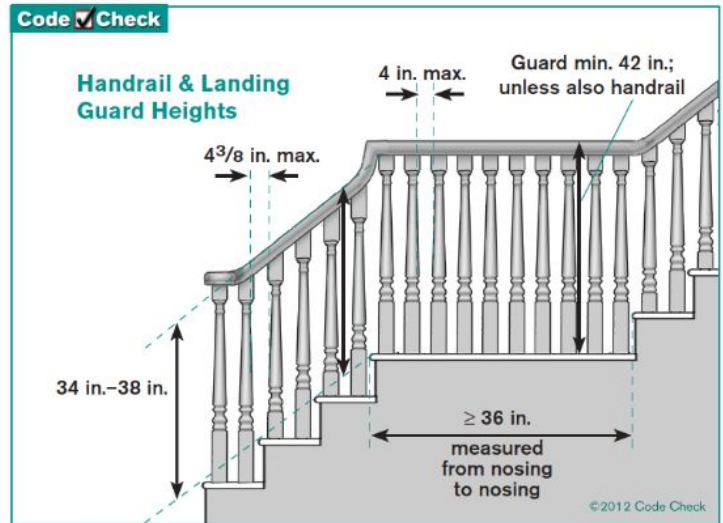
The stairway handrail has been installed too low. Stairway handrails are required to be installed between 34" and 38" above stair treads.

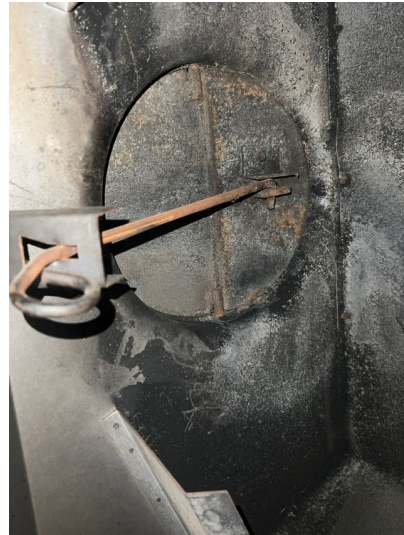
Fireplace damper missing damper clamp.

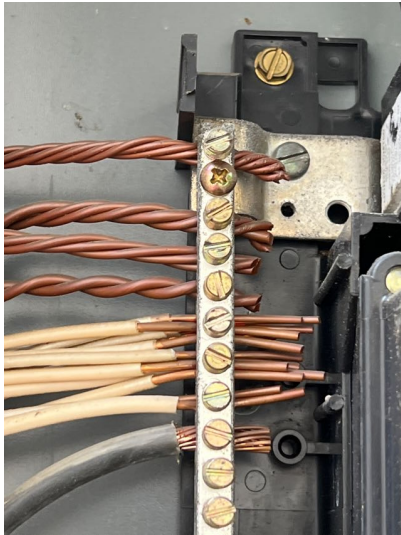
Double tapped neutral wires. More than one wire installed under one lug on bus bar.

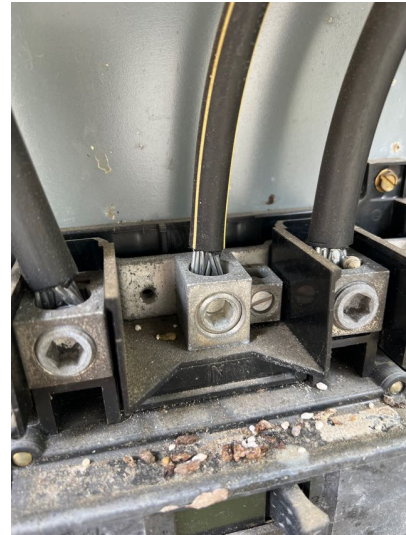
Aluminum service conductors missing anti-oxidant grease.

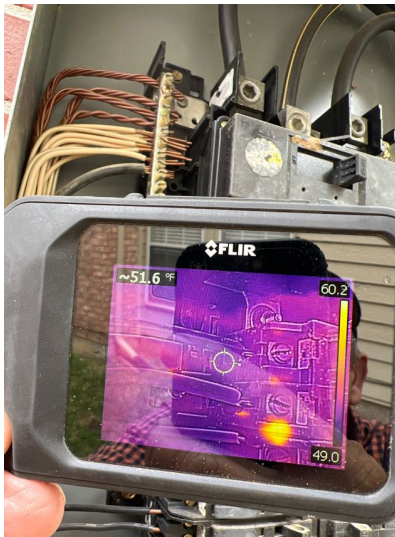
Thermal imaging camera used to detect over heating electrical components. No issues.

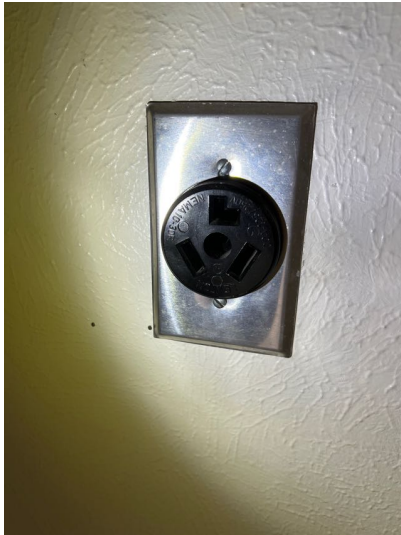
Female dryer outlet is the old three prong receptacle and should be exchanged for a four prong double grounded receptacle.

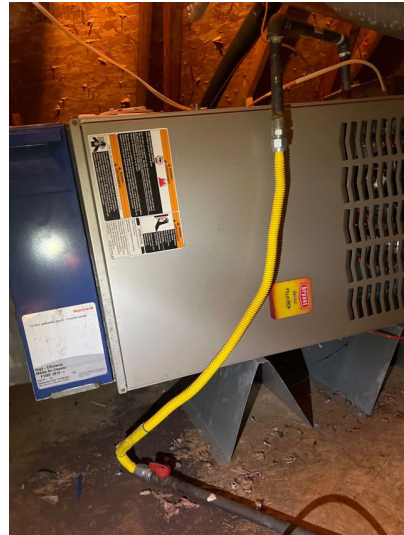
- **The gas supply line was not equipped with a required sediment trap just before the appliance connector. This condition does not meet current mechanical standards and should be corrected.**

Gas Piping missing sediment trap.

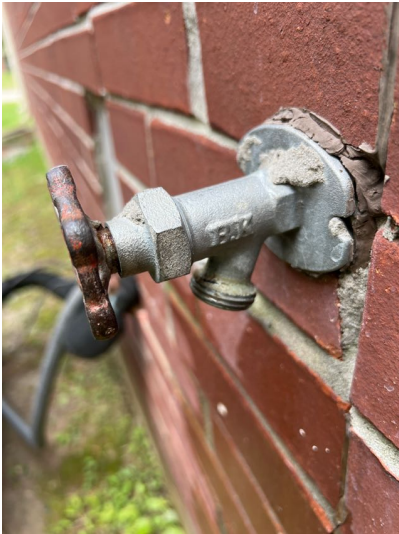
Hosebib missing anti-siphon device.

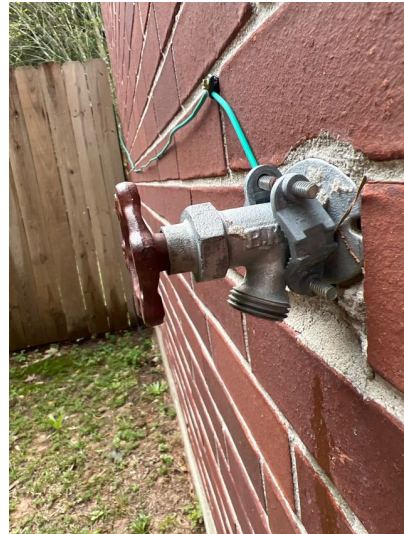
Hosebib missing anti-siphon device.

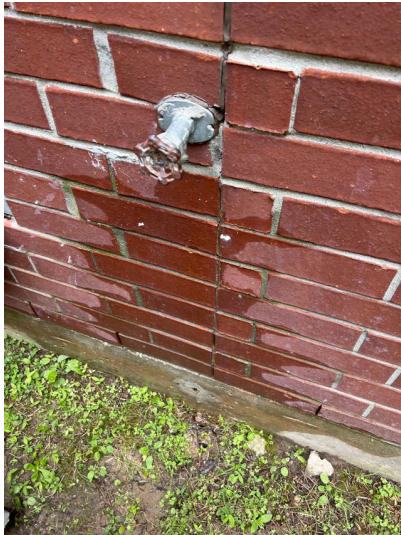
One or more of the exterior hose bibs {faucets} was observed to be leaking

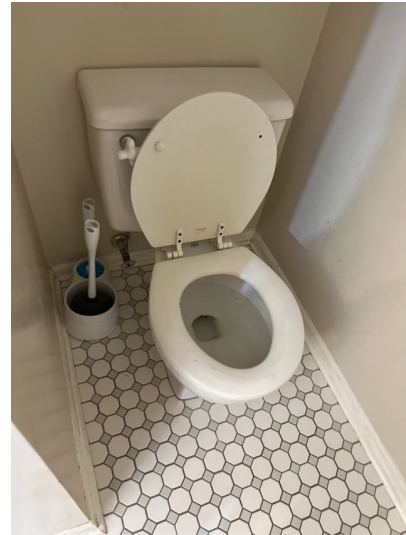
One or more commode(s) noted with constant water leaking into bowl from tank after flush cycle.

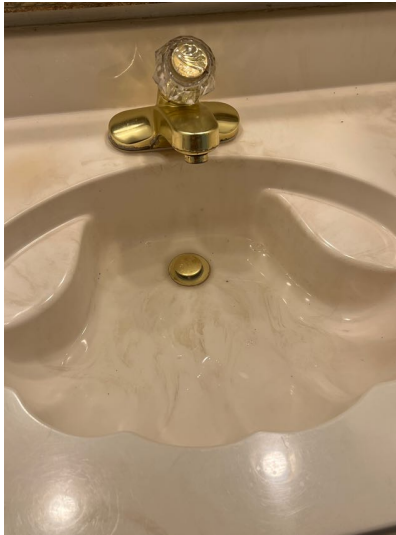
Downstairs half bathroom vanity noted with stopped drain

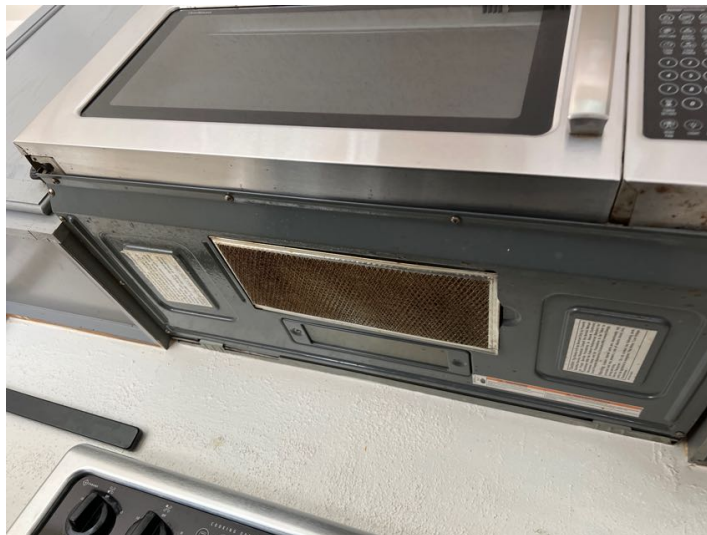
The vent hood light was not working at time of inspection.

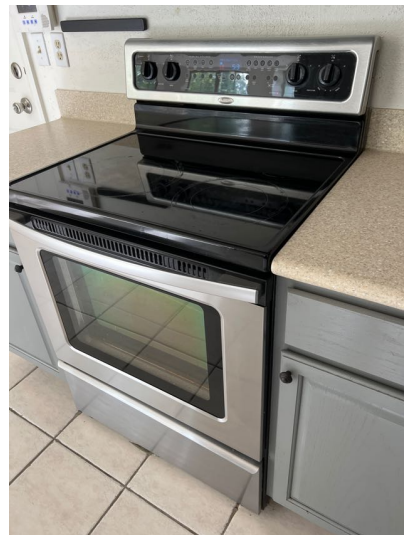
• **Anti-tip bracket is missing from range installation. All free-standing, slide-in ranges include an anti-tip device and is essential in the safe operation of the range. It provides protection when excess force or weight is applied to an open oven door**

Anti-tip bracket is missing from range installation. All free-standing, slide-in ranges include an anti-tip device and is essential in the safe operation of the range. It provides protection when excess force or weight is applied to an open oven door

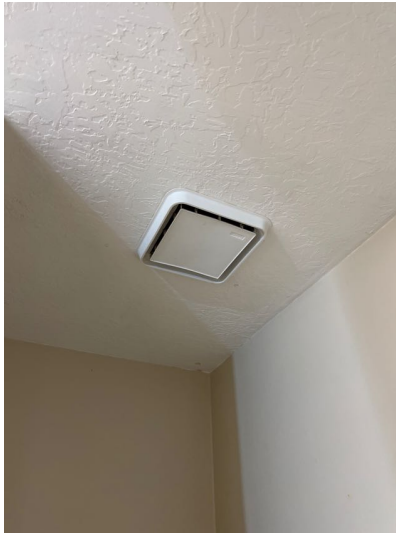
Bathroom exhaust fan noted with excessive noise.

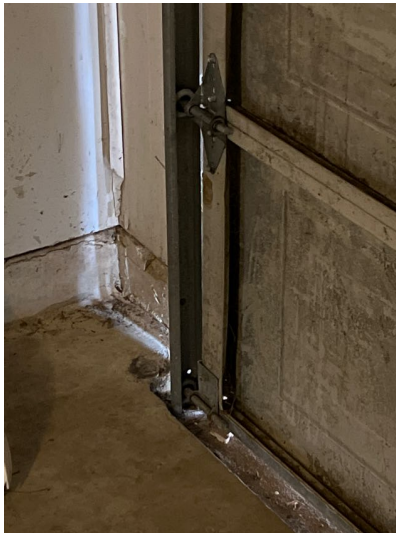
The garage door opener auto reverse sensors were missing at time of inspection.
