## Inspection Report

**Property Address:**  
107 Old Angleton Road  
Lake Jackson TX 77566

# PROPERTY INSPECTION REPORT FORM

Brad Porter, Johnny Smith	6/6/2022
<i>Name of Client</i>	<i>Date of Inspection</i>
107 Old Angleton Road, Lake Jackson, TX 77566	
<i>Address of Inspected Property</i>	
Austin Messina TREC# 21907	
<i>Name of Inspector</i>	<i>TREC License #</i>
<i>Name of Sponsor (if applicable)</i>	<i>TREC License #</i>

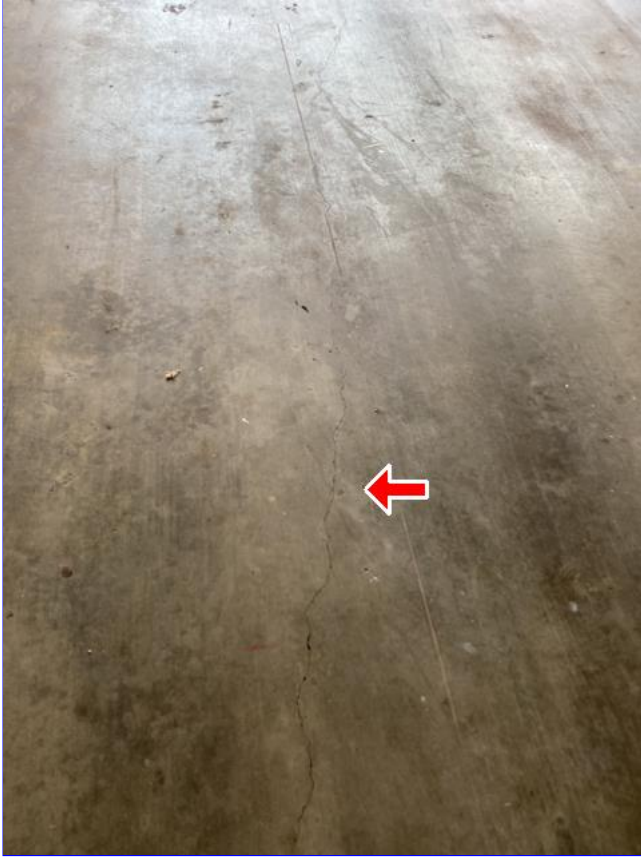
A. Item 1(Picture)

(2) Cracks in exposed concrete floors at garage

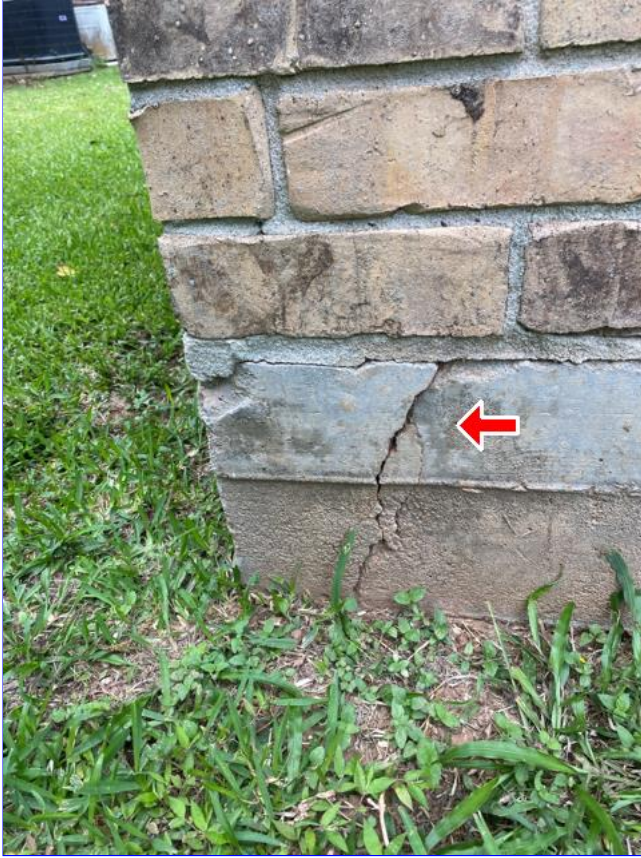
A. Item 2(Picture)

(3) Slab corner spalls require cleaning and/or resealing

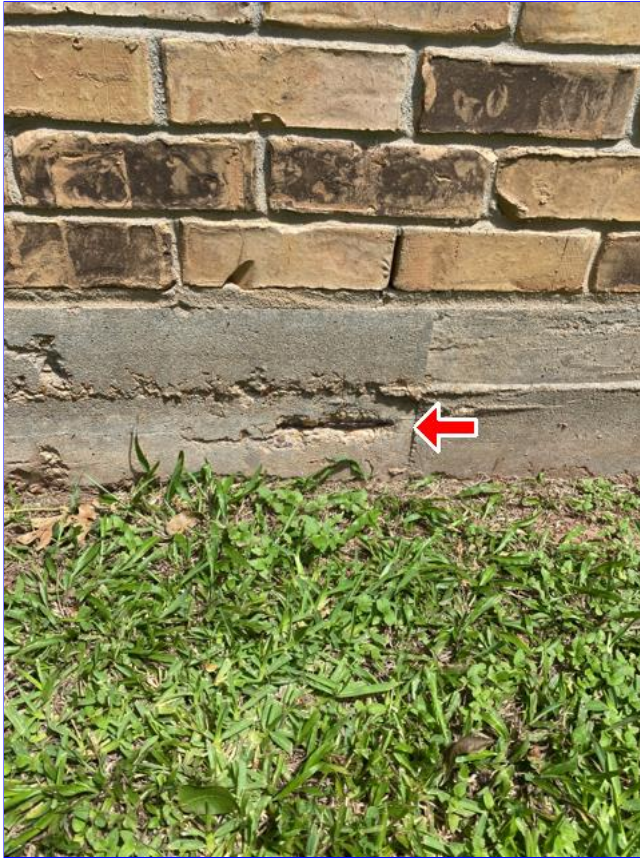
A. Item 3(Picture)

(4) Exposed rebar observed at garage

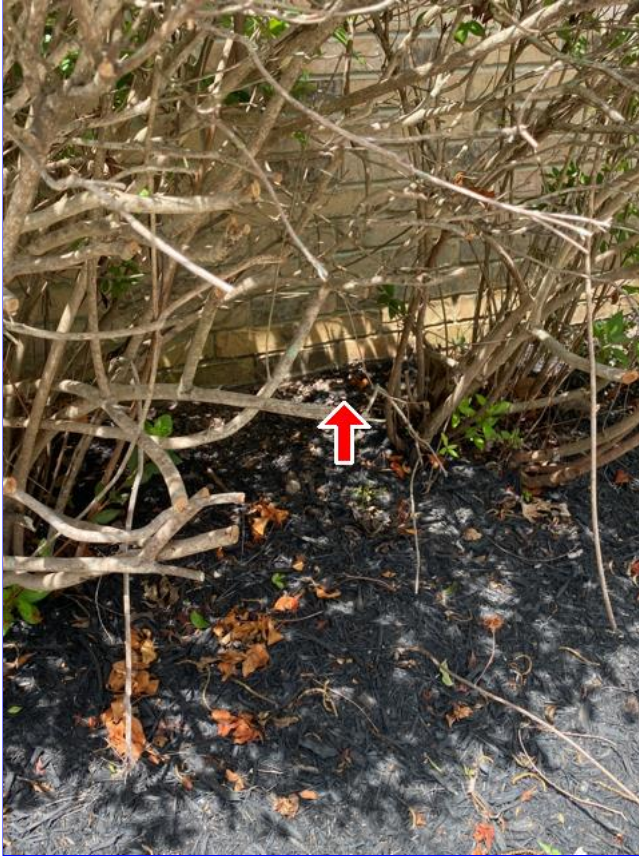
B. Item 1(Picture)

(2) Foundation lacks 4" exposure below brick.

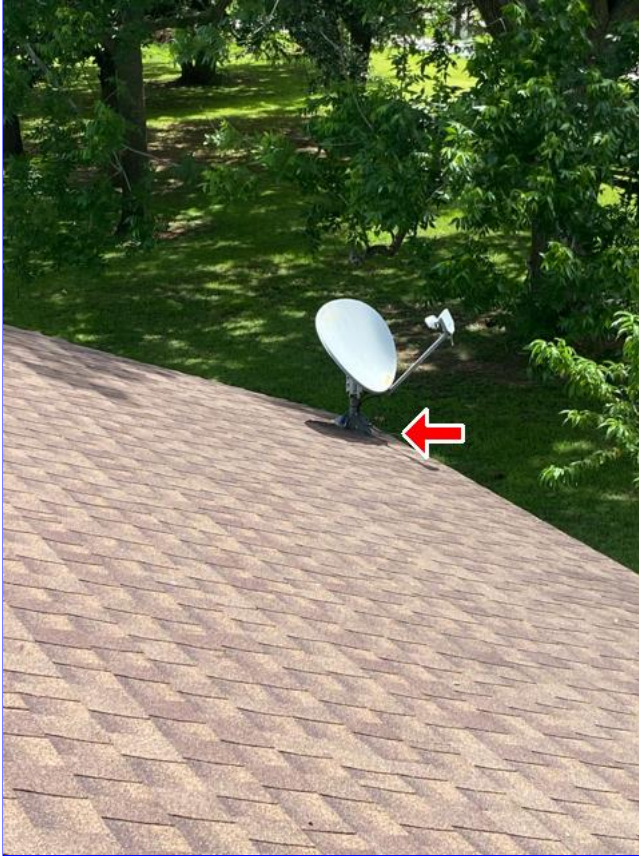
C. Item 1(Picture)

(2) Satellite dish mounted to roof surface. This presents the potential of roof leakage.

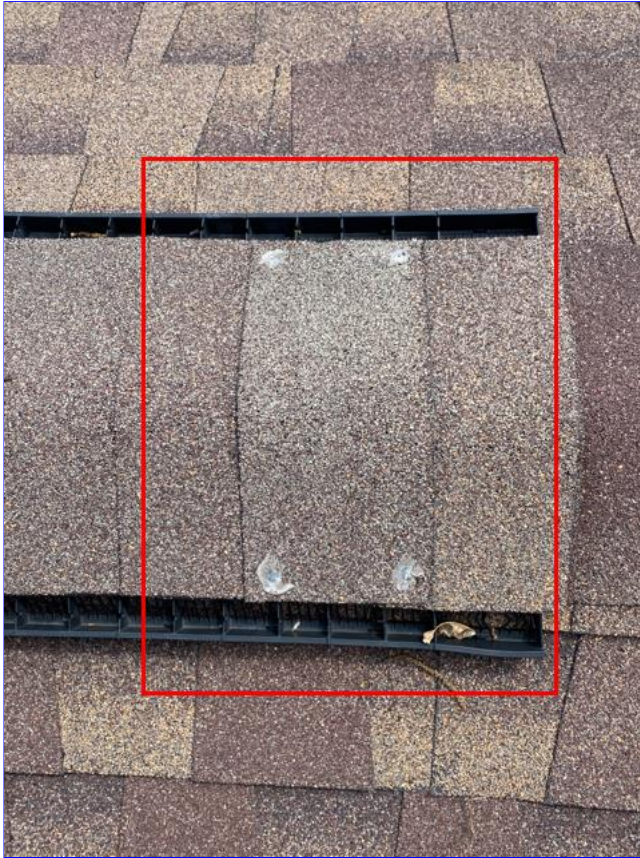
C. Item 2(Picture)

(3) Exposed nail heads were observed. Recommend caulking/sealing.

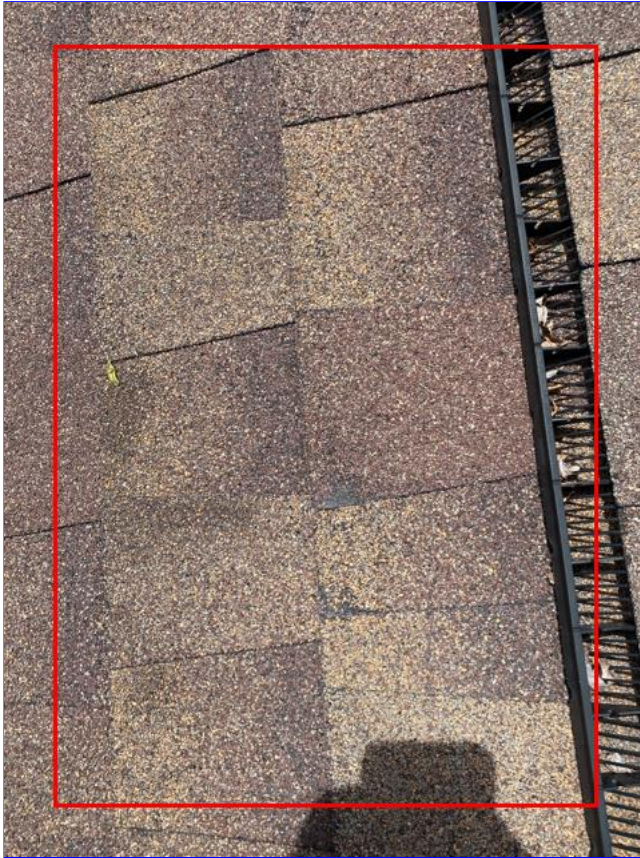
C. Item 3(Picture)

(4) Worn aggregate or gravel finish observed.

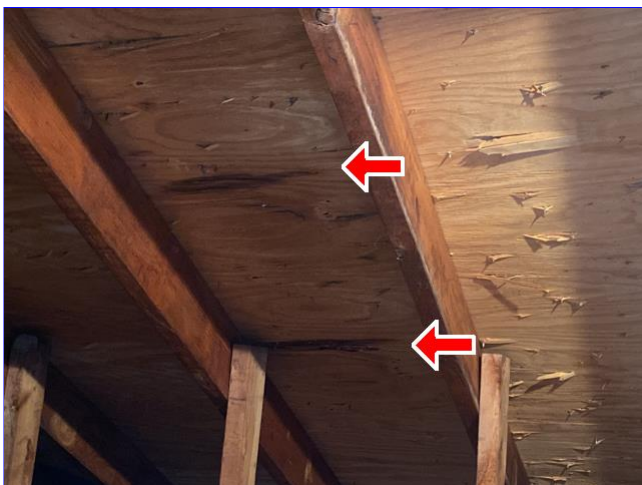
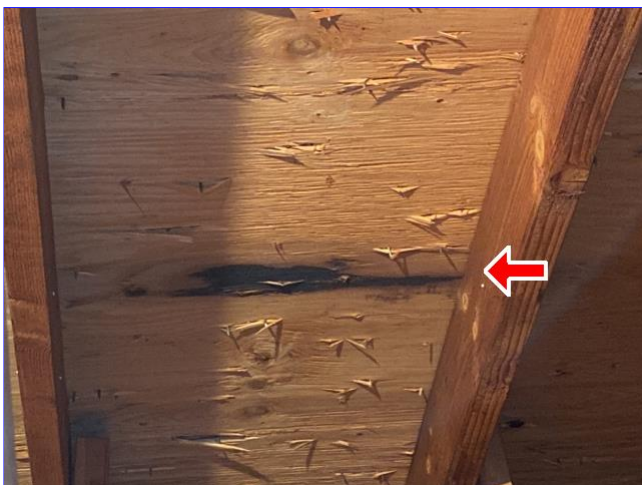
(4) Visual evidence of moisture penetration on roof decking. Further evaluation recommended.

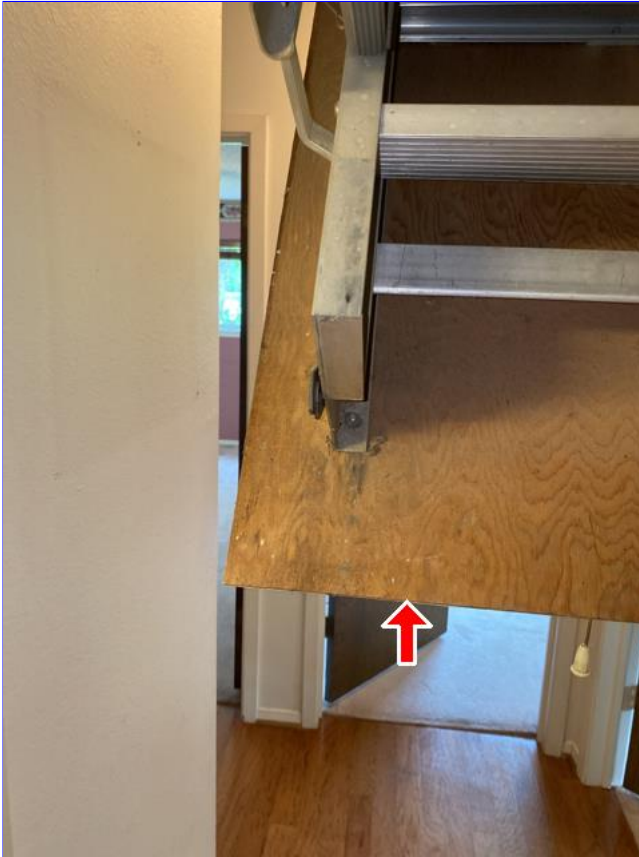
D. Item 4(Picture)

(5) Attic pull-down stairway is not weatherstripped.

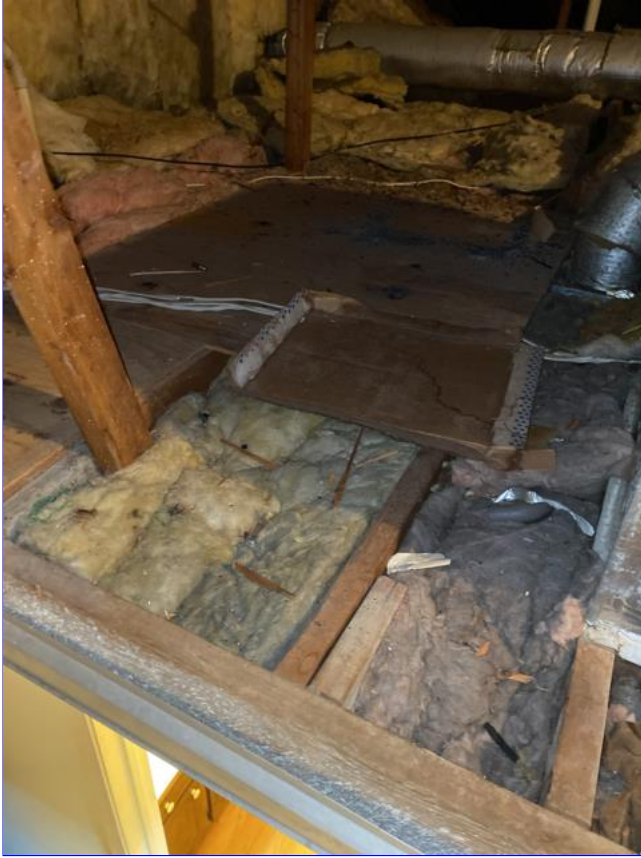
D. Item 5(Picture)

(6) Attic insulation is well below recommended 12" for fiberglass.

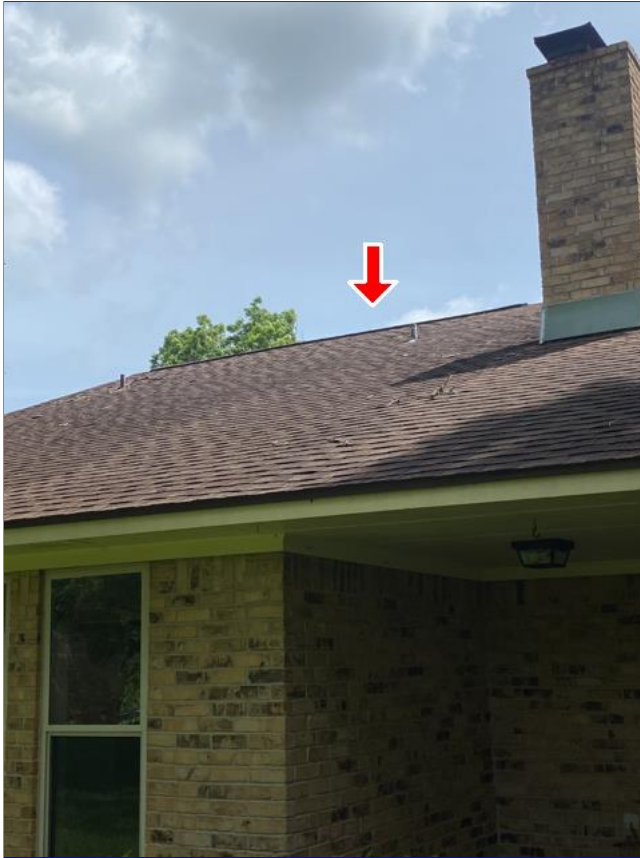
D. Item 6(Picture)

(7) Deflection and / or sagging observed on roof decking or structure

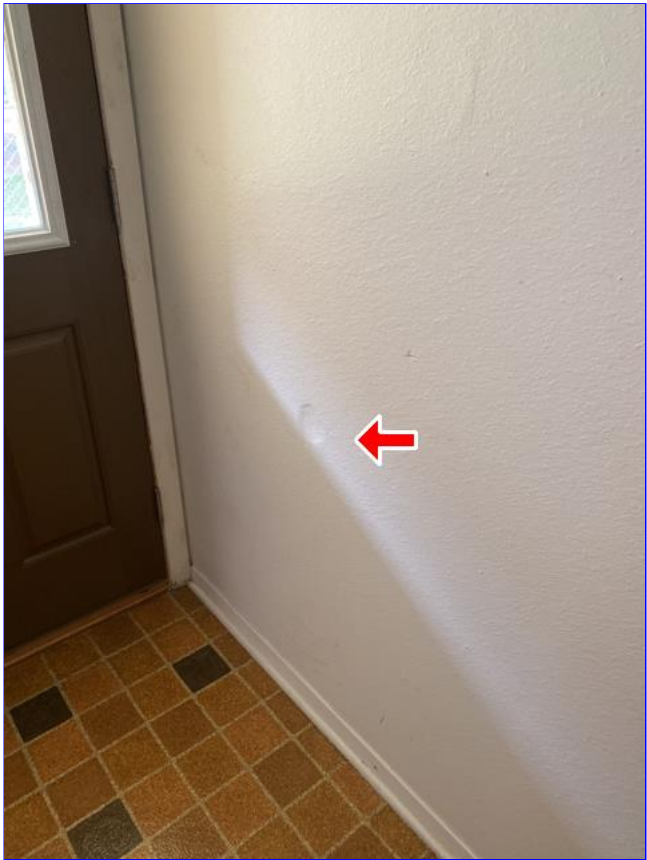
E. Item 1(Picture)

- (1) *The interior and exterior wall surfaces of the home were visually inspected from ground level. Interior walls were checked for sheet rock damage, cracking and signs of water penetration. Minor cosmetic flaws and deficiencies are not normally noted. Exterior walls were inspected for deteriorated wood, brick cracks, warping, levelness, proper flashing, caulking and proper installation of materials. Again, cosmetic deficiencies are not normally noted. The type of exterior wall material is listed below.*
- (2) Freshly painted walls previous repairs or deficiencies may not be observable.
- (3) Previously repaired sheetrock observed at side entry door

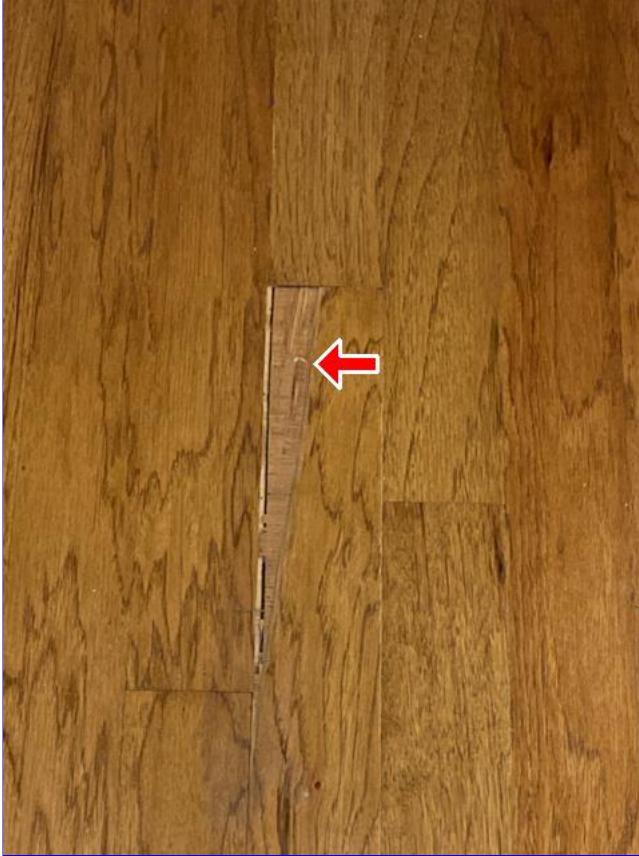
F. Item 2(Picture)

- (3) Freshly painted ceilings previous repairs or deficiencies may not be observable.
- (4) Previously repaired sheetrock observed at garage
- (5) Damaged flooring observed at hallway

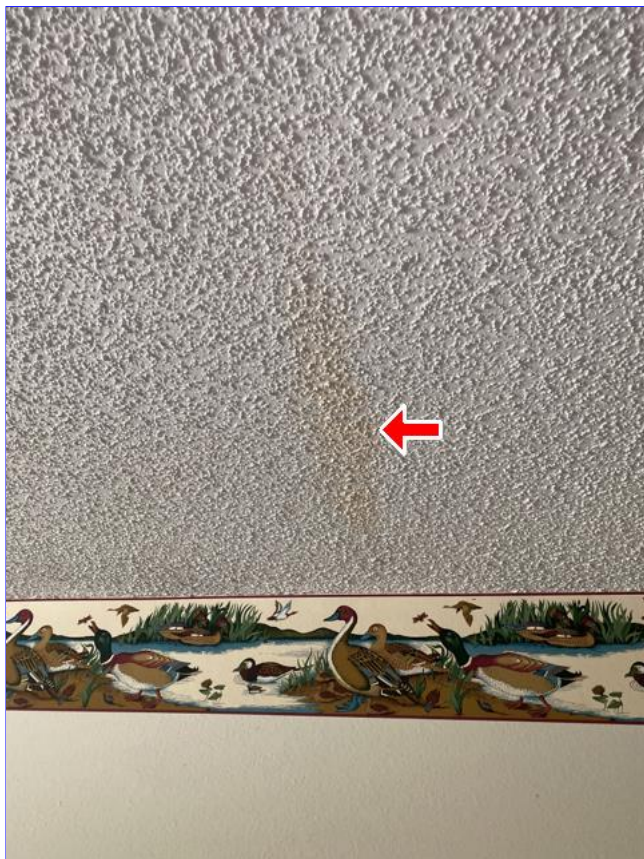
F. Item 3(Picture)

(6) Water stains observed on ceilings at front middle bedroom

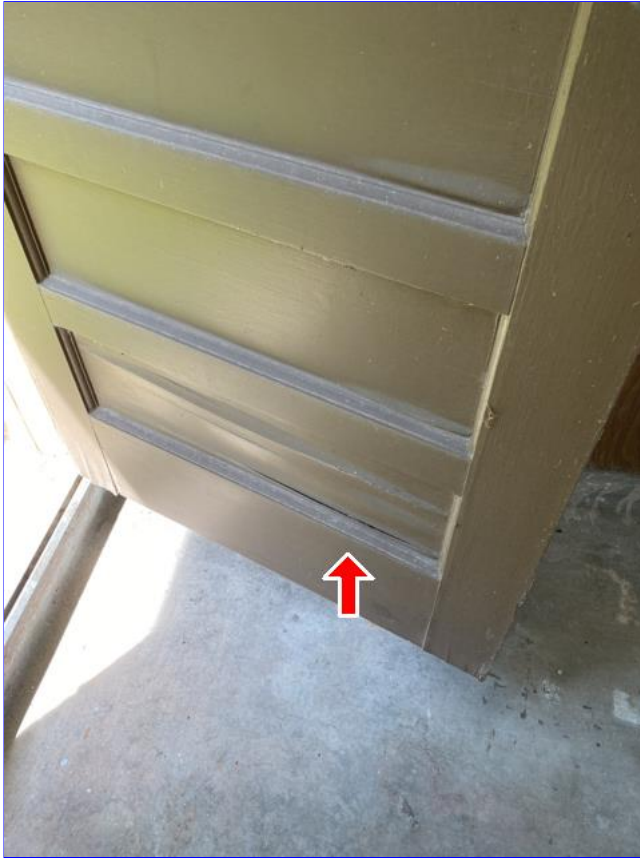
G. Item 1(Picture)

- (1) *All interior and exterior doors were checked for proper latching and proper fit and operation in door frames. Attic and exterior doors were inspected for proper weatherstripping. Installation of safety glass in exterior doors was verified. All exterior doors were inspected for proper operation. Wood frame doors were inspected for wood rot and deterioration. All exterior doors were checked for signs of water penetration.*
- (2) Door between living space and garage is not installed with self-closing hinges / is not fire rated
- (3) Deteriorated wood observed at garage side door

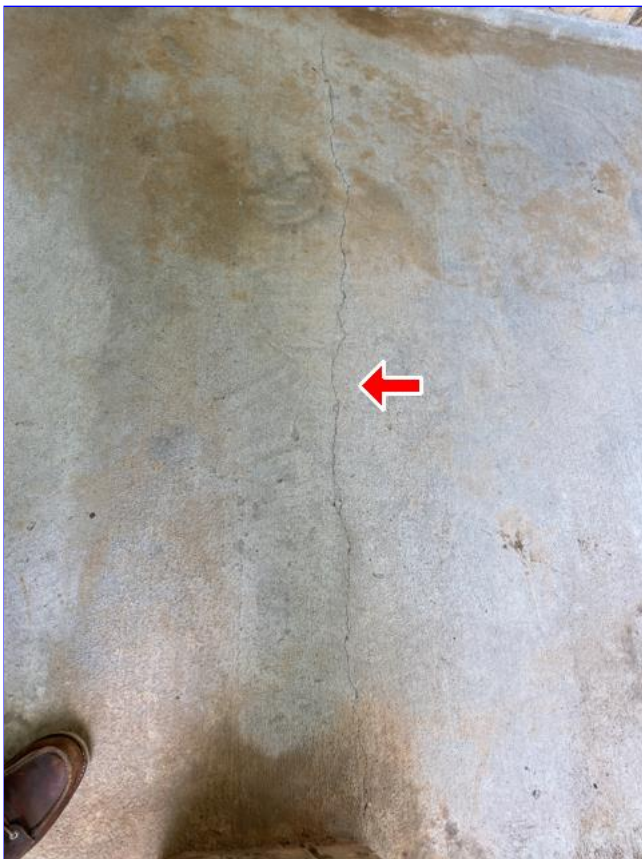
K. Item 1(Picture)

Cracks in concrete patio

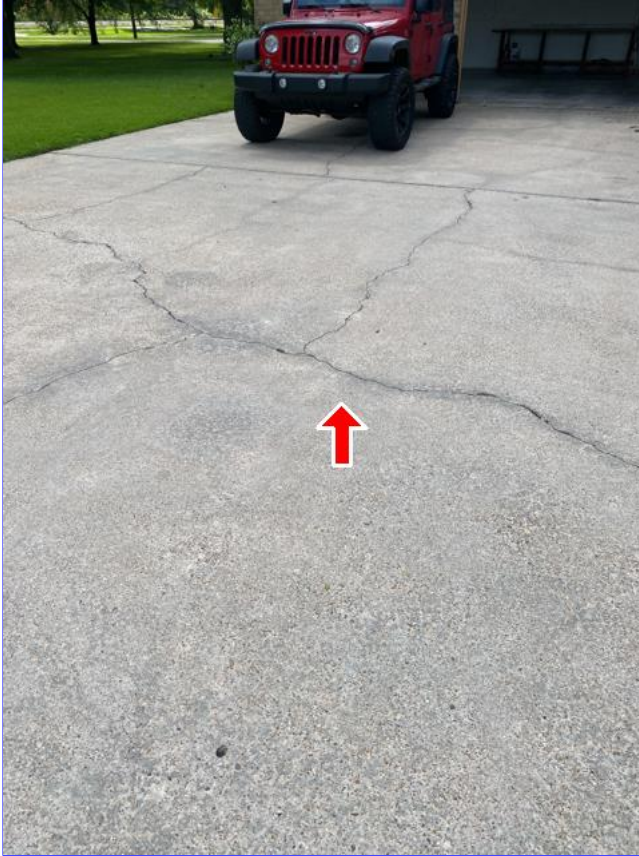
L. Item 1(Picture)

Driveway or sidewalk is cracked at multiple locations

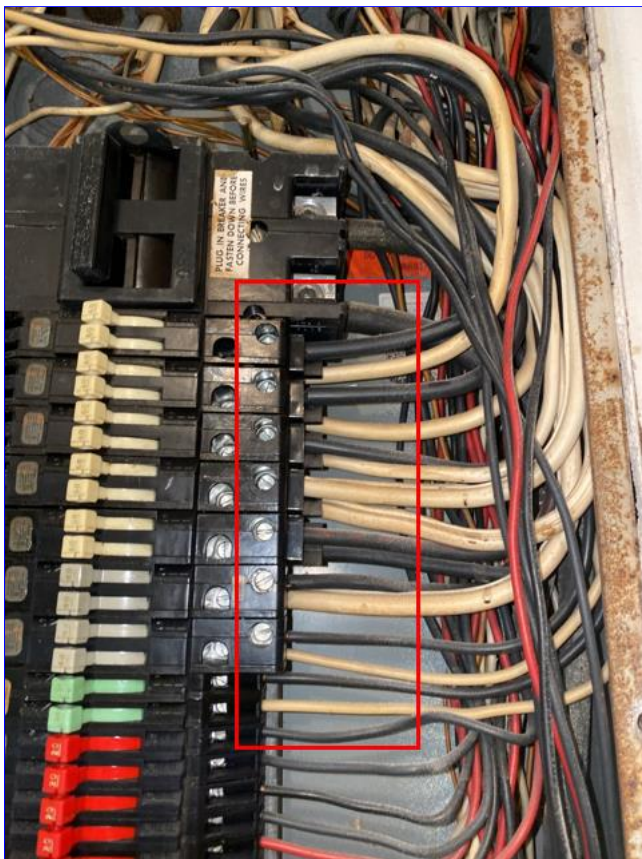
A. Item 3(Picture)

- (2) Screws missing at the front of panel
- (3) White wires are being used as hot leads

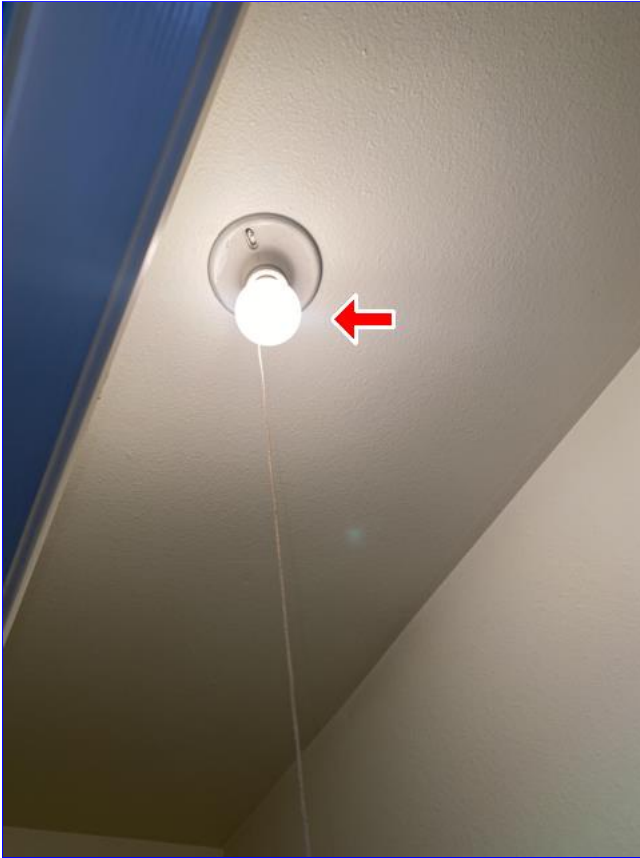
B. Item 1(Picture)

- (2) No GFCI protection at one or more locations - This is considered a recognized safety hazard
- (3) Closet light fixture is not globe protected at bedrooms or hallways

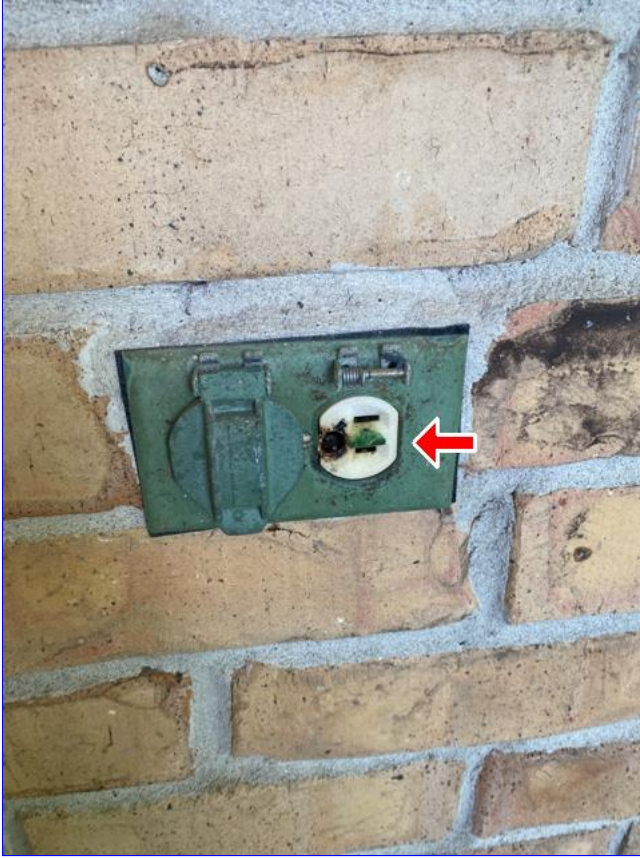
B. Item 2(Picture)

- (4) Unbalanced ceiling fan at master bedroom
- (5) Arcing observed an exterior plug outlet at back patio. Further evaluation recommended

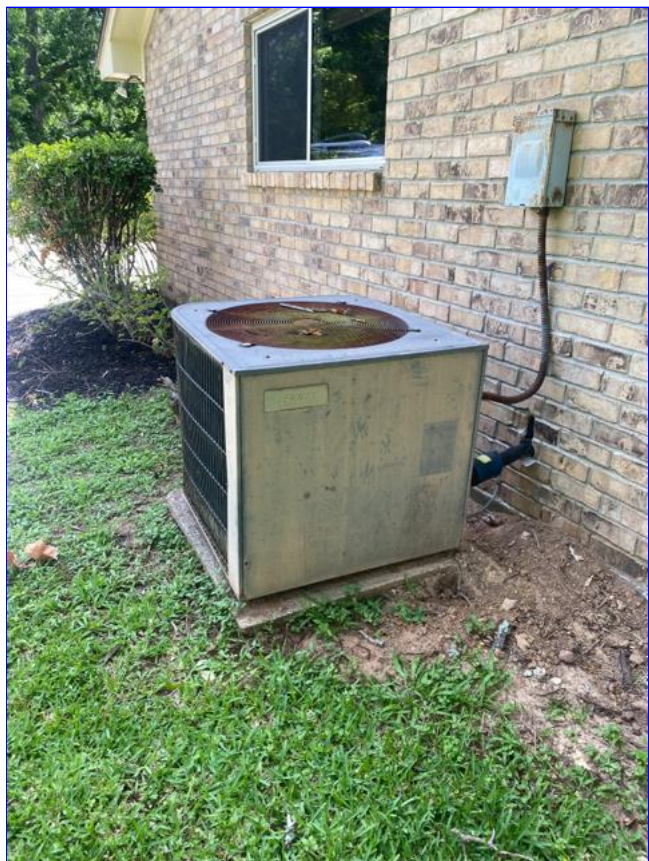
A. Item 7(Picture)

(2) Temperature differential between supply and return air is not within the range of 15-23 degrees fahrenheit- both units

(4) Condenser appears to be at the end of it's economic life at the time of the inspection- both units - Further evaluation recommended

(3) Recommend cleaning, servicing, and further evaluation by a licensed professional

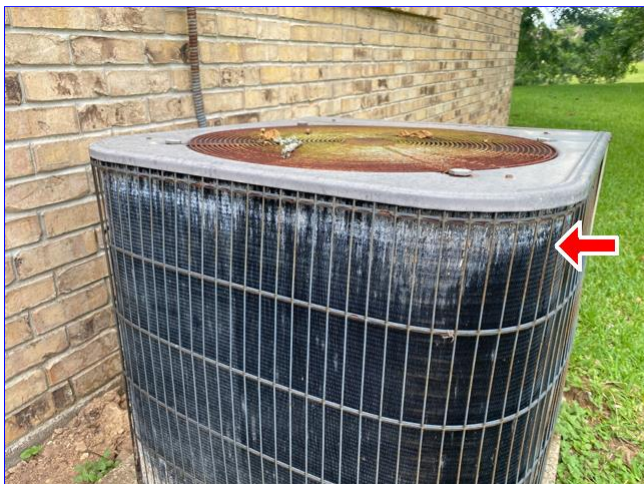
A. Item 8(Picture)

(5) Condenser unit coil fins are damaged

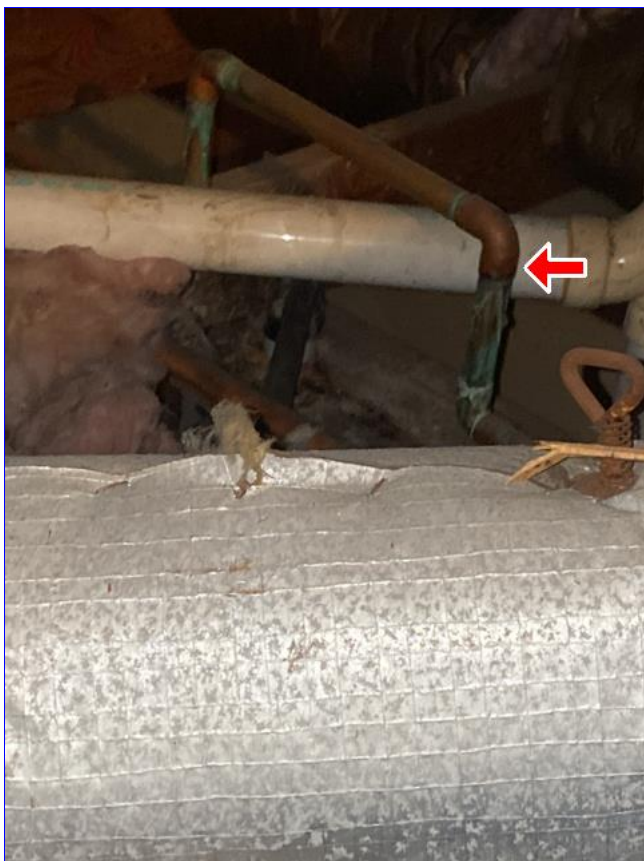
A. Item 9(Picture)

(6) Primary drainline terminates to an open drain - Connection point should be sealed

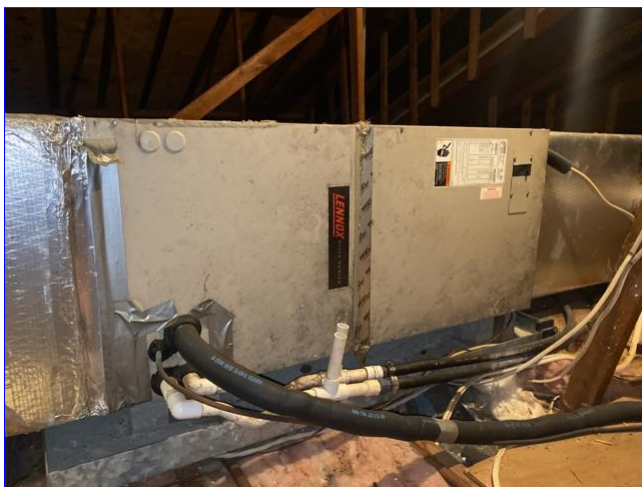
B. Item 5(Picture)

(2) Furnace appears to be at the end of it's economic life - Further evaluation recommended

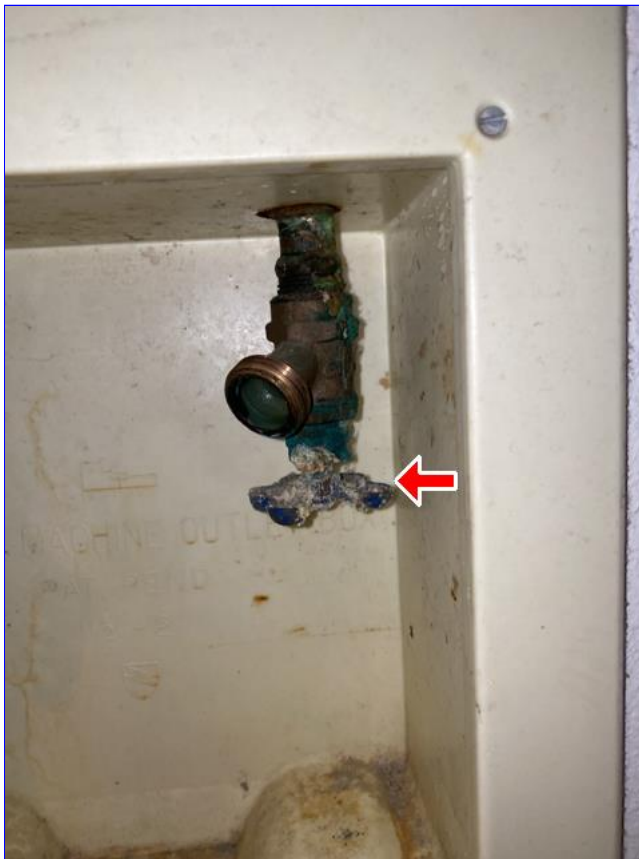
A. Item 1(Picture)

(2) Washing machine supply lines are corroded

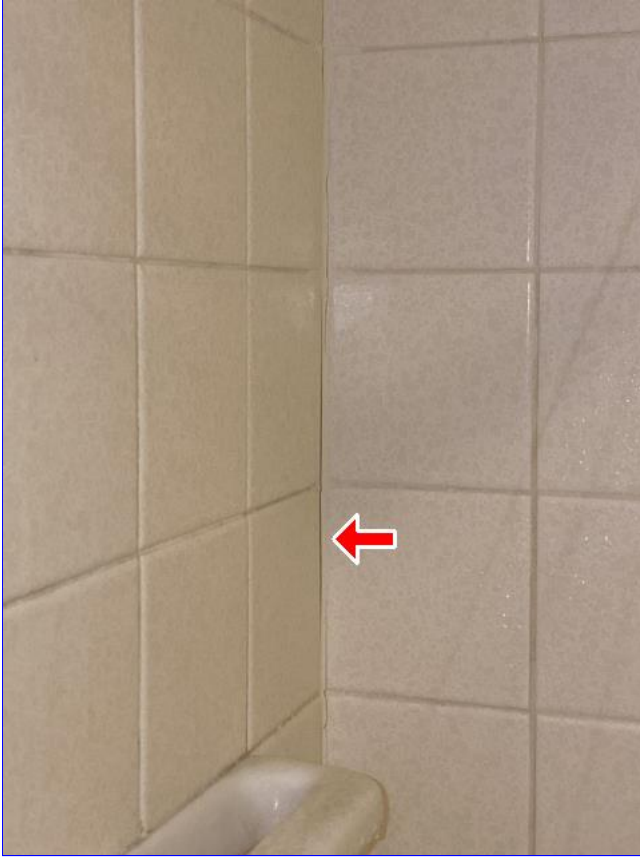
A. Item 2(Picture)

(3) Tub or shower requires caulking at hallway bathroom shower, hallway bathroom tub, master bathroom

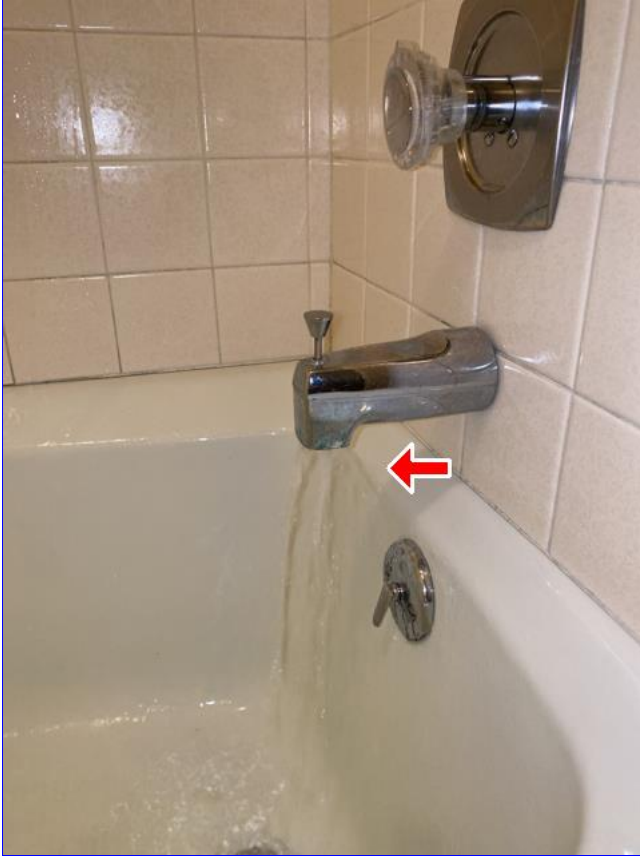
A. Item 5(Picture)

(4) Shower diverter valve not working properly at hallway bathtub, master tub

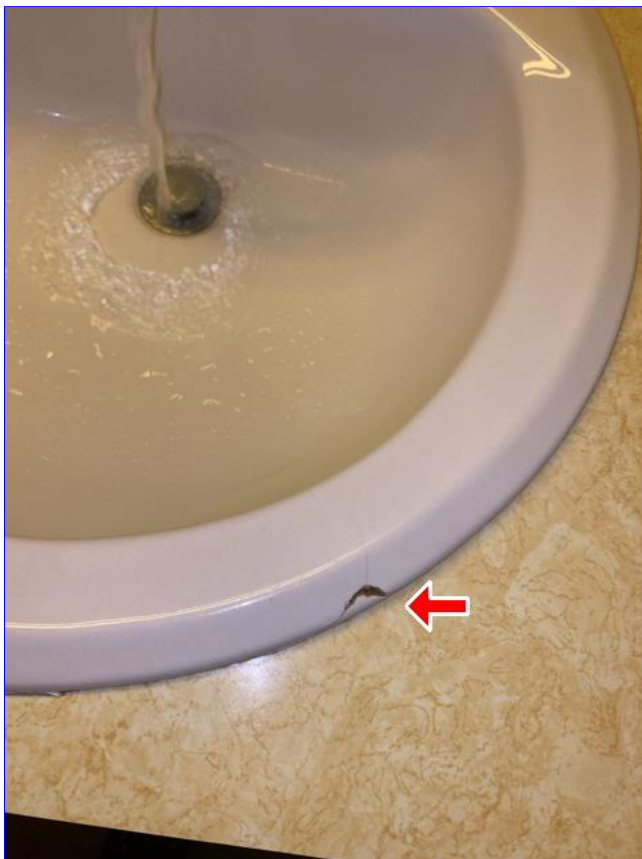
A. Item 6(Picture)

(5) Sink surface is damaged right master sink

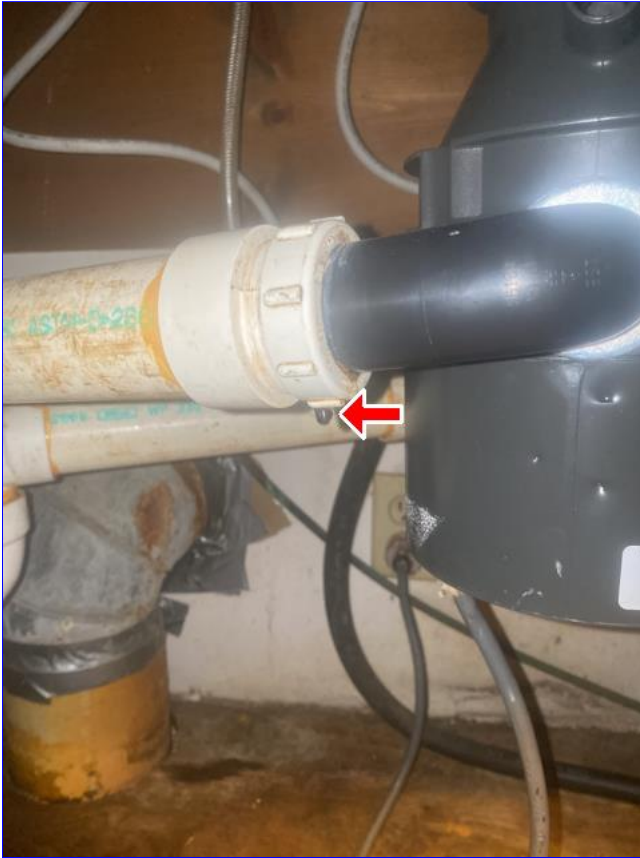
B. Item 1(Picture)

(2) Kitchen sink is actively leaking at drain connection. Repairs needed

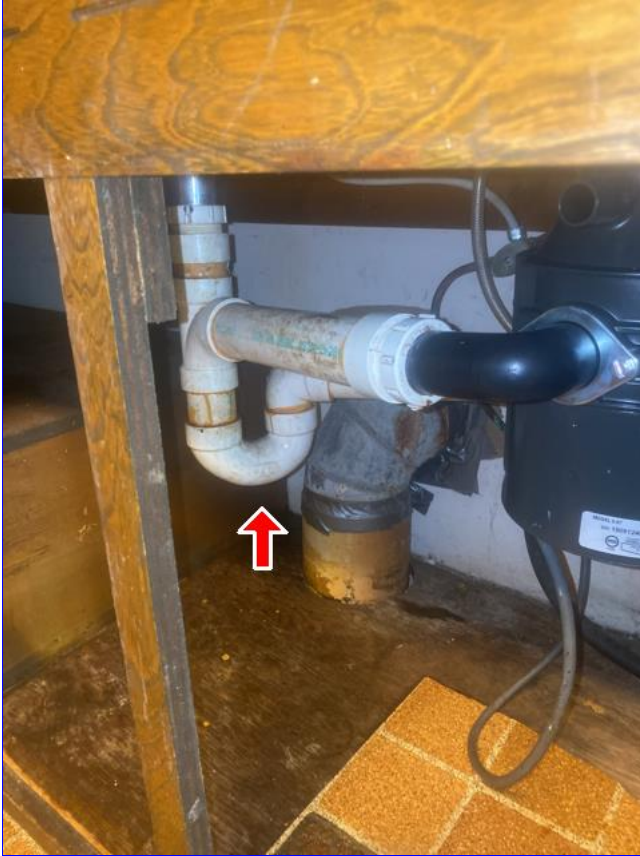
B. Item 2(Picture)

(3) Plumbing is installed incorrectly under kitchen sink. Further evaluation recommended by a licensed professional

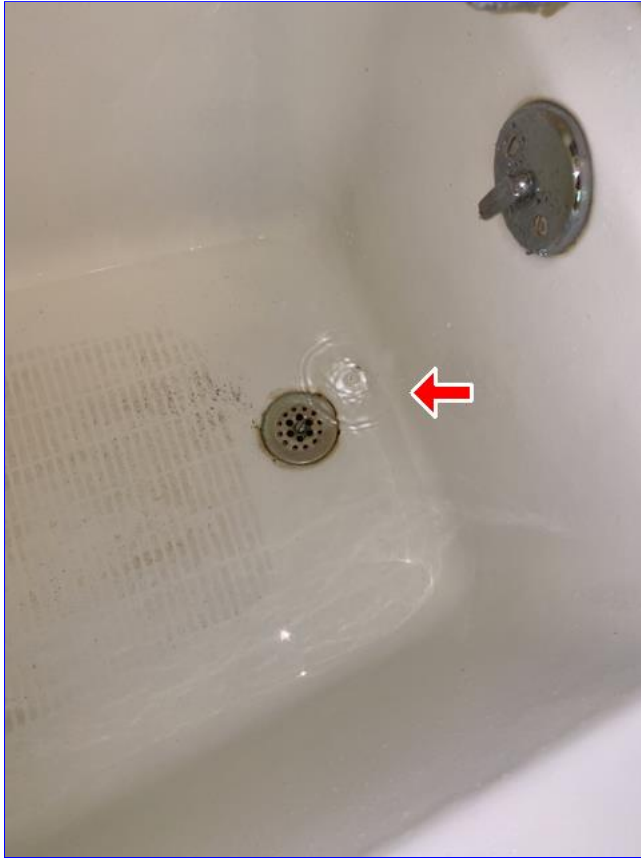
B. Item 3(Picture)

(4) Poor drainage observed at the following locations at master tub

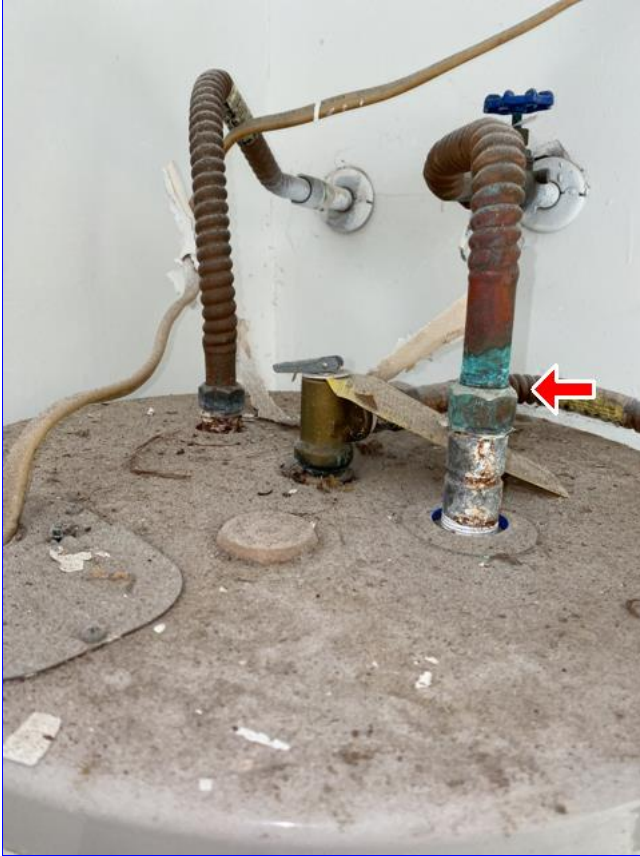
C. Item 4(Picture)

(2) Supply lines are leaking or corroded

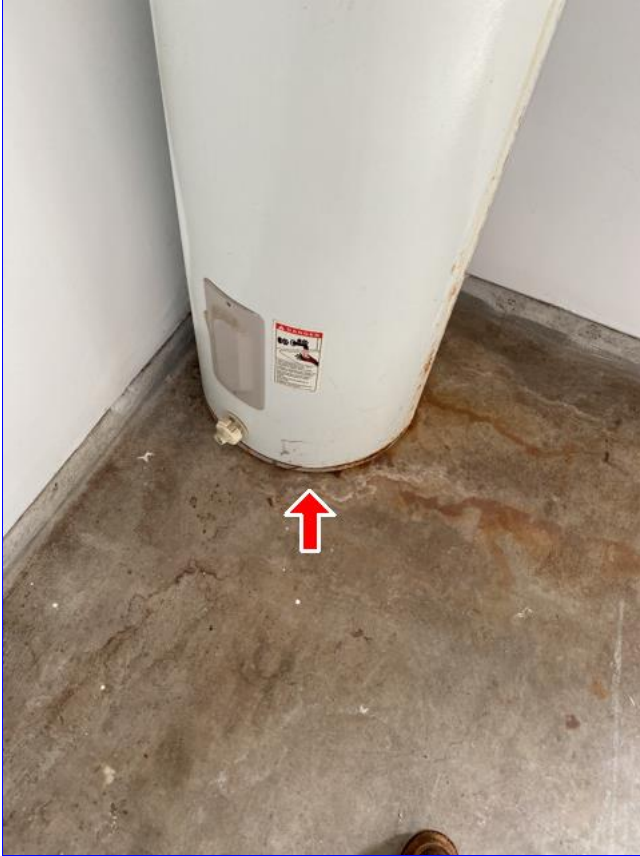
C. Item 5(Picture)

(3) Unit is located in garage or adjacent area and is not elevated so that the ignition source is 18" above the floor

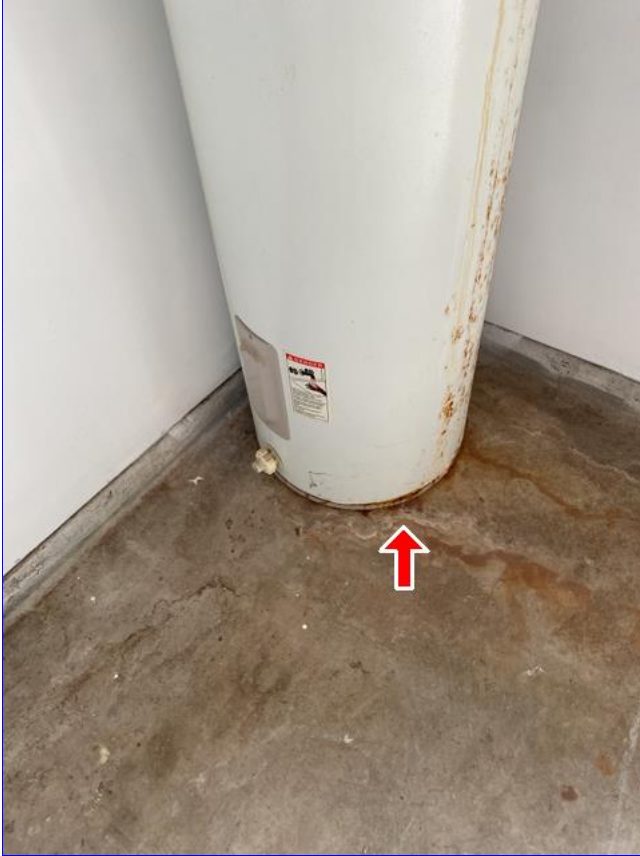
C. Item 6(Picture)

(4) Drain pan line is not plumbed to exterior

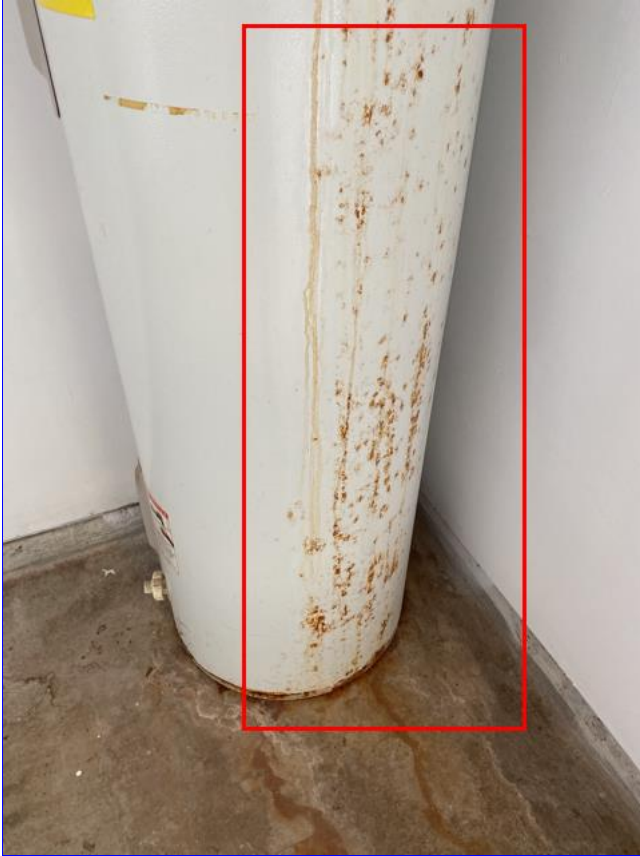
C. Item 7(Picture)

(5) Tank case is corroded

Water heater appears to be at the end of it's economic life at the time of inspection - Further evaluation recommended

(6) Water heater replacement is recommended due to extensive deficiencies

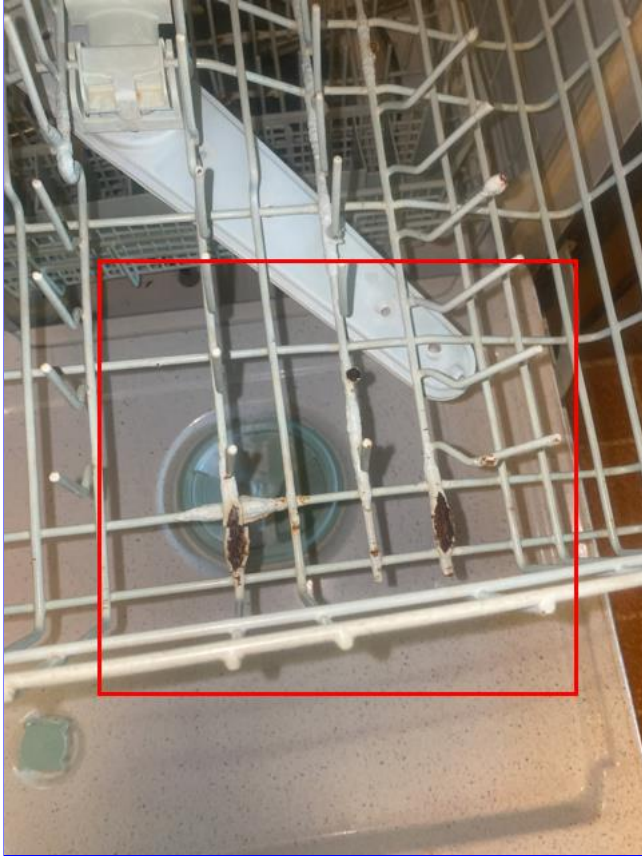
A. Item 2(Picture)

(2) Rust present on interior racks

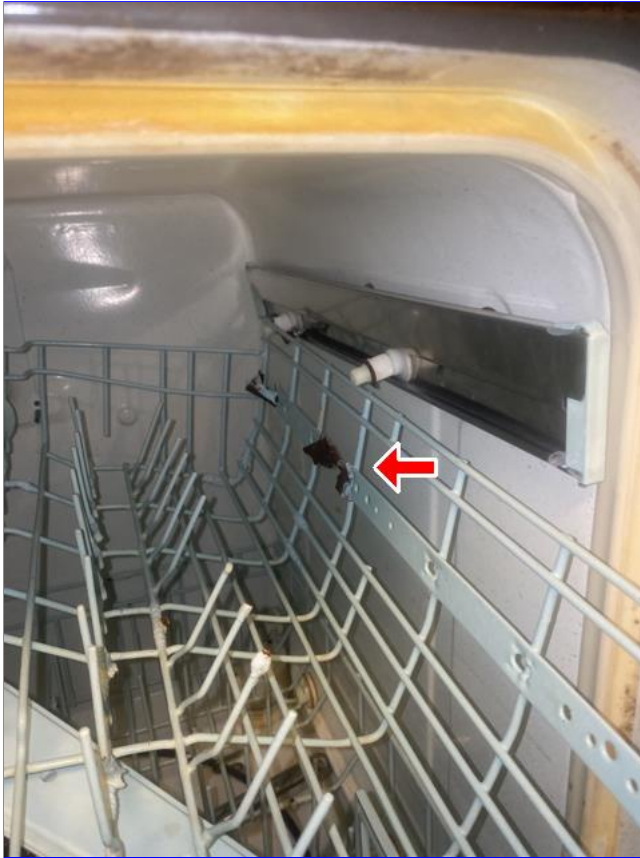
A. Item 3(Picture)

(3) Dishwasher rack is damaged

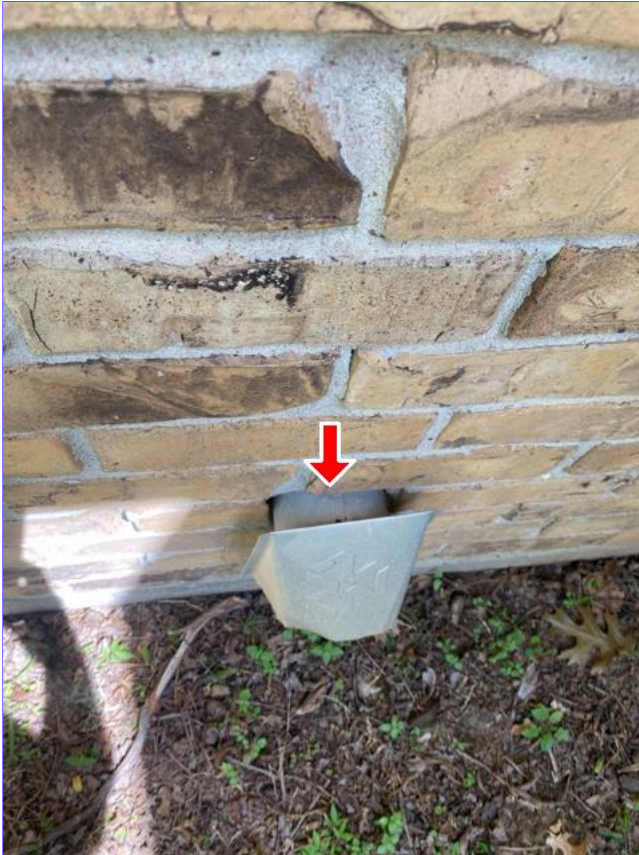
H. Item 1(Picture)

(2) Vent cover is loose, damaged and/or missing
