Acadian Home Inspection LLC

PROPERTY INSPECTION REPORT FORM

Debbie Greene <i>Name of Client</i>	03/10/2023 <i>Date of Inspection</i>
16407 Hexham, Spring, TX 77379 <i>Address of Inspected Property</i>	
Joseph Anthony Seeberger <i>Name of Inspector</i>	24185 <i>TREC License #</i>
Thomas Christopher Duhon <i>Name of Sponsor (if applicable)</i>	24185 <i>TREC License #</i>

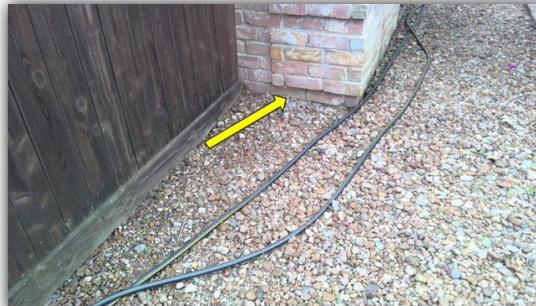
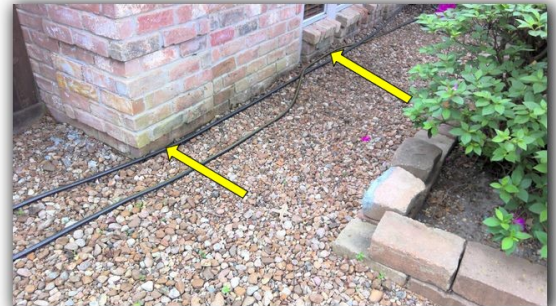
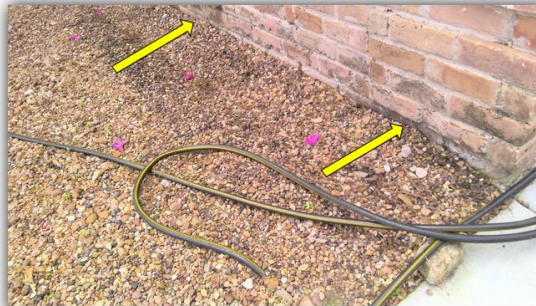
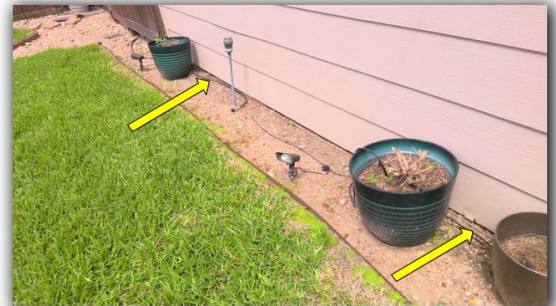
High soil levels noted at all side(s) of home exterior at foundation wall. These conditions could be conducive for moisture back-up or wood destroying insects. Keep soil lowered at least 3-4" below top of slab and graded away from foundation across back and down sides of house and garage to the street for positive drainage. Due to high soil it is recommended buyer have a termite inspection performed by a licensed pest control company.

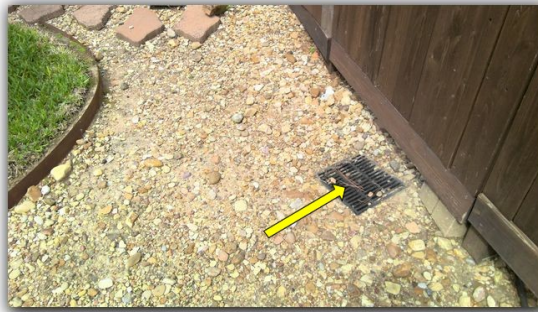
French drains noted at backyard/sides. Recommend buyer monitor these drains to ensure proper drainage during or after rainfall. Properly clean all drain basins and/or properly secure/replace loose or damaged grates, as needed.

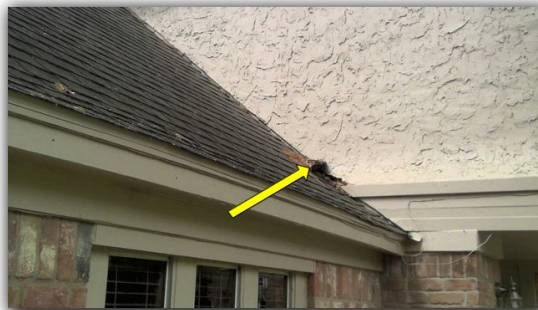
Roof appears to be a 25-30 year class A composition shingle with average wear for age and no leaks noted at this time. Buyer should be aware that roof covering appears to be, at minimum, beyond halfway past its reasonable life expectancy.

As needed, remove debris such as leaves, branches, pine needles....etc from roof covering at exterior to prevent premature aging or excessive wear on composition shingles.

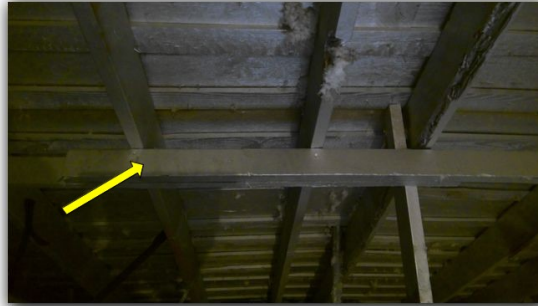
Lateral members of purlin braces are undersized. Lateral framing members should be

same dimensions of rafters being supported. A same size board, secured over existing lateral purlin brace would correct deficiency. Purlin support braces should be properly installed at 4' interval at lateral member. Purlin braces should be position between 45° and 90° at rafter. Purlin braces should be properly installed at all rafters that are in excess of 10'.

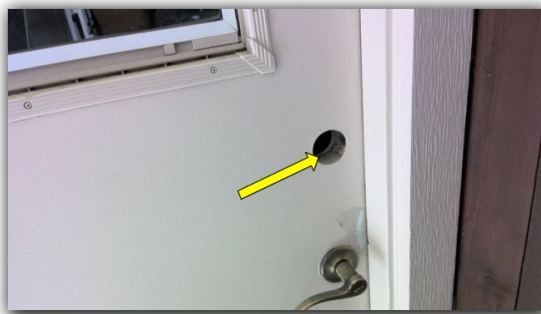
Missing door hardware noted on garage door.

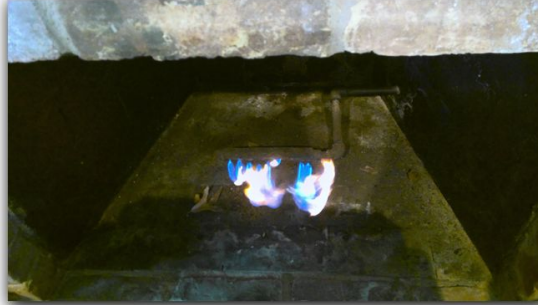
Brick wood burning firebox/flue with gas logs and a brick face and hearth noted.

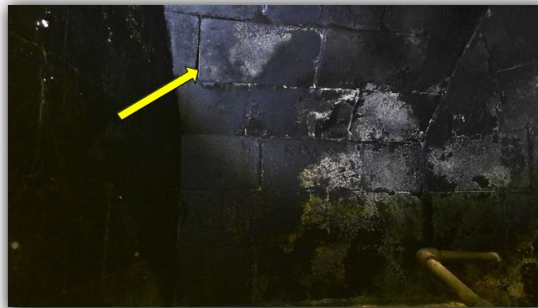
Bricks in back of firebox need pointing up with fire clay.

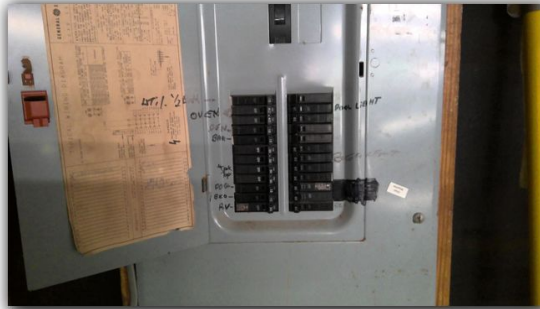
GE 150 amp main panel box with Copper feeder wire noted at garage interior.

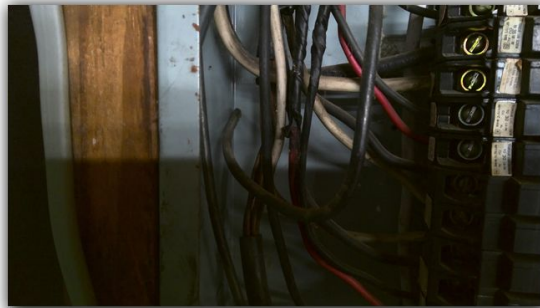
Label white 220V neutral wire red or black to denote neutral wire is being used as a "hot" wire at double pole breaker/disconnect boxes.

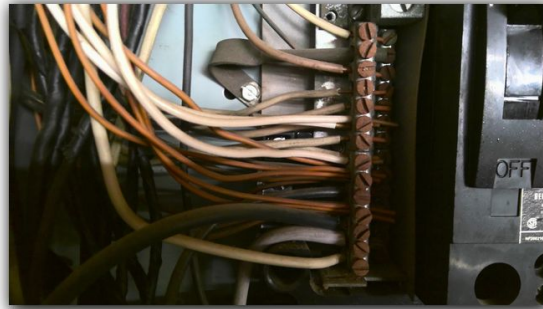
Separate neutral and ground wire to neutral and ground buss bars. Also be sure neutral wire is not double lugged at neutral buss slots and use all open slots at ground buss before double lugging if necessary.

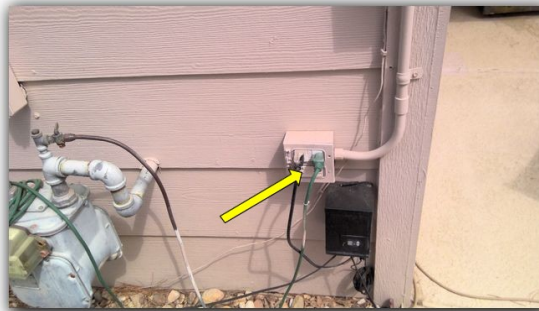
GFCI receptacle noted at garage exterior wall did not trip/reset when tested and is in need of proper replacement.

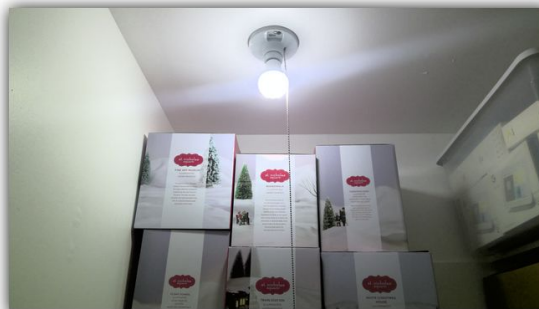
Per current electrical code it is proper to have globes installed at all closet light fixtures, however this was not code when home was built. It is recommended that light fixtures with globes be installed at all closets as needed.

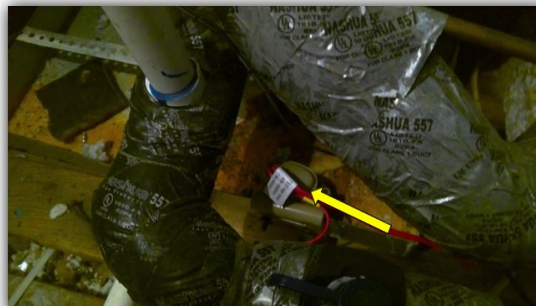
Float switch noted at emergency drain pan. Not tested for function.

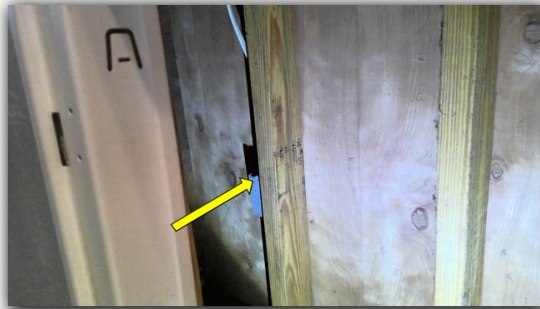
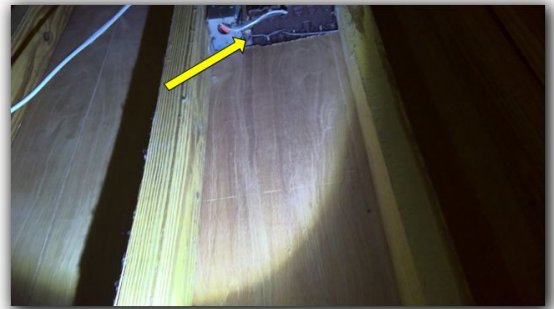
110V wiring/junction box noted at return and is not allowed for fire safety. Fire block under wire with 2 x 4 and/or face over at studs with A/C fiberboard, sheetrock, or other approved fire retardant material to isolate wiring from return.

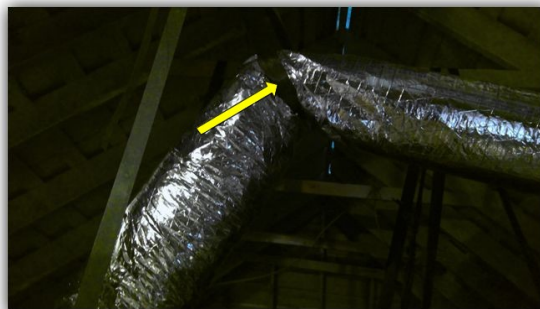
Vent in full bathroom upstairs appears to have very minimal flow. Recommend having a licensed hvac technician evaluate and repair or replace as needed.

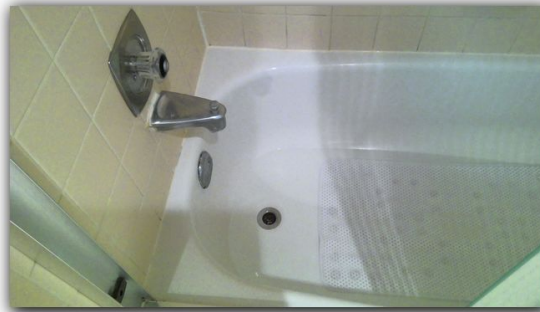
Primary bathtub is noted as slow to drain. Recommend having licensed plumber evaluate and repair or replace as needed.

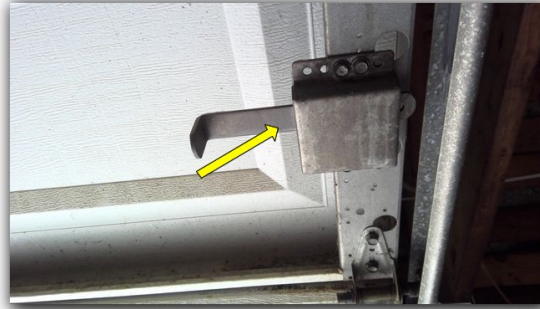
When garage door openers are present, garage door lock throw is to be disengaged.
