CHECK
INDEPENDENT FOUNDATION EVALUATIONS

January 19, 2021

Re: Foundation Evaluation
2327 Briarlee Dr
Houston, TX 77077

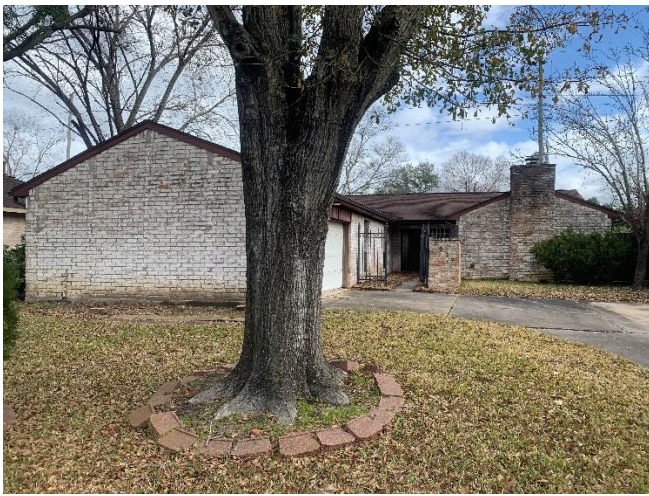
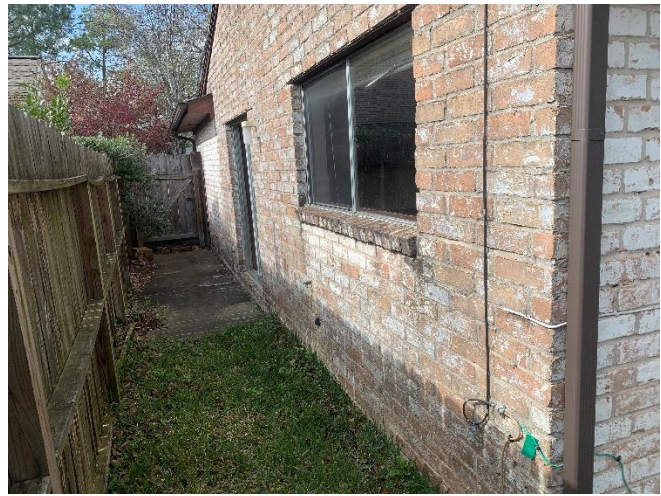
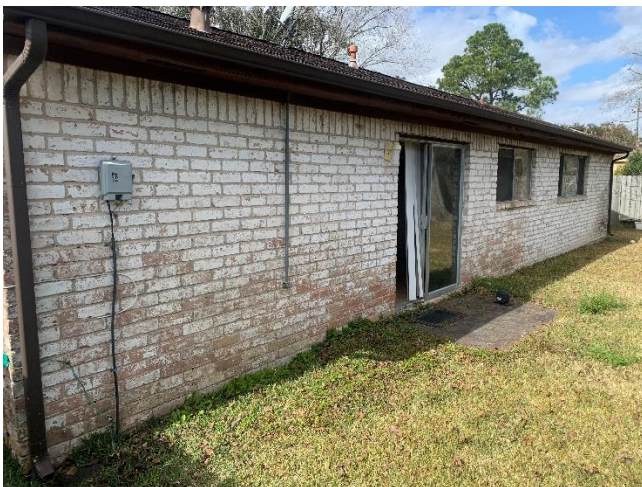
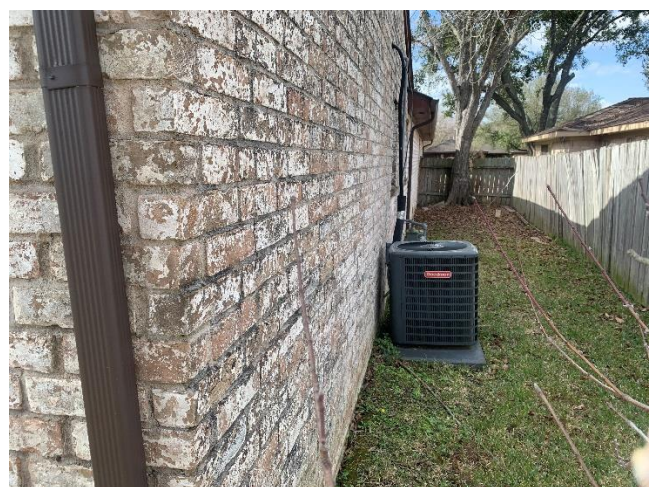
- There are large trees on this and the surrounding properties. (Pictures #1, 2, 3, and 4)
- There are visible cracks in the exterior brick of the home. (Picture #5)
- There are visible cracks in the interior sheetrock of the home. (Picture #6)
- There are visible cracks in the interior slab of the home. (Pictures #7 and 8)
- There are visible cracks in the interior slab of the garage. (Pictures #9 and 10)
