# K GARTNER ENGINEERING

REF: 12322 Burgoyne  
Houston, TX 77077

# FOUNDATION INSPECTION

RELATIVE ELEVATIONS - 03 JAN 2023

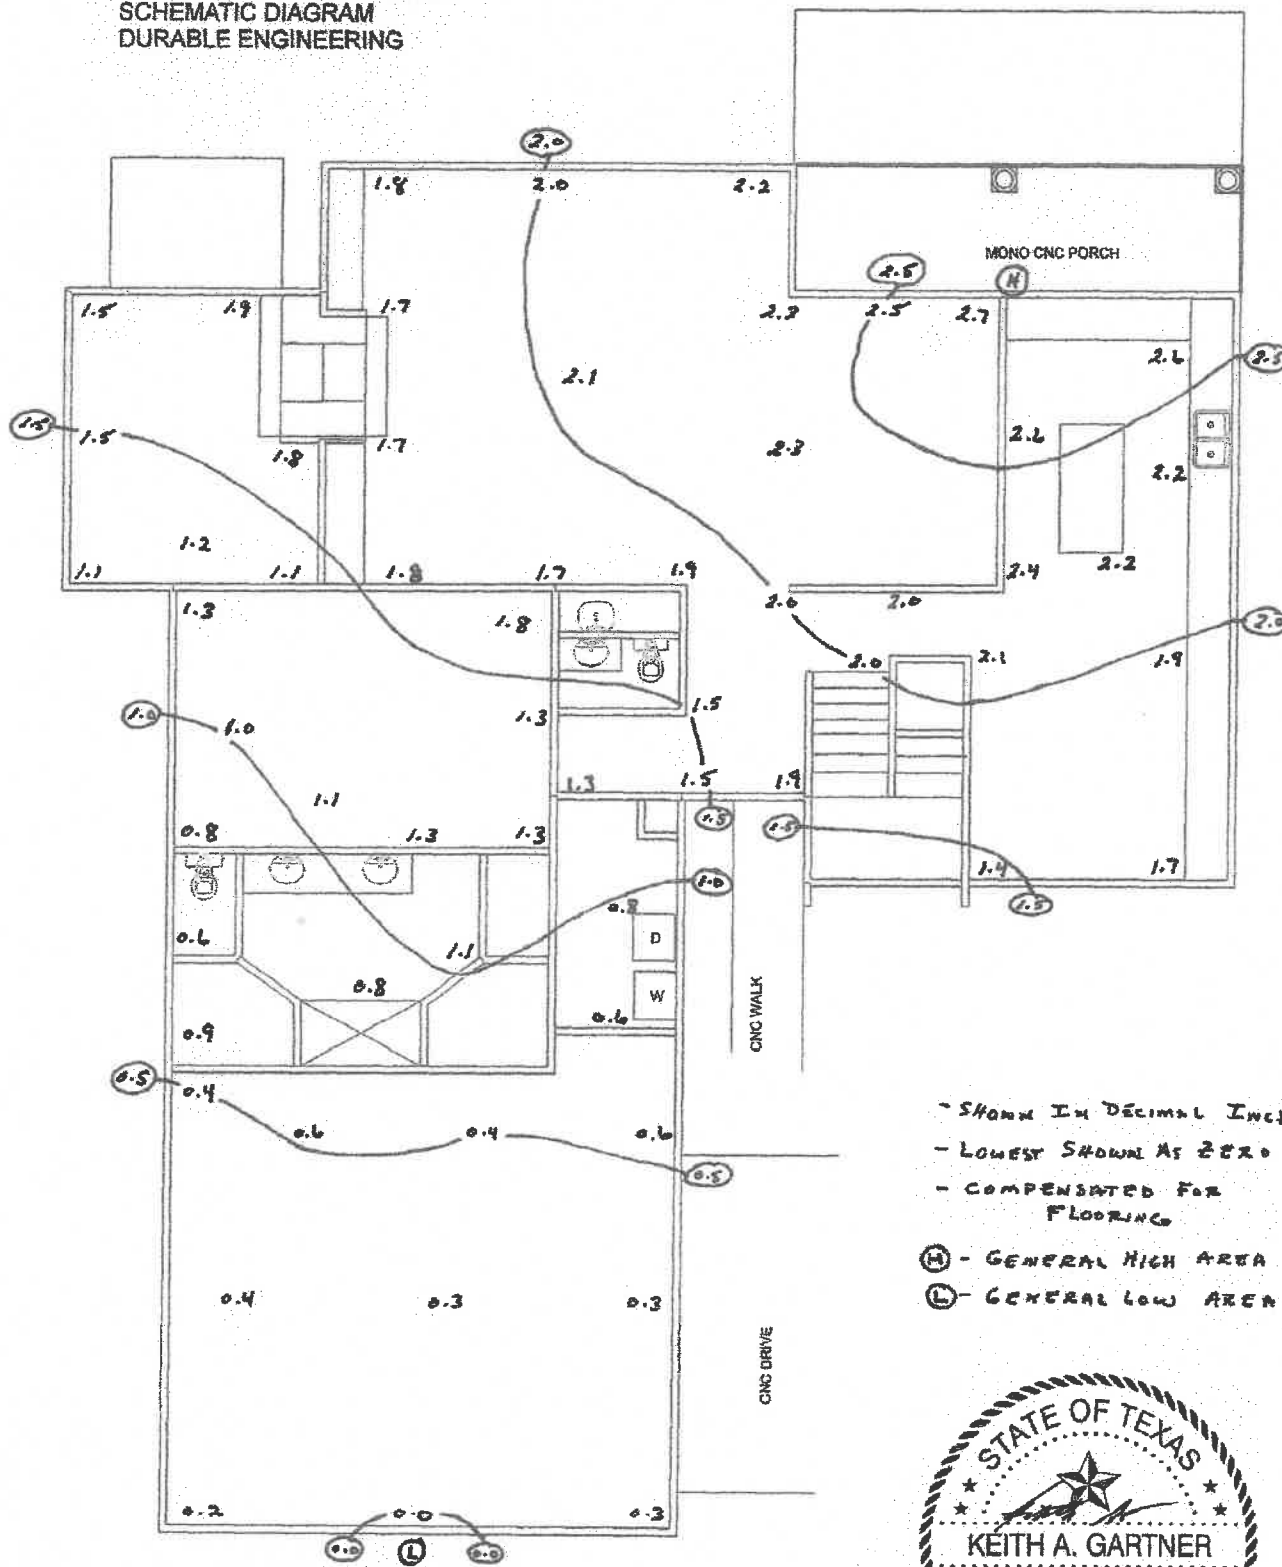
The normalized elevation readings taken in the site visit are shown in the attached diagram. The mapped elevations reveal the right rear corner of the dwelling is generally high and the low area is

located at the front wall of the garage. Between the high point and the low point, the floor levels differ approximately 2.7 inches.

The elevations at the perimeter of the garage are generally lower than the remainder of the dwelling, which is a typical condition for a foundation of this configuration. The high elevations at the rear right corner are fairly localized and appear to be due to heaving at that corner, possibly due to the installation of the pool and associated patio at that area allowing the soils below the foundation to retain more moisture than at the sides and front.

Of interest are the elevations within the garage, which are lower than the dwelling, but are fairly level throughout the garage. The crack on the left side brick wall of the garage indicates settlement towards the passage door. However, the repaired cracks on that side would indicate settlement towards the front corner of the garage. This condition may be due to the front corner having originally settled to the front, then experiencing heave, causing the crack to open towards the door, giving the appearance there is settlement towards the passage door.

Analysis of the floor elevations show the floor slopes through the dwelling to be within acceptable tolerances for a structure of this age. The elevations at the utility room just slightly exceed the tolerance, but the lack of damages in that immediate area would indicate the foundation to be stable.

It should also be noted the elevations at the right side of the kitchen show a downward slope from the rear corner towards the front corner. However, elevation readings of the kitchen cabinets along this wall show the countertops to be level. This would indicate the foundation had experienced slight movement, in the form of heaving at the rear corner, prior to the remodel of the kitchen. With the cabinets being level and the lack of other damages in the kitchen, the apparent heave at the rear corner should be considered as permanent heave.
