PREMIER INSPECTIONS REPORT

22 N Flamingo St La Marque, TX 77568

PROPERTY INSPECTION REPORT FORM

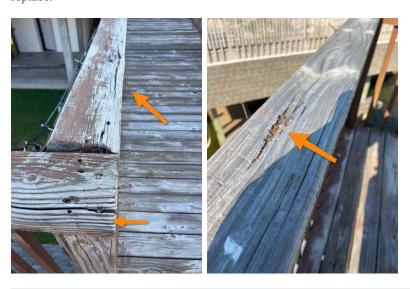
One or more deck boards are showing signs of rot and/or spongy. Recommend a qualified deck contractor replace.

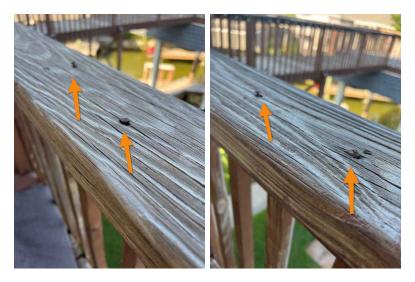
2: Deck - Nails Exposed

One or more nails were observed to be exposed. Recommend nails be reset.

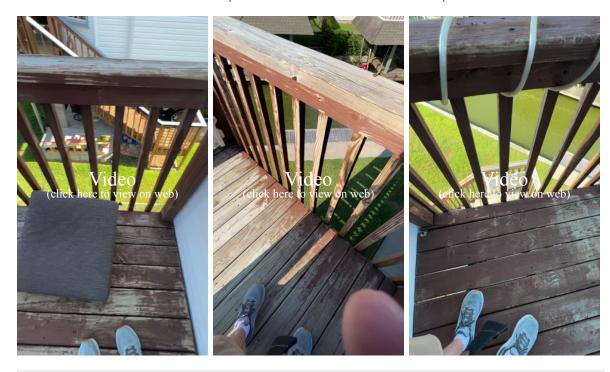
3: Deck - Unstable Support

One of more areas of the deck support appears unstable. This could cause a safety hazard and further deterioration of the deck. Recommend qualified deck contractor evaluate and repair.

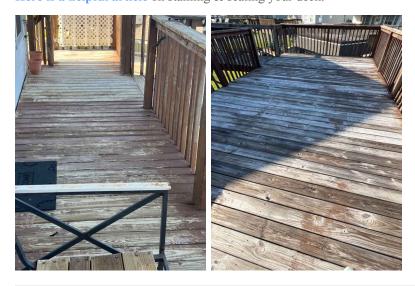
4: Deck - Water Sealant Needed

Deck is showing signs of weathering and/or water damage. Recommend sanding rough boards on the deck, replacing damaged boards and that water sealant/weatherproofing be applied.

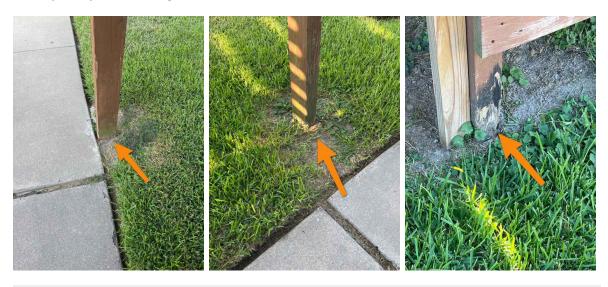
There is wood to ground contact in one or more areas of the property, this is considered a conducive condition that could allow wood destroying insects to gain access to the structure without being seen. We recommend that these areas be treated regularly by a pest control company as often as they recommended, which would be every 5-10 years on average.

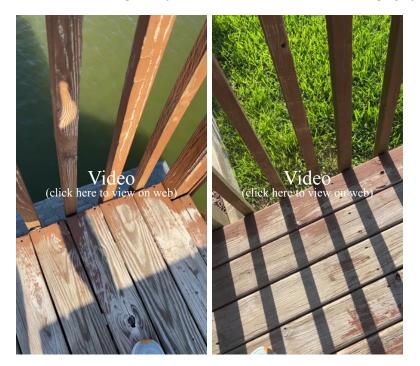
10: Loose balusters

Loose balusters can give way and allow someone to fall thru causing injury

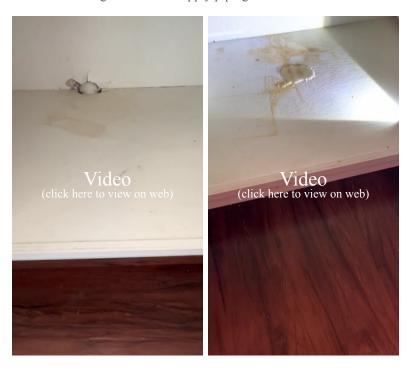
There is a leaking noted at the supply piping in one or more areas of this home.
